# **Impact Tests of Full-Tempered Glass Windshield Panels**

**TECHNICAL DEVELOPMENT REPORT NO. 71**

**CIVIL AERONAUTICS ADMINISTRATION  
TECHNICAL DEVELOPMENT CENTER  
INDIANAPOLIS, INDIANA**

October 1958

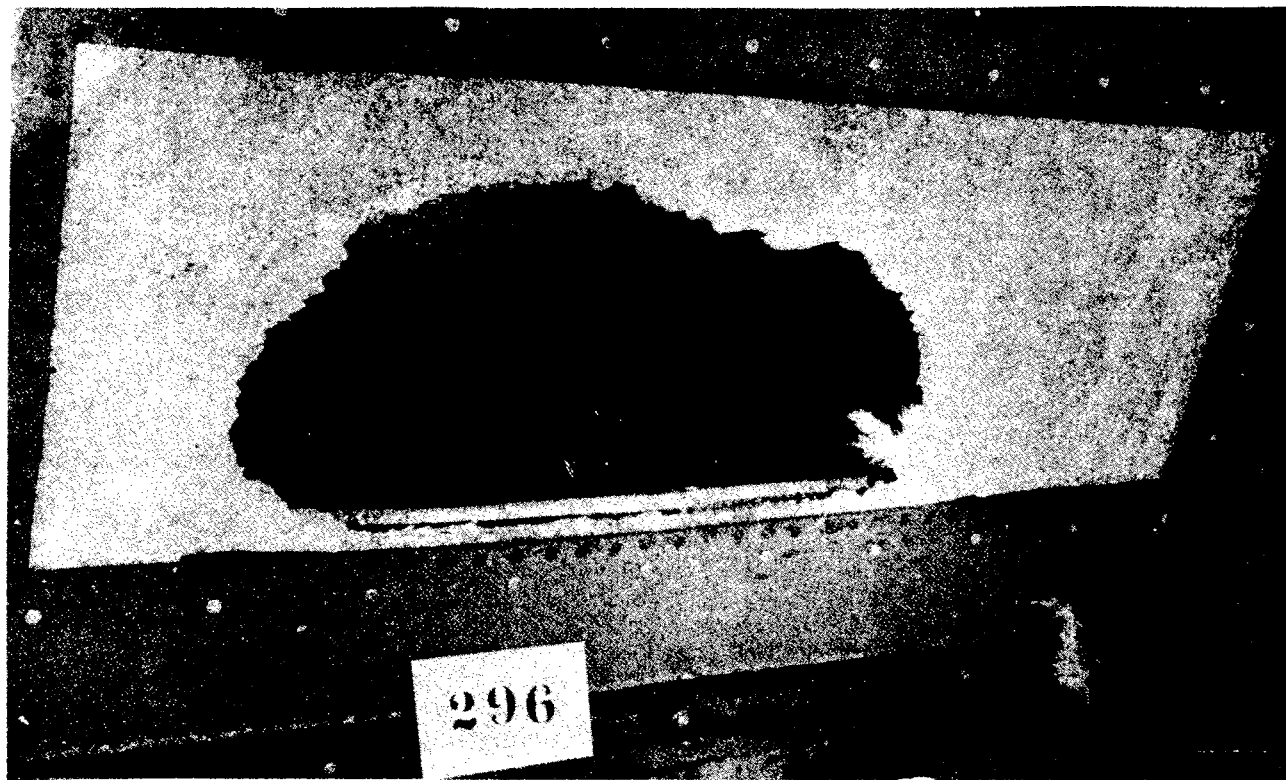
Fig. 4 Fracture of Full-Tempered Glass Panel of 3/4-Inch Thickness  
From Impact of 4-Pound Carcass at 260 MPH

The type of glass fracture which occurs is typical of that obtained in full-tempered glass, as shown in Fig. 4. Complete disintegration of the panel results. The main portion of the glass is broken into approximately cubical blocks, but many fine sharp splinters are produced.
