TECHNICAL DEVELOPMENT REPORT NO. 397

**DEVELOPMENT OF CRASH-RESISTANT
AIRCRAFT FLAMMABLE FLUID SYSTEMS**

**PART I
DELINEATION OF THE PROBLEM**

**FEDERAL AVIATION AGENCY
TECHNICAL DEVELOPMENT CENTER
INDIANAPOLIS, INDIANA**

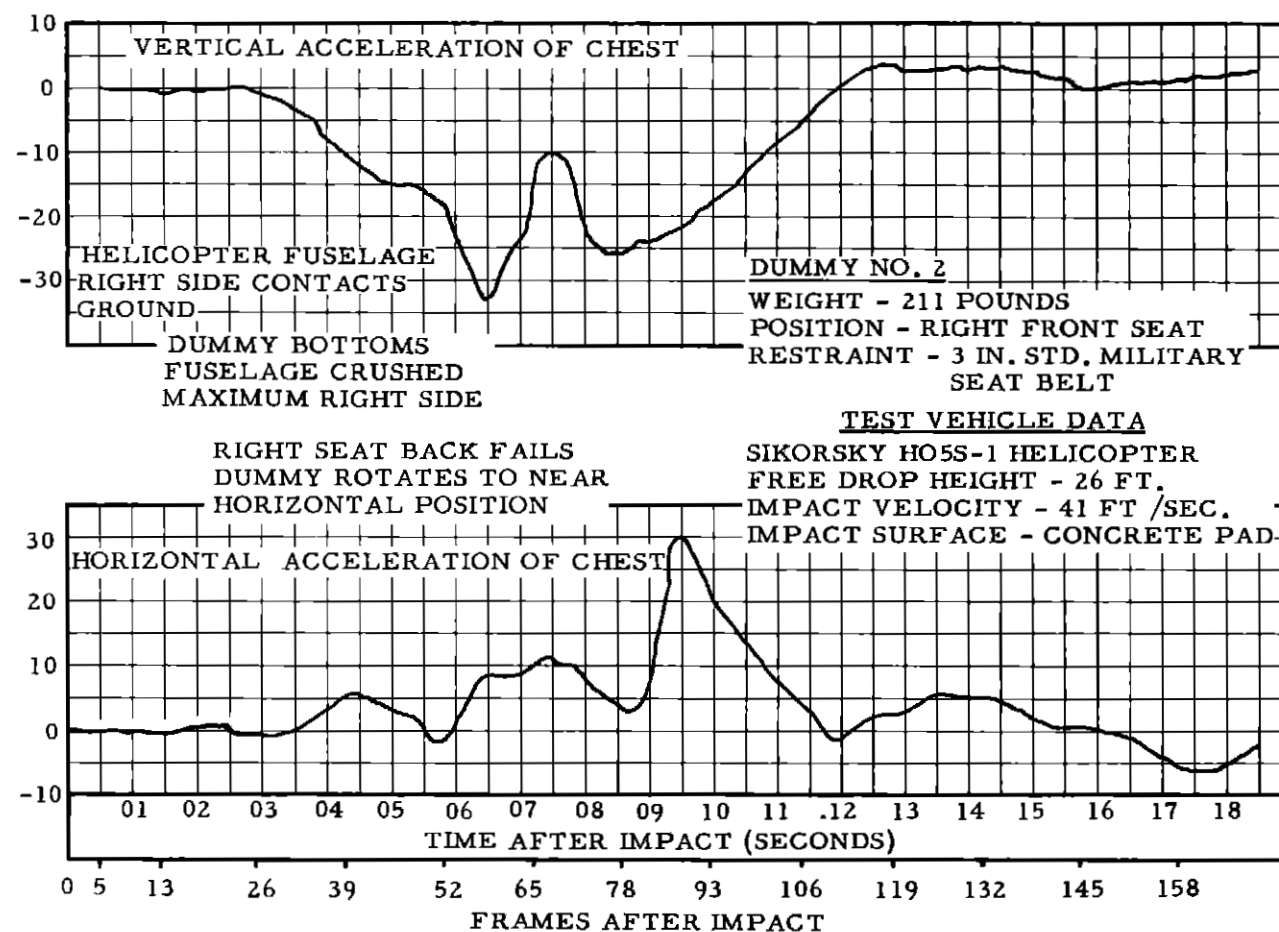
FIG. 6B ANTHROPOMORPHIC DUMMY NO. 2 ACCELERATIONS EXPERIENCED DURING HO5S-1 DROP CRASH TEST NO. 2

In an effort to appraise the meaning of these structural crash-load factors in terms of human survival, load factors experienced by two anthropomorphic dummies while seated in the helicopters of Tests Nos. 2 and 3 were recorded. The load factors suffered by the dummies are presented in Table II and the time history of the pertinent accelerations are shown in Figs. 6A and 6B.

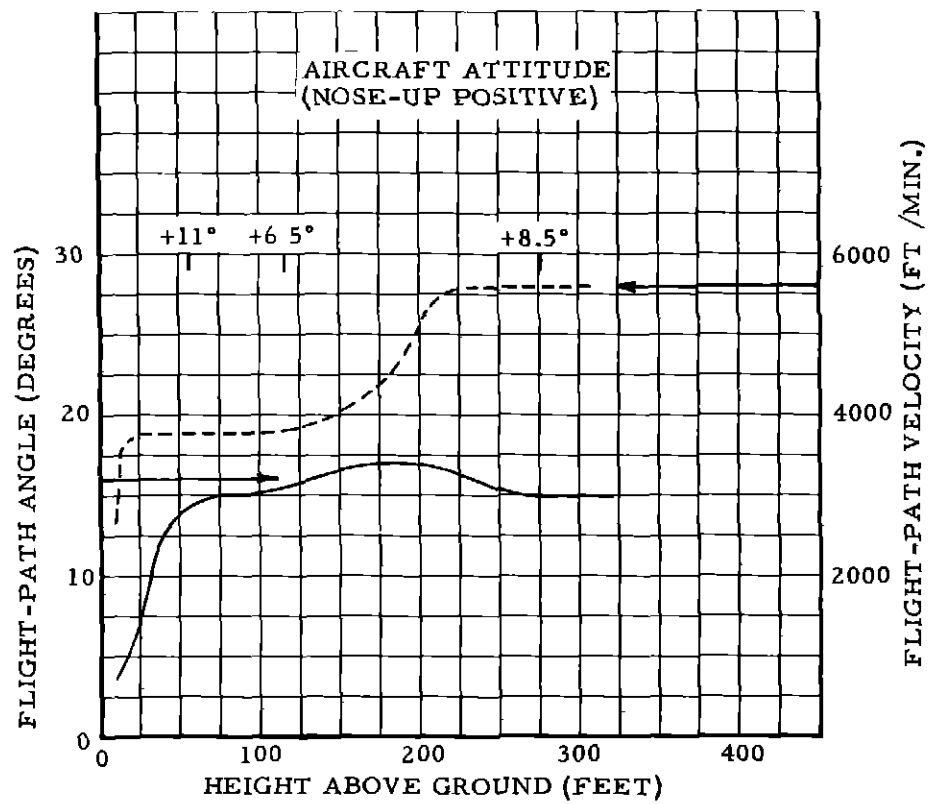
FIG 10 VERTOL H-21 VELOCITY, FLIGHT-PATH ANGLE, AND AIRCRAFT ATTITUDE VERSUS HEIGHT ABOVE GROUND FOR A NORMAL AUTOROTATIVE LANDING

In an effort to select a reasonable crash configuration which would simulate this type of crash, some data on actual flight-path velocities, flight-path angles, and fuselage attitudes versus height above the ground of four different model helicopters making normal autorotative landings to a panel were obtained by means of a Fairchild flight analyzer camera. The data obtained are shown in Figs. 7, 8, 9, and 10. A summary of information derived from these figures for an arbitrarily assumed height of 50 feet above the ground is presented in Table V. From this table it may be seen that the flight-path angles, fuselage attitudes, and velocities along the flight path vary appreciably among the four helicopters involved. These angles and velocities do not represent the only ones which can be experienced by these helicopters during autorotative landings. In any case it is believed that the angles and velocities associated with a point 50 feet above the ground can be used to establish exploratory test conditions for these helicopters to be crash tested for the explicit purpose of simulating this type of crash. The vertical drop-crash test condition will simulate the type of accident in which impact angles are high.
