REPAIR OF EPOXY-COATED REINFORCEMENT

Research Report No. 1265-5

STRUCTURAL INTEGRITY OF EPOXY-COATED BARS

Texas Department of Transportation

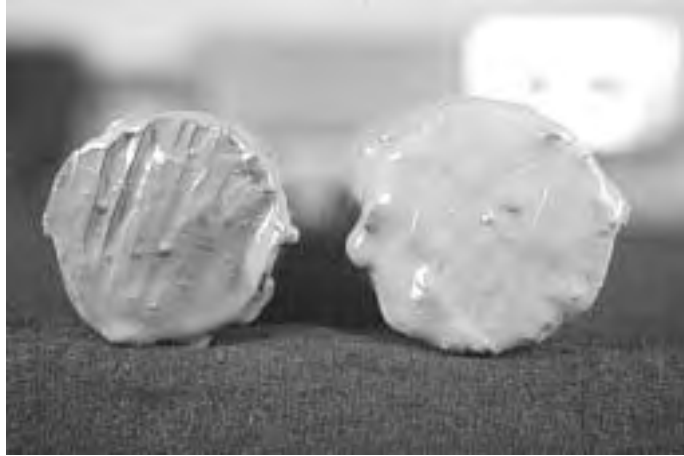
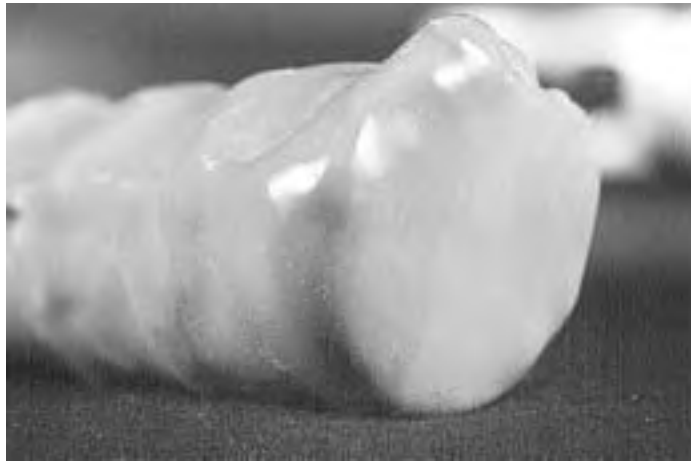
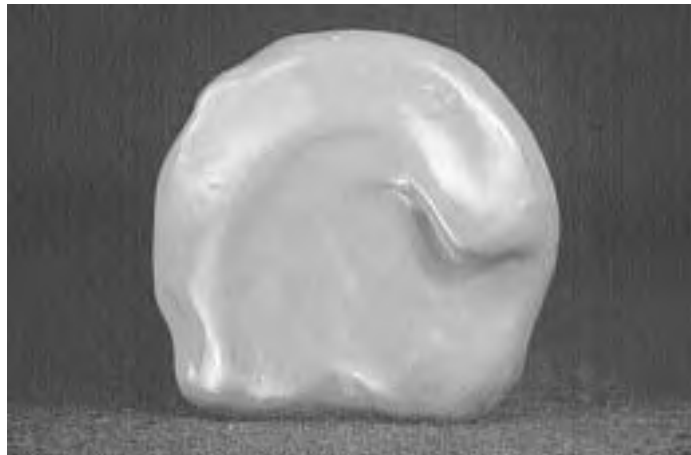
Figure 2.2 Specimens patched with different patching materials.

(a) Patching materials *A* (left specimen) and *B* (right specimen).

(b) Patching material *C*.

(c) Epoxy material *D*.

General properties of all four epoxy materials are included in Appendix A. Figure 2.2 shows bar ends patched with materials *A*, *B*, *C*, and *D*.

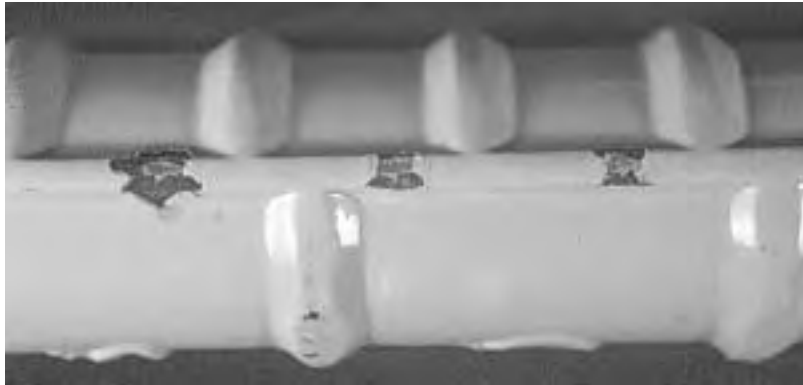
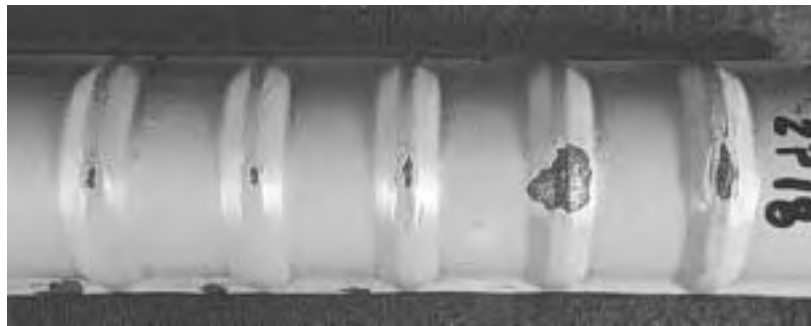
Figure 2.4 Damaged areas (II) on bar deformations.

(a) Coating damage on longitudinal rib.

(b) Coating damage on transverse ribs.

II-Areas on Bar Deformations: Intentional damage of irregular shape was created by subjecting ECR to different types of action, such as dragging, dropping, or hammering, which resulted in damage mainly at bar ribs (both transverse and longitudinal). In many instances, damaged areas were enlarged by chipping with a utility knife. This type of coating damage is similar to that produced in the field. Size of damaged areas ranged from barely visible areas of less than 1 mm² up to large areas (90 mm²). The average damaged area was 13.09 mm² and the median value was 2 mm². Figure 2.4 illustrates two typical samples with irregular shaped coating damage on bar ribs.

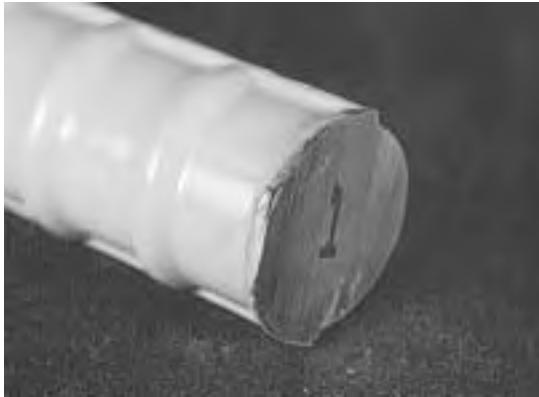
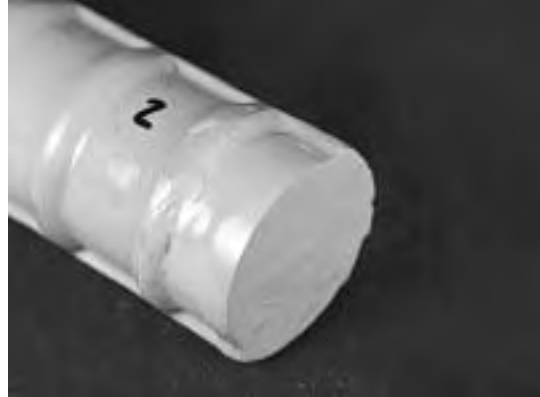
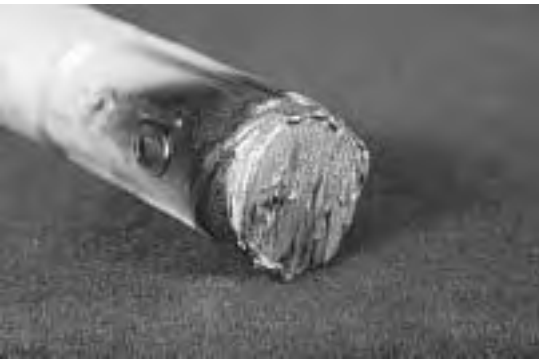
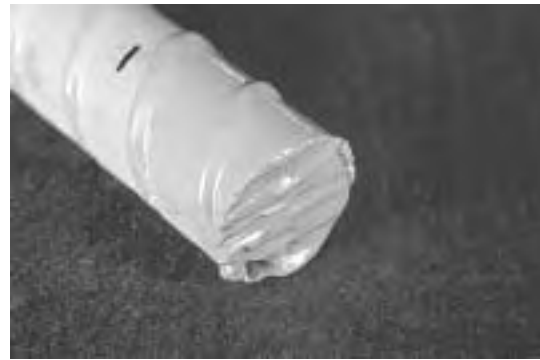
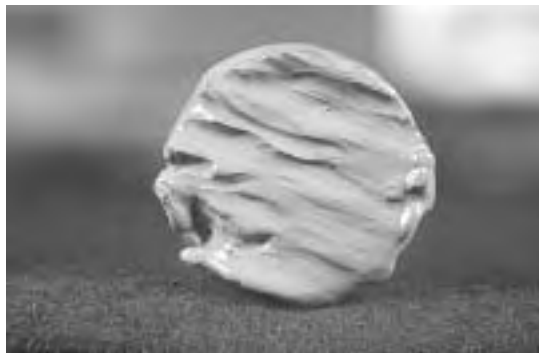
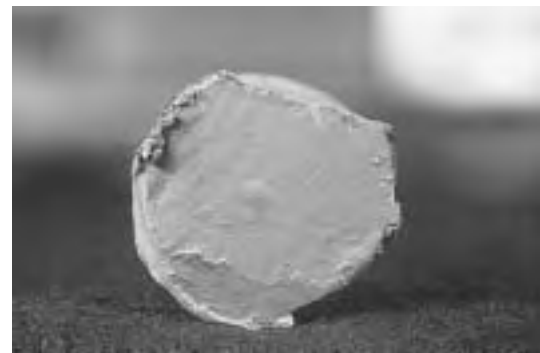
Figure 2.5 Condition of cut ends and patches (III–V).

(a) Saw-cut bar end (II).

(b) Patched bar end (saw-cut)(II).

(c) Torch-cut bar end (IV).

(d) Patched bar end (torch-cut) (IV).

(e) Patched bar end (torch-cut) (IV).

(f) Shear-cut bar end patched by coating applicator (V).

IV-Flame-Cut Bar Ends: Epoxy coated bar samples were cut with a torch and bar ends were patched. Samples with flame-cut ends were about twice as long as those samples with saw-cut ends because the torch cutting operation burned a significant area of epoxy coating. Although flame cutting epoxy coated rebars is not recommended, it is done in the field and it was felt important to investigate the possible repercussions of such practice. Figure 2.5 (c, d, e) shows samples with torch cut ends.

V-As-Received, Patched, Shear-Cut Bar Ends: Samples in which touching up of bar ends was done by the coating applicator. The use of these samples allowed comparison of the performance of samples patched by the coating applicator against that of samples patched in the laboratory. A bar end patched by the coating applicator is shown in Figure 2.5 (f).

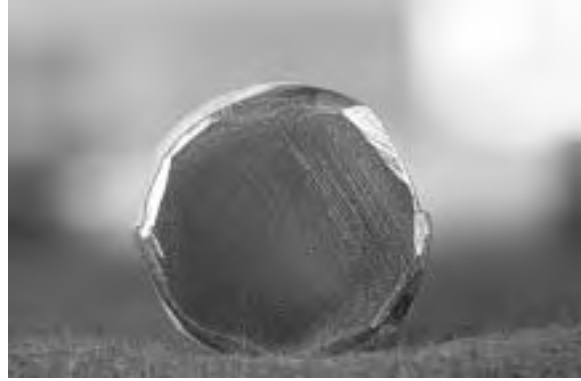
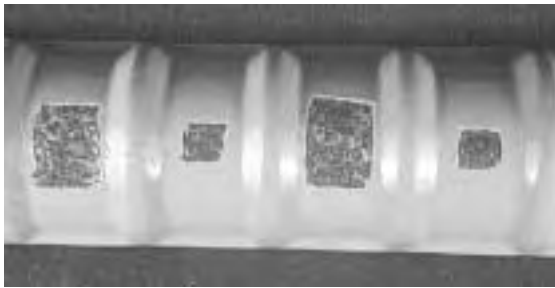
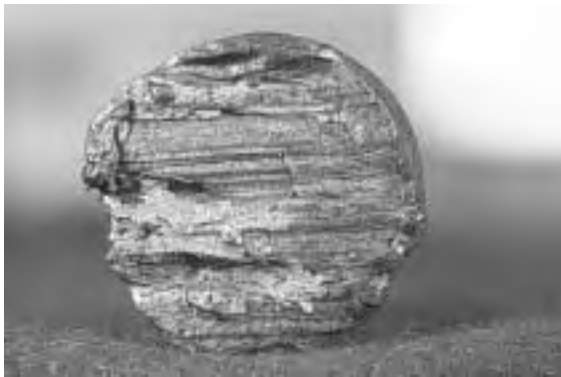
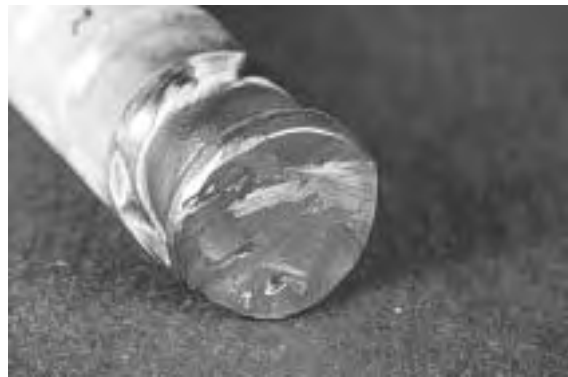
Figure 2.6 Appearance of specimens before and after surface preparation.

(a) Uncleaned bar end surface after 2 weeks of exterior exposure.

(b) Surface preparation with wheel grinder and wheel brush.

(c) Appearance of damaged areas after two weeks of outside exposure.

(d) Appearance of damaged areas after cleaning with a wire brush.

(e) Appearance of torch-cut end after two weeks of exterior exposure.

(f) Appearance of torch-cut end after wheel grinding and wheel brushing.

Specimens with no surface preparation: The exposed metallic surface at damaged areas and bar cut ends was not cleaned before patching. In several cases, bar samples were subjected to outdoor exposure for 1 or 2 weeks until rust developed on the steel surface. In other cases, patching material was applied on hot bar cut ends immediately after torch or saw cutting. Patching material was applied with a small paint brush, spread with spatula, or spread with glove-covered finger. Procedures *i*, *j*, *k*, *l*, *m*, and *n* are included in this category. Specimens with no surface preparation are illustrated in Figure 2.6 (a, c, e).

Specimens with surface preparation: The exposed metallic surface at damaged areas and bar cut ends was cleaned either with a wire brush or wheel brush before patching. Some bar cut ends were rounded and smoothed with a wheel grinder. In several cases, bar samples were subjected to outdoor exposure for 1 or 2 weeks before surface cleaning until rust developed on the steel surface. Some specimens were subjected to an additional 24 to 48 hours of outdoor exposure after surface cleaning and before patching application. Patching material was applied with a small paint brush or spread with spatula. Procedures *b*, *c*, *d*, *e*, *f*, *g*, and *h* are included in this category. Figure 2.6 (b, d, f) shows various specimens with surface preparation.

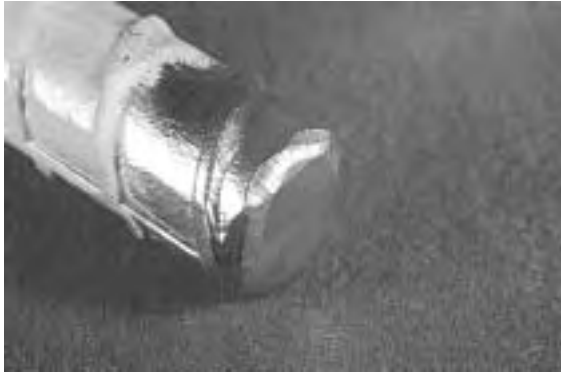
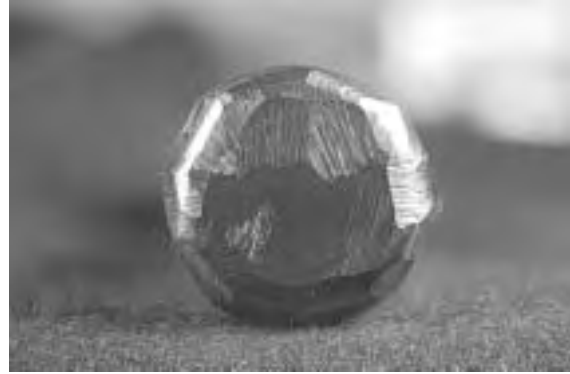
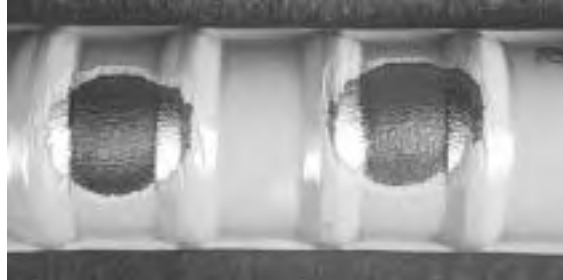
Figure 2.7 Surfaces specially cleaned before patching application (control specimens).

(a) Aspect of specially cleaned bar end.

(b) Front view of specially cleaned bar end.

(c) Specially cleaned surfaces on bar deformations.

(d) Specially cleaned areas between bar deformations

- Bar cut ends [Figure 2.7 (a, b)]: Sharp edges and burrs at cut sections were rounded and smoothed using a wheel grinder and wheel brush. The sharply ridged slag surface in flame-cut rebars was smoothed and rounded as much as possible. The metallic surface was

cleaned to a near-white, polished finish with the aid of a wheel brush. All dirt, slag, burrs, rust, coating, and other contaminants were thoroughly removed.

- Bar surface [Figure 2.7 (c, d)]: On an undamaged epoxy coated bar sample, portions of the coating were removed with a wheel brush at the following locations: a) bar surface between ribs (1.4 cm x 2.2 cm), and b) bar deformations or ribs (2.5 cm x 3.0 cm). The uncovered metallic surface was cleaned to a near white, polished finish with the wheel brush.

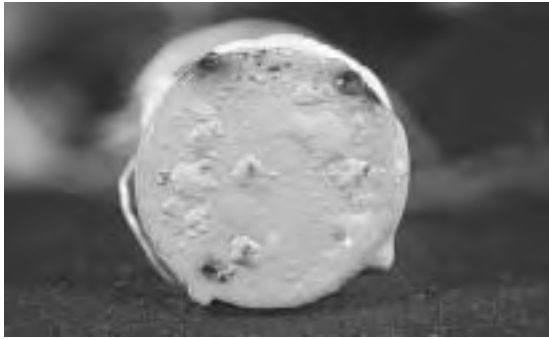
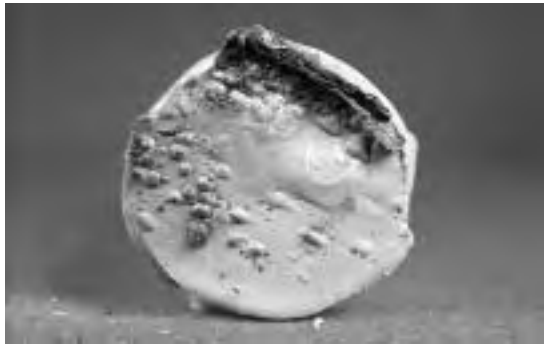
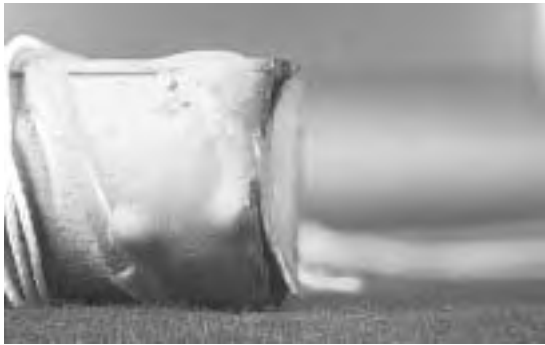
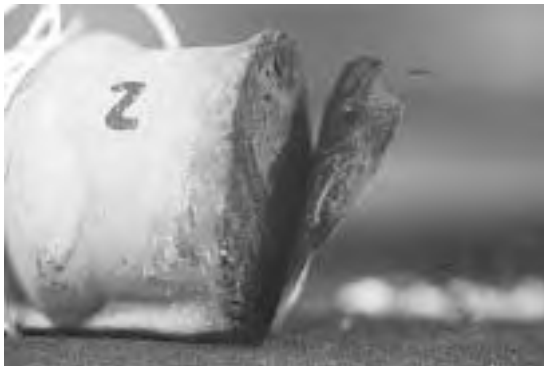
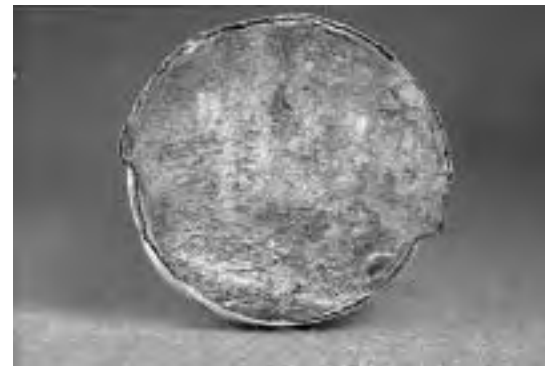
Figure 3.5 Corrosion progression of patched bar ends.

(a) Corrosion stage 1.

(b) Corrosion stage 2.

(c) Corrosion stage 3.

(d) Corrosion stage 4.

(e) Corrosion stage 4.

(f) Corrosion stage 4.

1. Salt solution permeated through patch layers until patch eventually lost adhesion and slightly bulged at certain areas of small to medium size [Figure 3.5(a)]. Solution seemed to be trapped underneath patch at such areas. This phenomenon is called patch softening in this discussion

because the patch felt soft at these areas. Small to medium size blisters developed on patched surface. At patched areas on bar sides, rust spotting or staining of small size formed anywhere on the patch surface (around blisters, at patch boundaries, on pinholes, etc.). On patched ends, rust spotting or staining of small or medium size formed preferentially around perimeter of bar end, at burrs, at slag ridges, and around blisters [Figure 3.5(a)].

2. Corrosion progressed with subsequent wet-dry cycles. Debonded, softened patch areas increased in size. More blisters formed and existent blisters enlarged and bulged further. Already present rust spots and stains gradually increased in size and additional rust spotting sometimes appeared, especially around perimeter of ends [Figure 3.5(b)].

3. Patch broke and rust exuded at blister edges (all patched areas) and perimeter edges (bar ends) [Figure 3.5(c)]. More salt solution and oxygen was accessible to steel surface through small zones of patch breakage. Areas of debonded patch material were of medium or large size. Medium to large rust stains were present. There was widespread rust staining around perimeter of bar ends and at sharp, projecting burrs and slag ridges [Figure 3.5(c)]. Rust staining and blistering spread beyond patched end section into adjacent bar side surface.

4. Widespread rust staining spread over the whole patch surface on bar ends (less extensive on other patched areas). Patch continued to break and separate from steel surface at perimeter of bar ends [Figure 3.5(d)]. In a few samples, patch material completely separated and lifted from the steel surface [Figure 3.5(e)]. Uniform corrosion (black or dark with spots of brown rust) developed on steel surface underneath the patch. Extent of uniform corrosion varied from a large portion of repaired area to the full patched area and spreading a few millimeters (centimeters on bar ends) into adjacent surface underneath epoxy coating [Figure 3.5(f)]. Fine reddish-brown (or other tones of brown) rust accumulated at areas where more salt solution was concentrated (softened or debonded patch and blisters). At blistered patch locations, corrosion products accumulated and formed hard mounds or protrusions. In some cases, shallow pits developed.

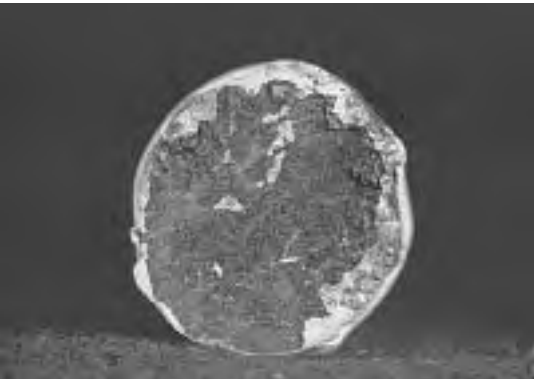
Figure 3.10 Corrosion rating of patched specimens.

(a) Rating 1.

(b) Rating 2.

(c) Rating 3.

(d) Rating 4.

observed over more than 90% of patch surface area. Patch adhesion to steel surface was poor. See Figure 3.10(e) for an example of extensive corrosion.

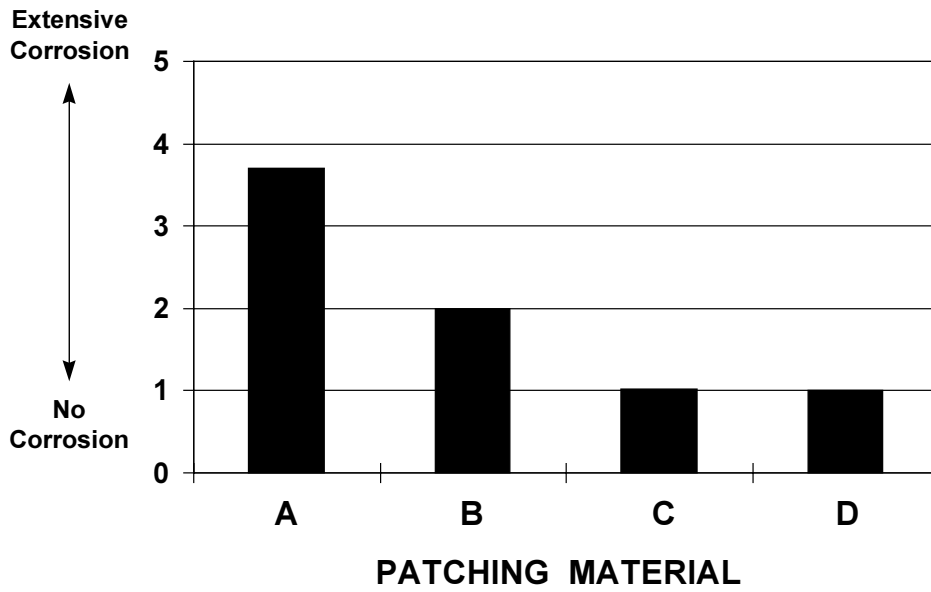
Figure 3.12 Corrosion performance of different patching materials.

Consistently, specimens patched with materials *C* and *D* showed excellent corrosion performance (Figure 3.12). Specimens repaired with material *B* exhibited more corrosion than those specimens patched with materials *C* and *D*. Specimens patched with material *A* performed poorly. Figure 3.13 illustrates the performance of areas type I (patched damage between ribs), type II (patched damage on ribs), type III (saw-cut and patched rebar ends), and type IV (flame-cut and patched rebar ends) repaired with different patching materials. For all cases, patching material *C* performed best and material *A* worst. The average thickness obtained with each patching material is plotted at the top of both figures. Clearly, as patch thickness increased, corrosion performance improved.

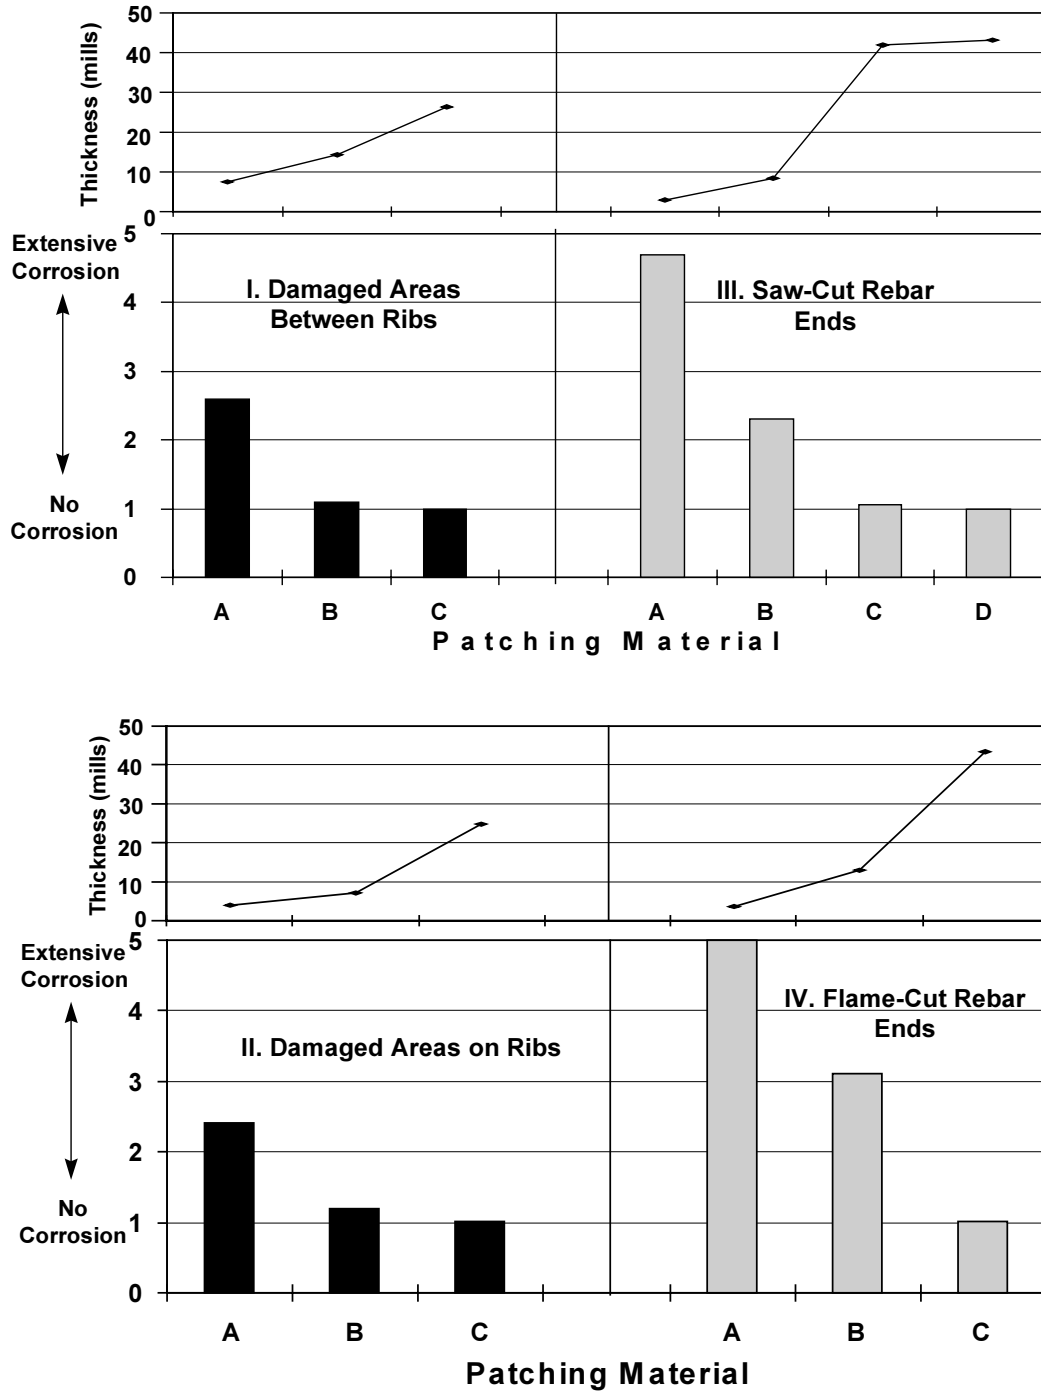
Figure 3.13 Comparative performance between different types of specimens repaired with different patching materials.

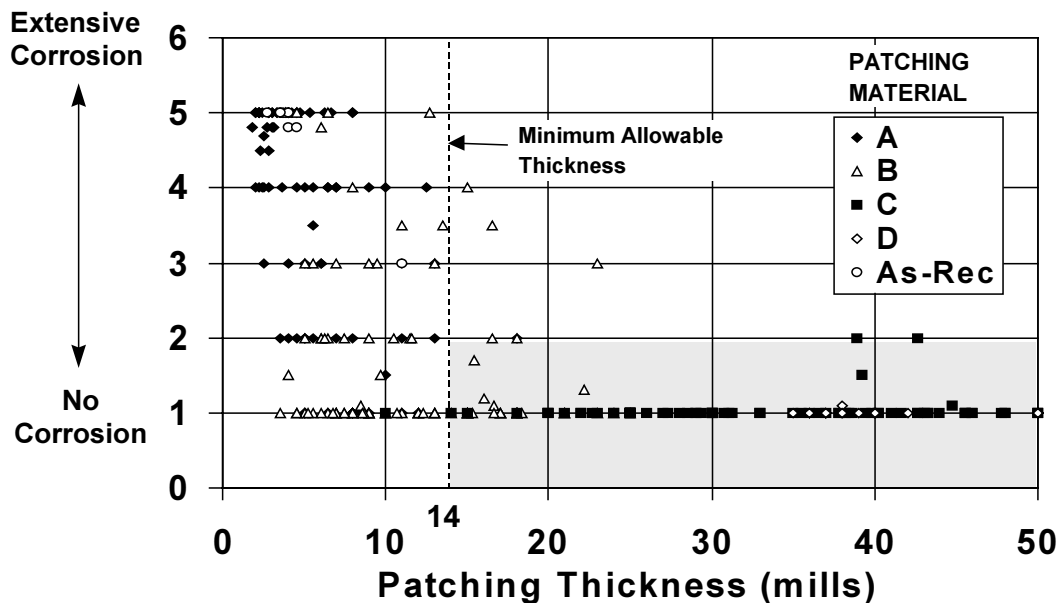
Figure 3.14 Corrosion rating vs. patch thickness of all specimens.

In Figure 3.14, thickness and corrosion performance are plotted for all patched areas. Although the data is scattered, trends can be observed. More specimens patched with material A lie in the high corrosion region and smaller patch thickness of the graph than specimens patched with other materials. For specimens patched with material B, more data points are in the low corrosion region and have greater

thickness than specimens patched with material A. Finally, specimens patched with materials C and D are prevalent in the region of greatest patch thickness and little to negligible corrosion. Again, performance improved with increasing patch thickness. Diffusion of chlorides through the patch was significantly delayed as patch thickness increased. Thicker patches provided good protection at vulnerable areas such as sharp edges of rebar ends, as shown in Figure 3.15.

A statistical evaluation of the data in Figure 3.14 may help determine minimum patch thickness. If ratings of 1 and 2 are considered acceptable (little to no corrosion) and ratings above 2 are unacceptable (moderate to extensive corrosion), analysis of the latter group of points shows that a thickness of 14 mils roughly corresponds to the 95 percentile of points with ratings greater than 2. In other words, 95% of data points with ratings above 2 (unacceptable performance) had thicknesses lower than 14 mils. Similarly, only 5% of data points with ratings above 2 had thicknesses greater than 14 mils (Figure 3.14). If it is assumed that the data constitutes a representative sample and 14 mils is established as the minimum effective patch thickness, material A would not be acceptable, material B would not be acceptable in most instances (only about one third of samples patched with material B had a thickness equal or greater than 14 mils), and materials C and D would be acceptable. The region containing data points with thicknesses greater than 14 mils and acceptable performance (ratings lower than 2) is shaded in the graph (Figure 3.14).

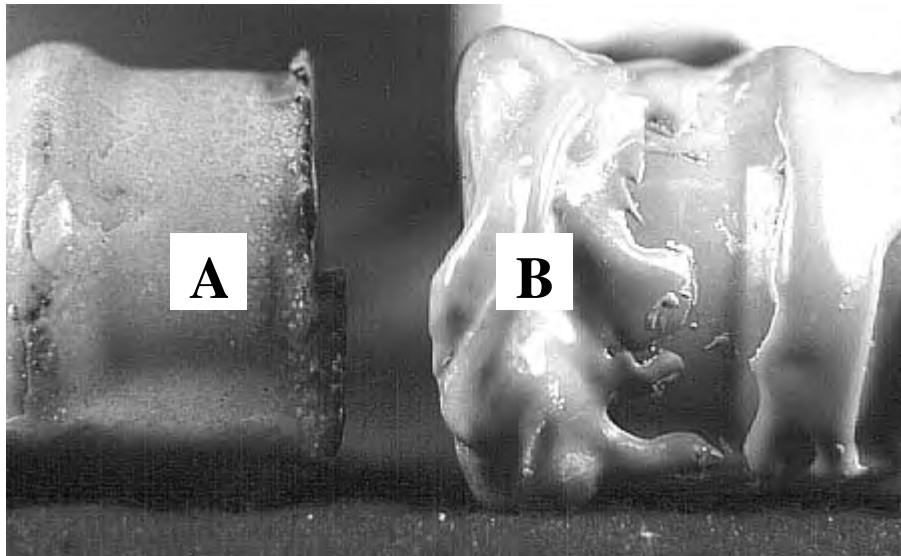
Figure 3.15 Performance of different patching materials.

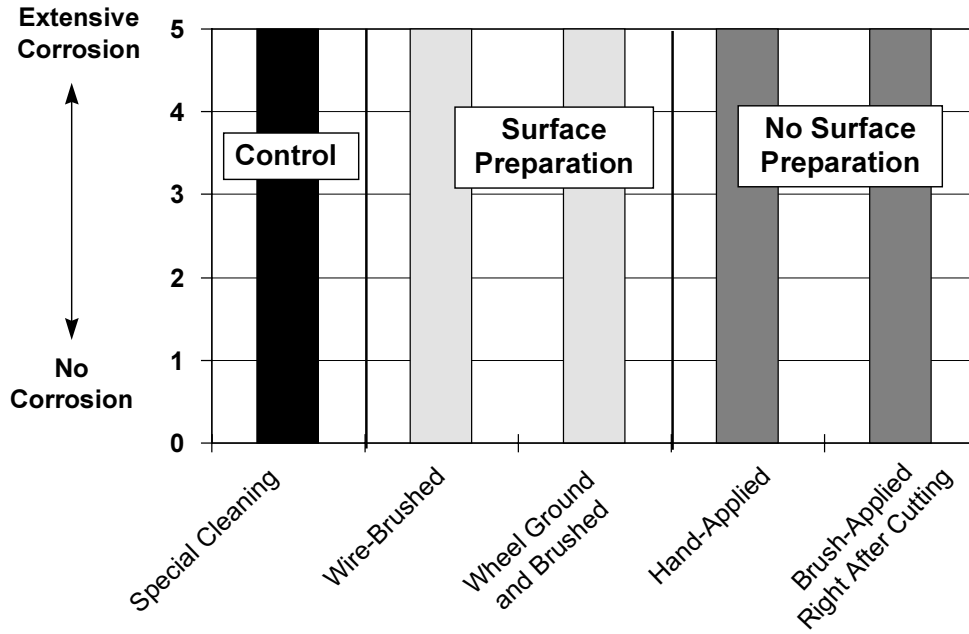
(a) Patching material A

Figure 3.16 Corrosion rating for different surface preparations of flame-cut ends.

No clear trend was observed in terms of surface preparation. No improvement in performance was observed with surface cleaning before patching, as can be seen in Figures 3.16 and 3.17. Rounding and smoothing sharp edges at bar ends did not prove successful. Even some control specimens where the surface was specially cleaned showed poor performance (Figure 3.18). Manufacturers' application procedures indicate that proper surface preparation is important for satisfactory performance but this correlation is not supported by results obtained in this study. No correlation was found between size of patched areas and corrosion performance, as illustrated in Figure 3.19.

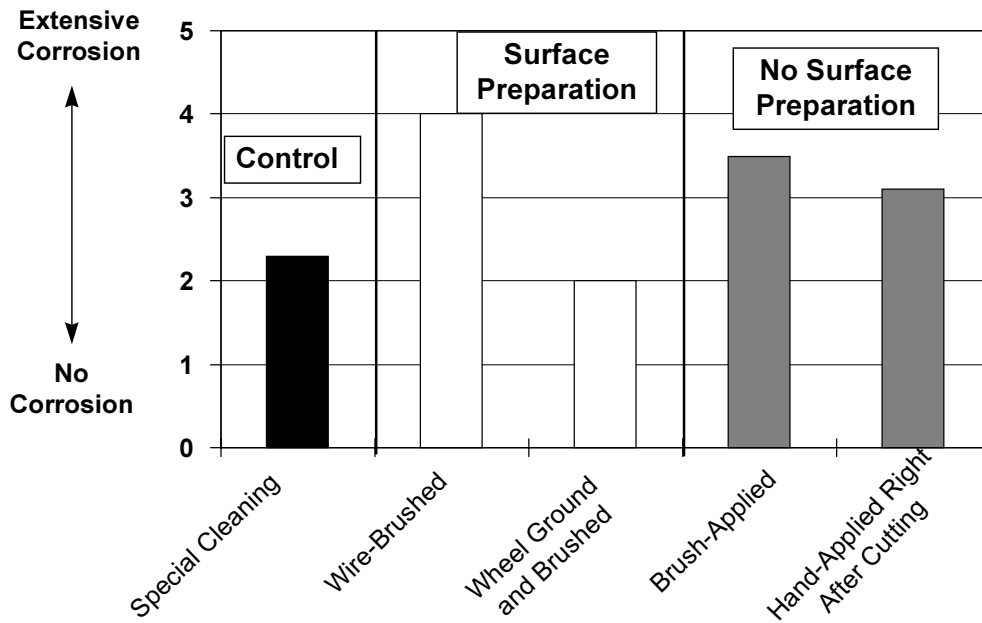
(b) Patching material B

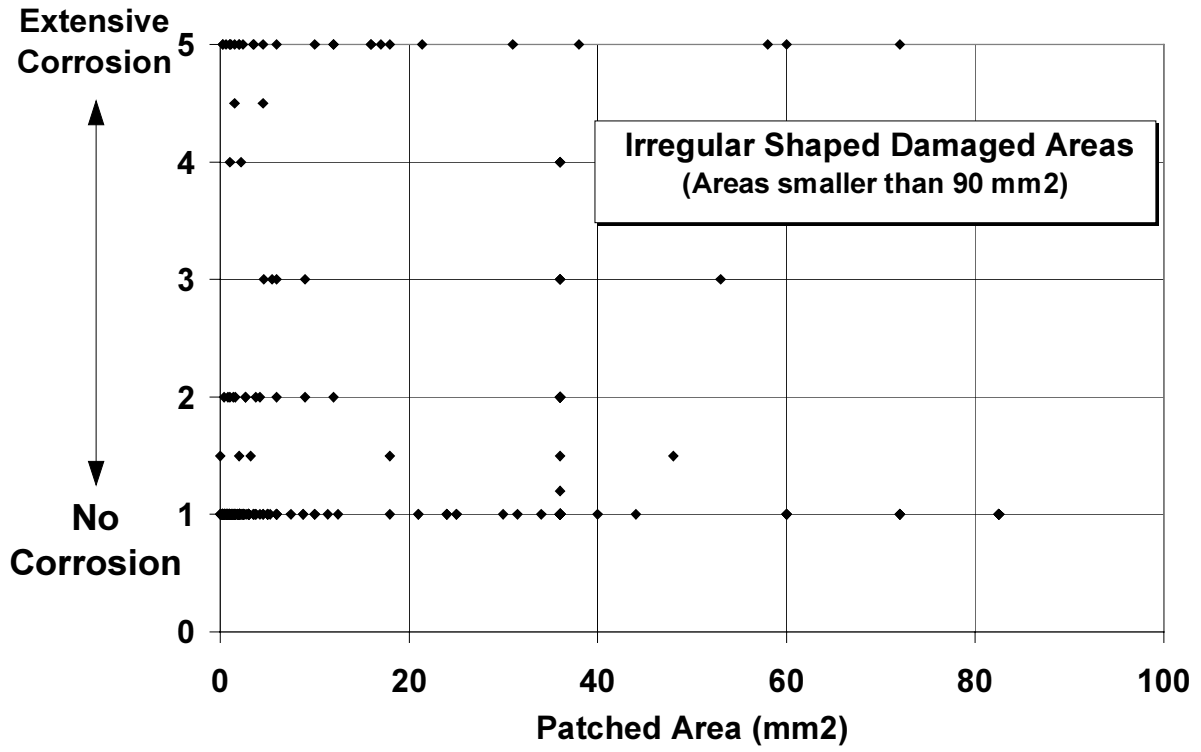
Figure 3.19 Corrosion rating vs. size of patched area.

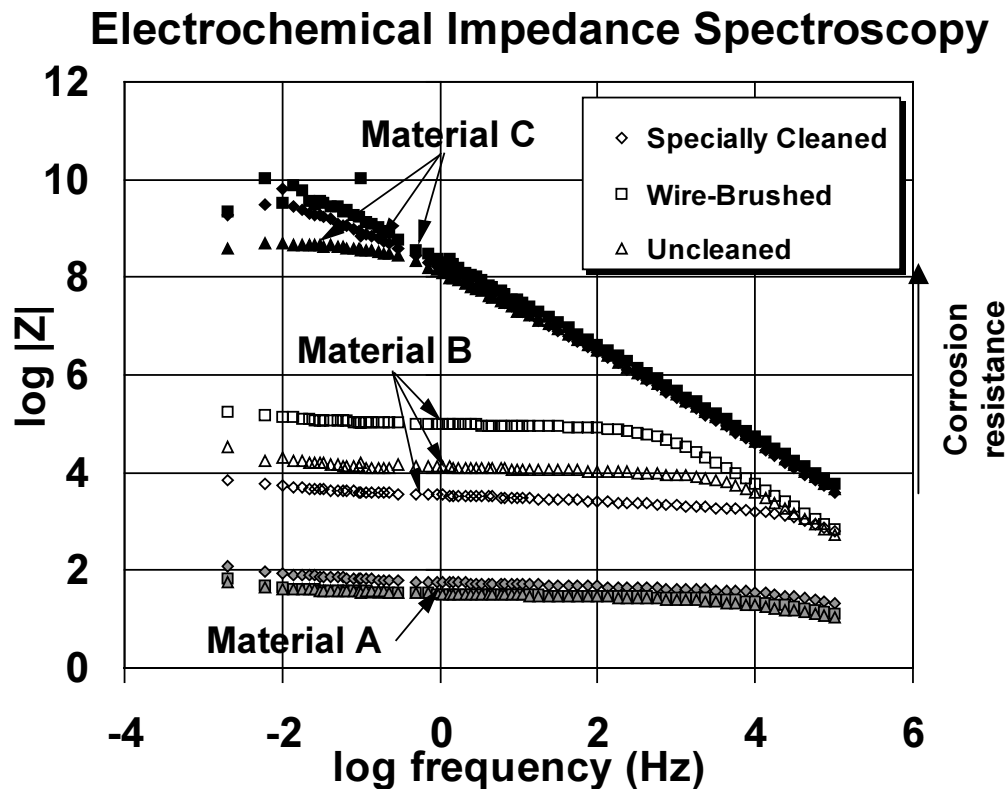
Figure 4.6 EIS results in Bode format (3 patching materials and 3 repair procedures) after 100 days in NaCl solution.

Electrochemical impedance results for all specimens are plotted in Bode format in Figure 4.6. There is a clear difference in behavior among the three patching materials. For the lower frequency region, the magnitude of impedance for patching material C is the greatest, followed by material B, and then by material A, regardless of surface preparation. The greater the impedance, the greater the corrosion resistance of the specimen. Therefore, patching material C showed the best corrosion performance, followed by B and A. Material C showed linear behavior with a slope of -1 throughout almost all frequencies. This represents purely capacitive behavior, which is indicative of a high quality coating with no defects. Curves for material B deviated from linearity and flattened at frequencies lower than 10^3 hertz. This is characteristic of a corrosion process largely controlled by diffusion of corrosive ions and oxygen to the steel surface. Curves for material A have small impedance magnitudes and are flat throughout the whole frequency range. The corrosion process is largely controlled by charge transfer reaction and is indicative of a coating with poor pore resistance (the coating does not retard the ingress of corrosive elements).

From Figure 4.6, it is clear that the effect of surface preparation on the corrosion performance of coated specimens is negligible when compared to the effect of patching material type. In addition, no surface preparation procedure was consistently better or worse. These results were in complete agreement with results from the cyclic immersion tests.
