# Evaluation of Rock Check Dam Performance using Large-Scale Testing Techniques

**Final Report**  
**May 2025**

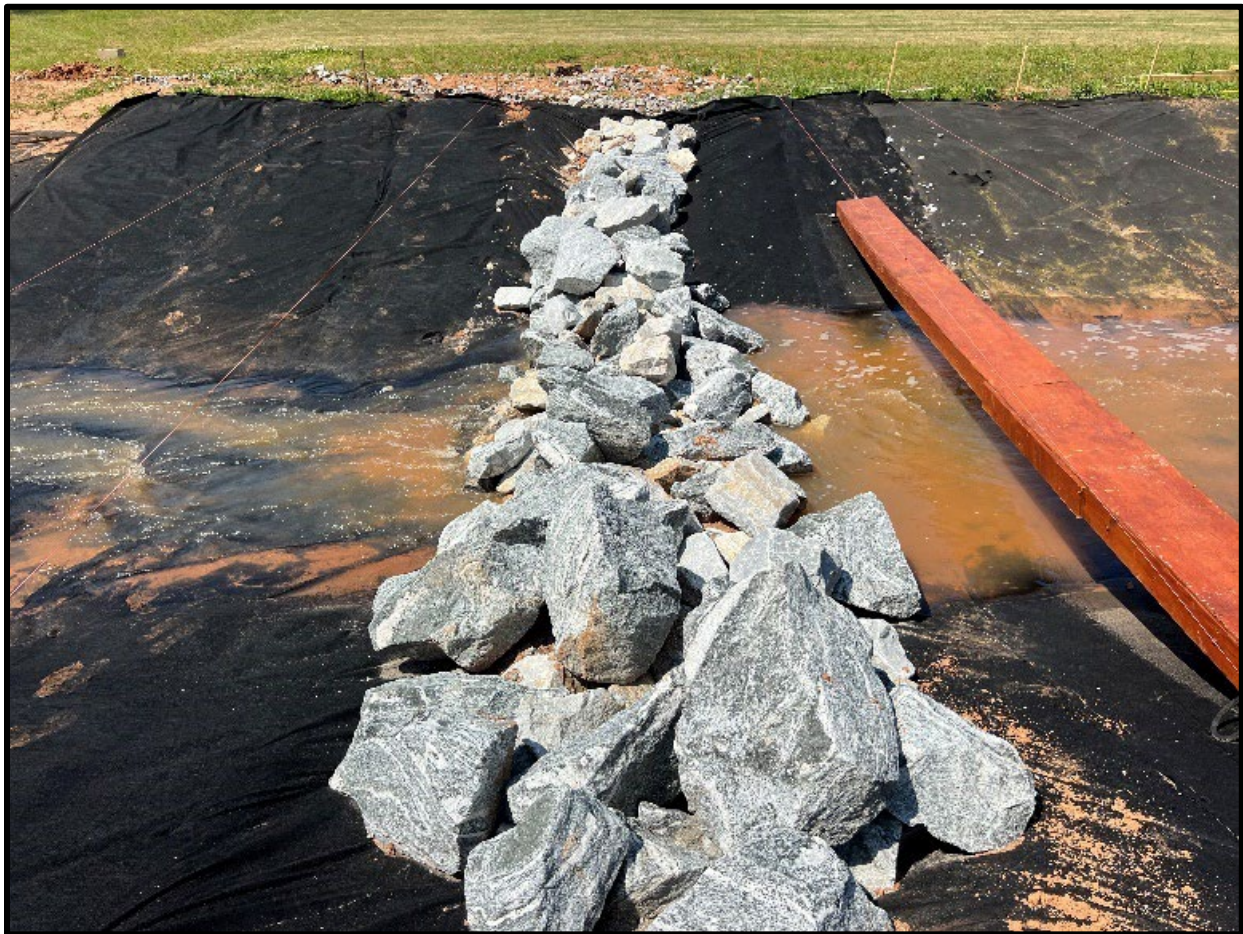
The standard Iowa DOT installation, under both the low and high flow rates, only slowed flow immediately upstream of the installation. An impoundment length of 4.2 ft (1.3 m) and 5.9 ft (1.8 m) was facilitated for the 0.85 and 1.70 ft<sup>3</sup>/s (0.024 and 0.048 m<sup>3</sup>/s) flow rates, respectively, indicating that only 7% and 9% of the channel was protected from erosive flows. Additionally, a maximum impoundment depth of 0.62 ft (0.19 m) was facilitated immediately upstream of the rock check dam, indicating much of the material in the installation was not playing a role in slowing flow. Only one cross-section upstream of the installation had subcritical flows during testing of both flow rates, further indicating much of the channel was subject to erosive flows. The performance of the Iowa DOT standard installation under clean-water conditions can be shown in Figure 4.1.

**Figure 4.1: Upstream Impoundment of Iowa DOT Standard Installation**

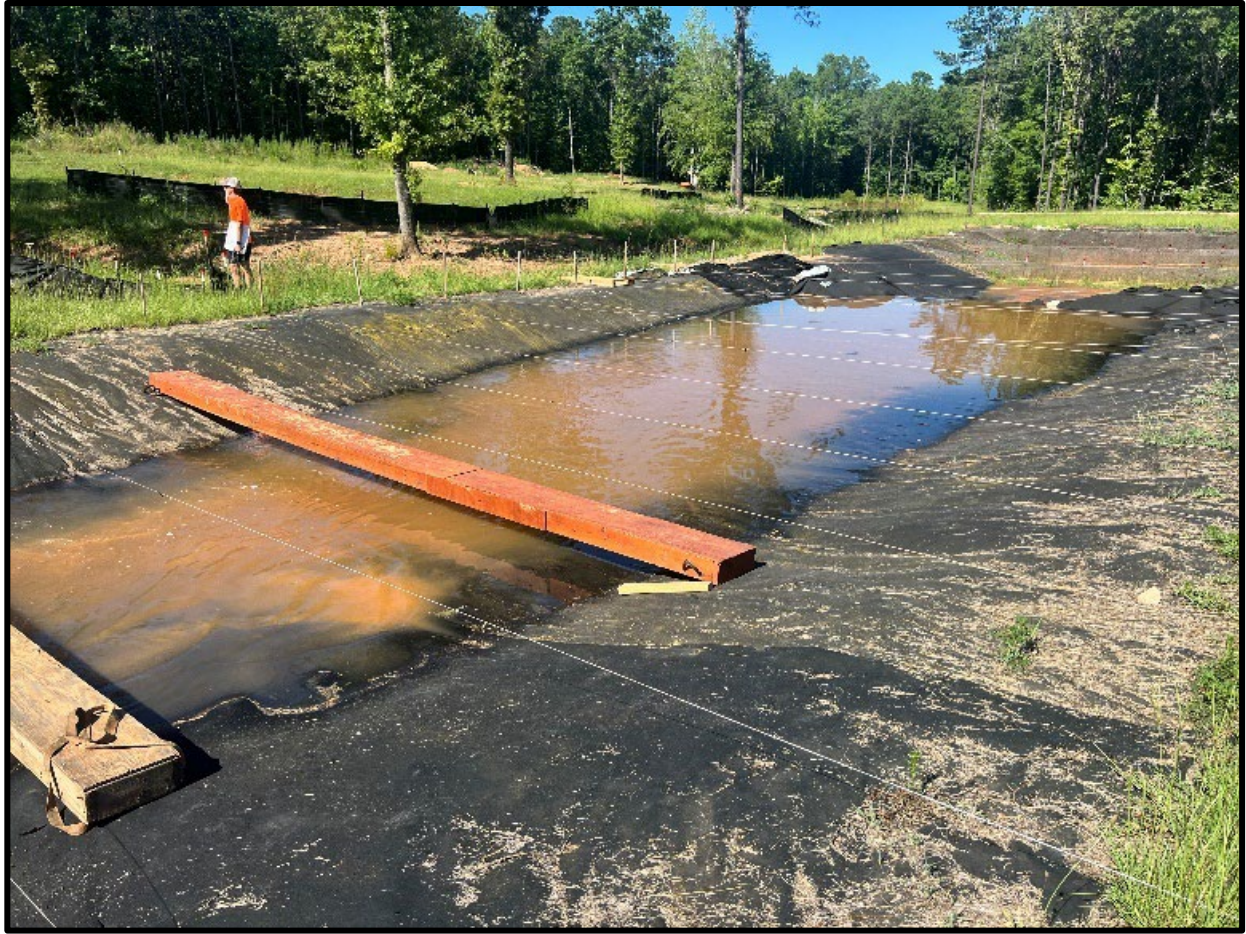
The smaller rock gradation and decreased pore size improved performance compared to the standard installation with the larger rock gradation; however, highly erosive flow velocities were still present for more than half of the channel indicating that additional performance improvements needed to be made to fully protect channels from erosion. Past performance evaluations of rock check dams have shown that adding a geotextile overlay improves performance through the formation of additional impoundment. M3 was developed using the Iowa DOT standard rock gradation with a non-woven geotextile secured with 6 in. (15.2 cm) sod staples 2 ft (0.6 m) upstream of the dam, draped over the front face of the installed and secured on the back side of the installation with loose rock. M3, due to the addition of the geotextile, increased impoundment length to 49.3 ft (15 m) and 48.4 ft (14.8 m) on average for the low and high flow rates, respectively. For the low flow testing, impoundment length increased during each subsequent test as the geotextile became clogged with the low amounts of sediment from the supply pond; the third simulated storm event had an impoundment length of 62.5 ft (19.1 m). A similar pattern was shown for impoundment depth, with the first simulated storm event having the lowest depth and increasing for each subsequent test for the low flow rate. Additionally, for all but the first simulated storm event, the higher testing flow rate had a lower impoundment length than the low flow rates, with all tests having between 47.5 and 49.1 ft (14.5 and 15 m). The improved performance of M3 is shown in Figure 4.4.

**Figure 4.4: Upstream Impoundment of M3**
