Test Report No. 0-7021-01-R1

**DEVELOPING AN ENHANCED PROTECTION OF MEDIAN OPENINGS
BETWEEN PARALLEL BRIDGE STRUCTURES**

Sponsored by the
**Texas Department of Transportation
and the
Federal Highway Administration**

TEXAS A&M TRANSPORTATION INSTITUTE PROVING GROUND

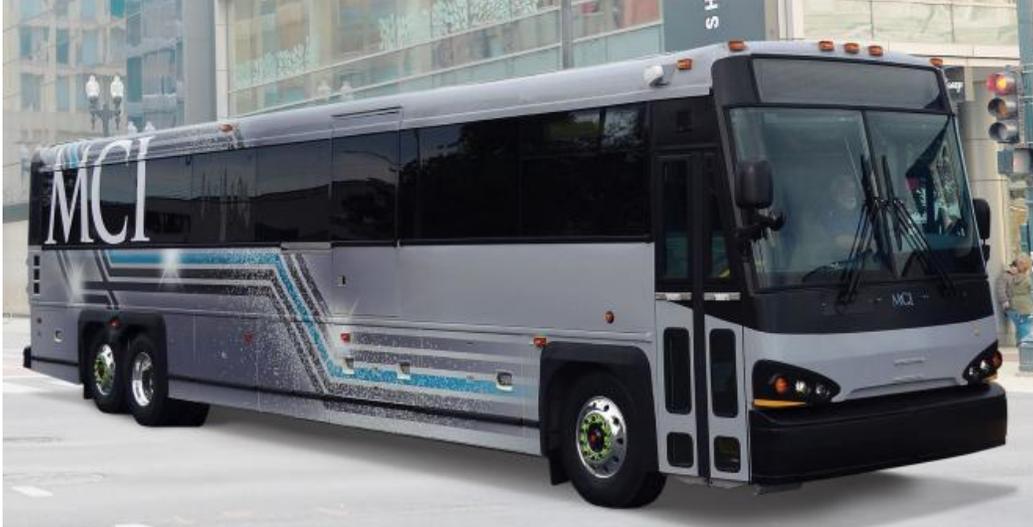
Figure 2.5. Example of an MCI D4500 (2).

The most common Class 8 vehicle was the MCI Intercity D4500. The year of the D4500 buses ranged from 1993 to 2018. Figure 2.5 shows an example of the Les Autobus MCI motorcoach. Table 2.10 shows the crash counts for each model year of the MCI Intercity D4500.

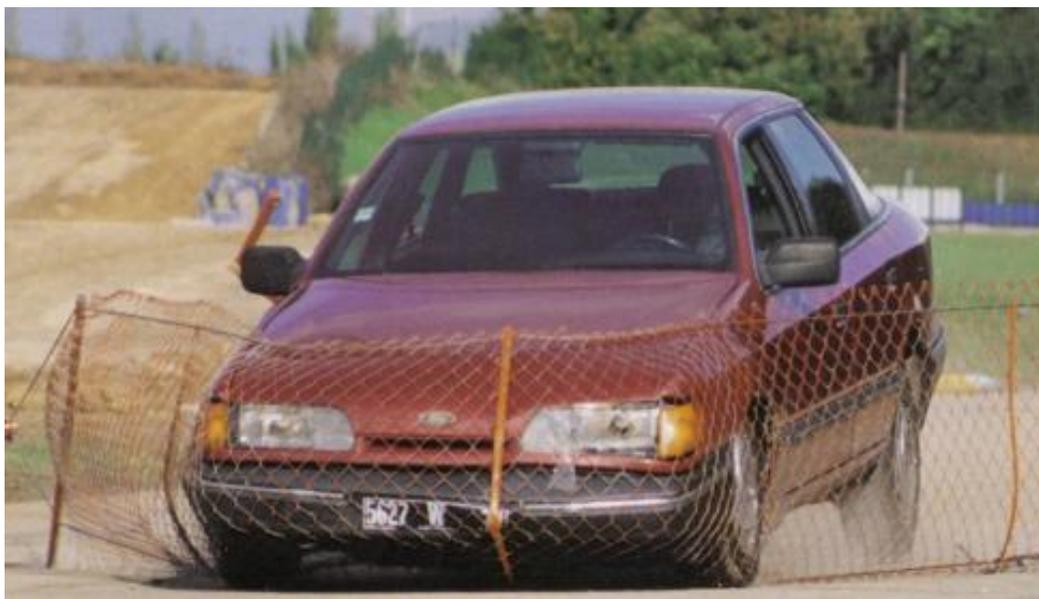
Figure 3.1. Vehicle Arresting Net (3).

The Dagnet vehicle arresting barrier (3) system uses a mesh net to span between two end posts. This mesh is connected to a set of steel tapes that unspool during a vehicular impact. The pull out of this steel tape dissipates the impact energy and safely brings the vehicle to a stop. The two end posts are bolted to concrete piers that are embedded 4 ft below grade. The span distance of the net can vary depending on the installation, and the top of the net rests at approximately 48 inches above grade. Because the net is anchored at the two ends, additional measures must be taken to maintain proper height above grade when installed in a sloped median. Figure 3.1 shows a photo of this system.

The Dagnet can safely stop a 20,000-lb truck traveling 52 mi/h in 200 ft. The Dagnet can stop a lighter passenger vehicle in a much shorter distance, depending on the impacting speed. The Dagnet also has modifications available to arrest much larger vehicles traveling at faster speeds. Maintenance is relatively simple after an impact, with the replacement of only the steel tapes and mesh net. Standard groundskeeping or median maintenance is also relatively simple. While the net prevents large equipment from mowing in that specific area, the equipment can easily drive around the system and resume mowing. Groundskeeping teams can then mow closely around the system with smaller equipment.

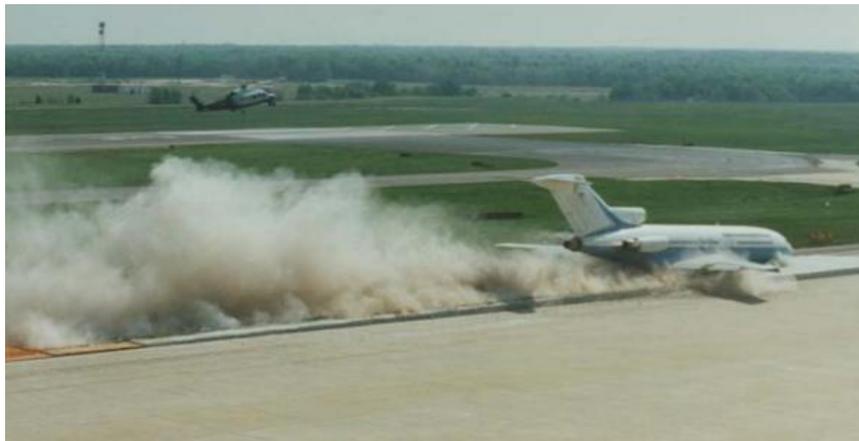
Figure 3.3. EMAS Airplane Test (5).

An engineered material arresting system (EMAS) (5) is a cellular cement arresting bed. The material is a set mixture of portland cement, an air entraining foaming agent, and water. Each cement brick is 4 ft wide by 8 ft long with varying thicknesses. A 1-inch topcoat of cement slurry is applied on top of the test bed. The installation is 40 ft wide by 376 ft wide, with a taper to 25 inches deep. While the specific application described in (5) used a flat installation surface, the system can be modified for sloped conditions. When impacted, the system deforms and applies a drag force that safely and predictably decelerates the test vehicle. Figure 3.3 shows a photo of this system arresting an airplane.

This system was evaluated using a B-727 aircraft weighing 131,600 lb (5). The B-727 was traveling at 55 knots (approximately 63.3 mi/h) and was successfully brought to rest with a stopping distance of 278 ft. Maintenance to the system after impact only involves replacing damaged cement bricks. The unaffected bricks may be left in place. Because this system will be placed at grade level, groundskeeping will not be required in this area. Despite this system being designed for aircraft use, a modified cement brick composition could be developed for roadway vehicles. Table 3.2 lists advantages and disadvantages of the EMAS.

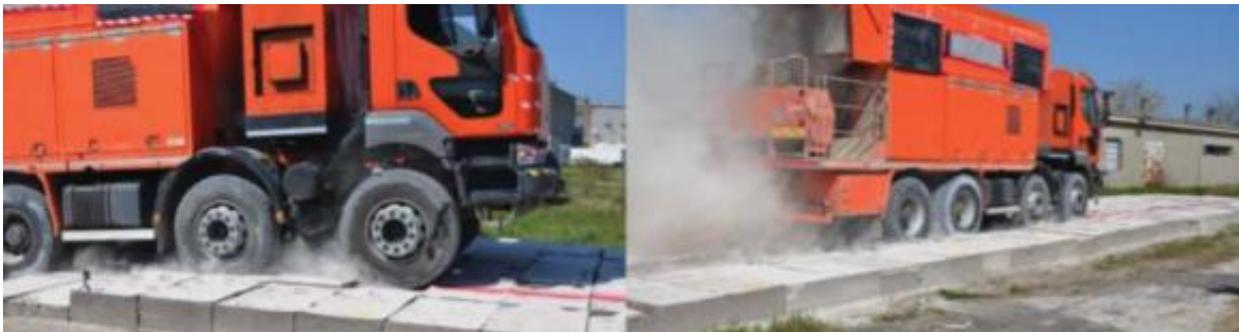
Figure 3.4. Vehicle Evaluation of Arresting Bed (6).

The EMAS alternative to runaway truck ramp system (6) is an arresting bed intended as an alternative to traditional gravel or gravity-based runaway truck ramps. This design consists of a variable number of deformable cement blocks similar to the airport EMAS. The cementitious block units are 110 cm in length and 70 cm in width, and they range from 15 cm to 60 cm in thickness. The total length of the system is 38.5 m long and 5.5 m wide. The design was implemented on flat ground; however, the system’s units can be modified to allow for median slope applications. Figure 3.4 shows a photo of this system arresting a truck.

This system was evaluated using a 88,000-lb truck traveling at 35 mi/h (6). The system successfully brought the vehicle to rest in 83.3 ft. Maintenance to the system after impact only involves replacing damaged cement bricks. The unaffected bricks may be left in place. Groundskeeping will not be required in this area because the cement blocks prevent vegetation from growing. Table 3.3 lists advantages and disadvantages of this system.

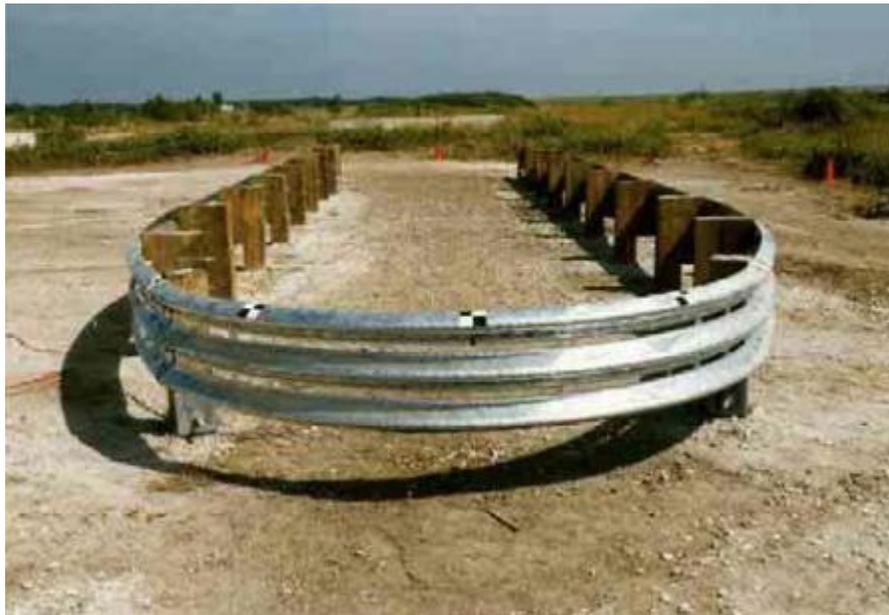
Figure 3.5. MwRSF Bullnose System (7).

The bullnose system (7–9) is a guardrail installation developed by researchers at the Midwest Roadside Safety Facility (MwRSF) for the purpose of protecting large gore areas. It is composed of a thrie-beam rail mounted to 22 wood posts (11 posts on each side). A steel cable is installed behind the first thrie-beam section to prevent rail rupture. The thrie beam has a radius of 1580 mm, and the barrier is a nominal height of 804 mm. The system is 4500 mm wide and 20,144 mm long. This bullnose system was designed and tested on flat ground. Because of the complexity of the system, a large development effort would be required to modify it for sloped medians. Figure 3.5 shows a photo of the bullnose system.

The system was successfully evaluated head on with an 886-kg small car impacting the system at 103.3 km/h (7–9). The test vehicle came to rest 6.55 m downstream. Furthermore, this bullnose system successfully brought a 2010-kg pickup truck impacting at 103.5 km/h to a stop in 16.33 m. After the test, much of the system requires costly replacement. Because of the design of the bullnose, groundskeeping crews will not be able to use large equipment to maintain the protected area. Therefore, smaller equipment will be required for upkeep. Table 3.4 lists advantages and disadvantages of the bullnose system.

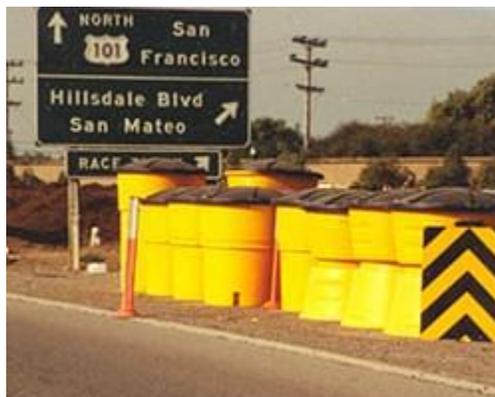
Figure 3.6. Sand Barrel Application (10).

Several sand barrel systems exist in the current market, and each varies slightly from manufacturer to manufacturer. Sand barrel systems arrest vehicles by displacing large volumes of sand. The sand barrels typically consist of three main parts: the plastic barrel, the sand filling, and the plastic lid. The sand barrels range widely in weight, from 200 to over 2000 lb when filled. The barrels are arranged in consecutive rows, but the overall system configuration varies per speed application. These systems were designed for installation on a flat surface, so it would need to be modified for a sloped median. Figure 3.6 shows a photo of a sand barrel array. These systems obstruct groundskeeping equipment, so groundskeeping will require manual effort with little help from larger equipment. Table 3.5 lists advantages and disadvantages of sand barrel systems.

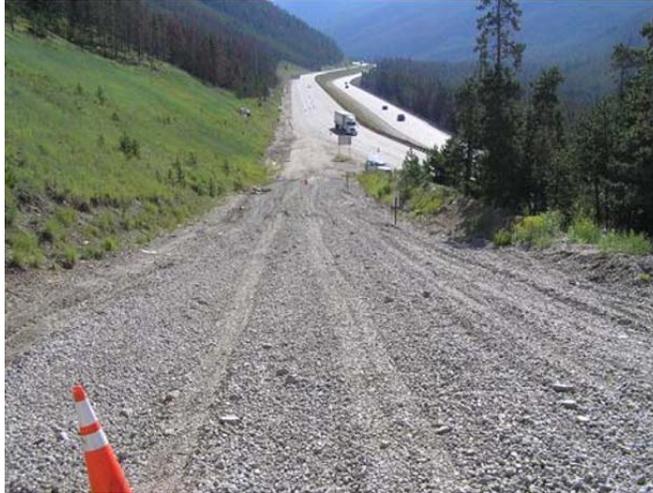
Figure 3.7. Truck Escape Ramp in Colorado (12).

State DOTs have varying research and guidelines regarding runaway truck ramps (also known as truck escape ramps) (11, 12). These guidelines describe the physical geometry of the runaway truck ramp required for the design vehicle size and speed. Figure 3.7 shows a photo of a runaway truck ramp. The AASHTO's *A Policy on Geometric Design of Highways and Streets* (Green Book) (13) provides several common recommendations:

Truck escape ramps use gravity and/or frictional resistance to safely arrest vehicles. Most use a gravel-like material that slowly decelerates the impacting vehicle. The frictional resistance of this material is a key element that needs to be carefully considered when designing a truck escape ramp. To aid the frictional material in slowing the vehicle, engineers often design truck escape ramps with an upward grade to force the impacting vehicle to fight against gravity when traveling forward. After a truck escape ramp is used, repair crews would regrade the ramp to smooth any tracks that were made by the impacting vehicle. While the repair effort may be minimal, the groundskeeping effort could be large. The gravel-like material would prevent large equipment from accessing the area but would allow vegetation to grow through the depth of the ramp. Therefore, manual groundskeeping would be required for the filled area. Table 3.6 lists advantages and disadvantages of truck escape ramps.

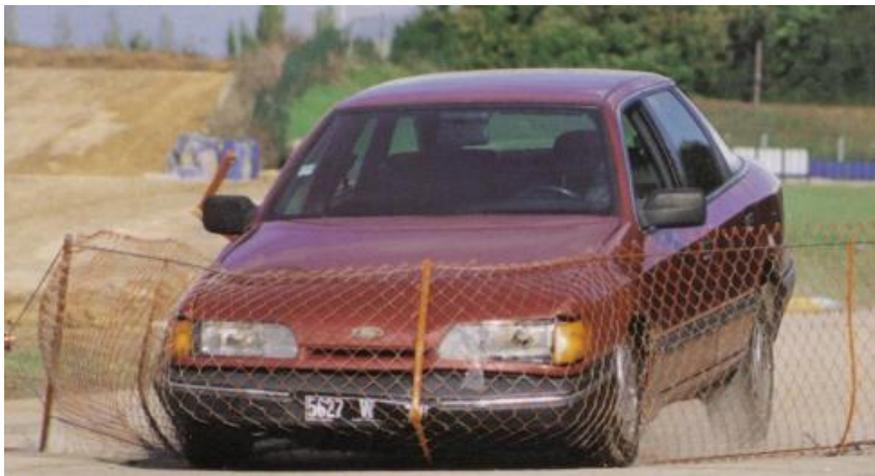
Figure 3.8. Vehicle Arresting Net (3).

The research team developed a MOPS based upon the readily available technologies investigated and the analytical crash data reviewed. After the technology investigation, TxDOT and the research team chose to pursue the use of net-based vehicle arresting technology. Consequently, the research team worked with Impact Absorption, a roadside safety company, to adapt its net arrestor product to the median opening condition. This system uses a mesh net that spans between two end anchors. This mesh is connected to a set of steel tapes that unspool after the net wraps around the front of a vehicle during an impact. The unspooling of this steel tape dissipates the impact energy and helps to safely bring the vehicle to a stop. The two end anchors are attached to concrete piers. The net is anchored at the midspan of the median ditch section to hold the net at the appropriate catch height. This configuration will minimize the risk of underriding the net during an impact. More details regarding the specific energy absorbers and the net configuration are included in the final installation drawings. Figure 3.8 shows a photo of this system.

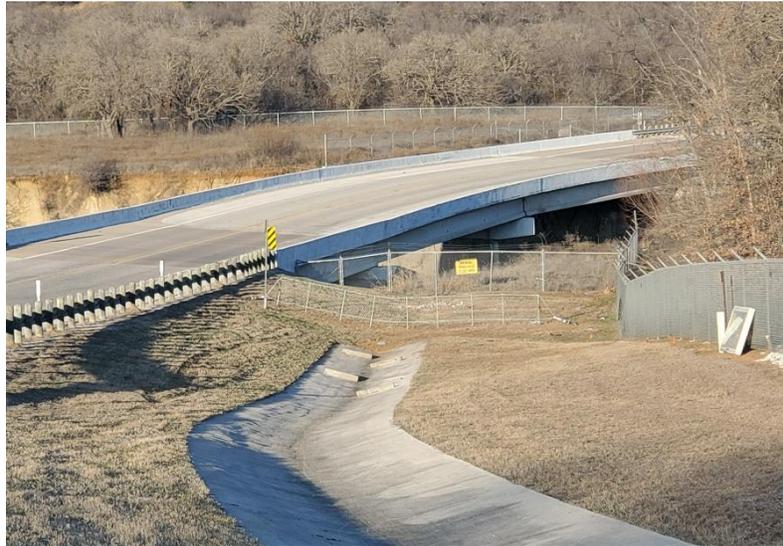
Figure 3.9. Net Arrestor Installed in Wise County (photo courtesy of A. Cruz).

The net arrestor system has been installed in Texas to provide hazard protection similar to the median opening scenario. In Wise County, the net arrestor was installed on FM 1658 to protect the roadside ditch area adjacent to the bridge ends (4).

Figure 3.9 shows the installation. This is a similar condition to the median opening, as it shows the net anchored at the center of the ditch.

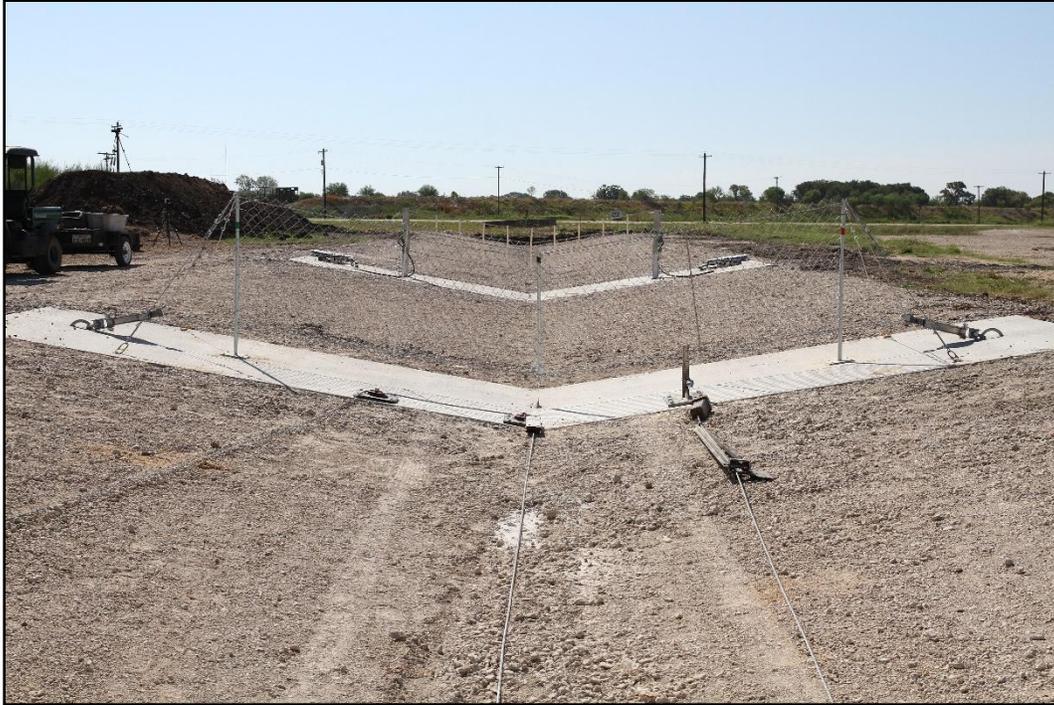
Figure 4.3. Upstream In-Line View of the Median Opening Protection System prior to Crash Tests 440210-01-1&2.

Figure 4.1 presents the overall information on the MOPS, Figure 4.2 presents the overall information for the first net, and Figure 4.3 through Figure 4.8 provide photographs of the installation. Appendix A provides further details on the MOPS. Drawings were provided by TTI Proving Ground, and construction was performed by TTI Proving Ground personnel and Impact Absorption installers. TTI Proving Ground personnel supervised installation efforts.

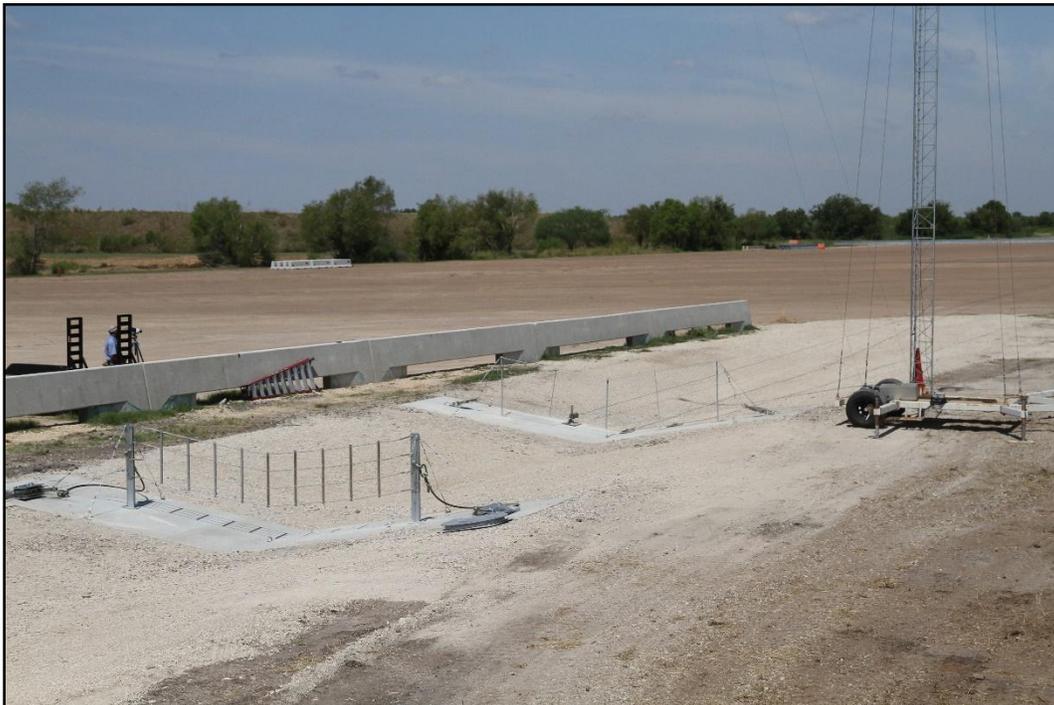
Figure 4.4. Oblique View of the Median Opening Protection System prior to Crash Tests 440210-01-1&2.

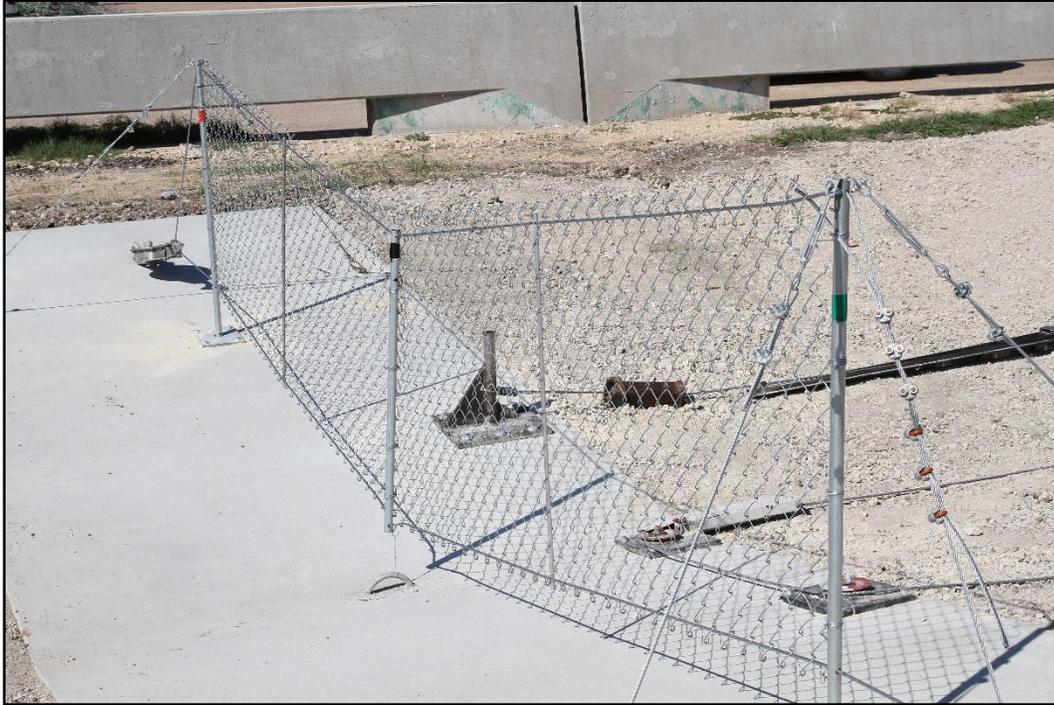
Figure 4.5. First Median Opening Protection System prior to Crash Tests 440210-01-1&2.

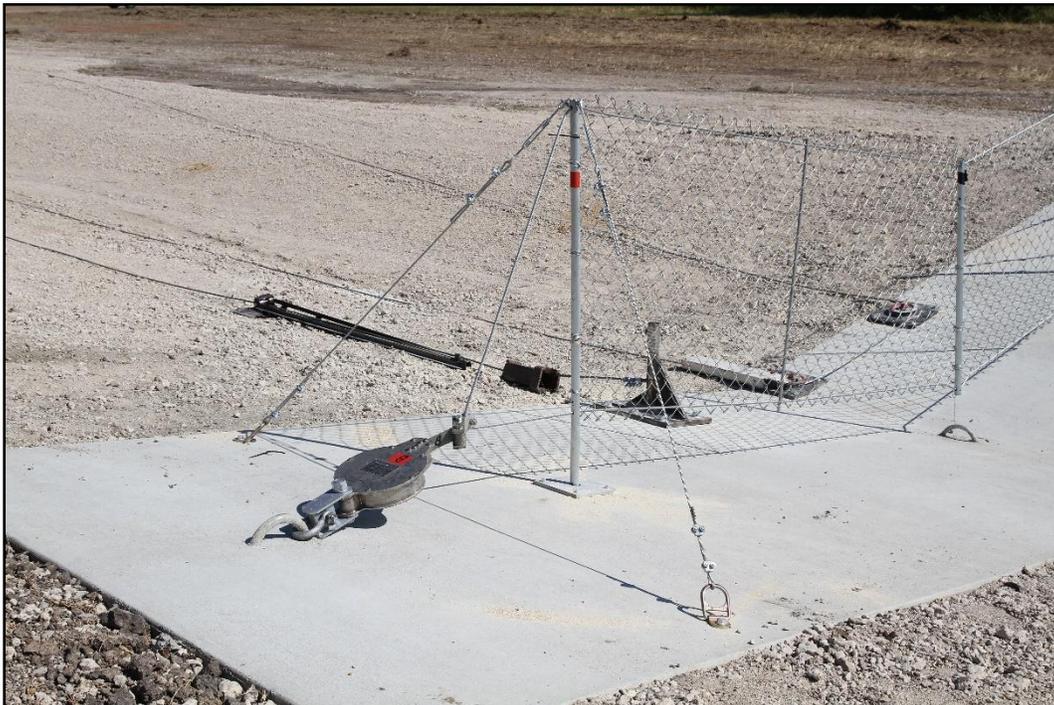
Figure 4.6. Anchor Hardware for the First Median Opening Protection System prior to Crash Tests 440210-01-1&2.

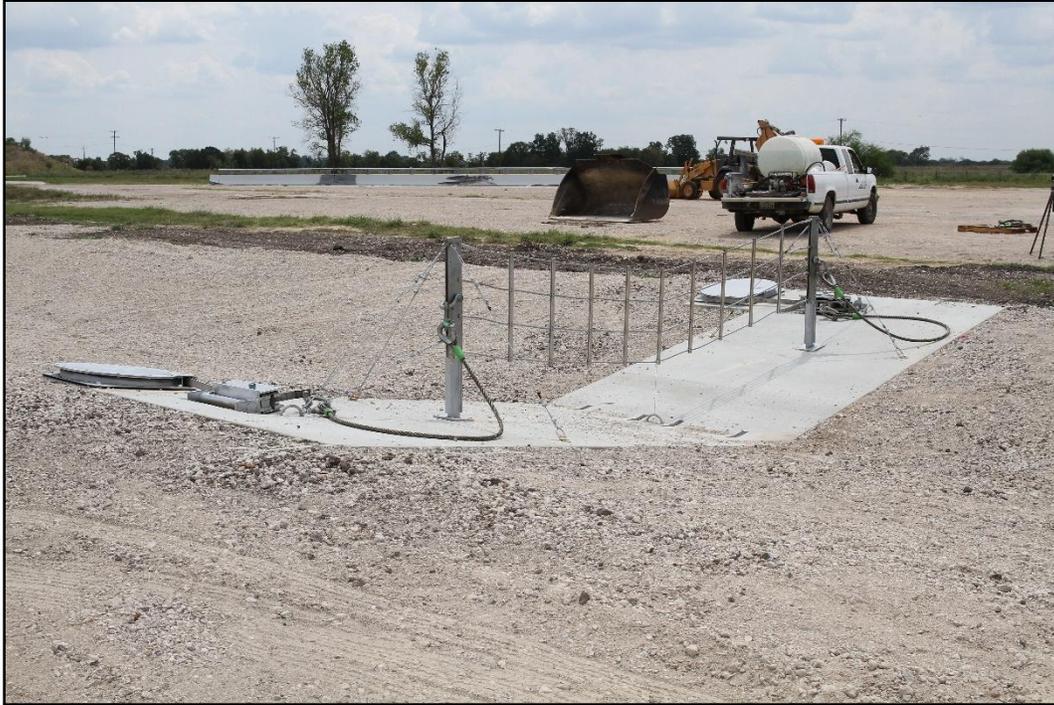
Figure 4.7. Second Median Opening Protection System Net prior to Crash Tests 440210-01-1&2.

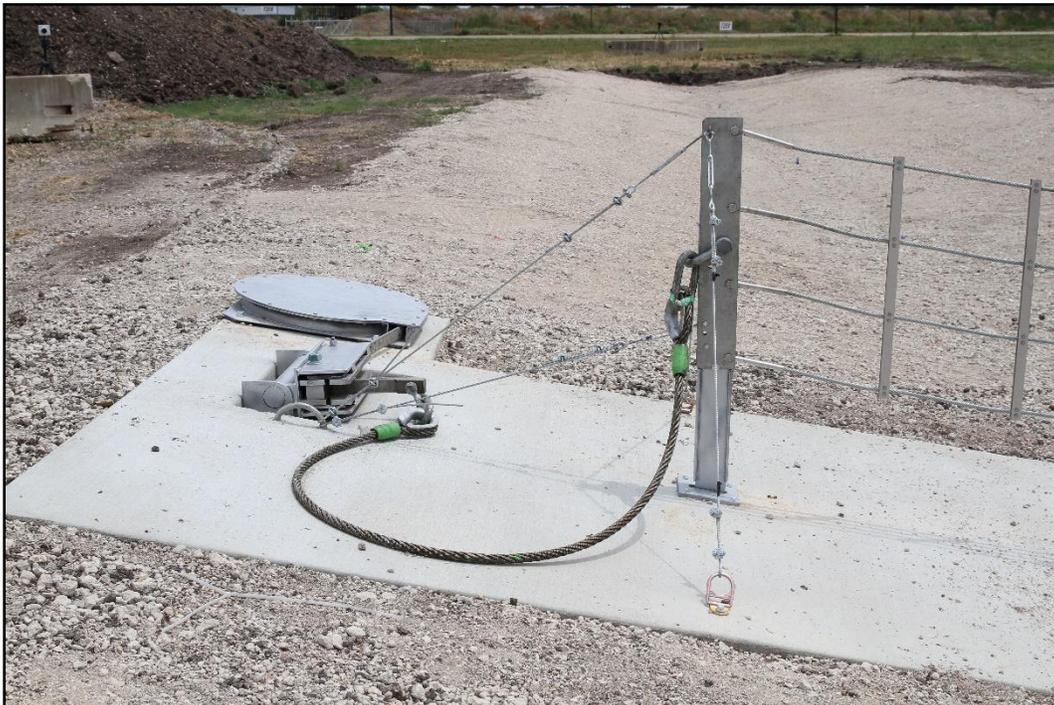
Figure 4.8. Anchor Hardware for the Second Median Opening Protection System Net prior to Crash Tests 440210-01-1&2.

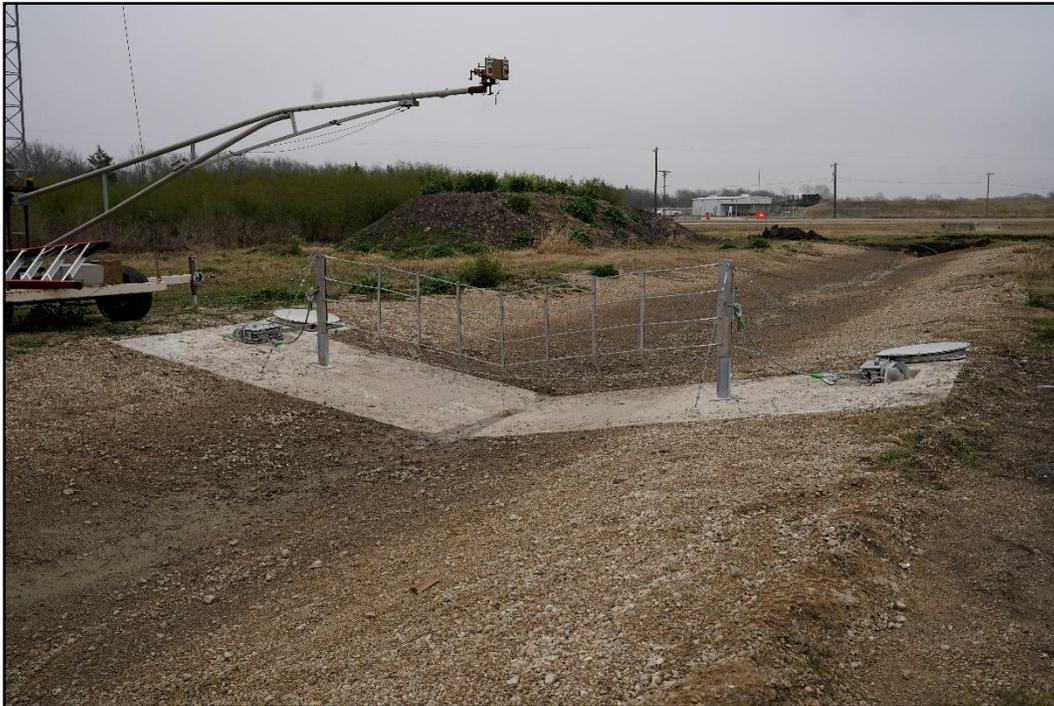
Figure 4.10. Second Median Opening Protection System Net prior to Crash Tests 440210-01-4, 440211-01-3, 440211-01-5, and 440213-01-6.

In Crash Test 440210-01-2, the test vehicle impacted the second net, causing the swivel mount for the second net's energy absorber to release the energy absorber. This was not intended in the design and was undesirable for future testing. Therefore, a new swivel mount was designed and utilized for all subsequent testing, including a retest of Test 440210-01-2 (440210-01-4). Test 3-40 (440210-01-1) was not repeated because the test vehicle did not contact the second net, and therefore the swivel mount design had no effect on the test results. Figure 4.9 presents the overall information for the second net after modifications, and Figure 4.10 through Figure 4.13 provide photographs of the installation.

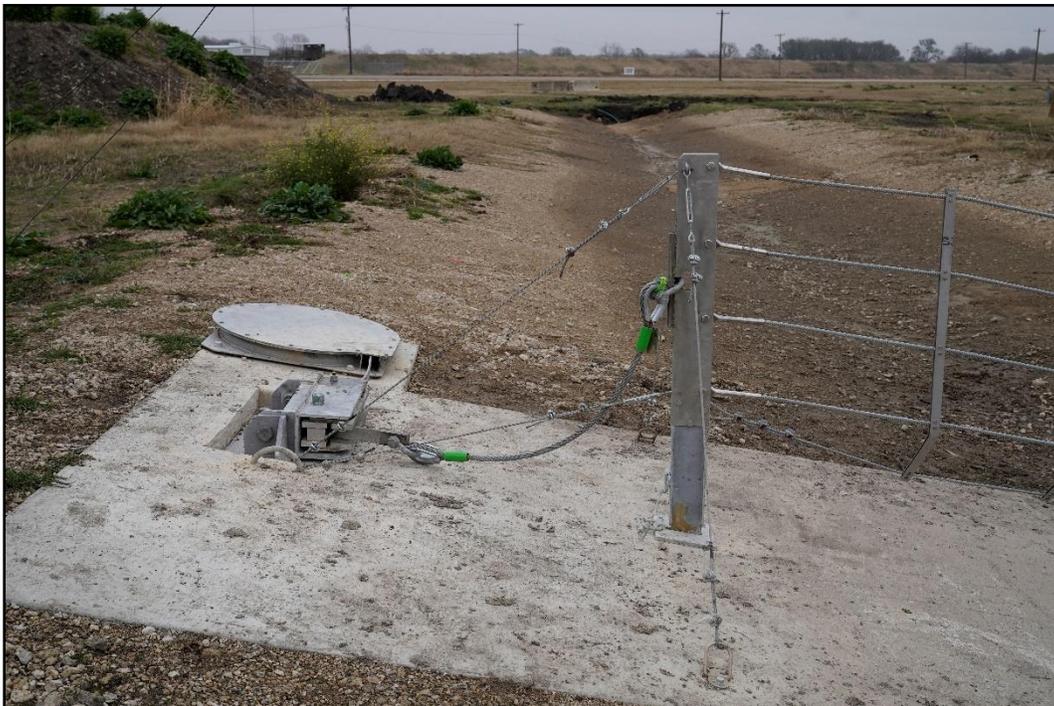
Figure 4.11. Anchor Hardware for the Second Median Opening Protection System Net prior to Crash Tests 440210-01-4, 440211-01-3, 440211-01-5, and 440213-01-6.

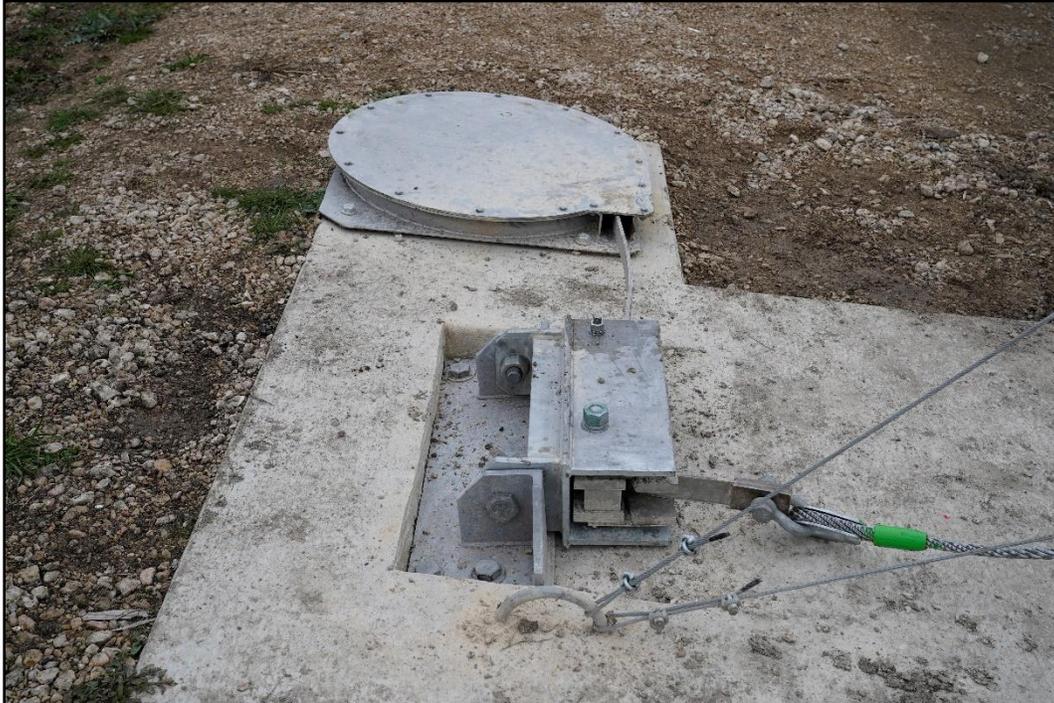
Figure 4.13. Swivel Mound System and Cannister for the Second Net prior to Crash Tests 440210-01-4, 440211-01-3, 440211-01-5, and 440213-01-6.

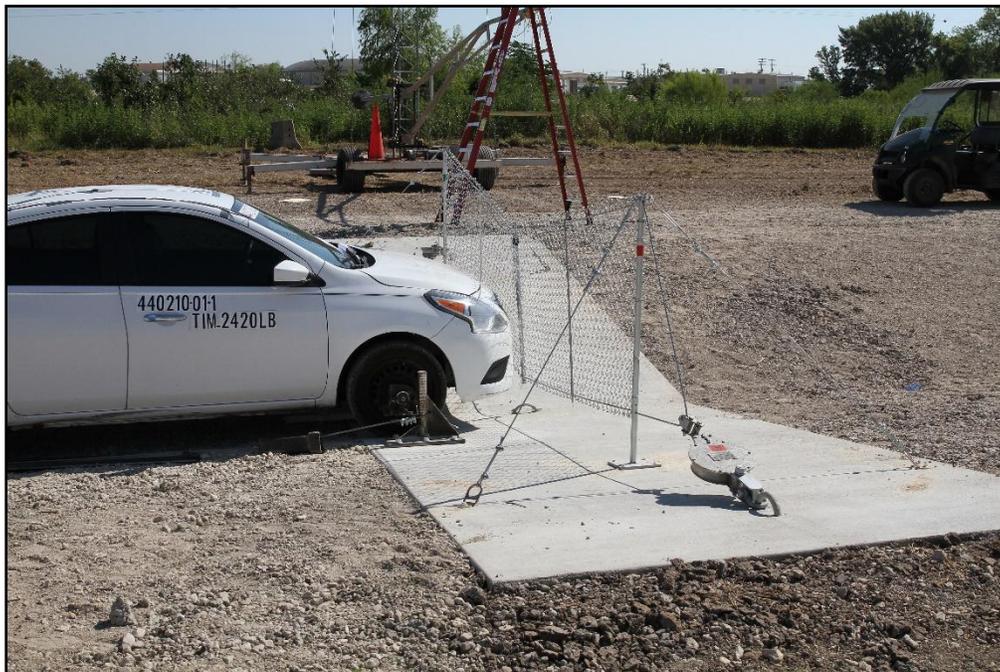
Figure 7.2. MOPS/Test Vehicle Impact Location for Test 440210-01-1.

See Table 7.1 for the *MASH* impact conditions and Table 7.2 for the exit parameters for Test 440210-01-1. Figure 7.1 and Figure 7.2 depict the target impact setup.

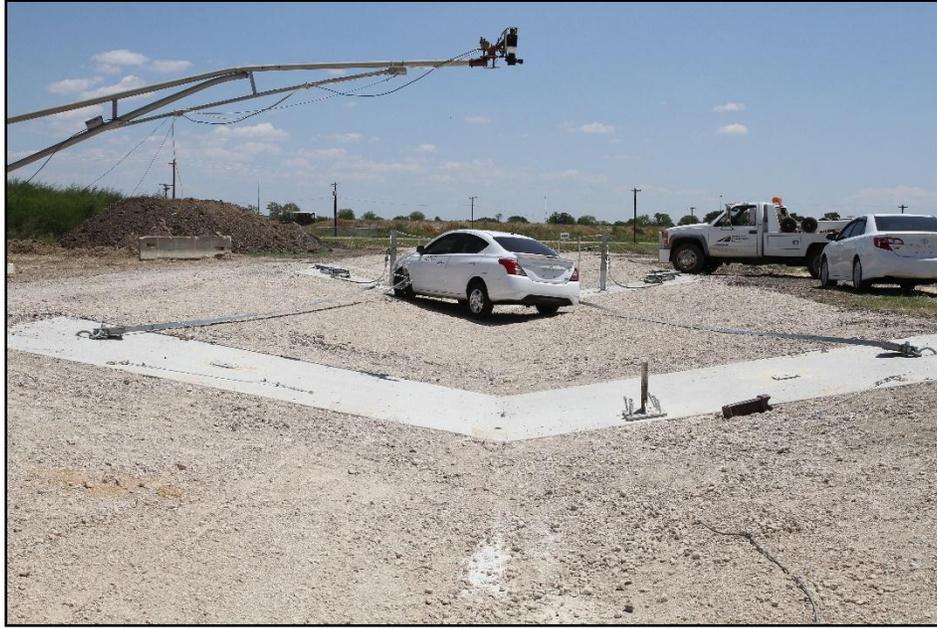
Figure 7.5. MOPS after Test 440210-01-1.

There was no movement or cracking noted on the foundation of the first net. The right and left post baseplates and the concrete immediately downstream of them had some scuffing, and the four oblique support cables all released from the net but remained attached to the concrete foundation. When facing the installation from upstream, the left tape pulled out from the canister 31 ft 11 inches, and the right tape pulled out 36 ft 7 inches. The fence remained attached to the tape and wrapped around the front and sides of the car. The left intermediate post fractured, and a section of it landed 46 ft downstream and 3 ft to the left of impact. Both the leftmost and rightmost posts deformed and sheared from the bottom cable. The test vehicle did not contact the second net (most downstream net) in the installation.

Table 7.6 describes the deflection and working width of the MOPS. Figure 7.5 and Figure 7.6 show the damage to the MOPS.

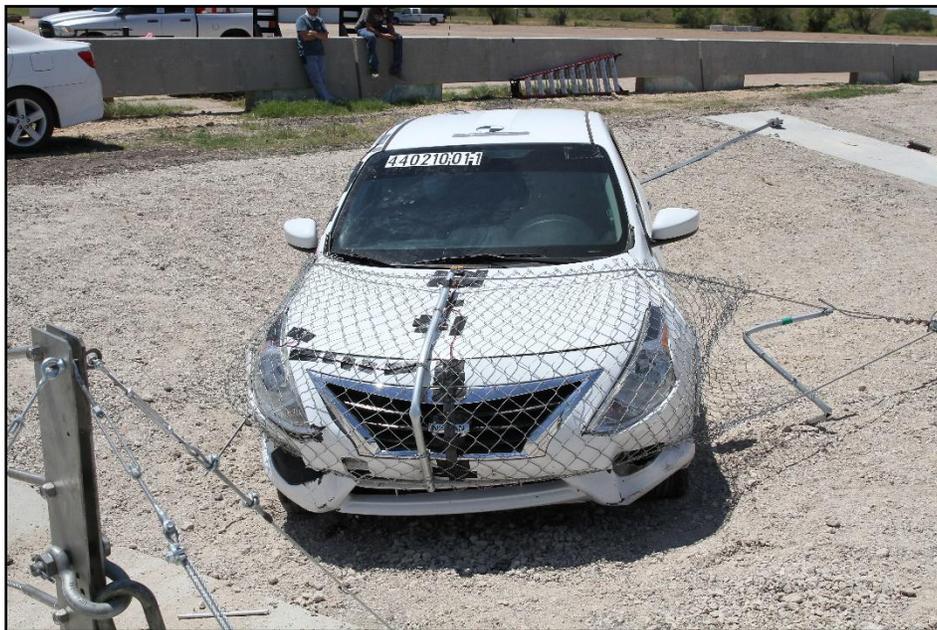
Figure 7.6. Maximum Penetration of the MOPS after Test 440210-01-1.

Test Parameter	Measured
Permanent Deflection/Location	45 ft toward field side
Dynamic Deflection	45 ft toward field side

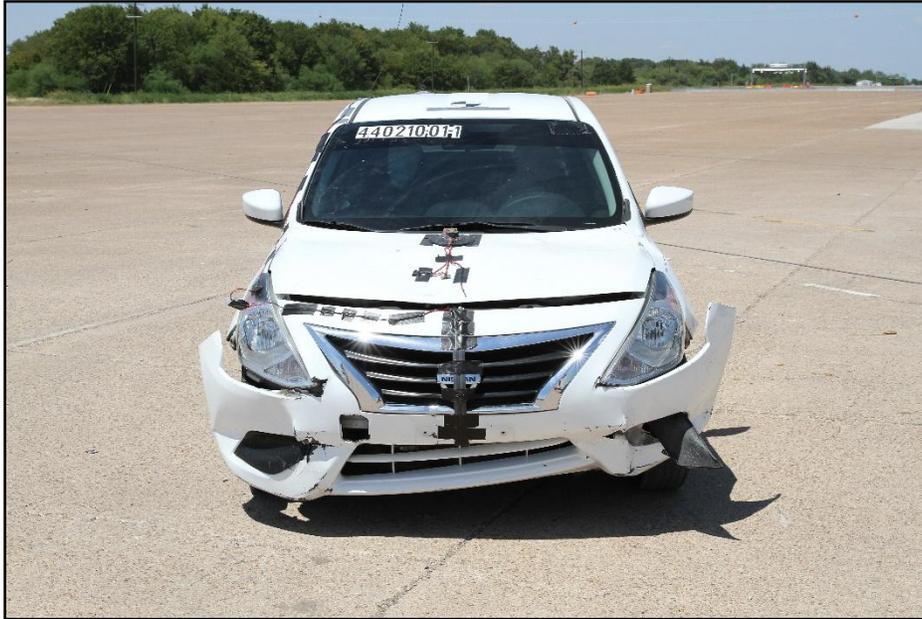
Figure 7.7. Test Vehicle after Test 440210-01-1.

Figure 7.7 and Figure 7.8 show the damage sustained by the vehicle. Figure 7.9 and Figure 7.10 show the interior of the test vehicle. Table 7.7 and Table 7.8 provide details on the occupant compartment deformation and exterior vehicle damage. Figures B.2 and B.3 in Appendix B.1 provide exterior crush and occupant compartment measurements.

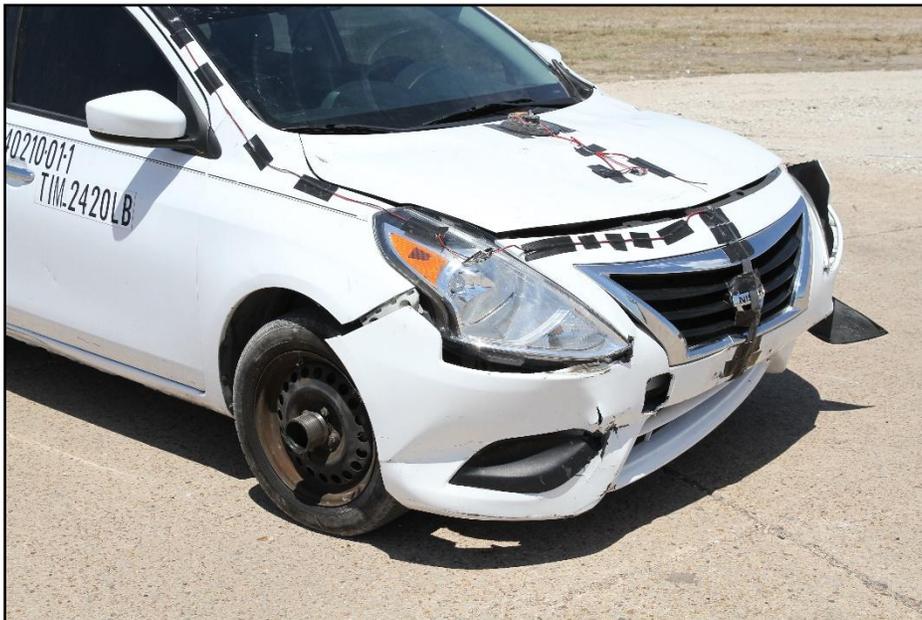
Figure 7.8. Front End of Test Vehicle after Test 440210-01-1.

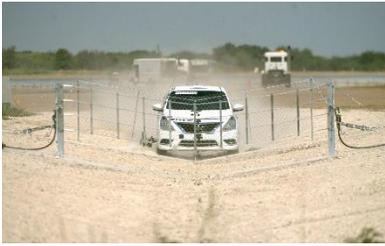
<p style="text-align: center;">0.000 s</p>	Test Agency		Texas A&M Transportation Institute (TTI)					
	Test Standard/Test No.		MASH 2016, Test 3-40					
	TTI Project No.		440210-01-1					
	Test Date		2020-08-20					
TEST ARTICLE								
		Type	Non-Redirective Crash Cushions					
		Name	MOPS					
		Length	50 ft					
		Key Materials	Wire mesh nets, wire rope net, energy absorbers					
		Soil Type and Condition	AASHTO M147-65(2004), Type 1, Grade D Crushed Concrete

<p style="text-align: center;">1.050 s</p>	EXIT CONDITIONS							
			Exit Speed (mi/h)	Vehicle did not exit the installation				
			Stopping Distance	45 ft downstream 5 ft to the left side				
	TEST ARTICLE DEFLECTIONS							
		Dynamic (ft)	45					
		Permanent (ft)	45					
VEHICLE DAMAGE								
		VDS	12FC1					
		CDC	12FCEN1					
		Max. Ext. Deformation (inches)	1					
		Max Occupant Compartment Deformation	No occupant compartment deformation					
OCCUPANT RISK VALUES								
Long. OIV (ft/s)	17.9	Long. Ridedown (g)	3.9	Max 50-ms Long. (g)	-3.5	Max Roll (deg)	6.3	
Lat. OIV (ft/s)	0.7	Lat. Ridedown (g)	1.9	Max 50-ms Lat. (g)	-1.6	Max Pitch (deg)	8.8	
THIV (m/s)	5.5	ASI	0.3	Max 50-ms Vert. (g)	1.3	Max Yaw (deg)	35

Figure 7.11. Summary of Results for MASH Test 3-40 on MOPS.

Figure 7.11 summarizes the results of *MASH* Test 440210-01-1.

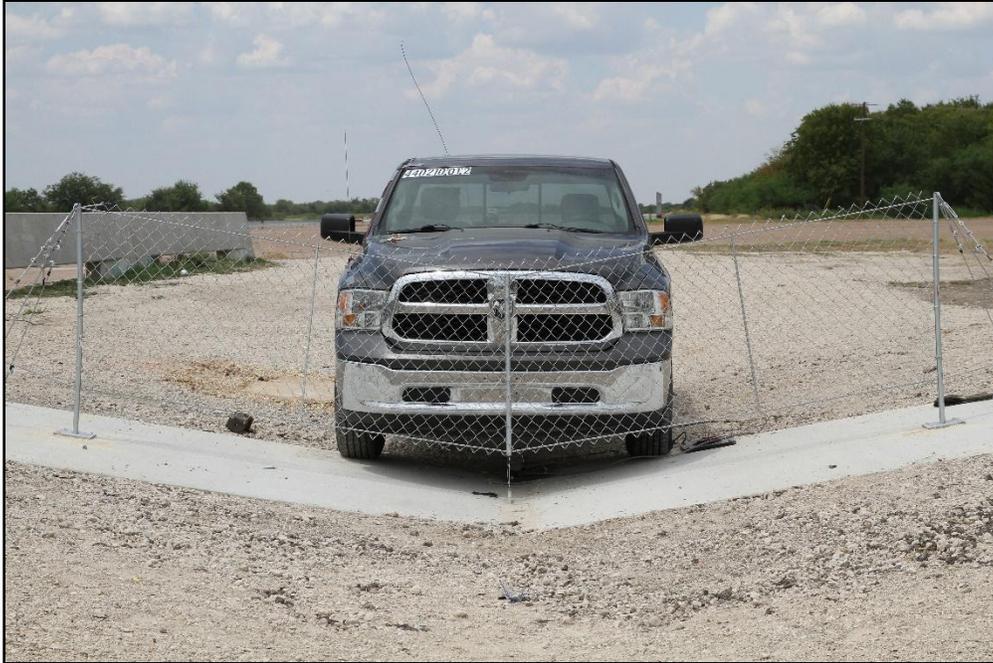
Figure 8.1. MOPS/Test Vehicle Geometrics for Test 440210-01-2.

See Table 8.1 for the *MASH* impact conditions and Table 8.2 for the exit parameters for Test 440210-01-2. Figure 8.1 and Figure 8.2 depict the target impact setup.

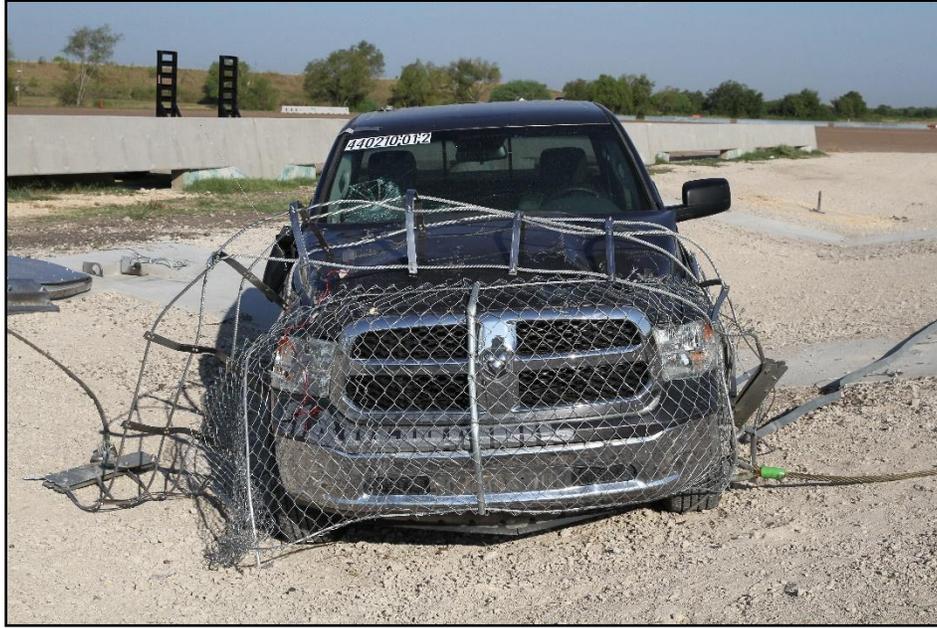
Figure 8.5. MOPSSs after Test 440210-01-2.

Table 8.6 describes the deflection and working width of the MOPS. Figure 8.5 and Figure 8.6 show the damage to the MOPS.

Test Parameter	Measured
Permanent Deflection/Location	67 ft toward field side
Dynamic Deflection	67 ft toward field side

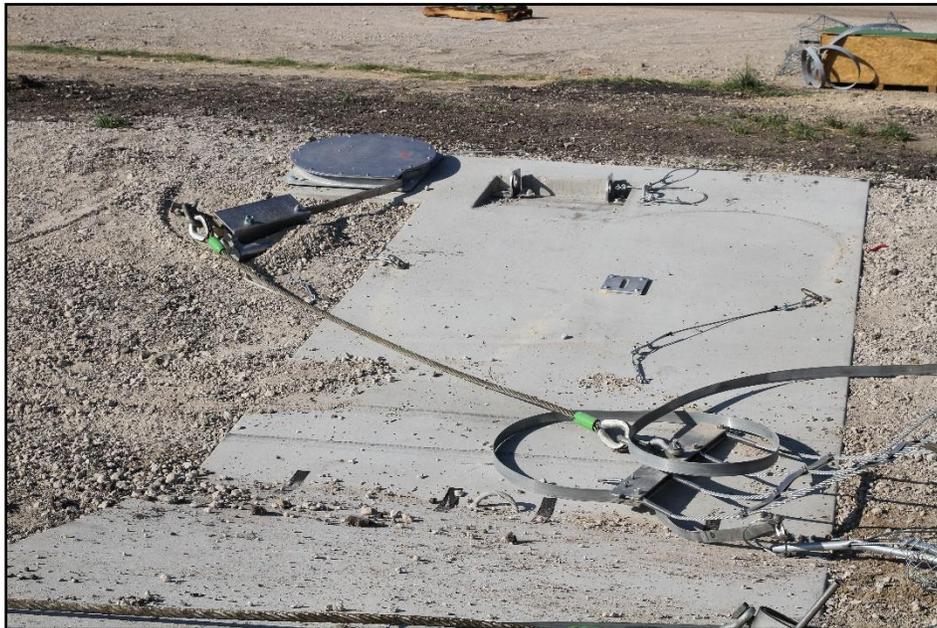
Figure 8.6. Second Net Swivel Anchor and Energy Absorbers after Test 440210-01-2.

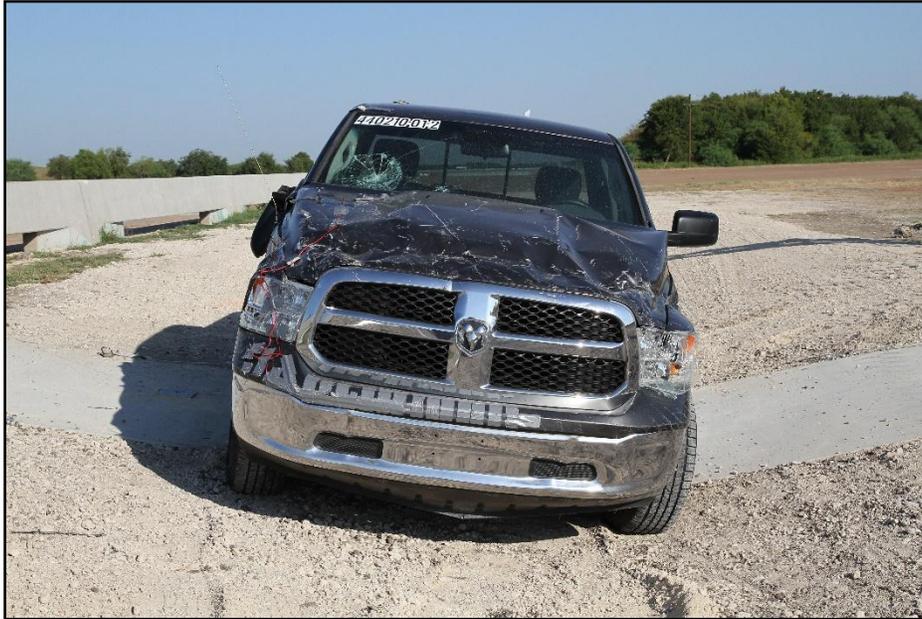
Figure 8.7. Front of Test Vehicle after Test 440210-01-2.

Figure 8.7 and Figure 8.8 show the damage sustained by the vehicle. Figure 8.9 and Figure 8.10 show the interior of the test vehicle. Table 8.7 and Table 8.8 provide details on the occupant compartment deformation and exterior vehicle damage. Figures C.2 and C.3 in Appendix C.1 provide exterior crush and occupant compartment measurements.

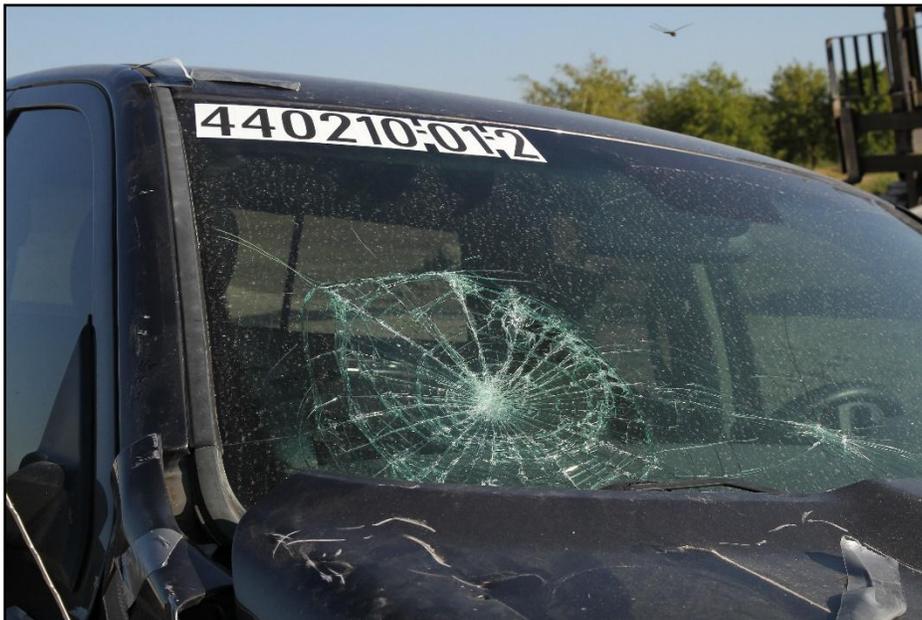
Figure 8.8. Windshield of Test Vehicle after Test 440210-01-2.

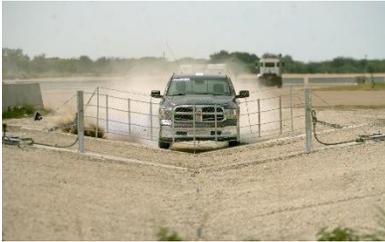
Figure 8.11. Summary of Results for MASH Test 3-41 on MOPS.

Test Agency		Texas A&M Transportation Institute (TTI)					
	Test Standard/Test No.		MASH 2016, Test 3-41					
	TTI Project No.		440210-01-2					
	Test Date		2020-08-24

Key Materials		Wire mesh nets, wire rope net, energy absorbers					
	Soil Type and Condition		AASHTO M147-65(2004), Type 1, Grade D Crushed Concrete					
	TEST VEHICLE							
	Type/Designation	2270P						
Year, Make and Model		2015 RAM 1500						
Inertial Weight (lb)		5020						
Dummy (lb)		N/A						
Gross Static (lb)		5020

IMPACT CONDITIONS							
	Impact Speed (mi/h)		62.1					
	Impact Angle (deg)		0.3					
	Impact Location		Centerline of the vehicle aligned 4.8 inches to the left of the centerline of the MOPS					
Kinetic Energy (kip-ft)		647.2						
EXIT CONDITIONS								
Exit Speed (mi/h)		N/A						
Stopping Distance		67 ft downstream 4 ft to the left side

TEST ARTICLE DEFLECTIONS								
Dynamic (ft)		67						
Permanent (ft)		67						
VEHICLE DAMAGE								
VDS		12FC3						
CDC		12CEN2						
Max. Ext. Deformation (inches)		1.5						
Max Occupant Compartment Deformation		1.5 inches in the windshield and right rear fender						
OCCUPANT RISK VALUES								
Long. OIV (ft/s)	13.4	Long. Ridedown (g)	7.6	Max 50-ms Long. (g)	-5.7	Max Roll (deg)	6.8	
Lat. OIV (ft/s)	3.1	Lat. Ridedown (g)	2.1	Max 50-ms Lat. (g)	-1.6	Max Pitch (deg)	6.1	
THIV (m/s)	4.2	ASI	0.5	Max 50-ms Vert. (g)	-2.1	Max Yaw (deg)	25.7

Figure 8.11 summarizes the results of *MASH* Test 440210-01-2. In Test 440210-01-2, the test vehicle impacted the second net, causing the swivel mount for the second net's energy absorber to release the energy absorber. This was not intended in the design and was undesirable for future testing. Therefore, a new swivel mount was designed and utilized for all subsequent testing, including a retest of 440210-01-2 (440210-01-4).

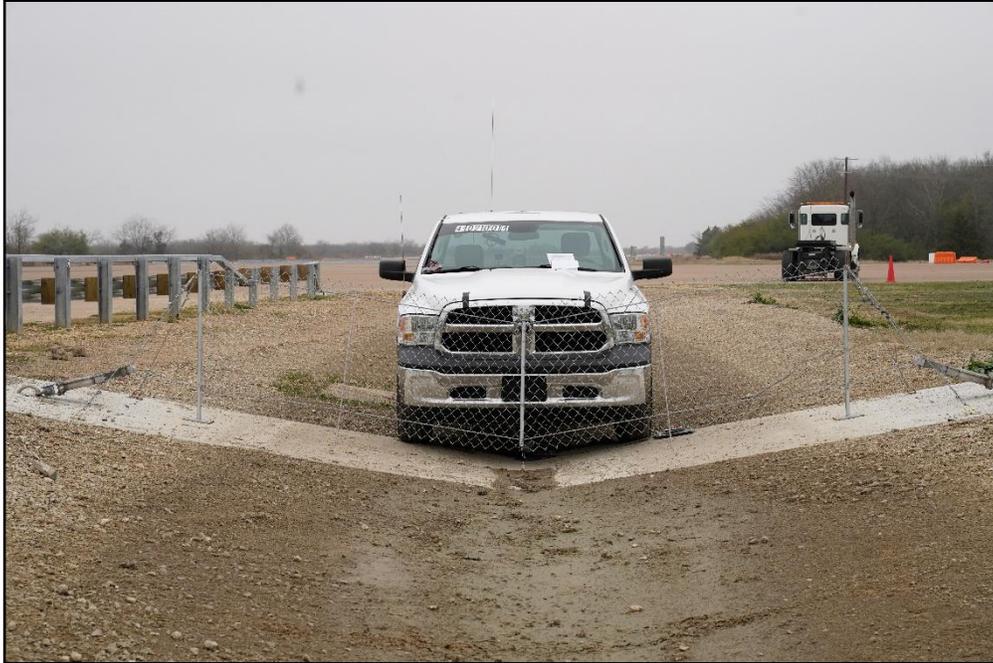
Figure 9.1. MOPS/Test Vehicle Geometrics for Test 440210-01-4.

See Table 9.1 for the *MASH* impact conditions and Table 9.2 for the exit parameters for Test 440210-01-4. Figure 9.1 and Figure 9.2 depict the target impact setup.

MASH specifies a ±6-inch tolerance for the impact location in Test 3-41. The test vehicle impacted the first net 7.3 inches away from the target centerline of the net, which is slightly outside of the allowable tolerance. This 6-inch tolerance is typically utilized for test articles when installed on flat and level terrain. In this test, the first net was installed 120 ft within a V-ditch. With this configuration, it is significantly more difficult to release a vehicle and impact a narrow target compared to flat and level terrain. Additionally, the energy absorbers on the net system are allowed to pivot around the anchorage bars, which allows the net system to self-align during an impact. The energy absorbers are also designed for the strap material to be pulled out of the canister at a specific force. Therefore, the strap material will be pulled out of the canister before any additional force can be applied to the energy absorber due to the slightly misaligned impact. Consequently, the research team chose to not rerun Test 3-41 and proceeded with the subsequent tests, detailed in later chapters.
