Test Report No. 0-7021-01-R1

**DEVELOPING AN ENHANCED PROTECTION OF MEDIAN OPENINGS
BETWEEN PARALLEL BRIDGE STRUCTURES**

Sponsored by the
**Texas Department of Transportation
and the
Federal Highway Administration**

TEXAS A&M TRANSPORTATION INSTITUTE PROVING GROUND

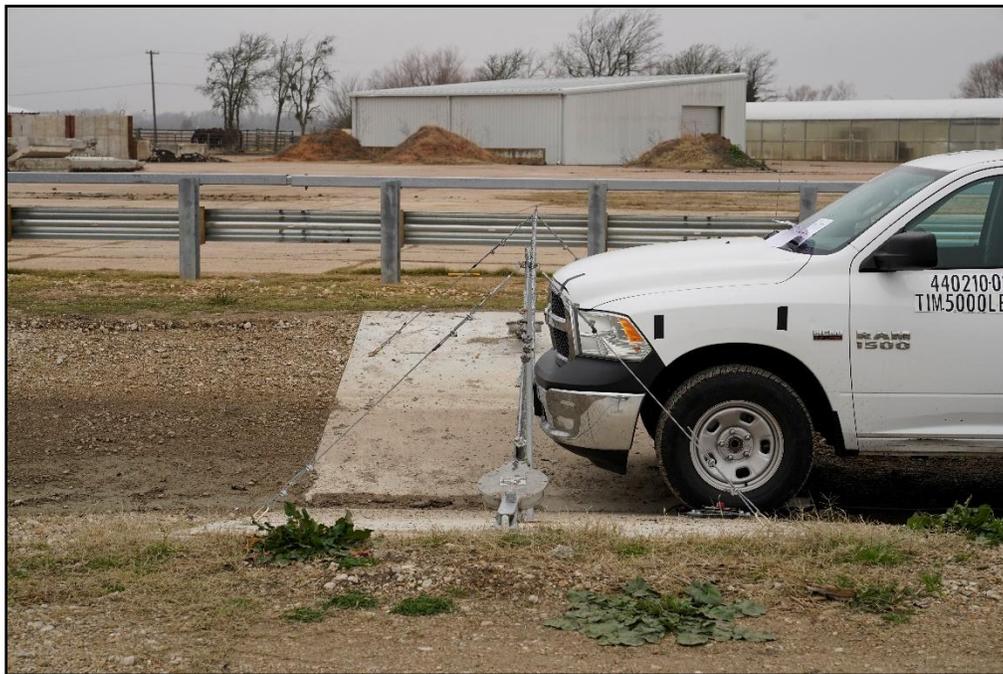
Figure 9.2. MOPS/Test Vehicle Impact Location for Test 440210-01-4.

See Table 9.1 for the *MASH* impact conditions and Table 9.2 for the exit parameters for Test 440210-01-4. Figure 9.1 and Figure 9.2 depict the target impact setup.

MASH specifies a ±6-inch tolerance for the impact location in Test 3-41. The test vehicle impacted the first net 7.3 inches away from the target centerline of the net, which is slightly outside of the allowable tolerance. This 6-inch tolerance is typically utilized for test articles when installed on flat and level terrain. In this test, the first net was installed 120 ft within a V-ditch. With this configuration, it is significantly more difficult to release a vehicle and impact a narrow target compared to flat and level terrain. Additionally, the energy absorbers on the net system are allowed to pivot around the anchorage bars, which allows the net system to self-align during an impact. The energy absorbers are also designed for the strap material to be pulled out of the canister at a specific force. Therefore, the strap material will be pulled out of the canister before any additional force can be applied to the energy absorber due to the slightly misaligned impact. Consequently, the research team chose to not rerun Test 3-41 and proceeded with the subsequent tests, detailed in later chapters.

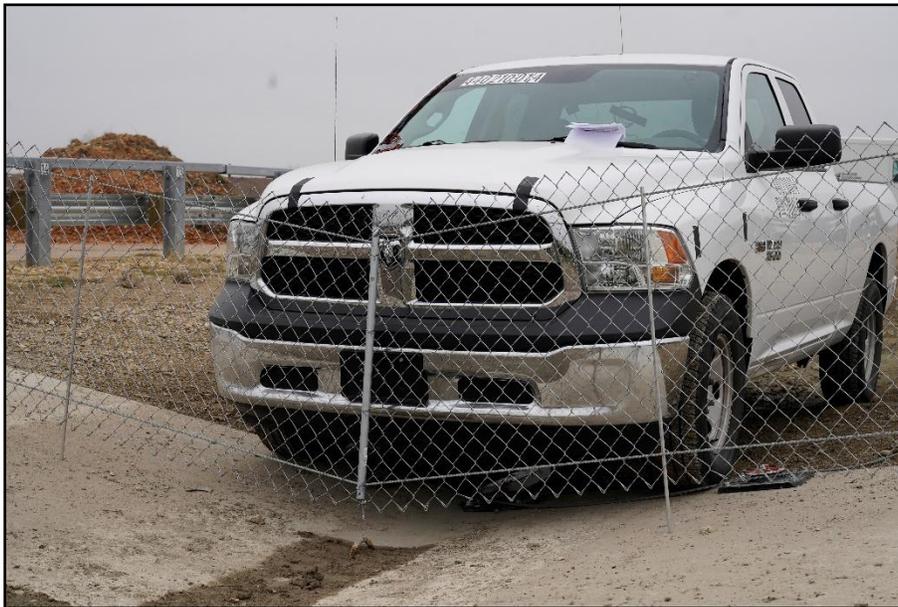
Figure 9.3. Front of Test Vehicle before Test 440210-01-4.

Figure 9.3 and Figure 9.4 show the 2016 RAM 1500 used for the crash test. Table 9.4 shows the vehicle measurements. Figure D.1 in Appendix D.1 gives additional dimensions and information on the vehicle.

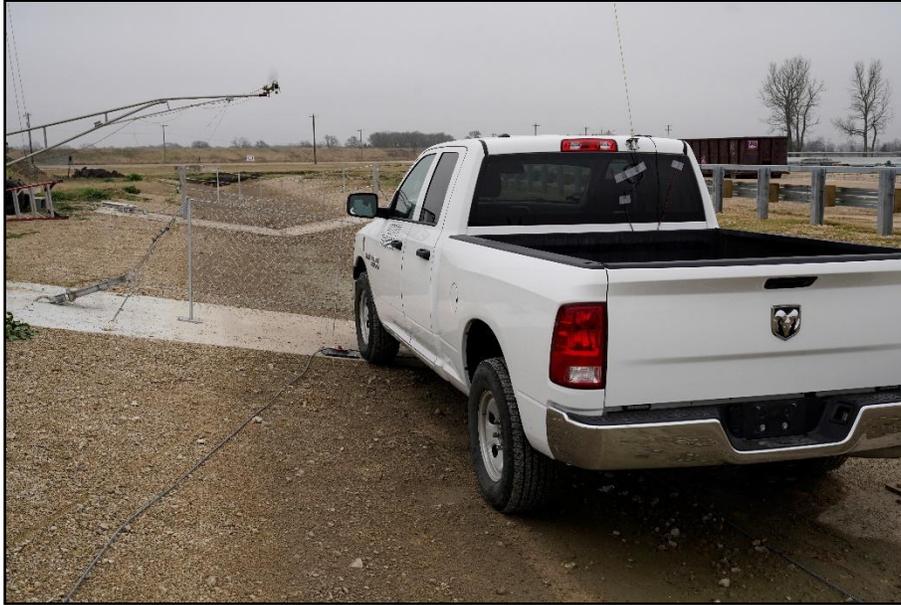
Figure 9.4. Back of Test Vehicle before Test 440210-01-4.

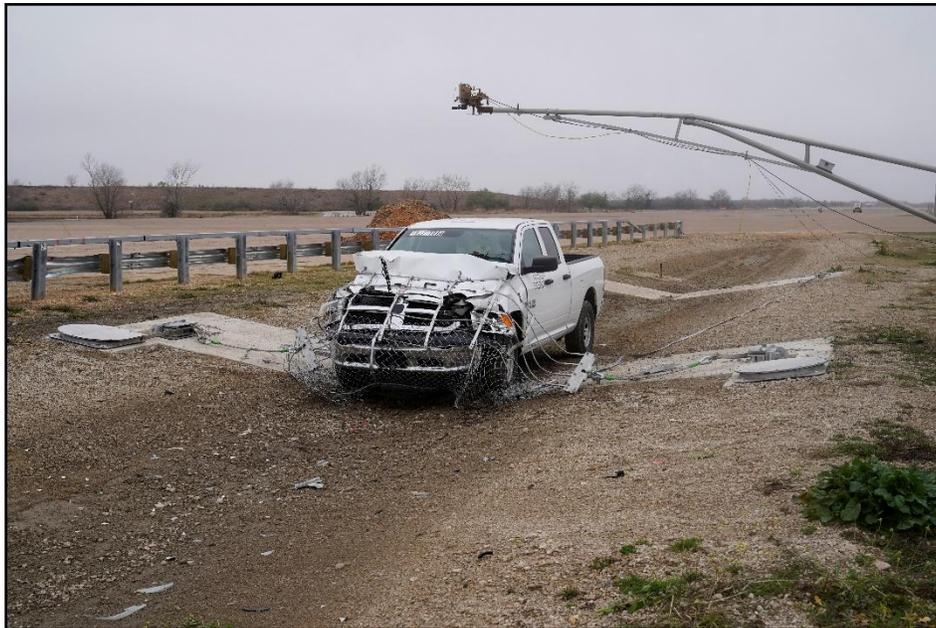
Figure 9.5. MOPS after Test 440210-01-4.

The first net was wrapped around the front bumper of the vehicle, while the second net was wrapped over the hood. Both nets remained attached to their straps. There was some slight gouging of the concrete at the second net. Table 9.6 describes the deflection and working width of the MOPS. Figure 9.5 and Figure 9.6 show the damage to the MOPS.

Test Parameter	Measured
Permanent Deflection/Location	52.7 ft toward field side
Dynamic Deflection	59.7 ft toward field side

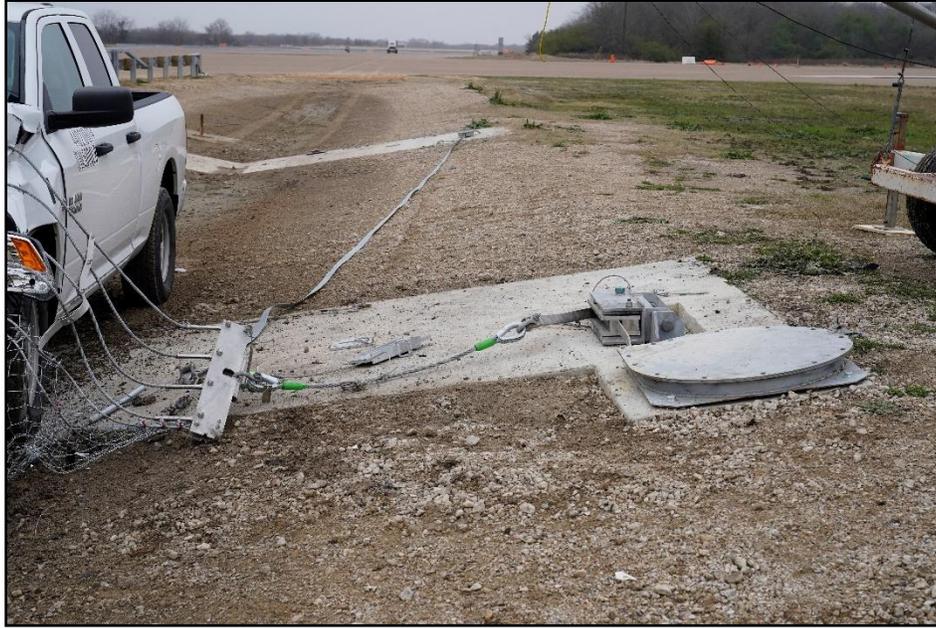
Figure 9.6. Second Net Swivel Anchor and Energy Absorbers after Test 440210-01-4.

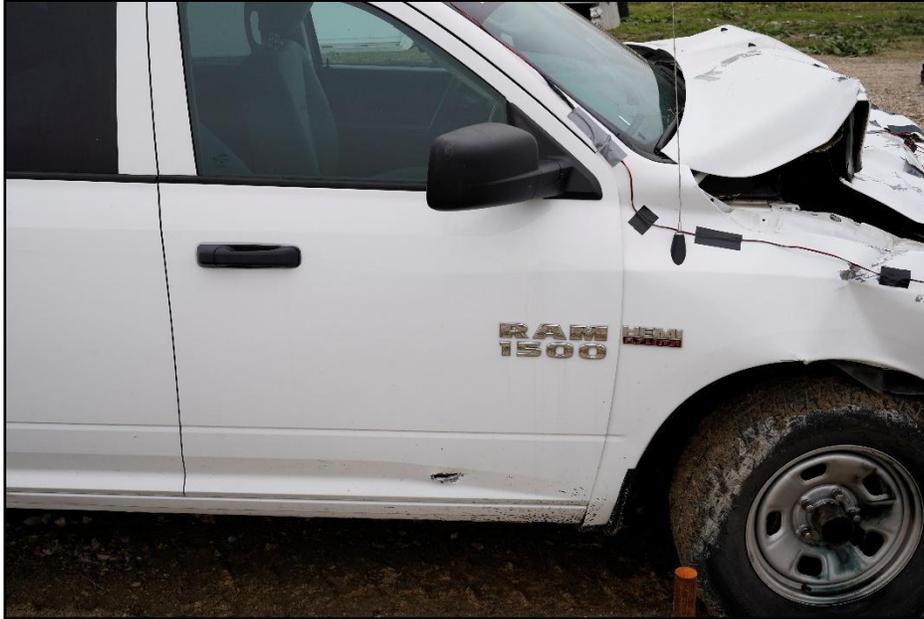
Figure 9.8. Right Side of Test Vehicle after Test 440210-01-4.

Figure 9.7 and Figure 9.8 show the damage sustained by the vehicle. Figure 9.9 and Figure 9.10 show the interior of the test vehicle. Table 9.7 and Table 9.8 provide details on the occupant compartment deformation and exterior vehicle damage. Figures D.2 and D.3 in Appendix D.1 provide exterior crush and occupant compartment measurements.

Side Windows	The side windows remained intact
Maximum Exterior Deformation	10 inches in the front plane at bumper height
VDS	12FC4
CDC	12CEN3
Fuel Tank Damage	None
Description of Damage to Vehicle:	The front bumper, hood, grill, right and left headlights, radiator and support, right and left fender, and right door were damaged. The right front door had a 3-inch-long and 1-inch-wide cut on the lower front corner. There was no penetration into the occupant compartment.

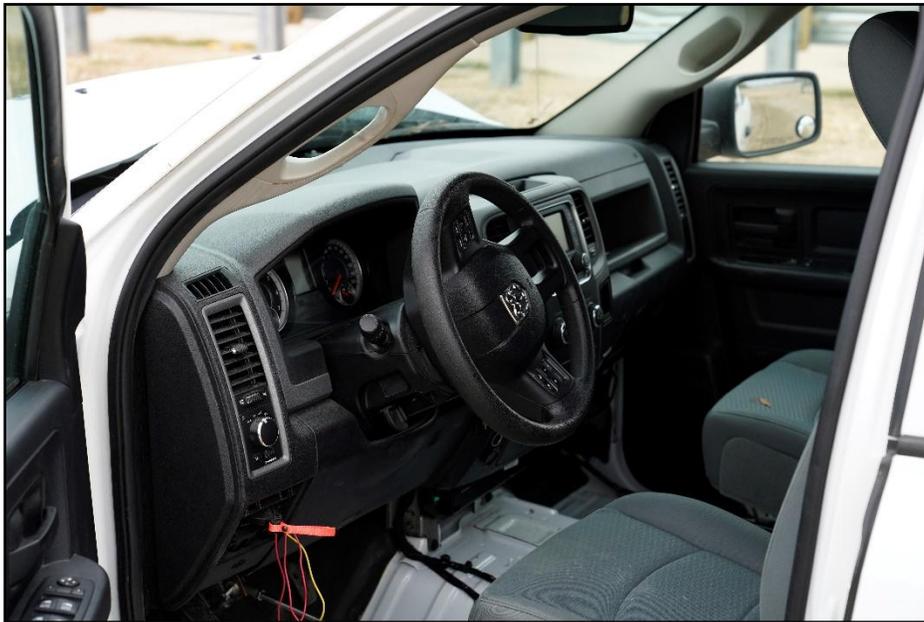
Figure 9.9. Overall Interior of Test Vehicle after Test 440210-01-4.

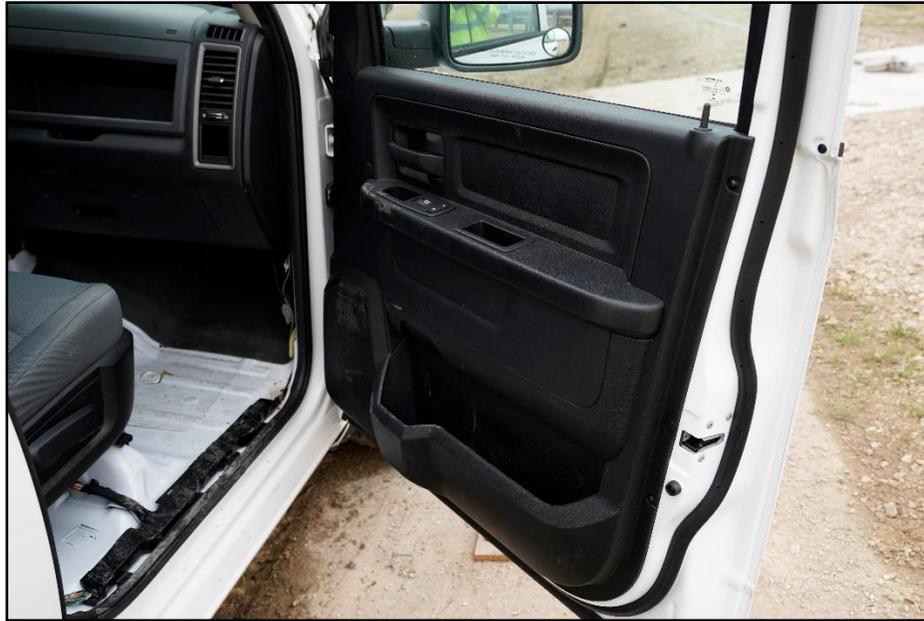
Figure 9.10. Right-Side Interior of Test Vehicle after Test 440210-01-4.

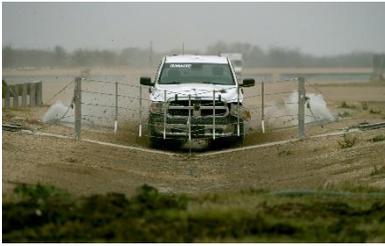
Figure 9.11. Summary of Results for MASH Test 3-41 on MOPS.

<p style="text-align: center;">0.000 s</p>	Test Agency		Texas A&M Transportation Institute (TTI)					
	Test Standard/Test No.		MASH 2016, Test 3-41					
	TTI Project No.		440210-01-4					
	Test Date		2021-01-20					
TEST ARTICLE								
		Type	Non-Redirective Crash Cushions					
		Name	MOPS					
		Length	50 ft					
		Key Materials	Wire mesh nets, wire rope net, energy absorbers					
		Soil Type and Condition	AASHTO M147-65(2004), Type 1, Grade D Crushed Concrete

<p style="text-align: center;">0.200 s</p>	TEST VEHICLE							
			Type/Designation	2270P				
			Year, Make and Model	2016 RAM 1500				
			Inertial Weight (lb)	5069				
		Dummy (lb)	N/A					
		Gross Static (lb)	5069					
IMPACT CONDITIONS								
		Impact Speed (mi/h)	62.8					
		Impact Angle (deg)	0.0					
		Impact Location	Centerline of the vehicle aligned 7.3 inches to the right of the centerline of the MOPS					
		Kinetic Energy (kip-ft)	668.3

EXIT CONDITIONS								
		Exit Speed (mi/h)	Vehicle did not exit the installation					
		Stopping Distance	52.7 ft downstream In line

<p style="text-align: center;">0.400 s</p>	TEST ARTICLE DEFLECTIONS							
			Dynamic (ft)	59.7				
			Permanent (ft)	52.7				
	VEHICLE DAMAGE							
		VDS	12FC4					
		CDC	12CEN3					
		Max. Ext. Deformation (inches)	10					
		Max Occupant Compartment Deformation	No occupant compartment deformation

<p style="text-align: center;">0.600 s</p>	OCCUPANT RISK VALUES							
	Long. OIV (ft/s)	15.7	Long. Ridedown (g)	13.3	Max 50-ms Long. (g)	-9.6	Max Roll (deg)	8.2
	Lat. OIV (ft/s)	1.1	Lat. Ridedown (g)	2.2	Max 50-ms Lat. (g)	-1.1	Max Pitch (deg)	5.3
	THIV (m/s)	4.8	ASI	0.9	Max 50-ms Vert. (g)	2.9	Max Yaw (deg)	2.1

Figure 9.11 summarizes the results of *MASH* Test 440210-01-4.

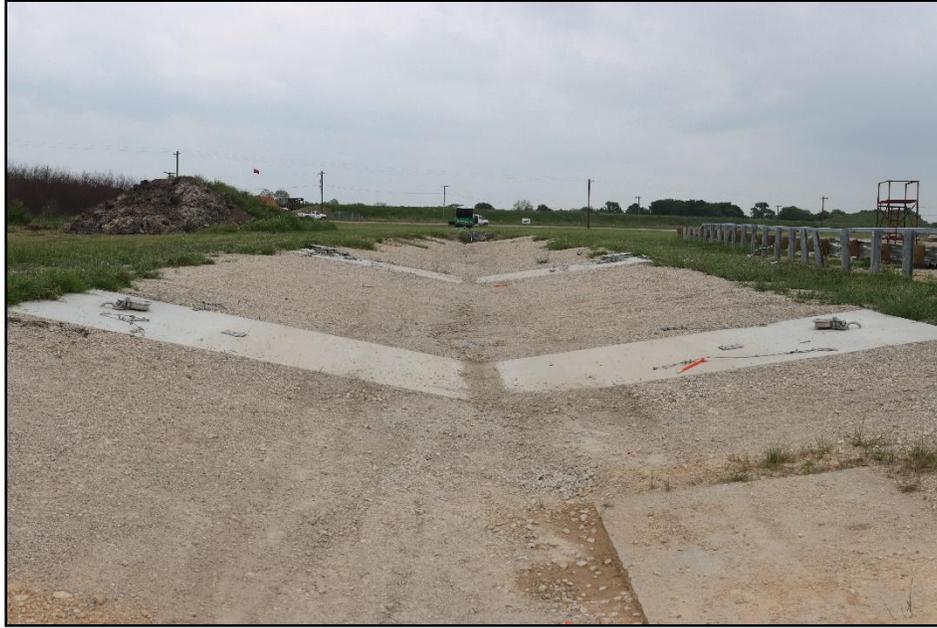
Figure 10.1. Crash Site after Test 440211-01-3.

The steel straps from the first net landed 197 ft downstream and 268 ft downstream, and the first net was 312 ft downstream. The second net ruptured and was still attached to the right side of the test vehicle and was laying 15 ft to the right from center. Table 10.6 describes the deflection and working width of the MOPS. Figure 10.1 and Figure 10.2 show the damage to the MOPS.

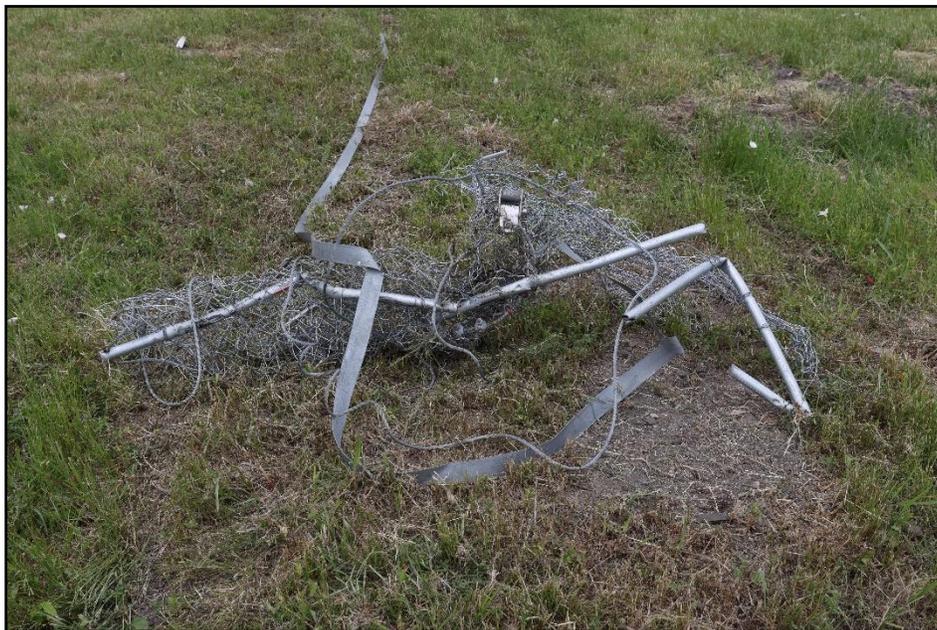
Figure 10.2. Second Net after Test 440211-01-3.

Figure 10.7 summarizes the results of Test 440211-01-3. The second net's wire rope cables failed during the impact. Upon inspection of the damaged test article, it was determined that swage fittings on each of the wire ropes were not installed correctly in the factory. This caused the wire ropes to slip out from the swage fittings and

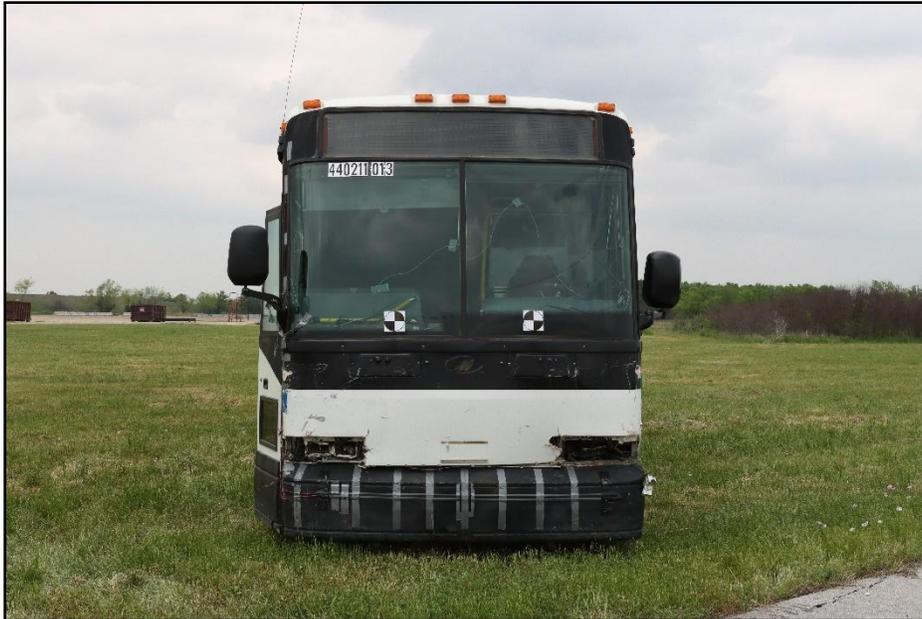
Figure 10.3. Front of Test Vehicle after Test 440211-01-3.

Figure 10.3 and Figure 10.4 show the damage sustained by the vehicle. Figure 10.5 and Figure 10.6 show the interior of the test vehicle. Table 10.7 provide details on the exterior vehicle damage. Due to the failure of the installation, occupant compartment deformation was not measured.

Side Windows	The side windows remained intact
Maximum Exterior Deformation	Maximum exterior deformation was not measured due to installation failure
VDS	12FC1
CDC	12FCEN1
Fuel Tank Damage	None
Description of Damage to Vehicle:	The front bumper, headlights, and front side panels were damaged.

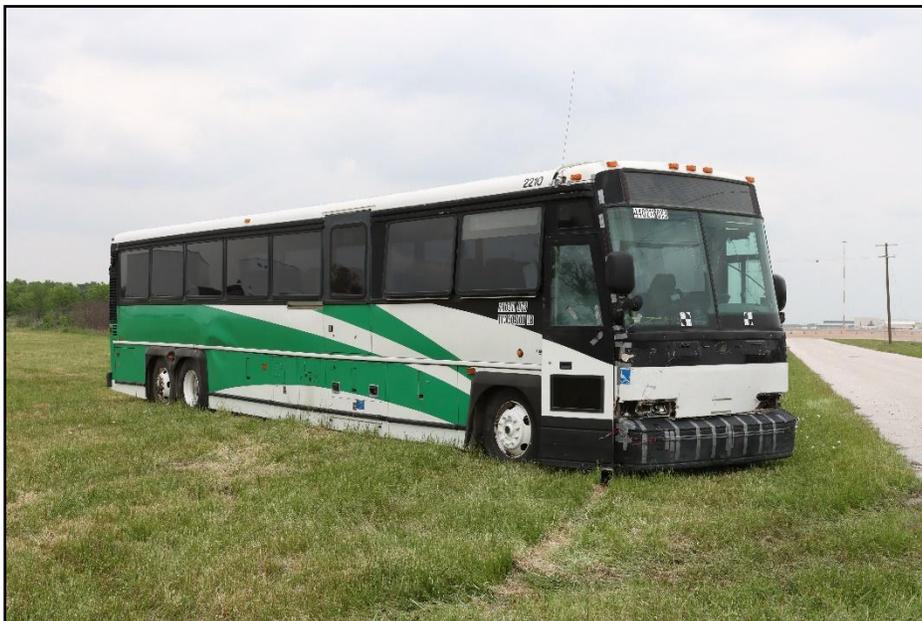
Figure 10.4. Oblique View of Test Vehicle after Test 440211-01-3.

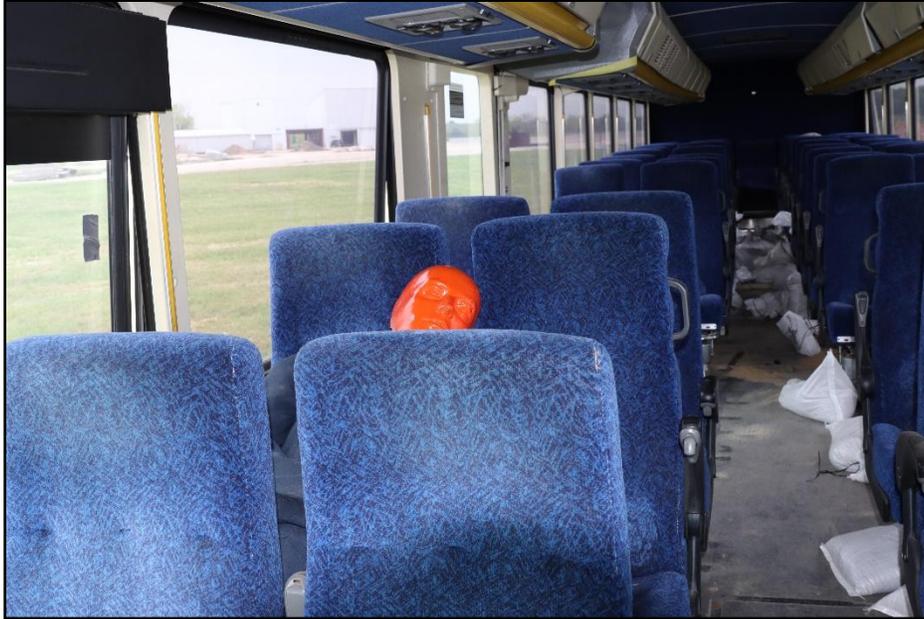
Figure 10.5. Overall Rear Interior of Test Vehicle after Test 440211-01-3.

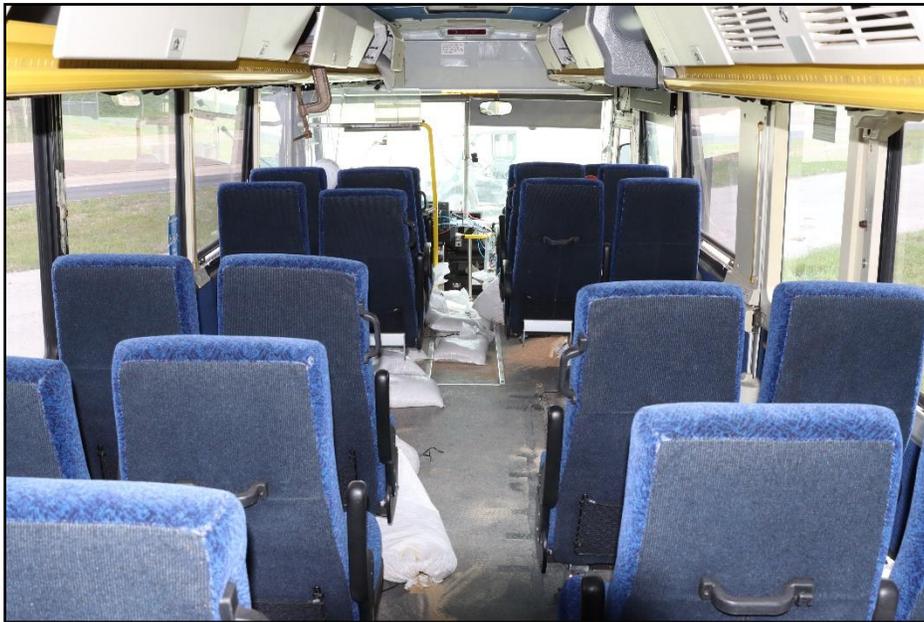
Figure 10.6. Overall Front Interior of Test Vehicle after Test 440211-01-3.

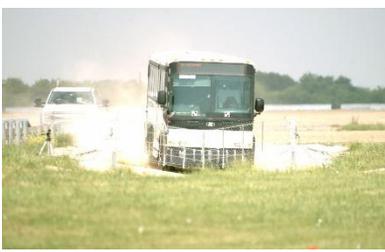
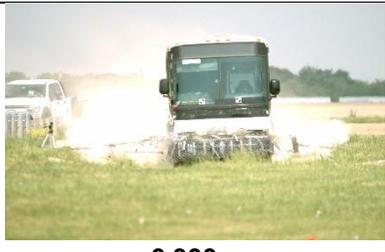
Figure 10.7. Summary of Results for Research and Development Test on MOPS.

<p style="text-align: center;">0.000 s</p>	Test Agency	Texas A&M Transportation Institute (TTI)					
	Test Standard/Test No.	Research and Development Test					
	TTI Project No.	440211-01-3					
	Test Date	2021-04-13

<p style="text-align: center;">0.100 s</p>	TEST ARTICLE						
	Type	Non-Redirective Crash Cushions					
	Name	MOPS					
	Length	50 ft

<p style="text-align: center;">0.200 s</p>	Key Materials	Wire mesh nets, wire rope net, energy absorbers					
	Soil Type and Condition	AASHTO M147-65(2004), Type 1, Grade D Crushed Concrete					
	TEST VEHICLE						
	Type/Designation	Passenger Bus

<p style="text-align: center;">0.300 s</p>	Year, Make and Model	2004 MCI D4500					
	Curb (lb)	37,120					
	Inertial Weight (lb)	50,160					
	IMPACT CONDITIONS						
Impact Speed (mi/h)	51.8						
Impact Angle (deg)	2.8						
Impact Location	Centerline of the vehicle aligned 8 inches to the left of the centerline of the first MOPS net, and 17.8 inches to the left of the centerline of the second net

Kinetic Energy (kip-ft)	4499.3						
EXIT CONDITIONS							
Exit Speed (mi/h)	N/A						
Stopping Distance	524 ft downstream In line						
TEST ARTICLE DEFLECTIONS							
Dynamic (inches)	N/A						
Permanent (inches)	N/A						
VEHICLE DAMAGE							
VDS	12FC1						
CDC	12FCEN1						
Max. Ext. Deformation (inches)	Not measured						
Max Occupant Compartment Deformation	Not measured						
OCCUPANT RISK VALUES							
Long. OIV (ft/s)	2.7	Long. Ridedown (g)	2.1	Max 50-ms Long. (g)	-1.5	Max Roll (deg)	5.5
Lat. OIV (ft/s)	3.2	Lat. Ridedown (g)	1.9	Max 50-ms Lat. (g)	-0.9	Max Pitch (deg)	7.1
THIV (m/s)	1.3	ASI	0.3	Max 50-ms Vert. (g)	-2.8	Max Yaw (deg)	1.7

consequently allowed the test vehicle to penetrate through the net. Therefore, the research team performed the test again with properly manufactured nets, and this effort is documented in the next chapter.

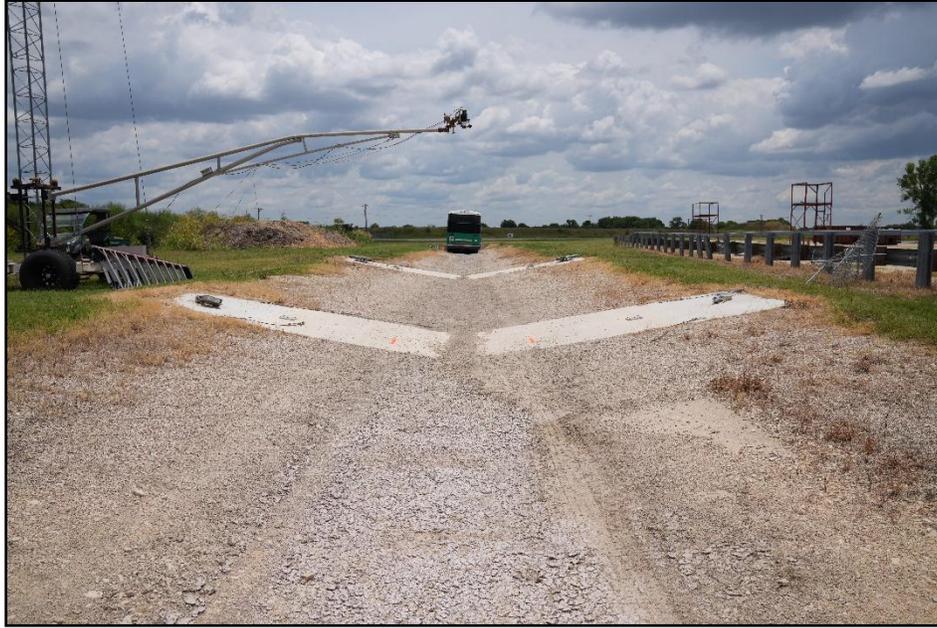
Figure 11.1. Crash Site after Test 440211-01-5.

The strap from the left cannister on the first net ruptured. The first net landed to the right of impact. The strap from the left cannister on the second net spooled out 71.5 ft. The strap from the right cannister on the second net ruptured and wrapped around the front of the bus. Table 11.6 describes the deflection and working width of the MOPS. Figure 11.1 and Figure 11.2 show the damage to the MOPS.

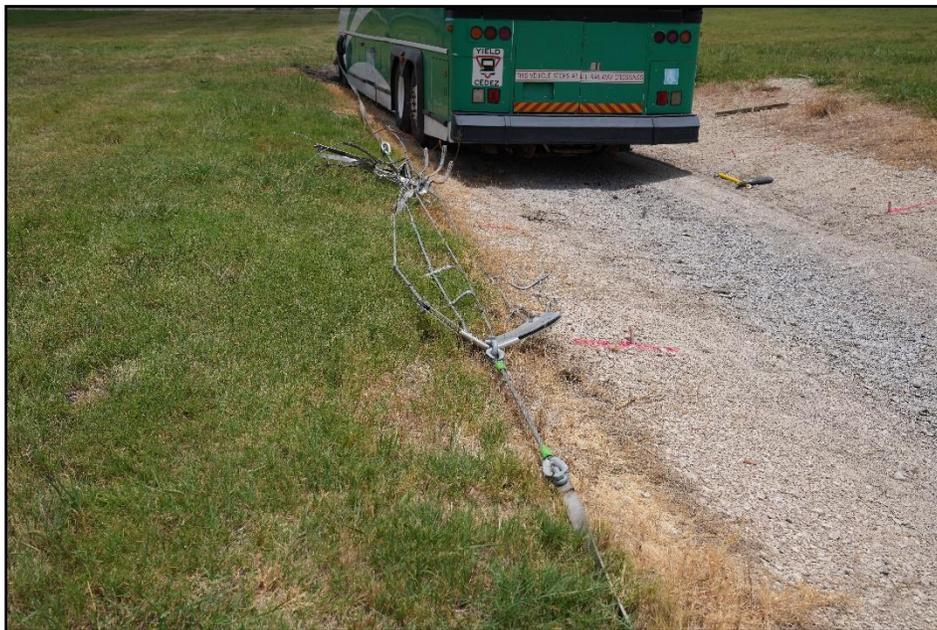
Figure 11.2. MOPS after Test 440211-01-5.

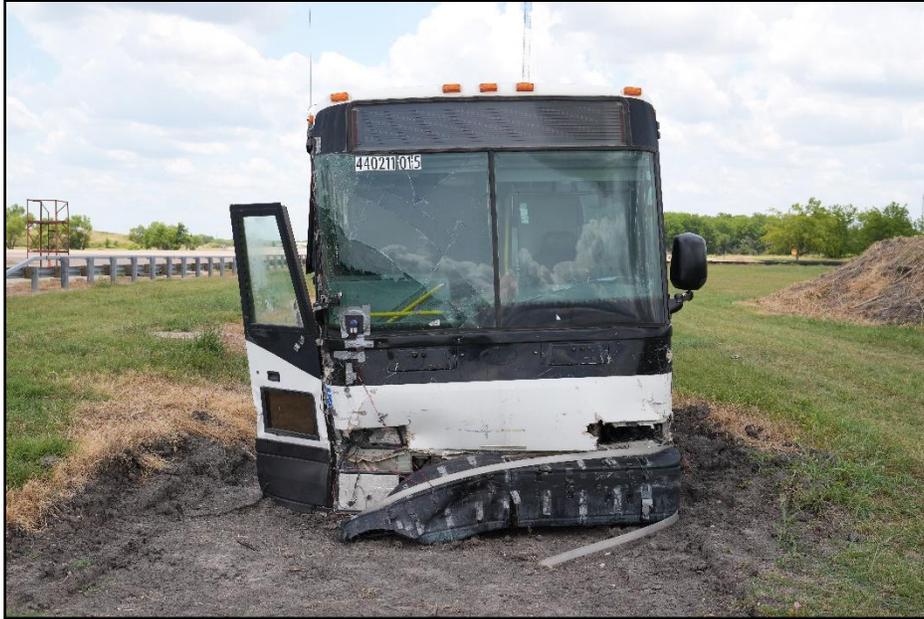
Figure 11.3. Front of Test Vehicle after Test 440211-01-5.

Figure 11.3 and Figure 11.4 show the damage sustained by the vehicle. Figure 11.5 and Figure 11.6 show the interior of the test vehicle. Table 11.7 provides details on the exterior vehicle damage. Due to the failure of the installation, occupant compartment deformation was not measured.

Side Windows	The side windows remained intact
Maximum Exterior Deformation	Maximum exterior deformation was not measured due to installation failure
VDS	12FC2
CDC	12FCEN1
Fuel Tank Damage	None
Description of Damage to Vehicle:	The front bumper, windshield, right-side mirror, and side panels were damaged. The windshield had some cracking and minor deformation. Due to the MOPS failing to contain and arrest the test vehicle, no measurements were taken on the deformation of the windshield.

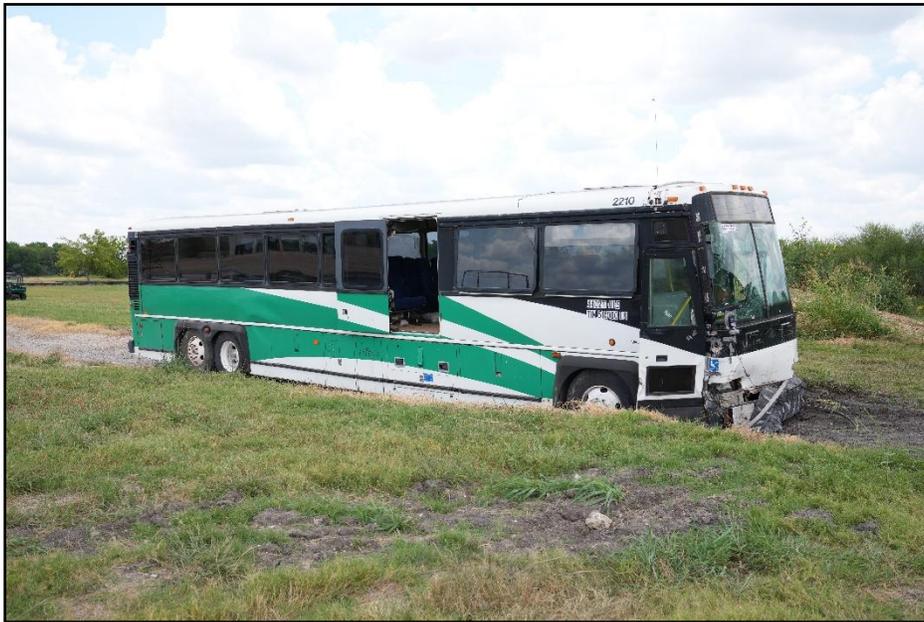
Figure 11.4. Oblique View of Test Vehicle after Test 440211-01-5.

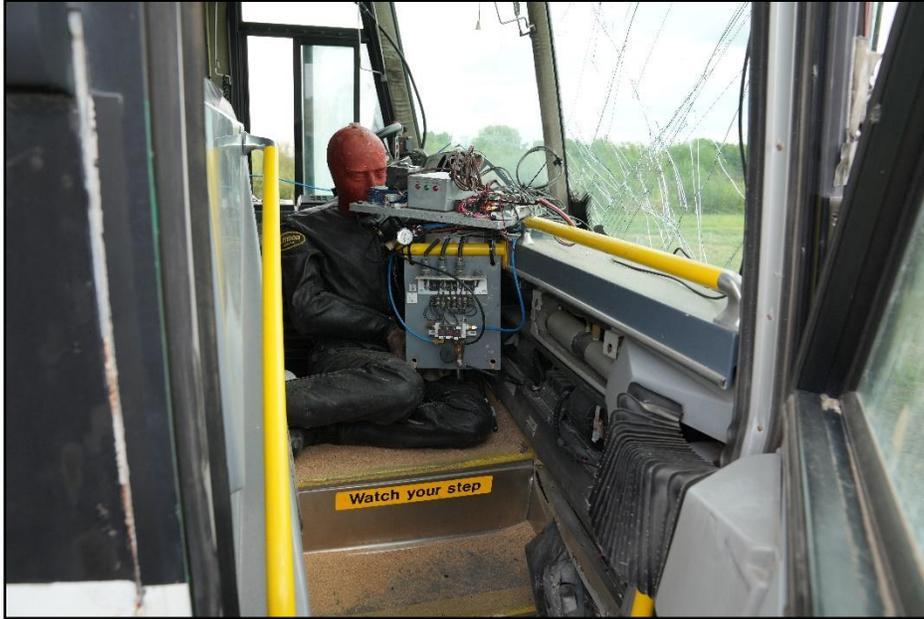
Figure 11.5. Overall Interior of Front of Test Vehicle after Test 440211-01-5.

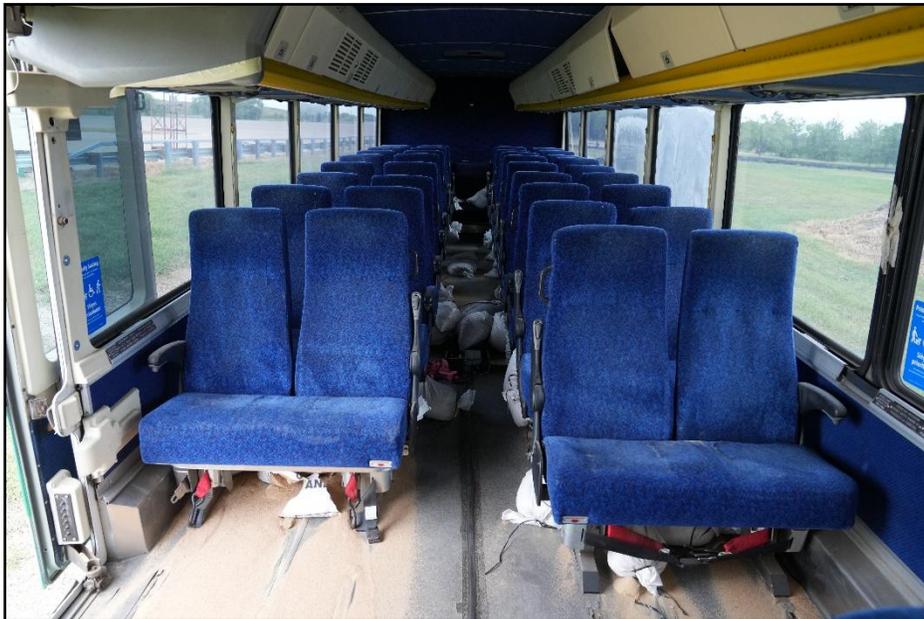
Figure 11.6. Overall Interior of Rear of Test Vehicle after Test 440211-01-5.

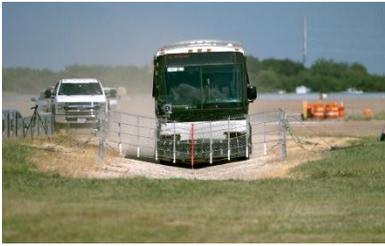
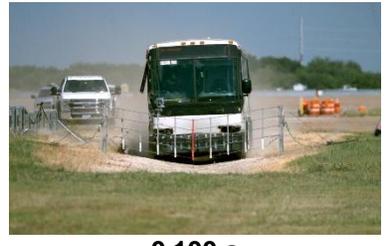
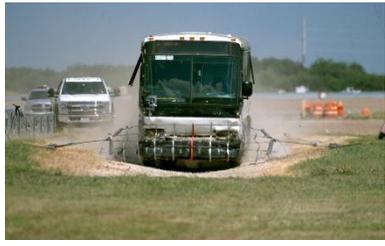
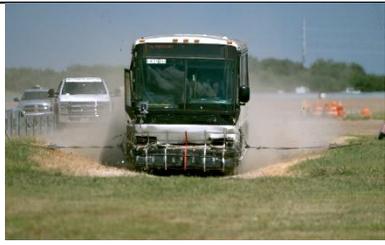
Figure 11.7. Summary of Results for Research and Development Test on MOPS.

<p style="text-align: center;">0.000 s</p>	Test Agency		Texas A&M Transportation Institute (TTI)						
	Test Standard/Test No.		Research and Development Test						
	TTI Project No.		440211-01-5						
	Test Date		2022-06-30

<p style="text-align: center;">0.100 s</p>	TEST ARTICLE		Type	Non-Redirective Crash Cushions					
			Name	MOPS					
			Length	50 ft					
			Key Materials	Wire mesh nets, wire rope net, energy absorbers

<p style="text-align: center;">0.200 s</p>	Soil Type and Condition		AASHTO M147-65(2004), Type 1, Grade D Crushed Concrete						
	TEST VEHICLE		Type/Designation	Passenger Bus					
			Year, Make and Model	2004 MCI D4500					
			Curb (lb)	37,120

<p style="text-align: center;">0.300 s</p>			Inertial Weight (lb)	50,340					
	IMPACT CONDITIONS		Impact Speed (mi/h)	50.5					
			Impact Angle (deg)	0.7					
			Impact Location	Centerline of the vehicle aligned 10.6 inches to the left of the centerline of the first MOPS net and 1.8 inches to the right of the centerline of the second net

Kinetic Energy (kip-ft)	4276.3						
EXIT CONDITIONS		Exit Speed (mi/h)	N/A						
		Stopping Distance	201 ft downstream 3 ft to the left side						
TEST ARTICLE DEFLECTIONS		Dynamic (inches)	N/A						
		Permanent (inches)	N/A						
VEHICLE DAMAGE		VDS	12FC2						
		CDC	12FCEN1						
		Max. Ext. Deformation (inches)	Not measured						
		Max Occupant Compartment Deformation	Not measured						
OCCUPANT RISK VALUES									
Long. OIV (ft/s)	1.4	Long. Ridedown (g)	1.1	Max 50-ms Long. (g)	-1.0	Max Roll (deg)	2.9		
Lat. OIV (ft/s)	4.1	Lat. Ridedown (g)	1.1	Max 50-ms Lat. (g)	-0.5	Max Pitch (deg)	7.5		
THIV (m/s)	1.3	ASI	0.16	Max 50-ms Vert. (g)	-1.6	Max Yaw (deg)	2.0

Figure 11.7 summarizes the results of Test 440211-01-5. Upon investigation of the damaged test article, it was determined the bearings in the energy absorber failed during the impact. These bearings were reused throughout the previous tests without repair or replacement. The lack of repair or replacement following an impact event was believed to be the cause of the bearing failure and subsequent strap rupture. Because of the failing bearings, the test was repeated with new bearings installed within the energy absorbers. This identification of component failure and the need to replace the bearings after impact events provided additional information for future in-field use and maintenance planning.

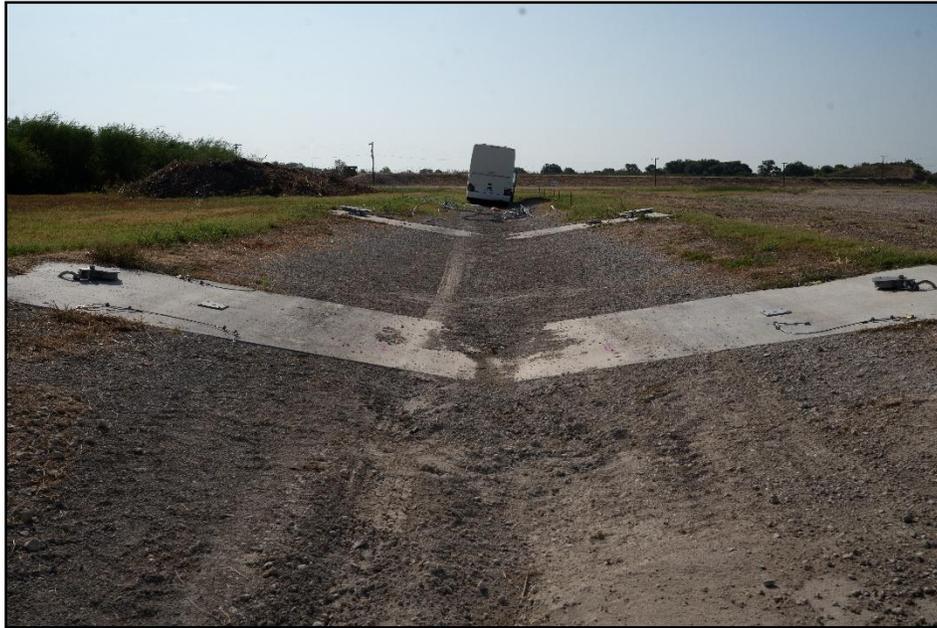
Figure 12.1. Crash Site after Test 440213-01-6.

Both straps on the first net paid out before releasing from their cannisters. The cable on the left side of the second net failed after spooling out 50 ft. Table 12.6 describes the deflection and working width of the MOPS. Figure 12.1 and Figure 12.2 show the damage to the MOPS.

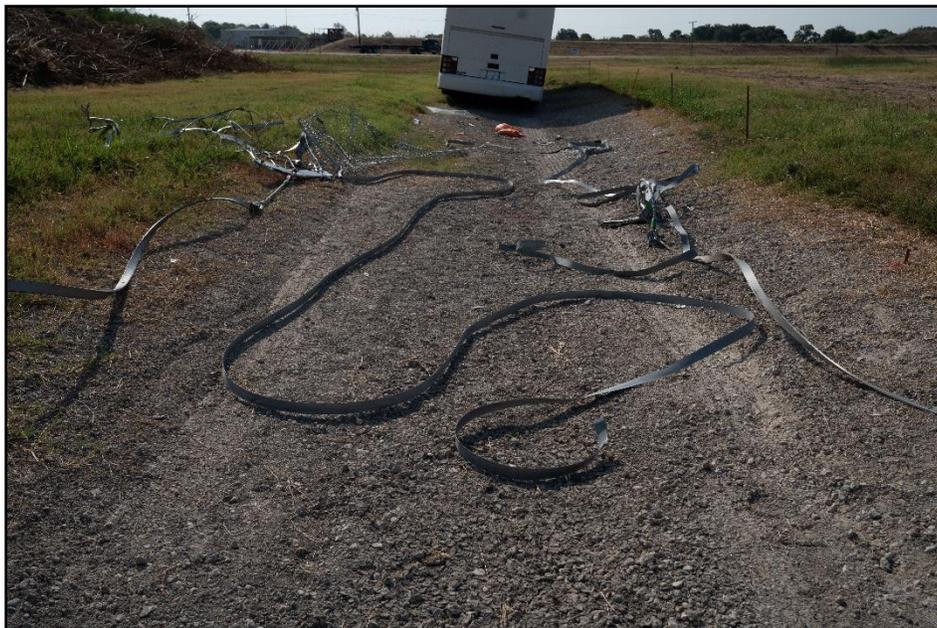
Figure 12.2. Second Net after Test 440213-01-6.

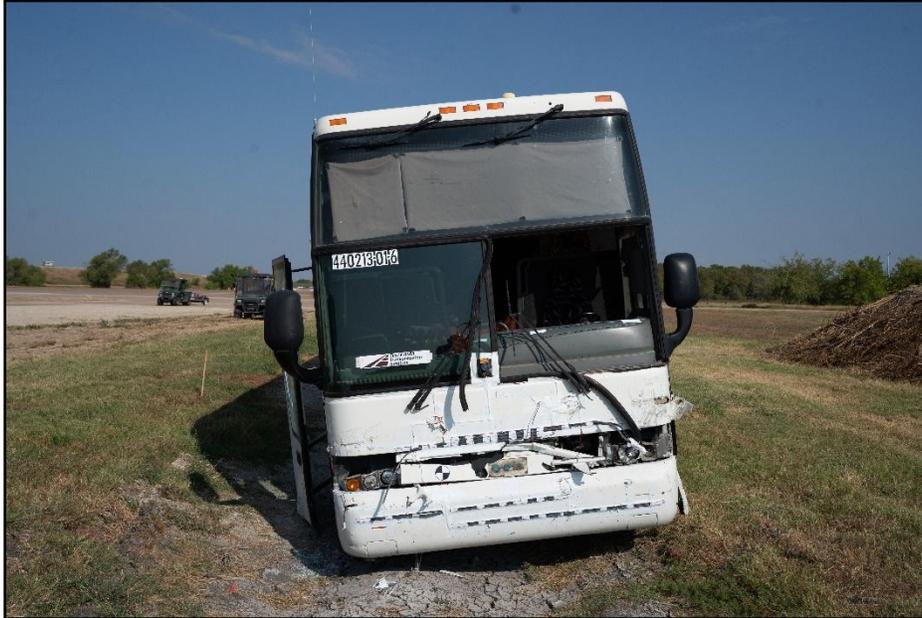
Figure 12.3. Front of Test Vehicle after Test 440213-01-6.

Figure 12.3 and Figure 12.4 show the damage sustained by the vehicle. Figure 12.5 and Figure 12.6 show the interior of the test vehicle. Table 12.7 provides details on the exterior vehicle damage. Due to the failure of the installation, occupant compartment deformation was not measured.

Side Windows	The side window on the door shattered
Maximum Exterior Deformation	Maximum exterior deformation was not measured due to installation failure
VDS	12FC1
CDC	12FCEN1
Fuel Tank Damage	None
Description of Damage to Vehicle:	The front bumper, windshield, headlights, door, and side panels were damaged. The windshield in front of the driver fell out due to ballast sandbags placed in the occupant compartment striking the windshield.

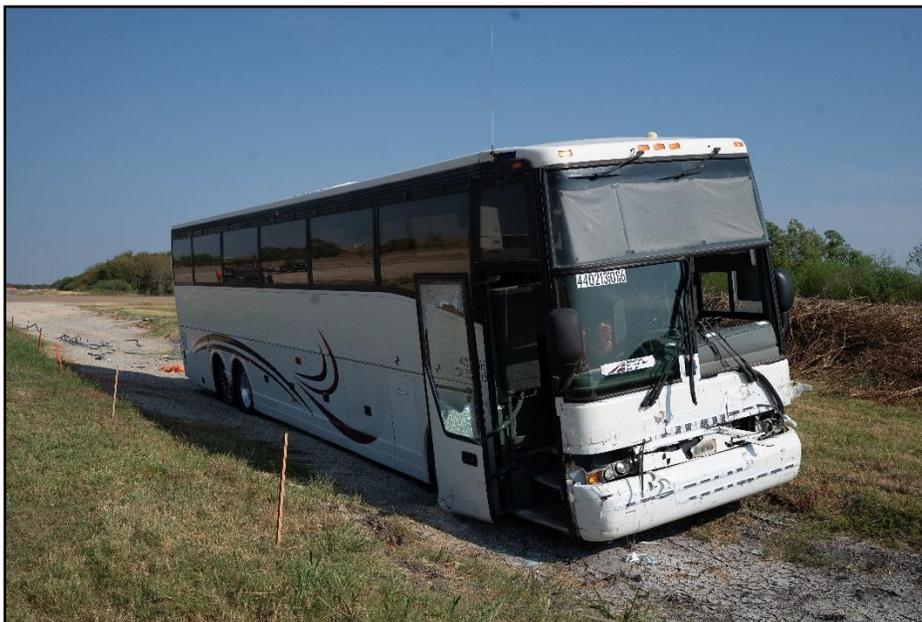
Figure 12.4. Oblique of Test Vehicle after Test 440213-01-6.

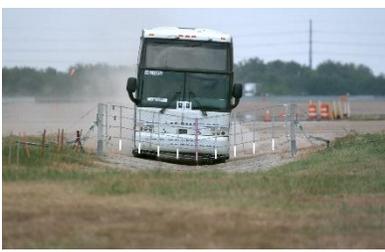
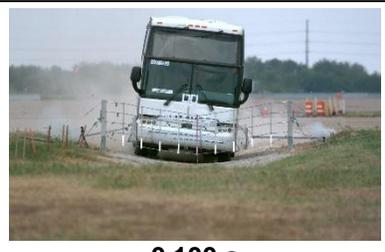
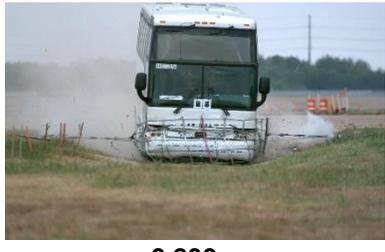
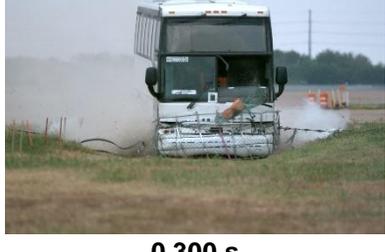
Figure 12.7. Summary of Results for Research and Development Test on MOPS.

Test Agency	Texas A&M Transportation Institute (TTI)					
	Test Standard/Test No.	MASH Research and Development Test					
	TTI Project No.	440213-01-6					
	Test Date	2023-08-28

TEST ARTICLE						
	Type	Non-Redirective Crash Cushions					
	Name	MOPS					
	Length	50 ft

Key Materials	Wire mesh nets, wire rope net, energy absorbers					
	Soil Type and Condition	AASHTO M147-65(2004), Type 1, Grade D Crushed Concrete					
	TEST VEHICLE						
	Type/Designation	Passenger Bus

Year, Make and Model	2002 Van Hool Commuter C2045 USA					
	Curb (lb)	34,120					
	Inertial Weight (lb)	50,140					
	IMPACT CONDITIONS						
Impact Speed (mi/h)	50.0						
Impact Angle (deg)	0.7						
Impact Location	Centerline of the vehicle aligned 16.6 inches to the right of the centerline of the first MOPS net and 7.3 inches to the right of the centerline of the second net						
Kinetic Energy (kip-ft)	4190.4

EXIT CONDITIONS							
Exit Speed (mi/h)	N/A						
Stopping Distance	180 ft downstream 1.5 ft to the left side						
TEST ARTICLE DEFLECTIONS							
Dynamic (inches)	N/A						
Permanent (inches)	N/A						
VEHICLE DAMAGE							
VDS	12FC1						
CDC	12FCEN1						
Max. Ext. Deformation (inches)	Not measured						
Max Occupant Compartment Deformation	Not measured						
OCCUPANT RISK VALUES							
Long. OIV (ft/s)	7.3	Long. Ridedown (g)	2.2	Max 50-ms Long. (g)	-1.7	Max Roll (deg)	3.3
Lat. OIV (ft/s)	1.4	Lat. Ridedown (g)	1.0	Max 50-ms Lat. (g)	-0.5	Max Pitch (deg)	1.4
THIV (m/s)	2.2	ASI	0.1	Max 50-ms Vert. (g)	-0.7	Max Yaw (deg)	1.8

Figure 12.7 summarizes the results of Test 440213-01-6. After investigation of the test results, the research team believed unequal loading between the wire ropes of the second net caused the wire ropes to rupture. Once the wire ropes began to rupture, a zipper-like behavior occurred, with other wire ropes rupturing soon after. A modification in the wire rope design is recommended for evaluation in future research.

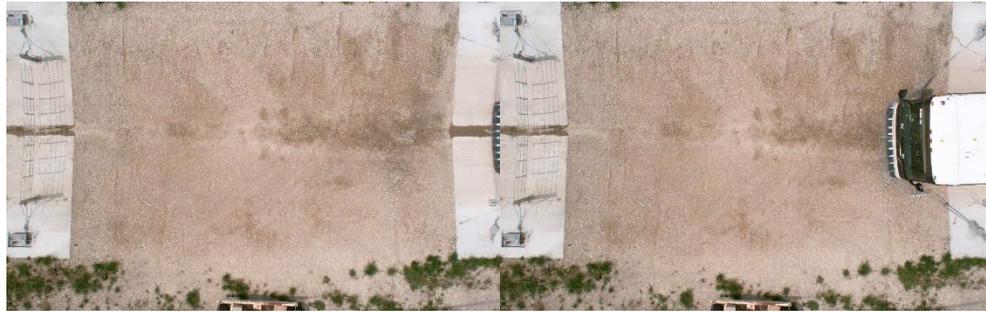
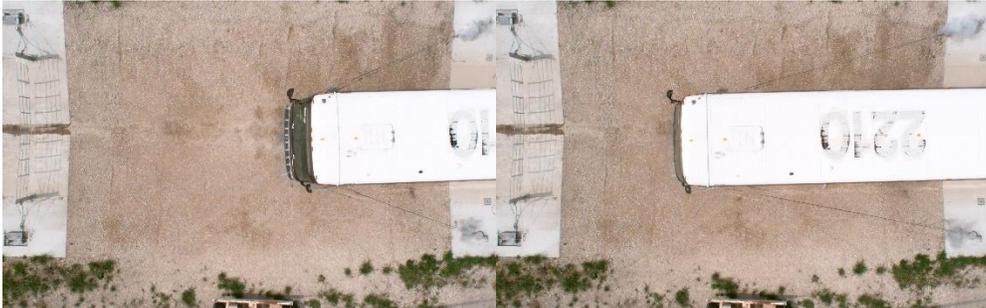
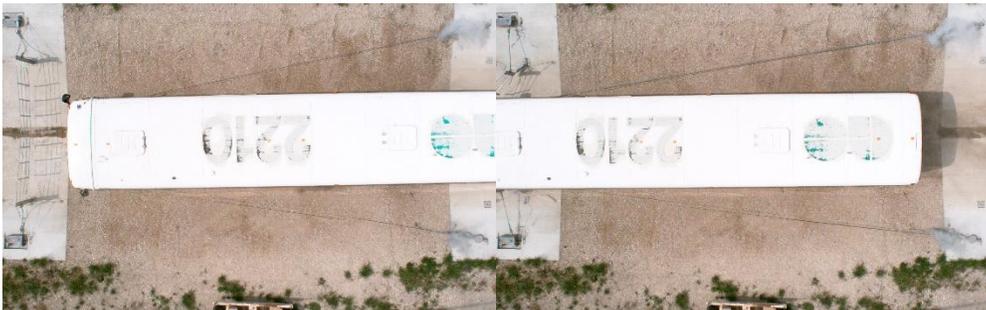
Figure E.2. Sequential Photographs for Test 440211-01-3 (Overhead Views).

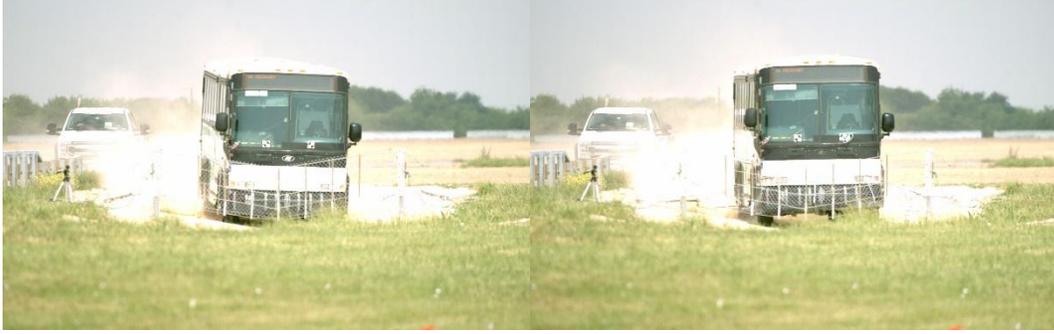
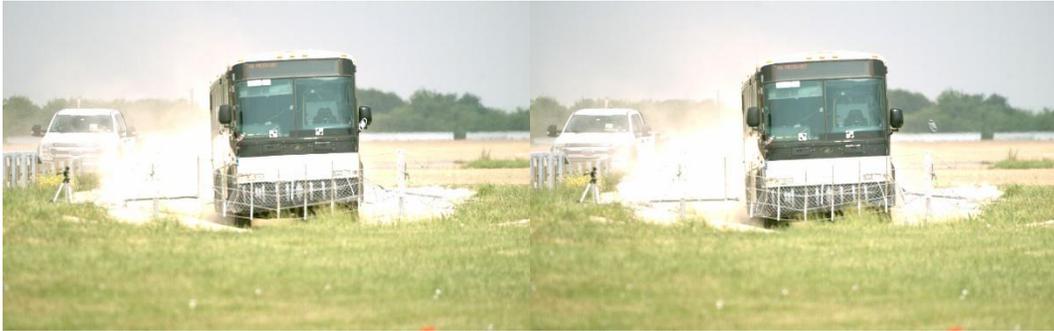
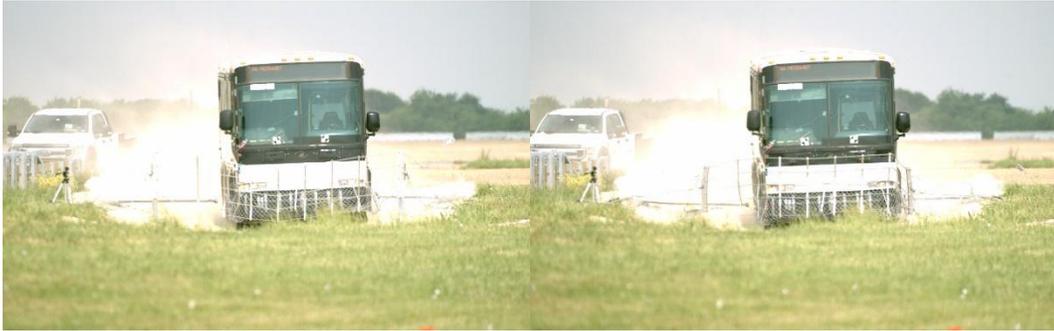
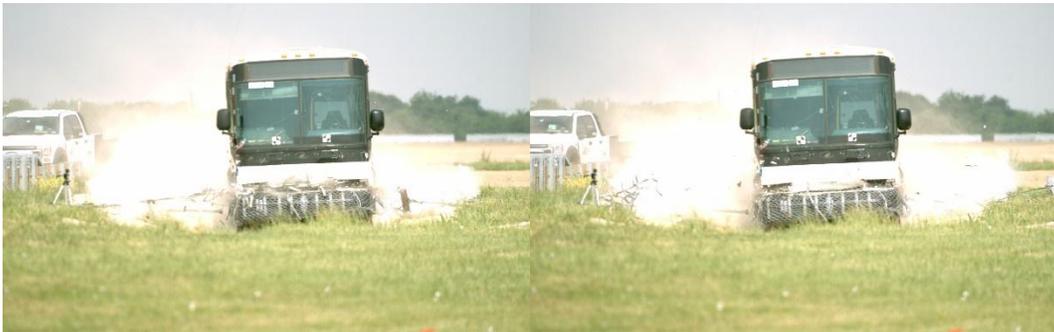
Figure E.3. Sequential Photographs for Test 440211-01-3 (Frontal Views).
