Test Report No. 0-7021-01-R1

**DEVELOPING AN ENHANCED PROTECTION OF MEDIAN OPENINGS
BETWEEN PARALLEL BRIDGE STRUCTURES**

Sponsored by the
**Texas Department of Transportation
and the
Federal Highway Administration**

TEXAS A&M TRANSPORTATION INSTITUTE PROVING GROUND

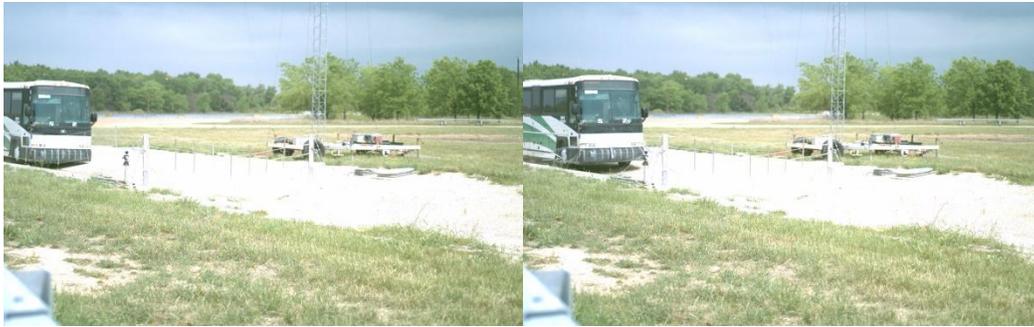
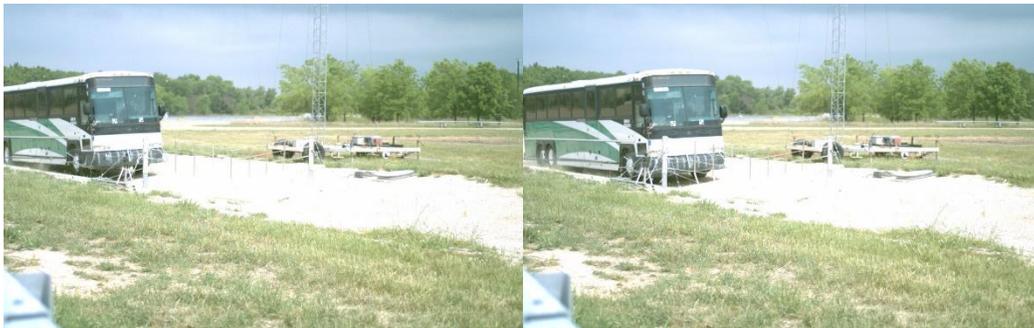
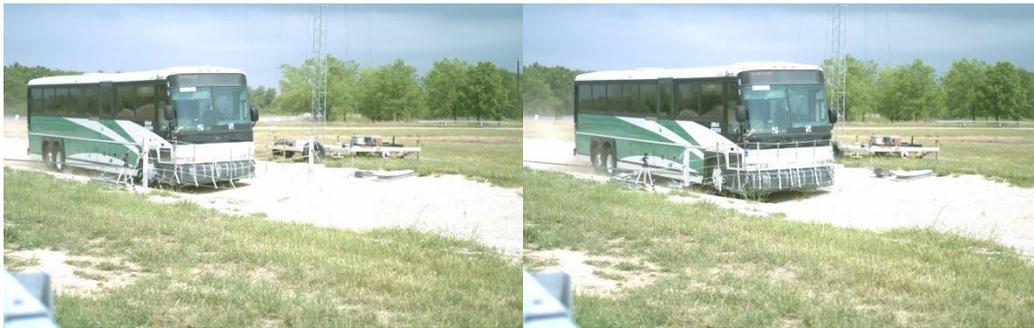
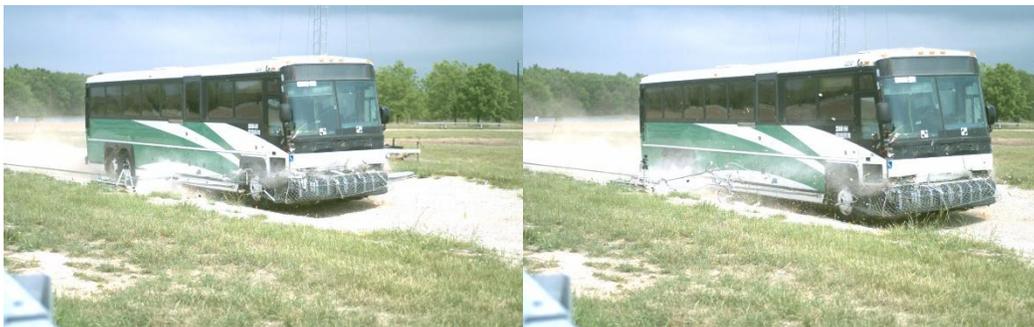
Figure E.4. Sequential Photographs for Test 440211-01-3 (Oblique Views).

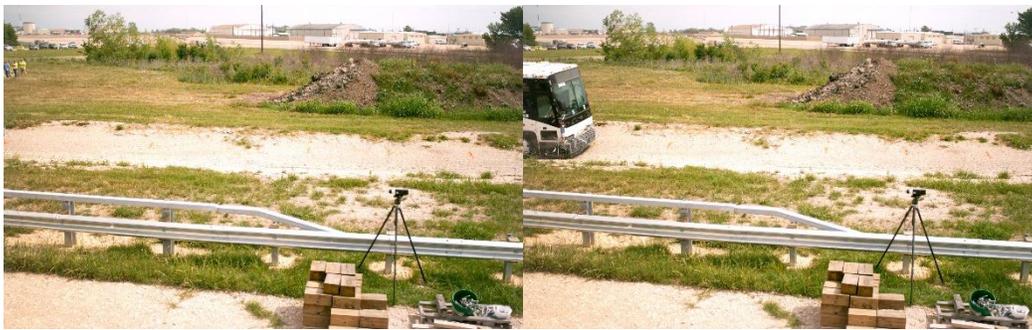
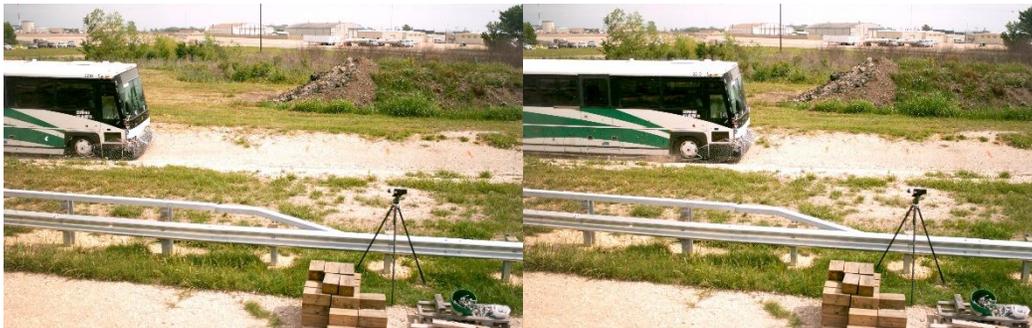
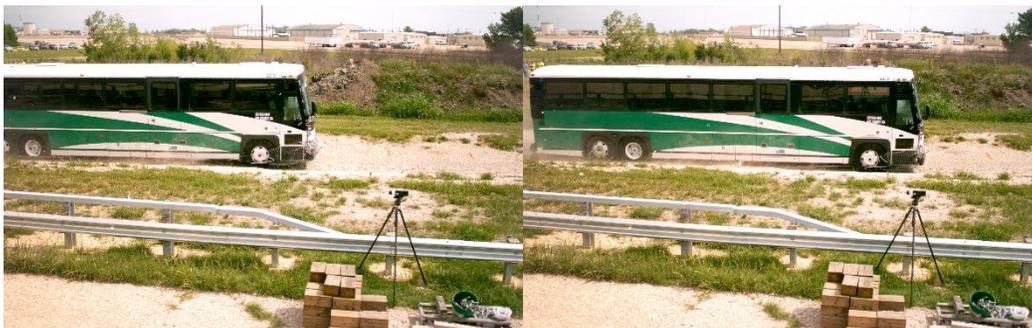
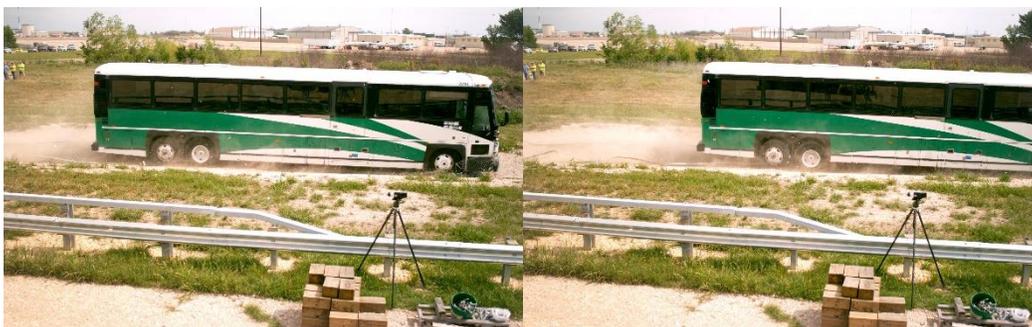
Figure E.5. Sequential Photographs for Test 440211-01-3 (Right Angle Views).

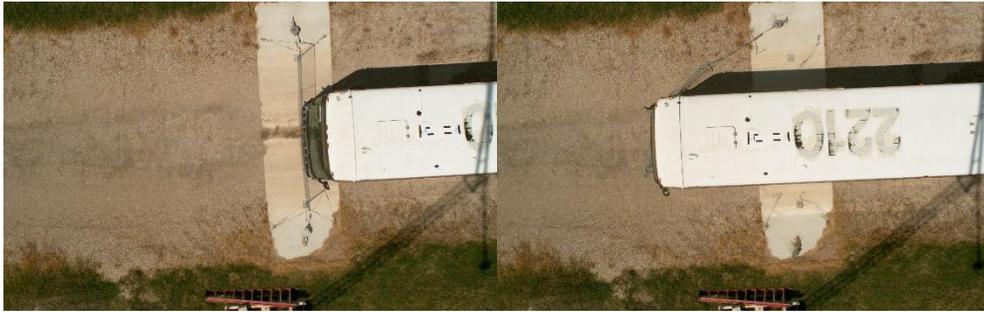
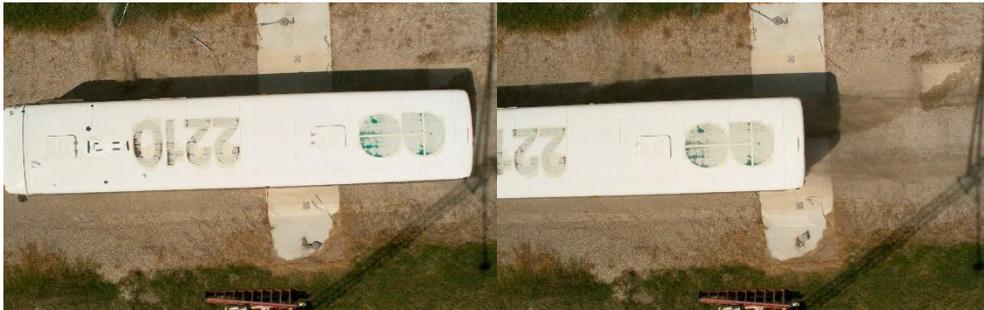
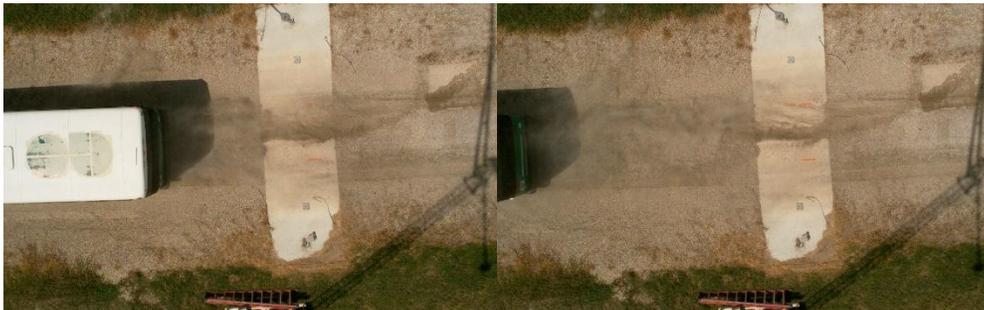
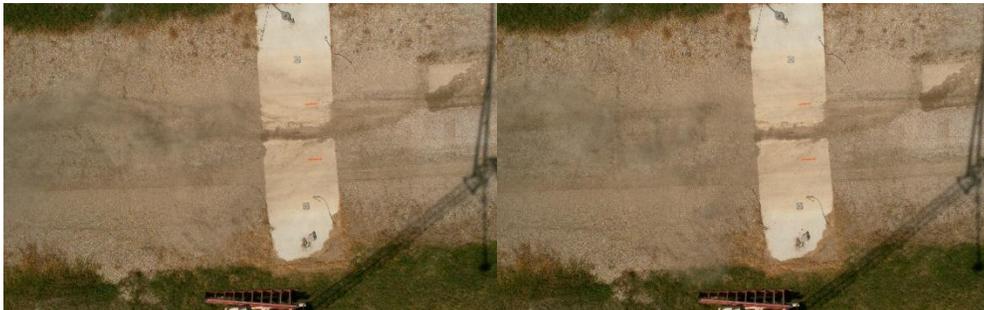
Figure F.2. Sequential Photographs for Test 440211-01-5 (Overhead Views).

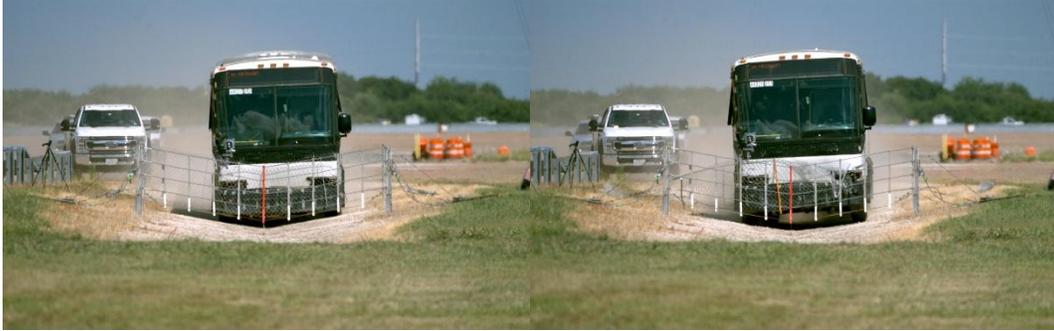
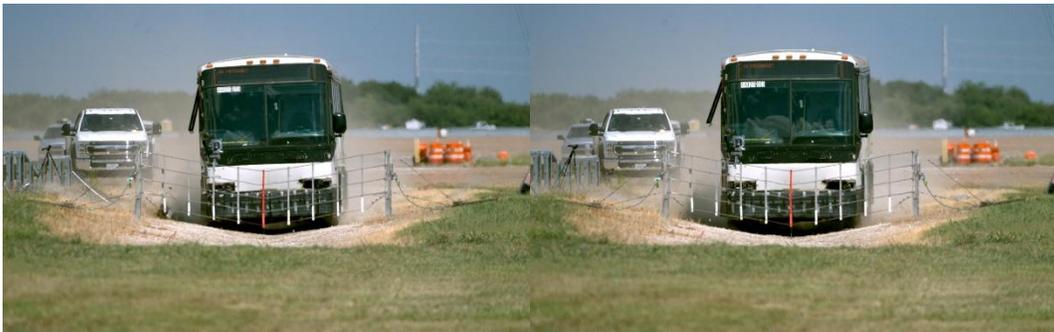
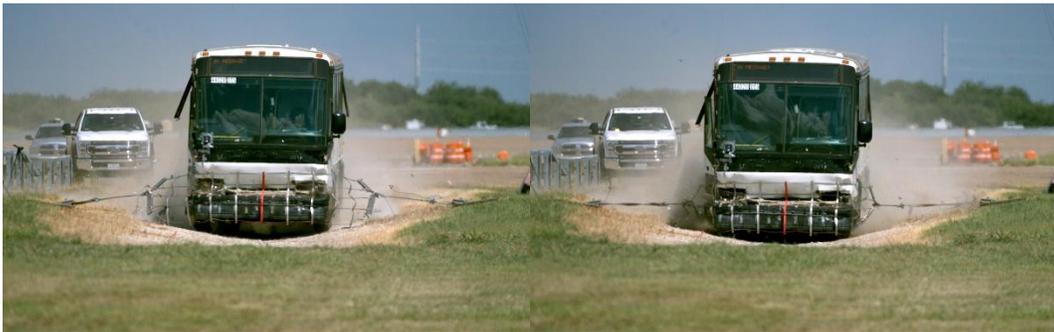
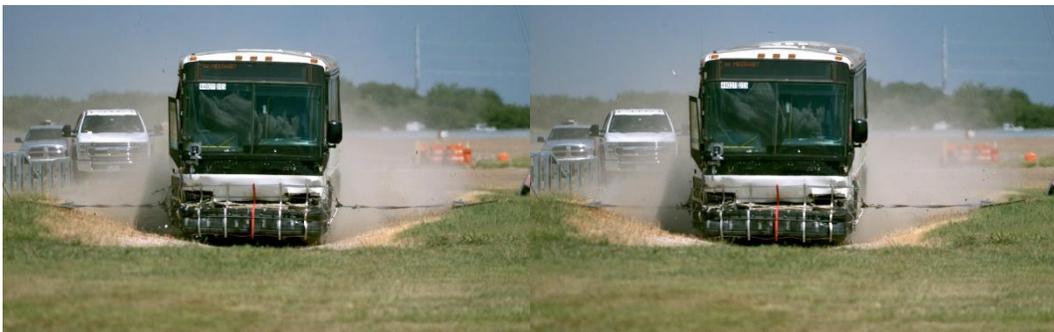
Figure F.3. Sequential Photographs for Test 440211-01-5 (Frontal Views).

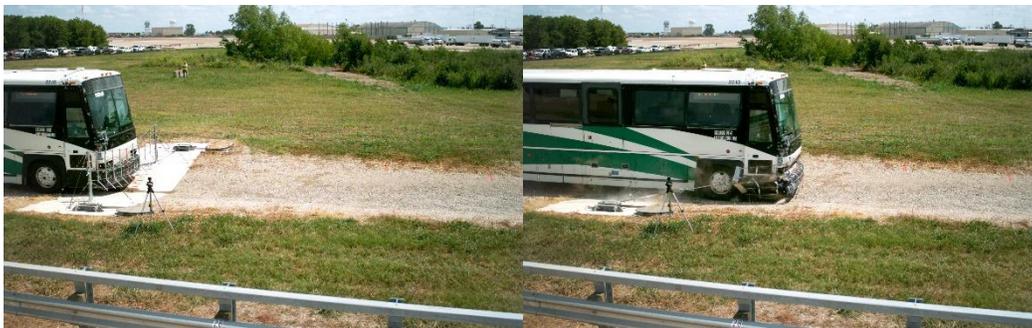
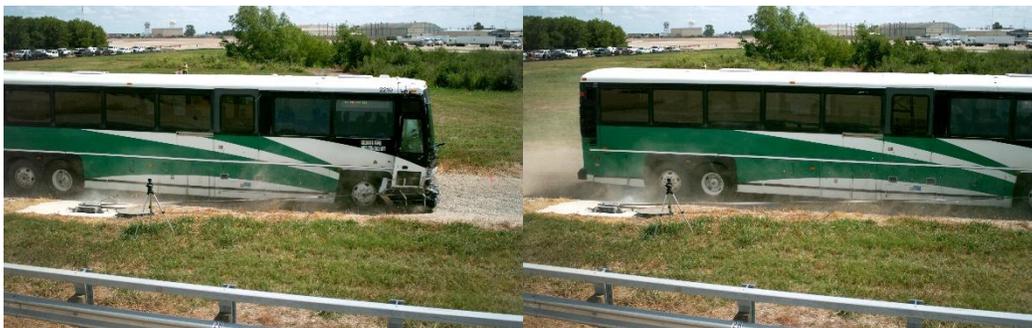
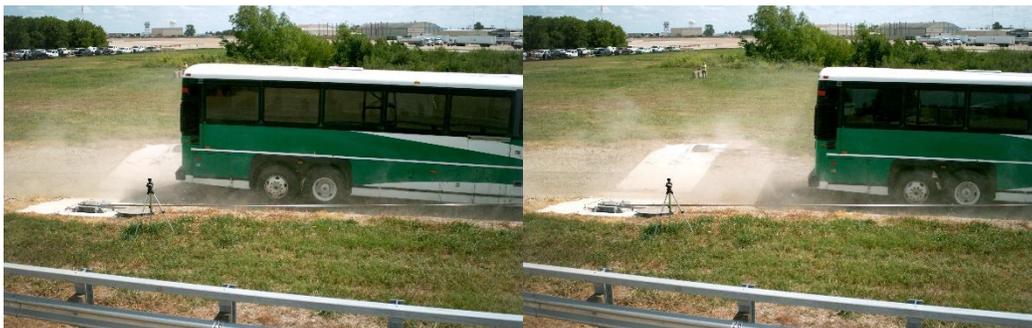
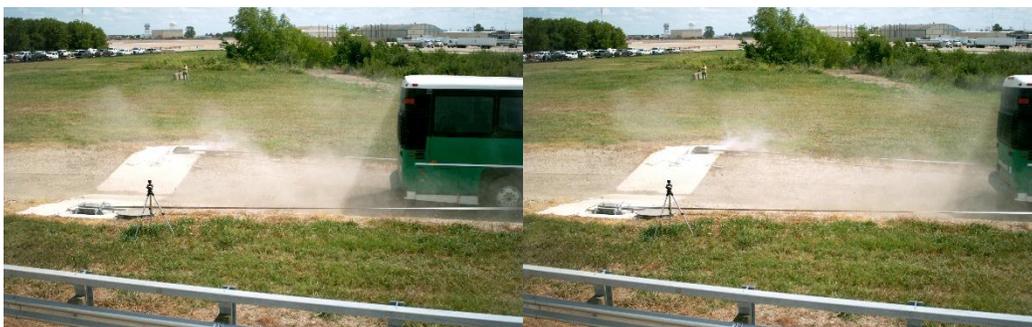
Figure F.4. Sequential Photographs for Test 440211-01-5 (Rear Views).

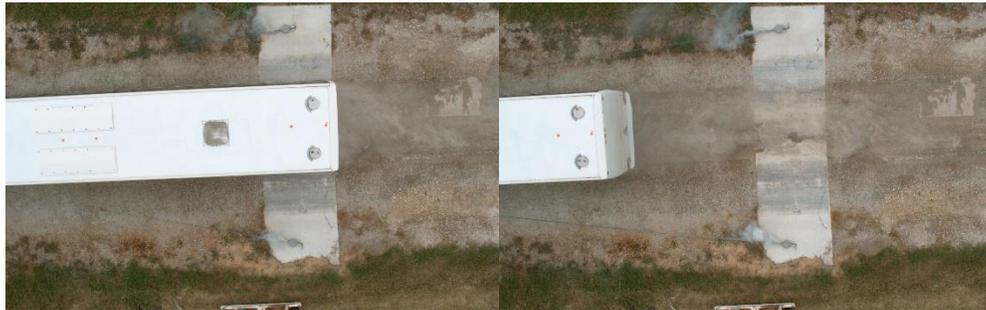
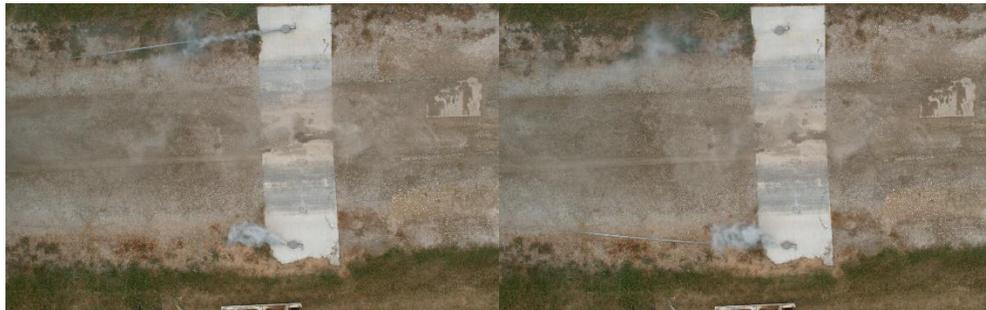
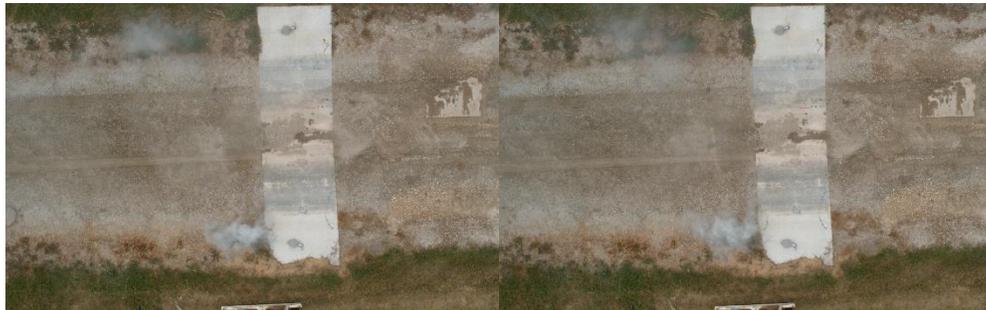
Figure G.2. Sequential Photographs for Test 440213-01-6 (Overhead Views).

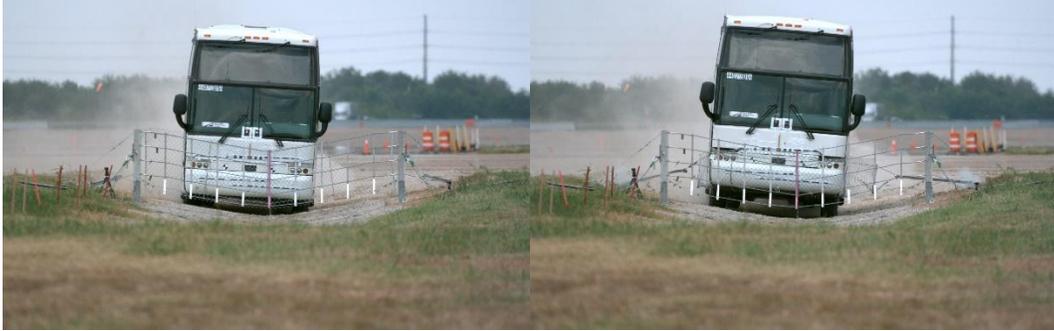
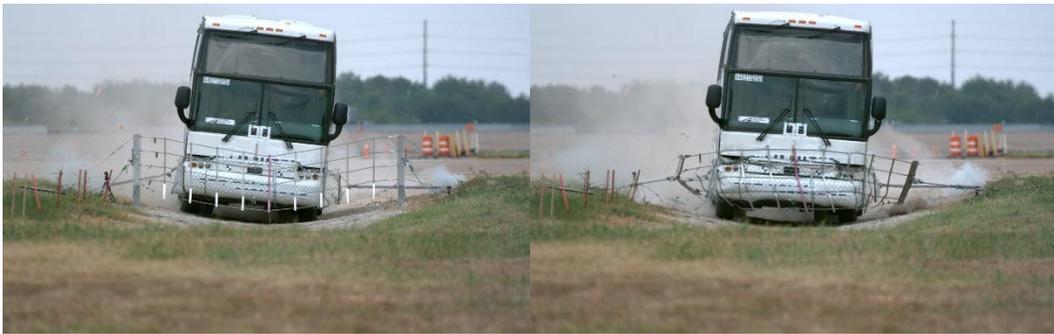
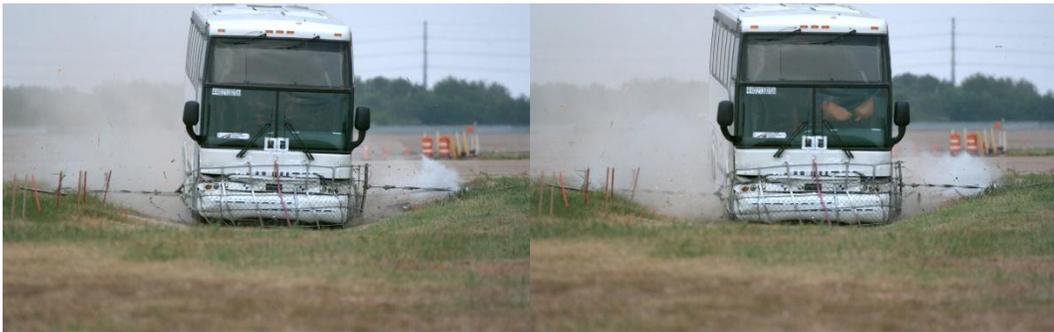
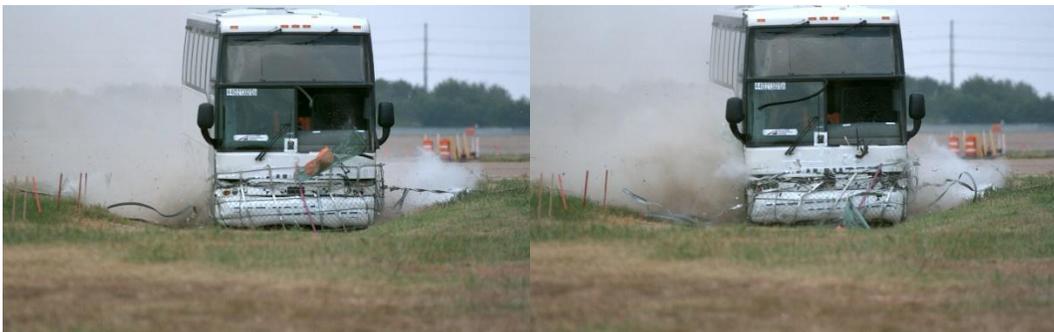
Figure G.3. Sequential Photographs for Test 440213-01-6 (Frontal Views).

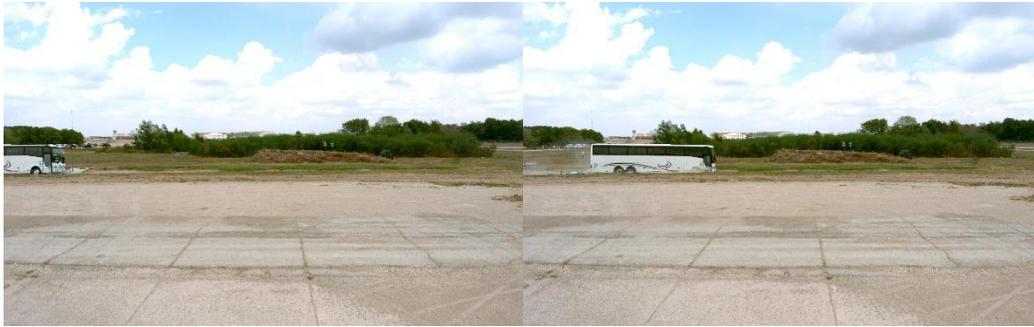
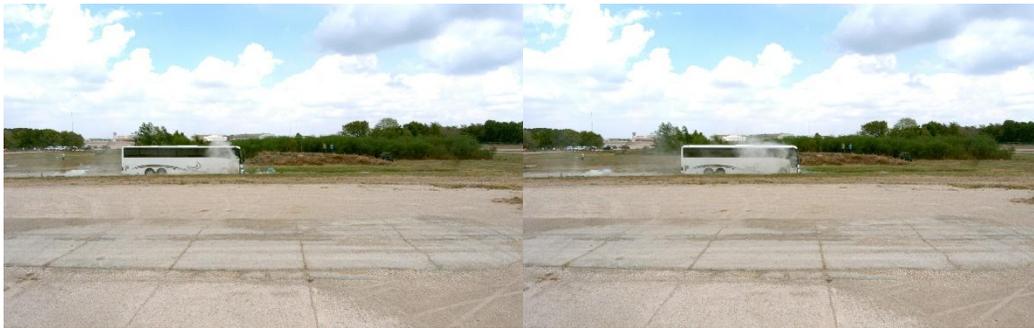
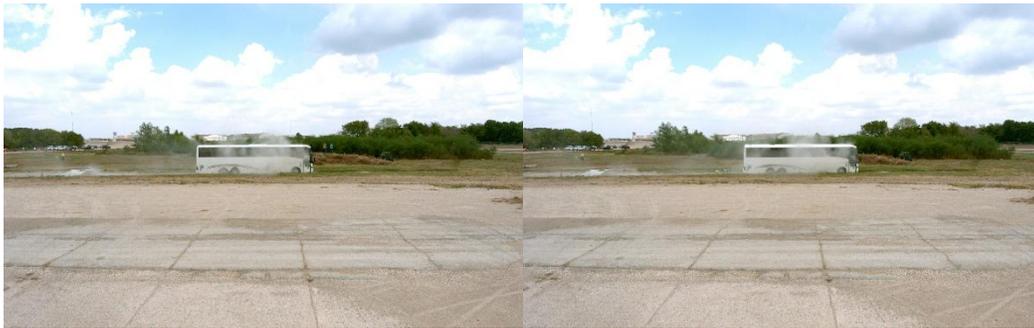
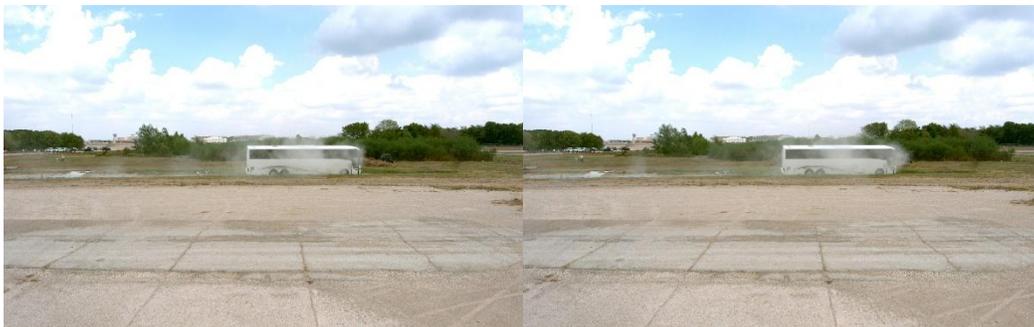
Figure G.4. Sequential Photographs for Test 440213-01-6 (Right Angle Views).
