**DOT/FAA/TC-26/4**

# **In-Service Ultrasonic Inspections for Turbine Engine, Life-Limited Rotating Parts**

January 2026

Final report

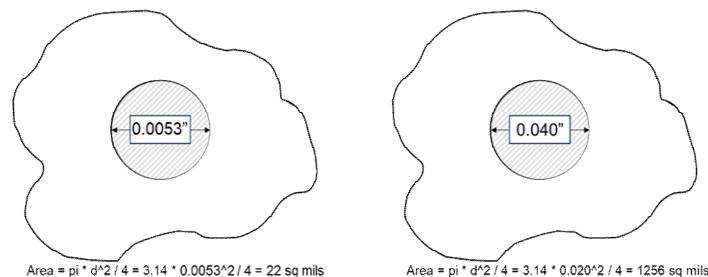
- Four powder parts were found cracked out of approximately 1300 inspected. This is an additional two finds and approximately 300 inspections compared to Table 3-1.
- All rejectable sonic indications in the fielded parts had cracks initiated from inherent anomalies within the disks. The anomalies found varied between partially cracked to fully cracked with additional growth into the base alloy. The initiating anomalies ranged in size from 100 square mils to 600 square mils. The cracks found ranged from 22 square mils to 1270 square mils.

**Figure 5. Crack Sizes Found in Field UT Inspected Hardware**
