Final Report

FDOT BDV31-977-121

Use of Infrared Thermography for the Inspection of Welds in the Shop and Field- Phase II

Department of Materials Science and Engineering
University of Florida
549 Gale Lemerand Dr.
Gainesville, FL 32611

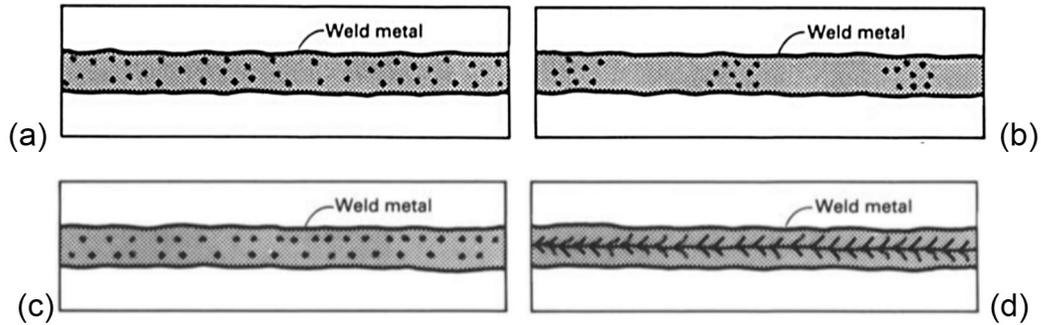
Porosity is a discontinuity type categorized under welding process-related metallurgical discontinuities [11], [12]. Its presence appears as 3-dimensional voids throughout the weld metal and fusion zone that result from the entrapment of gases [11]. Figure 0-2 displays the four main microstructural topographies of porosity.

Figure 0-2 – Different types of porosity observed in welds. The types of porosity given are as follows: (a) uniformly scattered, (b) cluster, (c) linear, (d) elongated [11].

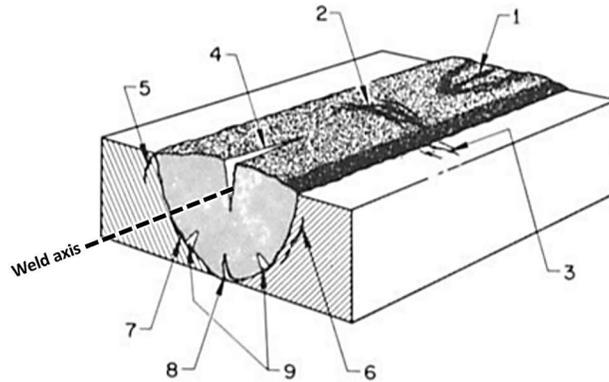
Figure 0-4 shows different types of weld cracks. Cracks can be identified as transgranular or intergranular, revealing the mechanism which resulted in the crack [13].

Figure 0-4 – The different types of weld cracks shown in a groove weld: (1) crater, (2) transverse (located in the weld metal), (3) transverse (located in the base metal), (4) longitudinal, (5) toe, (6) underbead, (7) fusion-line, (8) root, and (9) hat [11].

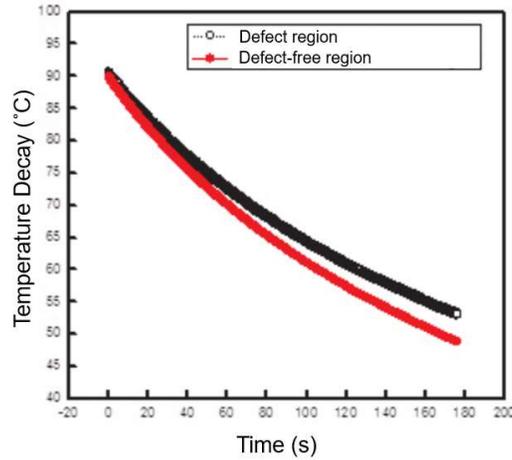
More recent studies have continued to test IR-TNDT for weld defect detection. One study detected and characterized defects in friction stir welded (FSW) Al joints. The cool-down of the defect-free and defect regions was monitored as a function of time to generate temperature distribution plots that could be analyzed for discontinuities [19]. The cool-down plot of the defect and defect-free regions of the weld is shown in

Figure 0-5 [19]. Only one Al joint was tested in this study, creating a need to verify the techniques' repeatability on other joint types. Another study that tested IR-TNDT on FSW Al joints analyzed weld process-related discontinuities, which can obscure the thermal signal from nearby defects [20].

Figure 0-5 – Temperature decay plot of an Al joint welded using FSW, comparing defect and defect-free regions of the weld [19].

Two studies have attempted to document the heat transfer behavior of a weld with a defect by analyzing the cool-down curves of carbon steel weld joints with defects and comparing them to weld regions without defects [7], [9]. An example is shown in Figure 0-7, where the time-dependent thermal profile differs in the defect-free and defective areas. The portion of the weld containing the defect cools faster than the defect-free region [9], opposingly to the data obtained for Al weld joints, as shown in Figure 0-5 [19].

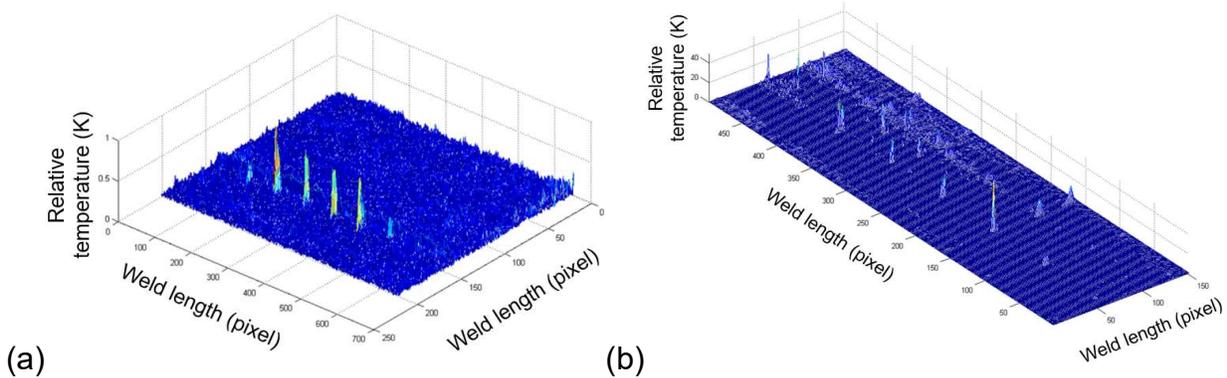
discontinuities [21]. Figure 0-6 shows the relative temperature versus position graphs of the SS weld joint with surface finishing and without surface finishing [21].

Figure 0-6 – Temperature plots of SS weld joints with defects. (a) A surface-finished SS weld joint reveals only temperature peaks in regions with defects. (b) A SS weld joint that was not surface finished showed temperature peaks in regions with and without defects [21].

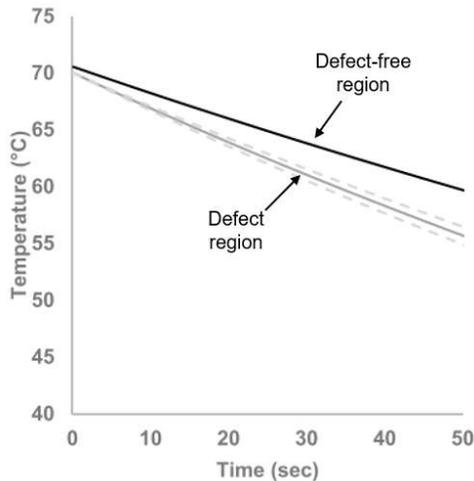
Figure 0-7 – Cool-down behavior of a carbon steel weld in a region with and without a crack defect [9].

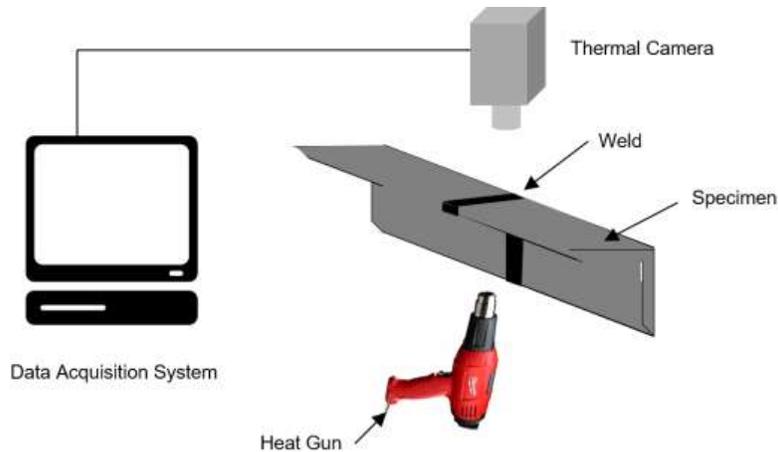
Dorafshan et al. [9] used the experimental setup shown in Figure 0-8 to address weld defects manufactured in the laboratory (porosity and cracks) previously diagnosed by UT NDT inspection. The heat gun, placed within 50 mm of the bottom of the specimens, increased the temperature of the area of interest. The maximum temperature reached by the active thermography was 70°C. After reaching that temperature, the heat gun was turned off, and the camera started recording a thermal sequence at a frequency of 10 Hz for 50 s and analyzed through ThermaVision Examine IR software.

Figure 0-8 – Schematic representation of the proposed active infrared thermography setup for weld inspection [9].

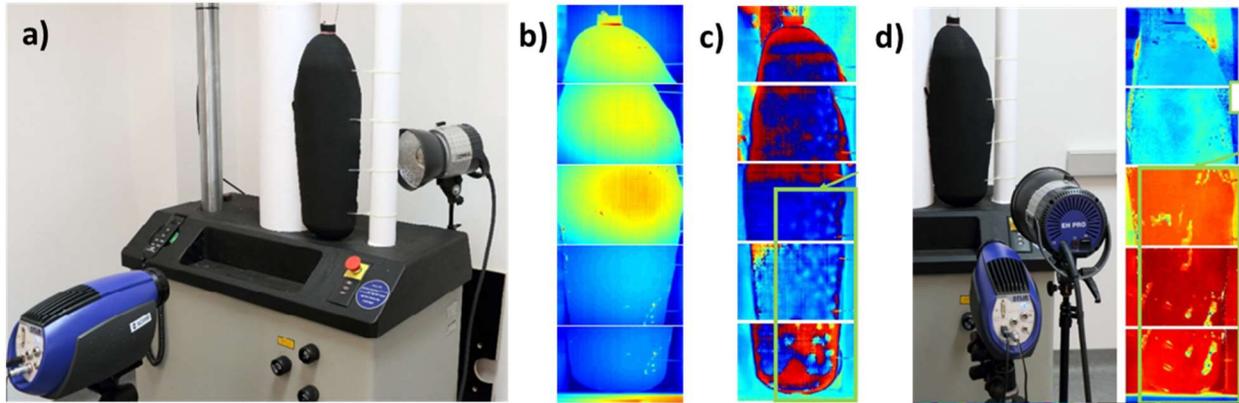
A Fast Fourier Transform (FFT) method was used to process IR images taken from steel pressure vessels to investigate pit corrosion [35]. Backside active thermography resulted in good detection of damaged areas after post-processing. However, the front-side reflection mode for IR image acquisition resulted in significant noise due to irregularities in the protective layer, showing that this mode is more susceptible to topographical issues. Figure 0-9a shows the setup for backside active thermography used by the authors [35]. The resulting FFT-processed image is illustrated in Figure 0-9(c), which compares the backside active thermography to the raw IR image in Figure 0-9(b). Figure 0-9(d) shows the reflection mode of IR image acquisition and the FFT-processed image, where the authors [35] identified features unrelated to the defective areas.

Figure 0-9 – (a) Backside active thermography setup; (b) raw IR image; (c) FFT processed IR image showing corroded regions; (d) front-side setup and resulting FFT processed image showing several misleading points due to irregularities in protective layer [35].

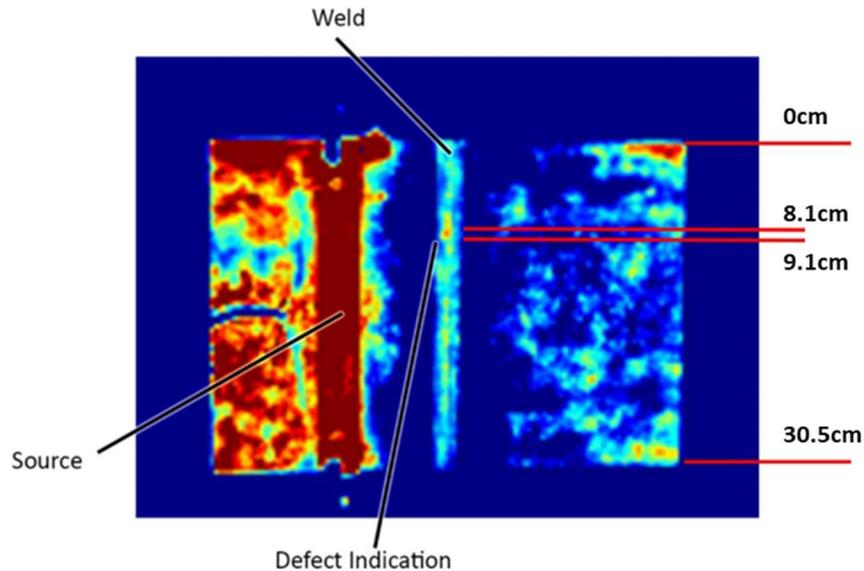
The author's FDOT BDV31 977-64 Phase I report [8] investigated an infrared ultra-time domain (IR-UTD) processing approach that utilizes time-lapse thermal images captured during the heating and cooling process to detect subsurface defects. As seen in Figure 0-10, it was demonstrated that in a conventional IR image produced without the time-lapse processing implemented in the IR-UTD, the crack identification did not appear clearly due to the noise created by other surface anomalies.

Figure 0-10 – IR-UTD processed image from weld cooling showing indication in the toe crack [8].

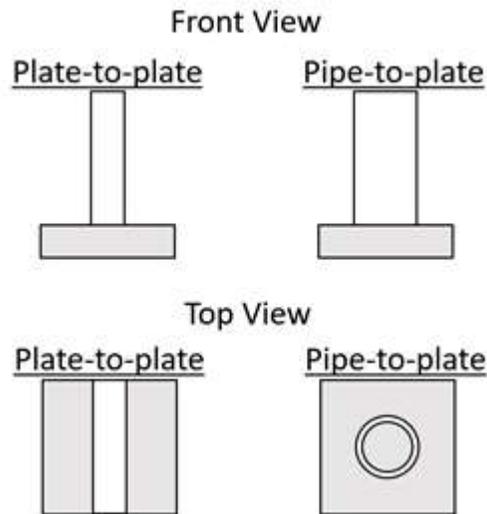
Figure 0-1 – The plate-to-plate and pipe-to-plate weld joint configurations used in this work.

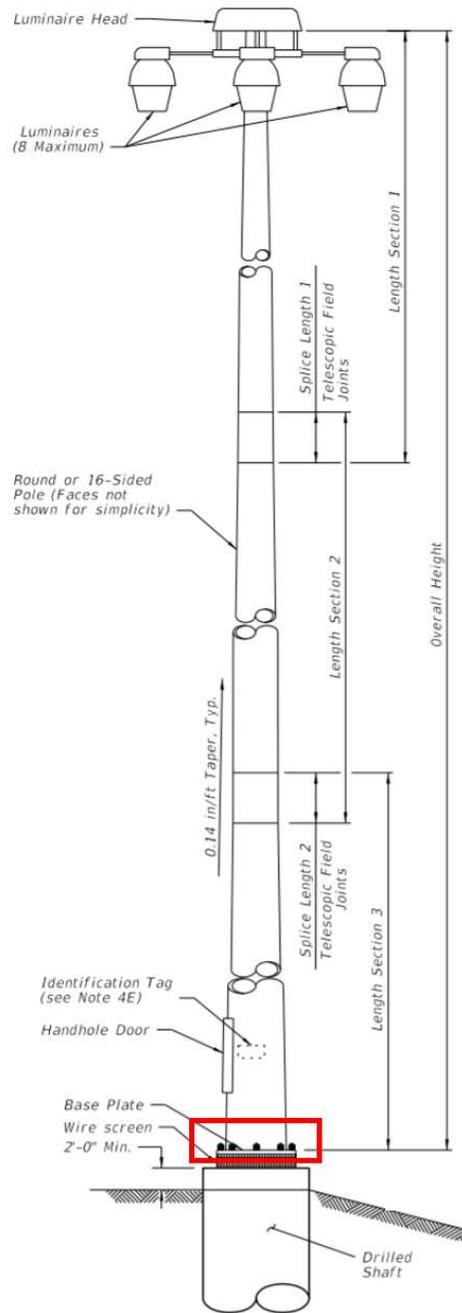
The two FDOT design indexes used to design the steel welding joints are Index #715-010 (High Mast Lighting) and Index #700-040 (Cantilever Sign Structure) [36]. Both designs were taken from the FY 2020-21 Standard Plans [36]. From these two design indexes, the types of steel included are ASTM A709 (Gr. 36) and ASTM A36 for the plates and API 5L x42 PSL2, ASTM A500 (Gr. B min.), and ASTM A572 (Gr. 50, 55, 60, and 65) for the pipes. Figure 0-2 illustrates the joint in Index #715-010 used to design the pipe-to-plate weld. The thickness of the pole is 0.6 cm and the thickness of the base plate is approximately 7.6 cm, however this will be downsized to 0.6 cm thick since a 7.6 cm thick base plate would require increased welding needs including more welding material and a pre-heat of the base metal prior to welding. Figure 0-3 shows the joint in Index #700-040 used to design the plate-to-plate weld. In the design, the small plate

Figure 0-2 – The base plate to pole connection in FDOT Design Index #715-010 that was used in this work to design the steel pipe-to-plate weld joint [36].

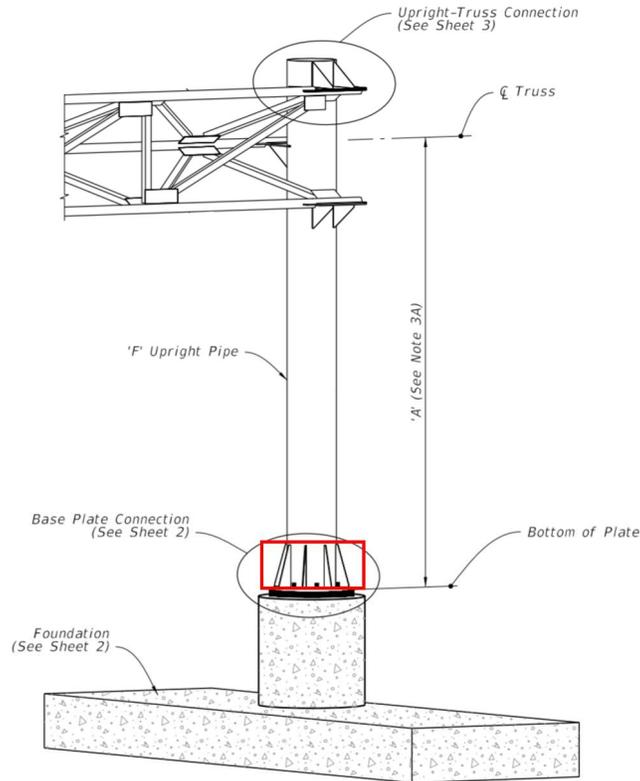
connections are welded to the pole. The pole in this design has a large diameter that allows for the joint to be simplified to a plate-to-plate configuration. The thickness of the pole is 2.2 cm thick which would require increased welding needs so to keep consistency with the other weld joint, a 0.6 cm thickness will be adopted here as well. The plate connections on the pole are 1.3 cm thick which can be changed to 0.6 cm thickness without affecting the welding procedures to be qualified [36].

Figure 0-3 – The joint in FDOT Design Index #700-040 that was used in this work to design the steel plate-to-plate weld joint [36].

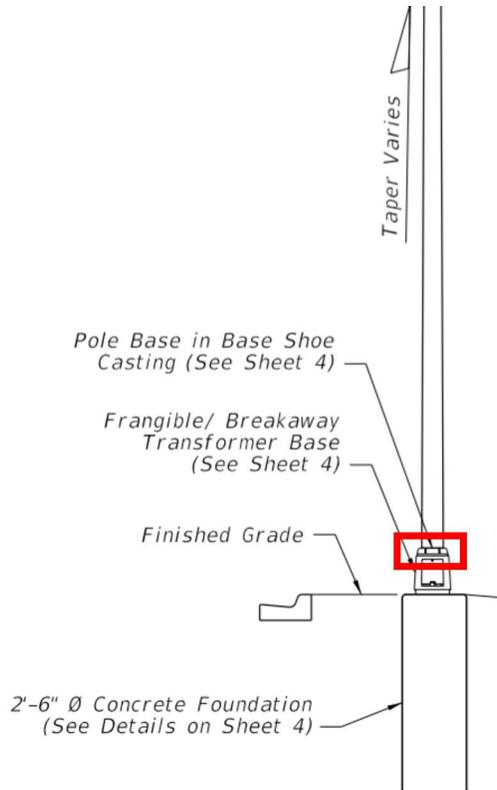
The FDOT Design Index used to design the Al weld joints is Index #715-002 (Standard Aluminum Lighting), taken from FY2020-21 [37]. The types of Al used in this design include Alloy 356-T6 (ASTM B26 or B108) cast Al plate and Alloy 6061-T6 and 6063-T6 extruded Al plate and pipe (ASTM B221). The joint shown in Figure 0-4 was used to design the cast plate to extruded pipe weld. There are several pole thicknesses given in the design but the thickness to be used in this work is 0.6 cm. The cast plate has an unspecified thickness as it is used as a shoe fitting for the pole but a thickness of 0.6 cm will be selected for this work to allow for weldability with the 0.6 cm thick pole. Figure 0-5 shows the joint used for the extruded Al plate-to-plate design. This joint is a bracket welded to the pole but was simplified to a plate-to-plate joint since they both use fillet welds. The thicknesses for each plate were selected based on the thickness of the pole which is 0.6 cm.

Figure 0-4 – The joint in FDOT Design Index #715-002 that was used in this work for the Al cast plate-to-extruded pipe weld joint [36].

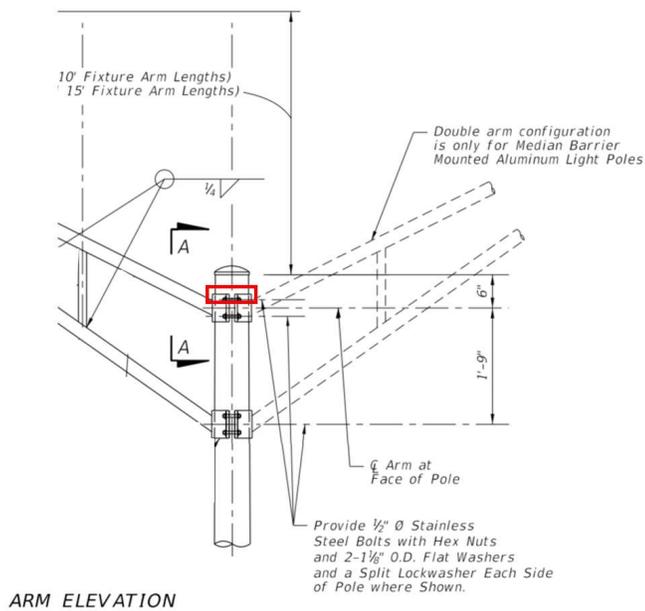
Figure 0-5 – The joint in FDOT Design Index #715-002 that was used in this work for the extruded Al plate-to-plate weld joint [36].

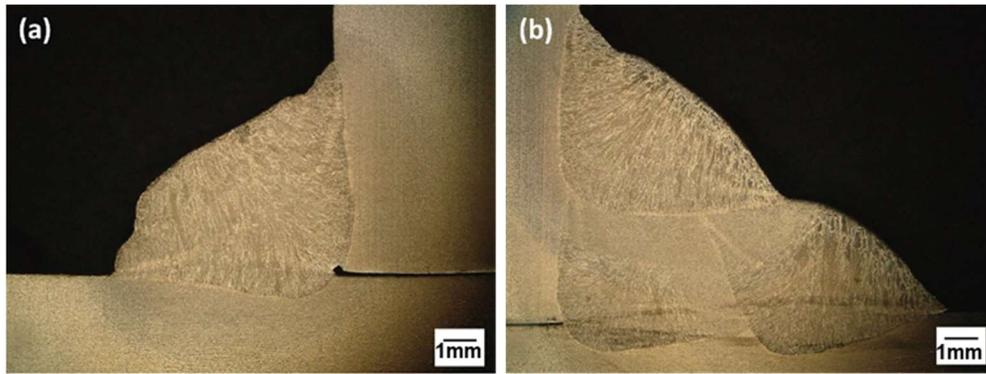
The welds were macroetched using a 2% nital solution [39] and then visually inspected to confirm that these settings and procedures yielded a baseline/sound weld joint. The optical images of the etched steel weld joints are shown in Figure 0-6 and Figure 0-7. There is complete fusion of the weld metal to the base metals with no signs of any discontinuities.

Figure 0-6 – Cross-section of the steel plate-to-plate weld joint. Image (a) shows the single-pass weld side, and (b) shows the multi-pass weld side of the joint.

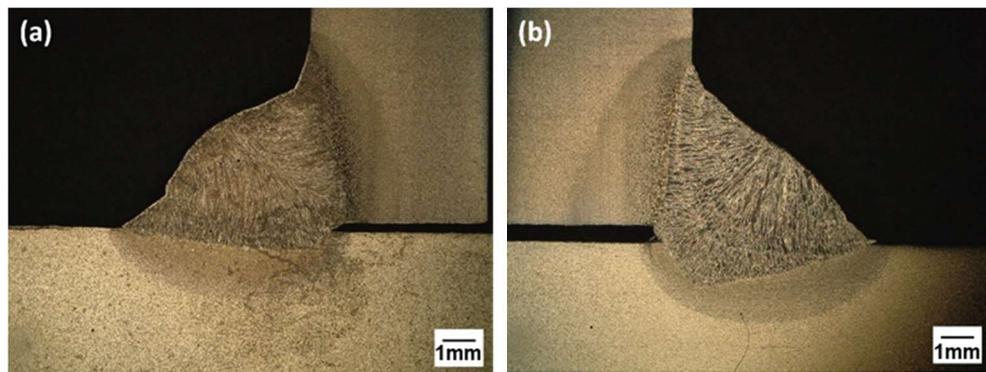
Figure 0-7 – Cross-section of the steel pipe-to-plate weld joint. Images (a-b) show each cross-section of this joint when machined down the middle.

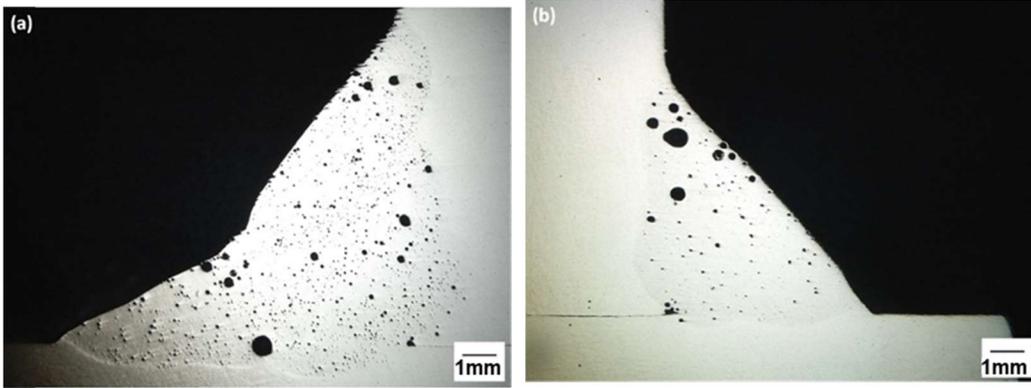
The welds were polished up to 0.05- μm grit using the Buehler MasterPolish alumina and colloidal silica suspension, which resulted in mild etching of the Al weld surface. The optical images of the polished Al weld joints are shown in Figure 0-8, Figure 0-9 and Figure 0-10. All samples had subsurface porosity within the allowable amount of discontinuity area for the relative weld size following Table 5.4 in AWS D1.2 [38]. Some samples have a LOF at the root (example shown in Figure 0-10), which is an impassable discontinuity [37], [38] but for this study, the LOF was treated as a pore defect.

Figure 0-8 – Cross-section of the Al plate-to-plate weld joint. Image (a) shows the multi-pass weld side, and (b) shows the single-pass weld side of the joint. The areal % and total area of porosity for each weld were calculated to be (a) 4.7% and 0.10 mm² and (b) 4.4% and 0.05 mm², respectively.

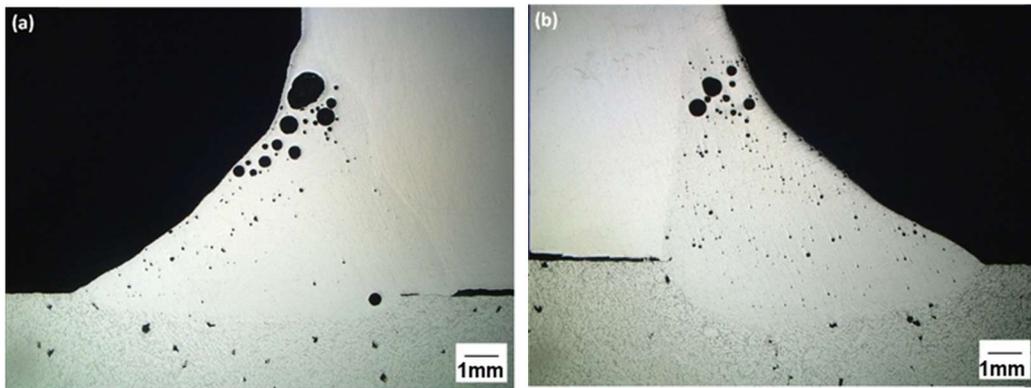
Figure 0-9 – Cross-section of the Al pipe-to-plate weld joint. Images (a) and (b) show each cross-section of this joint when machined down the middle. The areal % and total area of porosity for each weld were calculated to be: (a) 5.8% and 0.07 mm² and (b) 3.1% and 0.05 mm², respectively.

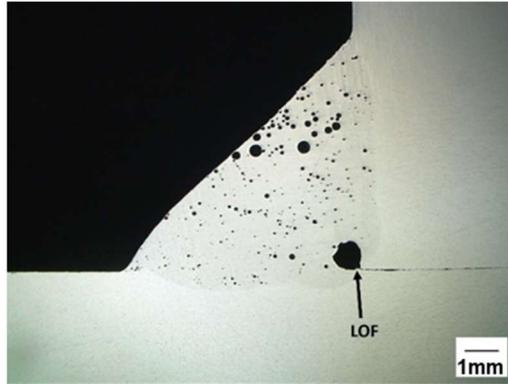
Figure 0-10 – Cross-section of the Al plate-to-plate weld joint. This sample has a LOF at the joint, which will be treated as a pore defect for this work. The areal % and total area of porosity for this weld are 6% and 0.05 mm², respectively.

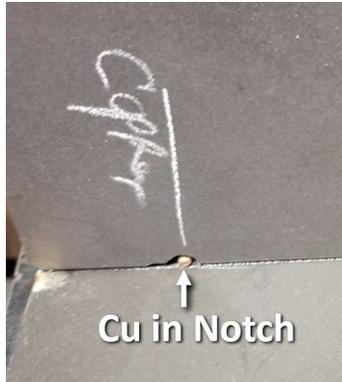
This method of defect manufacturing of subsurface cracks in the steel welds included the use of Cu located in a notch at the root of the weld joint. Approximately 100 mg of 99.9% pure Cu shot from Alfa Aesar was placed in the notch before welding. This method was developed by combining Steel Methods 1 and 2 to minimize the subsurface defect's appearance at the weld's surface. A demonstration of the notch and Cu shot placement before welding is shown in Figure 0-11 for the steel plate-to-plate joint.

Figure 0-11 – Steel plate-to-plate joint with a Cu shot placed in a notch at the root of the joint before welding.

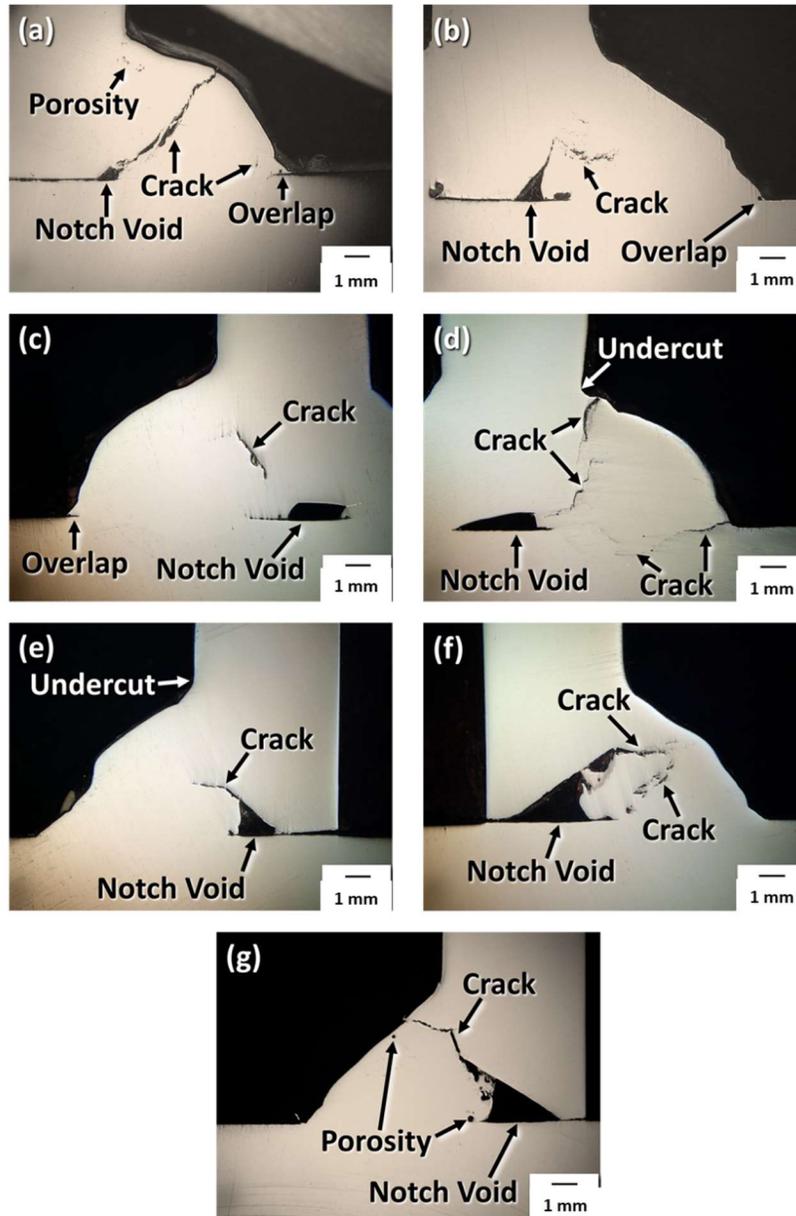
The cross-sections of the steel welds where the Cu in notch method was implemented, as shown in Figure 0-12

Figure 0-12, reveal the appearance of surface-breaking and subsurface cracks. These cracks were present in every sample tested and varied in dimension and position. Other discontinuities in these welds, but not in the baseline welds, include porosity, overfill, overlap, and underfill (labeled in Figure 0-12

Figure 0-12). These discontinuities are common in welding and are typically either passable or repairable during weld inspection [40].

Figure 0-12 – Steel (a-d) plate-to-plate and (e-g) pipe-to-plate weld joint cross-sections where the Cu and notch were placed. All samples resulted in one or more cracks that were subsurface or surface-breaking. In addition to cracks, the defect welds possessed overlap, porosity, and undercut effects.

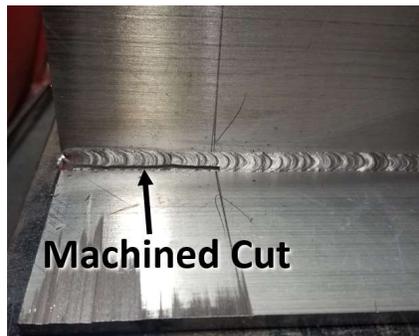
Figure 0-13 – The Al plate-to-plate joint after one side was welded, and then a band saw was used to machine a cut horizontally through the weld.

The Al plate-to-plate joint was first welded on one side, and upon completion of that single weld, a band saw was used to machine a cut horizontally through the entirety of the weld joint, as shown in Figure 0-13. Then, a single-pass weld was performed on the other side of the joint, which was the side that was imaged with the IR cameras. Finally, the first side was given two more weld passes to form a multi-pass weld, patching the cut on that side of the joint.

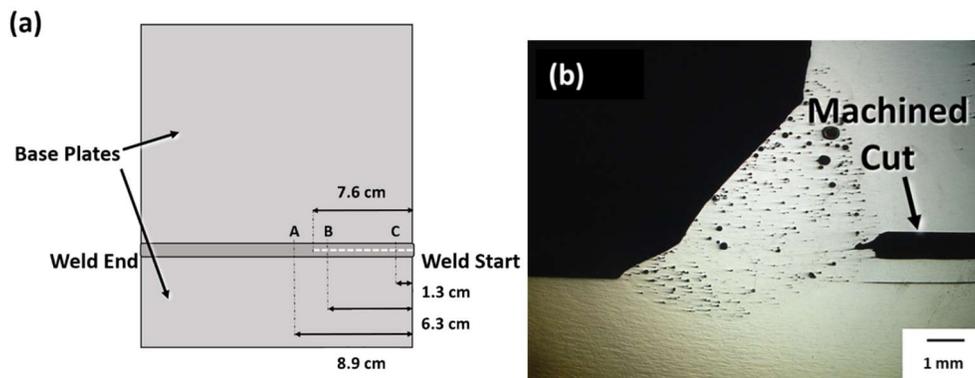
Figure 0-14 – (a) Schematic representation of the machine-cut into the root of the joint before welding to create a subsurface pseudocrack. (b) Cross-sections of the Al plate-to-plate weld joint with a machined cut going through 7.6 cm of the weld.

Subsurface pseudocracks in Al plate-to-plate weld joints were successfully created in-shop by machining a cut into the root of the joint before welding (Figure 0-14).

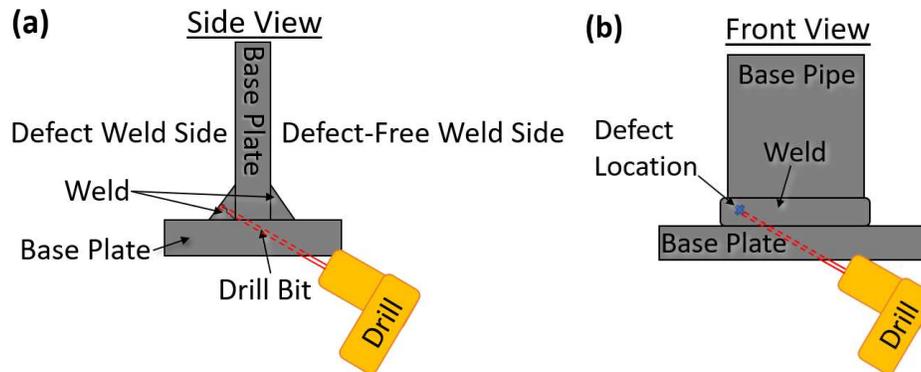
Figure 0-15 – Schematic representation of the drill holes applied to the weld joints using a 1.6-mm (1/16") diameter drill bit to create a surface-breaking hole. (a) Side view of the plate-to-plate weld joint and (b) front view of the pipe-to-plate weld joint.

(1/16") drill bit. This created a surface-breaking defect. Figure 0-15 shows a schematic representation of the drilling procedure.

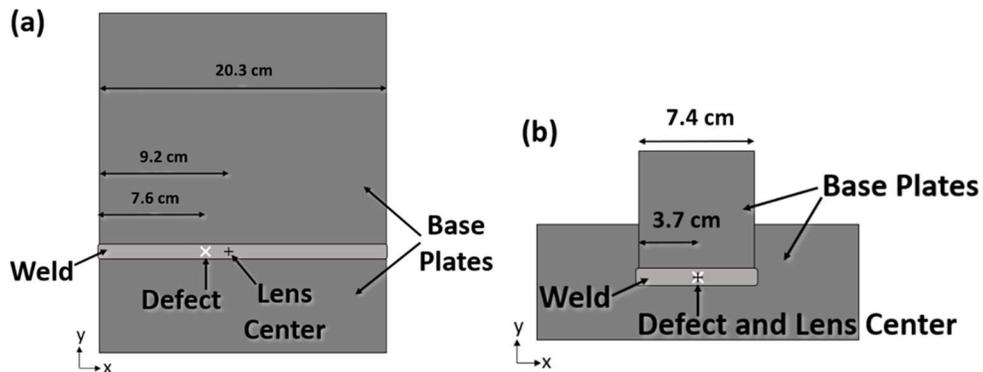
Figure 0-16 – Front view of the two different geometries of weld joints with labels indicating where the defect was located and where the FLIR T620 lens center was positioned. (a) Steel and Al plate-to-plate joint, (b) steel and Al pipe-to-plate joint.

Figure 0-16 gives a frontal view of weld joints and indicates the location of the defect relative to where the lens of the camera will be centered. The dimensions shown in Figure 0-17 for the FLIR T620 setup are based on the plate-to-plate joint configuration. The camera was kept in the same position with respect to the side view for the pipe-to-plate joints.

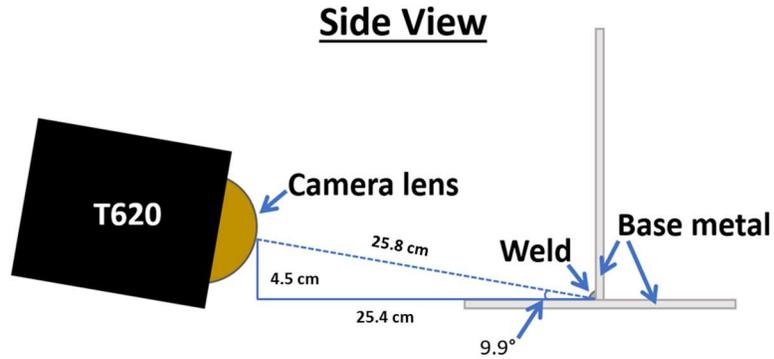
Figure 0-17 – Side view of the setup for the FLIR T620 camera based on the plate-to-plate weld joint.

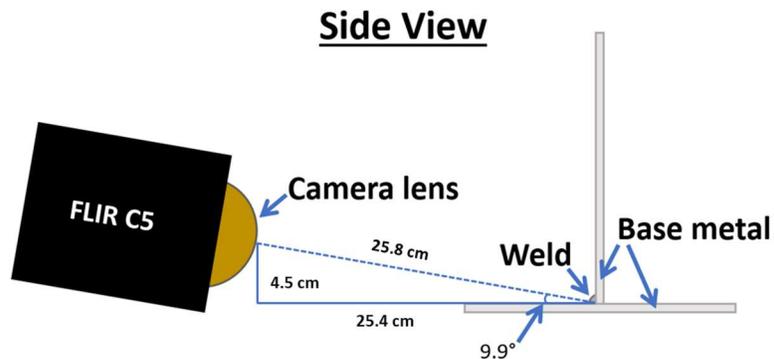
Figure 0-18 – Side view of the setup for the FLIR C5 camera based on the plate-to-plate weld joint.

The FLIR C5 camera was positioned at an equivalent distance used for imaging with FLIR T620, as illustrated in Figure 0-18. IR images were captured manually every 30 seconds since the C5 camera does not allow an automatic acquisition rate. All infrared images were analyzed using the native software provided on the FLIR website [49].

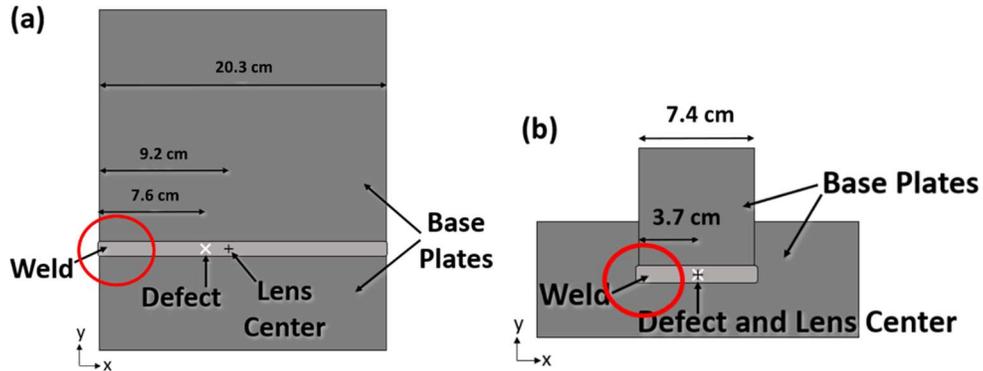
Figure 0-19 – Schematics indicating the location of the heat gun nozzle on both weld joints geometries when heating. (a) Steel and Al plate-to-plate weld joint, (b) steel and Al pipe-to-plate weld joint.

Figure 0-19 depicts the heating positions for the two weld joint geometries, where the red circle indicates where the heat gun nozzle will be placed. Once the weld reached the target test temperature, it was held for an additional 30 sec to equilibrate the sample. Then, the heat gun was removed, and IR imaging immediately ensued. The

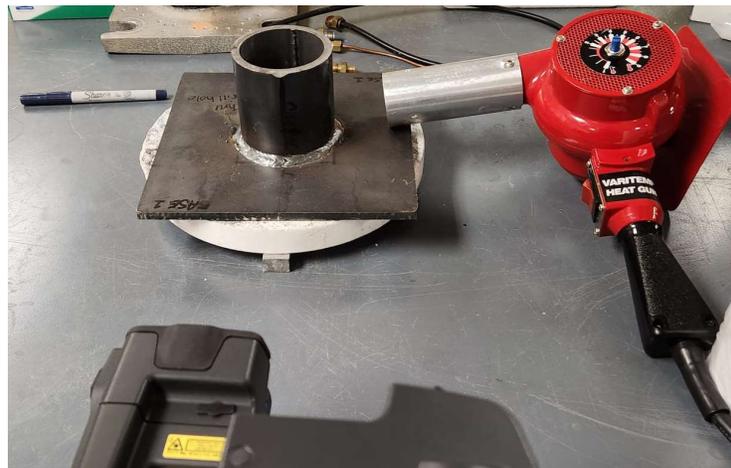
Figure 0-20 – Photography of the trial assembly, showing sample, camera, and heat gun positioning.

Infrared images were taken every 15 seconds for the Al samples and every 30 seconds for the steel samples until the sample cooled to 35°C. The temperature measurement during the cool-down was taken by positioning the measuring spot on top of the drilled hole. For the subsurface pseudocrack, the measuring spot was placed at the beginning of the machined region. The visual analysis examined any discontinuities in the weld thermal signal in regions with known defects. This technique simulates the investigation performed in the field, as represented in the trial assembly shown in Figure 0-20.

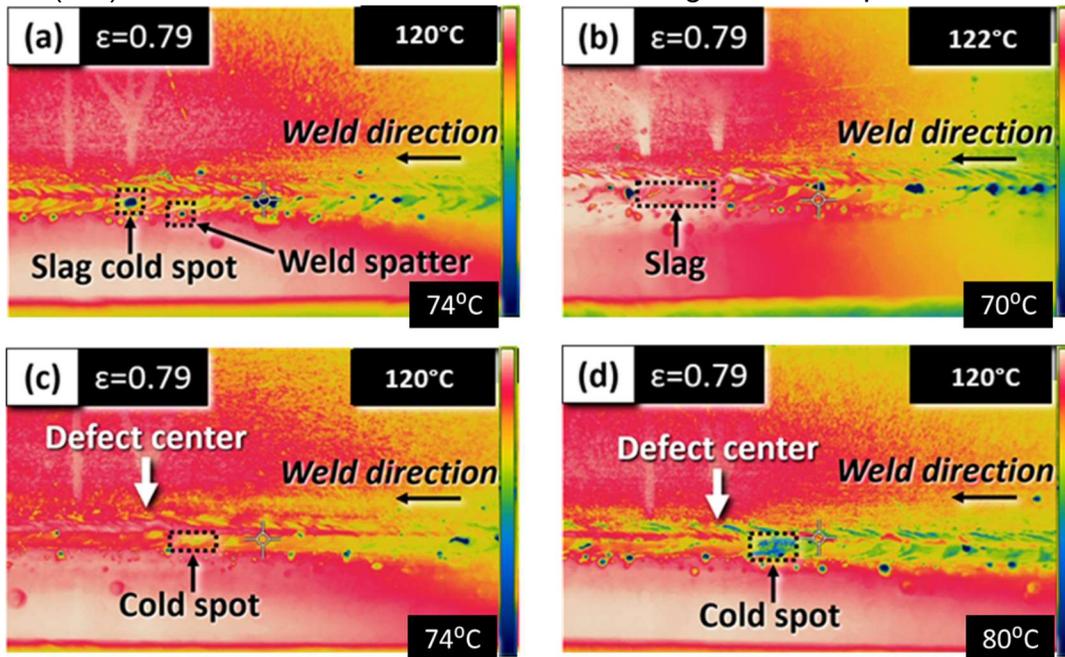
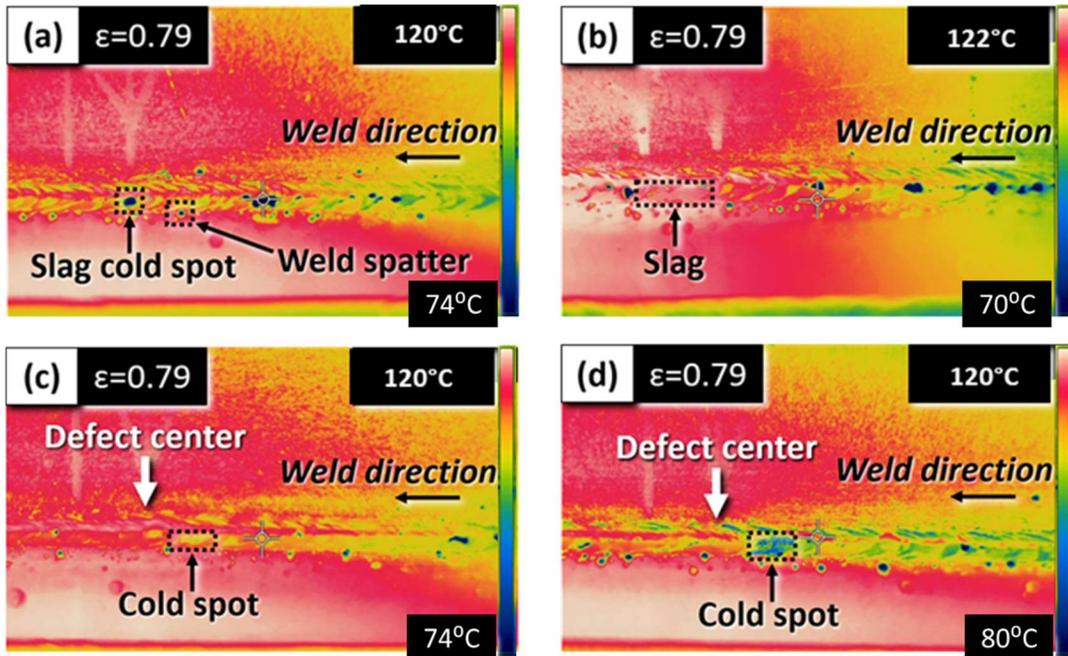
Figure 0-1 – (a-b) The defect-free IR images of the steel plate-to-plate joint using the FLIR T620 camera. (c-d) The FLIR T620 IR images of the steel plate-to-plate joints with manufactured subsurface cracks from a Cu contaminant (defect location labeled). The emissivity (ϵ) that the user sets in the camera is shown on the top left and on the right of the image is the corresponding temperature scale color scheme, which is automatically performed by the camera.

The IR images from two baseline defect-free control samples, and steel plate-to-plate weld joint samples that were taken using the FLIR T620 camera are given in Figure 0-1(a-b). The observed weld artifacts include slag and weld spatter.

Figure 0-1(b-c) shows representative IR images from two of the twelve defect steel plate-to-plate weld joints. The defects in the steel plate-to-plate joints have subsurface cracks formed by a Cu contaminant in the root of the joint. These images show a white arrow above the weld region where defects were placed (labeled defect center). The defects were not visually detectable in steel plate-to-plate joints using the FLIR T620 camera.

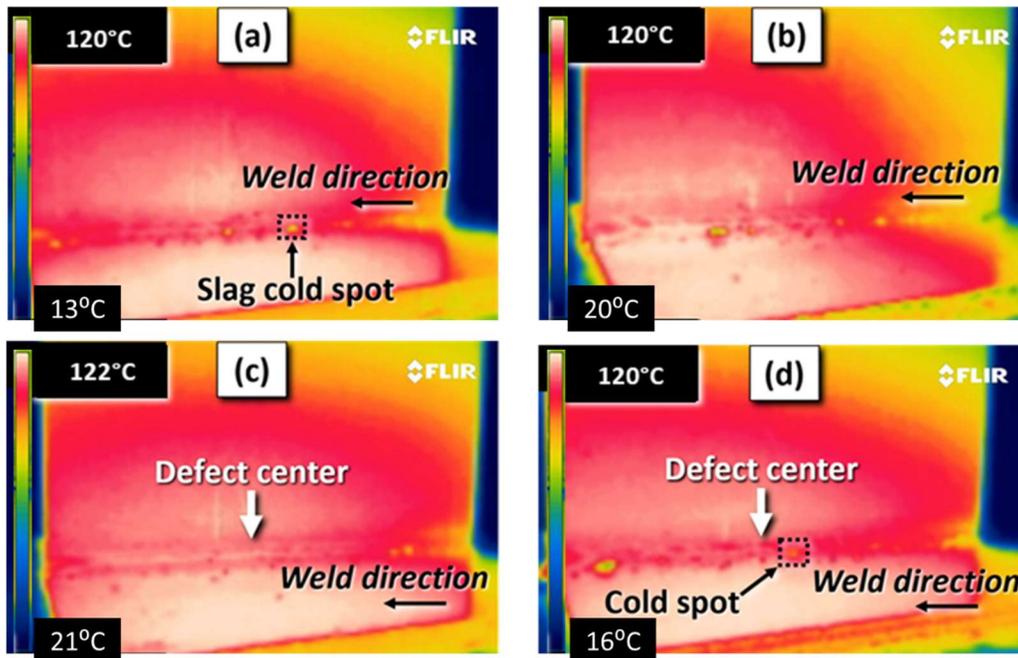
Figure 0-2 – (a-b) The defect-free IR images of the steel plate-to-plate joint using the FLIR C5 camera. (c-d) The FLIR C5 IR images of the steel plate-to-plate joints with manufactured subsurface cracks from a Cu contaminant (defect location labeled). The temperatures on the left of the images correspond to the temperature scale color scheme which is automatically performed by the camera.

The defect-free IR images from the FLIR C5 are shown in Figure 0-2(a-b). The weld artifacts include cold spots from regions where slag was present. Representative IR images of two of the twelve weld joints with defects for the FLIR C5 are shown in Figure 0-2(c-d). The defects were not visually detectable in the steel plate-to-plate joints using the FLIR C5 camera.

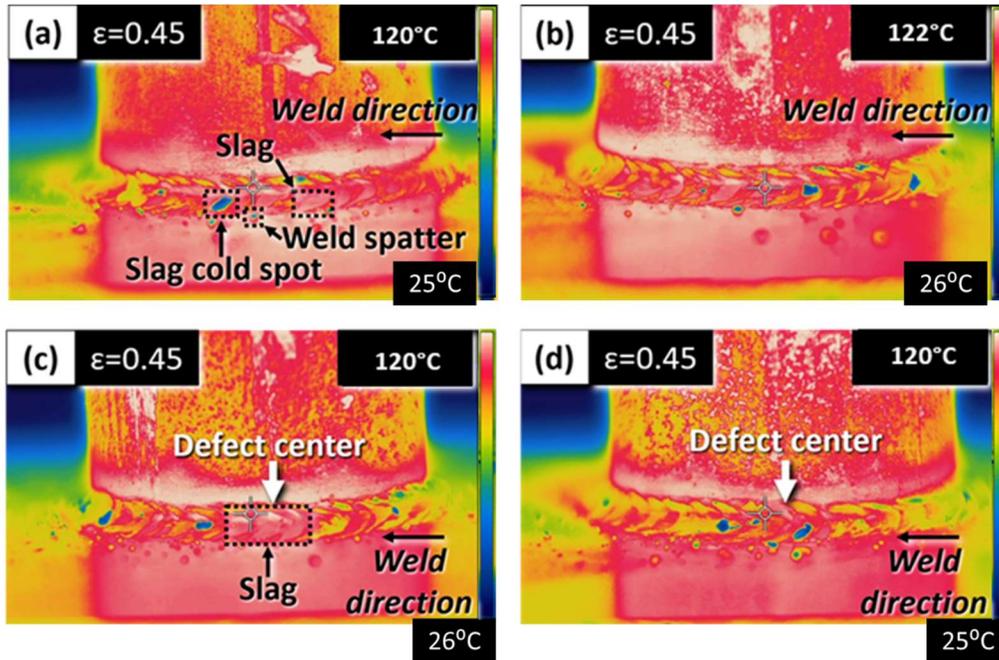
Figure 0-3 – (a-b) The defect-free IR images of the steel pipe-to-plate joint using the FLIR T620 camera. (c-d) The FLIR T620 IR images of the steel pipe-to-plate joints with manufactured subsurface cracks from a Cu contaminant (defect location labeled). The emissivity (ϵ) that the user sets in the camera is shown on the top left and on the right of the image is the corresponding temperature scale color scheme, which is automatically performed by the camera.

The IR images from the two defect-free steel pipe-to-plate weld joint samples that were taken using the FLIR T620 camera are given in Figure 0-3(a-b). Representative IR images from two of the twelve defect steel pipe-to-plate weld joint samples that were taken using the FLIR T620 camera are provided in Figure 0-3(c-d). The defects in the steel plate-to-plate joints are subsurface cracks formed by a Cu contaminant in the root of the joint. These images show an arrow indicating the location of the defect center. Figure 0-4 shows an optical image of slag covering the defect center, thus obscuring the subsurface defect in Figure 0-3(c). The defects were not visually detectable in the steel pipe-to-plate joints using the FLIR T620 camera.

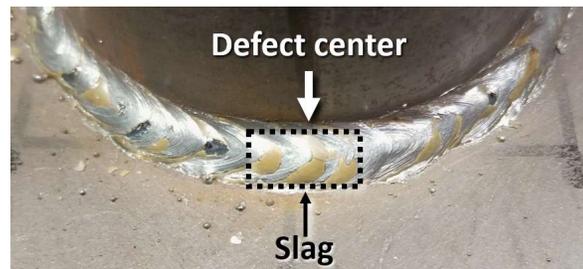
Figure 0-4 – Optical image of the steel pipe-to-plate weld joint with slag over the defect center corresponding to the IR image in Figure 35(c).

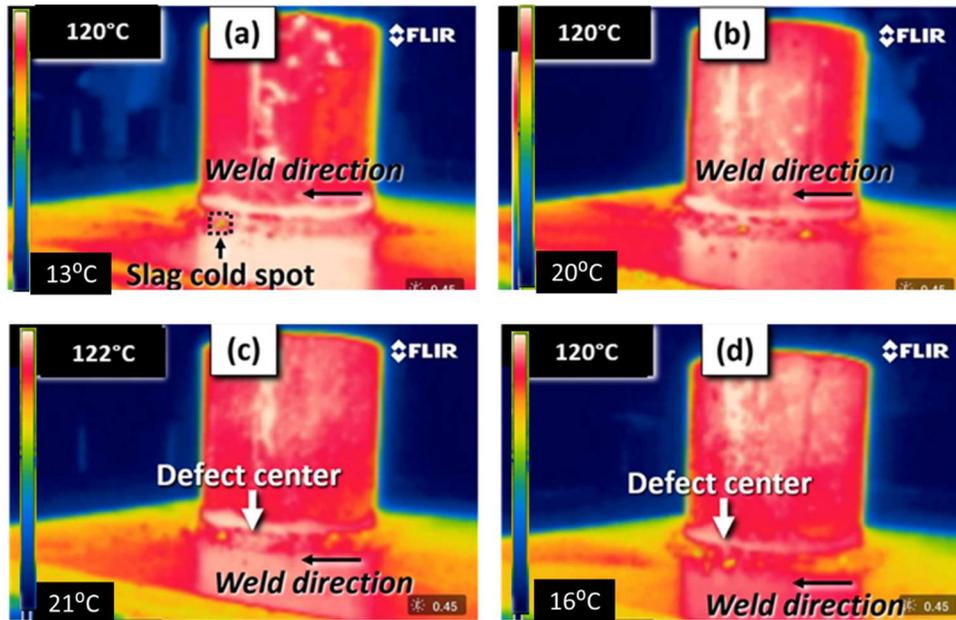
Figure 0-5 – (a-b) The defect-free IR images of the steel pipe-to-plate joint using the FLIR C5 camera. (c-d) The FLIR C5 IR images of the steel pipe-to-plate joints with manufactured subsurface cracks from a Cu contaminant (defect location labeled). The temperatures on the left of the images correspond to the temperature scale color scheme, which is automatically performed by the camera.

The defect-free IR images from the FLIR C5 are shown in Figure 0-5(a-b). Weld artifacts include cold spots from regions with slag in the images. Representative IR images of two of the twelve weld joints with defects for the FLIR C5 are shown in Figure 0-5(c-d). These images show a white arrow above the weld region where defects were placed (labeled defect center). The defects were not visually detectable in the steel pipe-to-plate joints using the FLIR C5 camera.

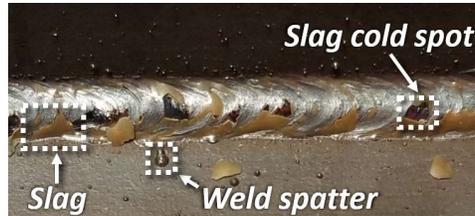
Figure 0-6 – Optical image of the baseline sample steel plate-to-plate weld joint with labels showing examples of slag, cold spots (regions where slag spontaneously removed from the weld during cool-down), and weld spatter.

In addition to the slag, there are regions where slag was present on the weld but spalled during cooling. These regions are referred to as cold spots. These spots result in weld metal with a different surface finish (emissivity) than the surrounding weld metal, as shown in Figure 0-6. For some weld samples, these cold spots can also be present in the regions of interest, e.g., defective location.

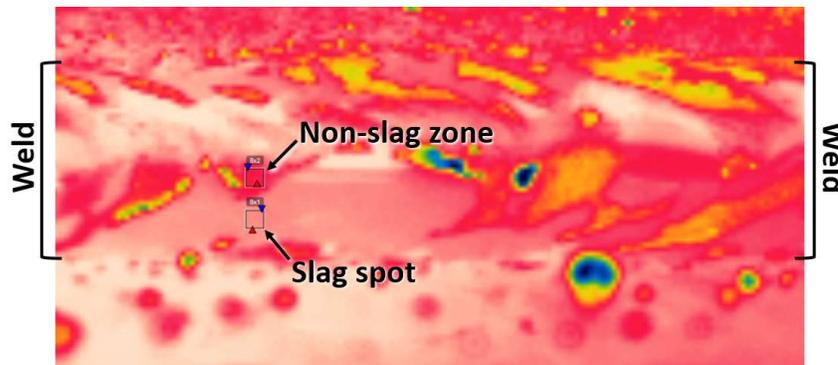
Figure 0-7 – The steel plate-to-plate weld joint with a 4x4-pixel box over a slag spot and a non-slag spot to measure the average temperatures of those regions. The slag spot box average temperature was 115°C, and the non-slag spot box average temperature was 112°C.

To determine the impact of the thermal signal from the slag, the FLIR Tools software was used to measure the average temperature of a 4x4 pixel box within a slag spot and in a non-slag weld zone vertical to it, as demonstrated in Figure 0-7. The average temperature of the pixels measured in the slag spot was 115°C, and the average temperature of the pixels measured in the non-slag zone was 112°C when the emissivity of the weld was used. However, there is a difference in emissivity between the slag and non-slag zone, which can result in incorrectly calculated temperature readings from the camera. Suppose the emissivity of the slag is only 0.06 higher than the surrounding weld, as it has a less reflective finish. If this new emissivity is used, the calculated average temperature of the pixels in the slag zone decreases by 12°C

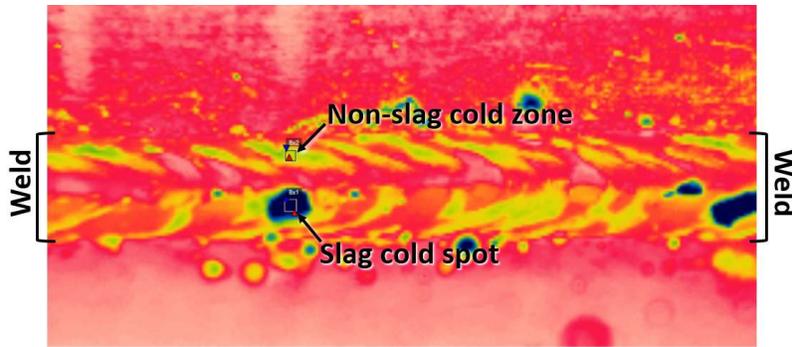
Figure 0-8 – The steel plate-to-plate weld joint with a 4x4-pixel box over a slag cold spot and a non-slag cold spot to measure the average temperatures of those regions. The cold spot box average temperature was 51°C, and the non-slag cold spot box average temperature was 107°C.

To determine the impact of the thermal signal from the cold spots, the FLIR Tools software was used to measure the average temperature of a 4x4 pixel box placed in the slag cold spot and compared to another 4x4 pixel box of the surrounding weld metal above it, as demonstrated in Figure 0-8. The average temperature of the pixels over the slag cold spot was 51°C, while the average temperature in the non-slag zone was 107°C. As a result, these cold spots result in a significant temperature differential from the surrounding weld metal and will disrupt the temperature readings taken from the weld. In addition, the cold spots have a different emissivity than the surrounding weld, which will result in incorrect temperature readings.

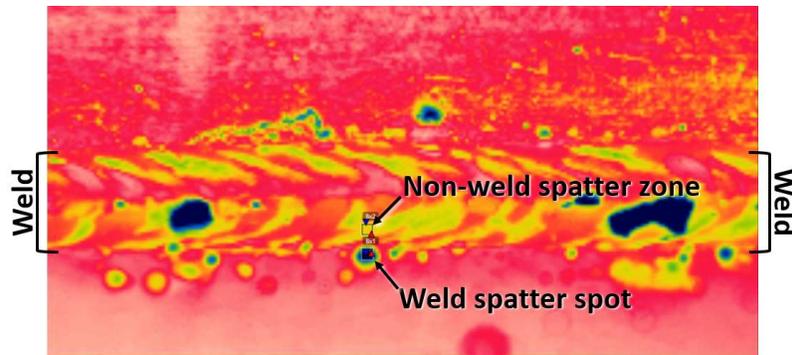
Figure 0-9 – The steel plate-to-plate weld joint with a 4x4-pixel box over a weld splatter spot and a non-weld splatter spot to measure the average temperatures of those regions. The weld splatter spot box average temperature was 77°C, and the non-weld splatter spot box average temperature was 109°C.

Weld spatter was another welding artifact found to cause a thermal signal in the steel welds. To determine the impact of the thermal signal from the weld spatter, the FLIR Tools software was used to measure the average temperature of a 4x4 pixel box within a region of weld splatter and compare it to a 4x4 pixel box placed in the surrounding weld metal above it, as demonstrated in Figure 0-9. The average temperature of the pixels in the weld splatter box was 77°C, while the average temperature in the non-weld splatter zone was 109°C. Similar to the cold spot, the weld splatter results in a significant temperature differential from the surrounding weld metal.

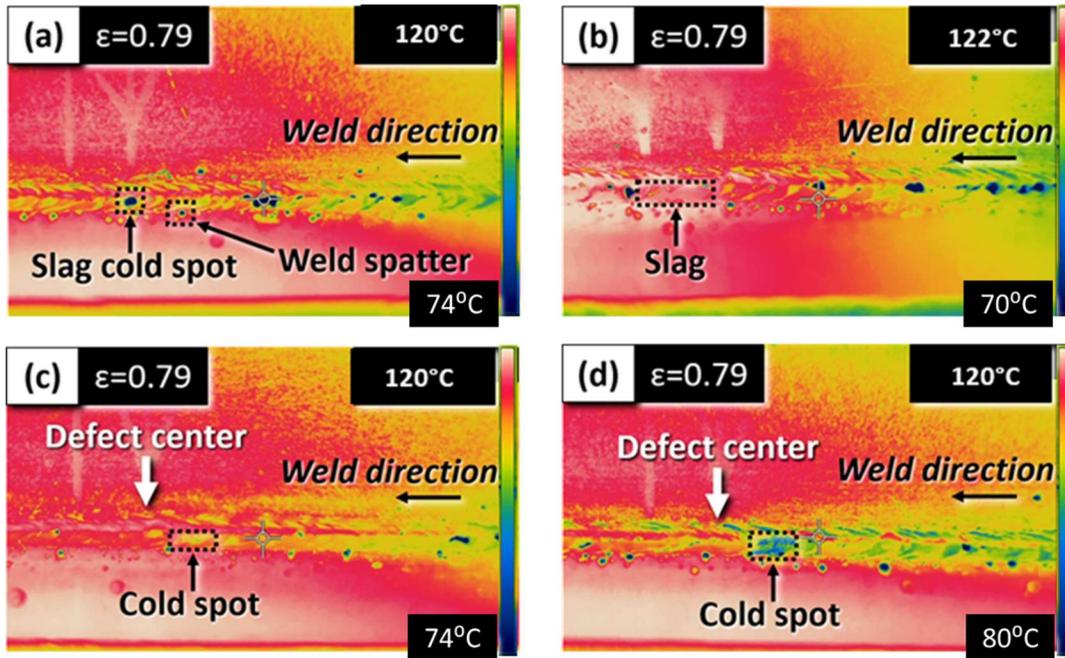
A weld artifact present in the FLIR T620 IR images and most of the FLIR C5 IR images of the steel plate-to-plate joints with artificial defects was a cold spot region located near

the defect center labeled in

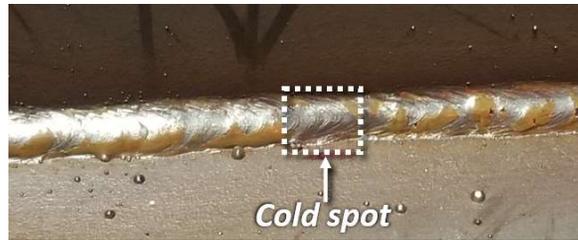
Figure 0-10 – Optical image of the defect sample steel plate-to-plate weld joint with a label showing the cold spot location.
