Final Report

FDOT BDV31-977-121

Use of Infrared Thermography for the Inspection of Welds in the Shop and Field- Phase II

Department of Materials Science and Engineering
University of Florida
549 Gale Lemerand Dr.
Gainesville, FL 32611

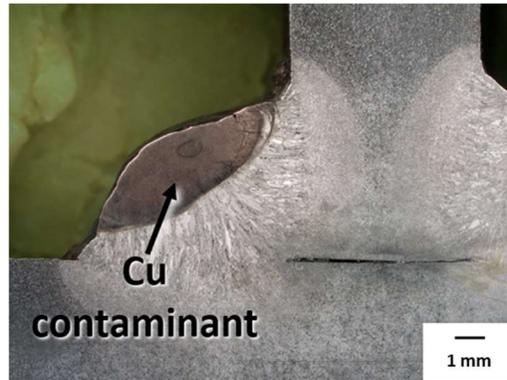
Figure 0-11 – Cross-section of the steel plate-to-plate defect weld joint where the cold spot was present in the IR images, labeled as Cu contaminant. A portion of Cu from the defect center melted backwards into this region, and this phenomenon resulted in the cold spots in the defect weld joint IR images.

This cold spot does reveal the ability of IR to qualitatively show regions of different thermal conductivities, especially due to elemental contamination. All FLIR T620 IR images of the defective steel plate-to-plate weld joints had the presence of the cold spot produced from the Cu deposits. All FLIR C5 IR images showed a cold spot except for one sample.

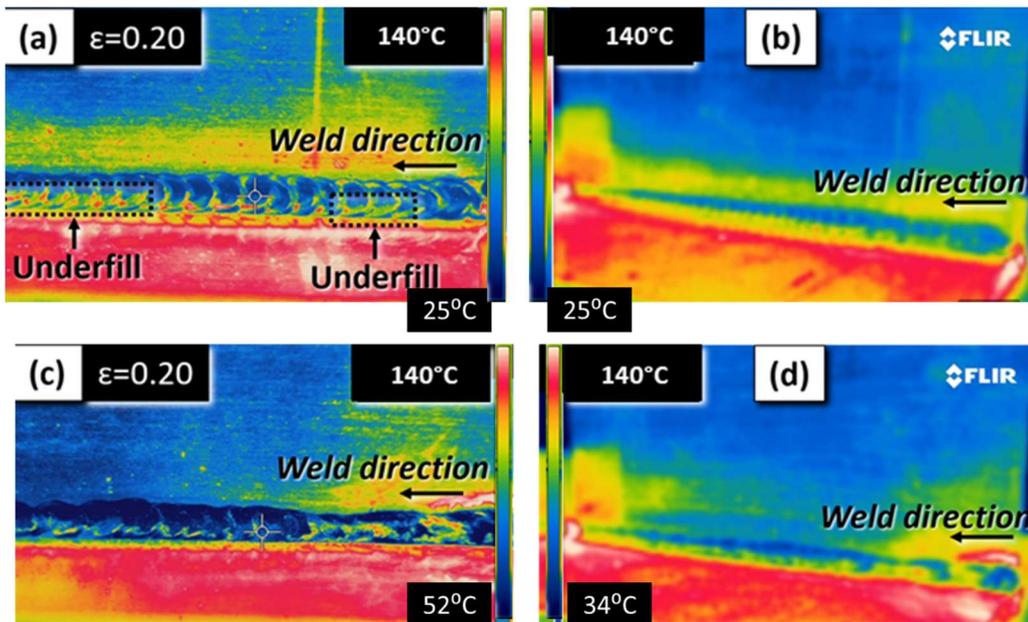
Figure 0-12 – (a-b) The baseline IR images of the Al plate-to-plate weld joints with less underfill and (c-d) with more underfill. The emissivity (ϵ) that the user sets in the camera is shown on the top left and the corresponding temperature scale color scheme, which is automatically performed by the camera.

The IR images from the two baseline defect-free Al plate-to-plate weld joint samples that were taken using the FLIR T620 and C5 cameras are shown in Figure 0-12. These images show the temperature scale, the direction of welding, emissivity (ϵ), and a thermal signal from the permanent marker line indicating the location of the defect. A weld discontinuity where less weld mass was present in regions of the weld, called underfill, is represented in both defect-free samples. The locations of underfill are labeled in the IR image of defect-free (Figure 0-12(a-b)) but not marked in the IR image of defect-free (Figure 0-12(c-d)) because it is present throughout the entirety of the portion of weld shown in the IR image.

There are qualitative differences between the thermal signals in the two defect-free Al plate-to-plate weld joints tested (Figure 0-12). These differences in the thermal signal are attributed to varying amounts of underfill present in each defect-free joint. Specifically, the defect-free weld joint (Figure 0-12(c-d)) has a higher occurrence of underfill than the defect-free weld joint (Figure 0-12(a-b)). The underfill indicates less weld mass than the surrounding weld metal, which will result in differences in thermal diffusivity. Optical images of the two baseline joints are shown in Figure 0-15 and include locations of weld underfill. Although the defects were always detectable, some joints also produced thermal signals in the sound regions of the weld where underfill was present that could be falsely identified as a defect.

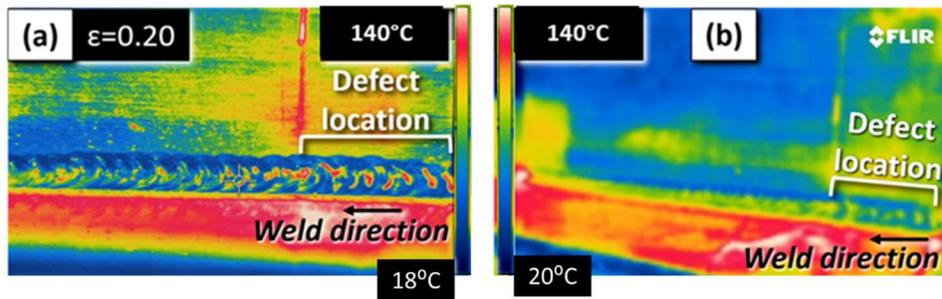
Figure 0-13 – The IR images of the defect sample Al plate-to-plate weld joint with a manufactured subsurface machined cut (defect location labeled). (a) FLIR T620 IR image of the defect sample weld joint. (b) FLIR C5 IR image of the defect sample weld joint. The emissivity (ϵ) that the user sets in the camera is shown on the top left and on the right of the image ‘a’ and left in ‘b’ is the corresponding temperature scale color scheme, which is automatically performed by the camera.

The defects in the Al plate-to-plate joints were detectable in all defect weld joints tested using both IR cameras. The FLIR T620 and C5 IR images of one of the Al plate-to-plate defect weld joints are shown in Figure 0-13(a-b). The defects in the Al plate-to-plate joints are machined cuts made at the root of the joint before welding, which act as a subsurface pseudocrack. These images show the temperature scale, the direction of welding, and a bracket indicating the location of the defect. A hotter thermal signal is present in the FLIR T620 IR image where the defect is located, in contrast to the defect-free weld joint IR image (Figure 0-13a)), which has a similar occurrence of underfill in it to this defect sample.

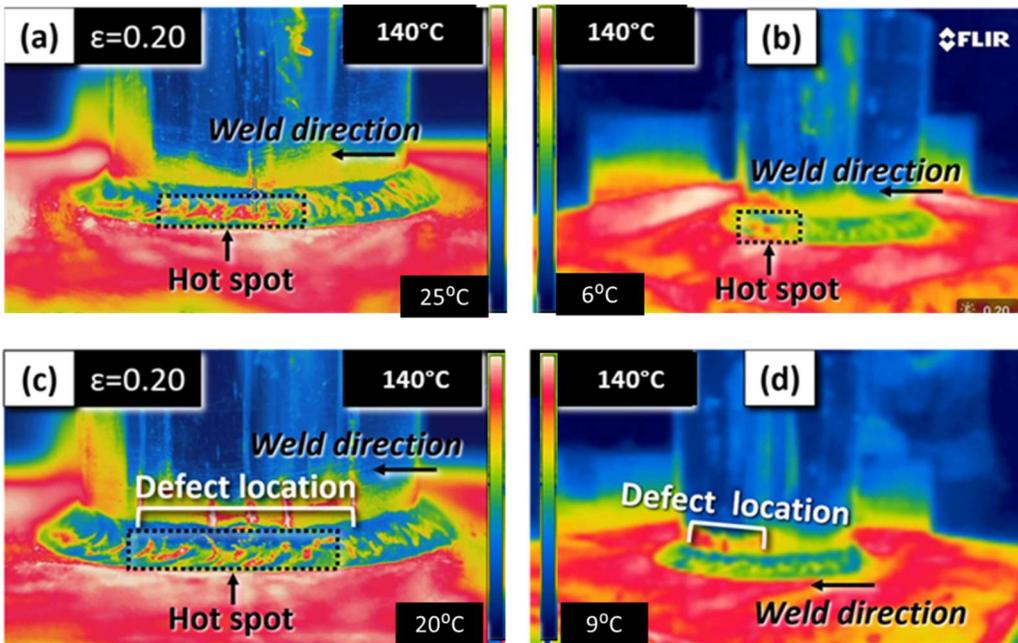
Figure 0-14 – (a-b) The IR images of the defect-free Al pipe-to-plate weld joint. (c-d)

The IR images of the defect in Al pipe-to-plate weld joint with a manufactured subsurface machined cut (defect location labeled). The emissivity (ϵ) that the user sets in the camera is shown on the top left, and each image shows the corresponding temperature scale color scheme, which is automatically performed by the camera.

The FLIR T620 and C5 IR images from one of the two defect-free Al pipe-to-plate weld joint samples are given in Figure 0-14(a-b). These images show the temperature scale, the direction of welding, a thermal signal from the permanent marker lines indicating where the defect would begin, and a hot spot present in all welds tested of this joint type. The FLIR T620 and C5 IR images of one of the nine defect Al pipe-to-plate weld joints are shown in Figure 0-14(c-d). The defects in the Al pipe-to-plate joints are machined cuts made at the root of the joint before welding, which act as a subsurface pseudocrack. These images show the temperature scale, the direction of welding, a bracket over the marker lines indicating the location of the defect, and the hot spot in the welds. The defects were not visually detectable in the Al pipe-to-plate joints using either IR camera.

Despite a correlation between longer weld times and the presence of the hot spot, the relative location of the hot spot in those joints is stochastic. In the baseline, the hot spot is more centralized, while in defect (Figure 0-14(c-d)) and baseline sample (

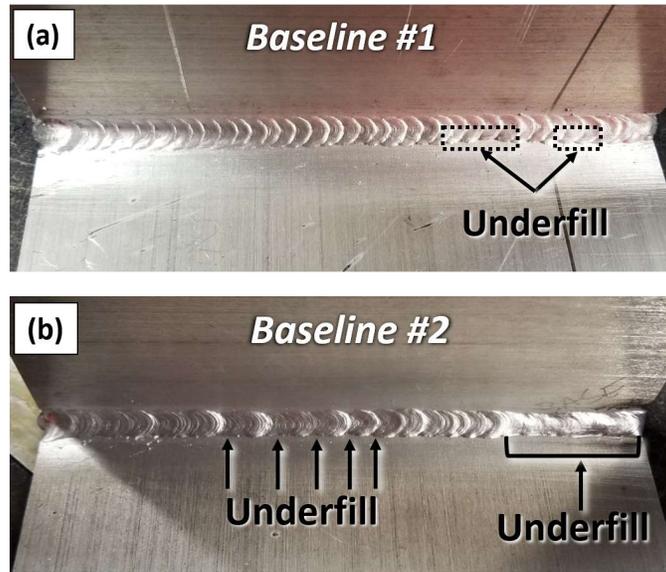
Figure 0-15 – Optical images of the two baseline Al plate-to-plate weld joints. (a) The baseline weld joint has some occurrences of underfill. (b) The baseline weld joint has a more frequent occurrence of underfill.

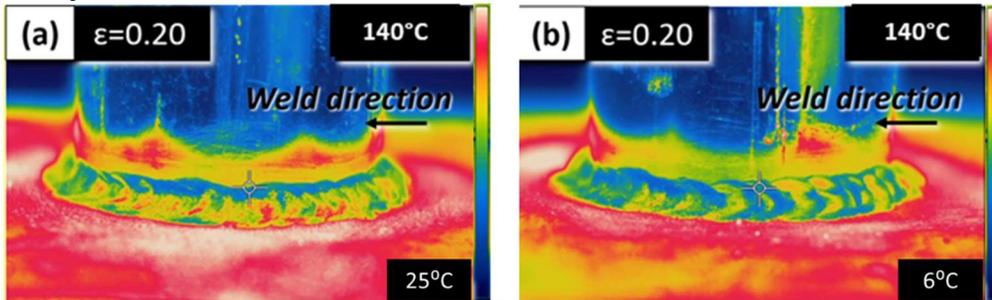
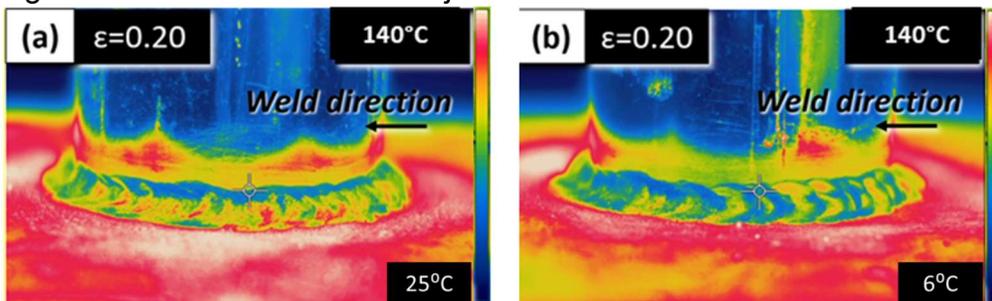
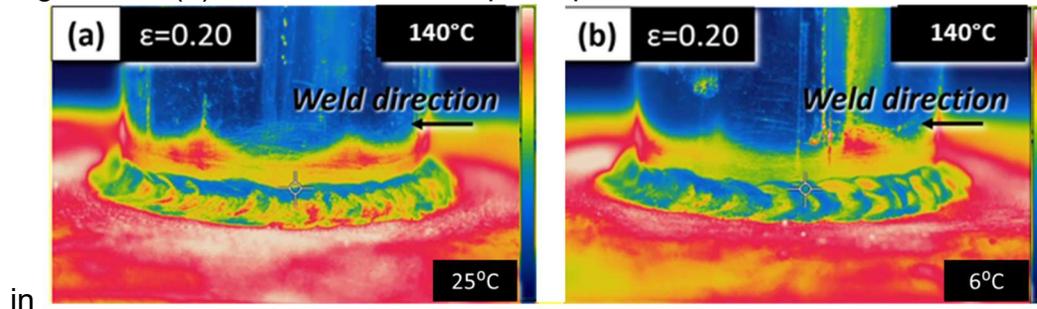
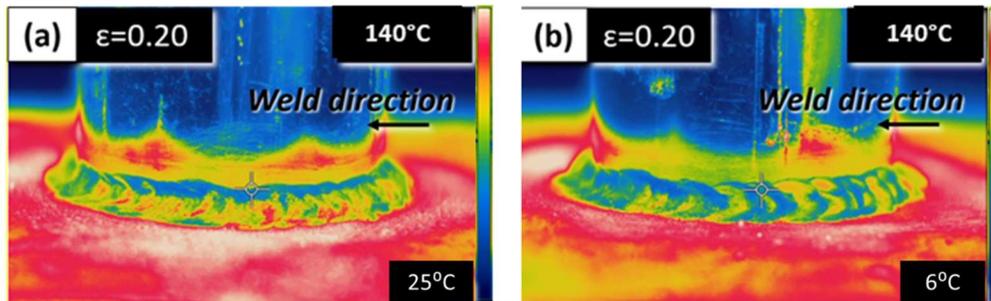
Figure 0-16 – FLIR T620 IR images of two additional baseline (defect-free) Al pipe-to-plate weld joints tested to further analyze the hot spot present in this joint type. (a) IR image of the baseline weld joint with the hot spot present. (b) IR image of the baseline weld joint imaged without a hot spot. The emissivity (ϵ) that the user sets in the camera is shown on the top left and on the right of the image is the corresponding temperature scale color scheme, which is automatically performed by the camera.

In all the baseline and defect Al pipe-to-plate weld joints tested, there was a hot spot present in the central region of the welds IR imaged. Two more sound weld joints were produced to analyze the presence of this hot spot. The IR images from these two sound weld joints are shown in

Figure 0-16. In the sound weld joint shown in

Figure 0-16(a), baseline, the hot spot is present, but in the other sound weld joint shown

Figure 0-16(b), baseline, there is not a hot spot.

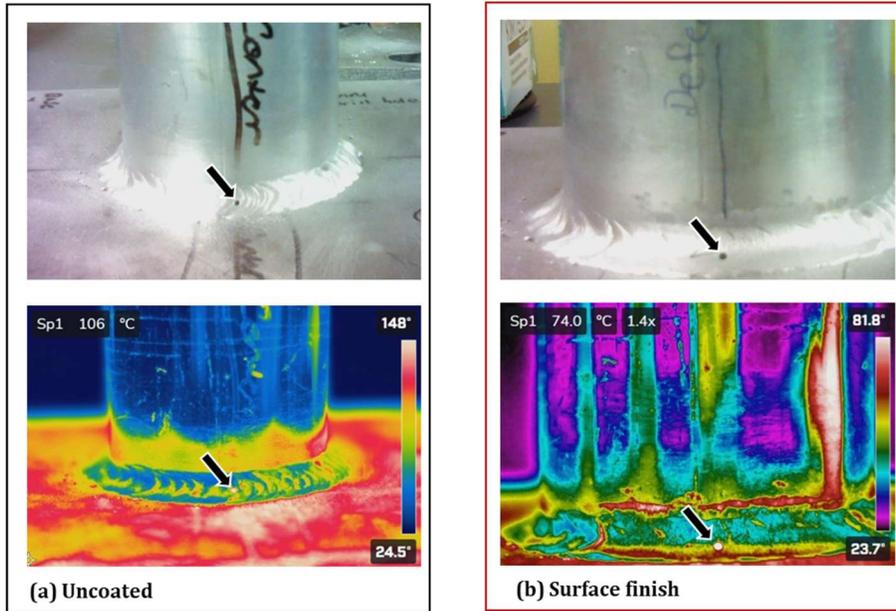
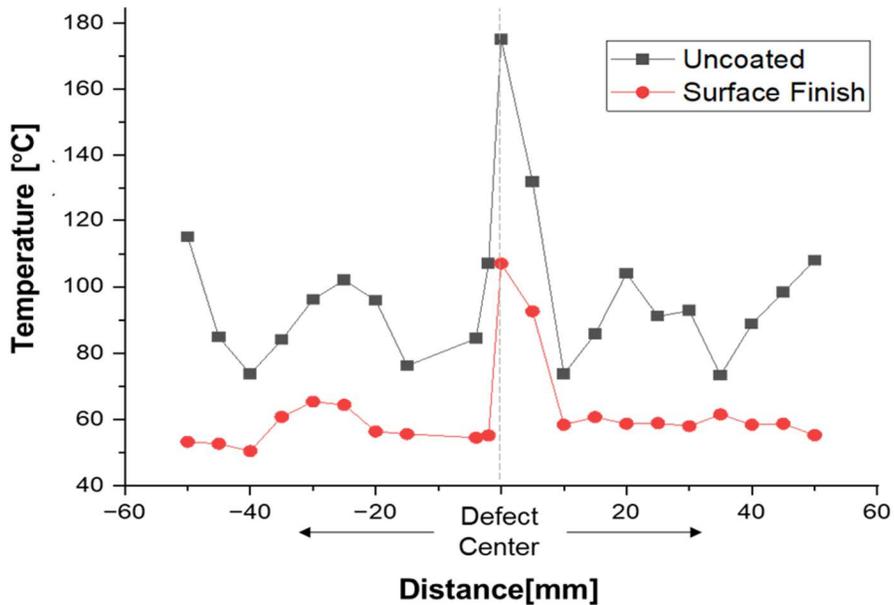
Figure 0-17 – Visual (top) and IR-TNDT (bottom) images at 100°C of the Al pipe-to-plate samples with the surface-breaking drill hole: (a) in the uncoated condition, (b) with the applied surface finish. The black arrows point to the location of the surface-breaking drill hole. (c) Analysis of the temperature profile along the weld line plotted from the IR images of the uncoated and with surface finish samples.

Analysis from the Al weld samples in the pipe-to-plate and plate-to-plate surface-breaking drill hole conditions are shown in Figure 0-17 and Figure 0-18, respectively. Visual and IR images of the weld joints are demonstrated for uncoated and surface-finished samples. In the IR images, the temperature color scale is positioned on the right side of each image. The temperature read by pointing to the measuring spot (Sp1) on the top of the drilled hole location is approximately 100°C, shown in the upper left corner of their IR image.

Analogously to the temperature versus position analysis presented by Teyssieux et al. [54] based on IR images, a linear temperature profile was plotted along the weld line and across the drilled defect, shown in Figure 0-17(c) and Figure 0-18(c). In those plots, the x-axis refers to the position relative to the defect center, and the y-axis refers to the temperature reading. The IR images with the reference temperature of 100°C were used to build the profiles. The uncoated and surface finish samples for Al pipe-to-plate and plate-to-plate geometries show a temperature peak at the defect center.

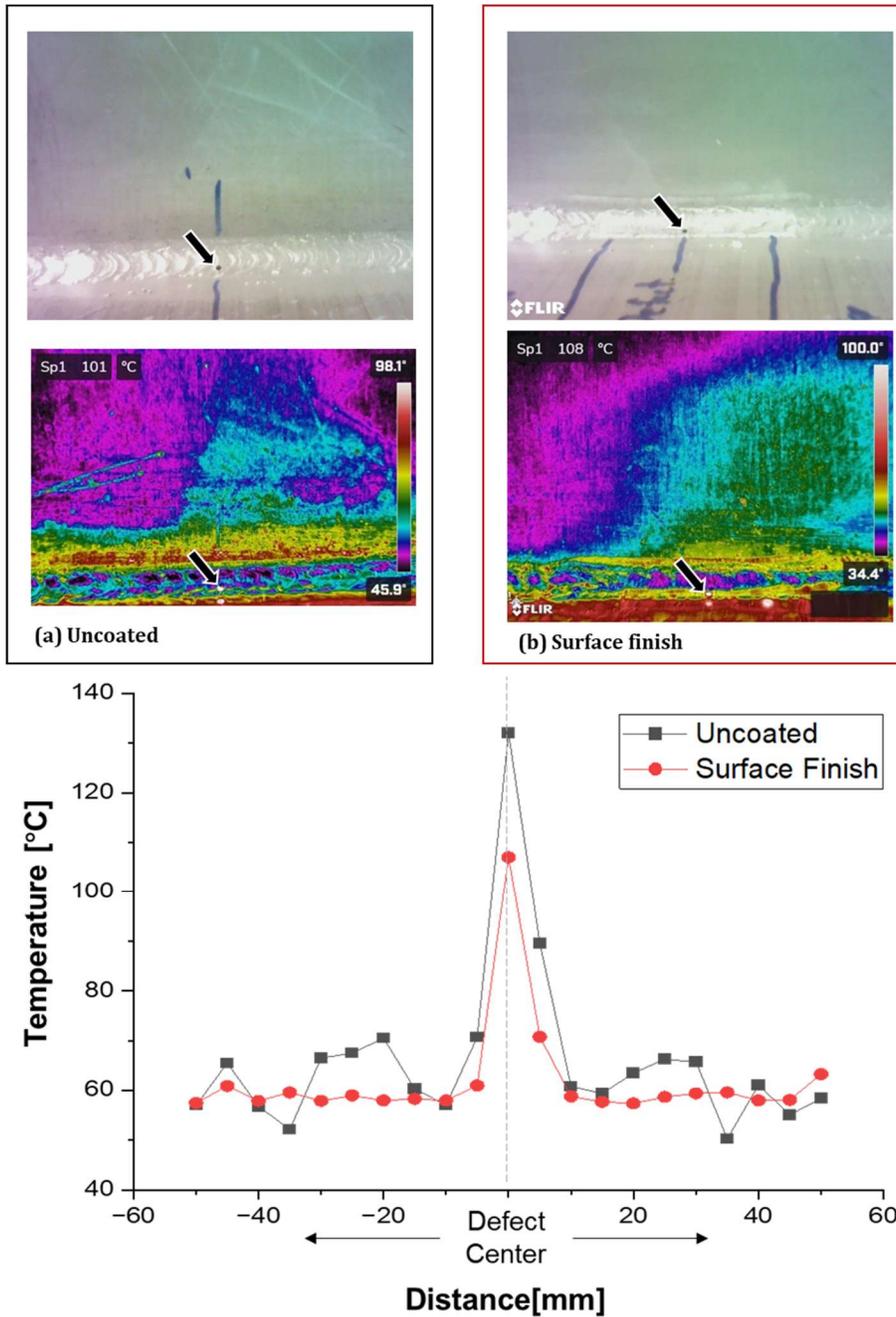
Figure 0-18 – Visual (top) and IR-TNDT (bottom) images at 100°C of the Al plate-to-plate samples with the surface-breaking drill hole: (a) the uncoated condition, (b) with the applied surface finish. The black arrows point to the location of the surface-breaking drill hole. (c) A linear temperature profile along the weld line plotted from the IR images of the uncoated and with surface finish samples.

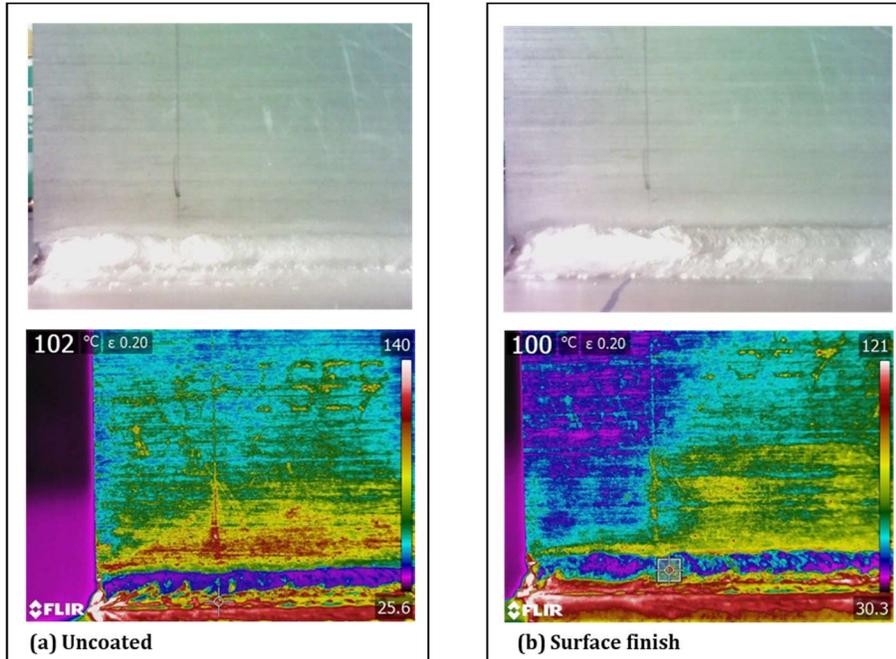
Figure 0-19 – Visual (top) and IR-TNDT (bottom) images at 100°C of the Al plate-to-plate samples with subsurface pseudocrack: (a) in the uncoated condition, (b) with the applied surface finish. No subsurface defect could be identified.

Figure 0-19 displays visual and IR images of Al plate-to-plate weld joints with a subsurface pseudocrack. The machined subsurface pseudocrack could not be identified in the uncoated (a) or applied surface finished condition (b). The temperature color

scale is positioned on the right side of each IR image. The temperature was read by pointing the camera on the measuring spot, Sp1, at the beginning of the machined pseudocrack and is shown in the upper left corner of the image. Since no defect could be detected, no temperature profile was produced.

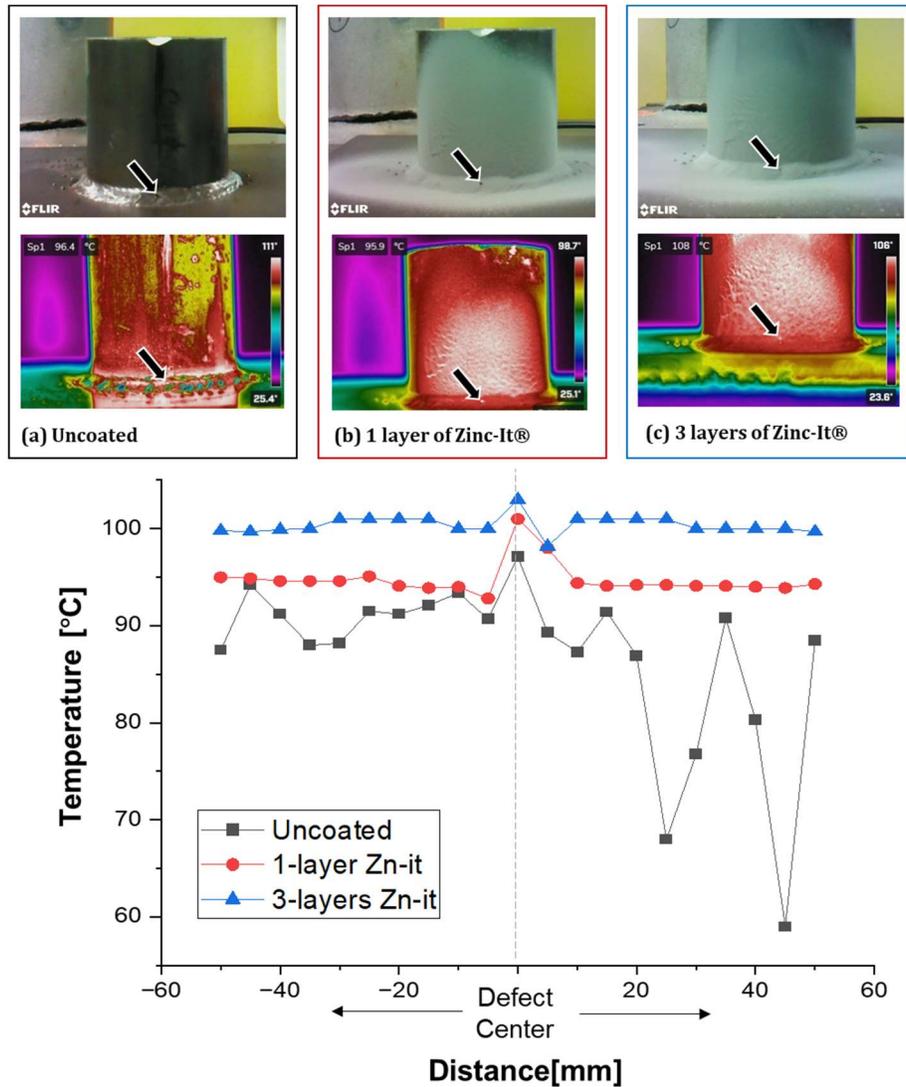
Figure 0-20 – Visual (top) and IR-TNDT (bottom) images at 100°C of the steel pipe-to-plate samples with the surface-breaking drill hole: (a) in the uncoated condition, (b) coated with 1 layer of Zinc-It® spray, (c) with 3 layers of Zinc-It® spray. Black arrows point to the location of the surface-breaking drill hole. (d) A linear temperature profile along the weld line plotted from the IR images of the uncoated and coated samples.

For the steel pipe-to-plate and plate-to-plate analysis presented in Figure 0-20 and Figure 0-21, the three sections compare the uncoated condition and samples with one and three layers of the Zinc-it® coating. The defect is visible in the IR images in all the samples with the surface-breaking drill hole, as highlighted by a black arrow. The temperature color scale appears on the right side of each IR image. The temperature on the upper left corner of each IR image refers to the reference temperature read by Sp1.

Analogously to the temperature *versus* position analysis presented by Teysieux et al. [54] based on IR images, a linear temperature profile was plotted along the weld line and across the drilled defect, shown in Figure 0-20(d) and Figure 0-21(d). In those plots, the x-axis refers to the position at the defect center, and the y-axis refers to the temperature reading. The IR images with the reference temperature of 100°C were used to build the profiles.

A peak in temperature at the defect center can be perceived in the uncoated, one layer of Zinc-It®, and three layers of Zinc-It® samples for both steel pipe-to-plate and plate-to-plate geometries. However, there are two main observations:

1. In the uncoated condition, represented by the black line in Figure 0-20(d) and Figure 0-21(d), the temperature profile varies continuously across the sample, affecting the ability to identify the defect visually.
2. The defect center's temperature peak decreased considerably upon applying the third layer of Zinc-It® coating in the steel pipe-to-plate geometry, as shown in Figure 0-20(d).

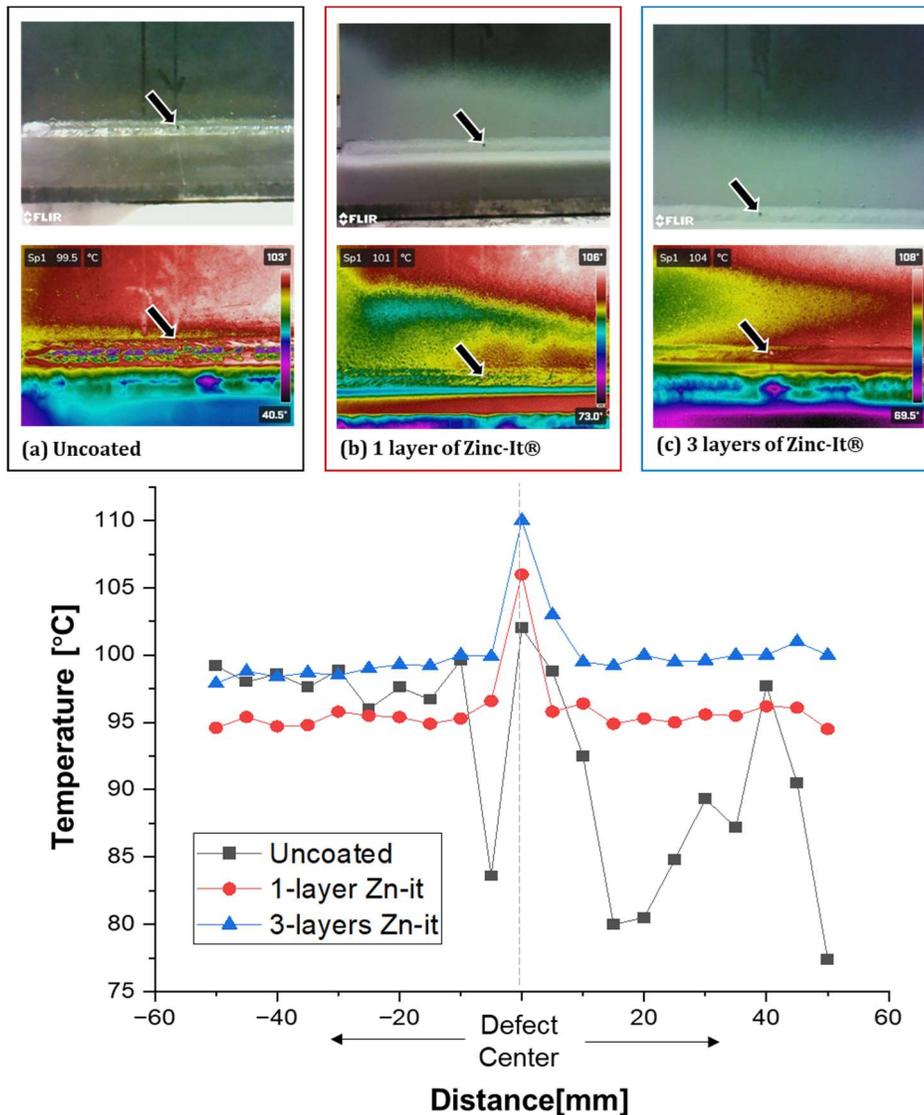
Figure 0-21 – Visual (top) and IR-TNDT (bottom) images at 100°C of the steel plate-to-plate samples with the surface-breaking drill hole: (a) in the uncoated condition, (b) coated with 1 layer of Zinc-It® spray, (c) with 3 layers of Zinc-It® spray. Black arrows point to the location of the surface-breaking drill hole. (d) A linear temperature profile along the weld line plotted from the IR images of the uncoated and coated samples.

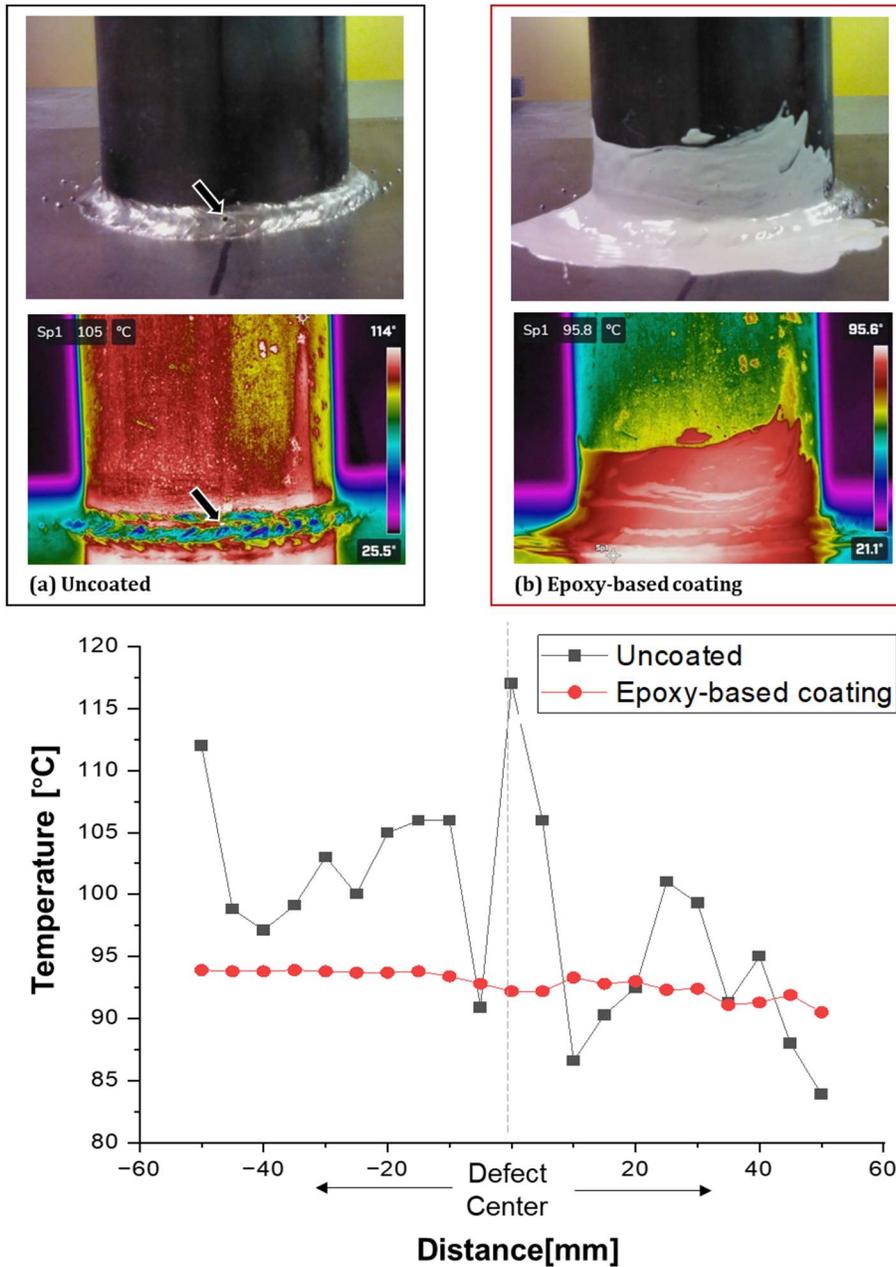
Figure 0-22 – Visual (top) and IR-TNDT (bottom) images at 100°C of the steel pipe-to-plate samples with the surface-breaking drill hole: (a) in the uncoated condition, (b) coated with the epoxy-based coating. The black arrows point to the location of the surface-breaking drill hole. In 'b', no defect can be detected. (c) A linear temperature profile along the weld line plotted from the IR images of the uncoated and coated samples.

The IR-TNDT in the steel welds coated with the epoxy-based coating is presented in Figure 0-22 and Figure 0-23. The temperature color scale appears on the right in the IR images. The temperature on the upper left corner of each image refers to the reference temperature read by Sp1. The defect is only visible in the IR images of the uncoated condition in Figure 0-22(a) and Figure 0-23(a) and is highlighted by a black arrow. Figure 0-22(b) and Figure 0-23(b) display the epoxy-based coating covering and obscuring surface-breaking drill holes.

A linear temperature profile was plotted along the weld line and is shown in Figure 0-22(c) and Figure 0-23(c), where the x-axis refers to the position in relation to the defect and the y-axis refers to the temperature reading. The IR images with the reference temperature of 100°C were used to build the profiles. In Figure 0-22(c) and Figure 0-23(c), the noisiness in the temperature profile of the uncoated samples can be noticed by the black line, however, a temperature peak can be observed at the defect center. Meanwhile, the red line shows the application of the epoxy-based coating, which covered and obscured the defect in the IR images.

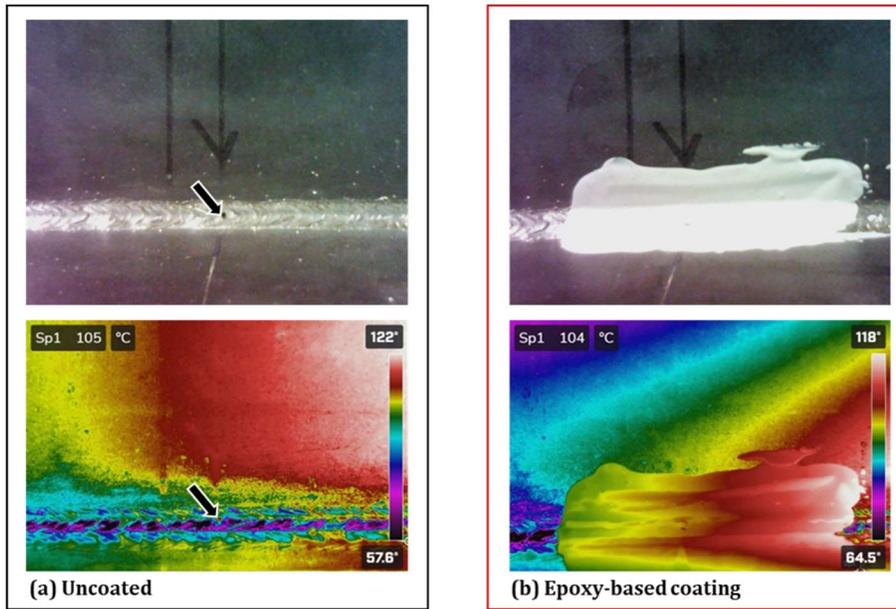
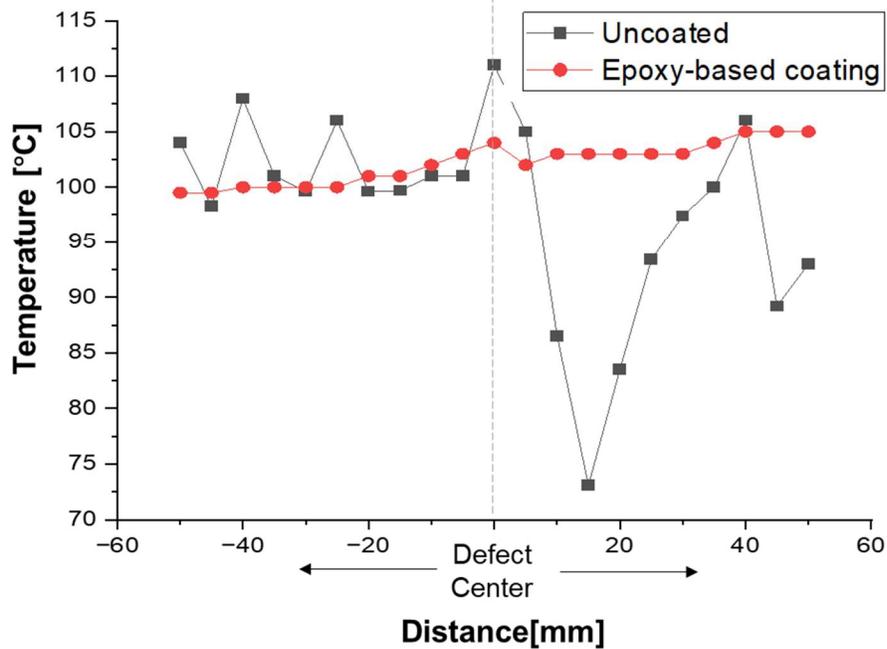
Figure 0-23 – Visual (top) and IR-TNDT (bottom) images at 100°C of the steel plate-to-plate samples with the surface-breaking drill hole: (a) in the uncoated condition, (b) coated with the epoxy-based coating. The black arrows point to the location of the surface-breaking drill hole. The defect was not observable after coating with the epoxy-based coating. (c) A linear temperature profile along the weld line plotted from the IR images of the uncoated and coated samples.

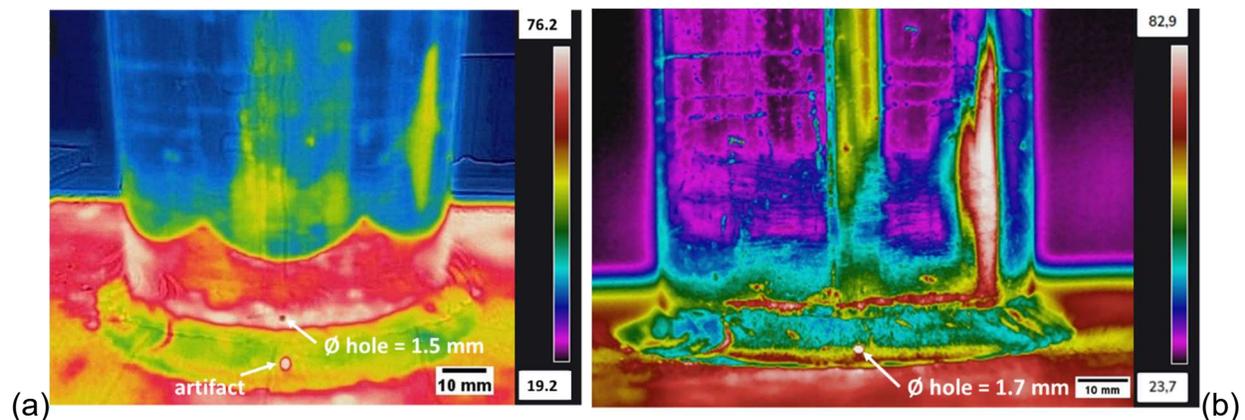
Figure 0-24 – Al pipe-to-plate weld joint sample, with surface-breaking drill hole and 120-grit surface finish: (a) IR image taken with FLIR C5 camera, (b) IR image taken with FLIR T620 camera. A white arrow points to the defect and a label informs the diameter of the hole. Some examples of artifacts are also labeled. A temperature scale in °C is provided on the right side of each IR image.

The IR images from different Al weld joint samples with 120-grit surface finish are given in Figure 0-24, Figure 0-25, and Figure 0-26, taken using the FLIR C5 and T620 cameras. These images show the temperature scale in °C, a white arrow pointing to the weld region where defects were visible, and labels giving information about the defect diameter in mm. Some examples of welding artifacts that produce a thermal signal are also pointed out in the IR images.

Despite being taken at a similar position and with the same parameter settings and environment calibration, it is possible to observe a very different temperature contrast acquired from FLIR C5 (Figure 0-24(a) to Figure 0-25(a)) and T620 (Figure 0-24(b) to Figure 0-25b)). Artifacts can be seen in the IR images obtained from both cameras. However, the decreased focus and contrast capabilities are evident in the FLIR C5 IR images compared to those acquired with the FLIR T620 camera.

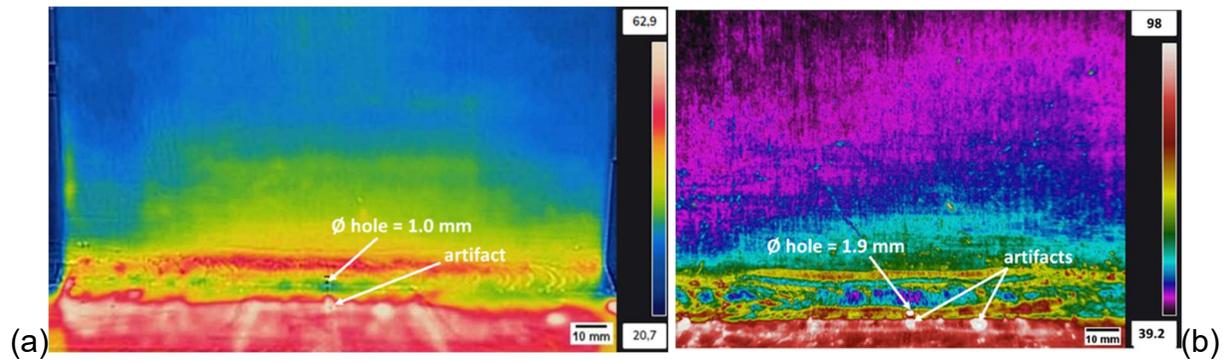
Figure 0-25 – Al plate-to-plate weld joint sample, with surface-breaking drill hole and 120-grit surface finish, in (a) IR image taken with FLIR C5 camera and in (b) with FLIR T620 camera. A white arrow points to the defect and a label informs the diameter of the hole. Some examples of artifacts are also labeled. A temperature scale in °C is provided on the right side of each IR image.

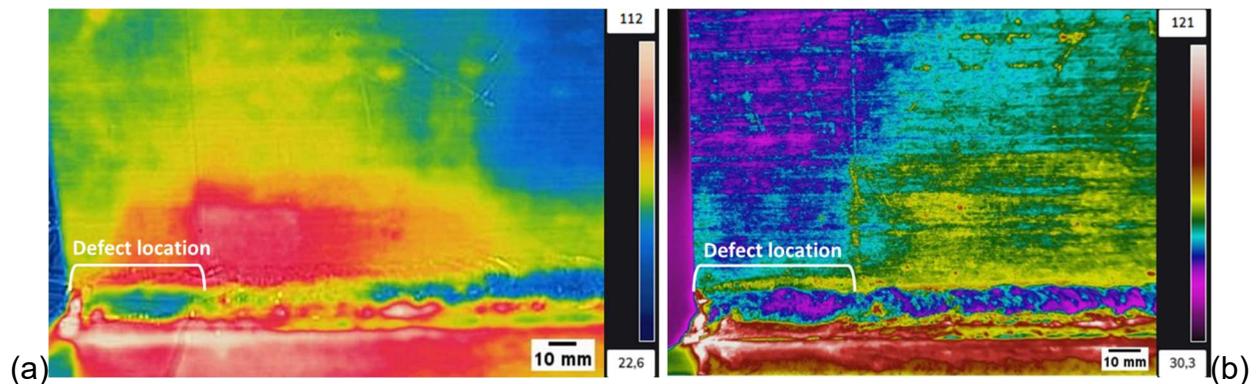
Figure 0-26 – Al plate-to-plate weld joint sample, with subsurface pseudocrack and 120-grit surface finish, in (a) IR image taken with FLIR C5 camera and in (b) with FLIR T620 camera. The location of the machined cut pseudocrack is indicated. A temperature scale in °C is provided on the right side of each IR image.

Ultimately, surface-breaking drill hole defects are visible using the FLIR C5 or T620 cameras. In Figure 0-26(a-b), neither camera delivered an enhanced subsurface defect detectability.

Analogously, the Al plate-to-plate weld joint sample cross-section, showing the machine cut subsurface pseudocrack, was also investigated through destructive analysis and optical microscopy, as shown in Figure 0-34. Other subsurface weld defects were observed from the cross-section and are pointed out in the optical image. None of these subsurface defects were identified in the corresponding IR image presented in Figure 0-26.

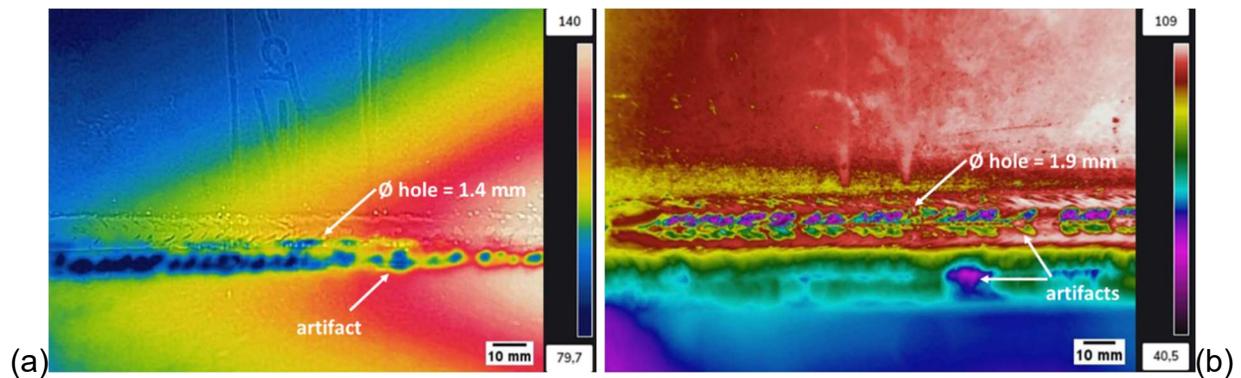
Figure 0-27 – Steel plate-to-plate weld joint sample, with surface-breaking drill hole without coating, in (a) IR image taken with FLIR C5 camera and in (b) with FLIR T620 camera. A white arrow points to the defect and a label informs the diameter of the hole. Some examples of artifacts are also labeled. A temperature scale in °C is provided on the right side of each IR image.

The steel plate-to-plate weld joint samples with surface-breaking drill holes were imaged with the FLIR C5 camera in the uncoated and coated with AMERCOAT® 399 conditions, as shown in Figure 0-27(a) and

Ultimately, surface-breaking drill hole defect is visible in Figure 0-27(a-b) and Figure 0-29(a-b) in both the plate-to-plate and pipe-to-plate uncoated conditions. In

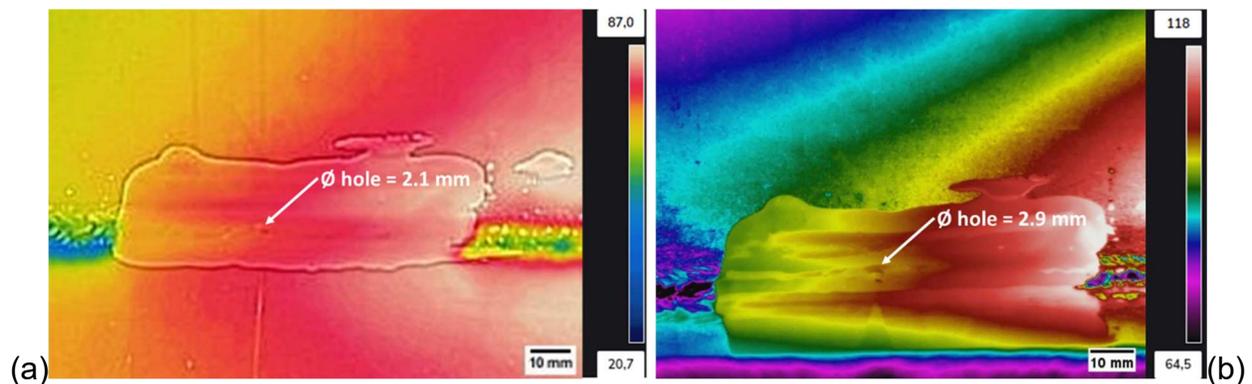
Figure 0-28 – Steel plate-to-plate weld joint sample, with surface-breaking drill hole coated with AMERCOAT® 399, in (a) IR image taken with FLIR C5 camera and in (b) with FLIR T620 camera. A white arrow points to the defect and a label informs the

diameter of the hole. A temperature scale in °C is provided on the right side of each IR image.

Figure 0-28(a), respectively. In Figure 0-27(b) and

Figure 0-28(b), the IR images taken with the FLIR T620 camera are presented for comparison. Figure 61(a) shows the steel pipe-to-plate weld joint sample with a surface-breaking drill hole imaged with C5 and T620 in the uncoated condition in Figure 0-29(b).

Figure 0-28, both cameras delivered poor defect detectability after coating with AMERCOAT® 399. Thermal contrast at the drill hole position was barely observed. Despite that, an estimation of the hole dimension was made for comparison.

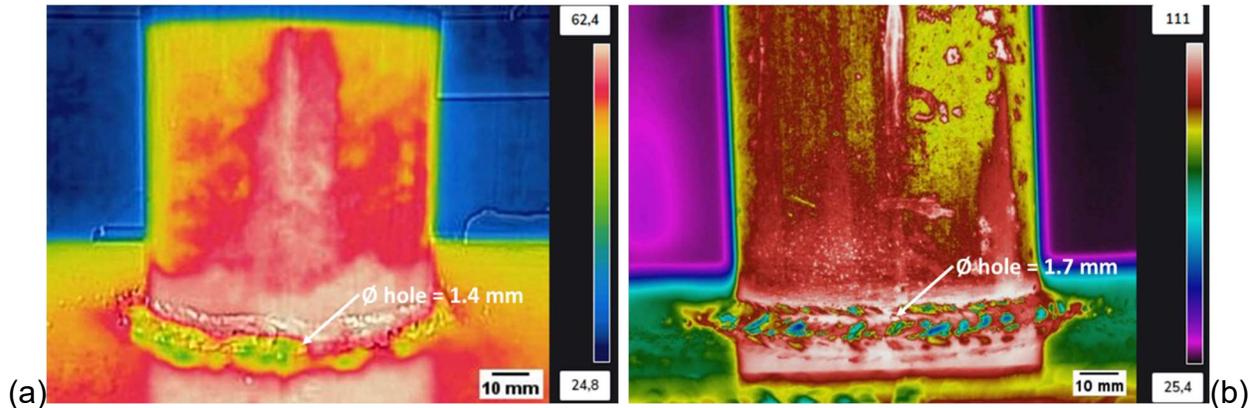
Figure 0-29 – Steel pipe-to-plate weld joint sample, with surface-breaking drill hole without coating, in (a) IR image taken with FLIR C5 camera and in (b) with FLIR T620 camera. A white arrow points to the defect and a label informs the diameter of the hole. A temperature scale in °C is provided on the right side of each IR image.

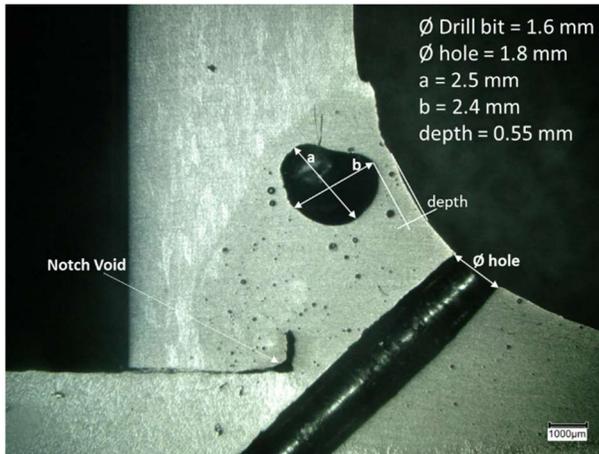
Figure 0-30 – Cross-section of the Al pipe-to-plate weld joint sample, showing the produced surface-breaking drill hole. Other subsurface weld defects could be observed from the cross-section and are pointed out in the optical image. Dimensions are labeled.

The diameter of the drill hole measured from the optical images in Figure 0-30, Figure 0-31, and Figure 0-32 ranged from 1.8 to 2.0 mm. Values are in accordance with the actual drill bit diameter used to machine the defects ($1/16'' = 0.0625'' = 1.6$ mm), knowing that the drilling procedure results in a larger diameter than the nominal drill bit dimension. Nevertheless, the cross-section of the steel pipe-to-plate weld joint sample, shown in Figure 0-33, is misadjusted to the center of the drill hole, which led to an inaccurate measurement of the hole diameter. This value was then underestimated.

An important observation that can be addressed from the optical images presented in Figure 0-30, Figure 0-31, Figure 0-32, and Figure 0-33 is that most of the investigated weld joints showed other subsurface defects such as LOF, notch voids, porosity, etc., which were not evidenced in any of the IR images. For instance, the LOF observed in Figure 0-30 presents a significant cross-section area of almost 5 mm² at a depth of 0.55 mm. There was no indication of such a significant subsurface defect in the IR images shown in Figure 0-24. Besides the surface-breaking drill hole, no feature was observed in these IR images. Accordingly, it has been stated in the literature that single raw IR thermograms might be misinterpreted when used to investigate subsurface features

The “OM hole diameter,” taken as the reference, was measured after destructive analysis from the cross-section optical micrographs (Figure 0-30, Figure 0-31, Figure 0-32, and Figure 0-33). The average OM and IR hole diameters and the calculated PDD values are listed in Table 0-1. For the “OM hole diameter,” the averages were calculated from 5 to 7 measurements at different positions along the hole section for each sample. Thus, the standard deviations represent the distribution and variability of the hole diameter along the hole length. The “IR hole diameter” was obtained from IR images for FLIR C5 and T620 cameras. Averages were calculated from 5 to 7 diameter

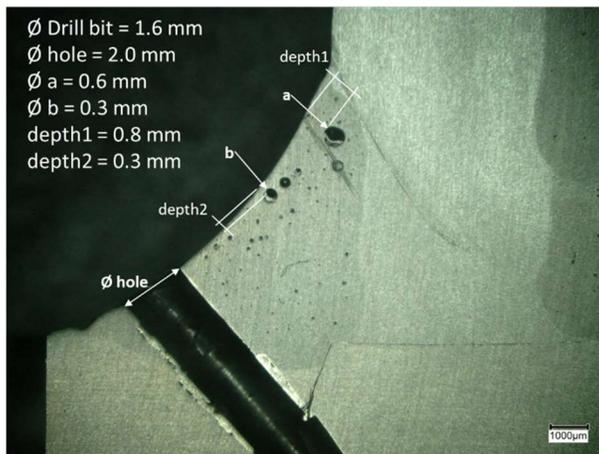
Figure 0-31 – Cross-section of the Al plate-to-plate weld joint sample, showing the produced surface-breaking drill hole. Other subsurface weld defects could be observed from the cross-section and are pointed out in the optical image. Dimensions are labeled.

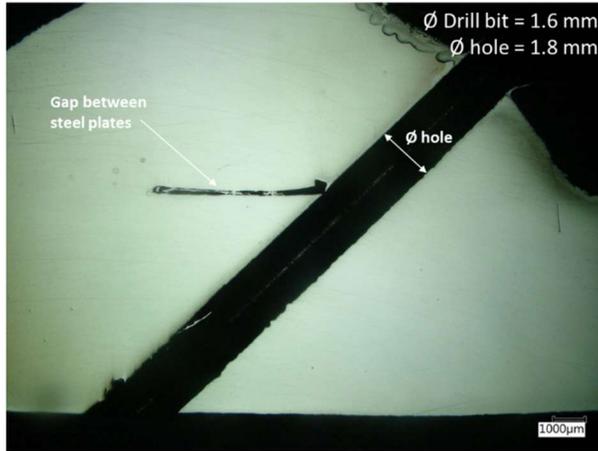
Figure 0-32 – Cross-section of the steel plate-to-plate weld joint sample, showing the produced surface-breaking drill hole. Other subsurface weld defects could be observed from the cross-section and are pointed out in the optical image. Dimensions are labeled.

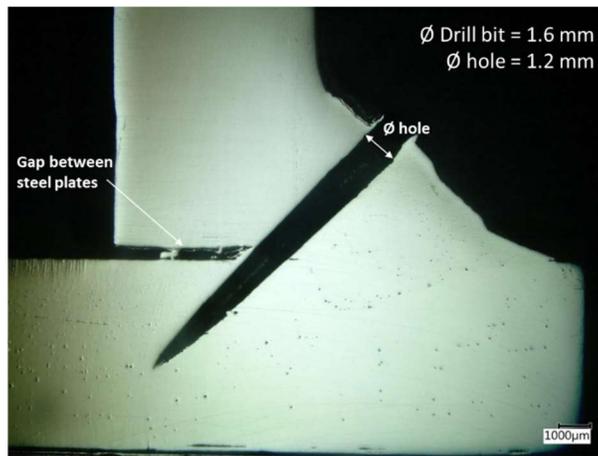
Figure 0-33 – Cross-section of the steel pipe-to-plate weld joint sample, showing the produced surface-breaking drill hole. Other subsurface weld defects could be observed from the cross-section and are pointed out in the optical image. Dimensions are labeled.

The uncoated steel pipe-to-plate weld joint sample had lower OM values due to the cross-section's misalignment to the hole's midline, leading to hole diameters smaller than the drill bit. This increased the PDD value since the reference value from the optical image was underestimated. However, the defect diameters obtained from the IR images were consistent with the values obtained in the uncoated steel plate-to-plate weld joints. Thus, similar performance and results would be expected.

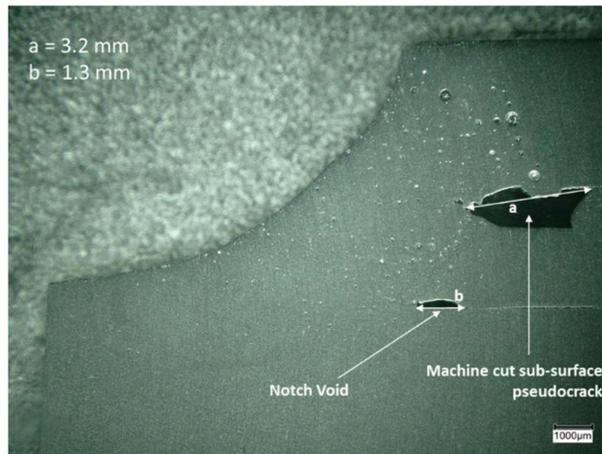
Figure 0-34 – Cross-section of the Al plate-to-plate weld joint sample, showing the machine cut subsurface pseudocrack. Other subsurface weld defects could be observed from the cross-section and are pointed out in the optical image. Dimensions are labeled.

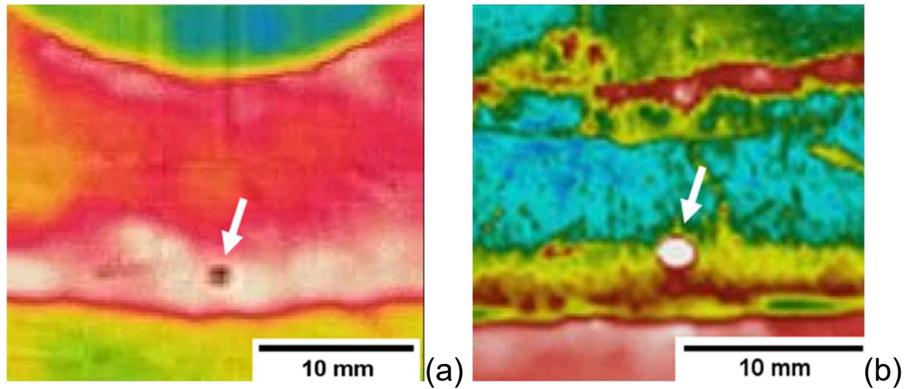
Figure 0-35 – Example of a zoomed in IR image (of the Al pipe-to-plate sample) taken with (a) C5 and (b) T620 cameras, evidencing increased sharpness of defect edges in the T620 image in ‘b’.

The Al pipe-to-plate, Al plate-to-plate (both with the surface finish), and uncoated steel plate-to-plate demonstrate a stronger correlation between the OM and IR images when using the FLIR T620 camera than the FLIR C5 camera. PDD values are larger for the IR images taken with the FLIR C5 camera, as would be expected due to its lower focus and contrast capabilities. Figure 0-35 illustrates how the defect edges present increased sharpness in the FLIR T620 IR image, ultimately leading to a more precise defect quantification.

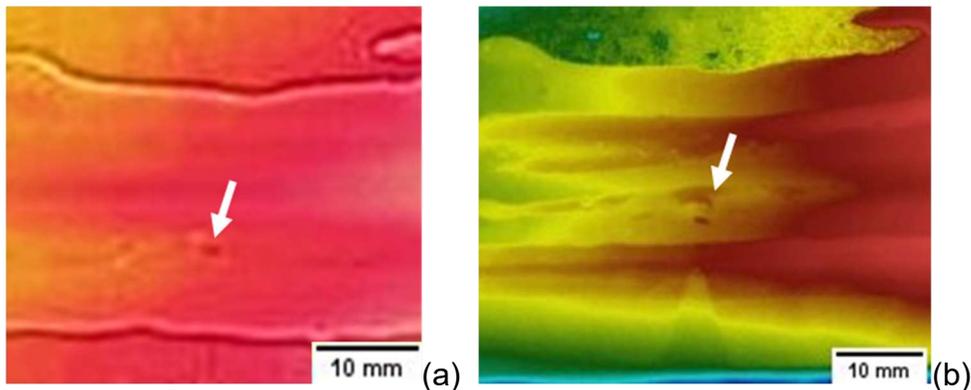
Figure 0-36 – Zoomed in IR image of the steel plate-to-plate sample coated with AMERCOAT®, taken with (a) C5 and (b) T620 cameras, evidencing very imprecise defect edges in both images.

For the steel plate-to-plate weld joint coated with AMERCOAT®, the epoxy-based coating hindered the defect detectability leading to poor thermal contrast in the IR images taken by both cameras, FLIR T620 and C5. This led to a high uncertainty (e.g., standard deviation) in the defect size due to topographical issues and imprecise edges, as shown in Figure 0-36.
