# **A Preliminary Examination of the Effectiveness of Hand-Held Extinguishers Against Hidden Fires in the Cabin Overhead Area of Narrow-Body and Wide-Body Transport Aircraft**

July 2007

DOT/FAA/AR-TN04/33

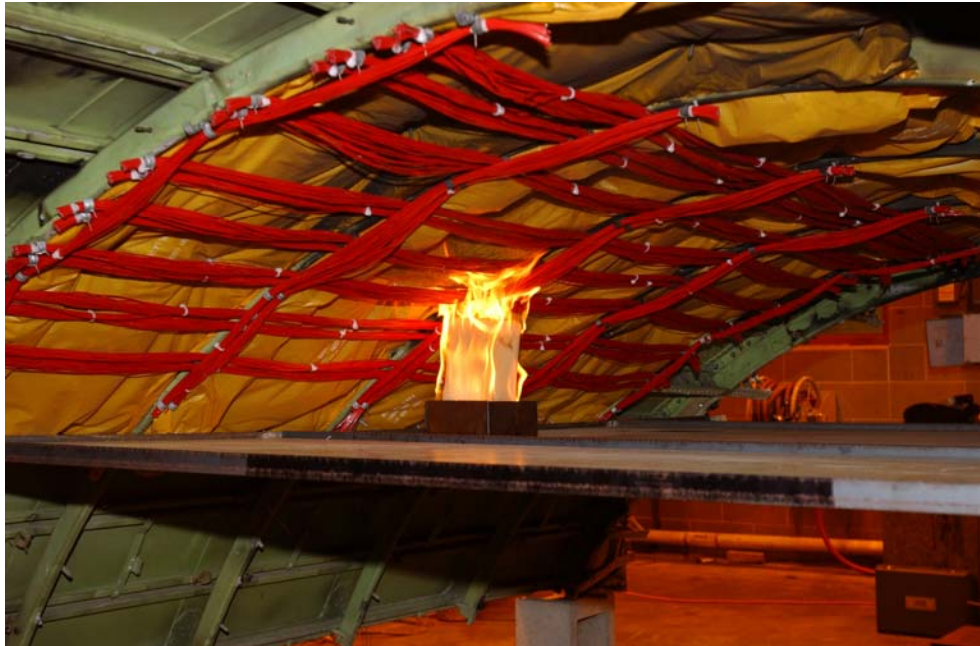
Figure 1. Wiring Test in a Simulated Cabin Overhead Area

Current Federal Aviation Administration (FAA) research is aimed at the development of more stringent fire test methods for materials located in hidden areas such as the ceiling overhead areas, cheek areas, and electronics and electrical (E/E) bays. This research targets the flammability of materials such as ducts, wires, panel closeouts, clamps, and other hardware located in the hidden and inaccessible areas to upgrade these materials to an equivalent level of fire resistance as recently adopted for thermal acoustic insulation [1]. The objective is to passively reduce the likelihood of an in-flight fire from occurring by substantially improving the fire resistance of materials in hidden areas. The research is coordinated with a subgroup of the International Aircraft Materials Fire Test Working Group, a government/industry group chaired by the FAA. Full-scale tests have been completed in which various types of wiring insulation were evaluated against a realistic fire threat (figure 1) [2].

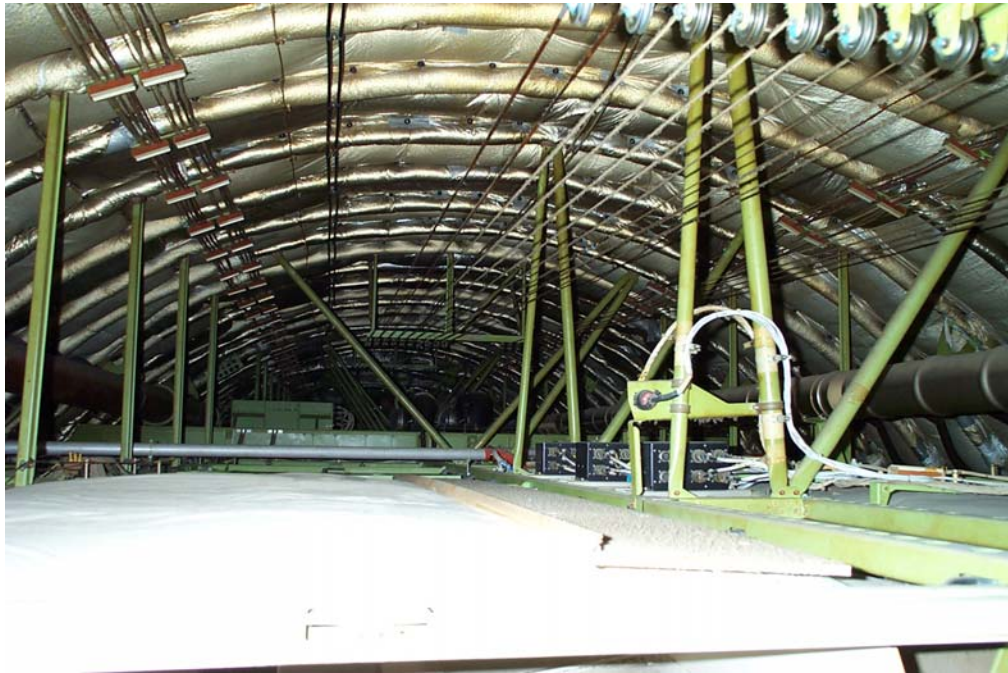
Figure 4. B-747SP Wide-Body Aircraft Aft Cabin Overhead Area

Although a majority of the cabin overhead volume is devoid of combustible materials, the periphery contains insulation blankets and adjacent wire bundles. There are also several wire bundles that run along the centerline, just above the ceiling panels. The aft overhead section of the B-747SP wide-body aircraft is shown in figure 4.

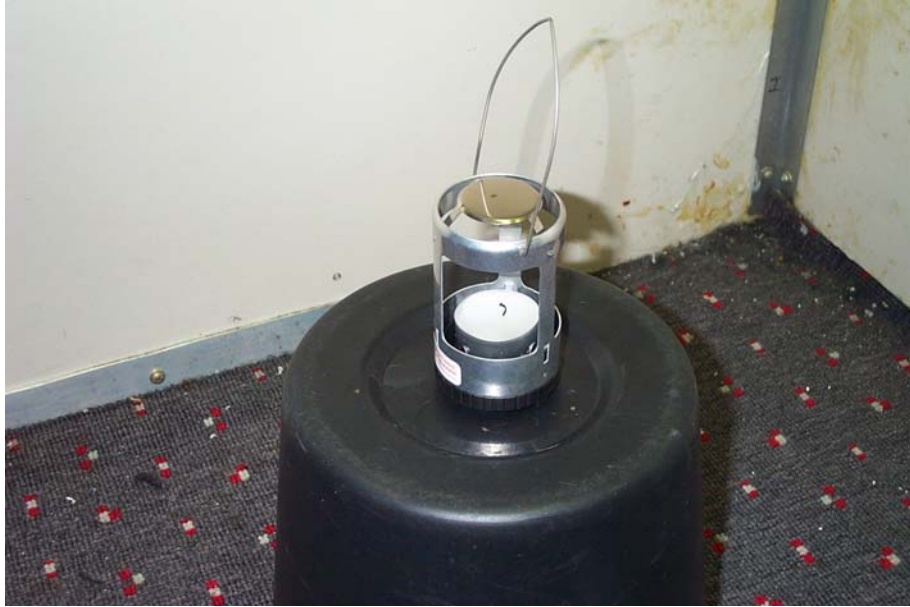
Figure 5. Candle Lanterns Used in Cabin Overhead Area Tests

Since the B-747SP was an operational test aircraft, as opposed to a true fire test article, care had to be taken not to cause damage to the interior during live fire tests. To create a realistic yet safe fire scenario, small candle lanterns were incorporated to measure the range and volume of fire extinguishant. The candles were paraffin-based discs, enclosed in a protective metal shroud to prevent wax spillage and ignition in the event that the candle tips over (figure 5). The candle lanterns were equipped with glass cylinders that shrouded the flames, making it somewhat difficult to extinguish them. For this reason, the glass shrouds were removed for all tests performed in the cabin overhead area. Once lit, the candle lanterns could burn continuously for 4 hours, making them ideal for this type of hidden space test.

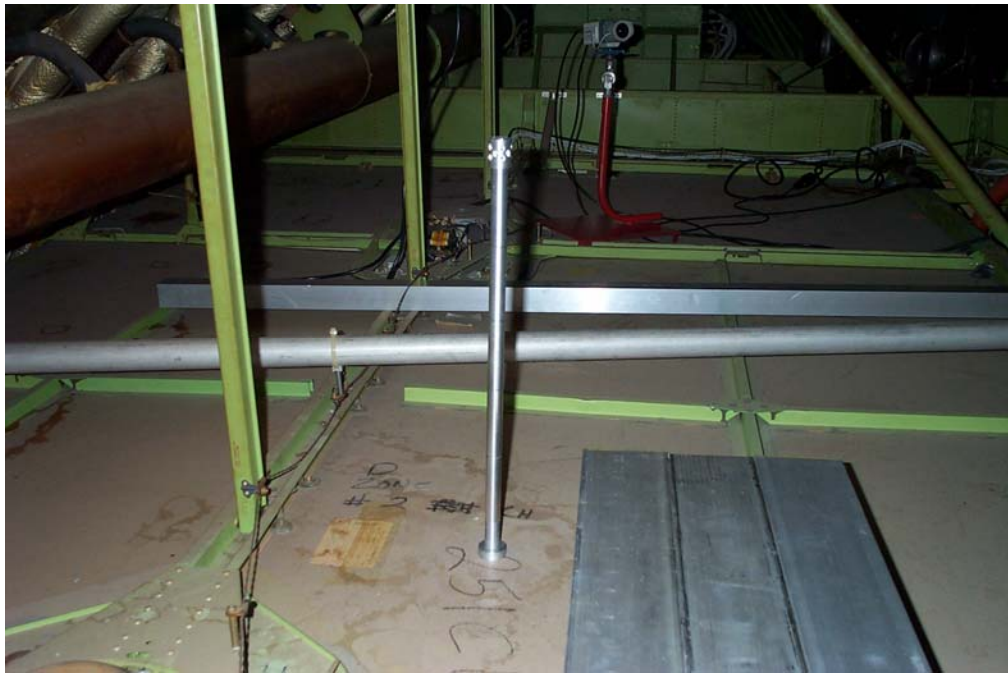
Figure 7. Ceiling-Mounted Port Extension Tube Mounted in Cabin Ceiling

To use the available extinguishing agent most efficiently, the initial ceiling-mounted port was designed to extend above the cabin ceiling to promote extinguishing agent transport to the combustible materials near the crown of the aircraft. The port and discharge head contained a series of threaded extension tubes, each measuring approximately 6 inches long. When five extension tubes were used in conjunction with the head, the discharge point was situated 30 inches above the cabin ceiling. The discharge head was designed to propel the agent radially (figures 7 and 8).

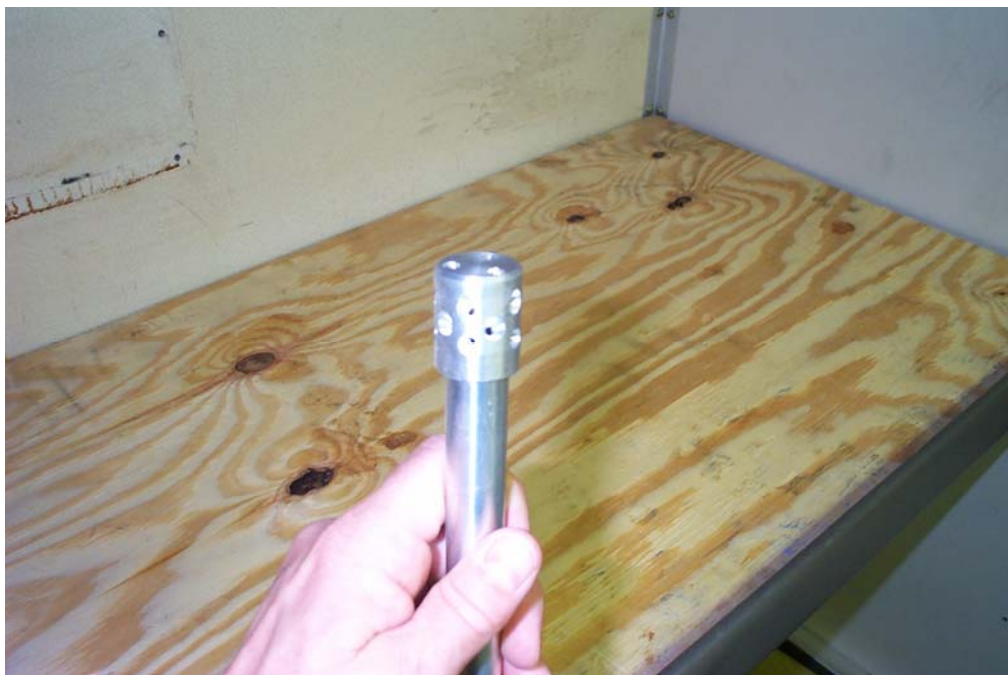
Figure 8. Ceiling-Mounted Port Prototype Discharge Head

Test 2 was run using the prototype discharge head (figure 8) attached to the end of the ceiling-mounted port. This configuration provided extinguishment of four of the six candles, a much better result than test 1. Although the overall thrust of the extinguisher was restricted with this design, it did convey the extinguishing agent far enough radially to give this outcome.

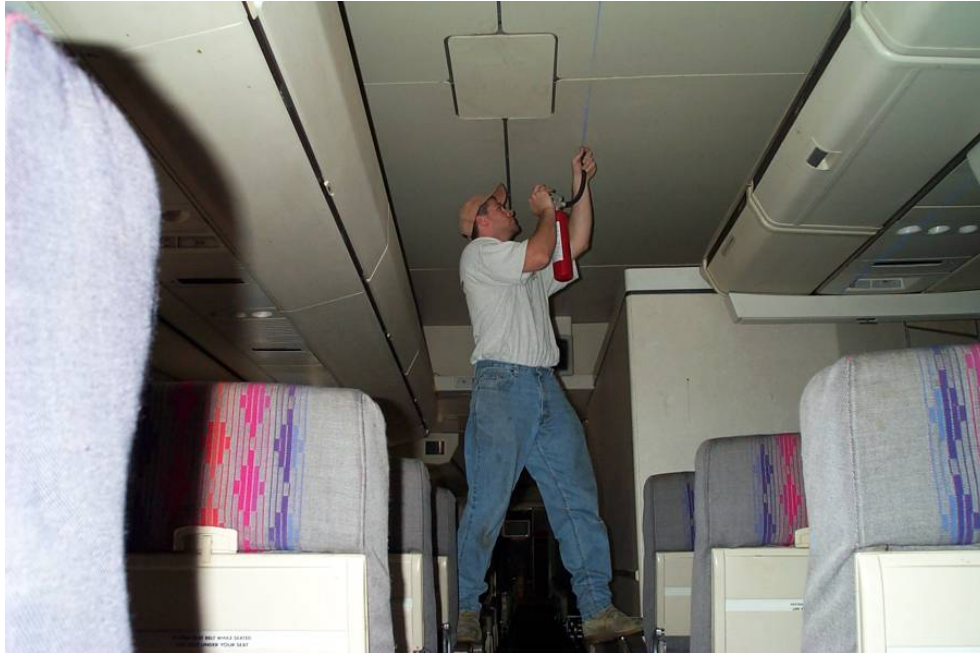
Figure 9. Extinguishing Agent Discharged Through the Port in the Wide-Body Aircraft

The ceiling-mounted port and associated tubes and head were centered over the left aisle, just aft of the crew rest area, which was converted into a control room for these tests. Cameras were mounted in the cabin overhead area to capture the sequence of events during extinguishing agent discharge. One important note was that all extinguishers incorporated a flexible discharge hose, allowing the extinguisher to remain perfectly upright during discharge. This enabled full expulsion of the extinguisher contents, which would not be possible otherwise, since the extinguisher would need to be held horizontally to engage the ceiling-mounted port. Also of note was the requirement that the person discharging the extinguishing agent needed to stand on the armrests of the seats to reach the ceiling-mounted port (figure 9).

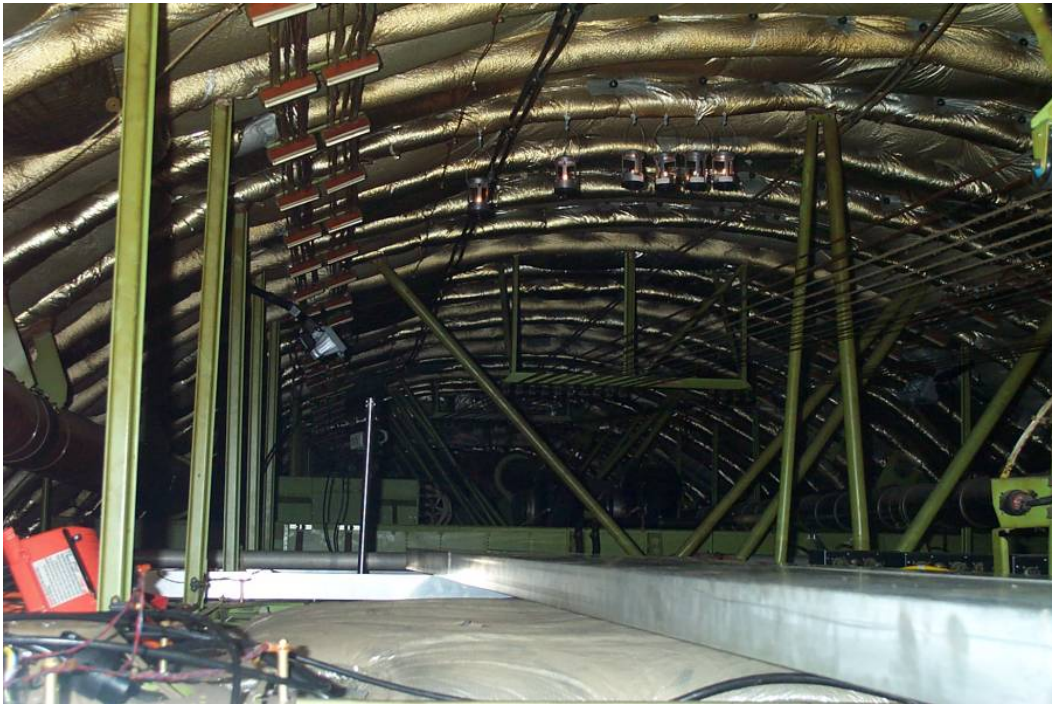
Figure 12. Modified Candle Lantern Test Configuration in Cabin Overhead Area

Using this arrangement, the candles were hung closer to the discharge head, perpendicular to the axis of the aircraft (figures 11 and 12). The distance from the first candle situated directly over the port to the last candle was approximately 42 inches.

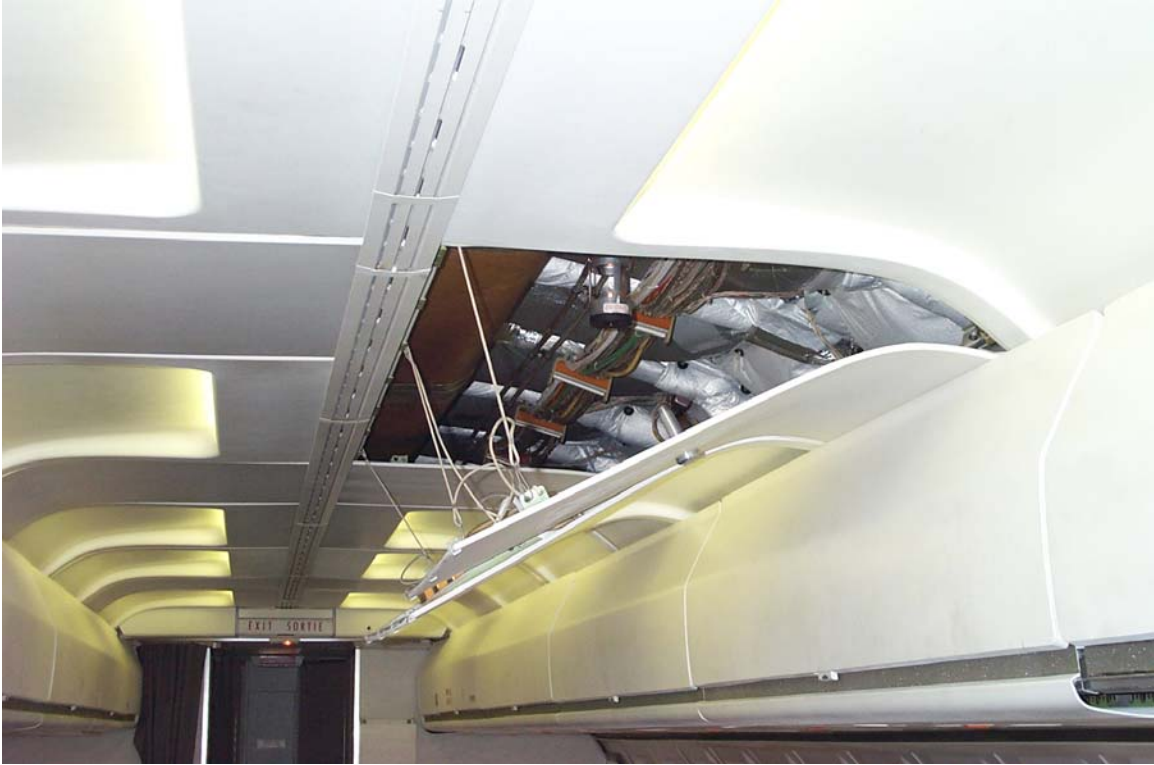
Figure 17. Narrow-Body Aircraft Showing Cabin Overhead Area Access

During the pretest inspection of the narrow-body aircraft, it was determined that the cabin overhead panels could be unfastened and rotated downward, giving nearly unlimited access to the cabin overhead area (figure 17). Although the locking mechanism for the panels was hidden in the overhead stowage bins and was somewhat difficult to activate, it became much easier to perform once the operator became familiar with it. This was a significant finding in that, given the proper training, a fire in the hidden overhead area of this type of aircraft with this particular panel attachment scheme could easily be accessed and extinguished. This was not true for the wide-body aircraft, in which the ceiling height was much greater and the ceiling panels were significantly larger.

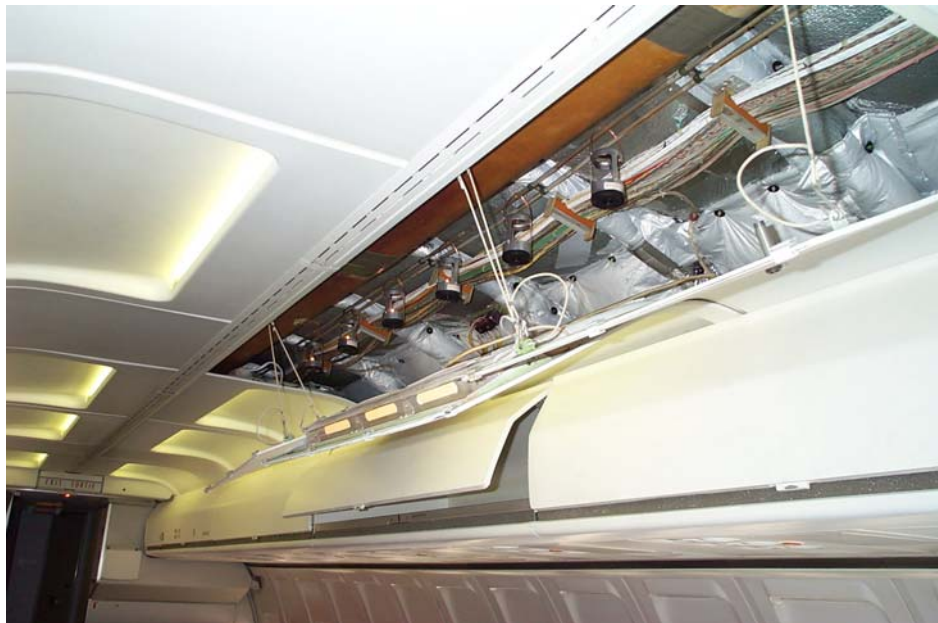
Figure 19. Narrow-Body Aircraft Test Configuration Showing Location of Candle Lanterns

Since the cabin overhead area of the narrow-body aircraft was relatively small and cluttered in comparison with the wide-body aircraft, there were only a few possibilities in terms of the location of the candle lantern fire sources. As such, the lanterns were hung from a hydraulic line that was mounted to the fuselage formers in the cabin overhead area (figure 18). This resulted in the lanterns being very close to a large wire bundle that ran forward to aft, which was a realistic simulation in terms of fire location (figure 19). The ceiling-mounted port was installed 15 inches from the centerline of the aircraft, which was approximately aligned with the candle lanterns.

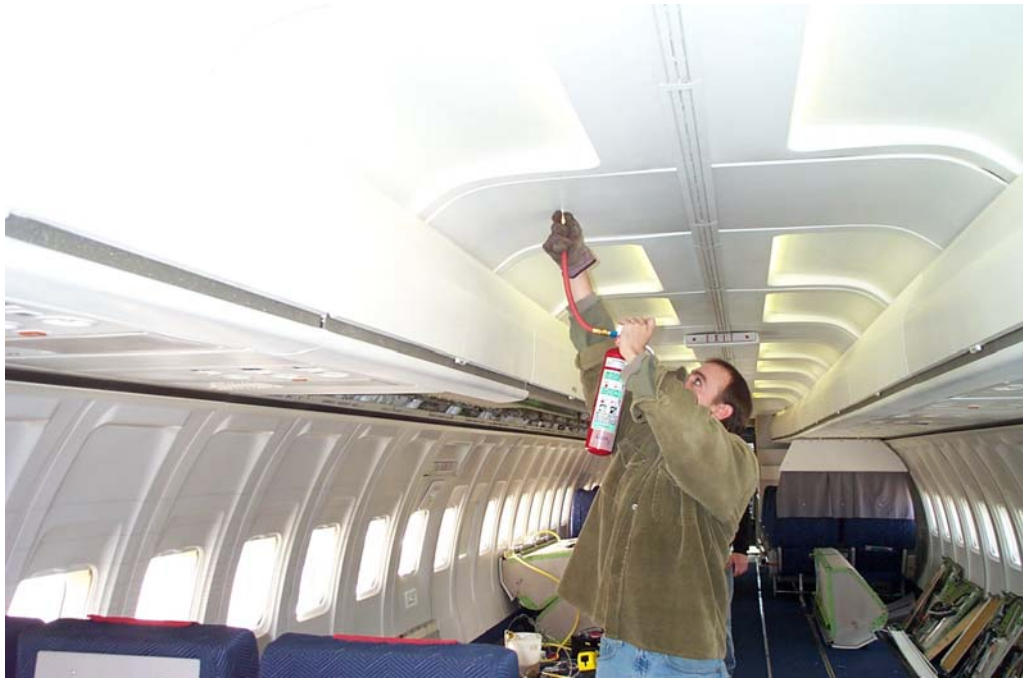
Figure 21. Halon 1211 Discharged Through Ceiling-Mounted Port

After lighting all six candle lanterns, the ceiling panels were quickly reinstalled to their proper position. The 2.5-lb Halon 1211 extinguisher was then fully discharged through the ceiling-mounted port, followed by a brief 1-minute settling period to allow the extinguishing agent to fully disperse in the cabin overhead area (figure 21). The ceiling panels were then unfastened to allow inspection of the candle lanterns. This procedure was followed for all tests.
