FAA GENERAL AVIATION NEWS

FEBRUARY 1976

A FLIGHT STANDARDS SAFETY PUBLICATION FOR AIRMEN

The Impossible Climb

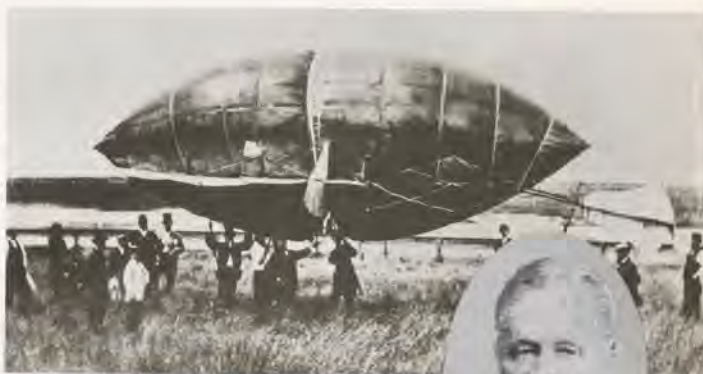
Frederick Marriott and his steam-driven airship
