# JOINT TRANSPORTATION RESEARCH PROGRAM

## Study on the Permissible Depth of Utilities Under the MSE Walls and Means and Methods of Protecting the MSE Walls When the Permissible Depth Cannot Be Provided

**Md Asad Ahmad and Antonio Bobet**

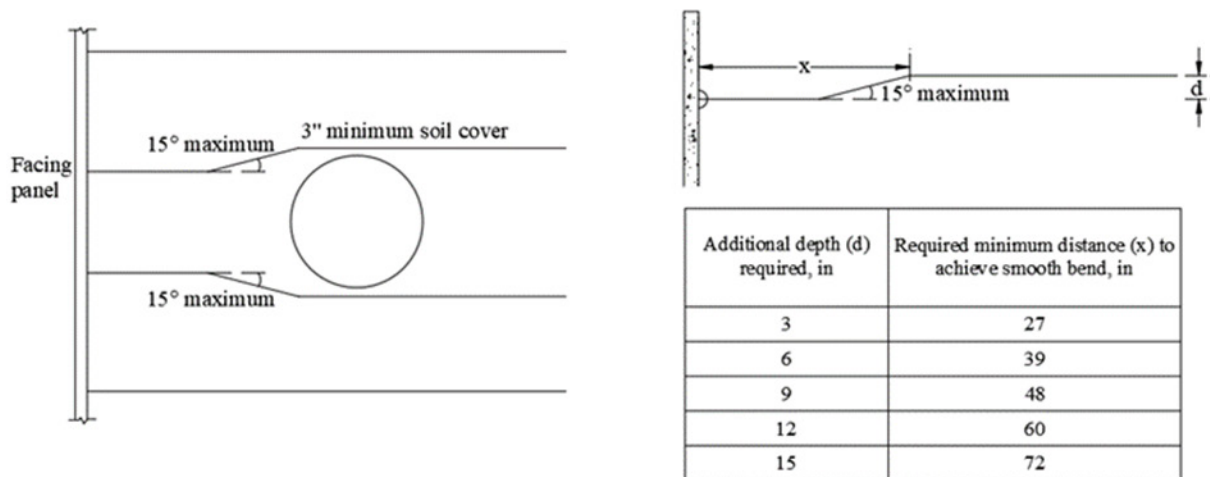
Figure 1.1 Requirements for Horizontal Obstructions Within the Reinforced Soil Mass (Redrawn From FHWA, 2009).

However, other DOTs, such as Florida (FDOT; Passe, 2000) and Kansas (KDOT), allow horizontal obstructions within the reinforced soil but limit the deviation from horizontal of the reinforcement and prescribe minimum distances from the face of the wall (Figure 1.1). Other DOTs, such as Iowa DOT, have wording similar to that of INDOT. Others are more permissible, such as Nebraska DOT, which allows horizontal obstructions as long as those are accounted for in the stability of the MSE wall. The Federal Highway Administration (FHWA, 2009), states, “The current AASHTO [American Association of State Highway and Transportation Officials] LRFD [load and resistance factor design] Specifications (2007) states that MSE walls should not be used under the following conditions: When utilities other than highway drainage must be constructed within the reinforced zone where future access for repair would require the reinforcement layers to be cut” (pp. 2–38).

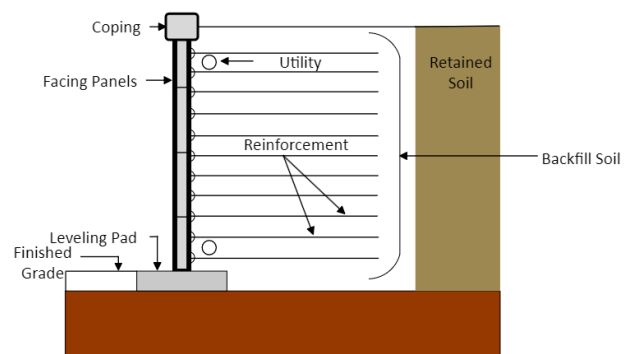
Figure 2.1 MSE Wall.

The chapter provides a review of case histories found in the technical literature where horizontal obstructions were placed inside or underneath MSE walls and describes their detrimental consequences when the utilities malfunctioned. Figure 2.1 shows a utility placed inside the reinforced backfill of the wall.

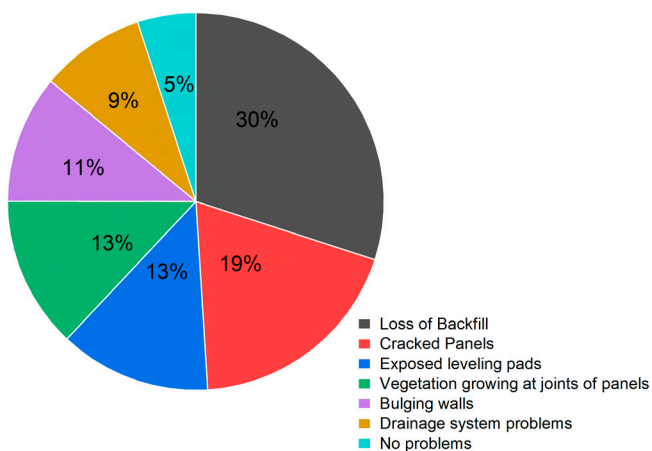
**Figure 2.2** Outcomes of the Inspection Program (Adapted from Tarawneh et al., 2017).

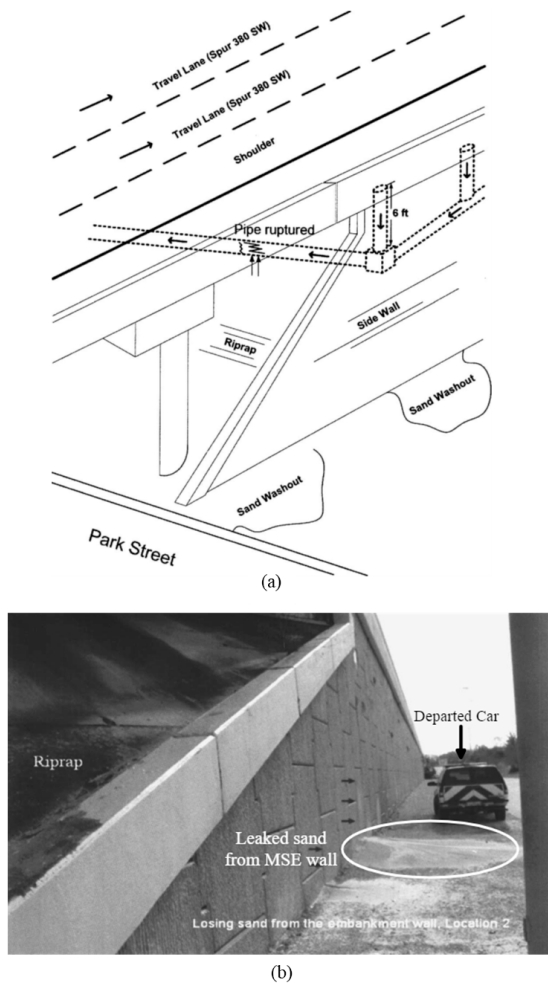
**Figure 2.3** MSE Wall at Park Street (a) Ruptured Pipe and (b) Leaking Sand Due to Utility Pipe Leakage (Adapted From D.-H. Chen et al., 2007).

Figure 2.3a shows the drainage system in an MSE wall section at the intersection of Park Street and Spur 380 southwest-bound in Beaumont, Texas. A polyvinyl chloride (PVC) pipe was placed in the backfill that collected water from multiple inlets. It ruptured at the location shown in Figure 2.3a. A test was conducted to check the pipe for leakage. Water pumped from the inlet fell on the riprap due to ruptured pipe water and entered into the MSE wall from a gap of 50 mm between MSE wall and the side wall. The fabric filter required to prevent the leakage of fine sand ruptured. It is reported that the massive inflow of water led to a significant loss of backfill material (Figure 2.3b), causing the formation of soil mounds near the face of the wall (D.-H. Chen et al., 2007).

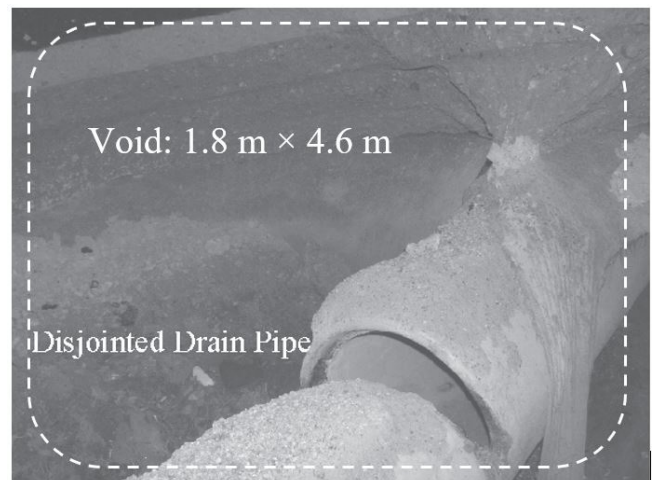
**Figure 2.4** Loss of Backfill Due to Disjointed Pipe (Adapted From D.-H. Chen et al., 2012).

Leaking of disjointed utility pipes can be catastrophic, if not detected. TxDOT reported a case of disjointed gravity water pipes in an MSE wall at US 290 in southwest Austin. The TxDOT personnel observed a crack on the pavement and performed an inspection using Ground Coupled Penetrating Radar (GCPR). The GCPR indicated the presence of a void underneath the pavement. Also coring detected a large (1.8 × 4.6 × 3.7 m) cavity under the pavement. Figure 2.4 shows the size of the void and the disjointed drain pipe. The joint in the pipe failed and the water leaked and washed out the backfill, resulting in a large cavity around the pipe. The formation of the void impacted the pavement, which caused the cracking observed on the surface. Fortunately, the problem was discovered before the safety of the MSE wall was compromised (D.-H. Chen et al., 2012).

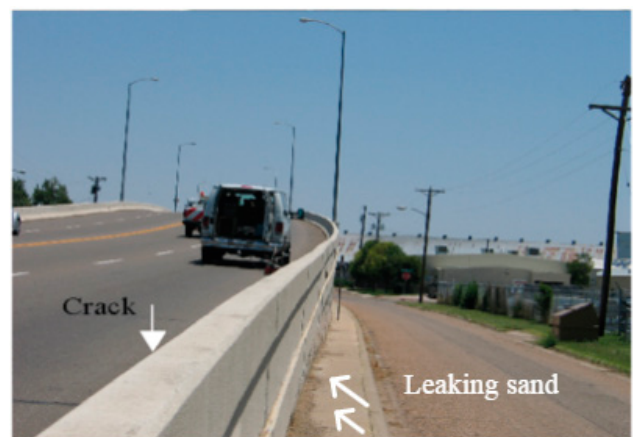
**Figure 2.5** Leaking Sand From MSE Wall Due to Water Seepage (Adapted From D.-H. Chen et al., 2007).

TxDOT carried out another inspection of an MSE wall in the Amarillo district because several transverse cracks appeared on the pavement, and deposits of fine sand were reported adjacent to the wall, as shown in Figure 2.5. While GCPR did

not detect any voids under the pavement, it was thought that the damage was the result of an early stage of pipe leakage (D.-H. Chen et al., 2007).

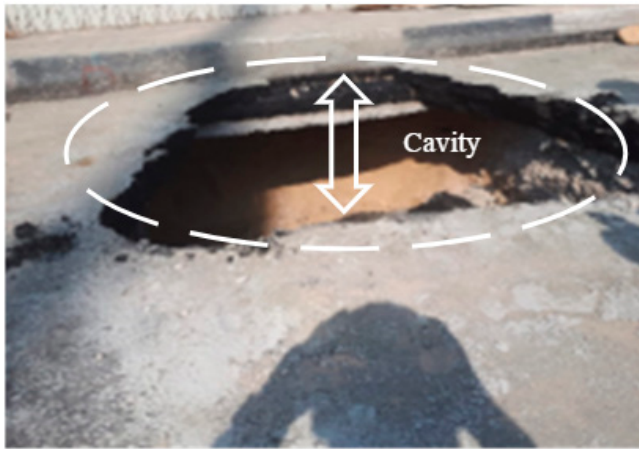
**Figure 2.6** Pavement Collapse Due to Internal Erosion of MSE Backfill (Adapted From Kara & Tahoun, 2020).

An MSE wall near a multilevel interchange located in a very congested traffic zone in Doha, Qatar, was built using loose sand. Due to the long-term continuous presence of water inside the backfill coming from drainage and storm pipes, the sand in the backfill was mobilized, internal erosion occurred, and a cavity formed within the backfill. The cavity then caused the collapse of the pavement near the wall, as shown in Figure 2.6 (Kara & Tahoun, 2020).

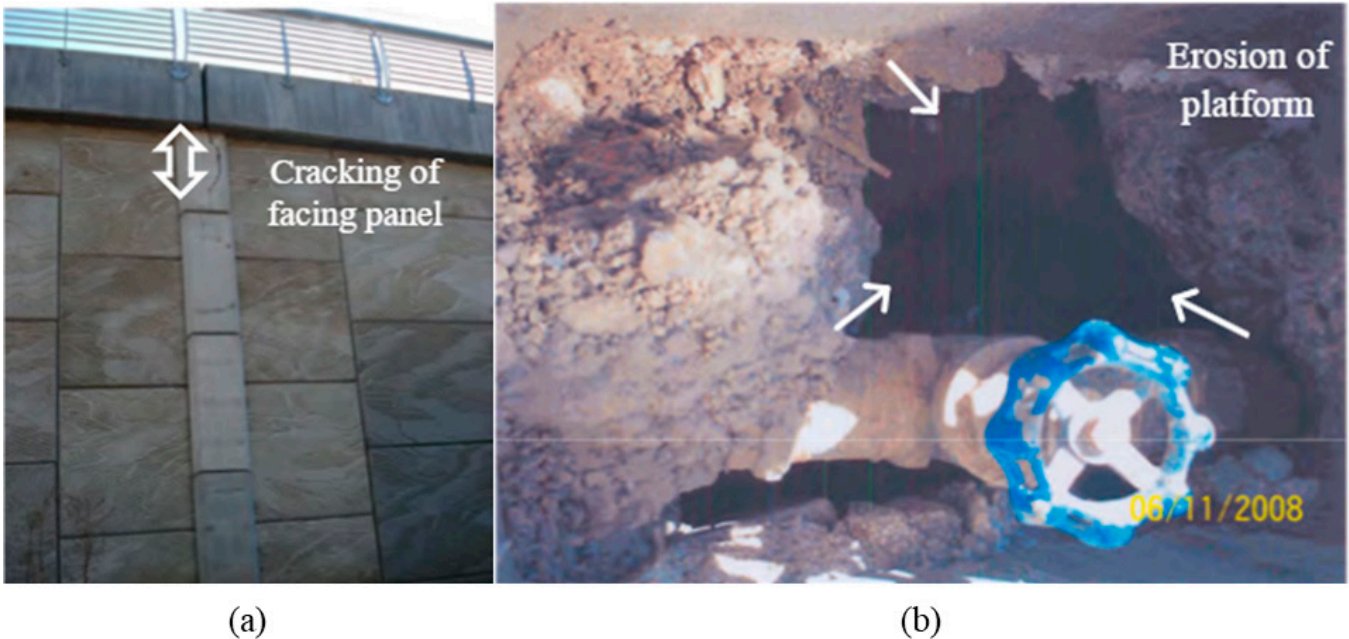
**Figure 2.7** MSE Wall in Santa Clara, California Displaying (a) Cracking of Face Panel and (b) Internal Erosion Due to a Leaky Valve (Adapted From Lee et al., 2013).

Occasionally, water leakage from utilities adjacent to an MSE wall leads to erosion of the wall base or consolidation of the foundation soil, which in turn induces differential settlements of the MSE wall leveling pad. Differential settlement is the phenomenon where nonuniform vertical displacement of multiple sections of the wall. Lee et al. (2013) conducted a study to observe the wall deformations because of leakage in an irrigation pipe. In 2004, a back-to-back MSE wall was constructed in Santa Clara, California, near Hamilton Avenue adjacent to the rail track. After construction, the wall experienced continuous settlement and lateral deformation, which required regular maintenance. The movements caused cracking of the facing panels, as shown in Figure 2.7a. In June 2008, it was found that a buried irrigation water pipeline valve was leaking which was the cause of the internal erosion, as shown in Figure 2.7b. The differential settlement between the two back-to-back walls was 48–100 mm (Lee et al., 2013).

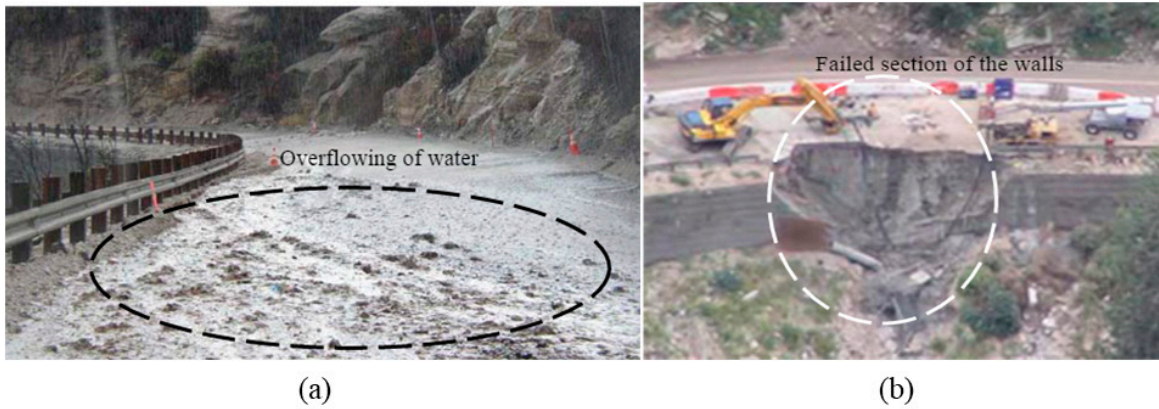
**Figure 2.8** MSE Wall in Tucson, Arizona Displaying (a) Overflow of Water and Debris on the MSE Wall and (b) Failure Section of the MSE Wall (Adapted From Haramy et al., 2010).

Haramy et al. (2010) describe a 25-mi-long highway connected the Santa Catalina Mountain range with Mount Lemmon, in Tucson, Arizona. The highway had a 350,000 sqft MSE wall. The wall contained utility pipes and had a corrugated metal pipe culvert to discharge storm water. In June 2003, the Aspen Fire, a wild forest fire, burned the Coronado National Forest near General Hitchcock Highway. The fire was followed by heavy rainfall in 2006 (a 1000-year storm), leading to erosion of the surrounding ground and to debris flow. The combination of these two events caused the utility drains and culvert to clog. As a result, water started to overflow the road and the wall as shown in Figure 2.8a. Figure 2.8b shows the collapse of the wall as a result of the overflow due to erosion and increased water content of the fill inside the wall (Haramy et al., 2010).

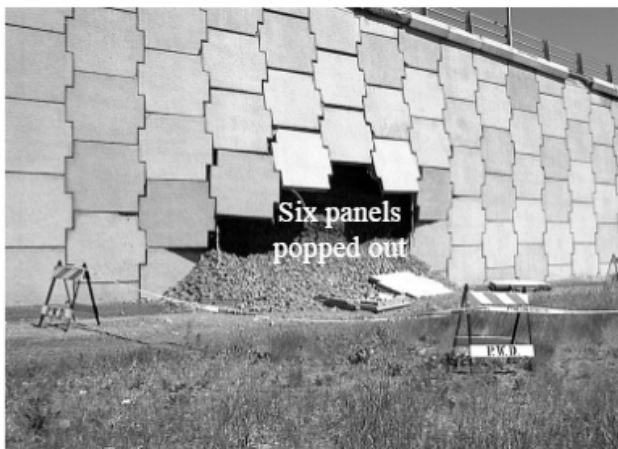
**Figure 2.9** MSE Wall on Idaho State Highway 34. Panel Failure Due to Corrosion of Reinforcement (Adapted From Armour et al., 2004).

of metallic structural elements of MSE walls. Components such as metal strips, connections, and even the pipes themselves can be subject to corrosion. Several cases of leaking utilities due to corrosion have been reported in the literature. For example, failure of the facing panels of the MSE wall on Idaho State Highway 34 occurred due to corrosion of the reinforcement approximately 45 m from the bridge abutment along the southwest approach section on July 9, 2002 (Figure 2.9). The soil used for the wall was loose- to medium-dense silty sand and was highly alkaline with a low permeability (Armour et al., 2004), which was thought to have contributed to the corrosion.

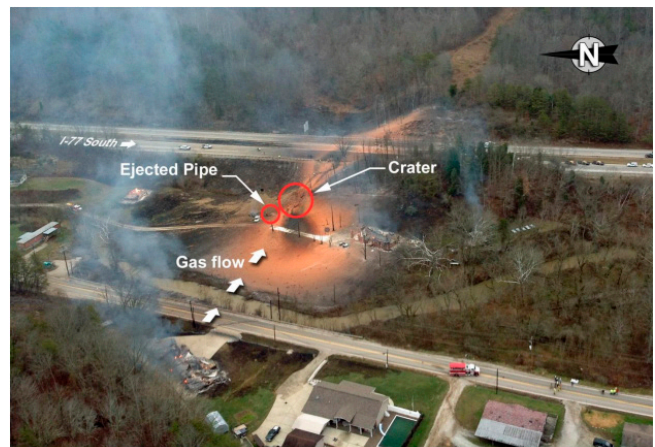
**Figure 2.10** Exploded Buried Pipeline Sissonville, West Virginia (Source: NTSB, 2014).

Another example of corrosion is the explosion of a natural gas conduit in Sissonville, West Virginia, on December 11, 2012 (Figure 2.10; National Transportation Safety Board [NTSB], 2014). The gas pipeline was buried in an embankment. Corrosion of the pipe caused leakage of natural gas leading to the explosion and damage of three houses and several residences nearby (NTSB, 2014).

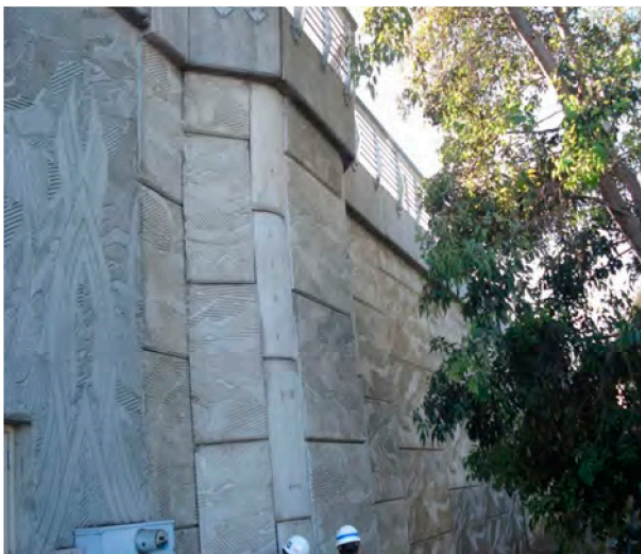
**Figure 2.11** Deformation of the MSE Wall in Santa Clara, California. (Source: Lee et al., 2013).

For example, the leakage of an irrigation pipe adjacent to an MSE wall in Santa Clara, California, caused the seepage of water into the MSE wall, which caused an increase of the pressure acting on the wall (Lee et al., 2013). This caused the wall to deform, as shown in (Figure 2.11).

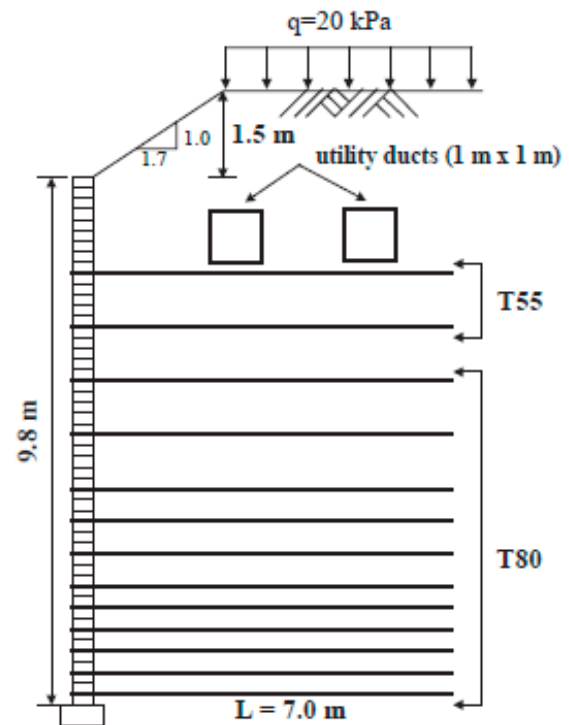
**Figure 2.12** Untied Utility Ducts (Source: Yoo, 2004).

Yoo (2004) provides another example—a segmental retaining wall of approximately 300 m in length at a chemical processing plant in South Korea. The east wall was constructed with two utility ducts above the reinforced zone, with dimensions  $1 \times 1$  m. They were installed along the length of the wall (Figure 2.12). There were no measures taken in the design to protect the unreinforced zone of the wall. Six years after construction, the wall next to the ducts experienced excessive bulging. The reason for the deformations was poor construction and excess rainfall during construction of the ducts. The wall section was dismantled and reconstructed (Yoo, 2004).

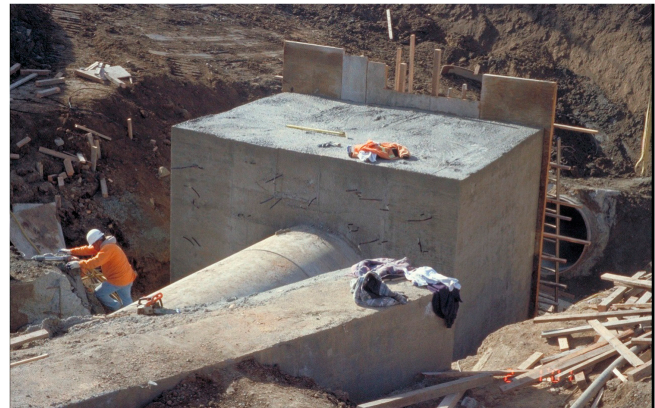
**Figure 2.13** Leakage and Joint Rotation Adjacent to the MSE Wall at Highway 87 in Santa Clara Valley (Source: Hook et al., 2006).

leaking. The water leak led to consolidation of the underlain layer, which caused a rotation of two concrete blocks supporting the pipe. Excavation was required to repair the pipe, and the pipe was shut down for four weeks. Figure 2.13 shows the repair of one of the deformed blocks. The total cost of the investigation and repair was about \$270,000 (Hook et al., 2006).

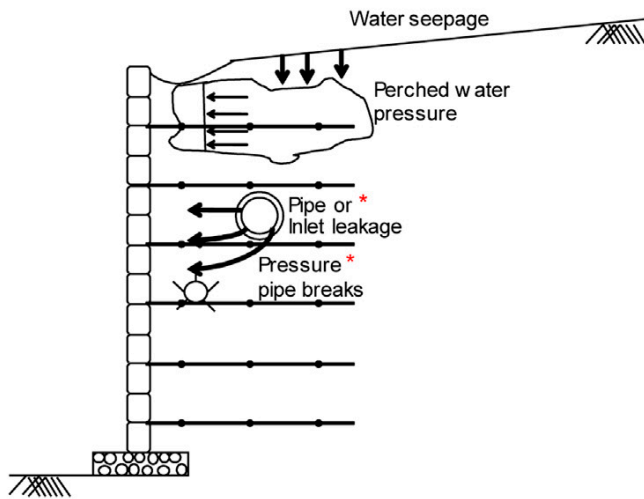
**Figure 2.14** Problems Due to Internal Water Leakage (Source: Koerner & Koerner, 2018).

into the wall, and pressure from perched water due to the water trapped in clay/silty backfill. Figure 2.14 shows the different sources of water in the MSE walls that can lead to problems.

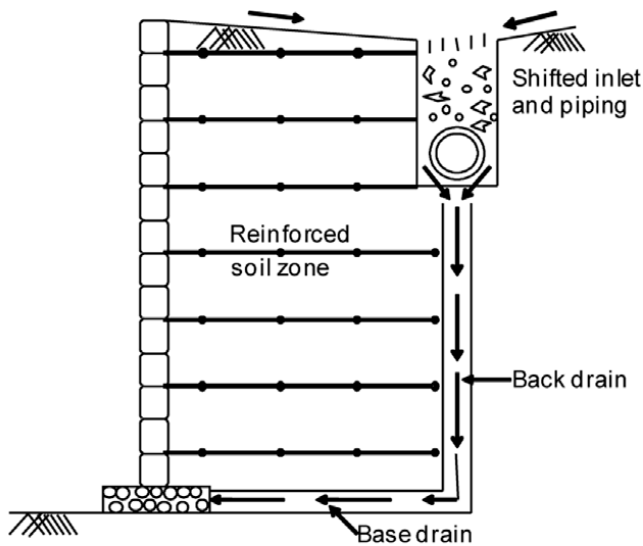
**Figure 2.15** Placement of Water Utilities in MSE Wall, Accompanied by Back Drain (Source: Koerner & Koerner, 2013).

Koerner and Koerner (2013) mention that placing water inlets or pipes within the reinforced zone is poor practice. This is consistent with the case studies reviewed showing that placement of utility pipes and ducts within the reinforced zone led to excessive wall deformations (Yoo, 2004). Koerner and Koerner (2013) proposed the solution (Figure 2.15)—water utilities should be located outside the reinforced soil zone. Note that the solution includes a back drain to safely direct any leakage outside the wall.

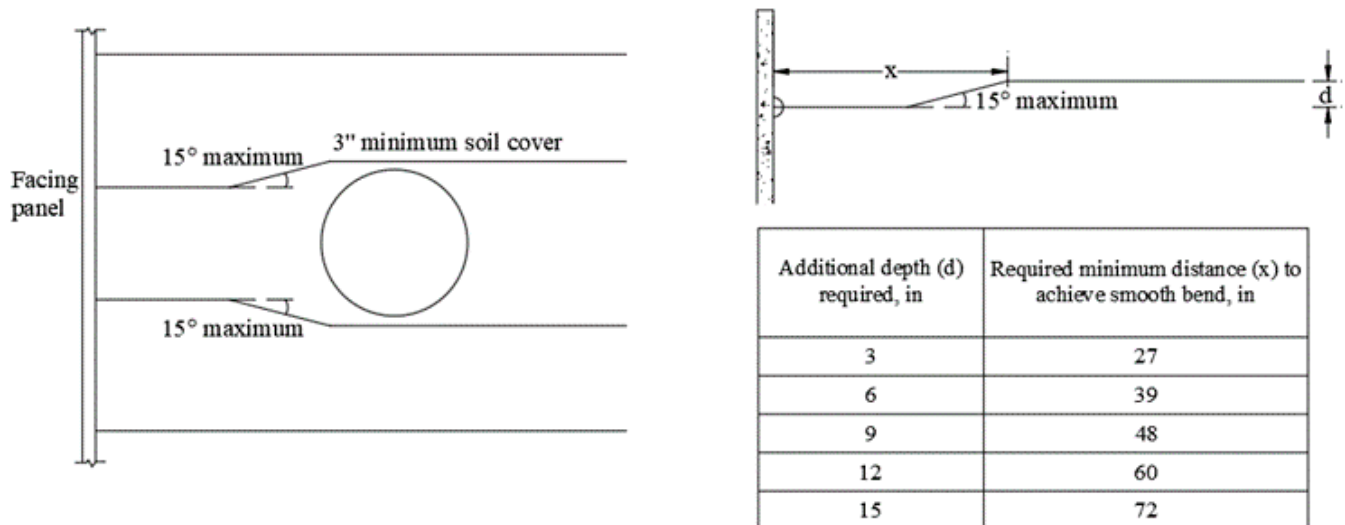
Figure 3.1 FHWA Guidelines for Inextensible Reinforcement (Redrawn From FHWA, 2009).

1. For inextensible reinforcement, a minimum cover of 3 in. should be provided;
2. Reinforcement should not bend more than 15°;
3. Utility pipes should be placed at a depth,  $d$ , to achieve a smooth reinforcement bend (Figure 3.1);
4. For extensible reinforcement, a minimum cover of 3 in. should exist between geogrid and pipe, and each affected geogrid segment should be spaced equally at a distance of at least 3 in. (Figure 3.2); and
5. The minimum length to bend the reinforcement should be equal to the pipe diameter, measured from the center of the pipe to each side (Figure 3.2).

As one can see, KDOT, FDOT, and ODOT have different reinforcement transition distances than FHWA, as defined in Figure 3.1a. Table 3.1 lists the requirements from those DOTs. In all cases, the minimum cover of the utility pipes is 4 in., higher than the FHWA recommendation of 3 in.

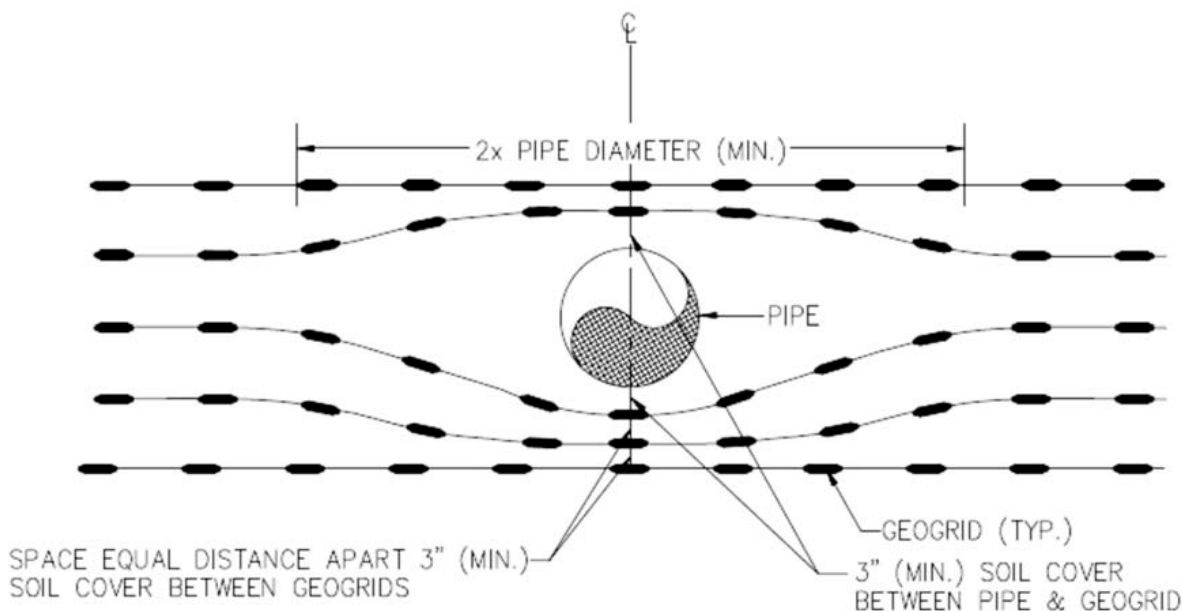
Figure 3.2 FHWA Guidelines for Extensible Reinforcement (Source: FHWA, 2009).

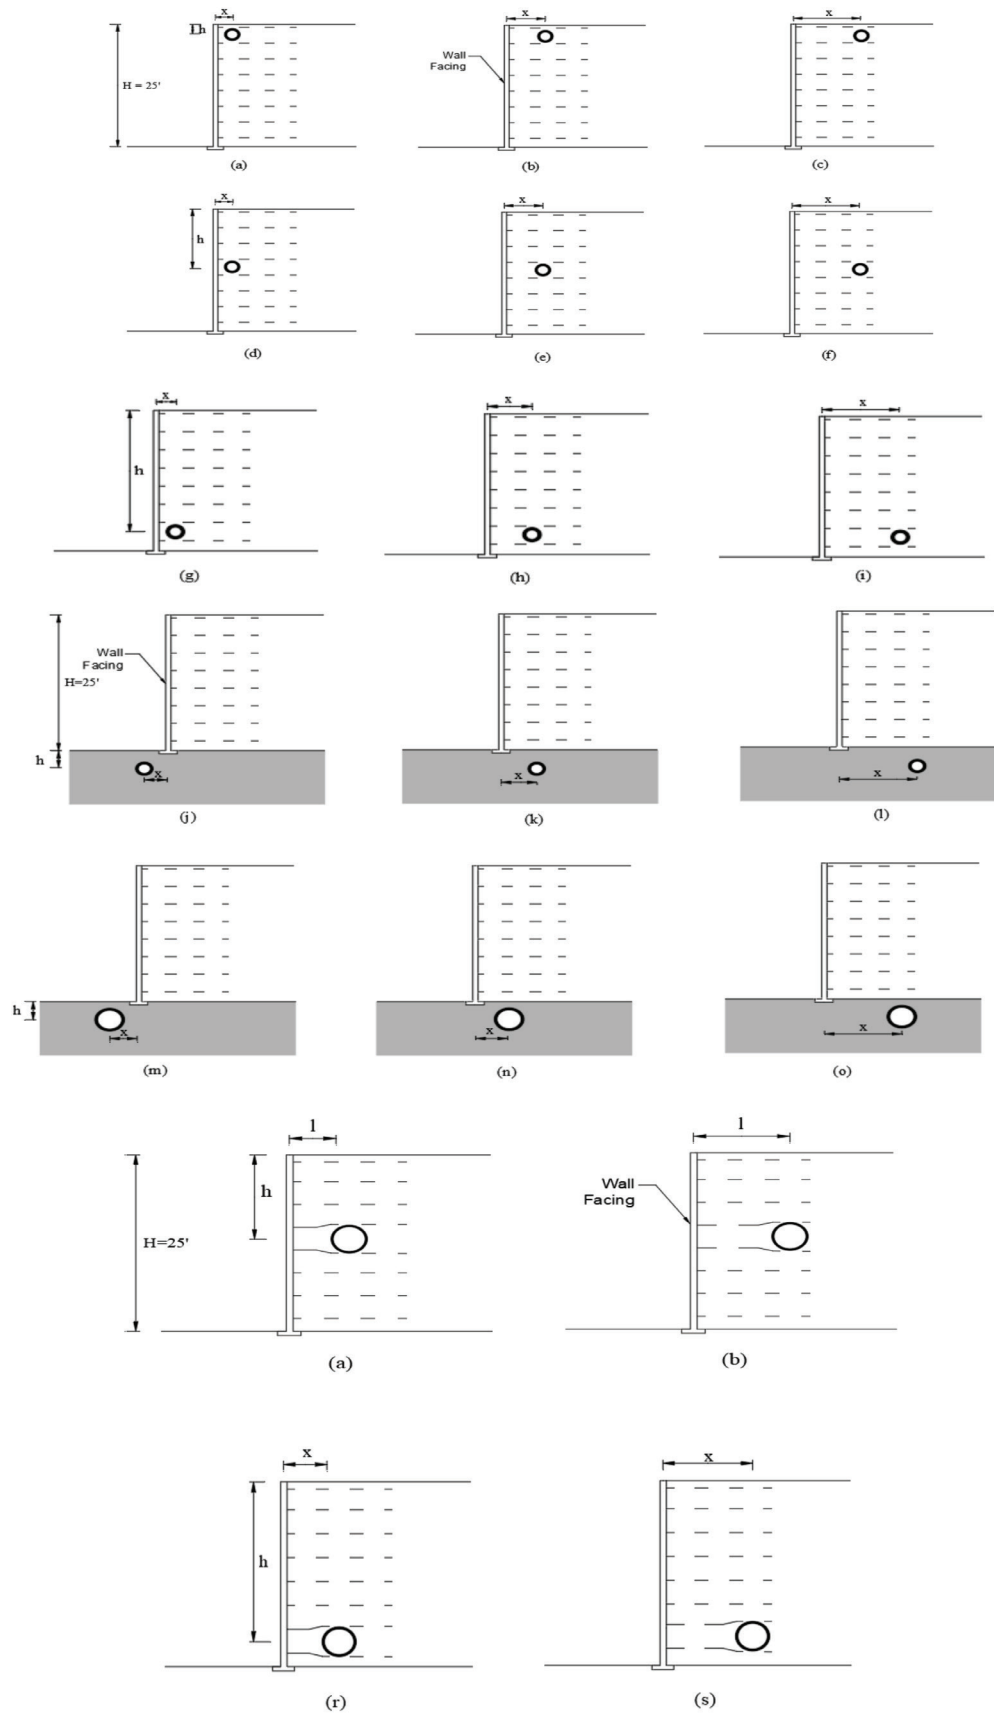
Figure 4.1 Schematic Diagrams of the MSE Wall With Utility.

The wall chosen for the simulations is based on a case study from INDOT (2019) and duplicates the geometry of a 7.62-m (25-ft) MSE wall built in Indiana that is intersected by a utility pipe. The simulations are done for the case of a circular pipe perpendicular to the cross-section of the wall. Thus, plane strain 2D simulations are performed. The pipe is located at different locations inside the wall to explore the effects of the presence of the pipe on the stability of the wall and on the reinforcement and on the reinforced fill. Figure 4.1 shows the schematic of the MSE wall with the utility pipes. The goal is to assess the impact of utility pipes intersecting the reinforced zone. Consequently, intersections can occur at various positions within the wall and with various diameters of the pipe. For the plane strain 2D simulation to comprehensively explore this, nine combinations were devised, involving placing the pipe at three distinct depths and, at each depth, at varying distances from the facing (Figure 4.1a–i). The pipe or culvert may also interact with the foundation soil, potentially intersecting the wall at different locations. Six scenarios resulting from the pipe intersecting the foundation soil were examined (Figure 4.1j–o). The pipe is positioned in front of the facing, behind the facing beneath the reinforced zone. Furthermore, all three scenarios were replicated with alterations in the pipe diameter. Figure 4.1p–s show the cases when a large

pipe intersects the MSE wall in the reinforced zone. As discussed in Chapter 1, the DOTs' and FHWA's recommendations are to splay the reinforcement when the pipe diameter is larger than the reinforcement spacing. Following those recommendations, the pipe is placed at two different depths and at  $x$  distance behind the facing.

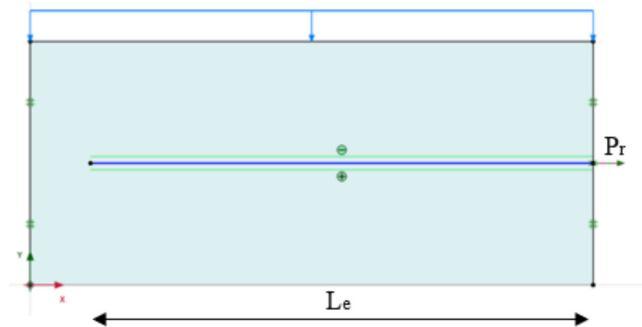
Figure 4.2 Pullout Test.

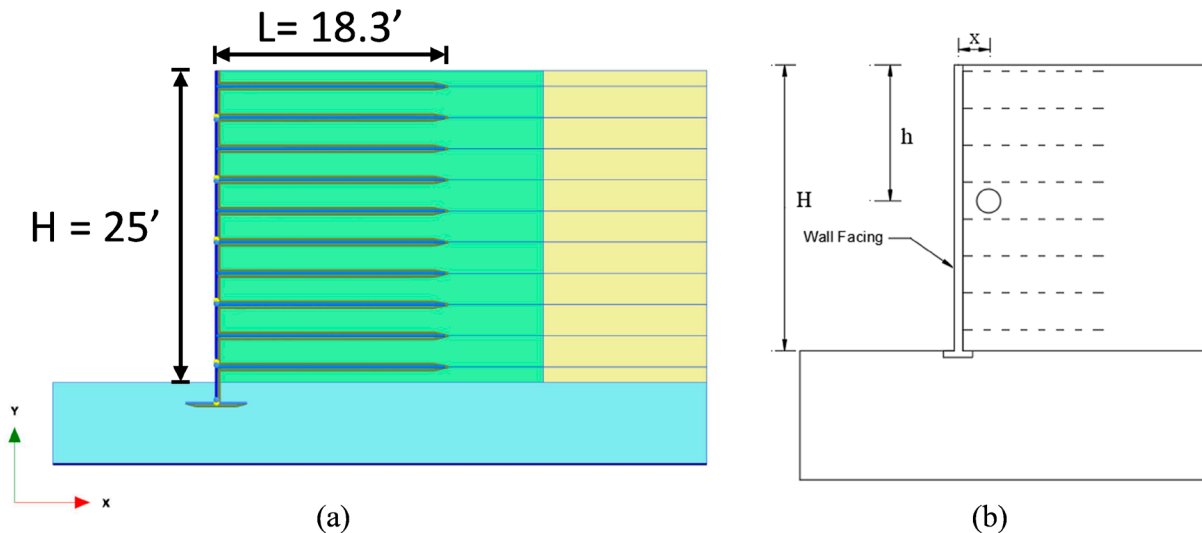
**Figure 4.3** Numerical Model: (a) Base Case and (b) Schematic Diagram of MSE Wall With a Pipe.

Figure 4.3a illustrates the base case, which is the MSE wall with no utility pipe. As already mentioned, the height of the wall is 7.62 m and the length of the reinforcement is 5.6 m. The backfill is reinforced with ten layers of reinforcement at a spacing of 76.2 cm. All elements in the model are 15-noded triangular elements. The mesh is composed of 9,146 nodes and 938 elements. This is the result of a sensitivity/optimization analysis where the size and number of elements in the model were changed until the results were found independent of the size and number of the elements in the mesh. The material properties are those in Table 4.1 to Table 4.4.

Figure 4.3b depicts the schematic of the MSE wall with a pipe placed in the backfill zone.  $H$  is the height of the wall,  $h$  is the depth at the centre of the pipe, measured from the top of the soil layer, and  $x$  is the distance of the center of the pipe from the facing panel.

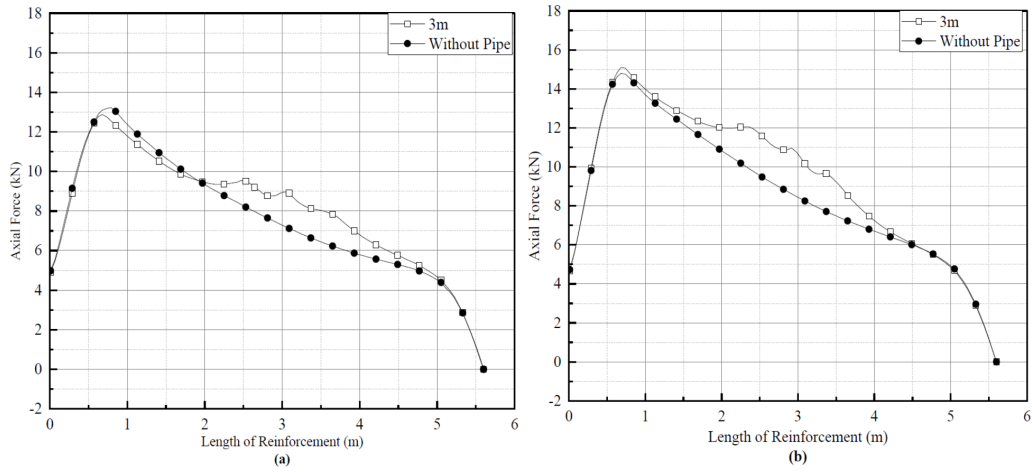
**Figure 4.4** Axial Force in the Reinforcement: (a) Above the Pipe and (b) Below the Pipe for the Base Case (No Reinforcement) and the Reference Case ( $h = 3.81$  m [12.5 ft],  $x = 3$  m [9.8 ft]).

Figure 4.4 is a plot of the axial forces in the reinforcement above and below the pipe for the reference case ( $h = 3.81$  m [12.5 ft] and  $x = 3$  m [9.8 ft]) and the base case. The figure shows that the reinforcement above the pipe has an increase of 25–30% in the axial force with respect to the base case. Below the pipe, the effects are slightly smaller, with an increase in the order of 20–25%. It is interesting to note that the presence of pipe leads to a localised change in the force. That is, the effect on the reinforcement load extends about two pipe diameters beyond the center of the pipe.

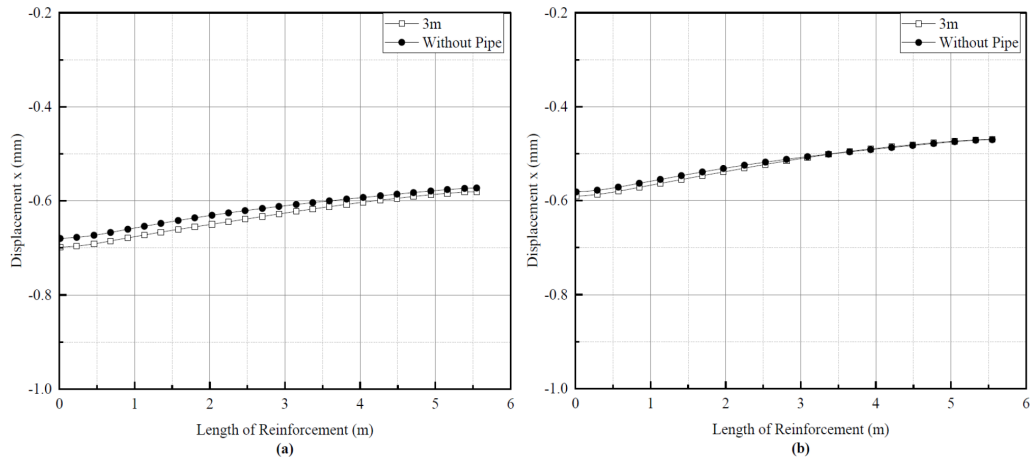
**Figure 4.5** Axial Displacement in the Reinforcement: (a) Above the Pipe and (b) Below the Pipe for the Base Case (No Reinforcement) and the Reference Case ( $h = 3.81$  m [12.5 ft],  $x = 3$  m [9.8 ft]).

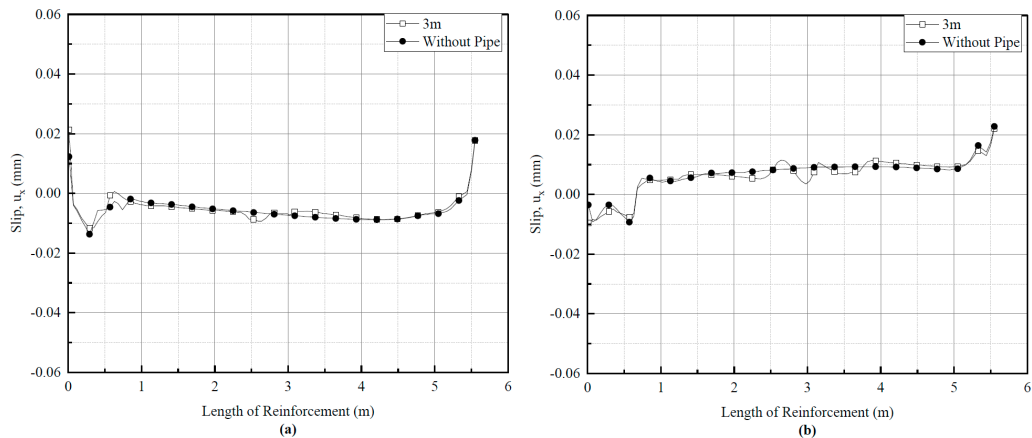
**Figure 4.6** Slip in the Reinforcement Above the Pipe: (a) Upper Contact; and (b) Lower Contact for the Base Case (No Reinforcement) and the Reference Case ( $h = 3.81$  m [12.5 ft],  $x = 3$  m [9.8 ft]).

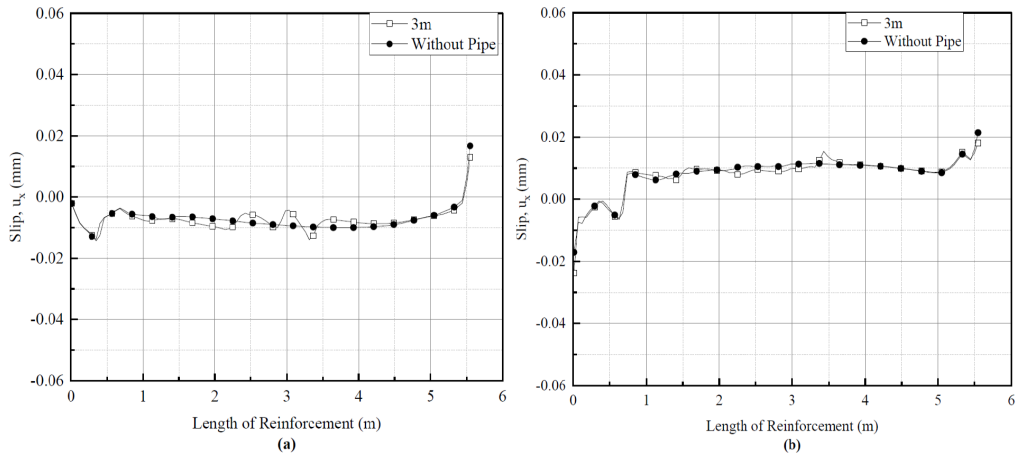
**Figure 4.7** Slip in the Reinforcement Below the Pipe: (a) Upper Contact and (b) Lower Contact for the Base Case (No Reinforcement) and the Reference Case ( $h = 3.81$  m [12.5 ft],  $x = 3$  m [9.8 ft]).

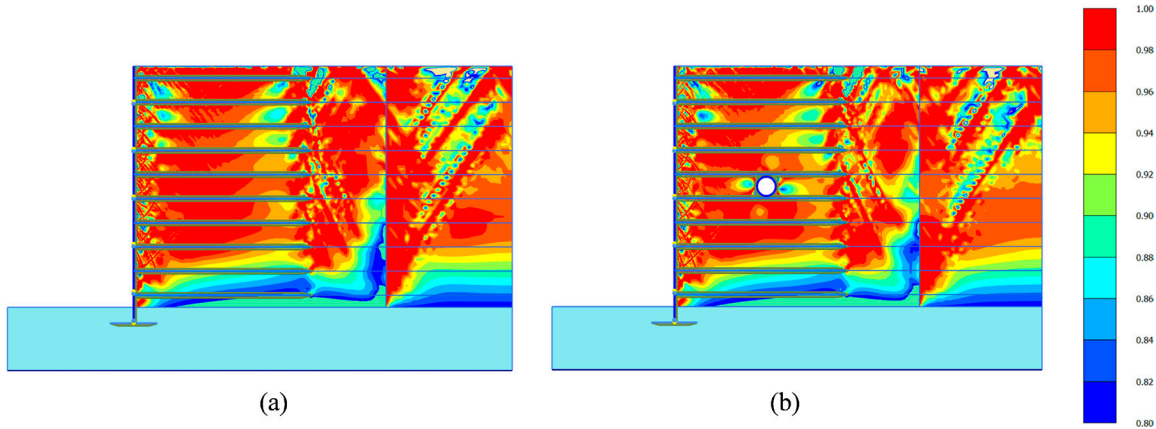
**Figure 4.8** Ratio Between the Maximum Shear Stress and the Mobilized Shear Stress in the Backfill and Soil, for (a) Base Case (No Pipe) and (b) Reference Case ( $h = 3.81$  m [12.5 ft] and  $x = 3$  m [9.8 ft]).

Figure 4.8 illustrates the ratio between the maximum shear stress and the mobilized shear stress in the backfill and soil of the MSE wall, without a pipe (base case, Figure 4.8a) and with the pipe (reference case, Figure 4.8b). Note that the results in the foundation soil are not meaningful because of the high strength/high stiffness given to the material; therefore, they are not included in Figure 4.8. The ratio is a measure of the demand with respect to the capacity of the soil. The contours show the capacity of the soil utilized. The presence of the pipe affects the relative shear stress, and the relative shear stress has decreased at the spring lines and increased near the crown of the pipe.

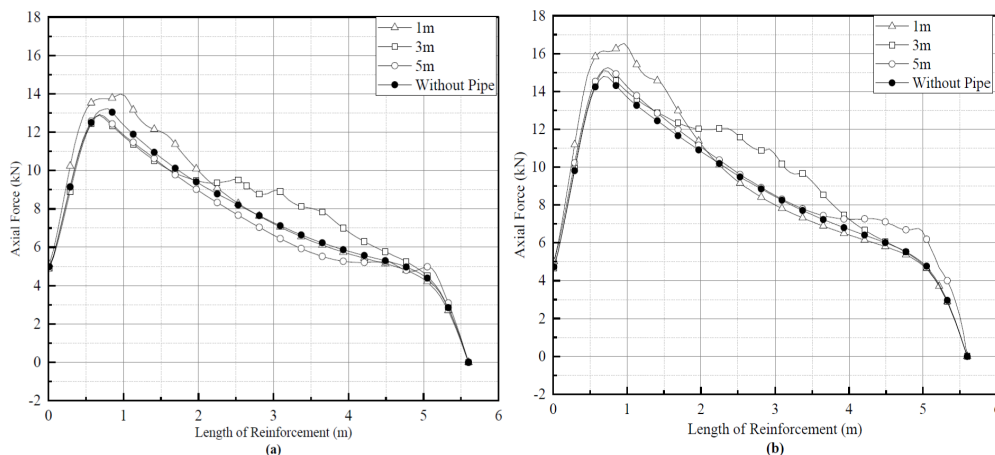
**Figure 4.9** Axial Force in the Reinforcement With Distance From the Facing Panel (a) Above the Pipe and (b) Below the Pipe. Pipe Location at  $h = 3.81 \text{ m}$  (12.5 ft).

Figure 4.9 shows that for the reference case, moving the pipe close to the facing panel increases the stresses in the reinforcement below the pipe by about 15%, with changes that affect only the area of influence of the pipe, about two diameters, as already mentioned. The changes in stress in the above reinforcement are relatively smaller. Moving the pipe away from the facing, at  $x = 5$  m (16.4 ft) induces small changes in the above reinforcement and an increase of about 20–25% on the reinforcement

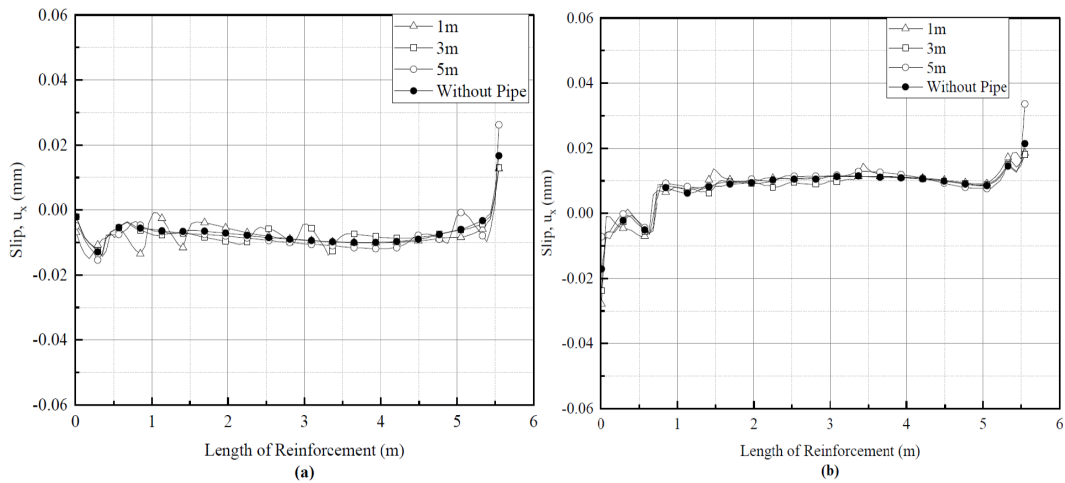
**Figure 4.12** Slip of the Reinforcement Below the Pipe (a) Upper Contact and (b) Lower Contact. Pipe Location at  $h = 3.81$  m (12.5 ft).

Figure 4.11 and Figure 4.12 are plots of the slip that occurs along the upper and lower reinforcement, respectively, as a function of the position of the pipe (reference case) with respect to the facing of the wall. Figure 4.11b and Figure 4.12a show that the magnitude of the slip on the inner contacts has more peaks due to shear stress around the pipe, similar to the redistribution of shear stresses around the pipe, and, at the same time, reinforcement is subjected to tension and pipe is subjected

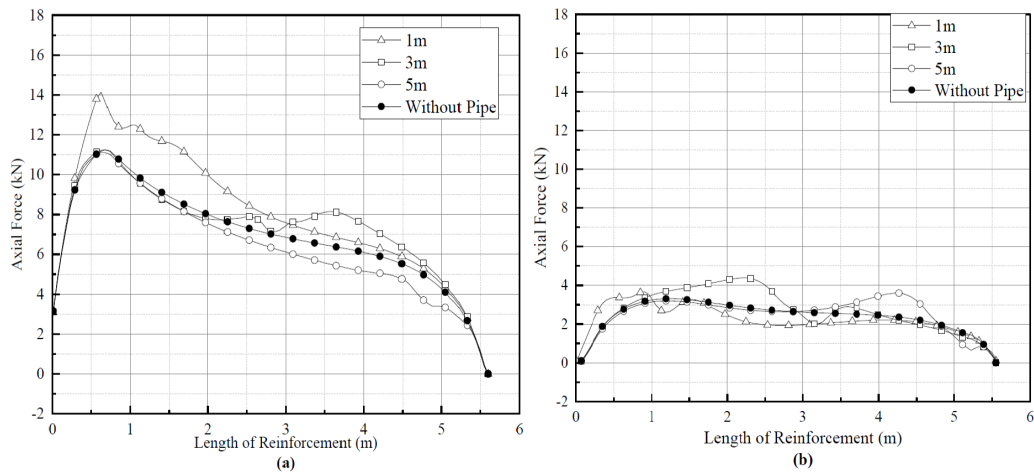
**Figure 4.14** Axial Force in the Reinforcement With Distance From Facing Panel (a) Above the Pipe and (b) Below the Pipe. Pipe Location at  $h = 6.85$  m (22.5 ft).

When the pipe is positioned right after the first layer of reinforcement ( $h = 76 \text{ cm}$  [2.5 ft]), or near the bottom of the backfill ( $h = 6.85 \text{ m}$  [22.5 ft]), the largest effects on the axial load on the reinforcement occur at the reinforcement below the pipe (Figure 4.13b and Figure 4.14b), with magnitudes increased by 30–50% in most cases, but can go up to 100% for the case with  $h = 6.85 \text{ m}$  (22.5 ft) and  $x = 1 \text{ m}$ , close to the facing of the wall. The change in axial load on the reinforcement above the pipe is small for the case  $h = 76 \text{ cm}$  (Figure 4.13a), or is in the form of an increase in load (Figure 4.14a) for the case with  $h = 6.85 \text{ m}$  (22.5 ft). In all cases, the effects of the pipe are confined to the reinforcements immediately above and below the pipe. Other reinforcement layers are not affected by the presence of the pipe. The only exception found is for the case of  $h = 76 \text{ cm}$  (2.5 ft), where changes in the axial force on the second reinforcement below the pipe (Figure 4.13c), where an important increase of axial load, with respect to the base case, is observed for  $x = 5$ , and a general reduction for  $x = 1 \text{ m}$  (3.3 ft) and  $3 \text{ m}$  (9.8 ft). However the changes, of the order of 15–20%, tend to be smaller than those on the reinforcement immediately below the pipe (30–50%; Figure 4.13b). By comparing the results in the two figures, it can be said that when the pipe is near the top of the wall and moving away from the facing of the wall, the axial force proportionally increases with respect to the base case. However, for a deeper pipe, the trend is the opposite: as the pipe is placed away from the facing of the wall, the axial force proportionally decreases.

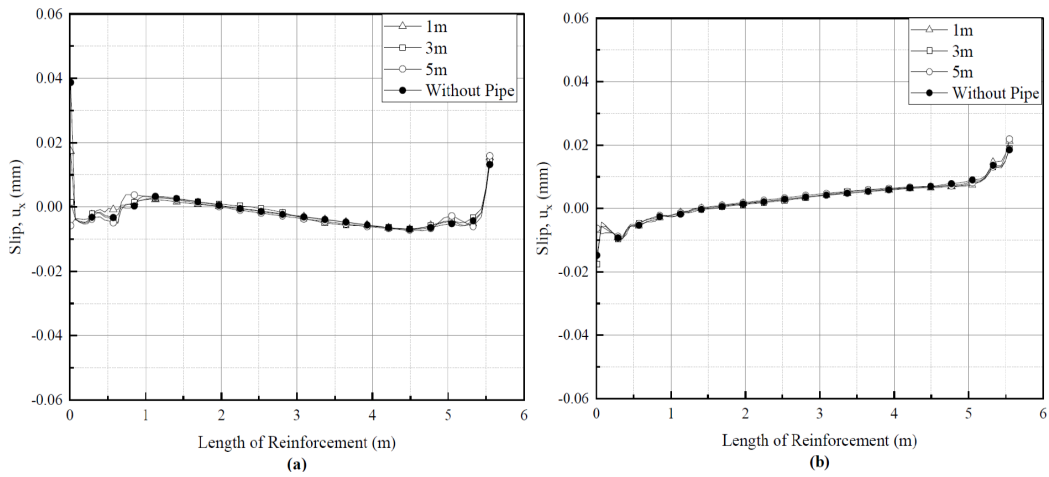
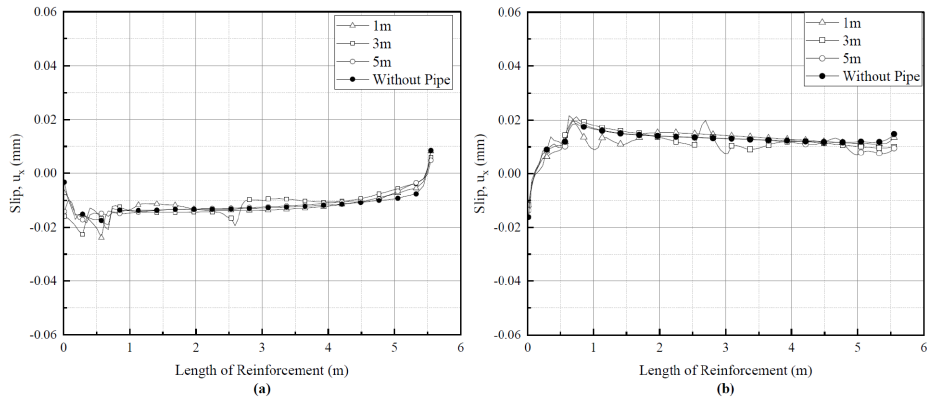
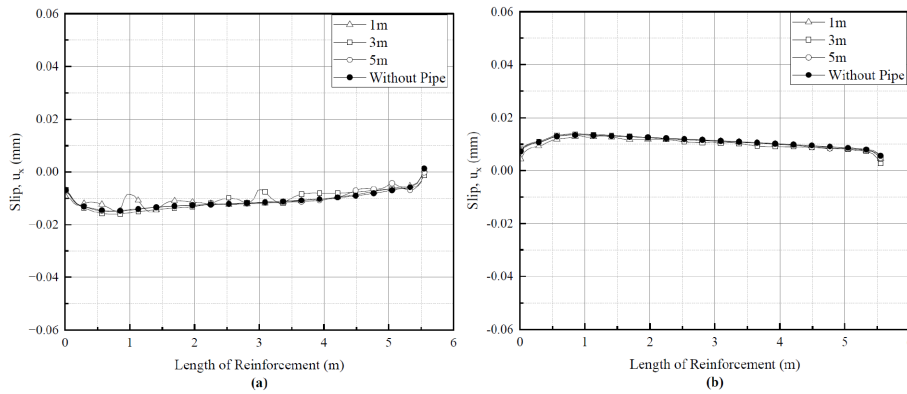
**Figure 4.17** Slip in the Reinforcement Above the Pipe for (a) Upper Contact and (b) Lower Contact. Pipe Location at  $h = 76$  cm (2.5 ft).

**Figure 4.18** Slip in the Reinforcement Below the Pipe for (a) Upper Contact and (b) Lower Contact. Pipe Location at  $h = 76$  cm (2.5 ft).

**Figure 4.19** Slip in the Second Layer Reinforcement Below the Pipe for (a) Upper Contact and (b) Lower Contact. Pipe Location at  $h = 76$  cm (2.5 ft).

**Figure 4.20** Slip in the Reinforcement Above the Pipe for (a) Upper Contact and (b) Lower Contact. Pipe Location at  $h = 6.85$  m (22.5 ft).

**Figure 4.21** Slip in the Reinforcement Below the Pipe for (a) Upper Contact and (b) Lower Contact. Pipe Location at  $h = 6.85$  m (22.5 ft).

Figure 4.17 to Figure 4.21 are plots of the slip between the reinforcements near the pipe and the surrounding soil. The trend is similar in all cases and is also similar to what was found for the reference case. Slip is more significant on the upper contact of the two reinforcements directly above and below the pipe. It is not different than the slip that occurs in the base case for the lower contact and in reinforcements not adjacent to the pipe. Slip tends to become more negative/less positive to the left of the pipe, within the area of influence, of about 1.5–2 diameters, and less negative/more positive to the right, and also over a similar distance from the center of the pipe. The changes in the magnitude of slip, with respect to the base case, seem to increase with the depth of the pipe, but they are similar irrespective of the horizontal position of the pipe. This is attributed to the disturbance that the presence of the pipe introduces to the reinforcement-ground interaction, as it changes the stresses acting on the reinforcement.

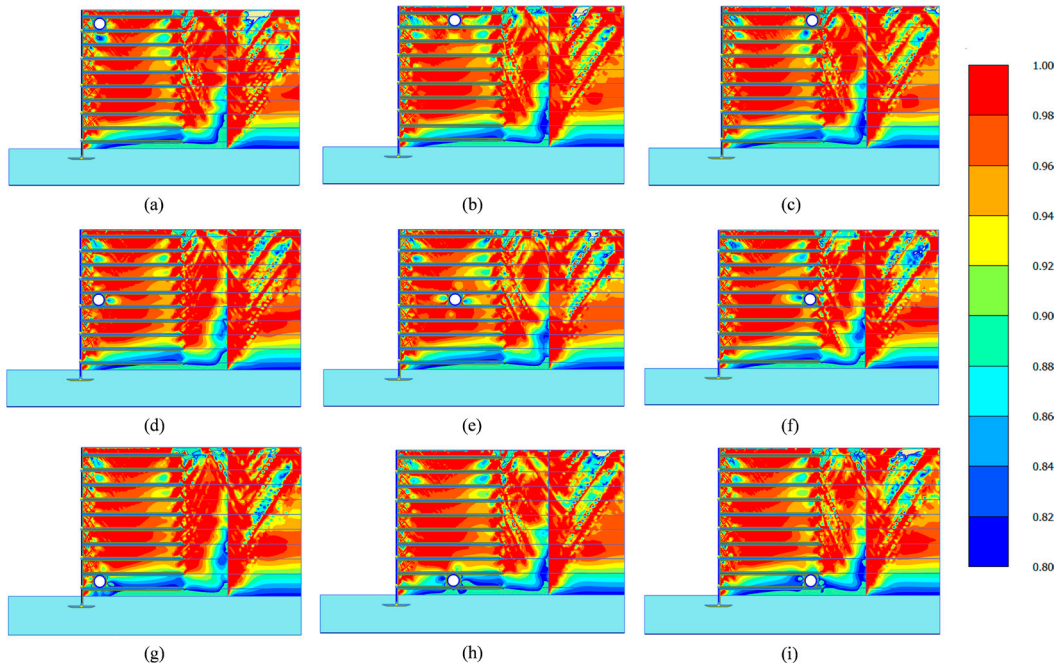
**Figure 4.22** Shear Stress Capacity vs. Demand for the Following Cases: (a)  $h = 76$  cm (2.5 ft),  $x = 1$  m (3.3 ft); (b)  $h = 76$  cm (2.5 ft),  $x = 3$  m (9.8 ft); (c)  $h = 76$  cm (2.5 ft),  $x = 5$  m (16.4 ft); (d)  $h = 3.81$  m (12.5 ft),  $x = 1$  m (3.3 ft); (e)  $h = 3.81$  m (12.5 ft),  $x = 3$  m (9.8 ft); (f)  $h = 3.81$  m (12.5 ft),  $x = 5$  m (16.4 ft); (g)  $h = 6.85$  m (22.5 ft),  $x = 1$  m (3.3 ft); (h)  $h = 6.85$  m (22.5 ft),  $x = 3$  m (9.8 ft); and (i)  $h = 6.85$  m (22.5 ft),  $x = 5$  m (16.4 ft).

Figure 4.22 shows contours of the ratio between the shear stress capacity to the shear stress demand on the reinforced backfill and soil (as in Figure 4.8, the results in the foundation soil are not meaningful because of the high strength/high stiffness given to the material). It can be seen from the figure that the region near to the wall and the region away from the wall

(end of reinforcement length) the soil is already mobilized. However, when the pipe is located 3 m (9.8 ft) from the facing at different depth, as the pipe moves downward the mobilization of the soil around the pipe is increased. It can also be noticed that the presence of a pipe changes the relative shear stress in the surroundings of the soil. In a later section, the area of influence caused by the pipe will be discussed. Table 4.6 summarizes the global FOS of the cases in Figure 4.1a–i. It shows the presence of pipe led to decrease in the FOS by 1–2%.
