# JOINT TRANSPORTATION RESEARCH PROGRAM

## Study on the Permissible Depth of Utilities Under the MSE Walls and Means and Methods of Protecting the MSE Walls When the Permissible Depth Cannot Be Provided

**Md Asad Ahmad and Antonio Bobet**

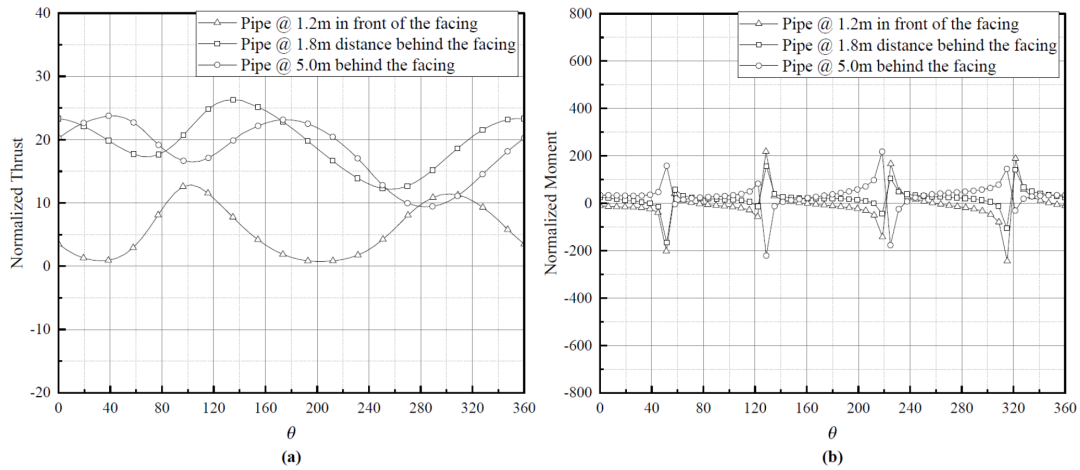
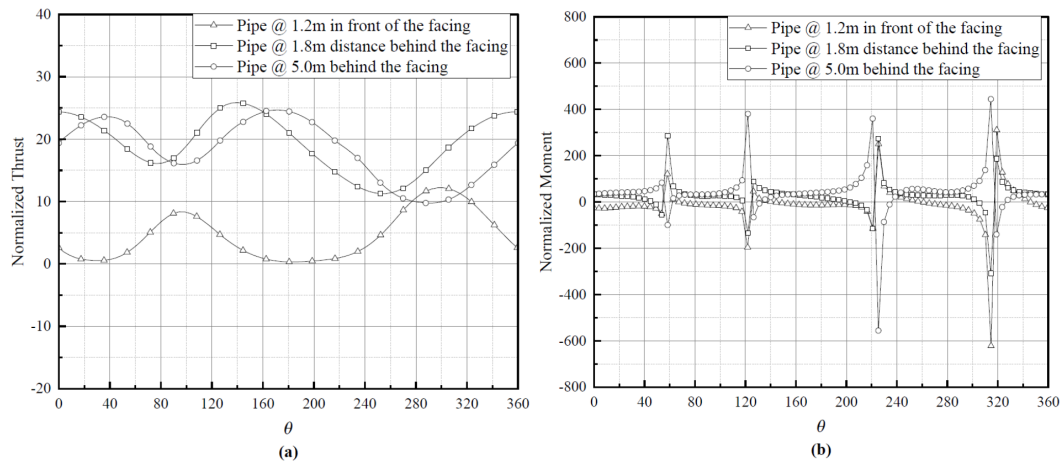
Figure 4.23 Forces on the Pipe (a) Normalized Thrust and (b) Normalized Moment.

Figure 4.24 Forces on the Pipe (a) Normalized Thrust and (b) Normalized Moment.

Figure 4.23 and Figure 4.24 are plots of normalized thrust and moment at the perimeter of the pipe when it is placed at the following location: 1.2 m (3.9 ft) in front of the facing, 1.8 m (5.9 ft) distance behind the facing, and 5 m (16.4 ft) behind the facing. It is observed that the pipe experiences an increase in thrust by approximately 12 times when placed in front of the wall. However, the thrust in the pipe increases by 24 times when it is placed below the MSE wall at 1.2 m from the facing. Due to the weight of the MSE wall, there is an overall increase in the normalized thrust compared to when it was in front of the wall. In addition, if it is placed behind the wall, the maximum thrust reaches up to 26 times when placed 5 m (16.4 ft) behind the facing. From Figure 4.23a, the pipe in front of the facing is found to have increase in normalized moment up to 250 times, because the loading on the pipe is nonsymmetric. When the pipe is placed below the MSE wall, the maximum normalized moment is approximately 225 times that of the pipe without the MSE wall. A similar increase in the normalized thrust is evaluated when the pipe diameter is increased from 60.9 cm (24 in.) to 91.4 cm (36 in.). With the increase in pipe diameter, the maximum normalized moment on the perimeter of the pipe in front of the wall increases up to 625 times that of the pipe without an MSE wall. Similar to the previous case, the pipe (1.8 m behind the facing) experiences a normalized moment up to 550 times when there is no MSE wall. This shows the significant increase in the forces on the pipe and even more when placed behind the

facing. The increase in pipe diameter causes substantial increase in the normalized moment.

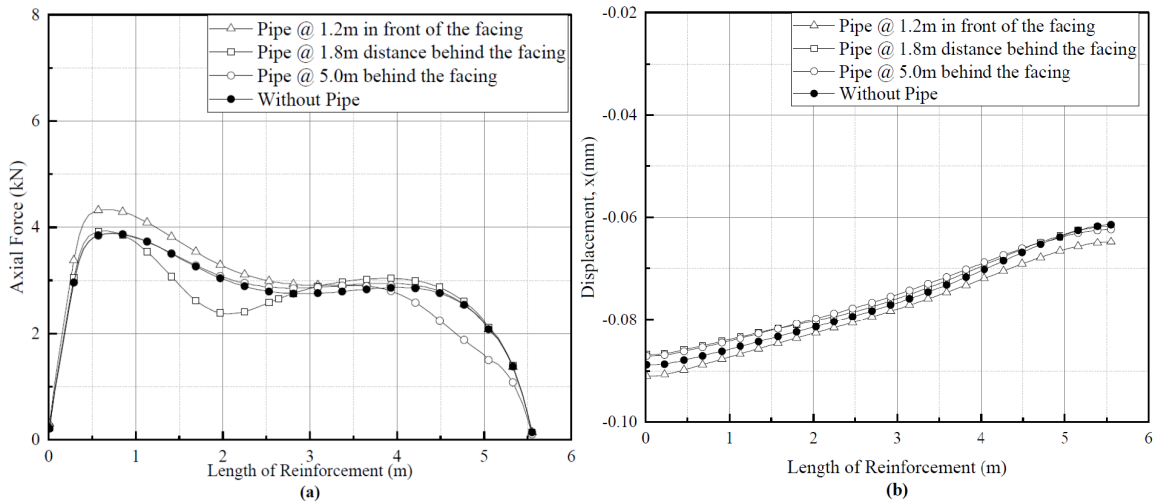
**Figure 4.26** First Layer of Reinforcement: (a) Axial Force and (b) Displacement. Pipe Diameter  $D = 60.9$  cm (24 in.)

Figure 4.26a and Figure 4.26b are the axial force and displacements in the metal strips in the first layer of reinforcement.

It is found that when the pipe is placed in front of the wall the maximum increase in axial force is 8–9%. When it is placed beneath the MSE wall, the maximum increase in axial force is decreased at both locations. Figure 4.26b is a plot of axial displacements in the metal strips; it is found that the strip undergoes 7% maximum displacement when it is placed in front of the wall. The displacement of the strip is considerably reduced to 2% when it is placed behind the wall. Therefore, when the pipe is placed in front of the wall it affects the strip axial force and axial displacement. However, when a pipe is placed behind, it affects the pipe, resulting in an increase in thrust and moment.

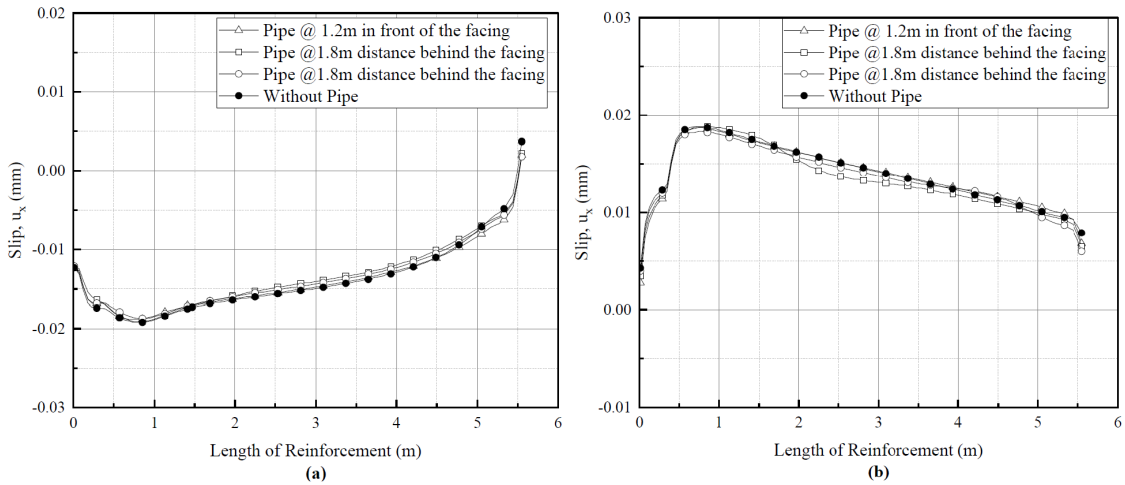
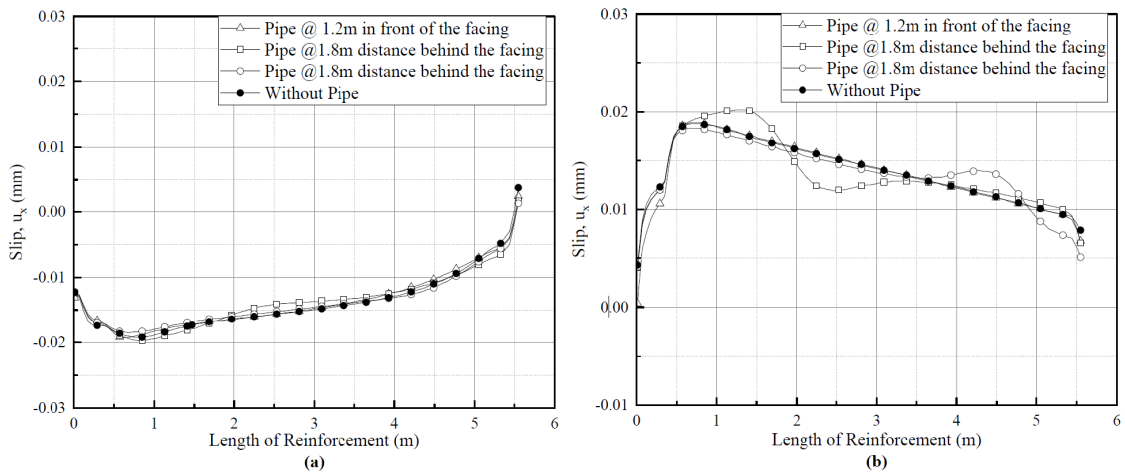
Figure 4.28 Slip in the First Layer of Reinforcement: (a) Upper Contact and (b) Lower Contact. Pipe Diameter  $D = 60.9$  cm (24 in.).

Figure 4.29 Slip in the First Layer of Reinforcement: (a) Upper Contact and (b) Lower Contact. Pipe Diameter  $D = 91.4$  cm (36 in.).

Figure 4.28 and Figure 4.29 plot the slip in the first layer of reinforcement. As discussed before, slip is the measure of the frictional demand in the reinforcement. From Figure 4.28, it is obvious that the pipe diameter led to a very significant change in slip and aligns with the axial force. However, with the increase in pipe diameter, the slip in the first layer of reinforcement has increased and happens to be consistent with the axial force and displacement, as shown in Figure 4.27 and Figure 4.29.

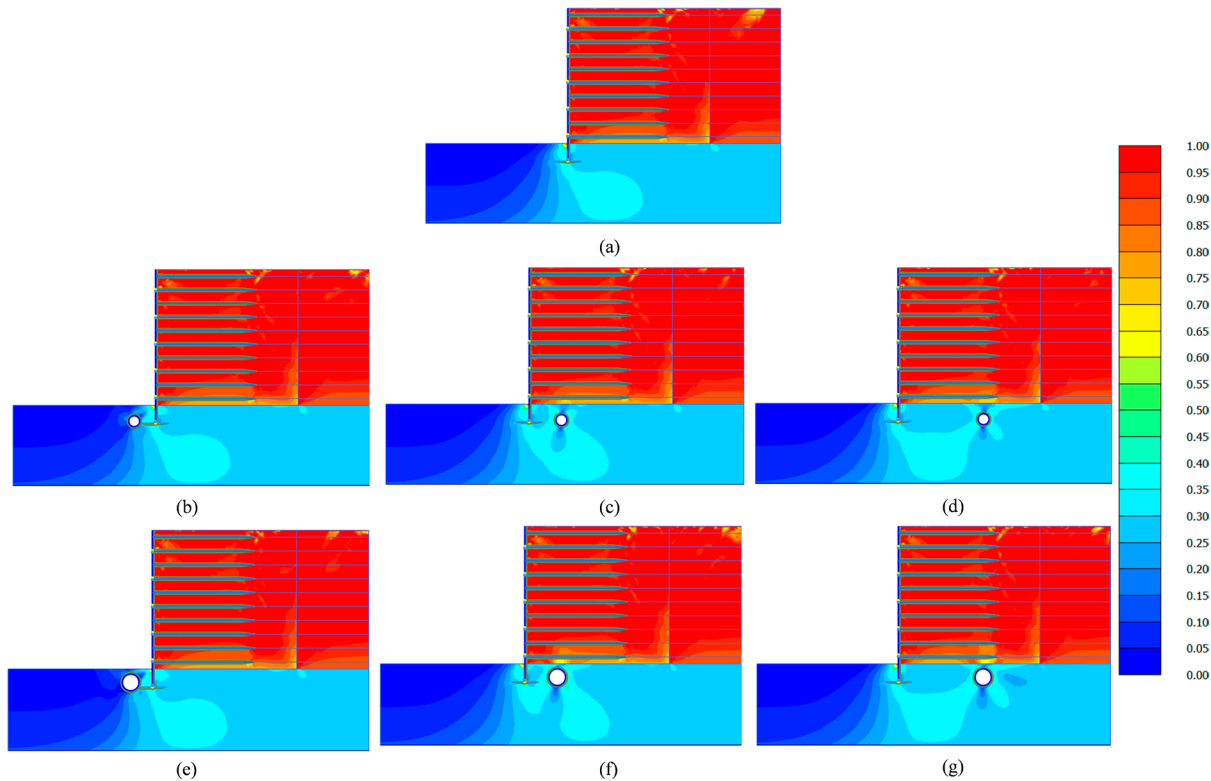
**Figure 4.30** Shear Stress Capacity vs. Demand for the Following Cases: (a) Base Case; (b) 1.2 m (3.9 ft) in Front of the Wall,  $D = 60.9$  cm (24 in.); (c) 1.8 m (5.9 ft) Behind the Wall,  $D = 60.9$  cm (24 in.); (d) 5 m (16.4 ft) Behind the Wall,  $D = 60.9$  cm (24 in.); (e) 1.2 m (3.9 ft) in Front of the Wall,  $D = 91.4$  cm (36 in.); (f) 1.8 m (5.9 ft) Behind the Wall,  $D = 91.4$  cm (36 in.); and (g) 5 m (16.4 ft) Behind the Wall,  $D = 91.4$  cm (36 in.).

This shows that the presence of a larger pipe led to an increase in the frictional demand of the reinforcement. The presence of a pipe does not change the global factor of safety, and the FOS of 1.88 remains conserved.

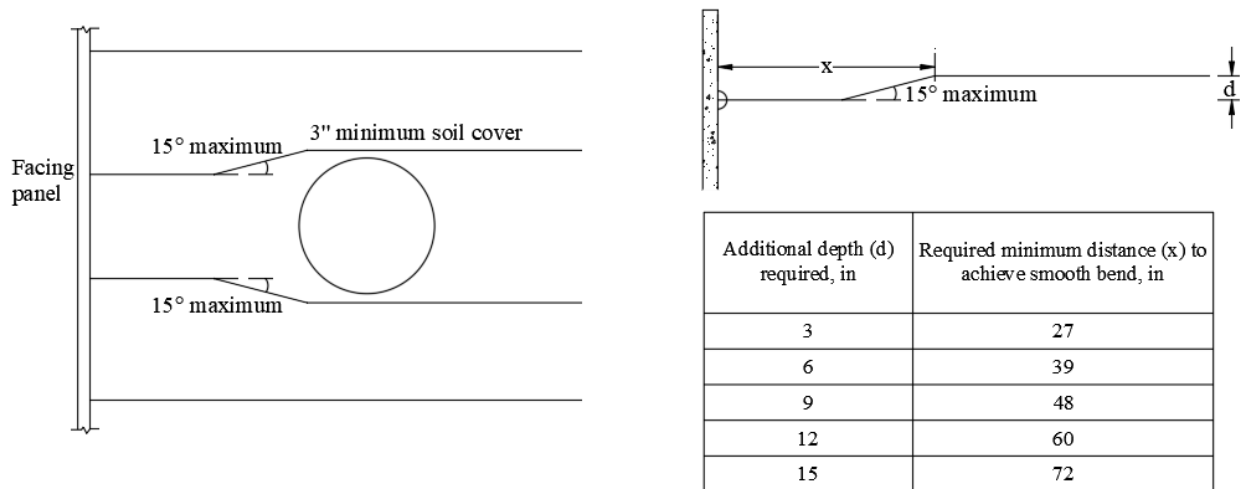
Figure 4.31 Guidelines for Inextensible Reinforcement (Redrawn From FHWA, 2009).

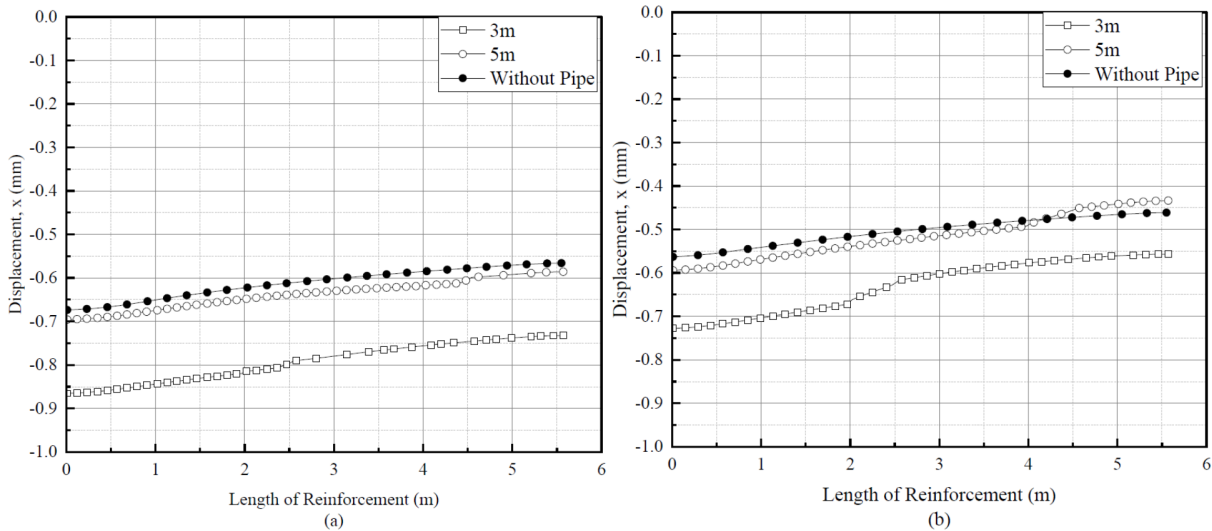
**Figure 4.34** Displacements in the Reinforcement With Distance From Facing Panel (a) Above the Pipe and (b) Below the Pipe. Pipe Location at  $h = 3.81$  m (12.5 ft).

**Figure 4.35** Axial Force in the Reinforcement With Distance From Facing Panel (a) Above the Pipe and (b) Below the Pipe. Pipe Location at  $h = 6.85$  m (22.5 ft).

Figure 4.34 and Figure 4.35 show the reinforcement axial displacement. The effects of the pipe on the reinforcement are more pronounced on the steel strip above the pipe. As one can

see in Figure 4.34a, Figure 4.35a, and Figure 4.35b, beyond the location where the pipe is placed, the displacement is rather constant. This is due to the large reduction of overburden above the reinforcement due to the bending of the steel strip.

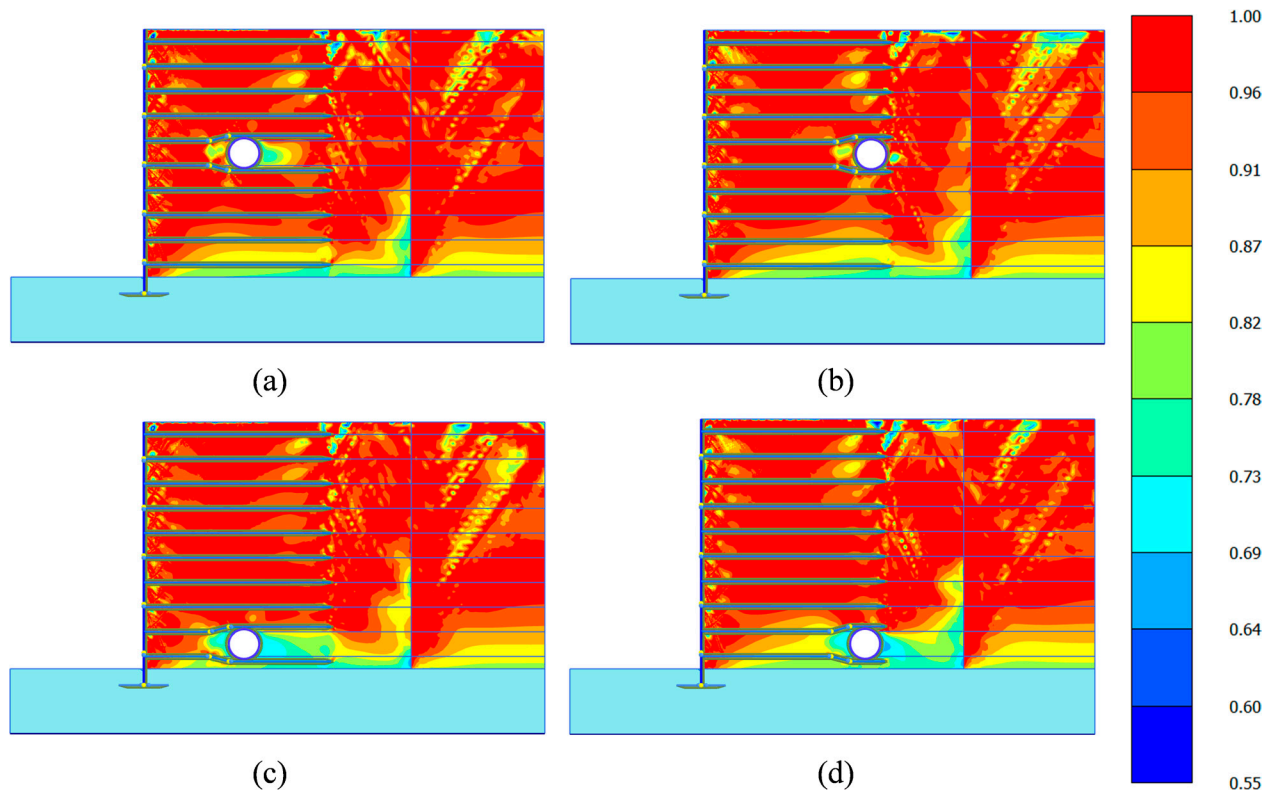
**Figure 4.40** Shear Stress Capacity vs. Demand for the Following Cases: (a)  $h = 3.81$  m (12.5 ft),  $x = 3$  m (9.8 ft); (b)  $h = 3.81$  m (12.5 ft),  $x = 5$  m (16.4 ft); (c)  $h = 6.85$  m (22.5 ft),  $x = 3$  m (9.8 ft); and (d)  $h = 6.85$  m (22.5 ft),  $x = 5$  m (16.4 ft).

Figure 4.40 illustrates the contours of shear stress mobilization in the soil. It is evident that the presence of the pipe increases the shear stress in the surrounding soil. However, it should be noted that the foundation soil is characterized by high strength and stiffness, rendering the results less applicable. In all instances, the contours indicate an increase in shearing at the crown and invert, with a reduction at the spring lines. Additionally, the global factor of safety remains relatively constant across different depths and locations, though it has increased by 5–10% in every case (Table 4.8).

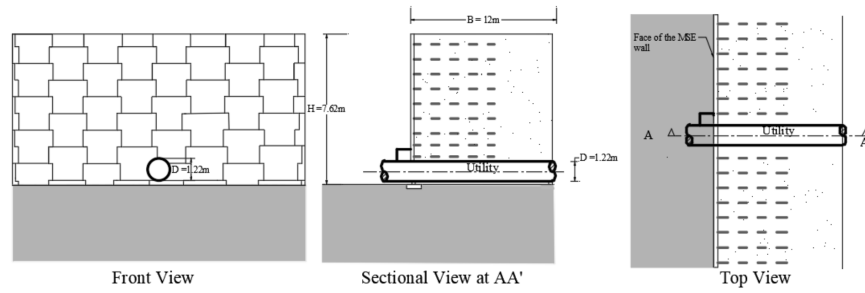
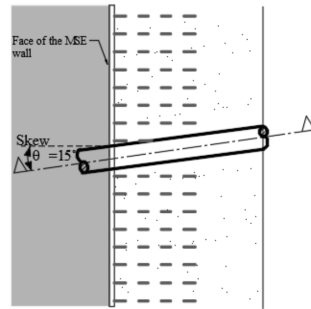
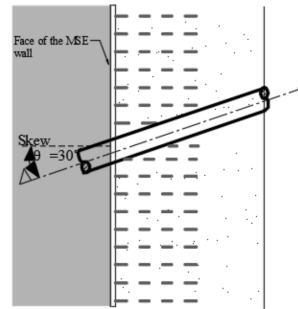
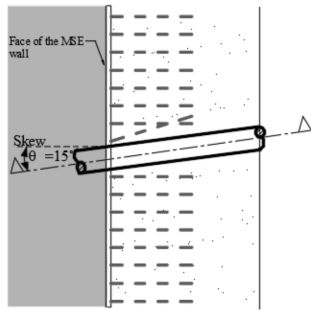
**Figure 5.1** Schematic Diagram of the MSE Wall With the Intersecting Pipe in the Reinforced Soil With: (a) Pipe Perpendicular to the Face of the Wall; (b) at  $15^\circ$  With Cut Reinforcements; (c) at  $15^\circ$  With Inclined Reinforcements; (d) at  $30^\circ$  With Cut Reinforcements; (e) at  $30^\circ$  With Inclined Reinforcements; With Pipe in the Foundation Soil With: (f) Pipe Below the Wall and Perpendicular to the Wall; (g) Pipe Below the Wall and at  $15^\circ$  With the Wall; (Continued on Next Page).

**5.2.1.1.2 Case 2: Pipe at a 15° With Reinforcements Affected by the Pipe Cut.** In this case (Figure 5.1b), the pipe is running at an angle of 15° from perpendicular to the wall facing

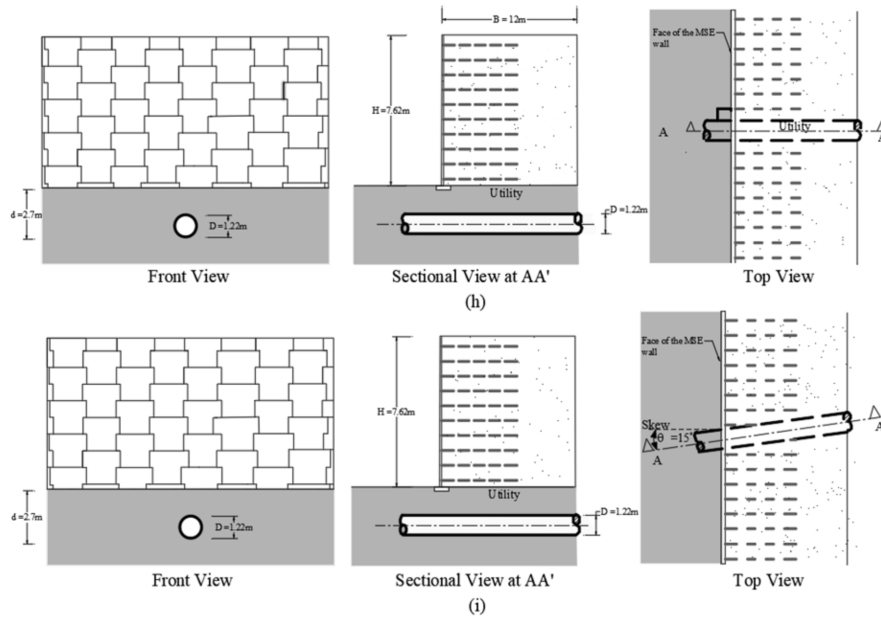
**Figure 5.1 (Continued)** Schematic Diagram of the MSE Wall With the Intersecting Pipe in the Reinforced Soil With: (h) at a Depth Under the Wall and Perpendicular to the Wall; and (i) at a Depth Under the Wall and at 15° With the Wall.

- Case 6: Pipe at a depth of invert  $d = 1.22$  m (4 ft) and perpendicular to the wall (Figure 5.1f).
- Case 7: Pipe at a depth of invert  $d = 1.22$  m (4 ft) and at an angle of 15° (Figure 5.1g).
- Case 8: Pipe at a depth of invert  $d = 2.70$  m (8.9 ft) and perpendicular to the wall (Figure 5.1h).

- Case 9: Pipe at a depth of invert  $d = 2.70$  m (8.9 ft) and at an angle of 15° (Figure 5.1i).

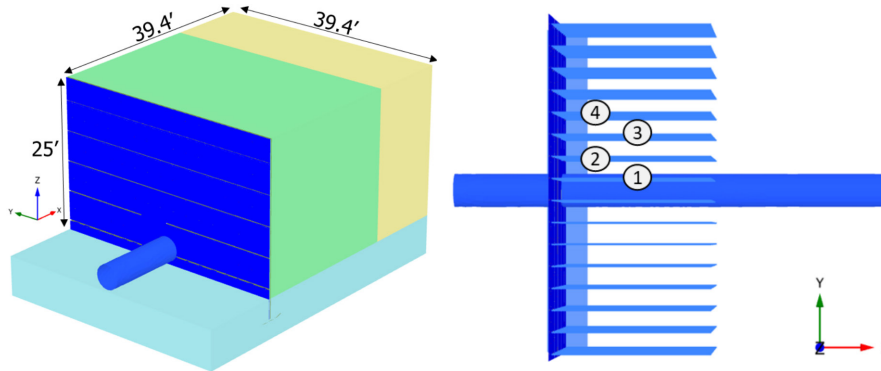
**Figure 5.2** Case 1. 3D Numerical Model (a) MSE Wall With a Pipe Running Perpendicular to the Wall and (b) Top View of Reinforcement and Pipe.

Figure 5.12 is a plot of the axial slip of reinforcements 1 to 4 in Layers 1 to 4 (Figure 5.2b). The trends shown are similar to those observed for the axial force and axial displacement. The slip in the reinforcement adjacent to the pipe is significantly reduced. An interesting observation is that the influence of the pipe is approximately 2–2.5 times its diameter. While it is expected that there will be an area around the pipe where the

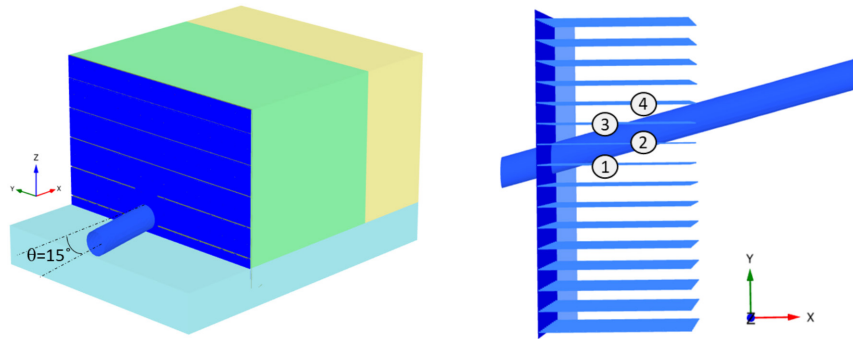
(Figure 5.3a). The pipe intersects the reinforcement at an angle of 15°, hence the need to cut/remove the steel strips affected by the pipe. The steel strips around the pipe are numbered 1, 2, 3, and 4 for each layer (Figure 5.3b).

**Figure 5.3** Case 2. 3D Numerical Model (a) MSE Wall With a Pipe Running at an Angle of 15° to the Wall and (b) Top View of Reinforcement and Pipe.

**5.3.1.2 Case 2: Pipe at a 15° With Reinforcements Affected by the Pipe Cut (Figure 5.1b).** The presence of the pipe results in the removal of the 1<sup>st</sup> reinforcement and the cutting of the 2<sup>nd</sup> reinforcement in Layers 1 and 2 (Figure 5.3b). Figure 5.13 to Figure 5.15 present a comparison between the results of Case 2 and the base case (no pipe).

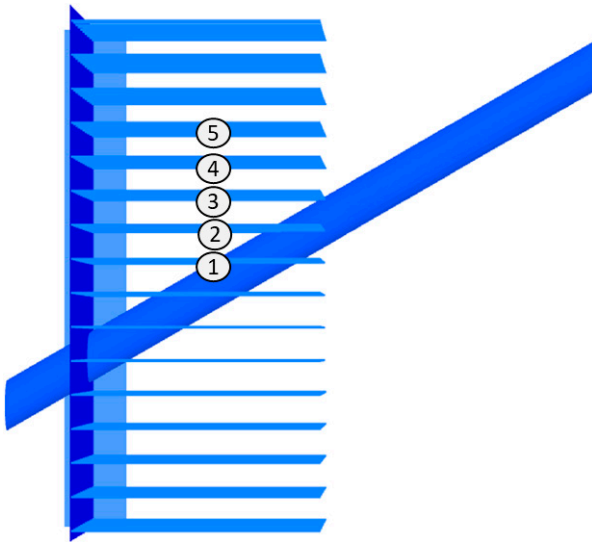
**5.2.1.1.3 Case 3: Pipe at a 30° With Reinforcements Affected by the Pipe Cut.** Case 3 (Figure 5.1c) is similar to Case 2 except that the pipe is running at an angle of 30° (Figure 5.4). In this case, the pipe is intersecting a large number of strips, which either need removed or cut. The reinforcement around the pipe is numbered from 1 to 5 for each layer (Figure 5.4).

**Figure 5.4** Case 3. Top View of Reinforcement and Pipe. Pipe at an Angle of 30°.

**5.3.1.3 Case 3: Pipe at a 30° With Reinforcements Affected by the Pipe Cut (Figure 5.1c).** The pipe at an angle of 30° results in the removal of the 1<sup>st</sup> reinforcement and the cutting of the 2<sup>nd</sup>, 3<sup>rd</sup>, 4<sup>th</sup>, and 5<sup>th</sup> reinforcement in Layers 1 and 2 (Figure 5.4). Figure 5.16 to Figure 5.18 include an assessment of the results with the pipe and the base case (no pipe).

Figure 5.18 shows the axial slip for reinforcements 1 through 4, as indicated for the strips numbered 1 to 5 (Figure 5.4). The slip trends are similar to those of the axial displacement, with increased slip observed in the reinforcement adjacent to the pipe, particularly in Layer 2 and in the 5<sup>th</sup> strip in Layer 3.

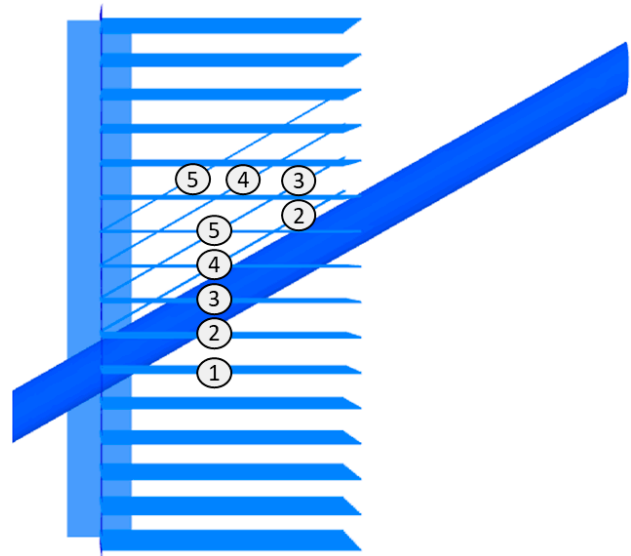
**5.2.1.1.5 Case 5: Pipe at a 30° With Reinforcements Affected by the Pipe Inclined.** In this case (Figure 5.1e), the pipe is at an angle of 30° and, again, the reinforcements affected are rotated parallel to the pipe. The strips are numbered from 1 to 5 in Layer 3 and 4. Additionally, the reinforcements 2 to 5 in Layers 1 and 2 are parallel to the pipe (Figure 5.6).

**Figure 5.6** Case 3. Top View of Reinforcement and Pipe. Pipe at an Angle of 30°.

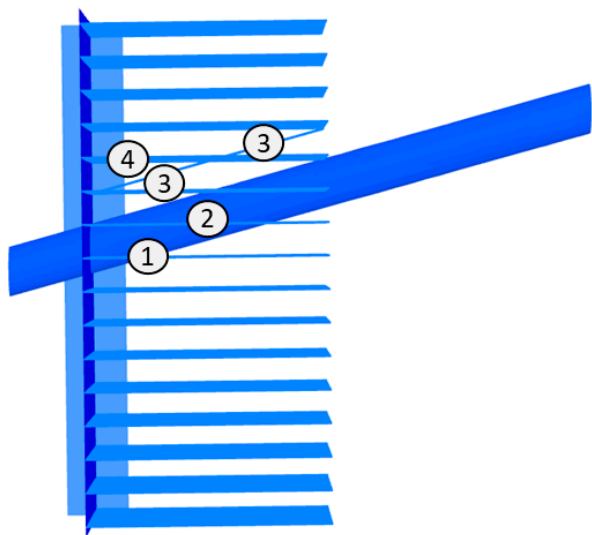
**5.2.1.1.4 Case 4: Pipe at a 15° With Reinforcements Affected by the Pipe Inclined.** Case 4 (Figure 5.1d) depicts the same case as 2, except that the reinforcement affected by the pipe is rotated parallel to the pipe. The reinforcements are numbered from 1 to 4, the same way as before, as shown in Figure 5.5.

**Figure 5.5** Case 4. Top View of Reinforcement and Pipe. Pipe at an Angle of 15°.

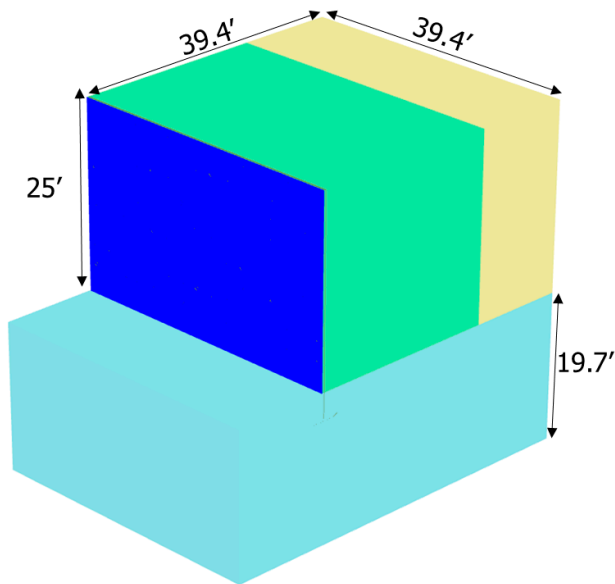
The study evaluates the overall stability of the wall and its components under these conditions. The depth of the foundation soil is 6 m (19.7 ft). The geometry of the numerical model is depicted in Figure 5.7.

Figure 5.7 3D Numerical Model.

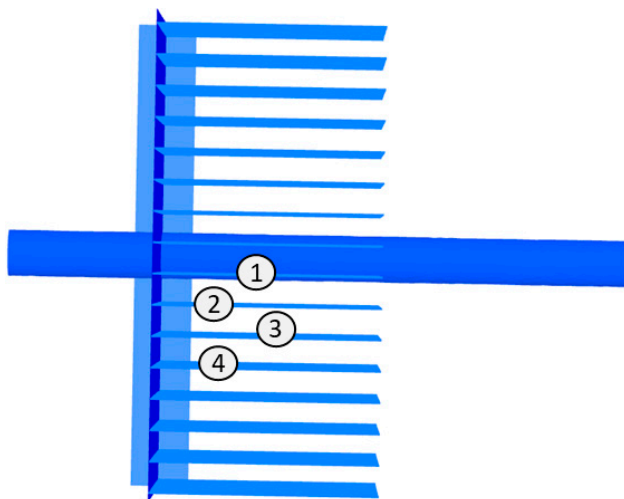
*5.2.1.2.1 Case 6: Pipe at a Depth of Invert  $d = 1.22$  m and Perpendicular to the Wall.* In this case (Figure 5.1f), the pipe is parallel to the MSE wall and the center of the pipe is located at a depth of 60.9 cm. The reinforcement is numbered from 1 to 4, for Layers 1 and 2, as shown in Figure 5.8.

Figure 5.8 Top View of Reinforcement and Pipe. Pipe Running Perpendicular to the Wall.

5.2.1.2.3 Cases 8 and 9: Pipe at a Depth of Invert  $d = 2.70$  m and Perpendicular to the Wall and at an Angle of  $15^\circ$ . The two scenarios consider a pipe located deep enough such that its influence on the wall is negligible, that is, at an invert depth of 2.70 m (8.9 ft). In one scenario, the pipe is placed perpendicular to the wall (Figure 5.1 h), and in the other scenario, at an angle of  $15^\circ$  (Figure 5.1i). The reinforcements are numbered following the convention in Figure 5.8 for the pipe perpendicular, and in Figure 5.9 for the pipe at an angle.

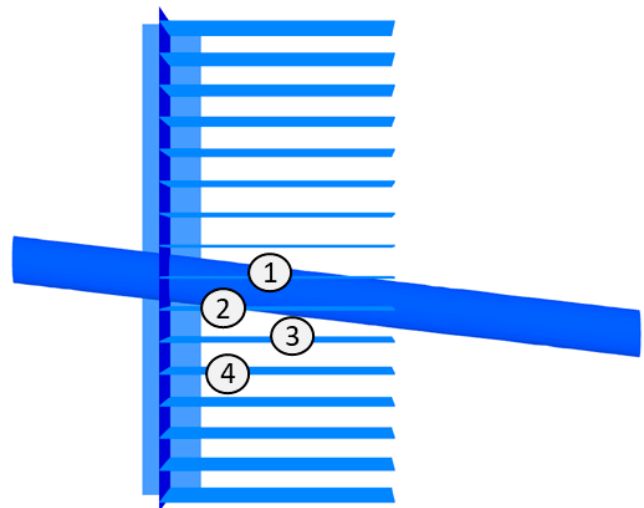
*5.2.1.2.2 Case 7: Pipe at a Depth of Invert  $d = 1.22$  m and at an Angle of 15°.* In Case 7 (Figure 5.1g), the pipe is at an angle of 15° and its center is located at a depth of 60.9 cm (24 in.). Once more, the reinforcements are numbered from 1 to 4, for each layer see Figure 5.9.

Figure 5.9 Top View of Reinforcement and Pipe. Pipe at an Angle of  $15^\circ$ .

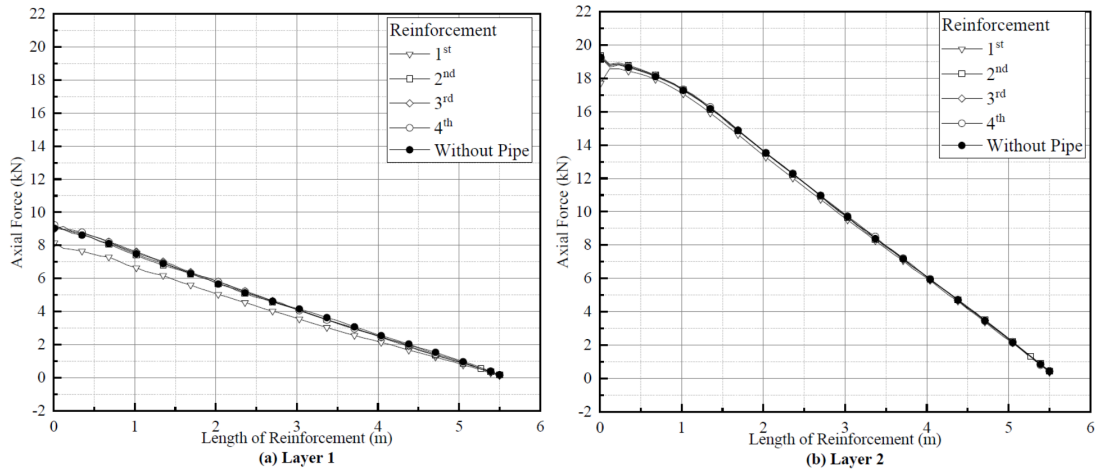
**Figure 5.26** Axial Force in the Reinforcement With Distance From the Facing Panel. Layer: (a) 1; and (b) 2. See Figure 5.8 for Reinforcement Numbering.

**5.3.2.1 Case 6: Pipe at a Depth of Invert  $d = 1.22$  m (4 ft) and Perpendicular to the Wall (Figure 5.1f).** Figure 5.26 to Figure 5.28 provide a comparison between the pipe running parallel to the wall and the base case (no pipe). Figure 5.26 displays the axial force, displacement, and slip, in the reinforcements 1<sup>st</sup> to 4<sup>th</sup> in Layers 1 and 2. The plots show that the presence of the pipe decreases the axial force only in the 1<sup>st</sup> strip of Layer 1 (Figure 5.26a), but by not much. Also, there is no difference in the axial force on the reinforcements in Layer 2.

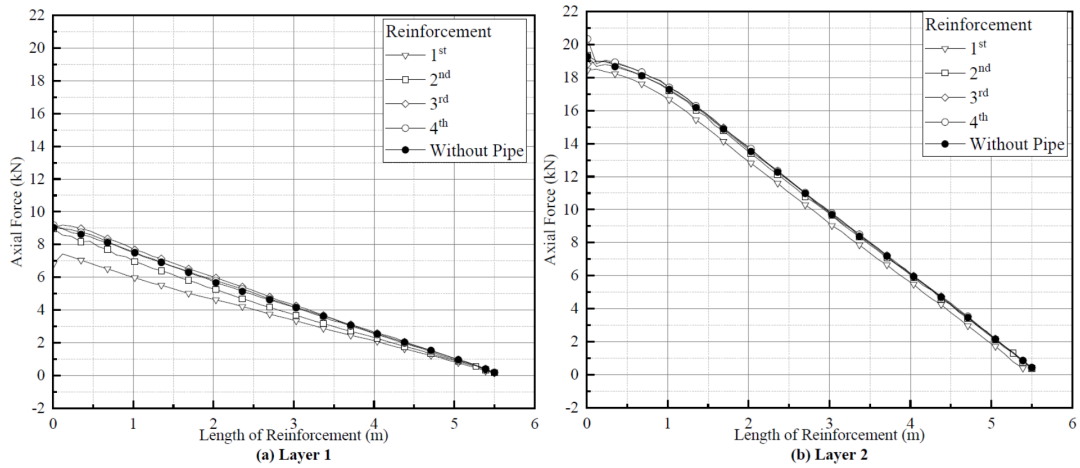
**Figure 5.29** Axial Force in the Reinforcement With Distance From the Facing Panel. Layer: (a) 1; and (b) 2. See Figure 5.9 for Reinforcement Numbering.

**5.3.2.2 Case 7: Pipe at a Depth of Invert  $d = 1.22$  m (4 ft) and at an Angle of 15° (Figure 5.1g).** Figure 5.29 to Figure 5.31 present the results of the case of the wall with a buried pipe running at an angle of 15°. They also include results for the base case, that is, wall with no pipe. Figure 5.29 plots the axial force of the reinforcements 1<sup>st</sup> to 4<sup>th</sup> in Layers 1 and 2 (see Figure 5.9 for numbering of the reinforcement). The general trend is a reduction in the axial force, which is more pronounced in the 1<sup>st</sup> layer, which is the closest to the pipe. The effects on the second layer are smaller than on the first layer. A comparison with the results for Case 6, the pipe perpendicular to the wall (Figure 5.26) suggests that the effects of the inclined pipe extend over a larger area than the perpendicular pipe.

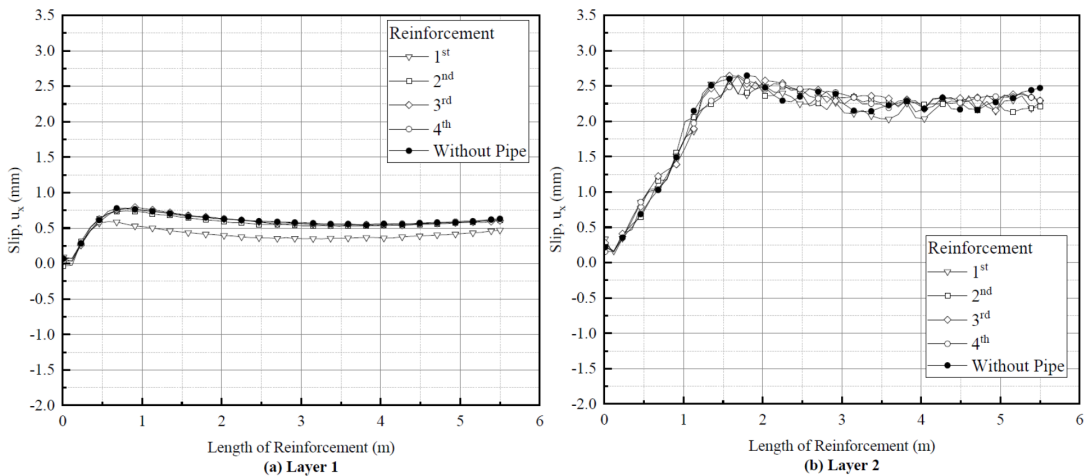
**Figure 5.31** Axial Slip in the Upper Contact of the Reinforcement With Distance From the Facing Panel. Layer: (a) 1; and (b) 2. See Figure 5.9 for Reinforcement Numbering.

The axial displacements and slip align with the results of the axial force. That is, they decrease in the 1<sup>st</sup> and 2<sup>nd</sup> strips of Layer 1 and in the 1<sup>st</sup> strip of Layer 2. The effect on the other reinforcements is very small.

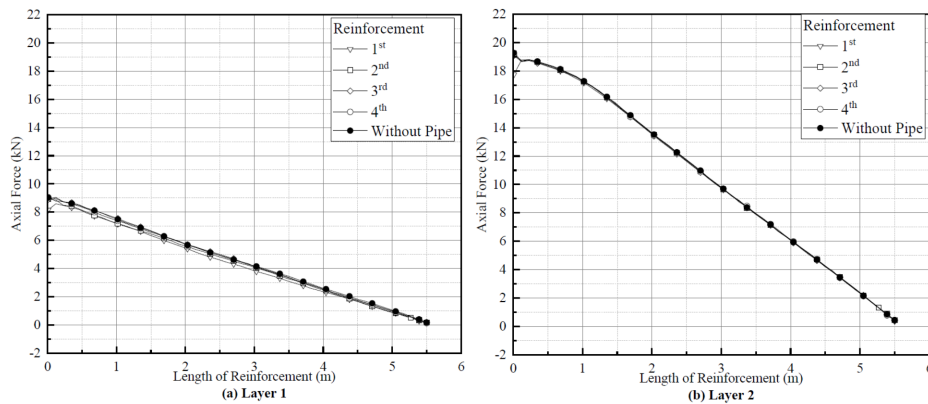
Figure 5.32 Axial Force in the Reinforcement With Distance From the Facing Panel. Layer: (a) 1; and (b) 2. See Figure 5.8 for Reinforcement Numbering.

**5.3.2.3 Case 8: Pipe at a Depth of Invert  $d = 2.70$  m (8.9 ft) and Perpendicular to the Wall (Figure 5.1h).** Figure 5.32 to Figure 5.34 show the plots of axial force, displacement, and slip when the pipe is running perpendicular to the wall at a depth of 2.14 m, measured from the surface to the center of the pipe. As shown in the figures, the effect of the pipe on axial force, displacement, and slip in the reinforcement Layers 1 and 2 is negligible. This shows that the pipe is deep enough to not have an impact on the wall performance.

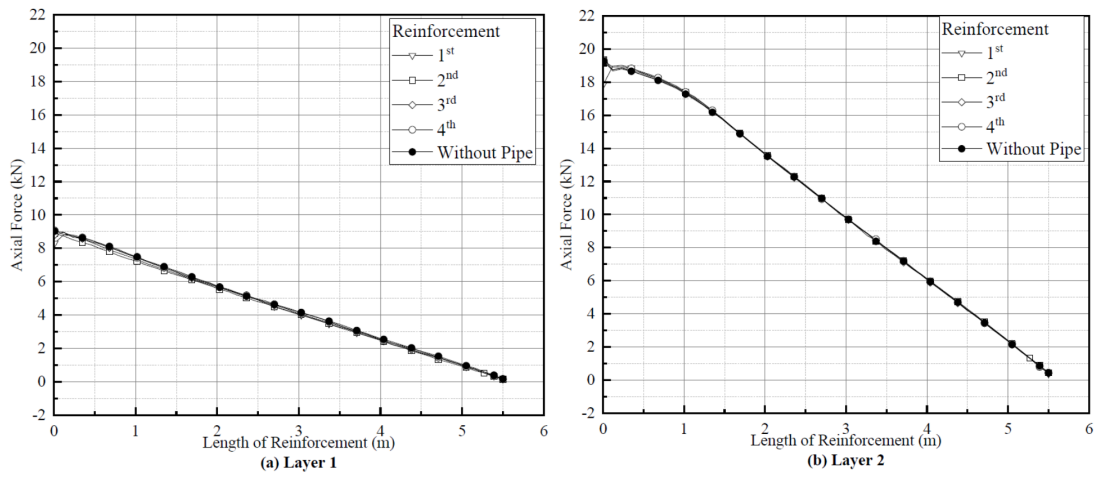
**Figure 5.35** Axial Force in the Reinforcement With Distance From the Facing Panel. Layer: (a) 1; and (b) 2. See Figure 5.9 for Reinforcement Numbering.

**5.3.2.4 Case 9: Pipe at a Depth of Invert  $d = 2.70$  m (8.9 ft) and at an Angle of  $15^\circ$  (Figure 5.1i).** Figure 5.35 to Figure 5.37 display the axial force, displacement, and slip when the pipe is at an angle of  $15^\circ$  with the perpendicular to the wall, and its center is located at a depth of 2.14 m. As with the previous case, Case 8, the pipe has no or minimal effect on the axial force, axial displacement or and slip in the reinforcement.

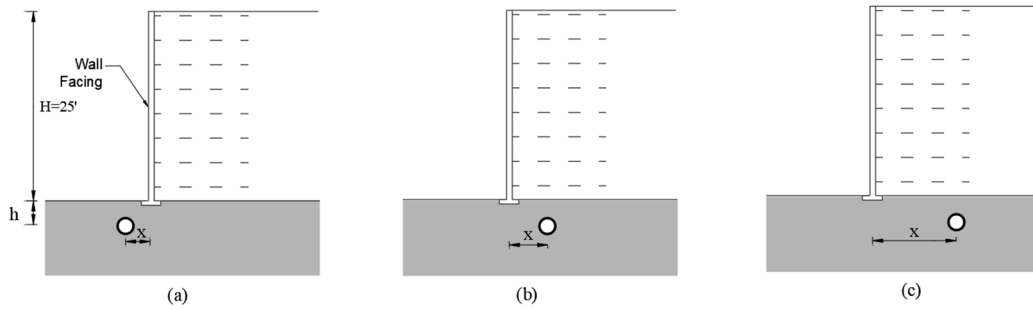
**Figure 6.1** Schematic of MSE Wall With a Utility Pipe in the Foundation Soil.

Figure 6.1 presents a schematic of the MSE wall and the intersecting utility pipe. Three pipe locations were analyzed, as shown in Figure 6.1a–c. The locations included one where the pipe was located in front of the wall and two, behind the wall.

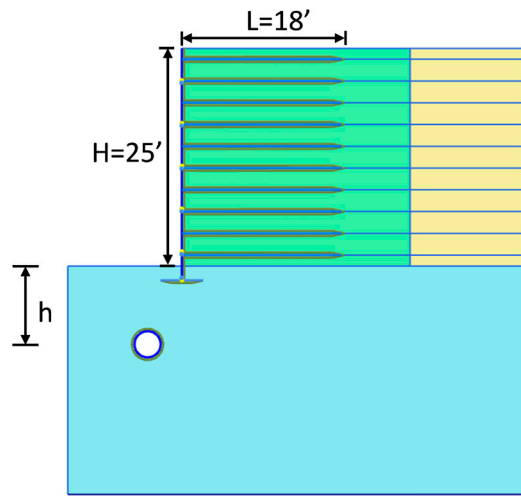
**Figure 6.3** Cross Section of a 25 ft MSE Wall With a Pipe Placed at a Depth of  $h$ .

Figure 6.3 illustrates a 25-ft-tall MSE wall with a pipe placed in the foundation soil. The pipe has a radius  $r_o$  of 18 in. This is the same wall and geometry used in all previous cases (see Chapters 4 and 5). The pipe is initially placed at  $h/r_o = 4$ , and the depth is progressively increased to determine the minimum safe depth. As mentioned, it is considered that failure of the pipe does not impact the performance of the MSE wall when: (1) the axial force in any reinforcement layer does not increase by more than 20%; and (2) the wall facing does not experience more than 2 in. of additional deformation.

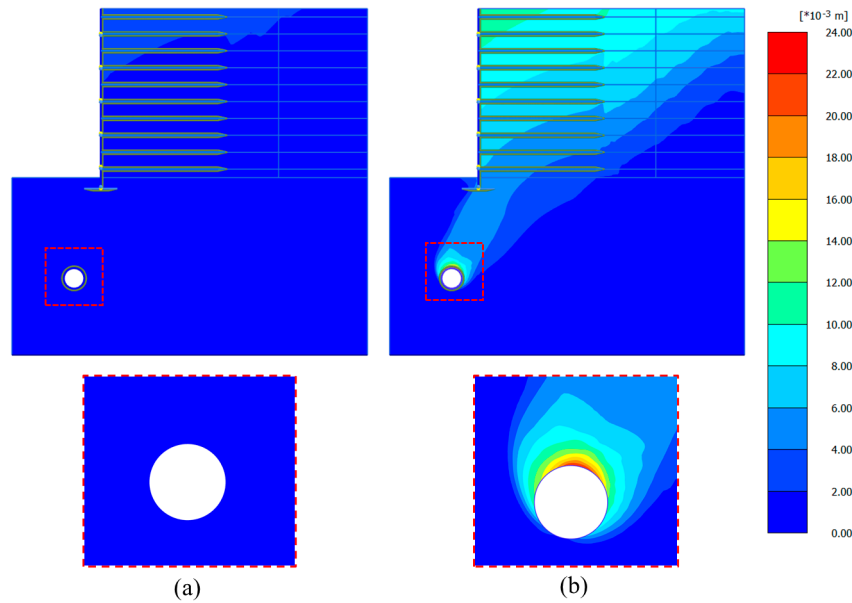
**Figure 6.6** Deformation Contours of the 25 ft Wall With Pipe Located at  $h/r_o = 10$  (Where  $r_o = 18$  in.) in Front of the Wall (a) Intact Pipe, and (b) Collapsed Pipe.

Figure 6.6 and Figure 6.7 examine the behavior of the MSE wall when the pipe is placed at a greater depth, at  $h/r_o = 10$  ( $r_o = 18$  in.). Figure 6.6 compares the wall deformations for the

intact (Figure 6.6a) and collapsed pipe conditions (Figure 6.6b). The wall with the intact pipe exhibits an FOS of 1.48, and the presence of the pipe does not cause any noticeable deformation in the soil. In contrast, with the collapsed pipe there are significant deformations around the pipe's perimeter. However, due to the large embedment depth of the pipe, the deformations induced in the soil remain confined to the location of the pipe and do not propagate upwards and do not impact the wall facing or its reinforcement layers.

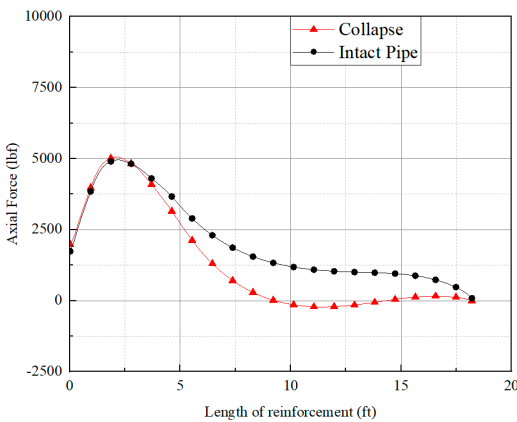
**Figure 6.10** Axial Force on the First Layer of Reinforcement When the Pipe is Placed in Front of the Wall Facing with a Radius  $r_o = 36$  in., and  $h/r_o = 10$ .

Additional simulations were performed with the pipe diameter doubled, that is, to  $r_o = 36$  in., to evaluate whether the criterion of  $h/r_o = 10$  remained valid. Figure 6.10 presents the axial force in the first layer of reinforcement for this pipe size and for the case of intact pipe and for the collapsed pipe. The results indicate that the increase in axial force remains within acceptable limits, and the associated deformation is also small (not shown). Therefore,  $h/r_o = 10$  can be considered a safe depth for the larger-diameter pipe. This conclusion also holds for the other two locations of the pipe, that is, at 5.9 ft and 16.4 ft behind the face of the wall.

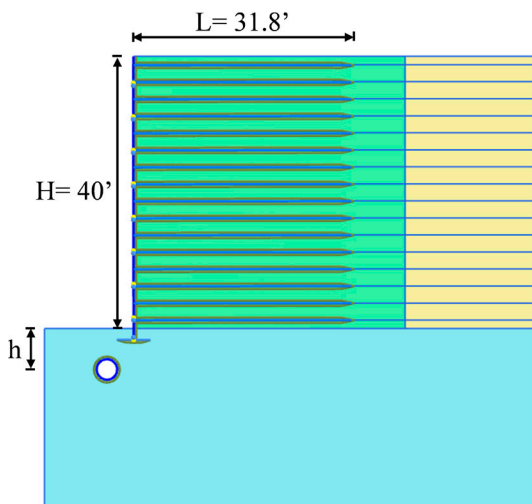
**Figure 6.11** Cross Section of a 40 ft MSE Wall With a Pipe Placed at a Depth  $h$ .

Figure 6.11 shows a 40-ft-tall MSE wall with a pipe placed in its foundation. The length of the strips is calculated as  $0.7H$ , where  $H$  is the height of the wall, satisfying the minimum recommendations from FHWA (2009). The overall FOS calculated using the strength reduction method is 1.48. The properties of the backfill, retained soil, and foundation soils are the same as used for 25-ft-tall wall. The construction of the wall is performed in

stages as discussed in Chapter 4, from Table 4.1 through Table 4.5. The pipe has a radius  $r_o$  of 18 in. Analyses were carried out for the pipe placed at two different depths, corresponding to  $h/r_o$  of 4 and 11, both cases with the pipe placed in front of the wall, which is the most critical location.

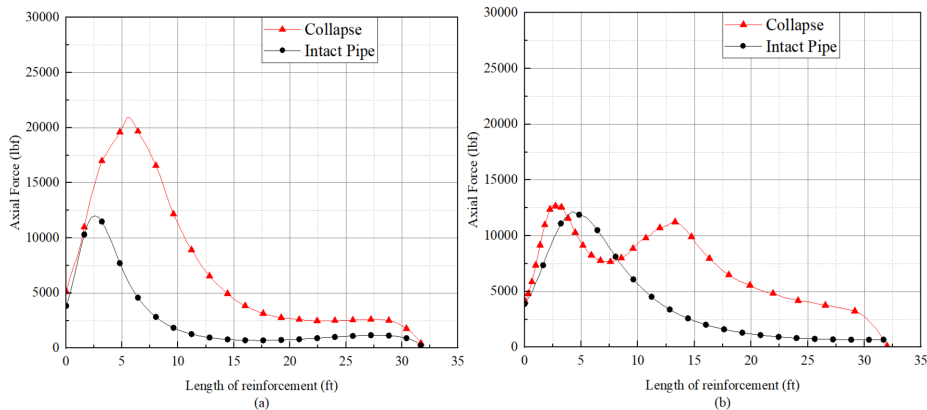
**Figure 6.14** Axial Forces on the First Layer of Reinforcement When the Pipe is Placed in Front of the Wall Facing ( $r_0 = 18$  in.). (a)  $h/r_0 = 4$ , (b)  $h/r_0 = 11$ .

Figure 6.14 is a plot of the axial force in the first layer of reinforcement, for a pipe placed in front of the wall at  $h/r_o = 4$  (Figure 6.14a) and at  $h/r_o = 11$  (Figure 6.14b). The plots also include, for comparison, the axial force in the reinforcement when the pipe is intact. As one can see in Figure 6.14a, when the pipe is placed at a depth  $h/r_o = 4$ , the axial force increases by 74% with respect to the intact pipe case, thus exceeding the acceptable limit. In contrast, when the pipe is located at a depth  $h/r_o = 11$  (Figure 6.14b), the increase remains below the permissible limits. This suggests that, for a taller wall, deeper placement of the pipe is necessary to mitigate the impact of pipe collapse. Therefore, for tall walls, a depth of  $h/r_o$  greater than 11 should be considered.

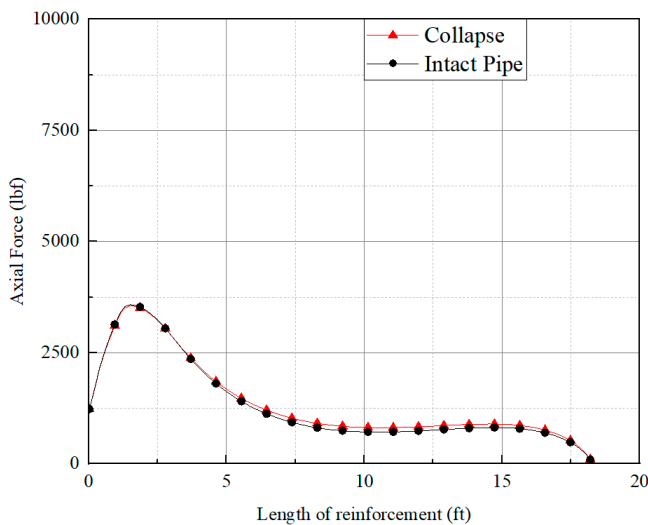
**Figure 6.18** Axial Forces on the First Layer of Reinforcement When the Pipe is Placed in Front of the Wall Facing. Pipe Radius  $r_0 = 9$  in., and  $h/r_0 = 10$ .

To assess the influence of pipe size, additional simulations were performed with the pipe diameter reduced by half, while keeping the ratio  $h/r_0 = 10$ . Figure 6.18 shows the axial force in the critical reinforcement when the pipe is intact and when it collapsed. The results show that at this depth, the failure of a pipe with 18 in. diameter does not affect the performance of the wall.

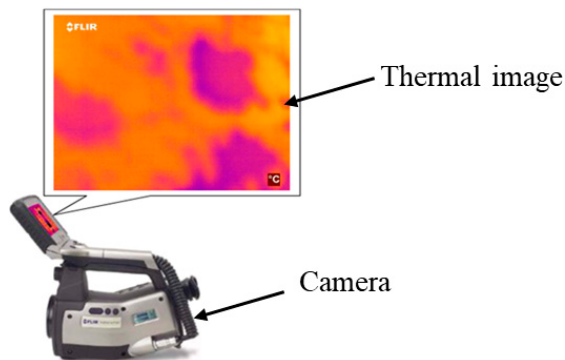
**Figure 7.2** The Infrared Camera Displays Thermal Contrast on the Pavement Surface Caused by a Water Leak (Adapted From Fahmy et al., 2010).

The objective of this experiment was to detect and locate underground leaks in pressurized water mains using infrared (IR) thermography, supported by acoustic sensing for validation. The setup consisted of water pipes buried approximately 1.8 m below a paved road surface. Above the road, an infrared camera system was mounted on a moving vehicle at heights ranging from 1.2–12 m above the pavement. Figure 7.2 shows the IR camera captured thermal images of the pavement surface where leaks caused subtle heat and moisture variations. The dark areas show no leak, which is normal pavement, while the bright area denotes leaking because the heat is transferred upward due to moisture.

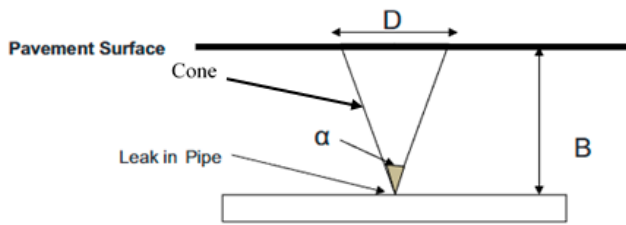
**Figure 7.3** Determination of Leak Location (Adapted From Fahmy et al., 2010).

The thermal signature formed a near-circular area on the pavement, modeled as the base of a cone with an angle between  $80.4^\circ$  and  $123.4^\circ$ , pointing down toward the actual leak in the pipe (Figure 7.3). The size of this thermal spot, in combination with the pipe depth, allowed estimation of the precise location of the leakage.

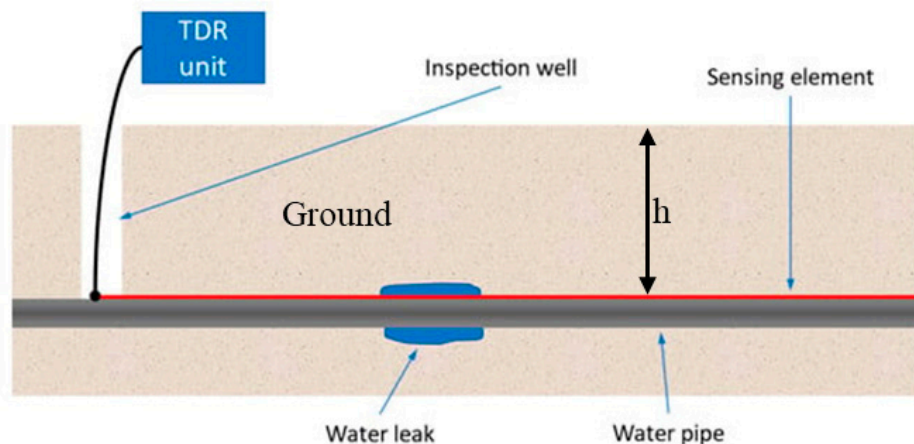
**Figure 7.4** Schematic of the Leaking Pipe With a TDR Unit (Adapted From Scarpetta et al., 2023).

Time domain reflectometry (TDR) is a sensing technique that can be used to detect water leaks in underground pipes. Figure 7.4 shows an optical fiber placed along the pipe and connected to a TDR unit. The sensing element (SE) used in the experiments was a 15-m-long biwire cable laid out on the floor to simulate its placement near a buried pipe. The SE was connected to a TDR unit composed of an arbitrary waveform generator and an oscilloscope, via a coaxial cable and T-junction. One advantage of this setup is that leaks can be identified along

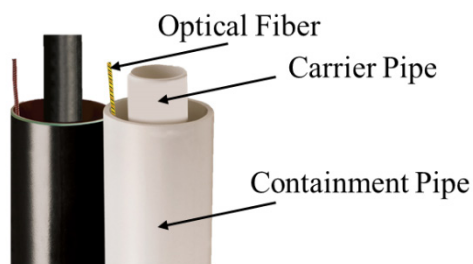
One of the common practices by the oil and gas industry to mitigate the risk of pipeline leaks is the use of double wall containment systems. Figure 7.5 shows the double wall containment system. The fundamental structure of a double containment system involves placing a smaller diameter pipe inside a larger diameter pipe. The inner pipe is called the carrier pipe, which transports the hazardous or sensitive fluids such as oil, gas, and acids. It is made up of carbon steel, stainless steel, fiber-reinforce plastic (FRP), or PVC, and a wide variety of materials is available. Some systems could have multiple carrier pipes. The outer pipe is known as the containment pipe, which encases the carrier pipe to contain any potential leaks. There are several options such as fiberglass, PVC, and steel. Between the carrier and containment pipes is the annular space, or annulus. This space serves several functions. It can be used for monitoring through the installation of leak detection systems such as optical fibers that sense the presence of fluids. It may also be filled with inert gases (e.g., nitrogen) or evacuated to create a vacuum, both of which reduce corrosion risk and improve thermal insulation. In some cases, this space can be part of the secondary containment system, temporarily holding leaked fluid. To maintain pipe alignment and allow for thermal expansion/contraction, centering supports are installed approximately every 10 ft along the carrier pipe. These supports prevent mechanical stress and ensure system longevity.

**Figure 7.5** Double Wall Containment Piping System (Adapted From Rovanco Piping Systems [n.d.]

Inspection of the carrier pipe can be done through the annulus. For example, inspection of welds in the carrier pipe can be done through radiographic monitoring. Pressure monitoring in the annulus is an easy method to check the containment.

Additionally, strain-sensitive optical fibers placed along the containment pipe can detect deformations or stress concentrations, potentially indicating pipe degradation. To facilitate inspection and maintenance, access outlets may be installed on the outer pipe near structural features (e.g., MSE walls). These outlets allow for pressure readings, strain monitoring, and even fluid sampling, if needed.

This system offers several significant advantages. The probability of failure of the carrier and containment pipe simultaneously is very low, thus providing improved safety to an MSE wall above the pipe. It also provides enhanced environmental protection because the outer pipe prevents leaks from reaching the surrounding ground. In addition, routine pressure monitoring would help with early detection of the leak. If there is vacuum or inert gas in the annular space, the corrosion risk of the inner pipe is significantly reduced. Maintenance of the inner pipe is facilitated; if a section of the carrier pipe fails, it can be isolated by removing only the affected portion of the pipe.
