# JOINT TRANSPORTATION RESEARCH PROGRAM

## Study on the Permissible Depth of Utilities Under the MSE Walls and Means and Methods of Protecting the MSE Walls When the Permissible Depth Cannot Be Provided

**Md Asad Ahmad and Antonio Bobet**

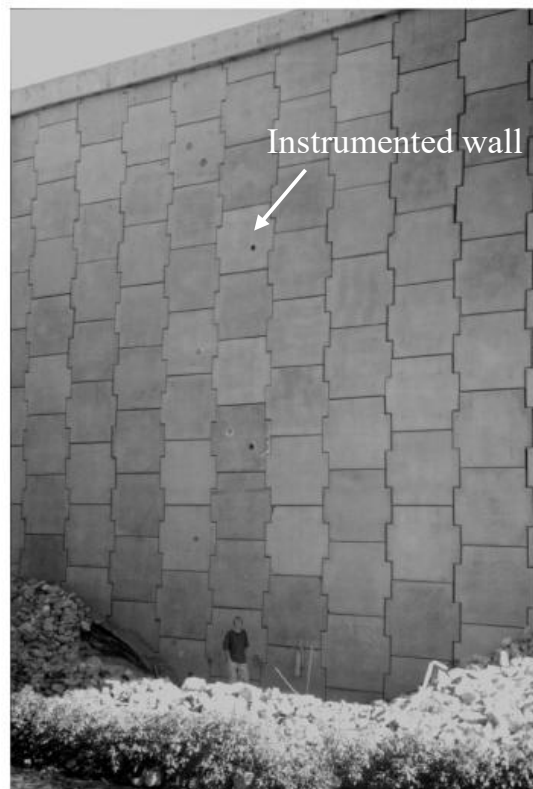
The case study involves a 55.4-ft-tall (16.9 m) MSE wall (Runser et al., 2001), as illustrated in **Figure A.1**. The numerical model replicates the wall's cross-section under plane strain conditions, aiming to validate the modeling approach used in the report by comparing simulated results with field-measured data.

**Figure A.1** Instrumented Section of the MSE Wall (Adapted From Runser et al., 2001).

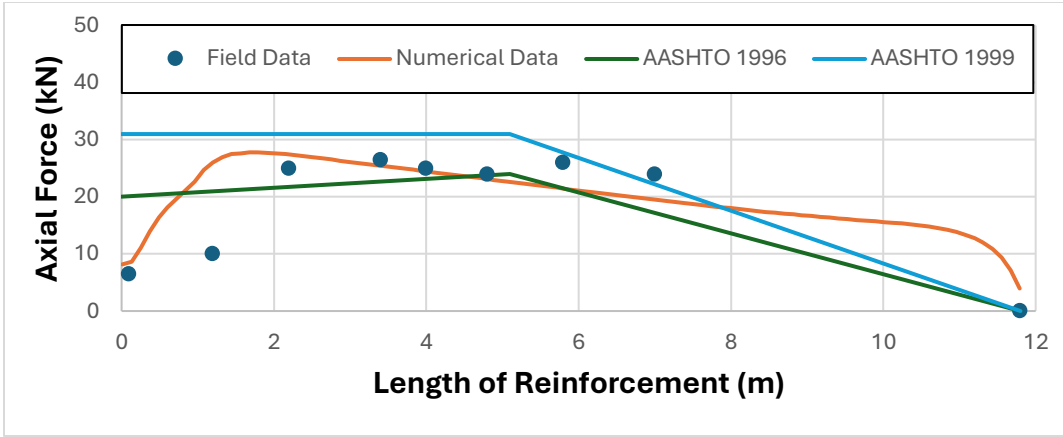
**Figure A.4** presents the distribution of axial tension along the length of the reinforcement strips, where field measurements, numerical simulation results, and design predictions based on AASHTO 1996 and AASHTO 1999 guidelines, are compared. The numerical results show good agreement with both the measured data and the AASHTO design curves, successfully capturing the overall trend. However, near the strip ends, the numerical model exhibits a sharp change in the slope of the axial force, which deviates from the observed and expected behavior. This discrepancy is likely the result of limitations inherent to the 2D plane strain modeling.

**Figure A.4** Axial Force Along the Length of the Reinforcement for: (a) Layer 1; (b) Layer 4; (c) Layer 12; (d) Layer 16; and (e) Layer 20 (see **Figure A.3** for the Location of the Layers).

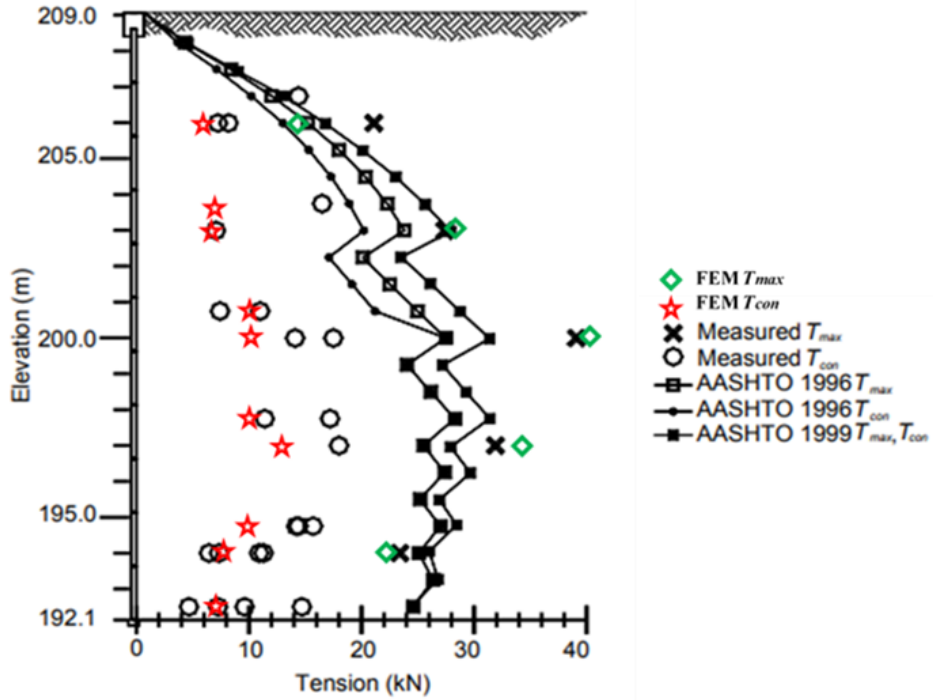
**Figure A.5** illustrates the variation of maximum axial tension and connection tension with strip elevation. The figure compares field measurements, numerical predictions, and design values based on AASHTO (1996 and 1999) guidelines. The numerical results show good agreement with both the maximum and connection tensions and experimental data, thus accurately capturing the overall load distribution in the reinforcement.

Figure A.5 Axial Force at the Connection and Maximum Axial Force in the Strip at Different Elevations (Adapted from Runser et al., 2001).
