DOT/FAA/TC-25/31

An Approach to Fly-by-Wire Handling Qualities Testing Linking Development Tools to Civil Certification Requirements

Final Report

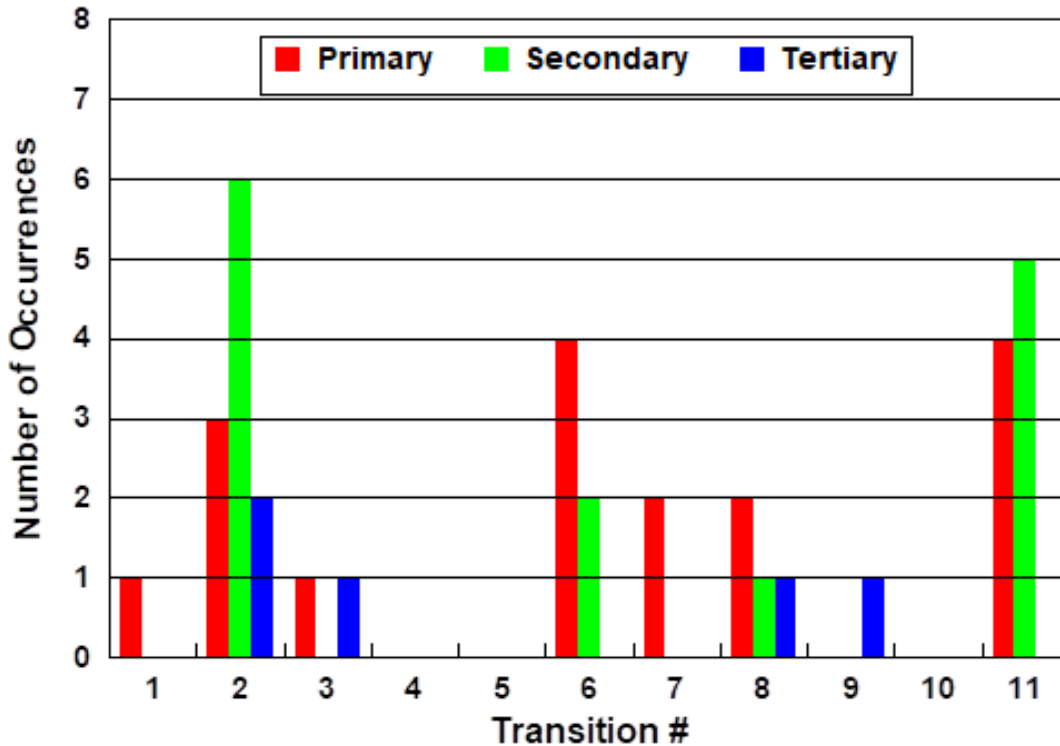
Figure 1: Key Transitions Identified from STI Event Database

The number of primary, secondary, and tertiary occurrences of a given transition and/or mode change (1 – 11) are identified in Figure 1 for the 20 events listed in Table 2 and detailed in Appendix A. For this mixed vehicle database, the following observations are made:

- Transitions 3 (Envelope Protections including prioritization, warnings, and blending), 8 (Dynamic Behavior at Limits/Insufficient Control Power) and 9 (System nonlinearities including rate and position limits, hysteresis, command gain shaping, etc.) appear once (5% of cases).

- From the review of the STI database, Transitions 2 (Response Type Changes), 6 (Wind and Turbulence Effects including Vortex Ring State and other rotor interactions), and 11 (FCS software challenges that include gain blending, logic trees, integrator wind-up, etc.) are most prevalent.

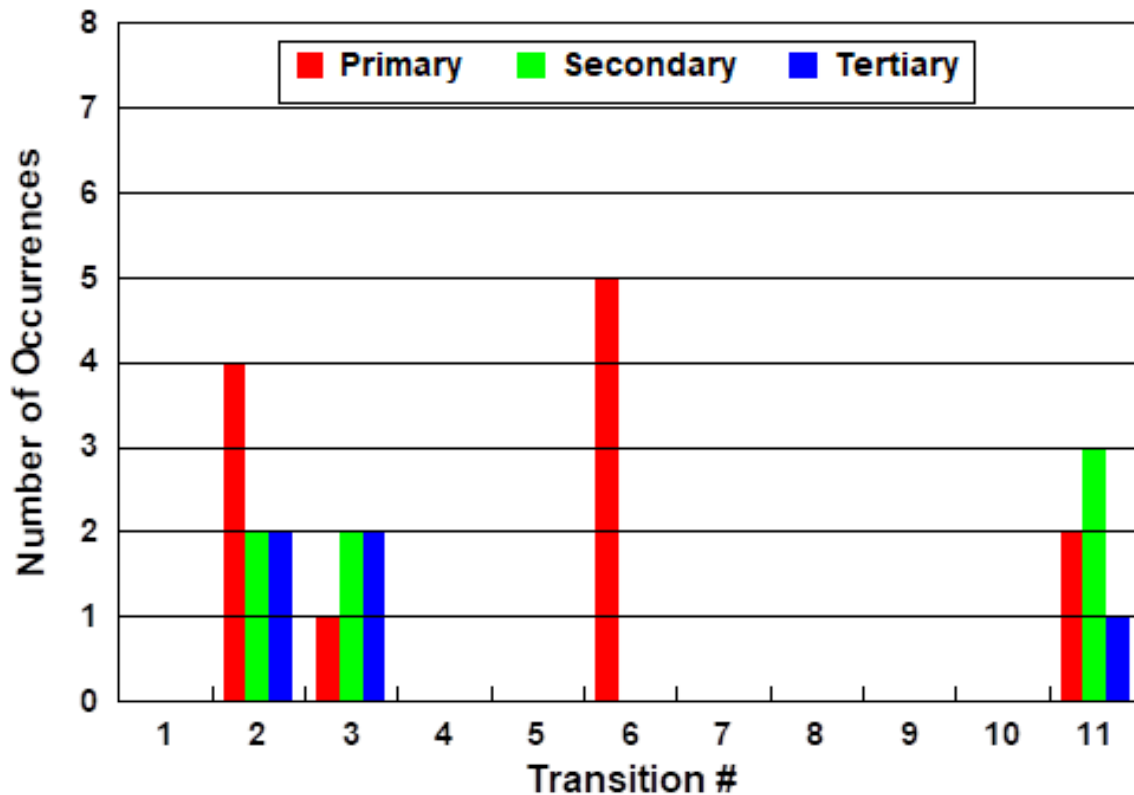
Figure 3: Key Transitions as Identified from CS Event Database

The number of primary, secondary, and tertiary occurrences of a given transition and/or mode change (1 – 11) are identified in Figure 3. For this transport database of 13 events, the following observations are made:

- Tertiary: For the tertiary causal factors, like the secondary factors, only Transitions 2, 3, and 11 are present.

- Transition 2 (Response Type Changes) and Transition 3 (Envelope Protections including prioritization, warnings, and blending) each appear twice (15% of cases)
 - Transition 11 (FCS software challenges that include gain blending, logic trees, integrator wind-up, etc.) appears once (7.7% of cases).
- From the review of the CS database, Transitions 2, 3, 6, and 11 are the only transitions and/or mode changes that appear with Transition 2 (Response Type Changes) and Transition 6 (Wind and Turbulence Effects including Vortex Ring State and other rotor interactions) most prevalent as primary factors.

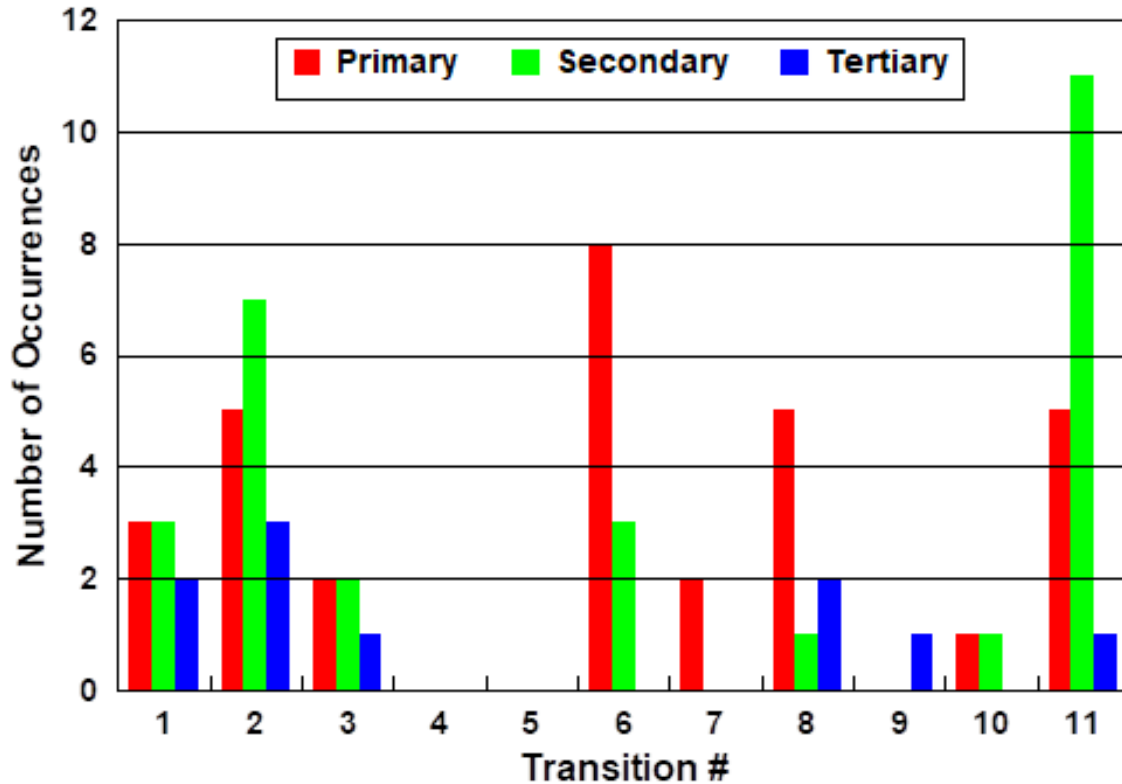
Figure 4:Key Transitions Identified from Combined Event Databases

There were a total of 42 events in the combined databases when duplicates were removed. The combined number of primary, secondary, and tertiary occurrences of a given transition and/or mode change are identified in Figure 4. The figure illustrates that Transitions 4 (Ground Mass to Air Mass including frames of reference used by FCS) and 5 (Radar Altitude vs MSL) were not

found to be causal in any of the 42 events. For the remaining transitions and/or mode changes, the following observations are made:

- Primary:
 - Transition 6 (Wind and Turbulence Effects including Vortex Ring State and other rotor interactions) was found to be the most pervasive at 19% of cases.

- Secondary:
 - Transition 11 (FCS software challenges that include gain blending, logic trees, integrator wind-up, etc.) at 26%.
 - Transition 2 (Response Type Changes) at 17% were found to be the dominant secondary causal factors.

- Tertiary: No transition has more than three appearances in the database though Transition 2 (Response Type Changes) and Transition 11 (FCS software challenges that include gain blending, logic trees, integrator wind-up, etc.) show here as well.

- When combining all factors, Transitions 2 (Response Type Changes), 6 (Wind and Turbulence Effects including Vortex Ring State and other rotor interactions), and 11 (FCS software challenges that include gain blending, logic trees, integrator wind-up, etc.) appear most and should be considered when assessing new aircraft fly-by-wire flight control designs.

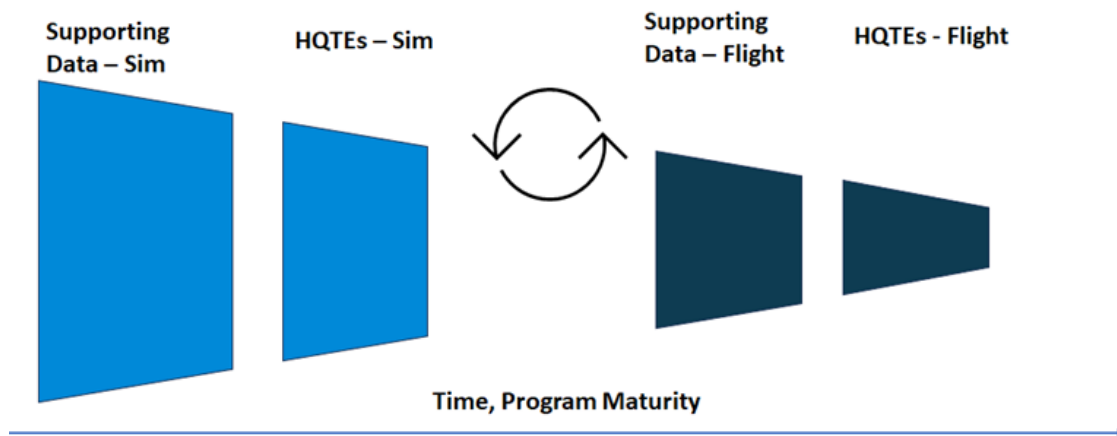
Figure 6: Flight Test Scorecard Approach

Figure 6 shows a diagram of the elements proposed for inclusion in the FTSC approach. Four categories are defined:

- Supporting Data – Simulation
- HQTEs – Simulation
- Supporting Data – Flight
- HQTEs – Flight

As also shown in the diagram, it is expected that the progression from simulation to flight, and from supporting data to HQTEs is a function of program maturity and time. Collecting supporting data from simulation tests is considered a precursor to piloted HQTEs. Additionally, it is also hypothesized that applicants will collect more data from the former than the latter, due to the ability to collect this data using simulations. This may also include batch mode processing and faster than real-time analysis. Blocks shown in the diagram are sized based on the amount of testing required. It is envisaged that dedicating time to simulation testing can reduce the required flight test points. Arrows represent continuous feedback between flight and simulation testing. Flight test results may be used to update simulation results, or findings in simulation may motivate specific tests in-flight test. If the FTSC proves to be successful in the goal of reducing dependency on flight testing, the expected supporting data and HQTE sets from flight will be further reduced from those in simulation. Reasons for a potential reduction in flight testing following the adoption of the FTSC may be due, but not limited to, the following considerations:

During a certification program, the recommended approach is to work through the Scorecard process shown in the diagram first from left to right. The applicant should start by collecting supporting data from simulation. Next, where possible, HQTEs should be conducted in simulation. At this stage, both objective and subjective data have been collected. Following simulation testing, a subset of these tests should be performed in flight testing. Supporting data should be collected and compared with those from simulation. Discrepancies or unexpected results should be revisited through further simulations. Following confidence in supporting data from flight, a subset of the HQTEs recorded from simulation should be conducted. As with supporting data, discrepancies between HQTEs from flight test and the simulation should be explained.

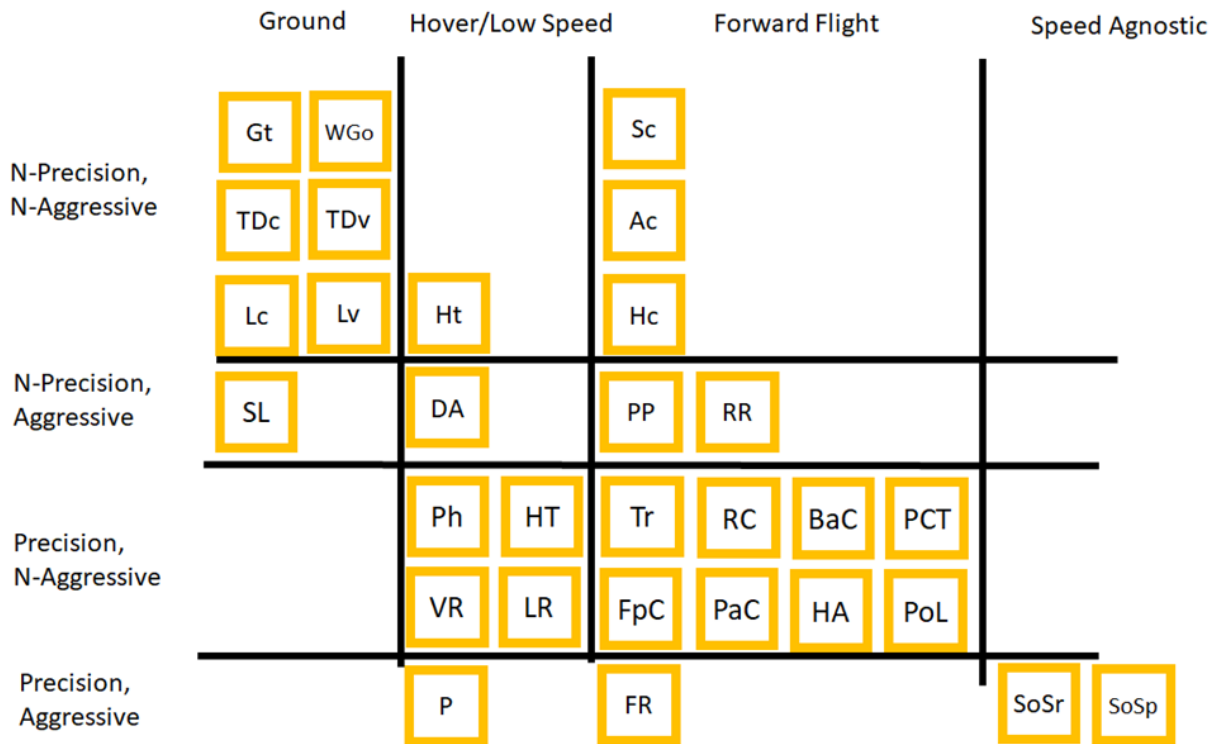
Figure 8: Proposed HQTEs for Flight Test Scorecard Approach

Figure 8 shows a visual representation of the HQTEs with respect to Precision/Aggression level and flight speed. Selecting the correct range of applicability for the HQTE is critical for its use in the certification process. Each can only be used for the correct speed range/configuration for means of compliance demonstration.

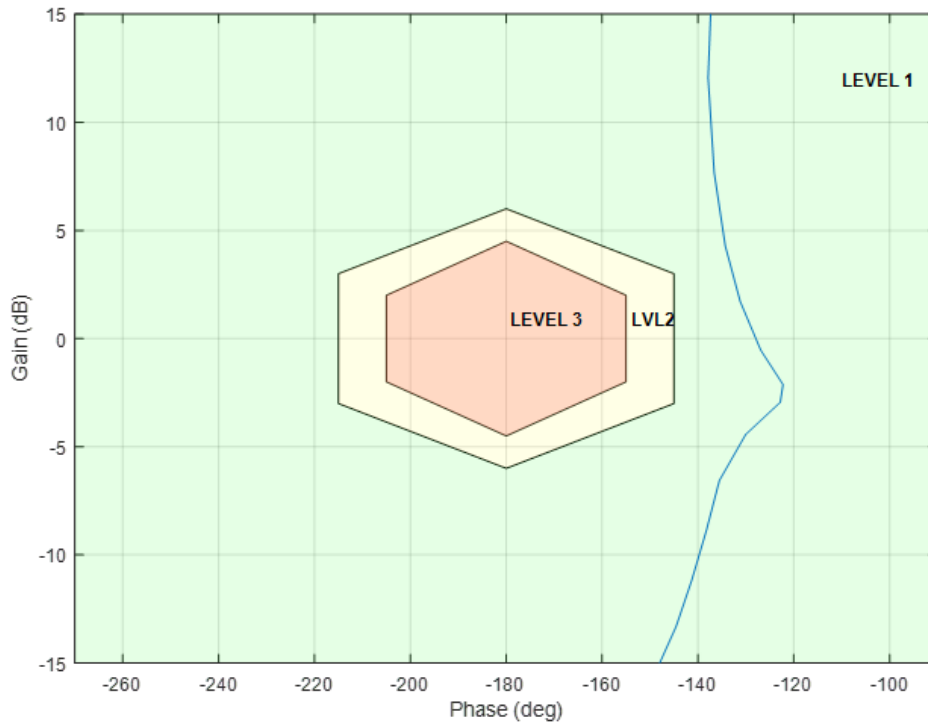
Figure 19: Nichols Margin and Exclusion zone, Corresponding Levels

Nichols margins, or Nichols stability criteria, use the same data as used for stability margins but present a locus of points with respect to gain and phase. The Nichols chart features an exclusion zone. If the locus violates the boundary of the Nichols exclusion zone, this is not considered acceptable. Conveniently, the same frequency sweep data can be used to determine both the Nichols and stability margins, depending on overall quality. An example of the Nichols margin is shown in Figure 19.

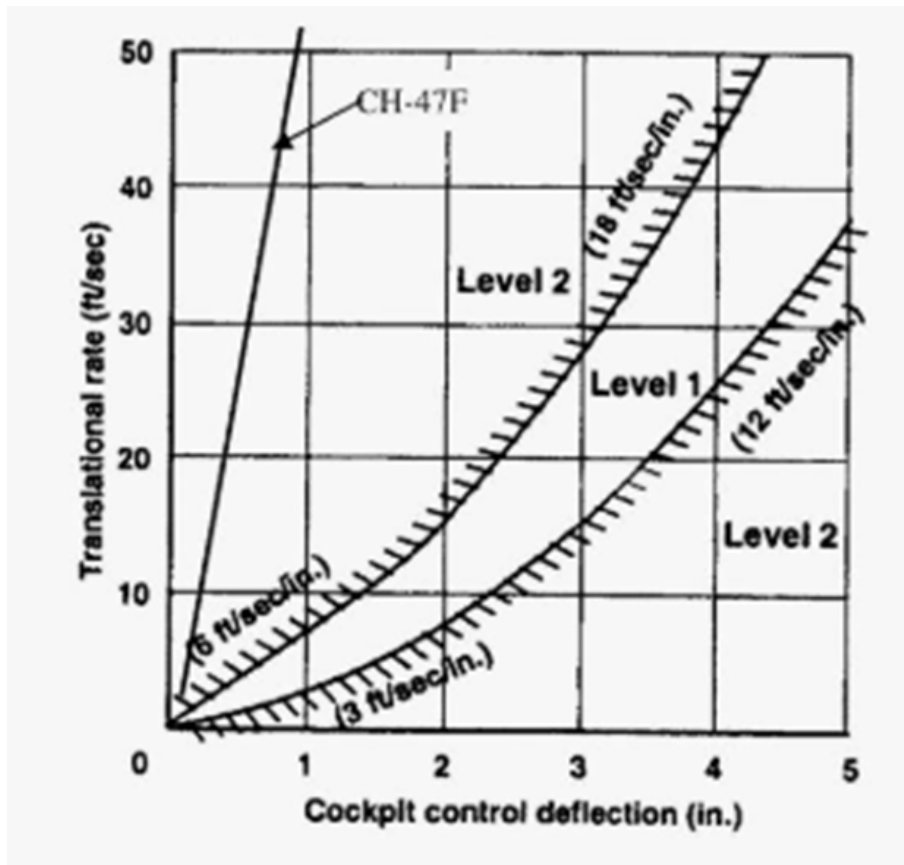
Figure 21: Control Deflection with Translational Rate (Blanken, Hoh, Mitchell, & Key, 2008)

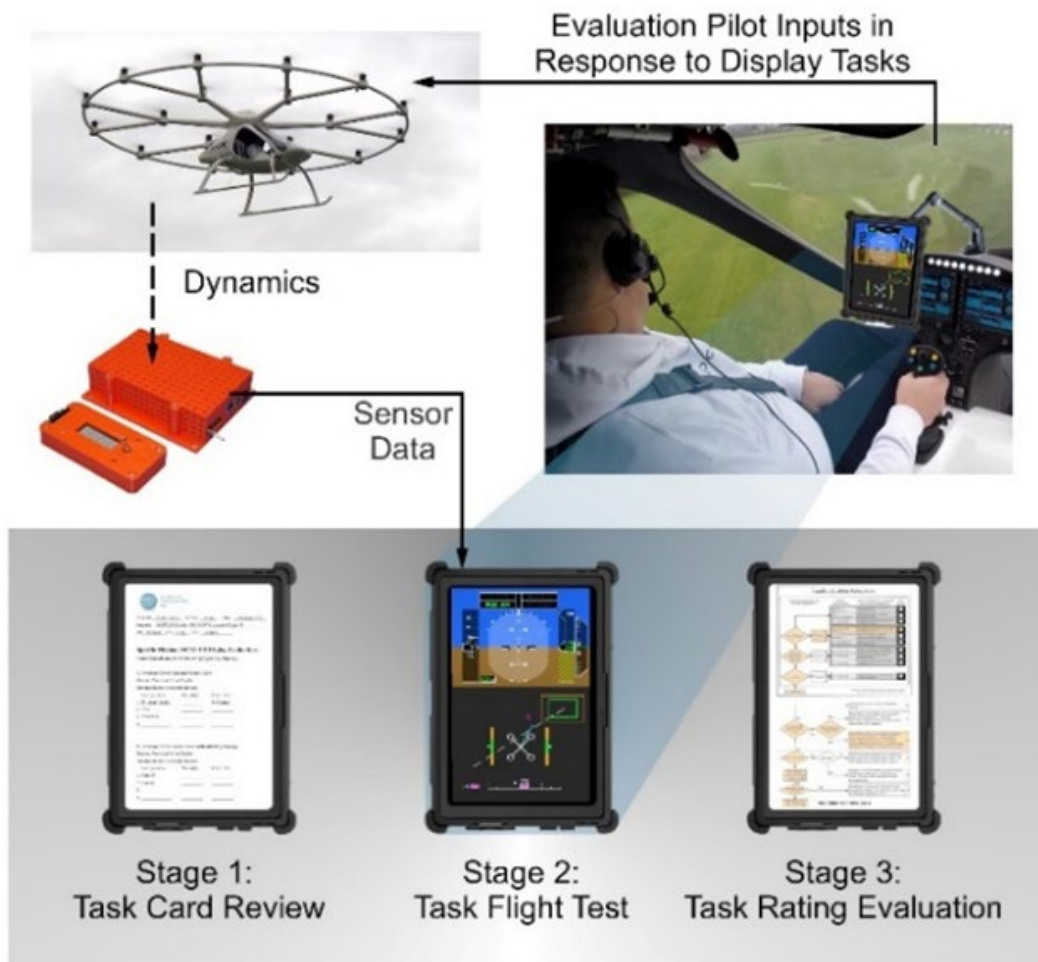
Figure 27: MCRUER System Overview

The system is composed of two key elements for onboard usage: the tablet-based displays and the MCRUER Data Acquisition System (MDAS). The tablet-based displays provide the interface for pilot cueing and data collection for the FTE. The MDAS is a system that collects live-time research quality inertial data and GPS position. The MDAS drives the displays, directly feeding data to both pilot and FTE applications.

The tablet-based display provided to the pilot is mounted on the dash, practically becoming a heads-down display that gives pilots general aircraft state information when no test points are being collected. The pilot tablet is controlled by the FTE tablet which resides with an onboard FTE. On the first checkout day, the virtual HQTE courses being displayed to the pilot are used to verify the boundaries of the physical courses. As seen in Figure 26, the desired and adequate boundaries are displayed with the MCRUER system. The checkout pilot was able to fly the physical courses against the virtual display to confirm proper course setup. For the rest of the test campaign, MCRUER was used for its testing process. Figure 27 highlights the key elements of the system.

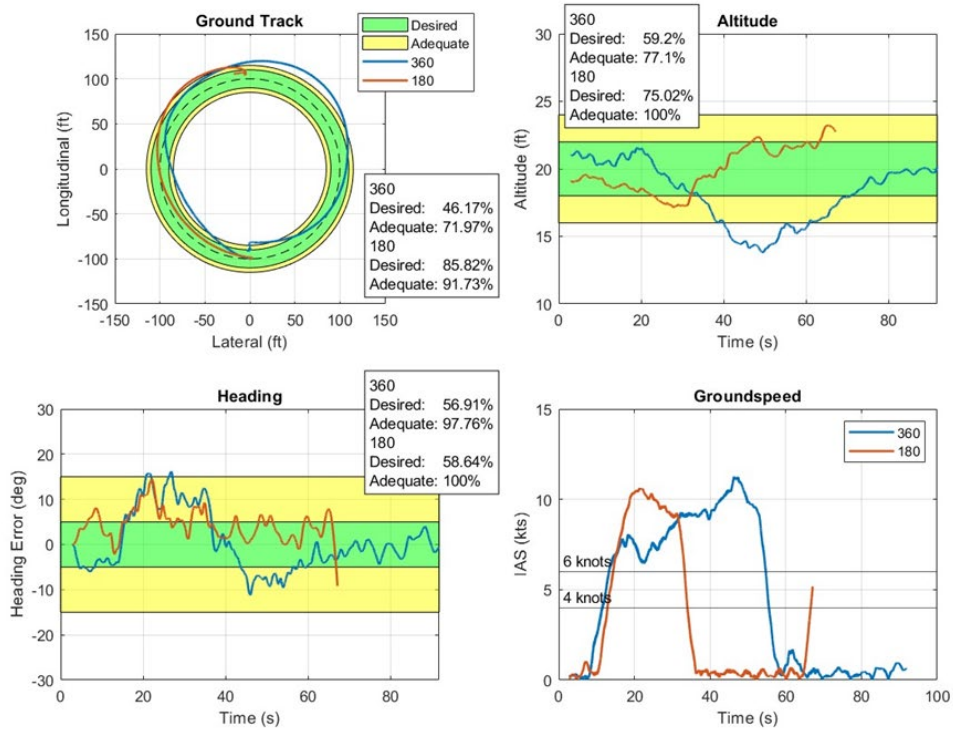
Figure 32: Pirouette AC Pilot 2

Figure 31 and Figure 32 show results from the completion of the Pirouette HQTE, both for the 180° and 360° tailored versions. As shown, the 360° version was completed within the time available, with results suggesting that this time could be shortened. However, the reader is reminded that the tests were conducted with a helicopter, and not a powered-lift aircraft. Halving the course length led to a reduction in time required by approximately 25%. This shows that the relationship between time required and course length is not linearly correlated and requires calculation to ensure similar levels of aggression, if the course will be reduced. One observation was that both pilots were able to hold ground speed for both tailored versions of the maneuver.

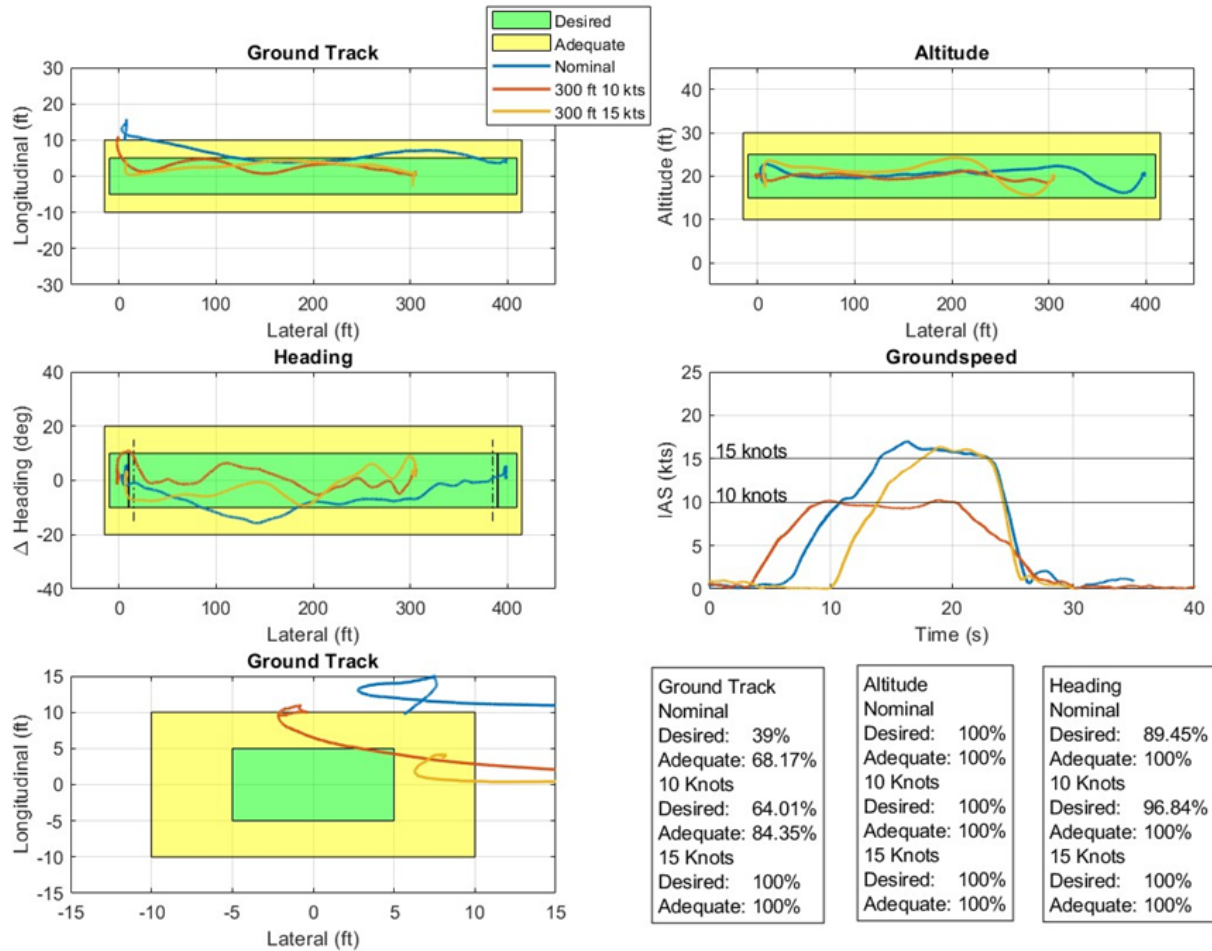
Figure 33: Lateral Reposition Pilot 1

Figure 33 shows three versions of the Lateral Reposition completed by Pilot 1. These were flown with different aspects of tailoring. This includes changes to the course length, and the speed. Performance for all of the attempts was consistent throughout. It was found that the 4 second stable translation did force the aggression in the maneuver and appears a good requirement to drive the length of the course. For the 10 kt case, the pilot was able to maintain a stable 10 kt translation for over 10 seconds. This indicates that the course could be shortened for this case.

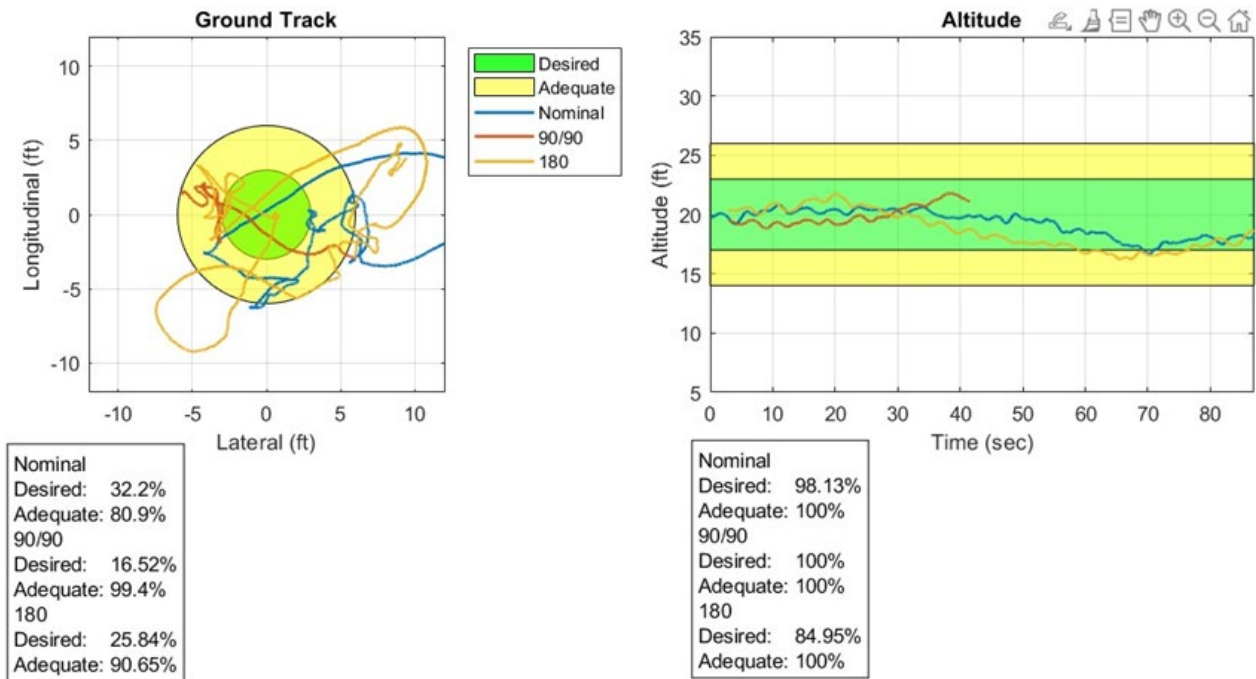
Figure 34: HTH Pilot 2

Figure 34 shows the results from three of the Hover Turn HQTEs. As shown, ground track maintenance was a significant issue during the completion of the HQTE, as the course cueing was not adequate for the pilot to correctly maintain his position. There were no apparent changes in performance with various course lengths and timings were generally found to be acceptable.

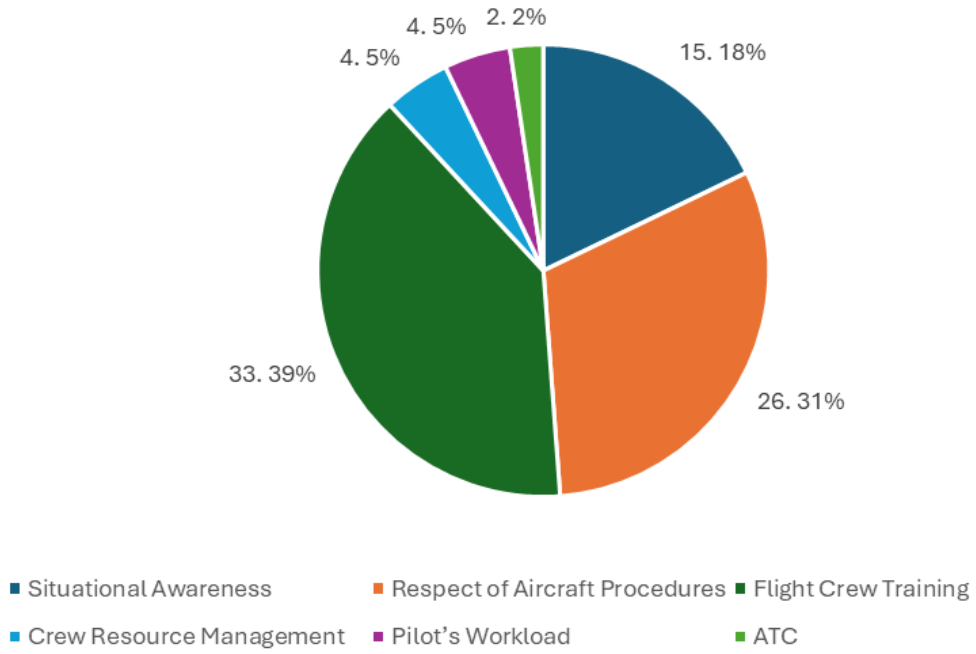
Figure A-1: Incidents/Accidents Critical Human Factor Aspects

Figure A-1 and Figure A-2 are the graphical representations of the incidence of human factor and system related aspects, respectively, on the occurrence of the incidents and accidents reported above. The prevalence of the four main categories reported above is visible and it is a potential indication of a trend, even if they derive from the current selective, non-comprehensive group of occurrences.

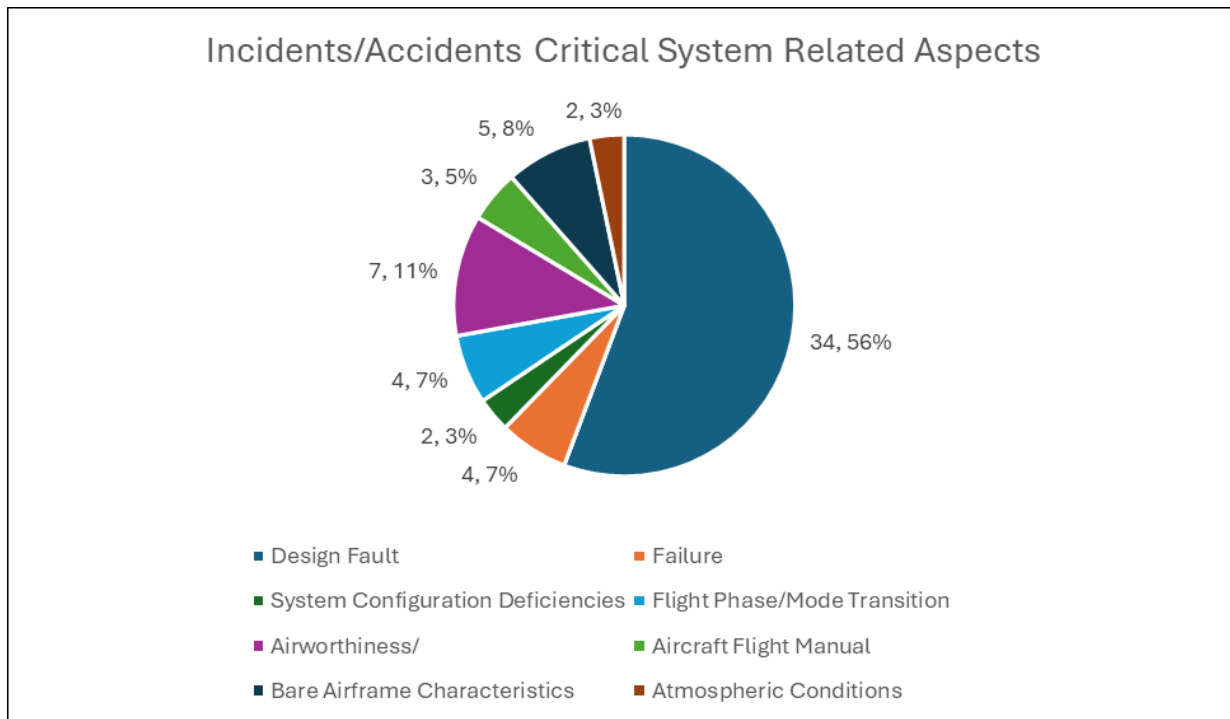
Figure A-2: Incidents/Accidents Critical System Related Aspects

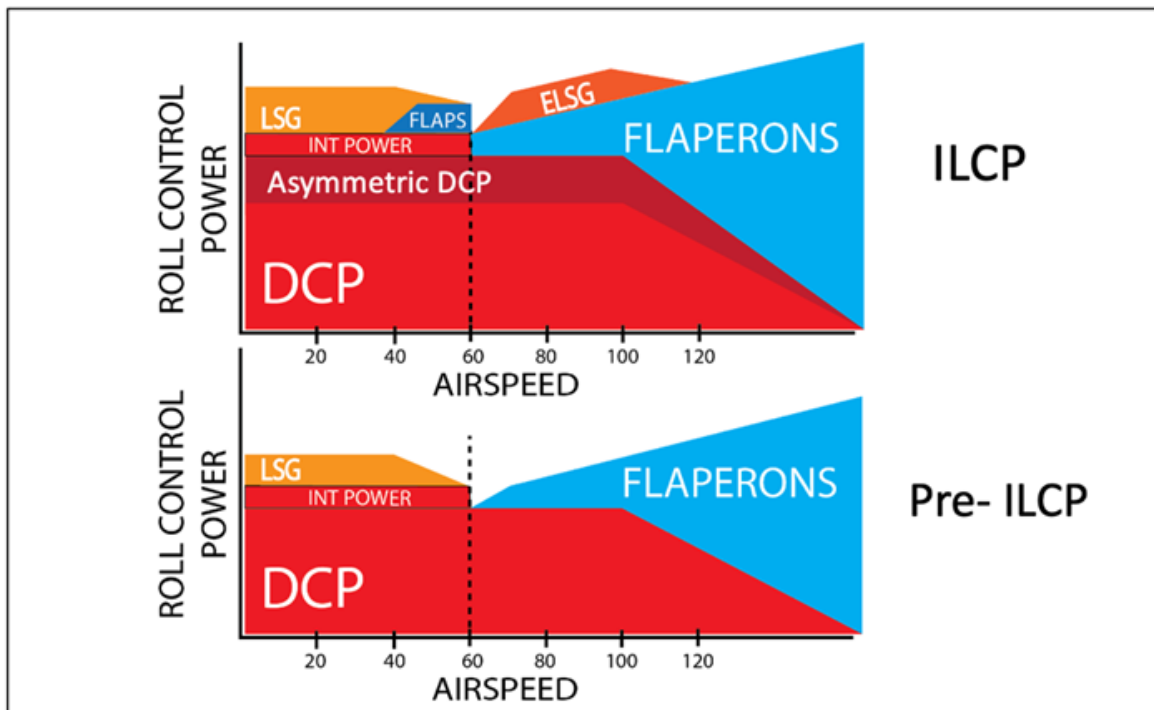
Figure A- 7: Roll Control Power Improvements for V-22

application, an asymmetric application of DCP was permitted to work with the Structural Load Limiting. This is illustrated in Figure A- 7, below.

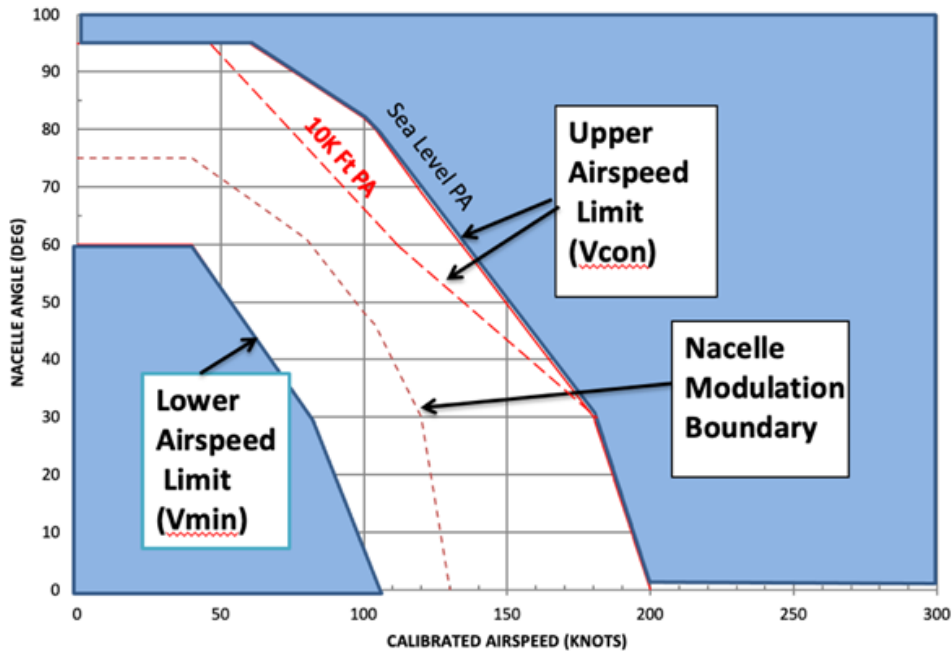
In tiltrotors the upper conversion corridor boundary represents restrictions based on flight loads on the aircraft and proprotor system as opposed to the risks of controllability as seen on the lower corridor boundary already described. For the AW609 in conversion, if the pilot fails to slow sufficiently through a combination of thrust reduction and pitch attitude change, the nacelles will slow their upward movement when the airspeed is within three kts of V_{con} and stop it if the airspeed is at V_{con} or above. Interaction with this boundary can in essence slow a deceleration if the deceleration is inappropriately attempted with just nacelle as opposed to pitch attitude and thrust reduction. Additionally, as implemented in the V-22, the nacelles may even reverse in order to preserve loads boundaries so if the pilot is attempting to rapidly decelerate, this boundary may interfere with good handling qualities in that a pitch ratcheting may occur when on the boundary and distract the pilot. This is likely to contribute to what has already been discussed as pilot adaptation to flight characteristics changes with transition/conversion reconfiguration. Altitude effects can exacerbate this issue in that at higher altitudes the V_{con} occurs at lower nacelle settings for a given speed so interaction with envelope protections is more likely to occur which is even worsened for approaches by the fact that groundspeeds can be appreciably higher for a given airspeed at higher altitudes. The effect of altitude is reflected in Figure A- 9, showing how the corridor must be restricted further due to loads related to retreating blade stall. This boundary is conservatively predicated on pressure altitude as opposed to density altitude in order to avoid use of temperature as a parameter for control.

Figure A- 9: V-22 Envelope Protection for Transition/Conversion
