DOT/FAA/CT-82/143

# Safety Benefits Analysis of General Aviation Cockpit Standardization

KAPPA Systems, Inc.  
1501 Wilson Boulevard  
Arlington, Virginia 22209

Final Report

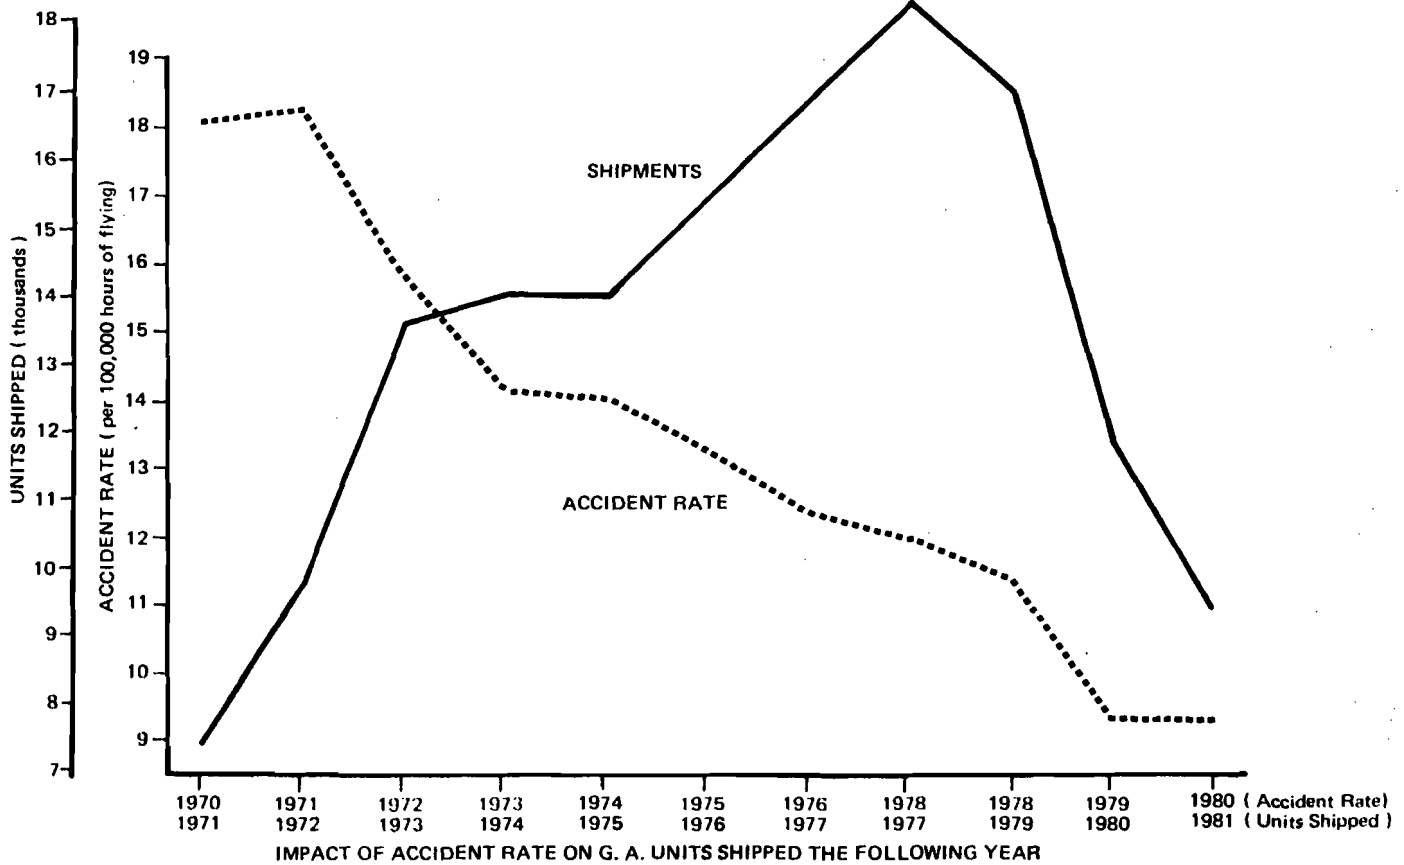
FIGURE 11. AIRCRAFT SHIPMENT - SAFETY RELATIONSHIP

Statistical Correlations. Correlation analysis is another avenue for measuring the relationship between variables. This technique was applied to the problem of determining the dependence of aircraft shipments and new pilot starts on general aviation safety. The main results are found to be these values of coefficient of correlation (r):

1. Aircraft shipments versus accident rate, 1972-79  
 $r = -0.896$
2. Aircraft shipments versus accident rate, 1970-80  
 $r = +0.299$
3. Aircraft shipments versus prior year accident rate, 1972-79  
 $r = -0.104$
4. Aircraft shipments versus number of accidents, 1972-79  
 $r = +0.316$
5. Aircraft shipments versus prior year number of accidents, 1972-79  
 $r = +0.483$

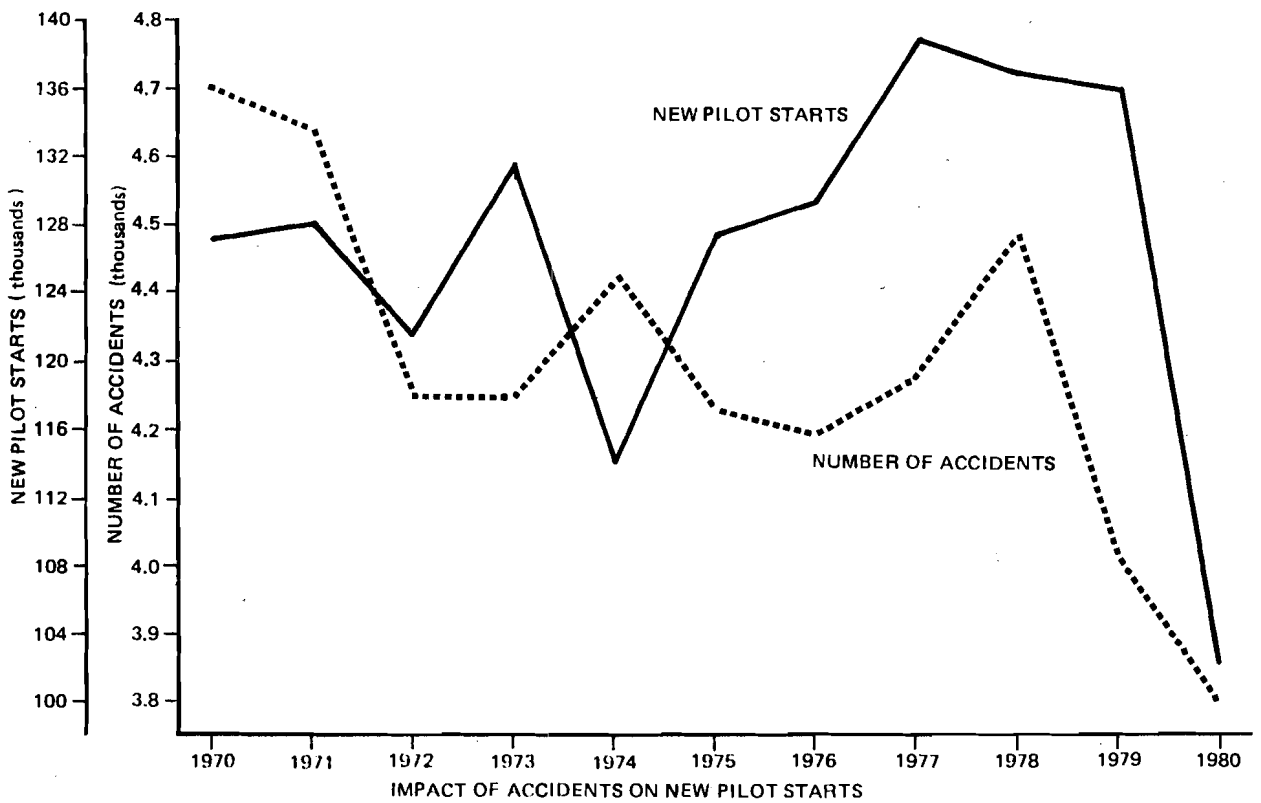
FIGURE 12. NEW PILOT STARTS AND SAFETY

New Pilot Starts. New pilot starts are found to be nearly independent of time with a substantial year to year variation. The mean value is 125,901 starts annually. A best straight line curve fit has a slope of -424 starts per year. While this is a very minor slope, it is negative and thus does not show an increasing number of new pilot starts during a period of improving safety performance. For the best curve fit, the standard deviation is 10,407 starts annually with five points outside the plus or minus band. Replotting the data so that new pilot starts are aligned one year behind the accident rate values does not change the situation. There is no apparent relationship between accident rates and new pilot starts from examination of the two sets of data. Figure 12 contains new pilots starts plotted against both total accidents and the accident rate. In the plots of new pilot starts and accidents, the prevalence of opposite slopes for several short periods is clearly apparent. The second set of plots shows randomness in new pilot starts when compared to the steady improvement in the accident rate.

6. Student licenses versus accident rate, 1972-79  
r = -0.880
7. Student licenses versus accident rate, 1970-80  
r = -0.561
8. Student licenses versus number of accidents, 1972-79  
r = -0.161
