DOT/FAA/CT-86/5

# Halon Extinguisher Agent Behavior in a Ventilated Small Aircraft

Final Report

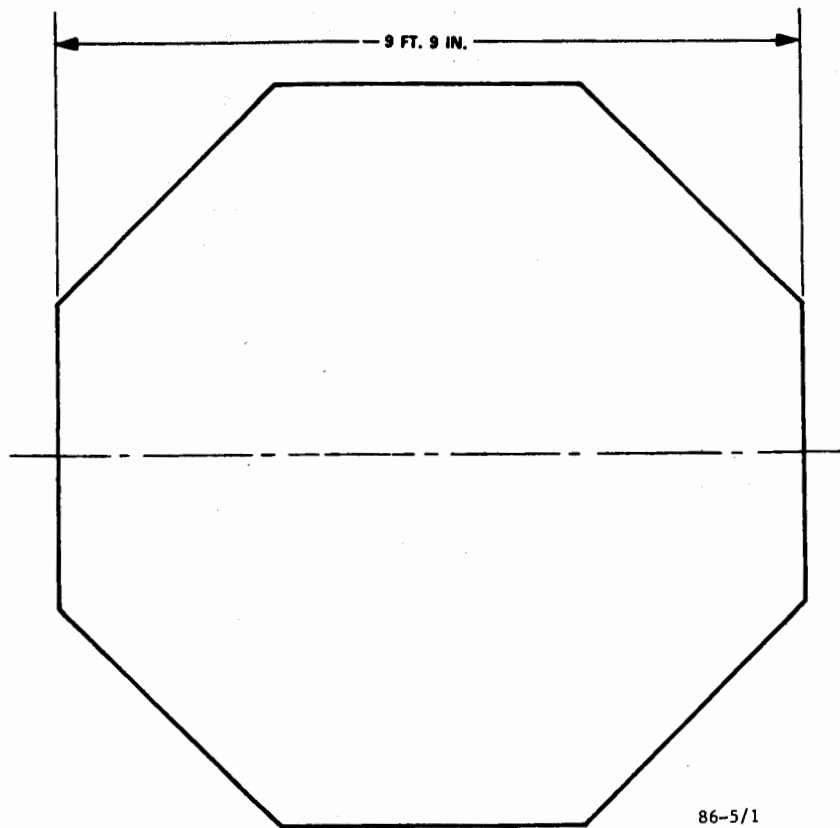
FIGURE 1. GENERAL AVIATION AIRFLOW FACILITY TEST SECTION - CROSS SECTION

A 10-foot diameter by 24-foot-long airflow facility was designed and constructed from flat 4-foot by 8-foot sheets of low carbon steel. The cross section, figure 1, is octagonal in shape. The entrance is a bellmouth design with a 5-foot radius. This extension is attached to an existing 5-foot diameter airflow facility, figures 2 and 3. Performance of the 5-foot facility is near Mach 1 airspeed. Two J57 turbo jet engines provide power to drive the facility by ejector action. The 10-foot

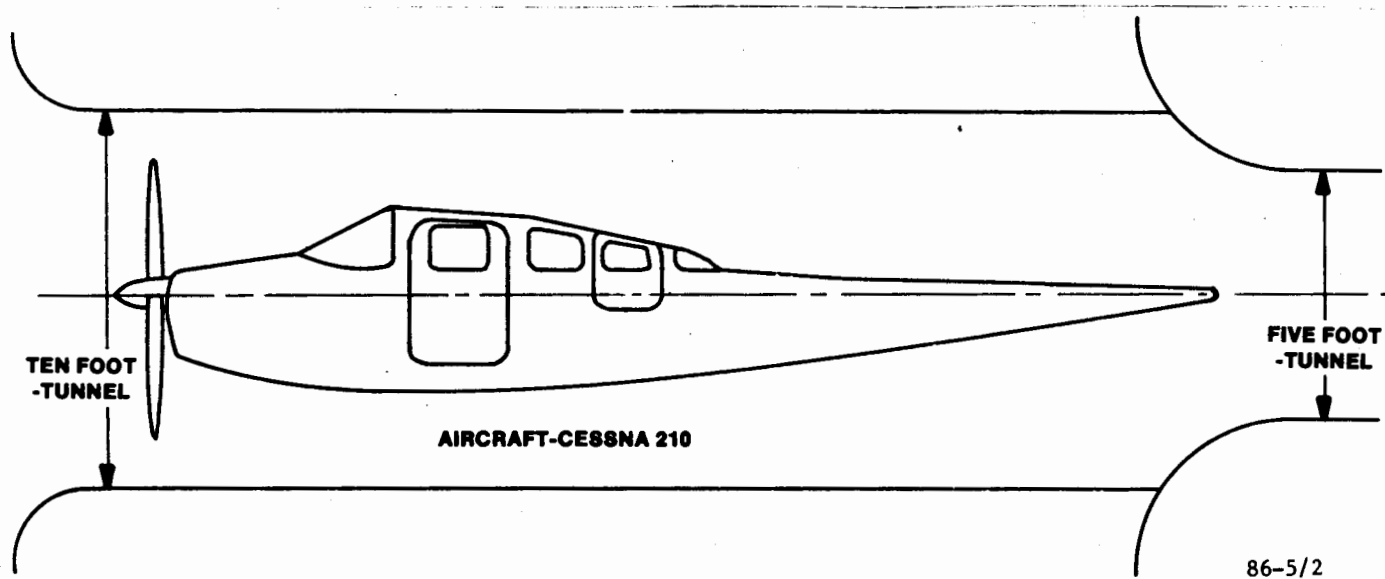
FIGURE 2. GENERAL AVIATION AIRFLOW FACILITY TEST SECTION - PROFILE

The test article is a 1963 model Cessna 210C with retractable landing gear (figures 2 and 3). The airplane is a four-place high-wing monoplane, powered by a single six-cylinder, horizontally-opposed fuel injection Continental IO470 engine. For installation in the facility, mounts were designed, fabricated, and installed at the wing spar attachment points and at the wing strut attachment points. The fuselage was installed in the tunnel with 3/4-inch high carbon steel rods connected to the mounts and to the tunnel walls. The wings were cut at the 32-inch section and then were installed on the fuselage in the tunnel. The sections were installed to provide the cabin ventilation air inlet ports located in the wings. It was necessary to move the ports inboard for inclusion in the 32-inch wing root sections.

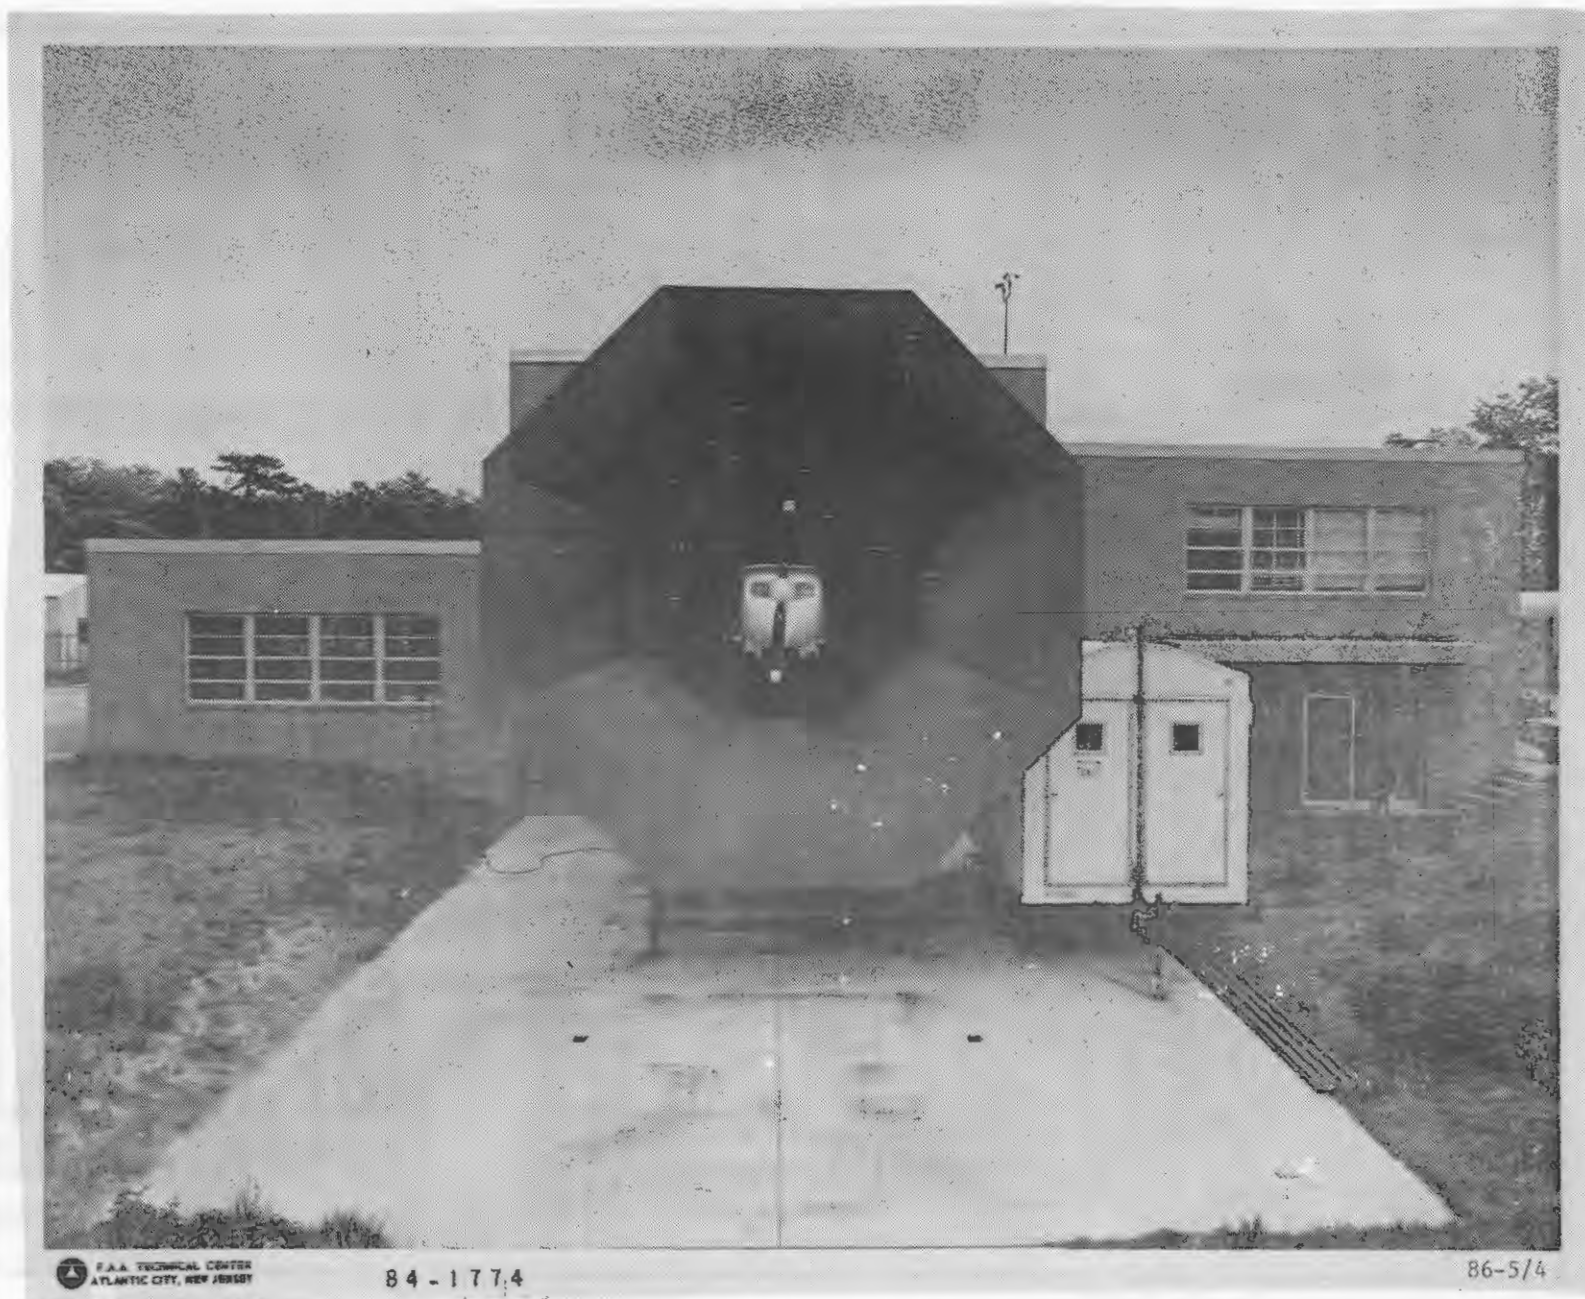
FIGURE 3. CESSNA 210C AIRPLANE WITHIN AVIATION FLOW FACILITY TEST SECTION

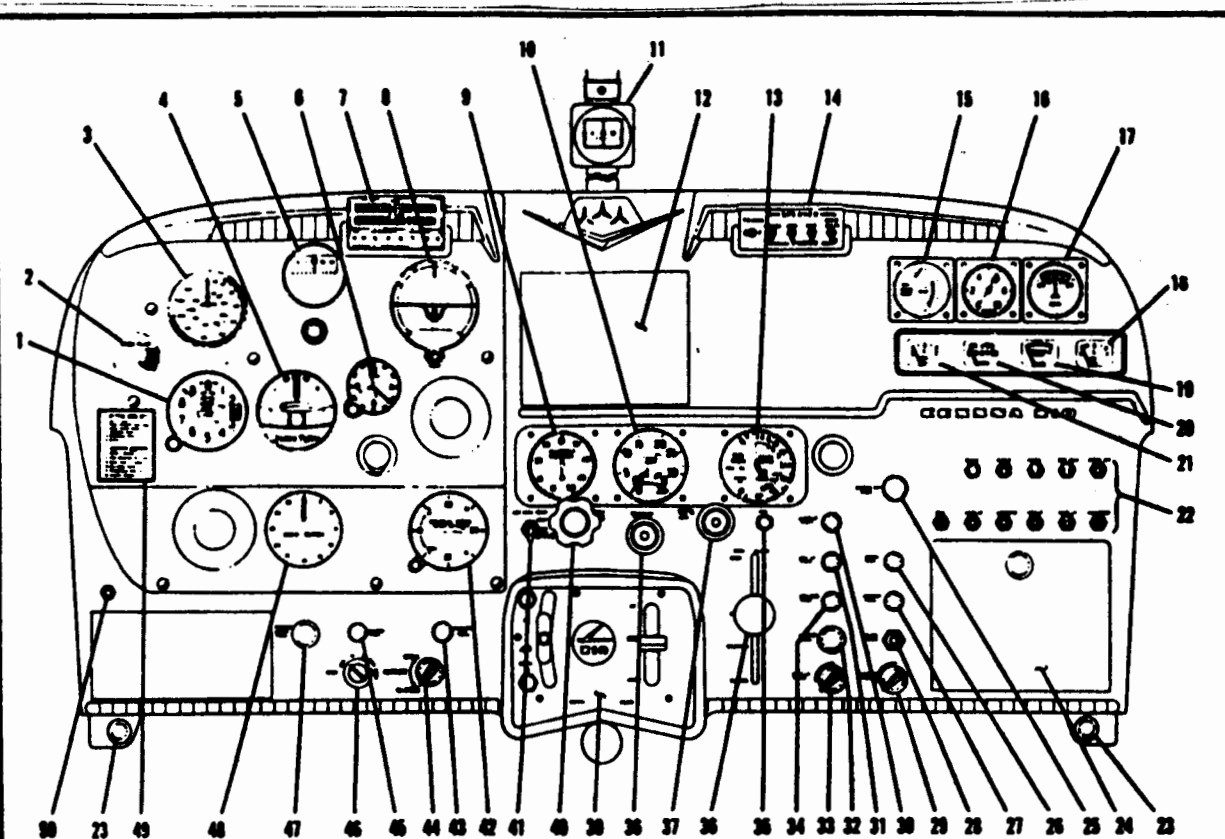
35. Generator Warning Light
36. Cowl Flap Lever
37. Mixture Control
38. Propeller Control
39. Power Pack (See Section 5)
40. Throttle
41. Auxiliary Fuel Pump Switch
42. Vertical Speed Indicator
43. Induction Hot Air Knob
44. Defrost Knob
45. Master Switch
46. Ignition - Start Switch
47. Fuel Strainer Drain Knob
48. Radio Compass
49. Check List
50. Microphone Jack
51. Shock Mount
52. Ground Strap

FIGURE 4. INSTRUMENT PANEL - CESSNA MODEL 210C AIRPLANE

The electrical and electronic components are primarily located in and under the instrument panel. The instrument panel for the test aircraft (Cessna 210) is shown in figure 4. Identification of the equipment is also listed. Electrical power for the aircraft is supplied by a 12-volt direct current, negative ground electrical system. A single 12-volt battery supplies power for starting and provides reserve power in the event of a generator or alternator failure. On the extreme left side of the instrument panel, one item that could be involved in a fire is the master switch. Operation of the switch connects the battery solenoid coil and the generator field coil to ground, thereby, activating the power system.

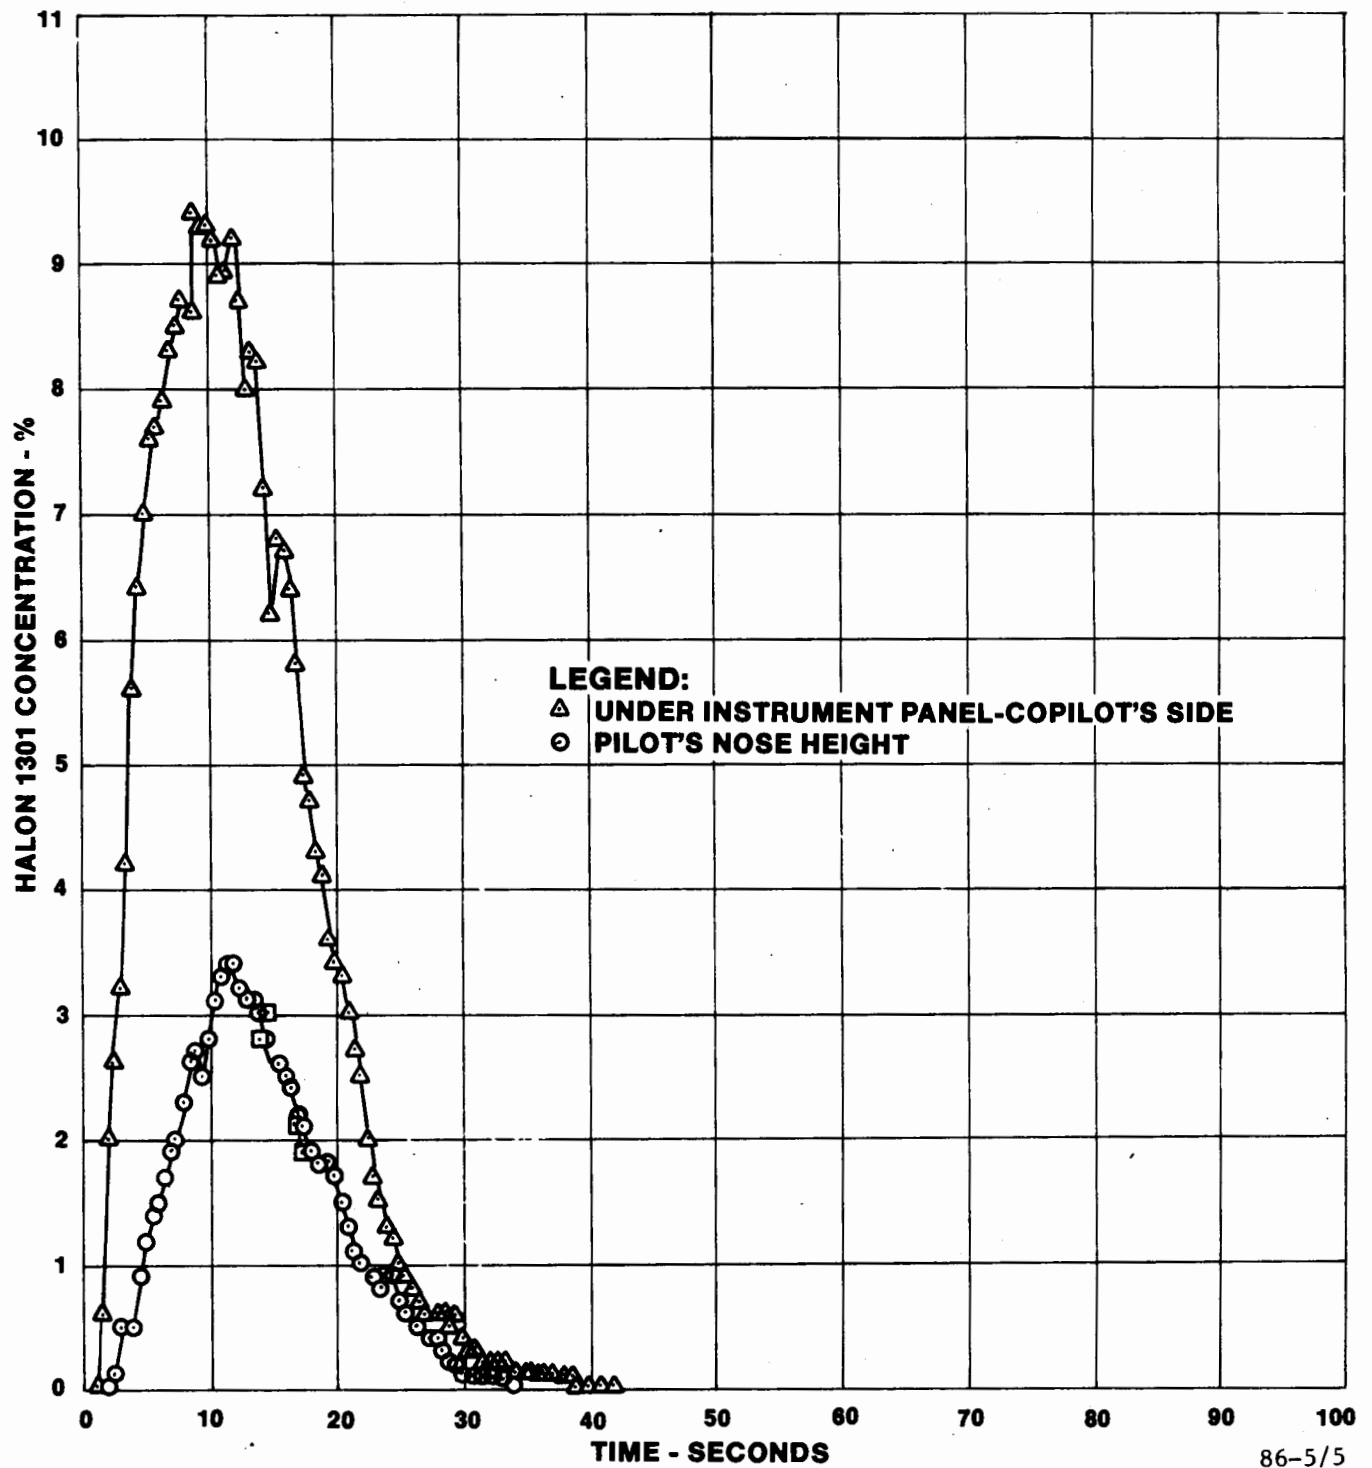
FIGURE 5. HALON 1301 CONCENTRATIONS - 3-POUND EXTINGUISHER DIRECTED UNDER INSTRUMENT PANEL - COPILOT'S SIDE - OVERHEAD VENTS OPEN

The gas measurements for the tests conducted with extinguishers discharged under the instrument panel were plotted against time in seconds and are presented in figures 5 through 12, and certain selected values were tabulated in table 2.

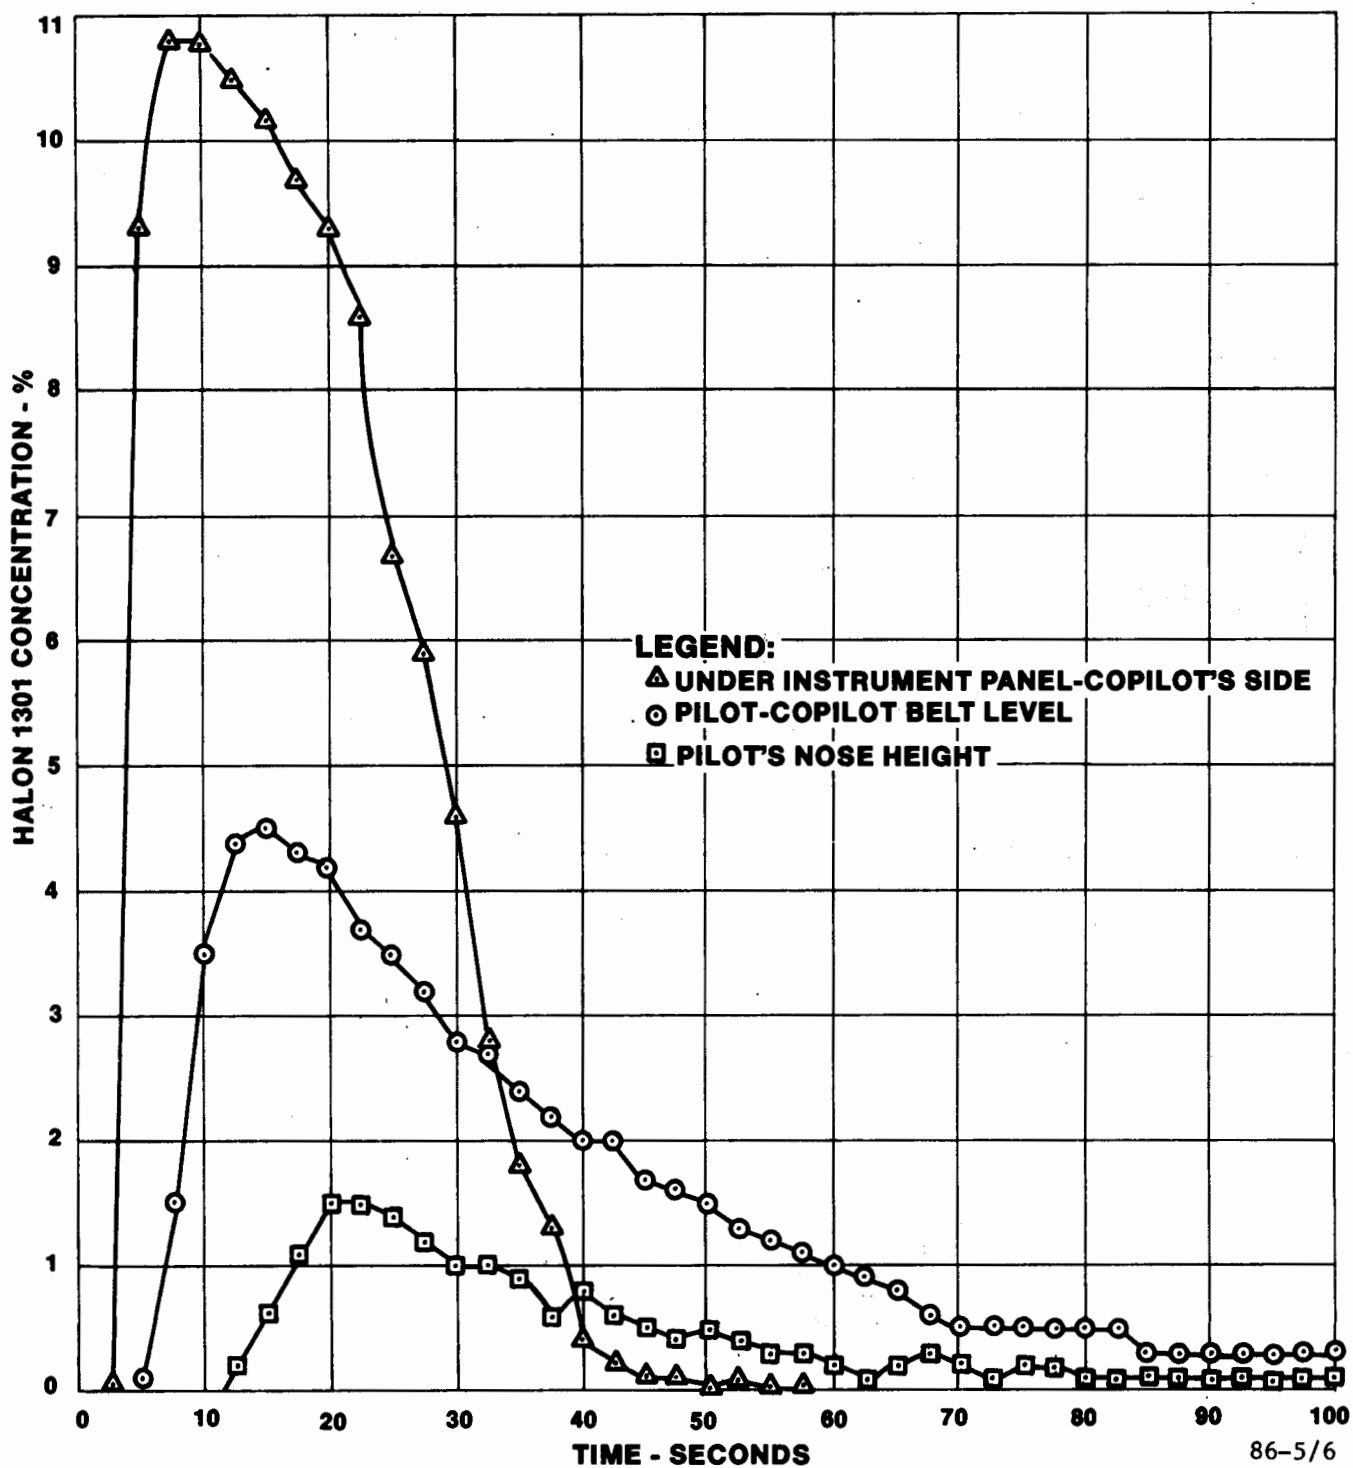
FIGURE 6. HALON 1301 CONCENTRATIONS - 3-POUND EXTINGUISHER DIRECTED UNDER INSTRUMENT PANEL - COPILOT'S SIDE - OVERHEAD VENTS CLOSED

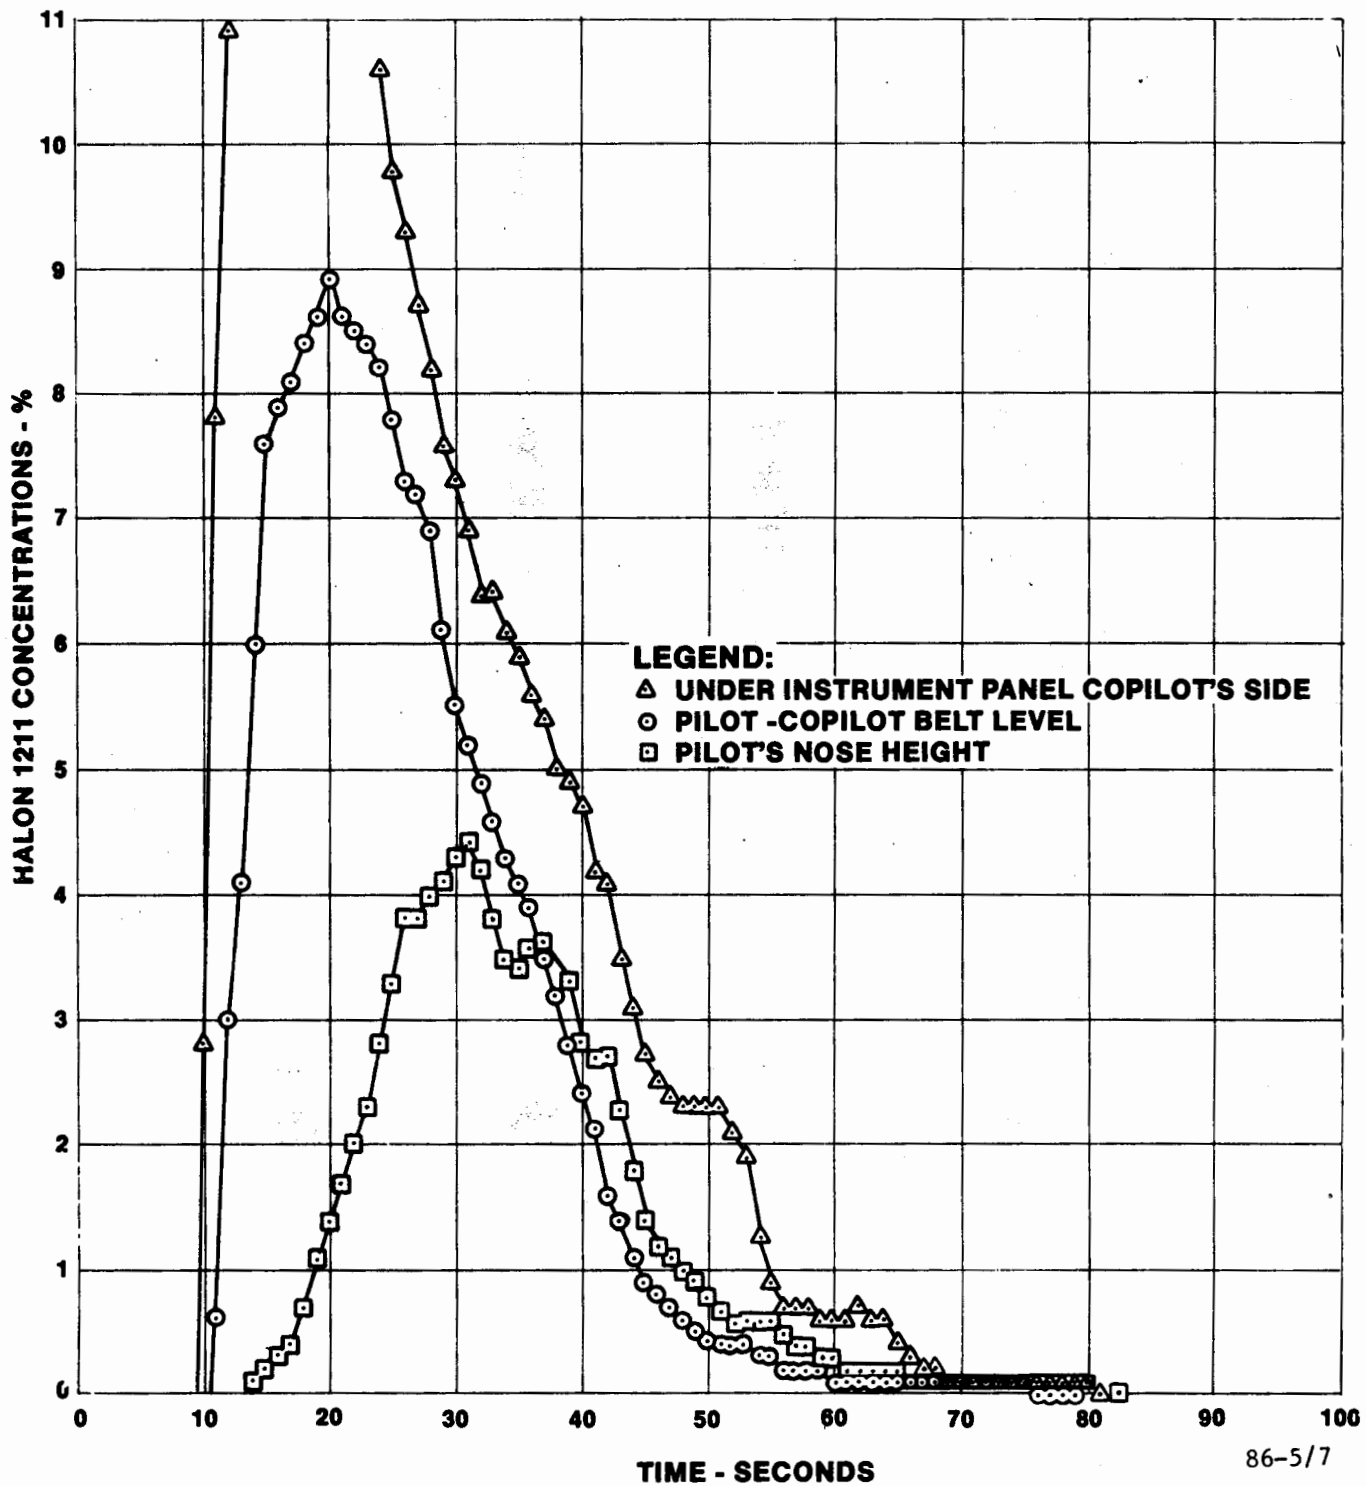
FIGURE 7. HALON 1211 CONCENTRATIONS - 2.5-POUND EXTINGUISHER DIRECTED UNDER INSTRUMENT PANEL - COPILOT'S SIDE - OVERHEAD VENTS OPEN

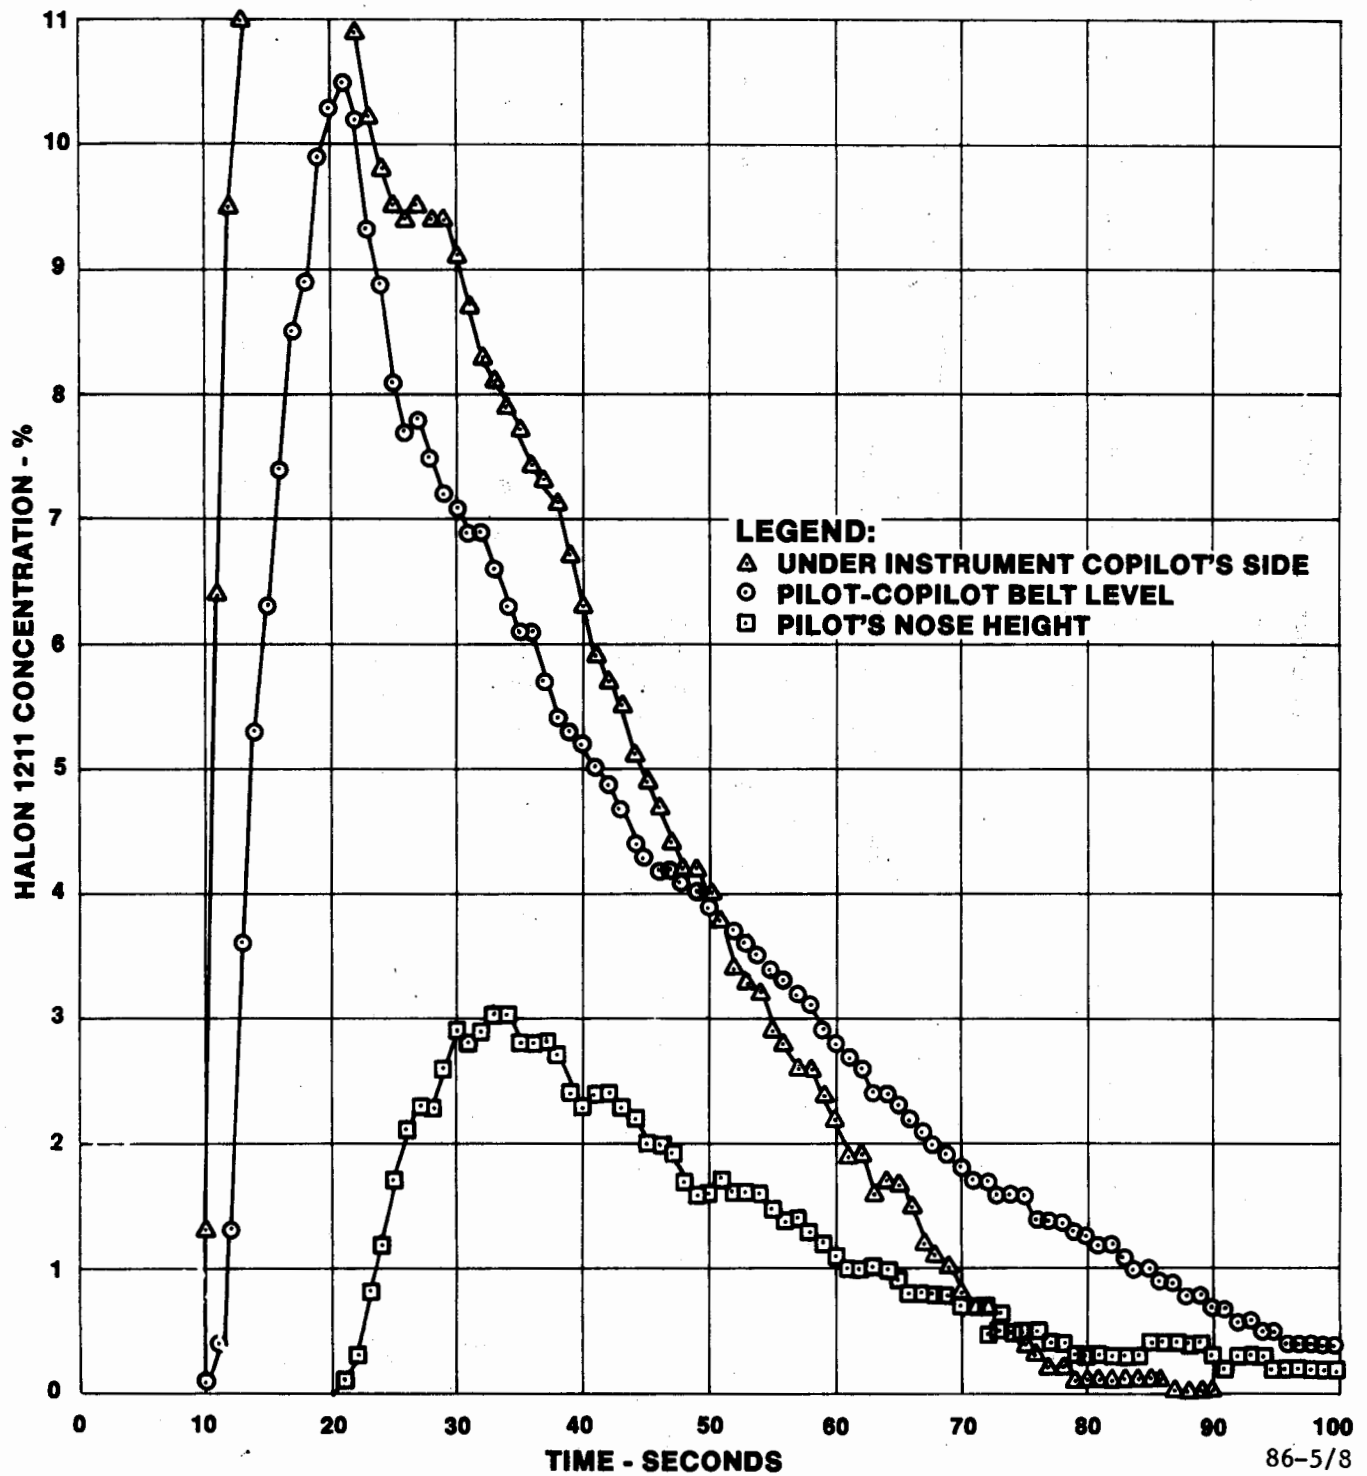
FIGURE 8. HALON 1211 CONCENTRATIONS - 2.5-POUND EXTINGUISHER DIRECTED UNDER INSTRUMENT PANEL - COPILOT'S SIDE - OVERHEAD VENTS CLOSED

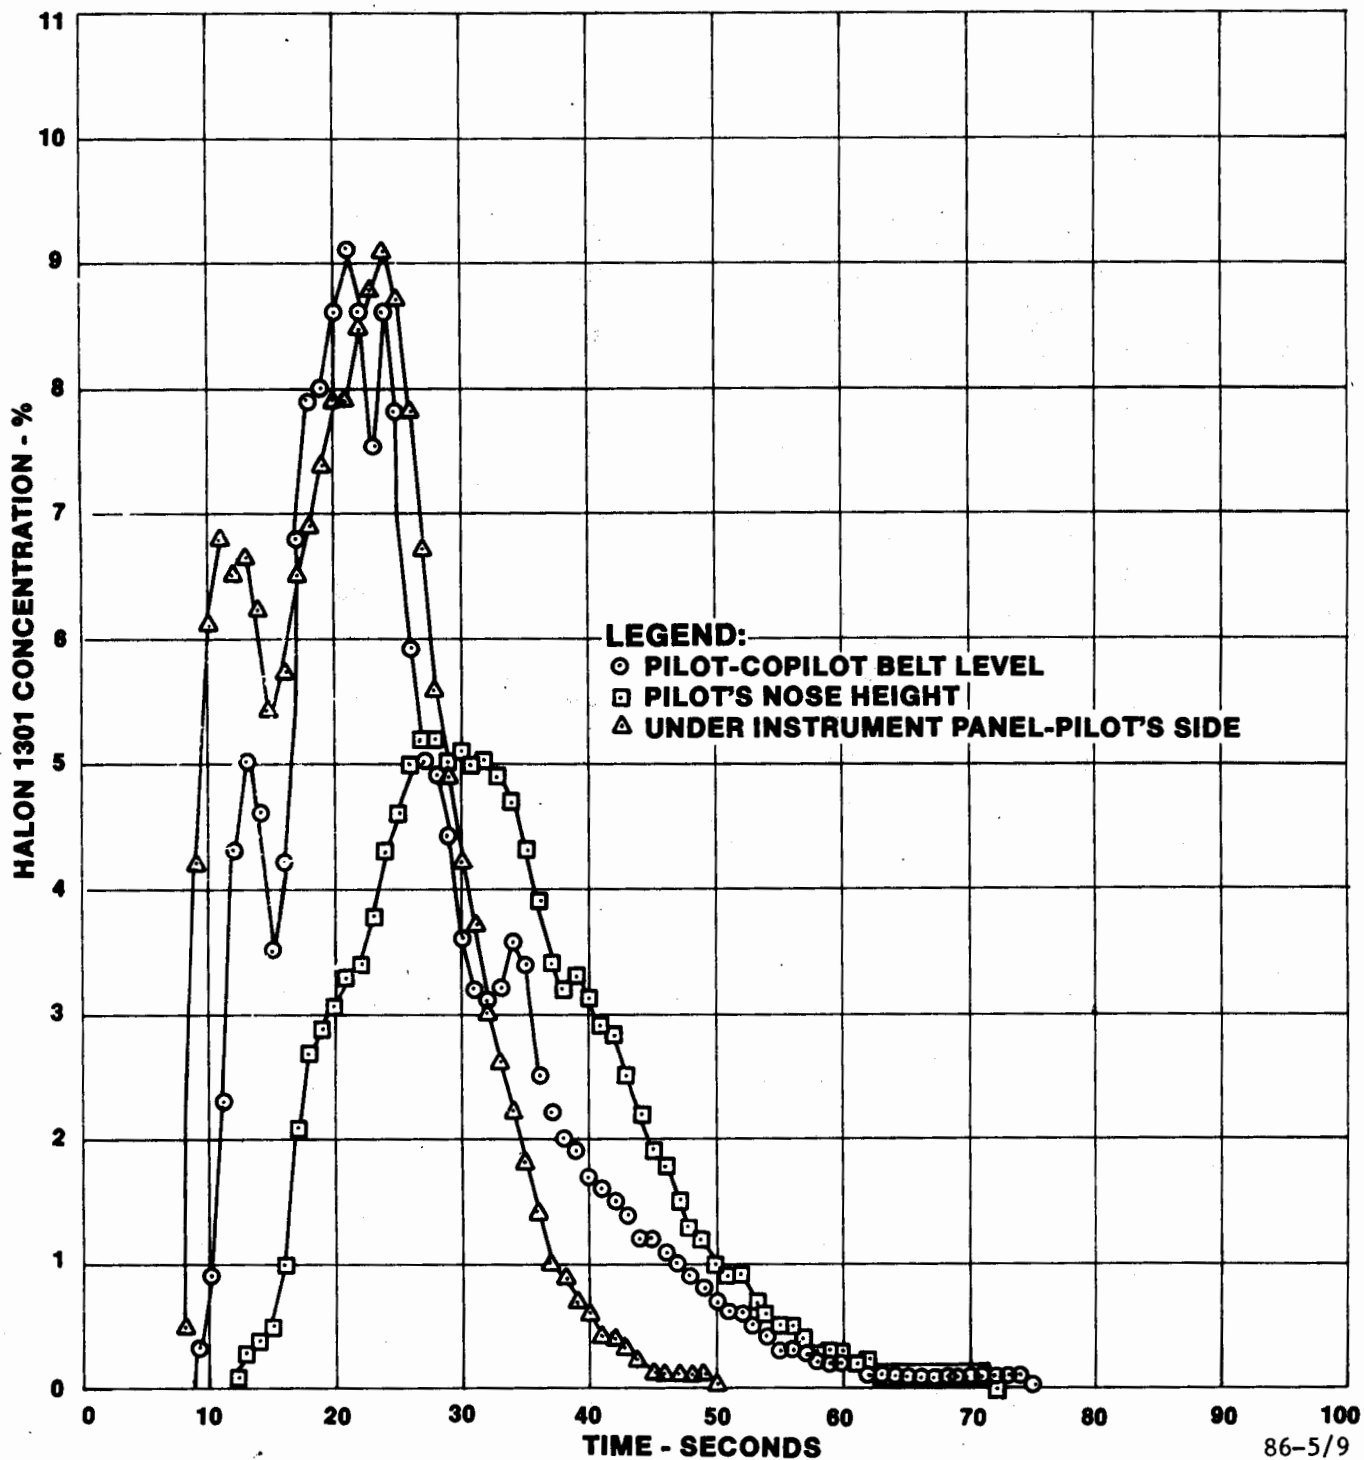
FIGURE 9. HALON 1301 CONCENTRATIONS - 3-POUND EXTINGUISHER DIRECTED UNDER INSTRUMENT PANEL - PILOT'S SIDE - OVERHEAD VENTS OPEN

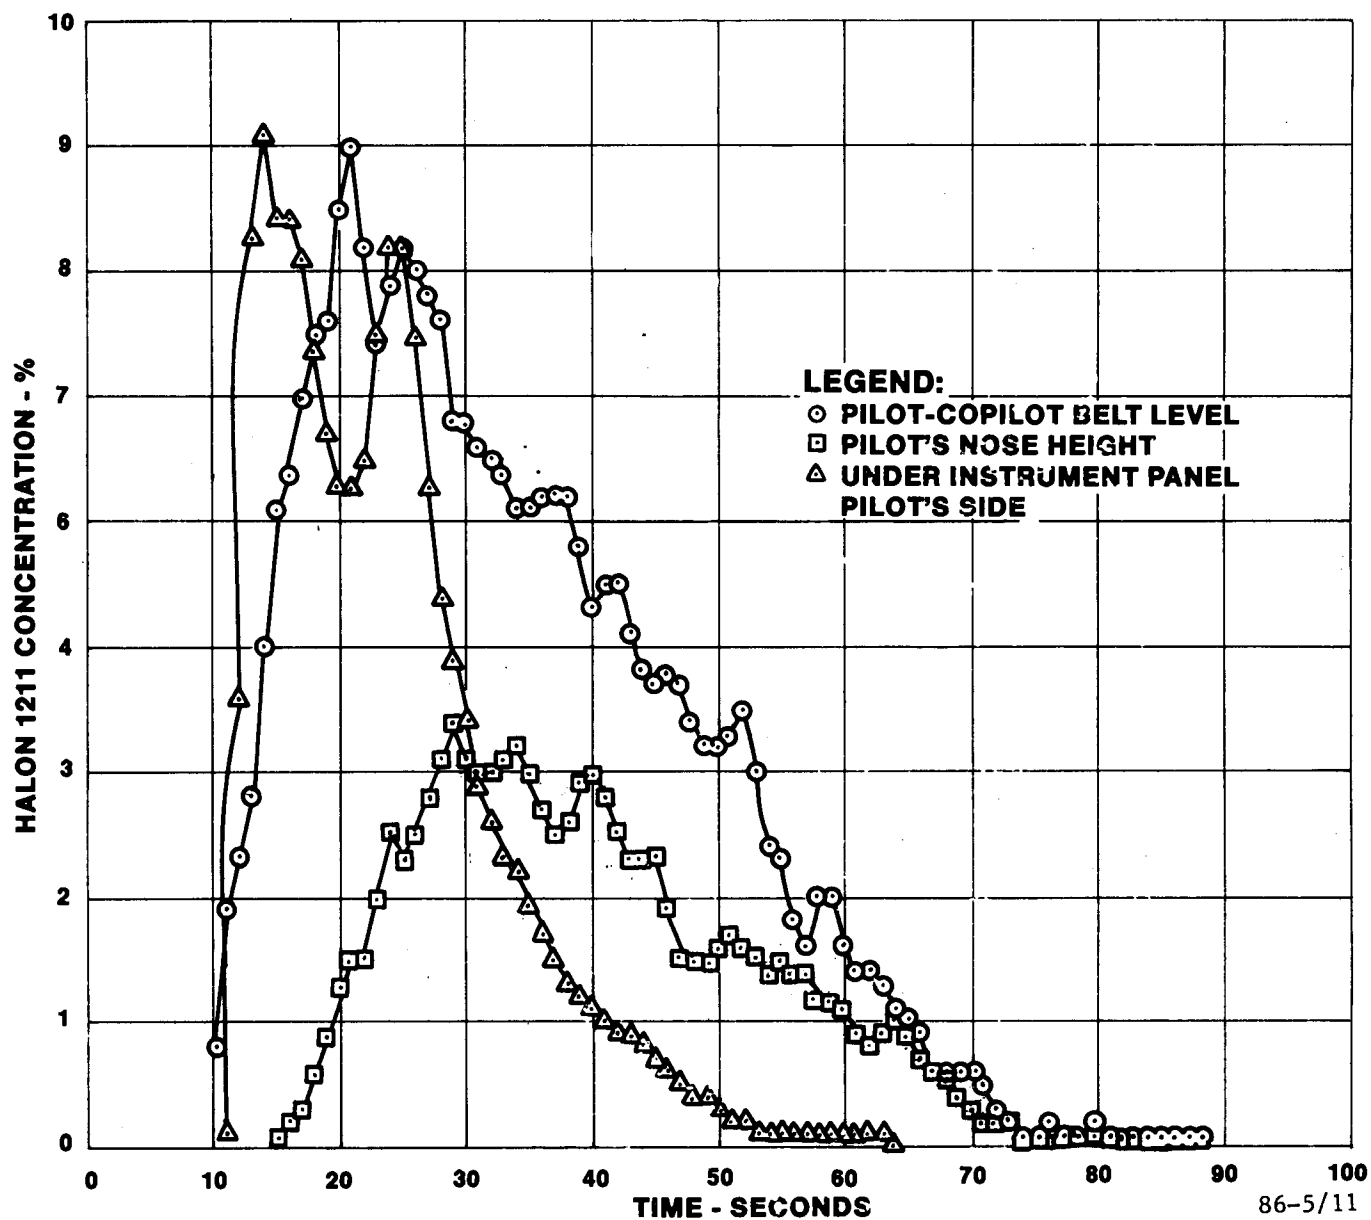
FIGURE 11. HALON 1211 CONCENTRATIONS - 2.5-POUND EXTINGUISHER DIRECTED UNDER INSTRUMENT PANEL - PILOT'S SIDE - OVERHEAD VENTS OPEN

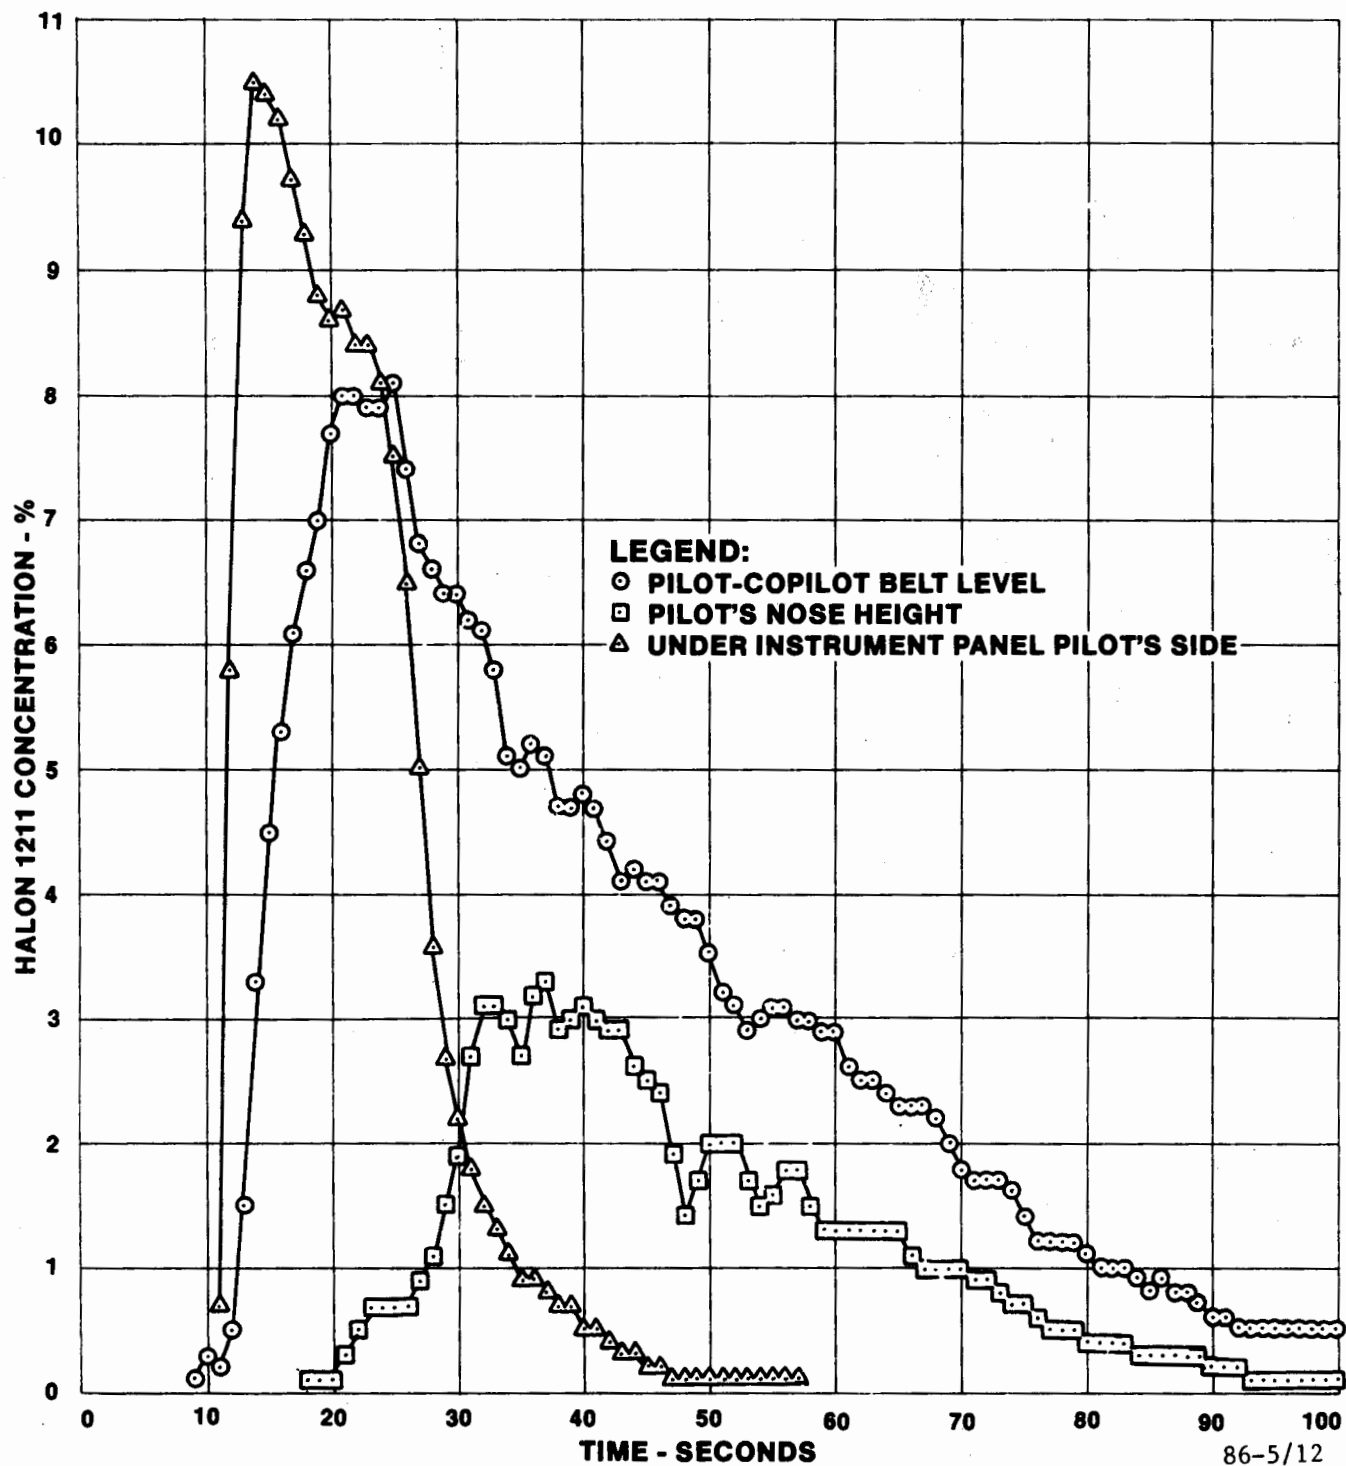
FIGURE 12. HALON 1211 CONCENTRATIONS - 2.5-POUND EXTINGUISHER DIRECTED UNDER INSTRUMENT PANEL - PILOT'S SIDE - OVERHEAD VENTS CLOSED

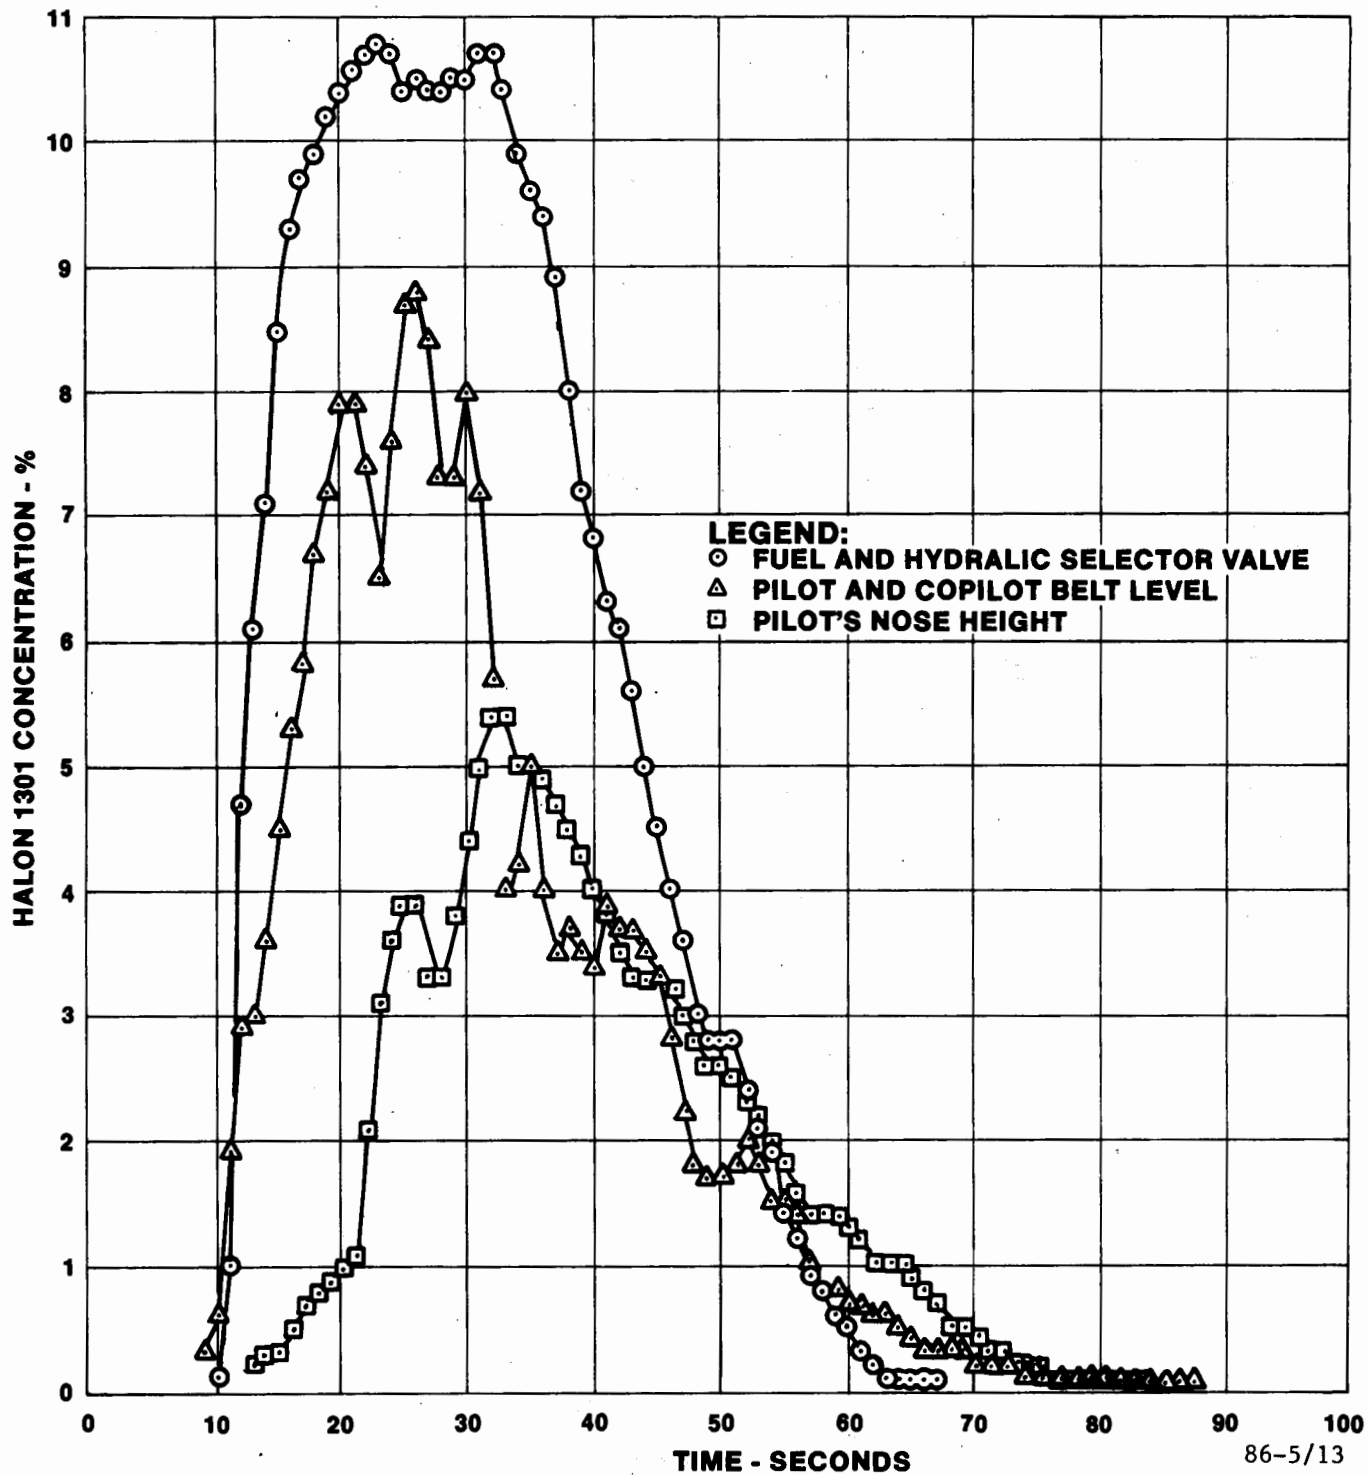
FIGURE 13. HALON 1301 CONCENTRATIONS - 3-POUND EXTINGUISHER DIRECTED TO THE FUEL AND HYDRAULIC SELECTOR VALVES - OVERHEAD VENTS OPEN

The extinguishers were directed to the fuel and hydraulic selector valves located on a console raised approximately 6 inches from floor between the pilot and copilot. Two 2.5-pound Halon 1211 extinguishers and two 3.0-pound Halon 1301 extinguishers were tested with identical ventilation conditions as previously described. The gas measurements are plotted in figures 13 through 16 and selected data are tabulated in table 2. Dose calculated for the pilot's nose was 1.72 and 2.56 percent minutes and is up to 64 percent of the limit for Halon 1211 and 2.69 and 3.10 for Halon 1301 which is 31 percent of the limit dose. Maximum dose at the pilot's and copilot's belt level was 4.88 and 5.78 percent minutes for Halon 1211 and 5.82 and 6.53 of Halon 1301. The pilot could bend over the 10 seconds without exceeding the limit dose when discharging Halon 1211 and could bend over indefinitely after discharging Halon 1301.
