DOT/FAA/CT-86/5

# Halon Extinguisher Agent Behavior in a Ventilated Small Aircraft

Final Report

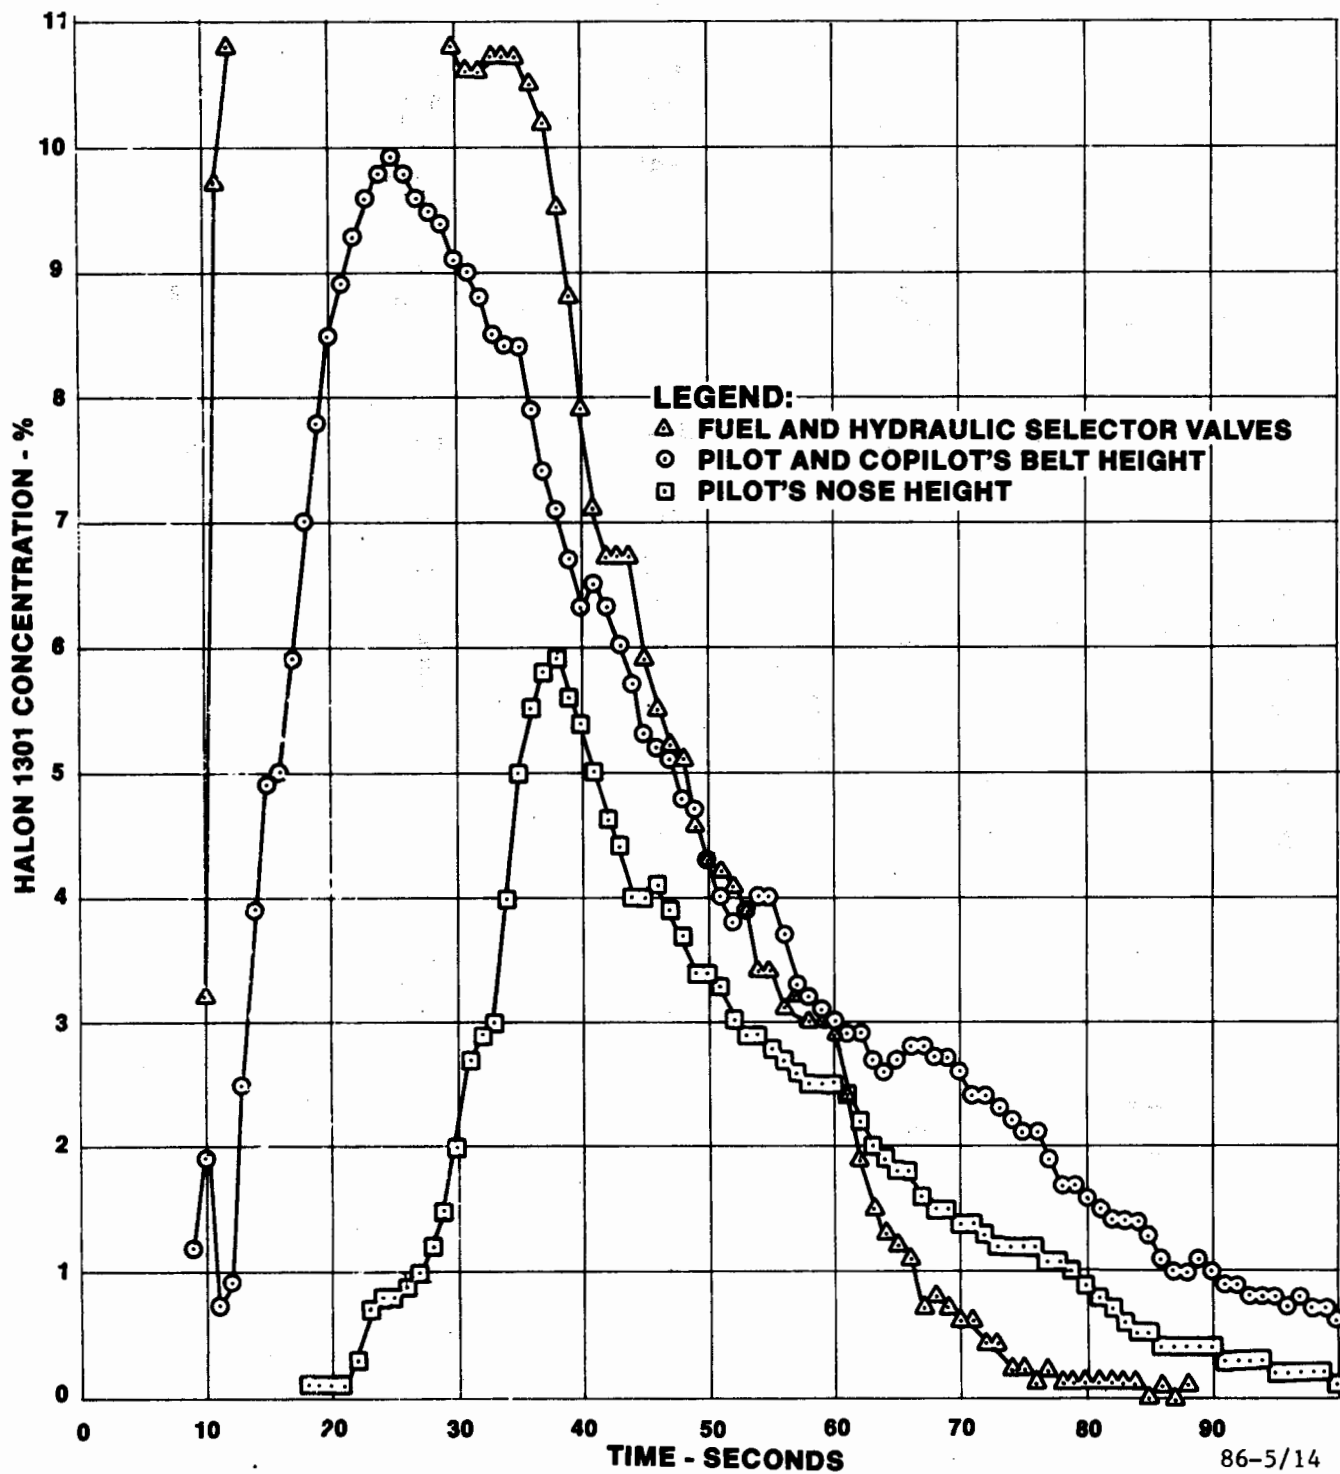
FIGURE 14. HALON 1301 CONCENTRATIONS - 3-POUND EXTINGUISHER DIRECTED TO THE FUEL AND HYDRAULIC SELECTOR VALVES - OVERHEAD VENTS CLOSED

The extinguishers were directed to the fuel and hydraulic selector valves located on a console raised approximately 6 inches from floor between the pilot and copilot. Two 2.5-pound Halon 1211 extinguishers and two 3.0-pound Halon 1301 extinguishers were tested with identical ventilation conditions as previously described. The gas measurements are plotted in figures 13 through 16 and selected data are tabulated in table 2. Dose calculated for the pilot's nose was 1.72 and 2.56 percent minutes and is up to 64 percent of the limit for Halon 1211 and 2.69 and 3.10 for Halon 1301 which is 31 percent of the limit dose. Maximum dose at the pilot's and copilot's belt level was 4.88 and 5.78 percent minutes for Halon 1211 and 5.82 and 6.53 of Halon 1301. The pilot could bend over the 10 seconds without exceeding the limit dose when discharging Halon 1211 and could bend over indefinitely after discharging Halon 1301.

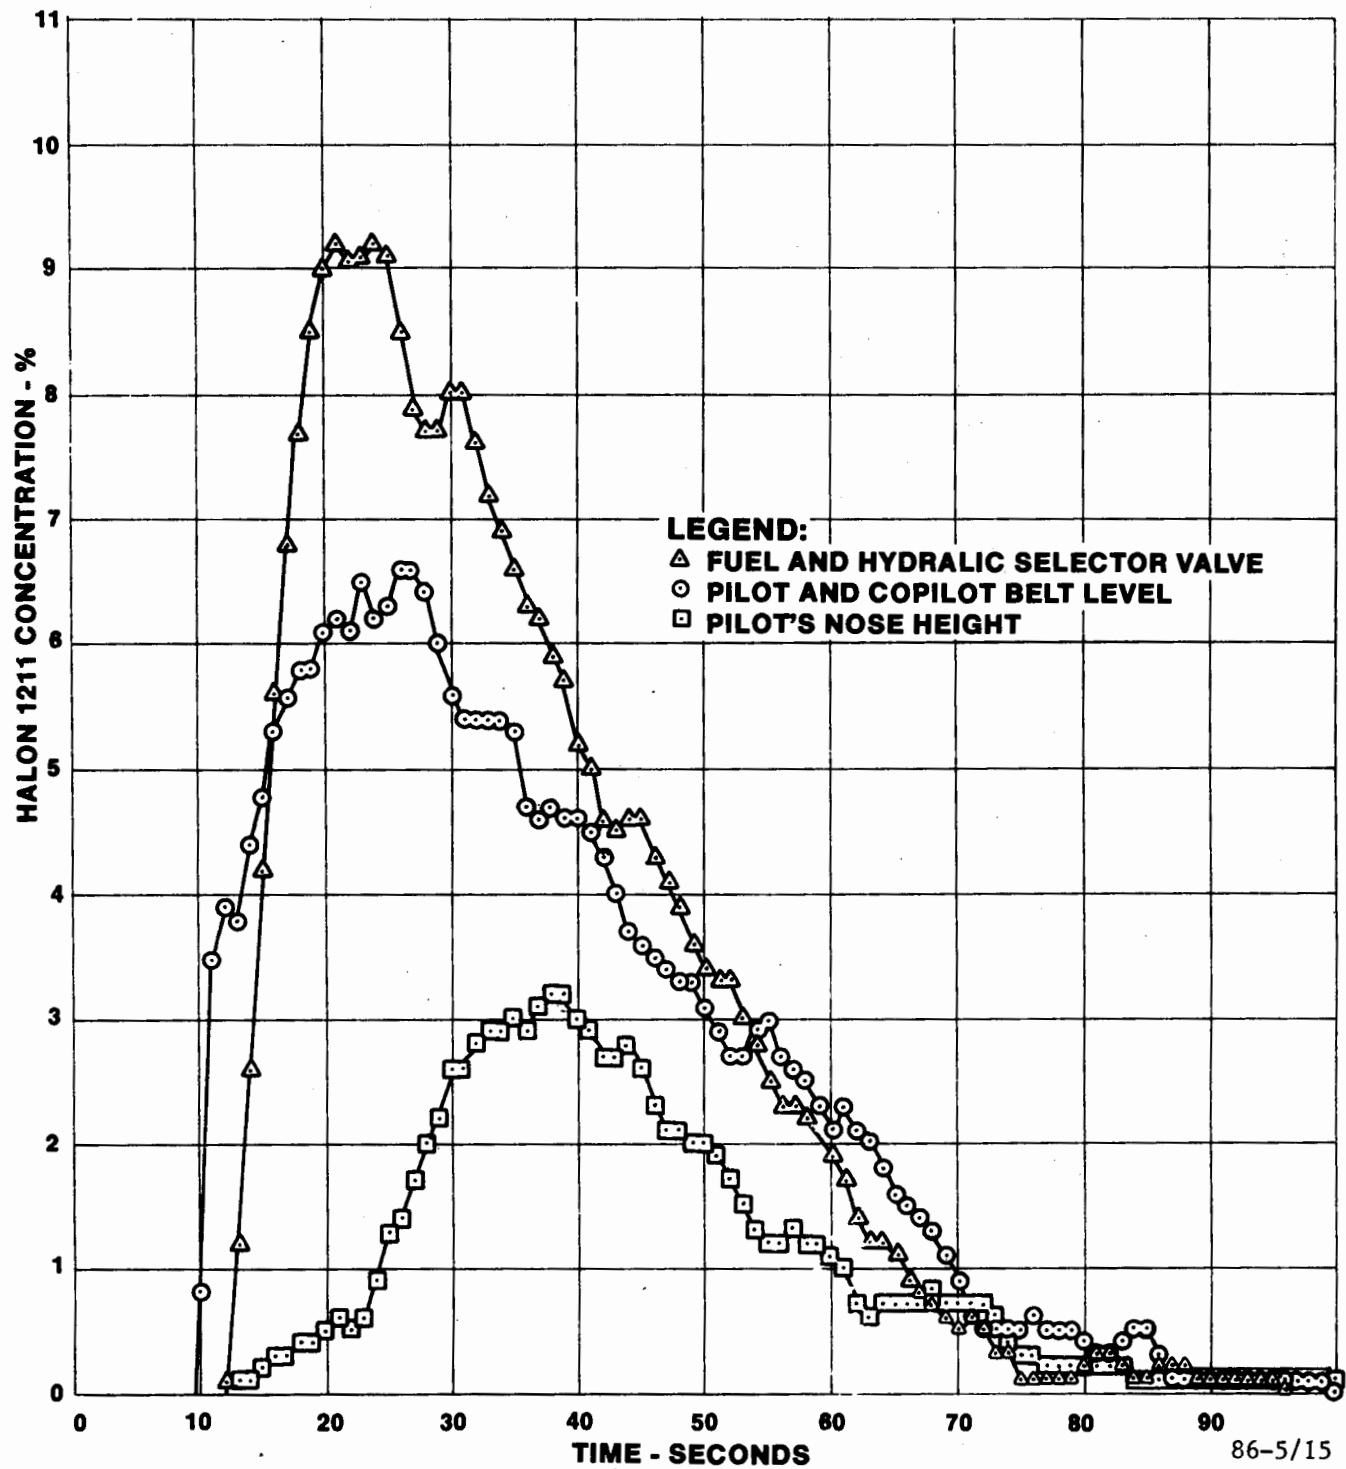
FIGURE 15. HALON 1211 CONCENTRATIONS - 2.5-POUND EXTINGUISHER DIRECTED TO THE FUEL AND HYDRAULIC SELECTOR VALVES - OVERHEAD VENTS OPEN

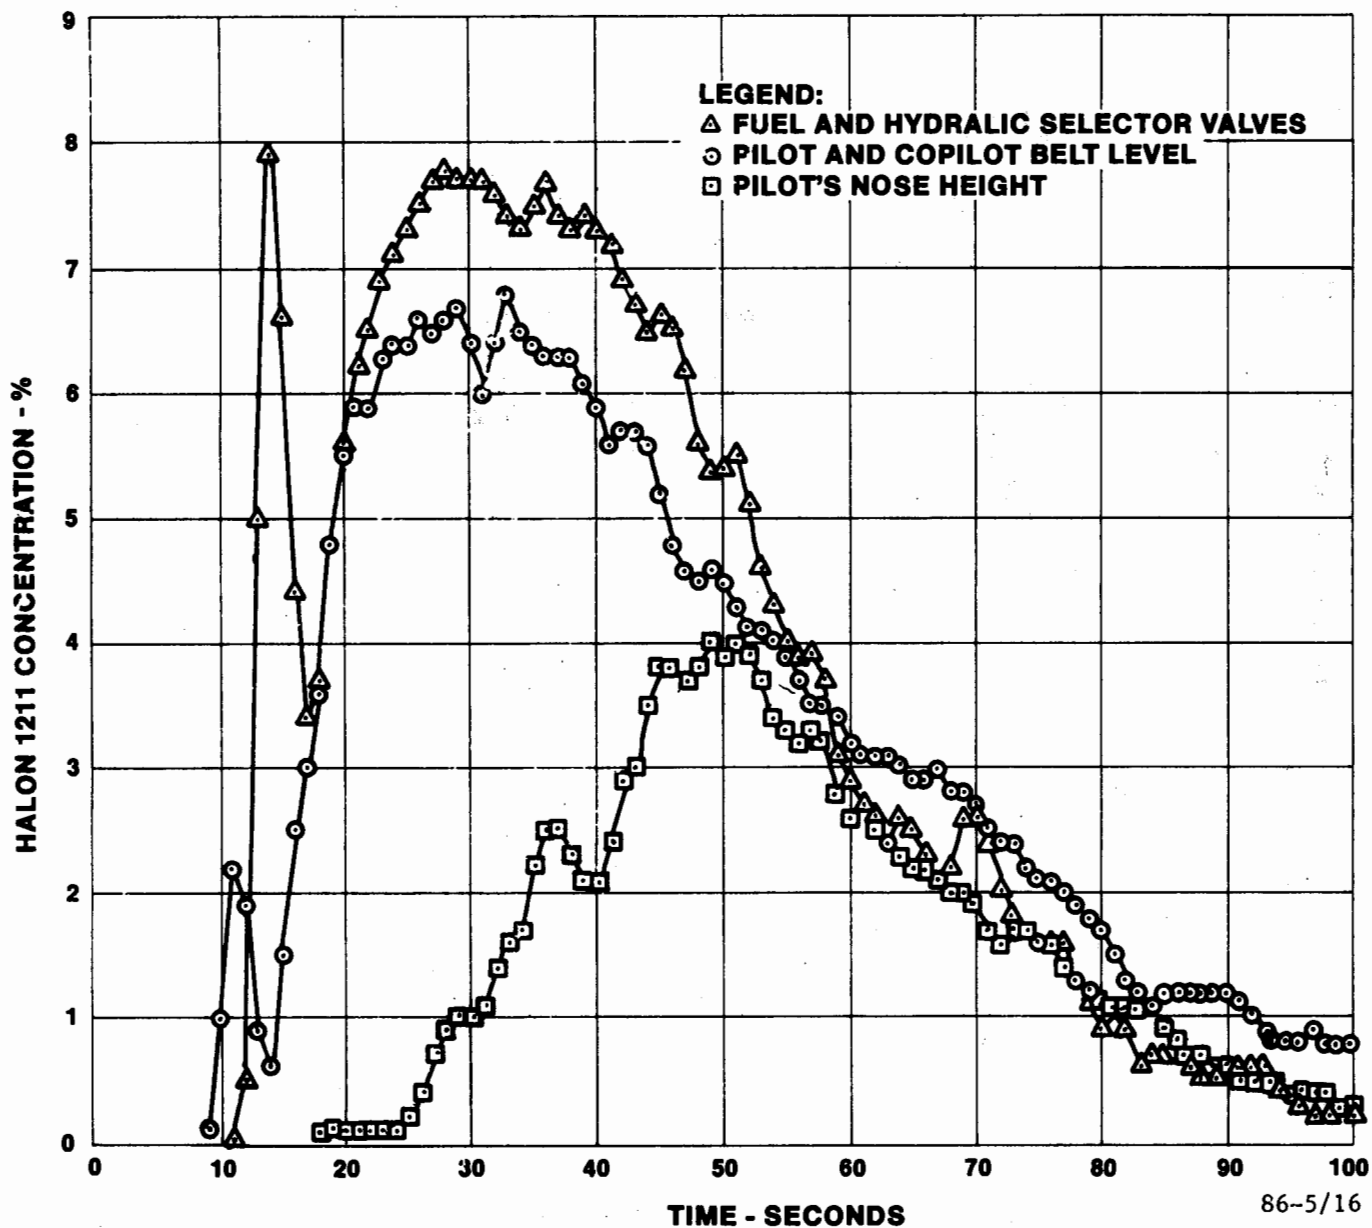
FIGURE 16. HALON 1211 CONCENTRATIONS - 2.5-POUND EXTINGUISHER DIRECTED TO THE FUEL AND HYDRALIC SELECTOR VALVES - OVERHEAD VENTS CLOSED

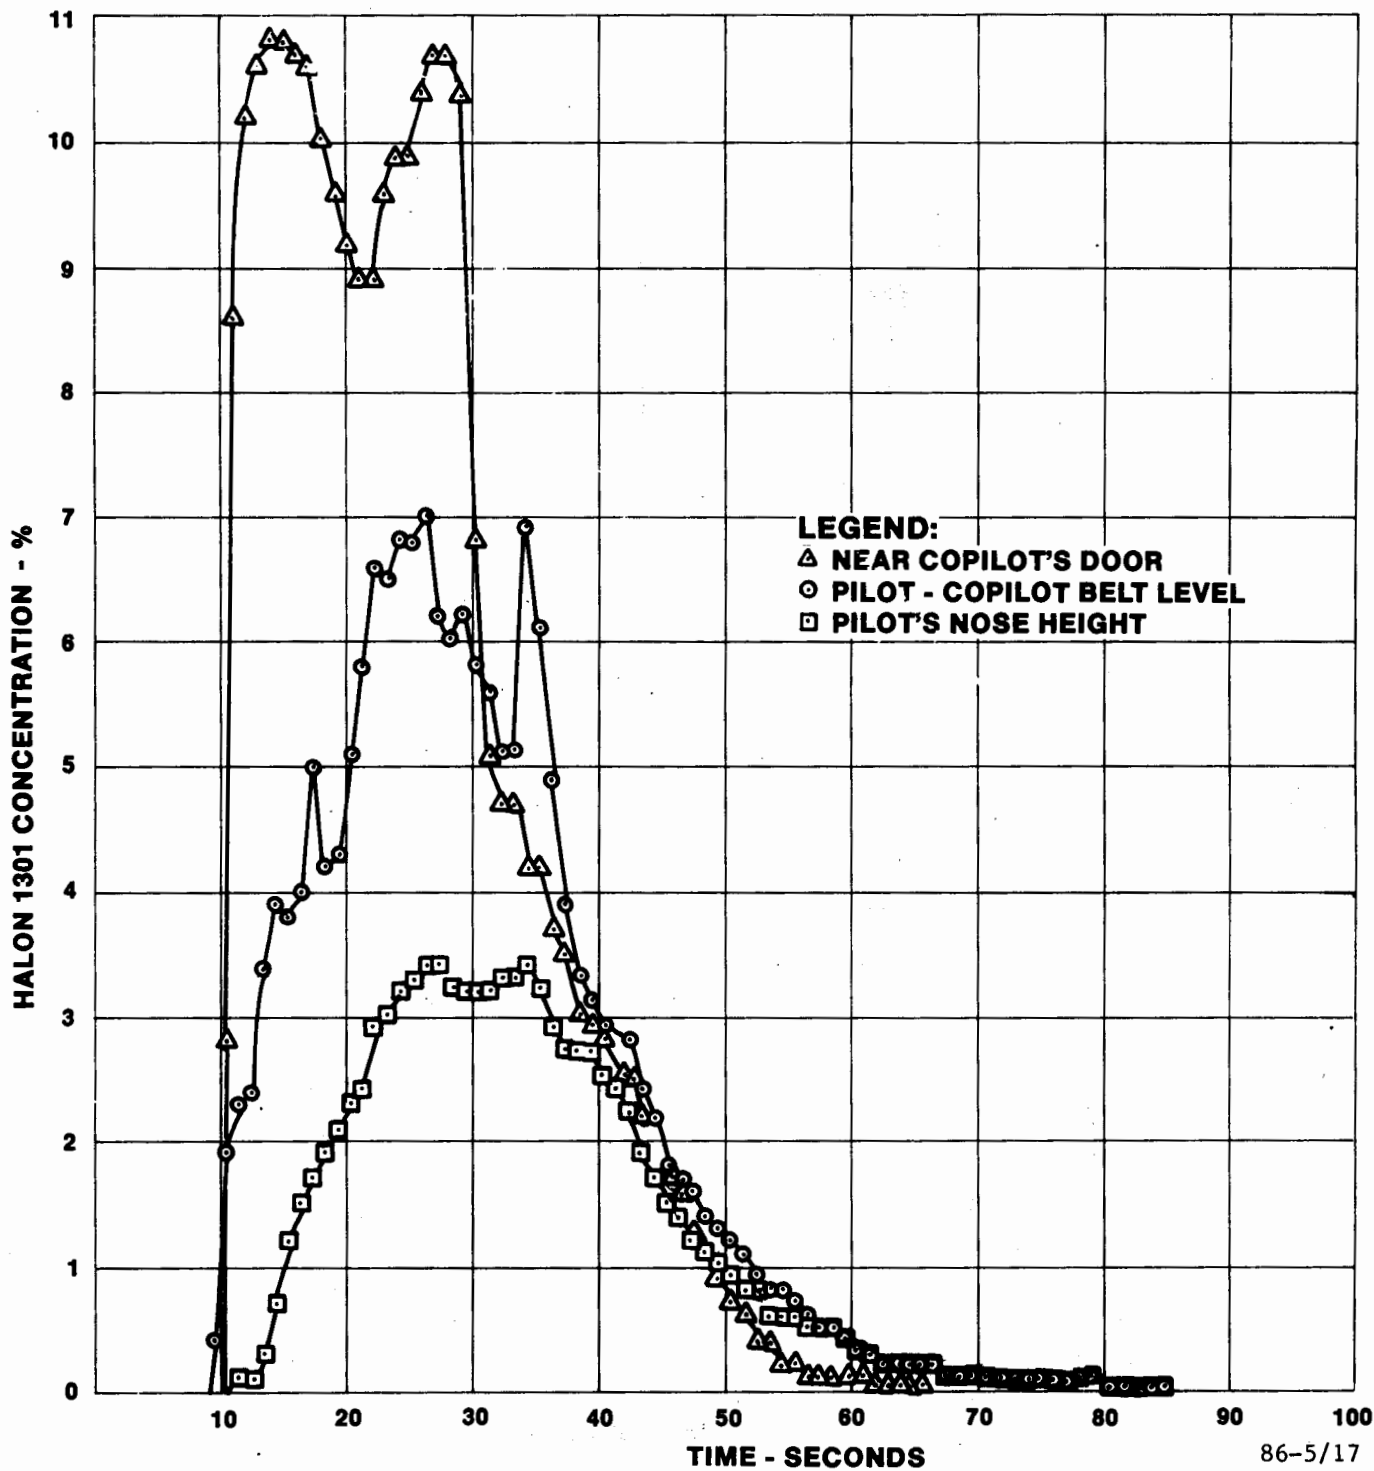
FIGURE 17. HALON 1301 CONCENTRATIONS - 3-POUND EXTINGUISHER DIRECTED TO THE COPILOT'S DOOR - OVERHEAD VENTS OPEN

Two Halon 1211 and two Halon 1301 extinguishers were discharged to the copilot's door at a point below the arm rest. Figures 17 through 20 show the agent concentrations plotted against time. As the discharge location was moved in relation to the pilot, dose calculations are less. The dose for the pilot was only 19 percent of the limit for Halon 1211, and 17 percent of the limit for Halon 1301.

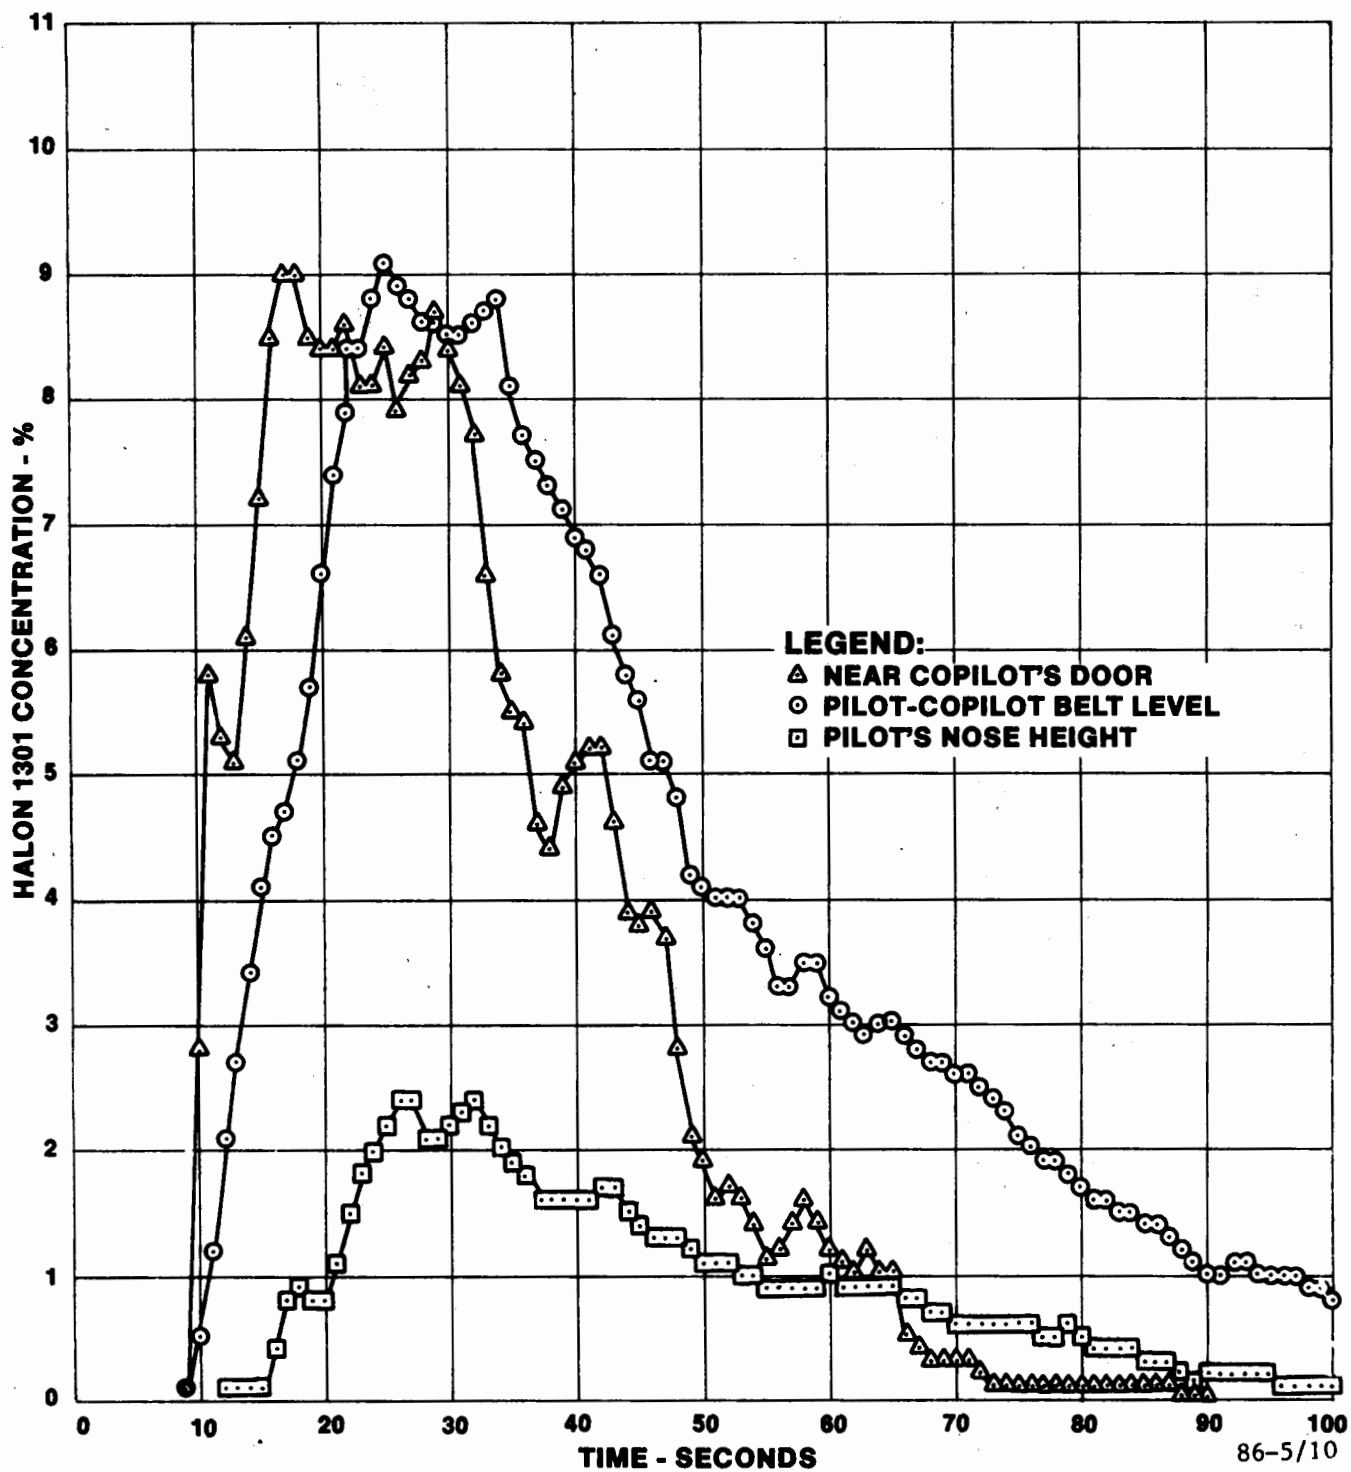
FIGURE 18. HALON 1301 CONCENTRATIONS - 3-POUND EXTINGUISHER DIRECTED UNDER INSTRUMENT PANEL - PILOT'S SIDE - OVERHEAD VENTS CLOSED

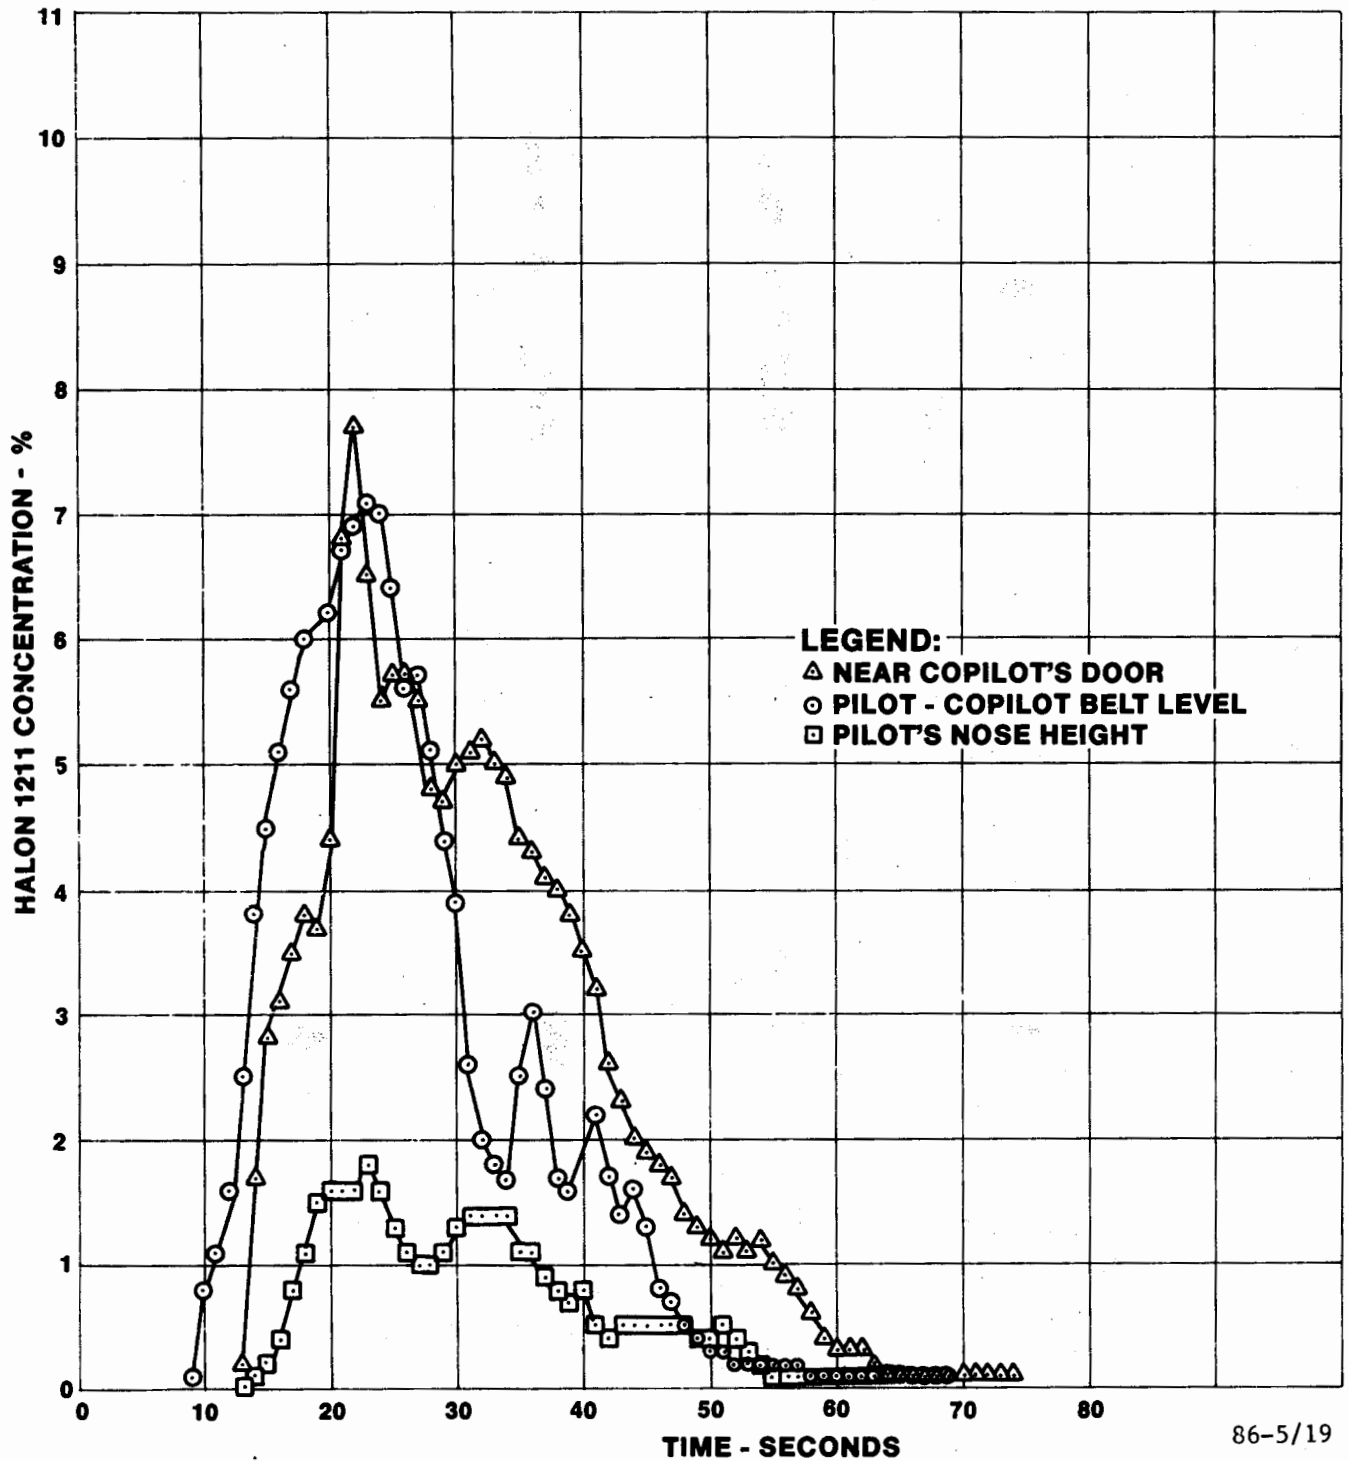
FIGURE 19. HALON 1211 CONCENTRATIONS - 2.5-POUND EXTINGUISHER DIRECTED TO THE COPILOT'S DOOR - OVERHEAD VENTS OPEN

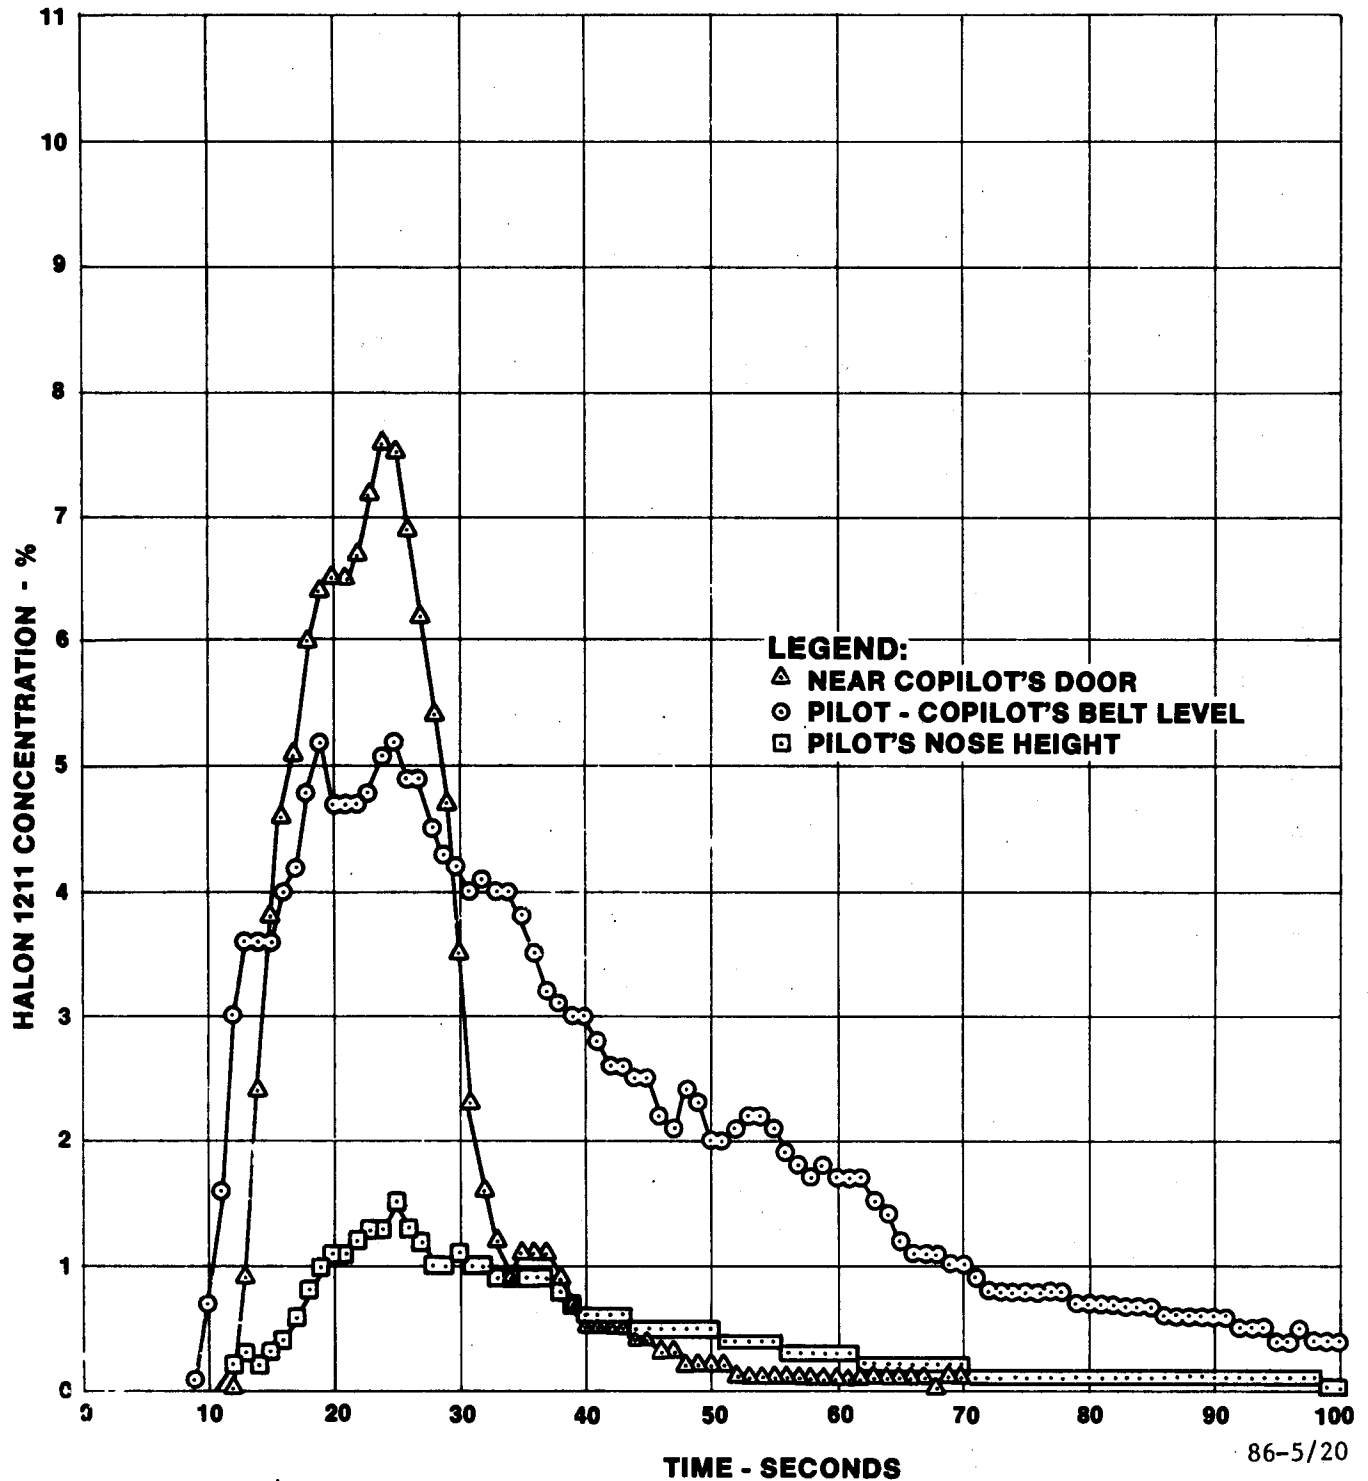
FIGURE 20. HALON 1211 CONCENTRATIONS - 2.5-POUND EXTINGUISHER DIRECTED TO THE COPILOT'S DOOR - OVERHEAD VENTS CLOSED

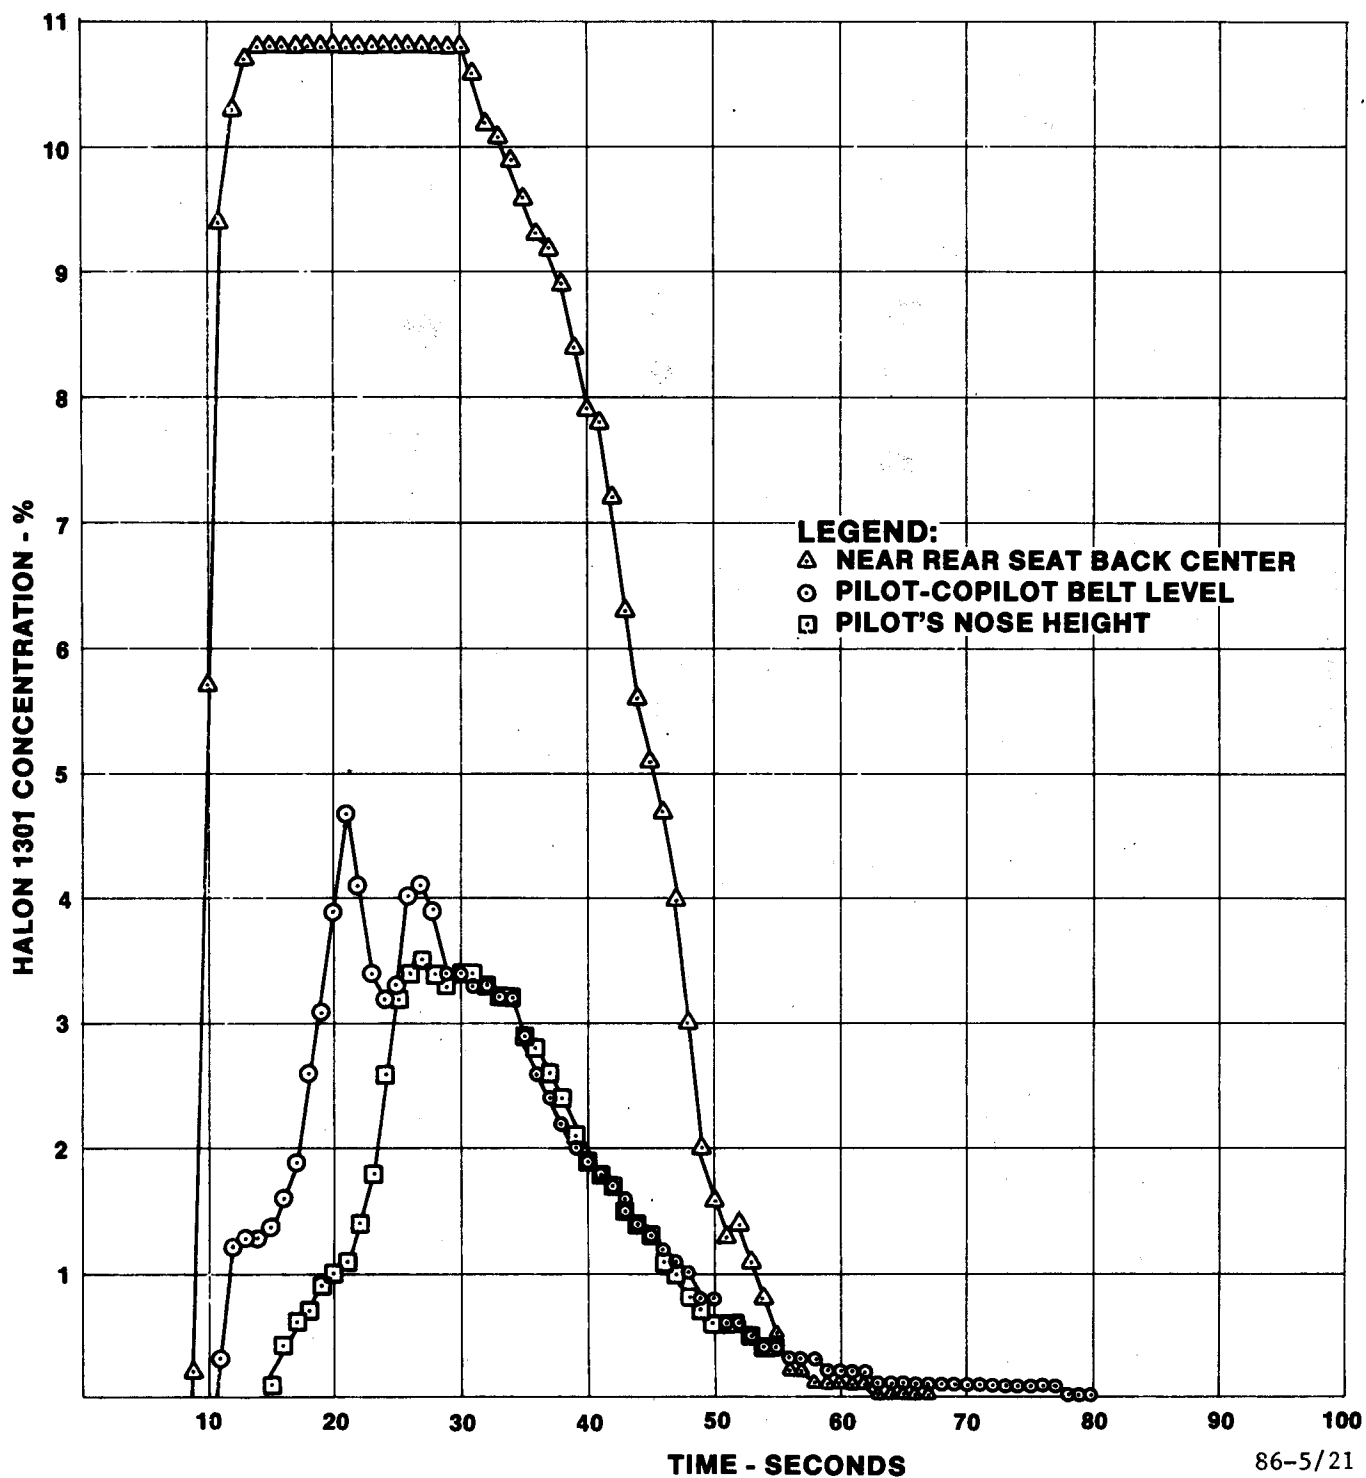
FIGURE 21. HALON 1301 CONCENTRATIONS - 3-POUND EXTINGUISHER DIRECTED TO THE REAR SEAT - OVERHEAD VENTS OPEN

Two Halon 1211 and two Halon 1301 bottles were discharged to the center of the rear seat back. The measurements plotted versus time are in figures 21 through 24 and values are tabulated in table 2. Dose calculations for the pilot's nose was only up to 33 percent of the limit for Halon 1211 and up to 23 percent of the limit for Halon 1301. Dose for the pilot's belt level was also low and was below the limit dose for both agents.

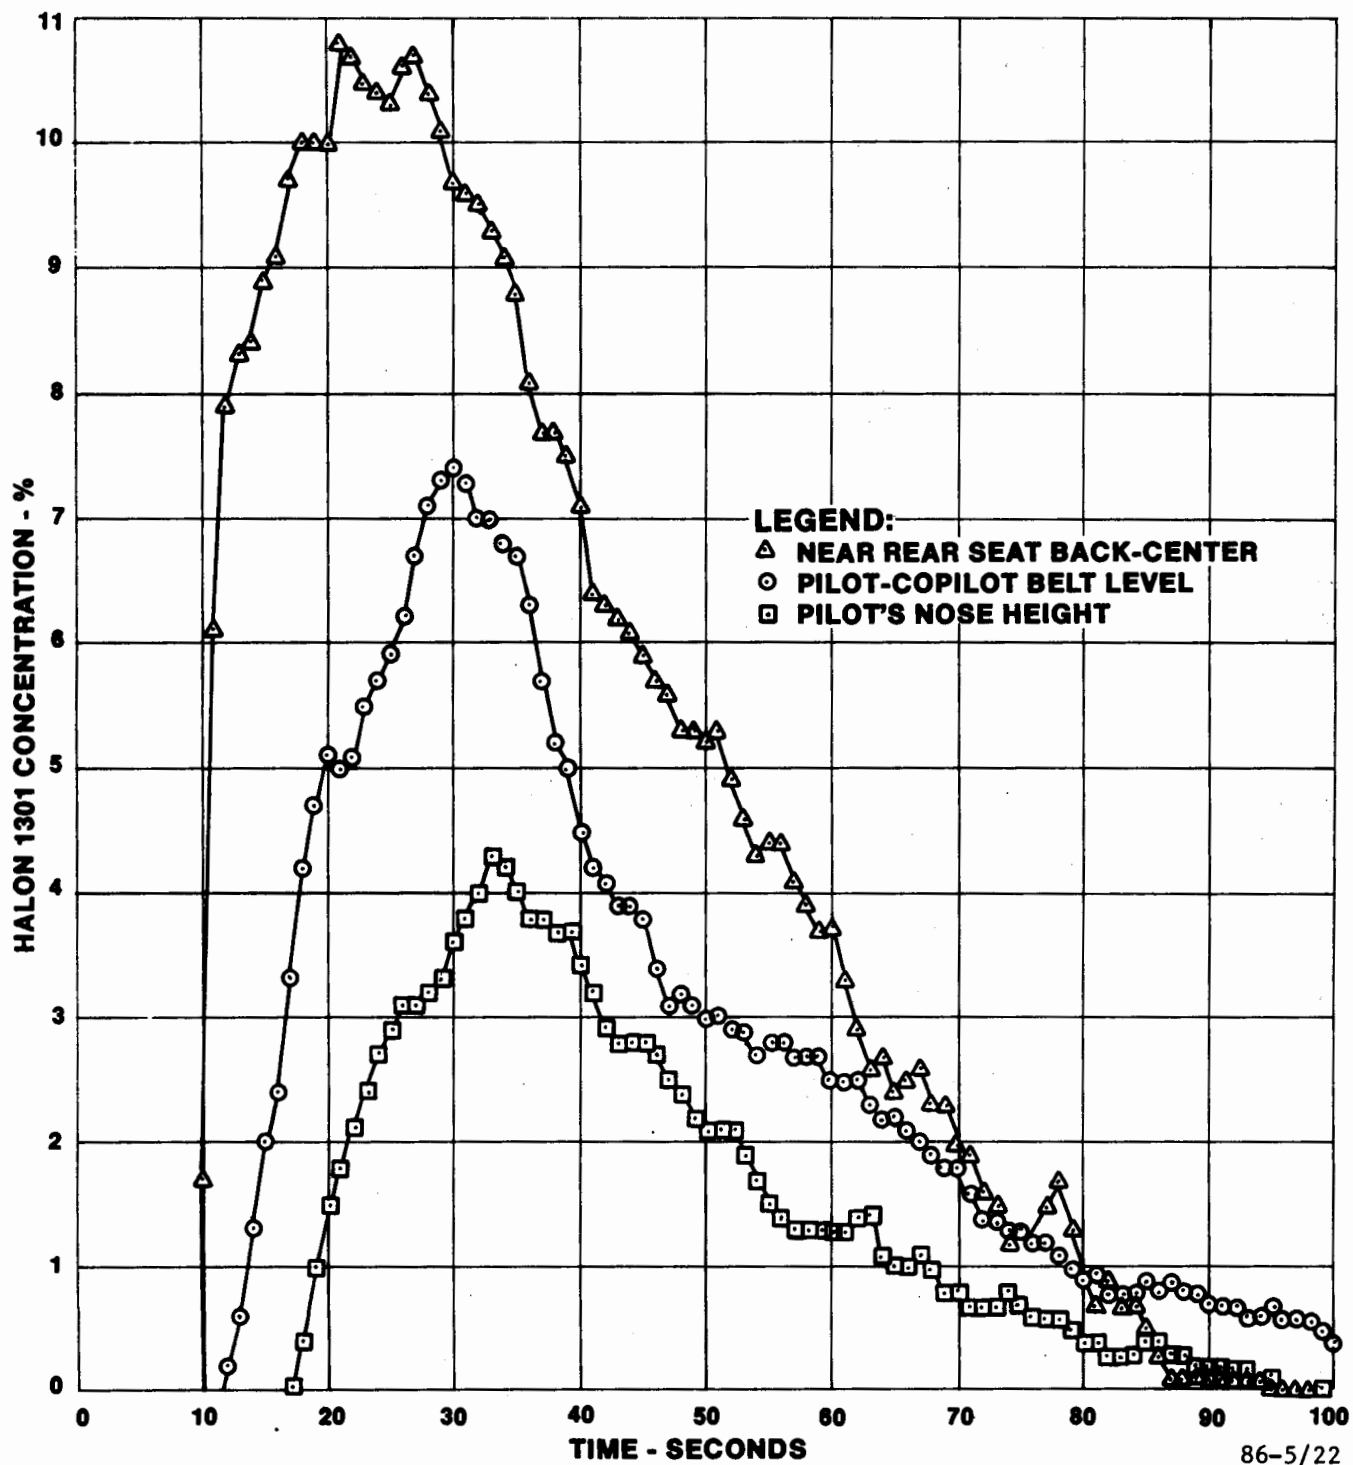
FIGURE 22. HALON 1301 CONCENTRATIONS - 3-POUND EXTINGUISHER DIRECTED TO THE REAR SEAT - OVERHEAD VENTS CLOSED

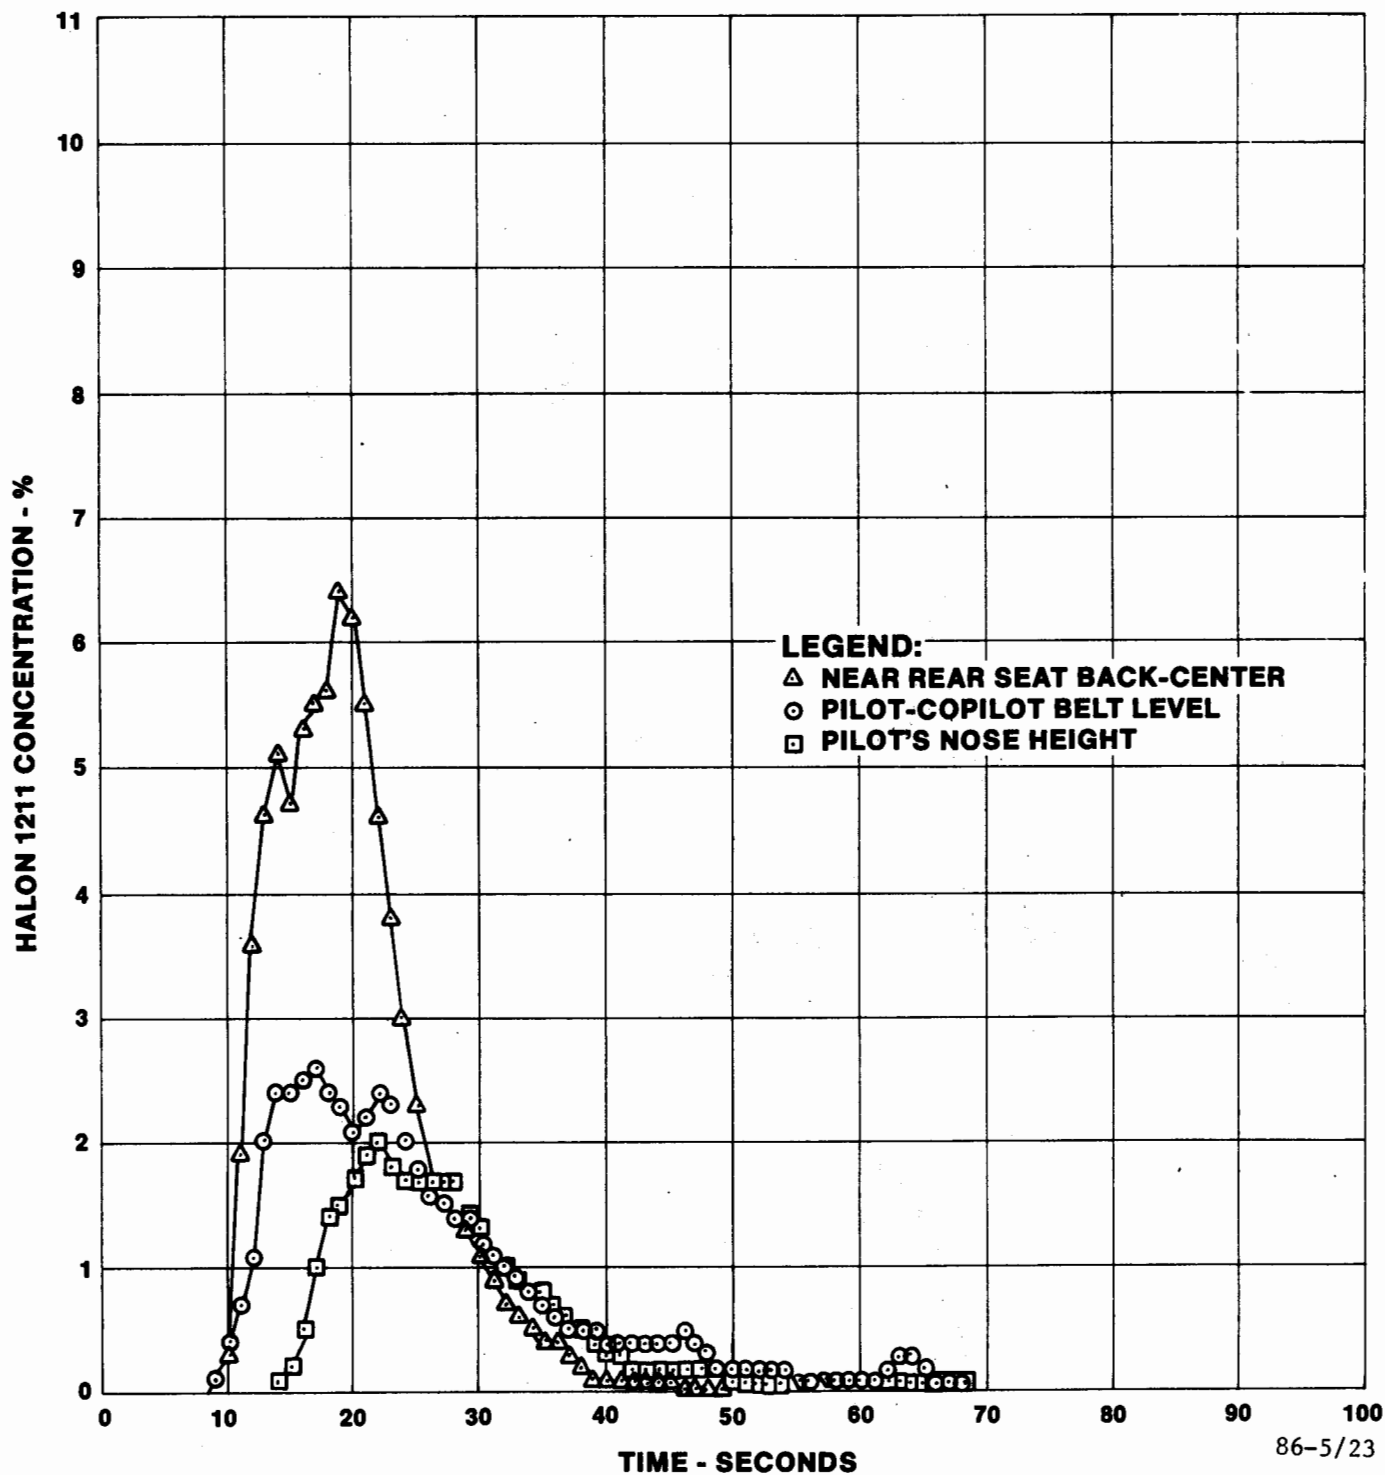
FIGURE 23. HALON 1211 CONCENTRATIONS - 2.5-POUND EXTINGUISHER DIRECTED TO THE REAR SEAT - OVERHEAD VENTS OPEN

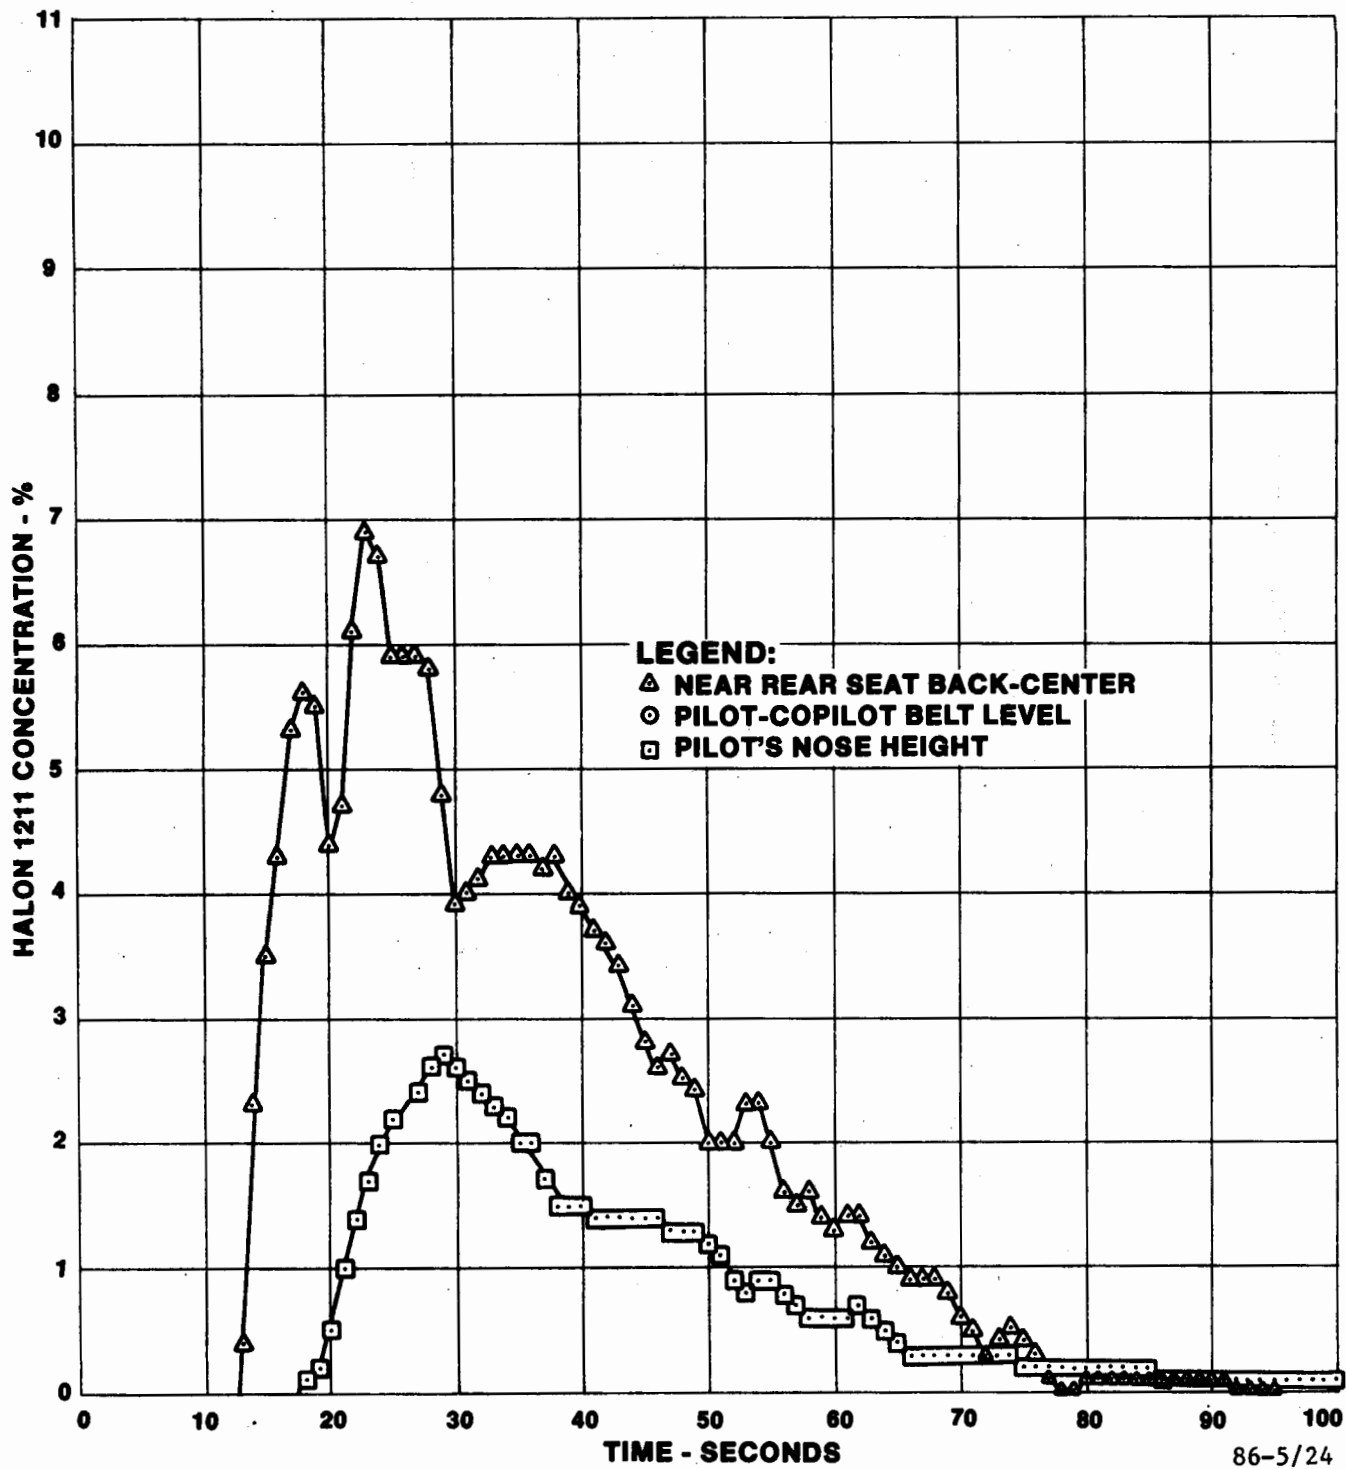
FIGURE 24. HALON 1211 CONCENTRATIONS - 2.5-POUND EXTINGUISHER DIRECTED TO THE REAR SEAT - OVERHEAD VENTS CLOSED
