DOT/FAA/CT-86/5

# Halon Extinguisher Agent Behavior in a Ventilated Small Aircraft

Final Report

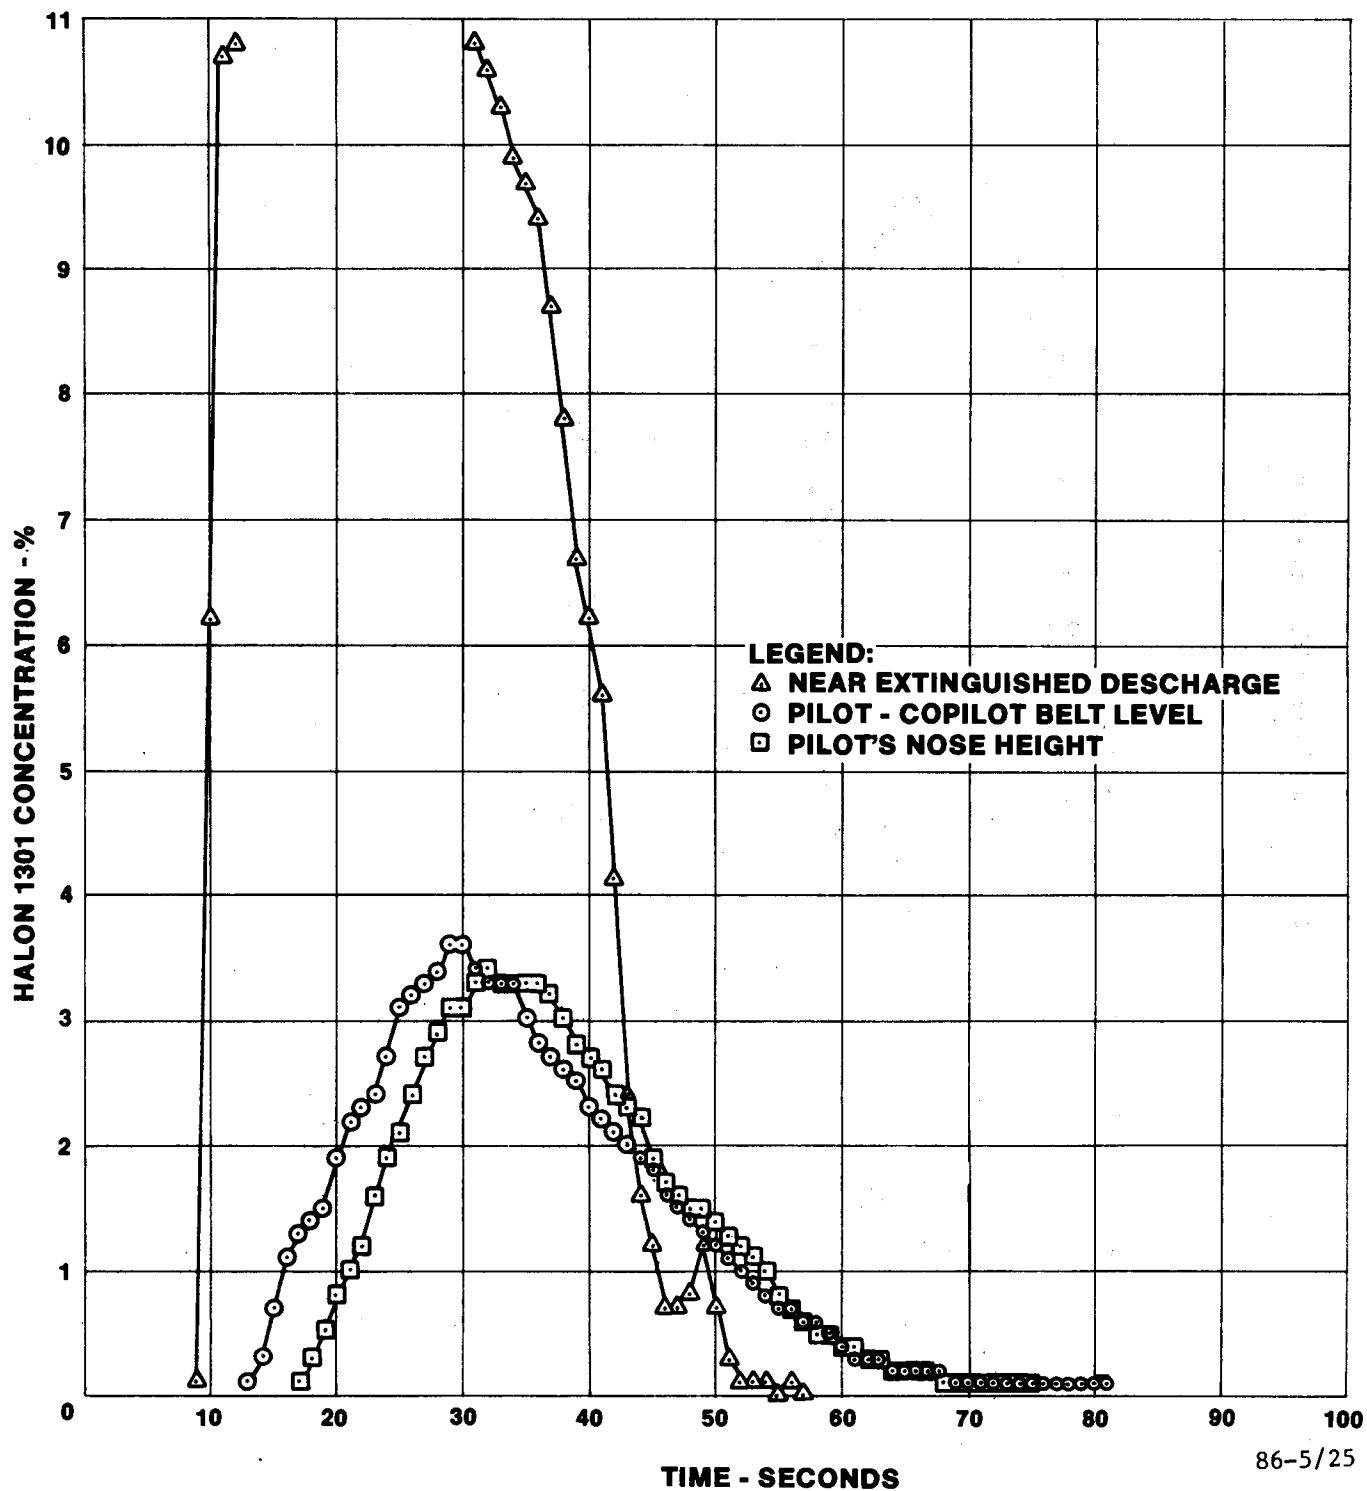
FIGURE 25. HALON 1301 CONCENTRATIONS - 3-POUND EXTINGUISHER DIRECTED TO THE BAGGAGE COMPARTMENT - OVERHEAD VENTS OPEN

Extinguishers were directed to the center section of the baggage compartment. Tests of both Halon 1211 and Halon 1301 extinguishers were completed. The measurements are plotted in figures 25 through 28 and selected values are tabulated in table 2. The dose calculations for the pilot's nose was only 16 percent of the limit for Halon 1211, and only up to 15 percent of the limit for Halon 1301. Dose for the pilot's belt level was also low and was below the limit dose for both agents.

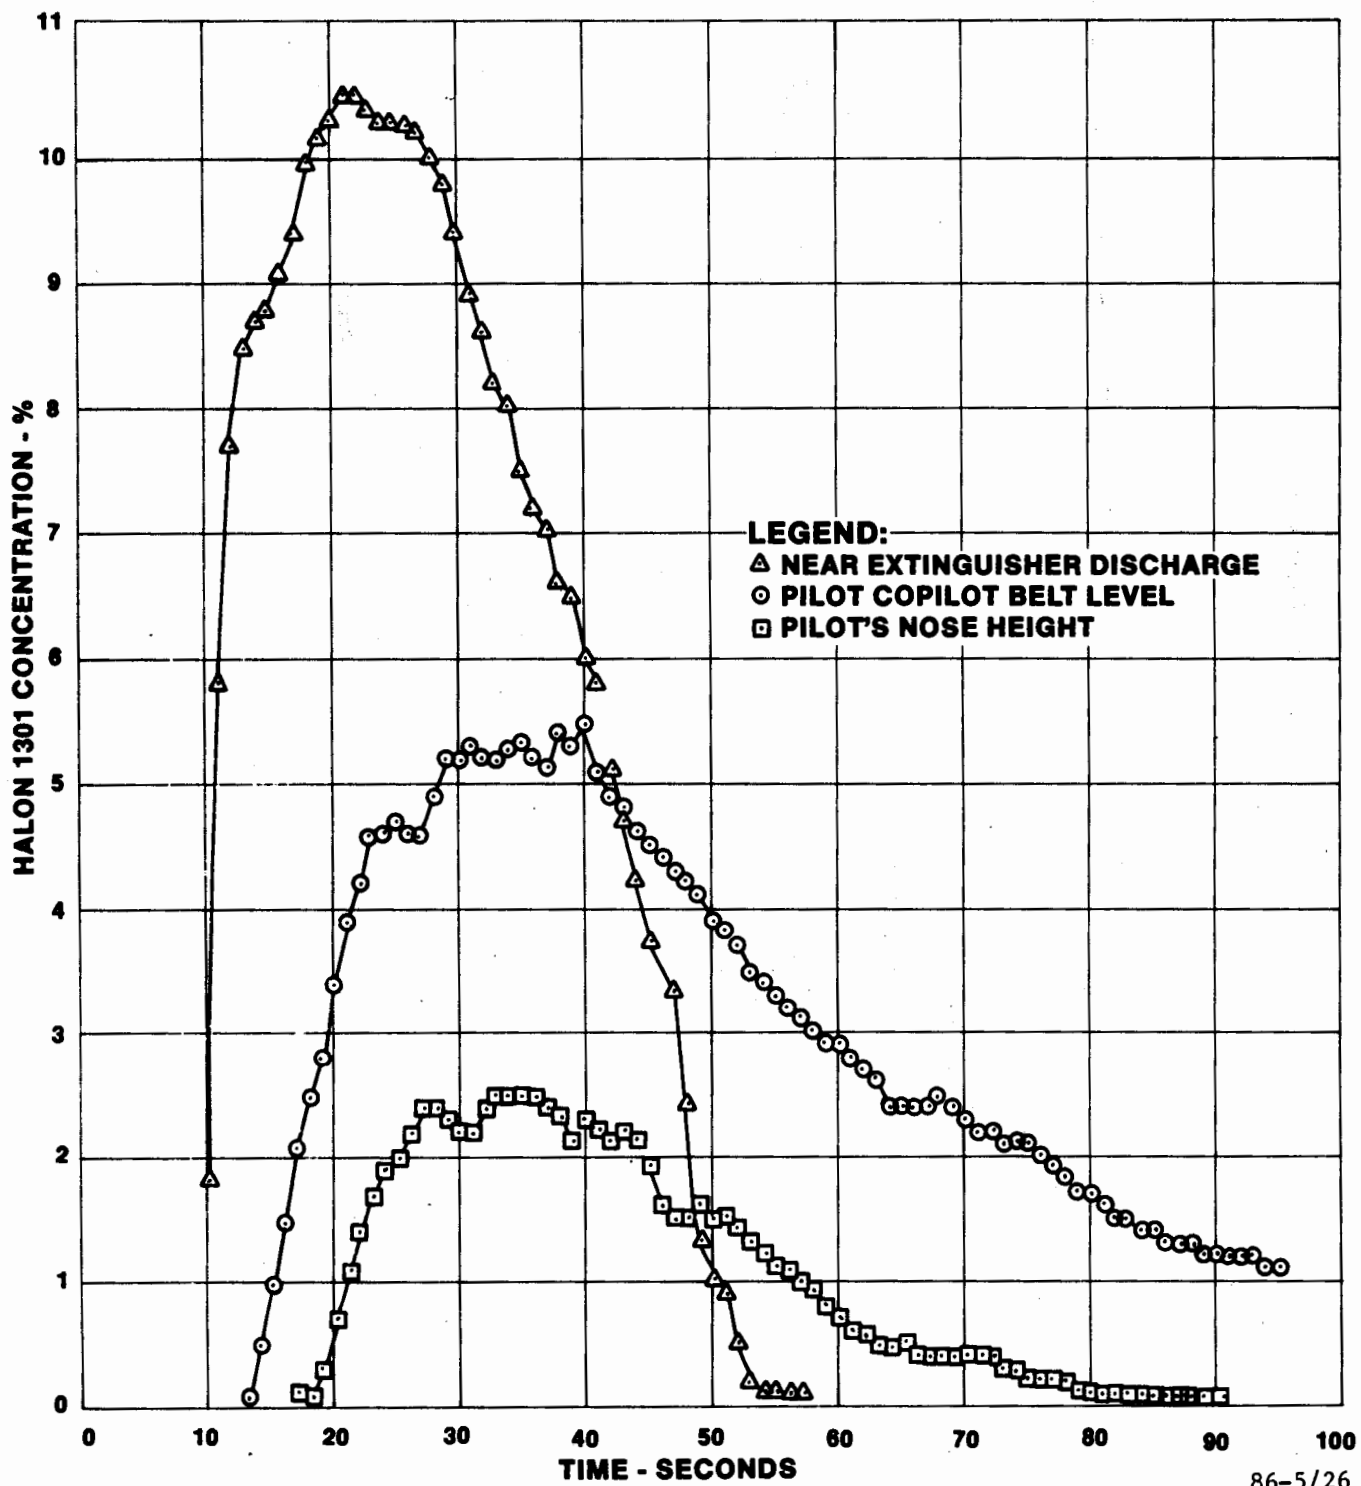
FIGURE 26. HALON 1301 CONCENTRATIONS - 3-POUND EXTINGUISHER DIRECTED TO THE BAGGAGE COMPARTMENT - OVERHEAD VENTS CLOSED

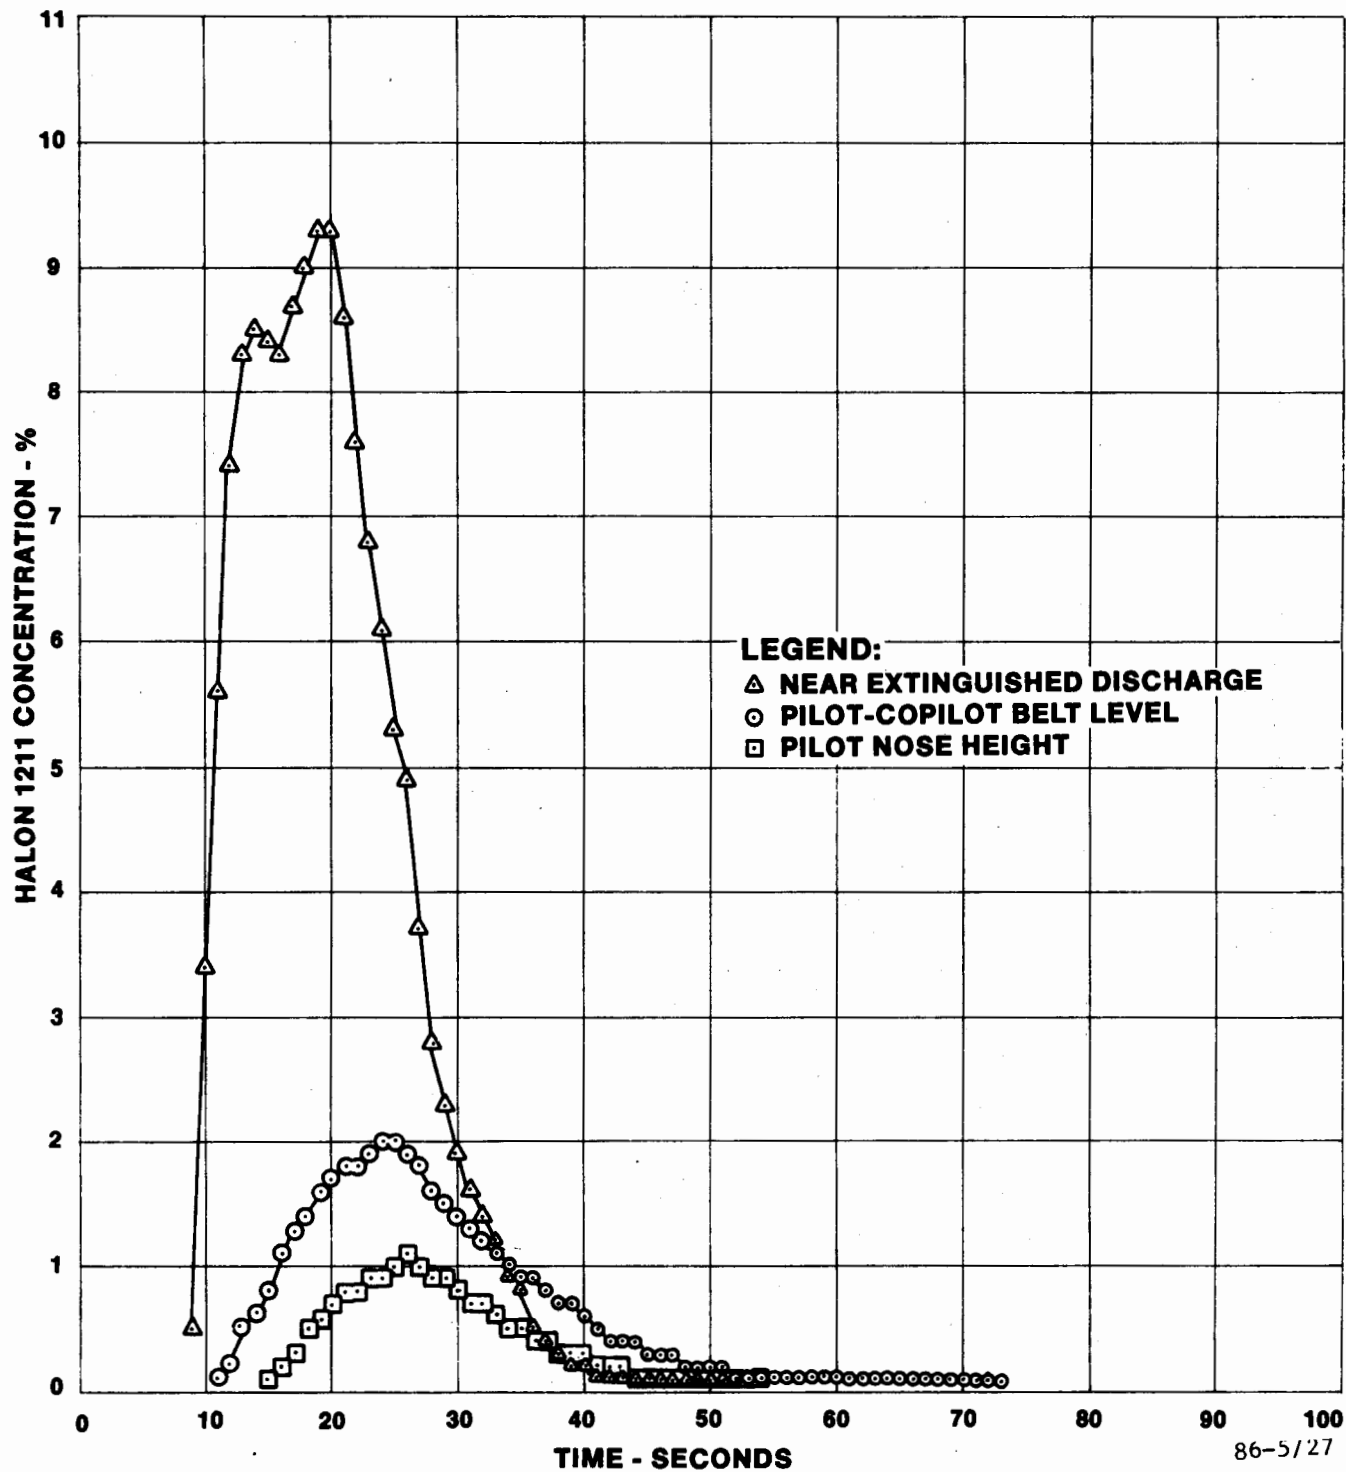
FIGURE 27. HALON 1211 CONCENTRATIONS - 2.5-POUND EXTINGUISHER DIRECTED TO THE BAGGAGE COMPARTMENT - OVERHEAD VENTS OPEN

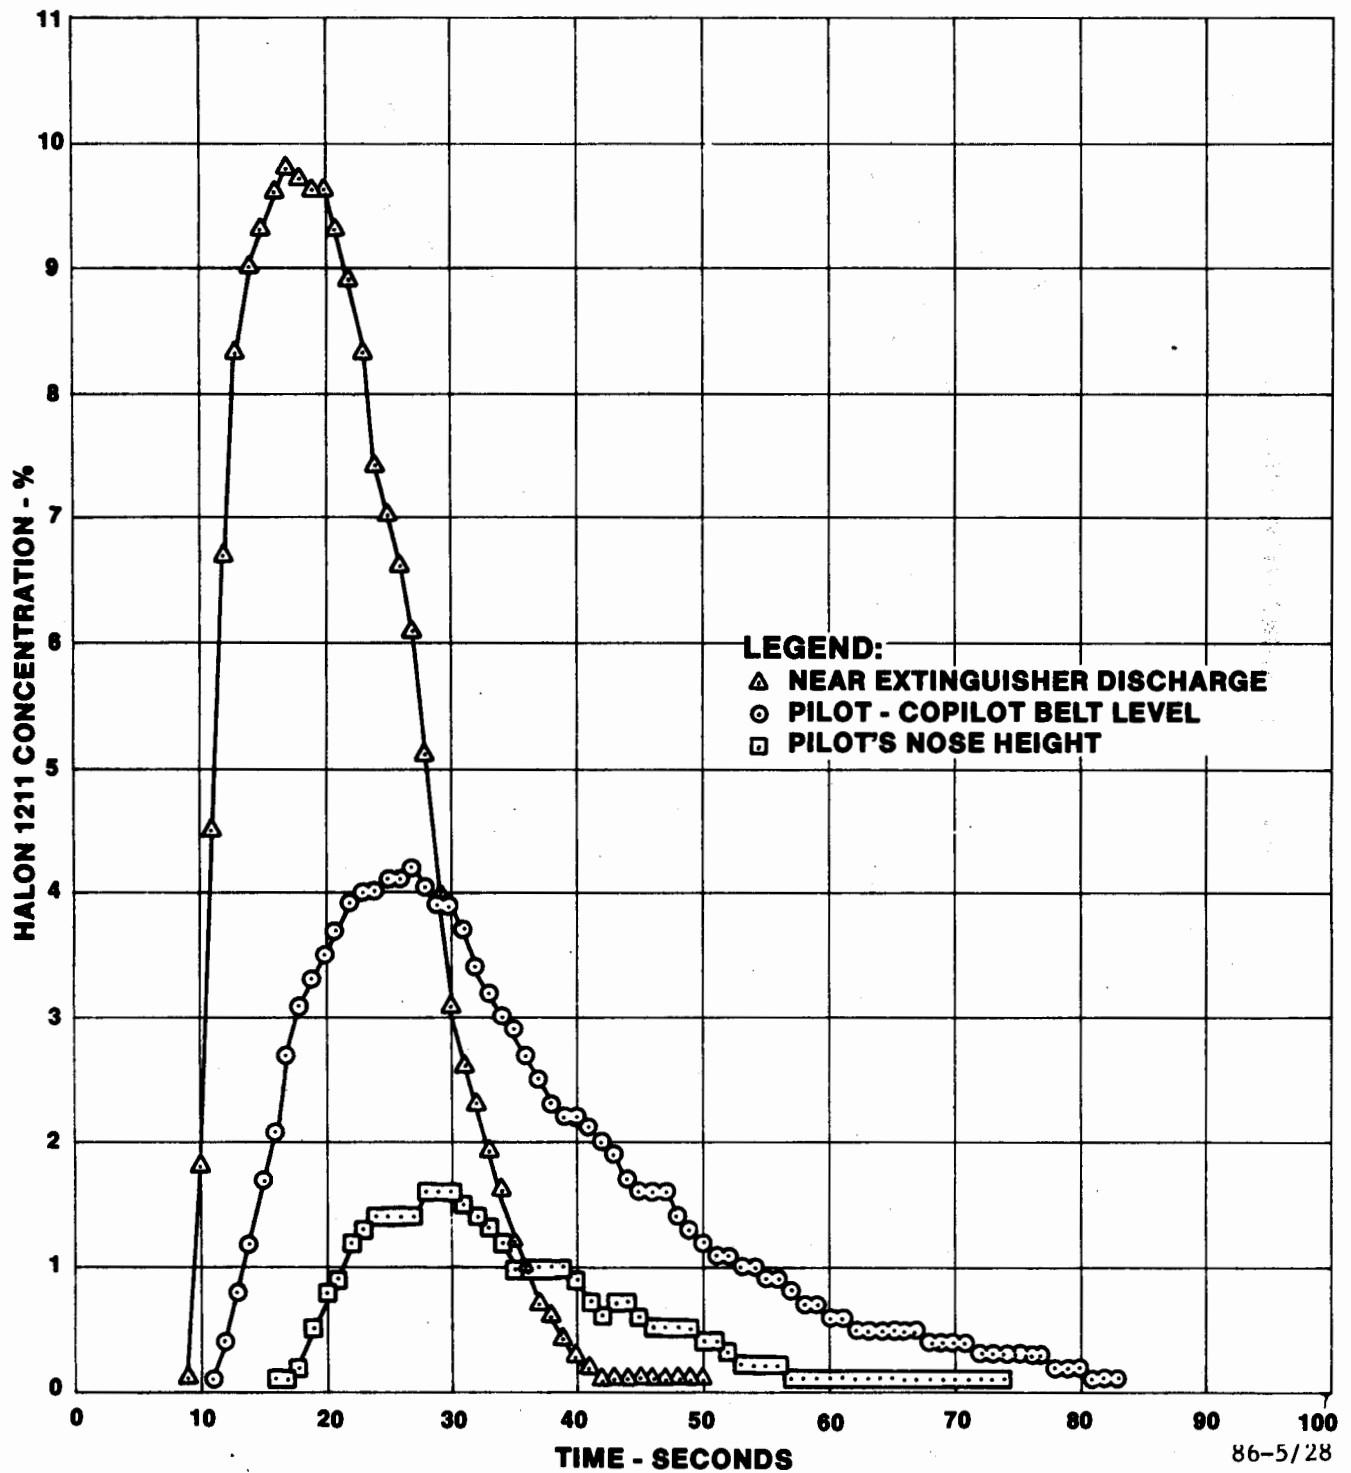
FIGURE 28. HALON 1211 CONCENTRATIONS - 2.5-POUND EXTINGUISHER DIRECTED TO THE BAGGAGE COMPARTMENT - OVERHEAD VENTS CLOSED

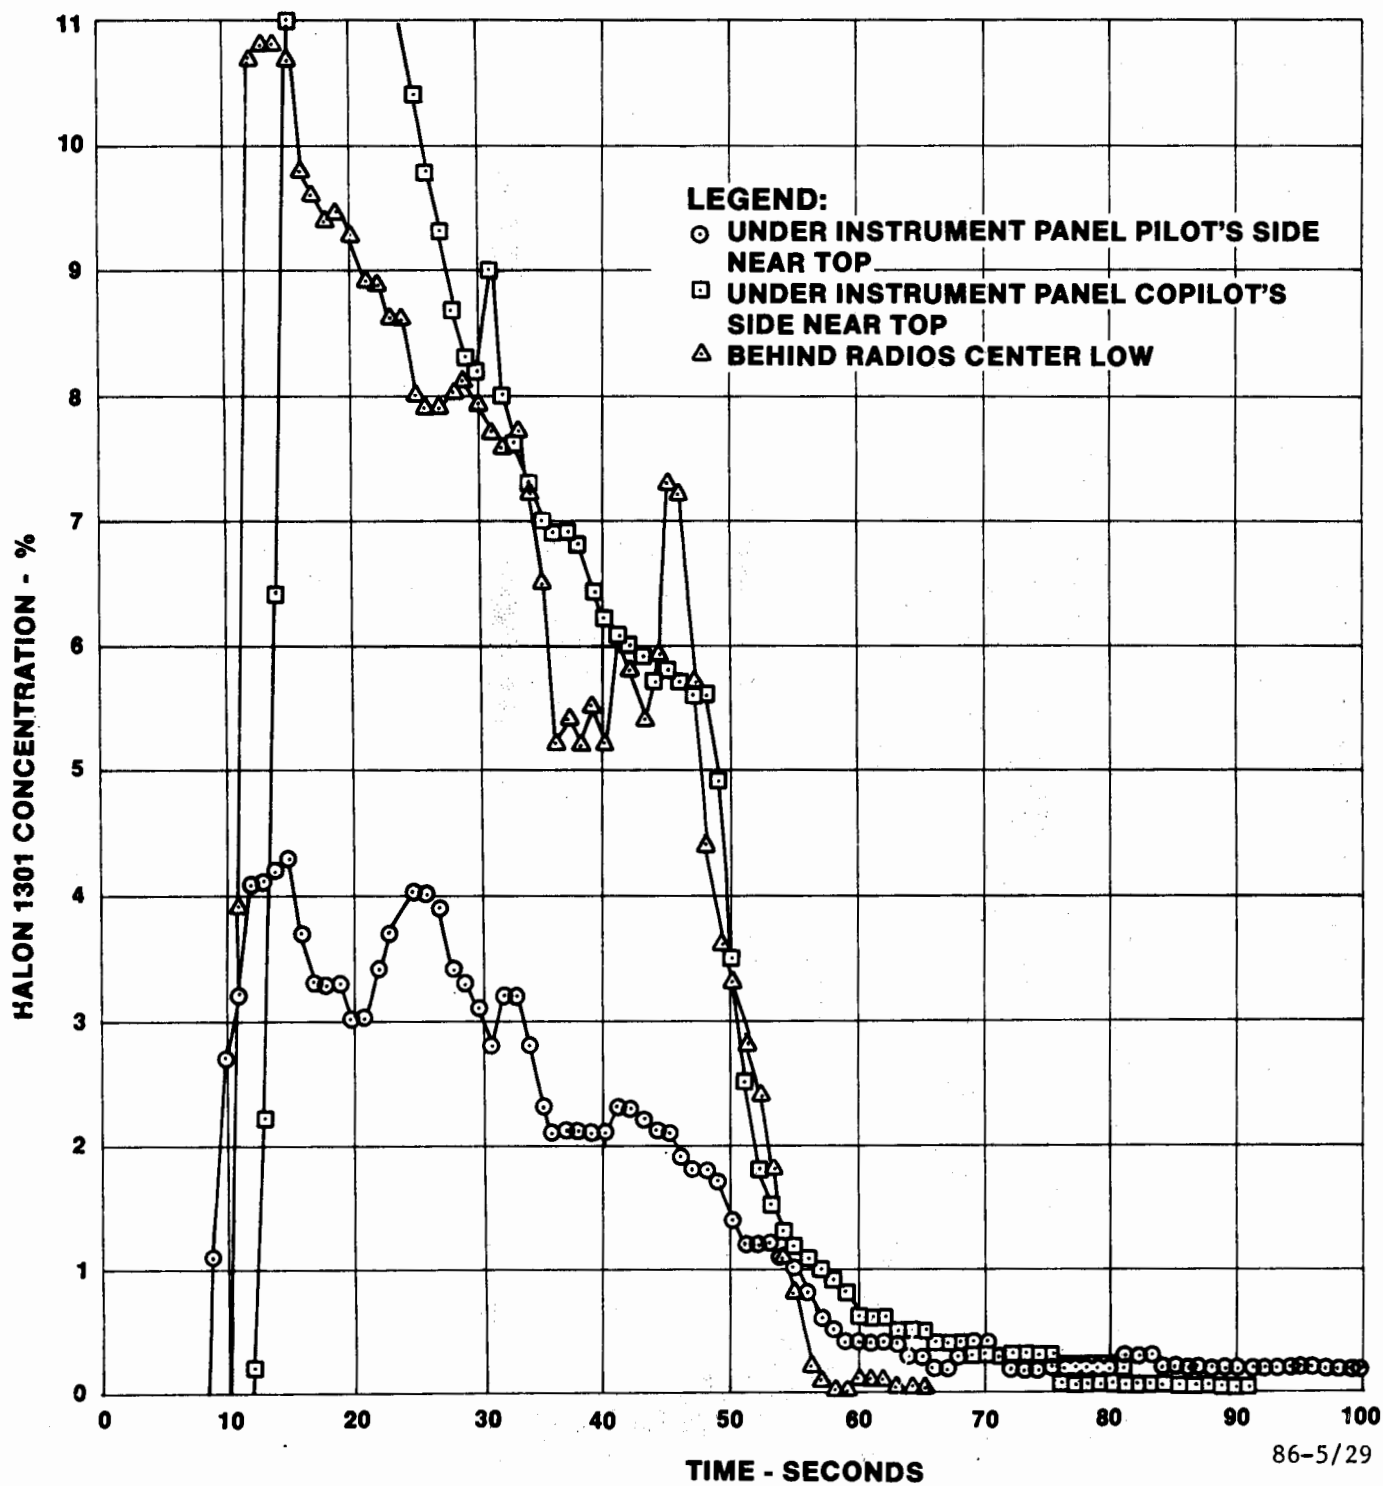
FIGURE 29. HALON 1301 CONCENTRATIONS - 3-POUND EXTINGUISHER DIRECTED UNDER THE INSTRUMENT PANEL - COPILOT'S SIDE - ALL SAMPLE LINES UNDER INSTRUMENT PANEL

An investigation was conducted to determine the distribution of extinguisher agents under the instrument panel. The gas sample lines were arranged to sample near the top of the instrument panel (pilot's side), near the top of the instrument panel (copilot's side), and at the very low center section under the stack of radios and direction finding electronics. The measurements are plotted versus time, figures 29 through 32, and selected values are listed in table 4. One Halon 1211 extinguisher and one 1301 extinguisher were discharged under the instrument panel on the copilot's side and identical testing was completed by discharging the extinguishers under the instrument panel pilot's side. High levels of agent (10 to 11 percent) were measured under the instrument panel on the side where the extinguishers were discharged. On the opposite side of the instrument panel, extinguisher gas concentrations ranged from 3.8 percent to 4.5 percent. Under the stack of radios located in the center section, concentrations ranged from high levels to low levels of 3.8 percent. Thus, both agents exhibited good distribution throughout the sampled area beneath the instrument panel.

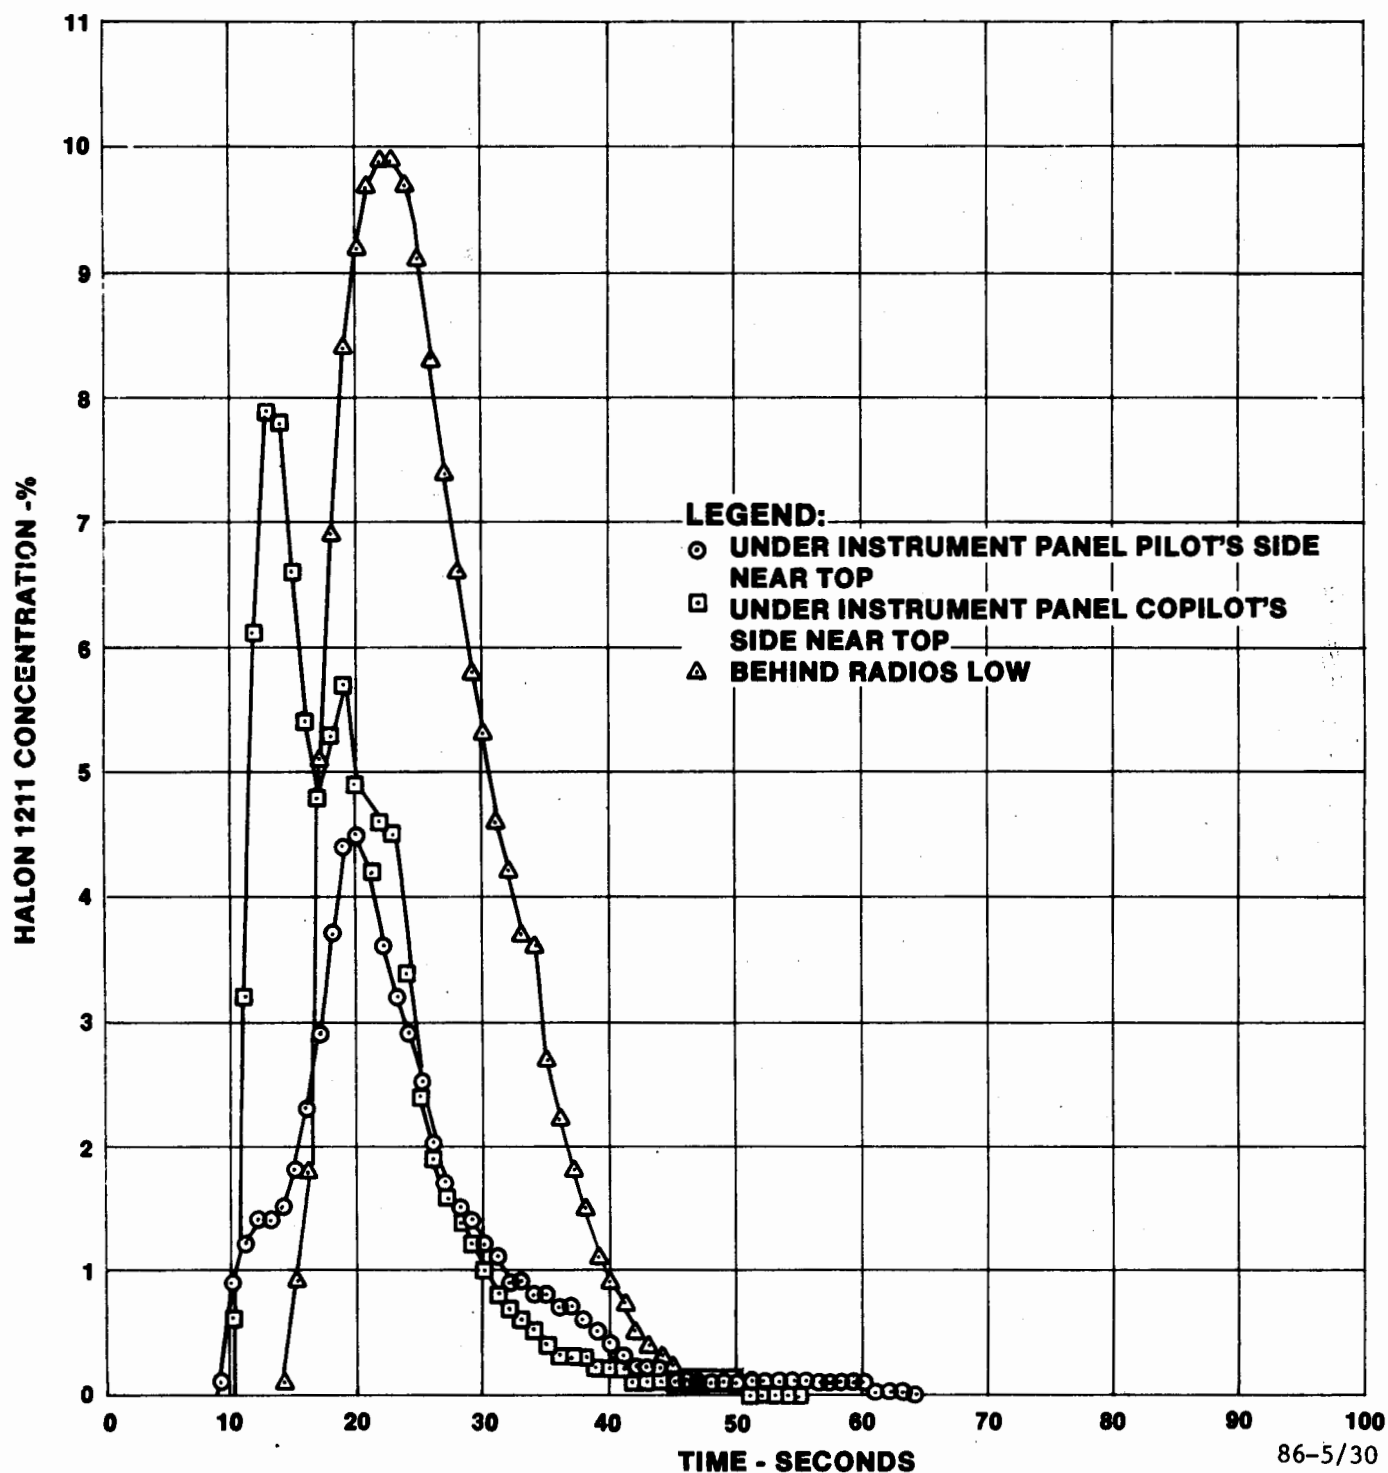
FIGURE 30. HALON 1211 CONCENTRATIONS - 2.5-POUND EXTINGUISHER DIRECTED UNDER THE INSTRUMENT PANEL - COPILOT'S SIDE - ALL SAMPLE LINES UNDER INSTRUMENT PANEL

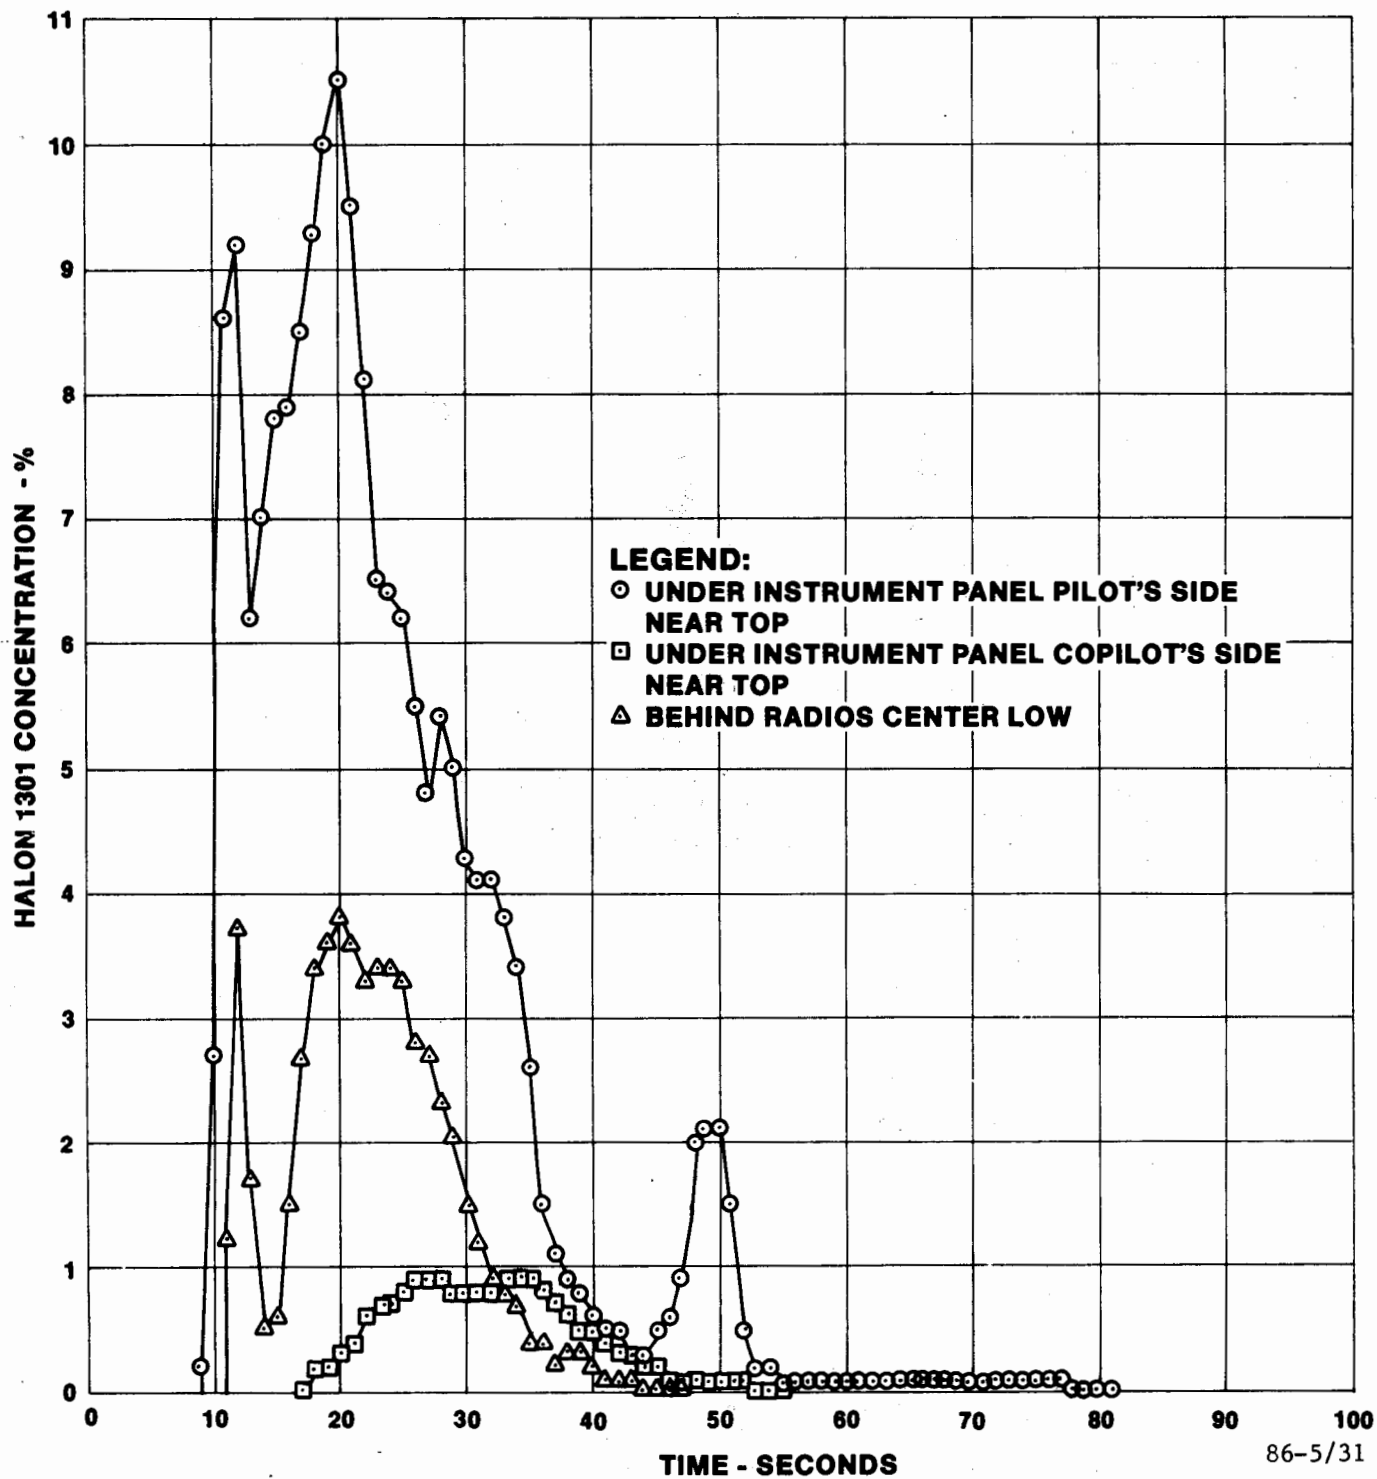
86-5/31

FIGURE 31. HALON 1301 CONCENTRATIONS - 3-POUND EXTINGUISHER DIRECTED UNDER THE INSTRUMENT PANEL - PILOT'S SIDE - ALL SAMPLE LINES UNDER THE INSTRUMENT PANEL

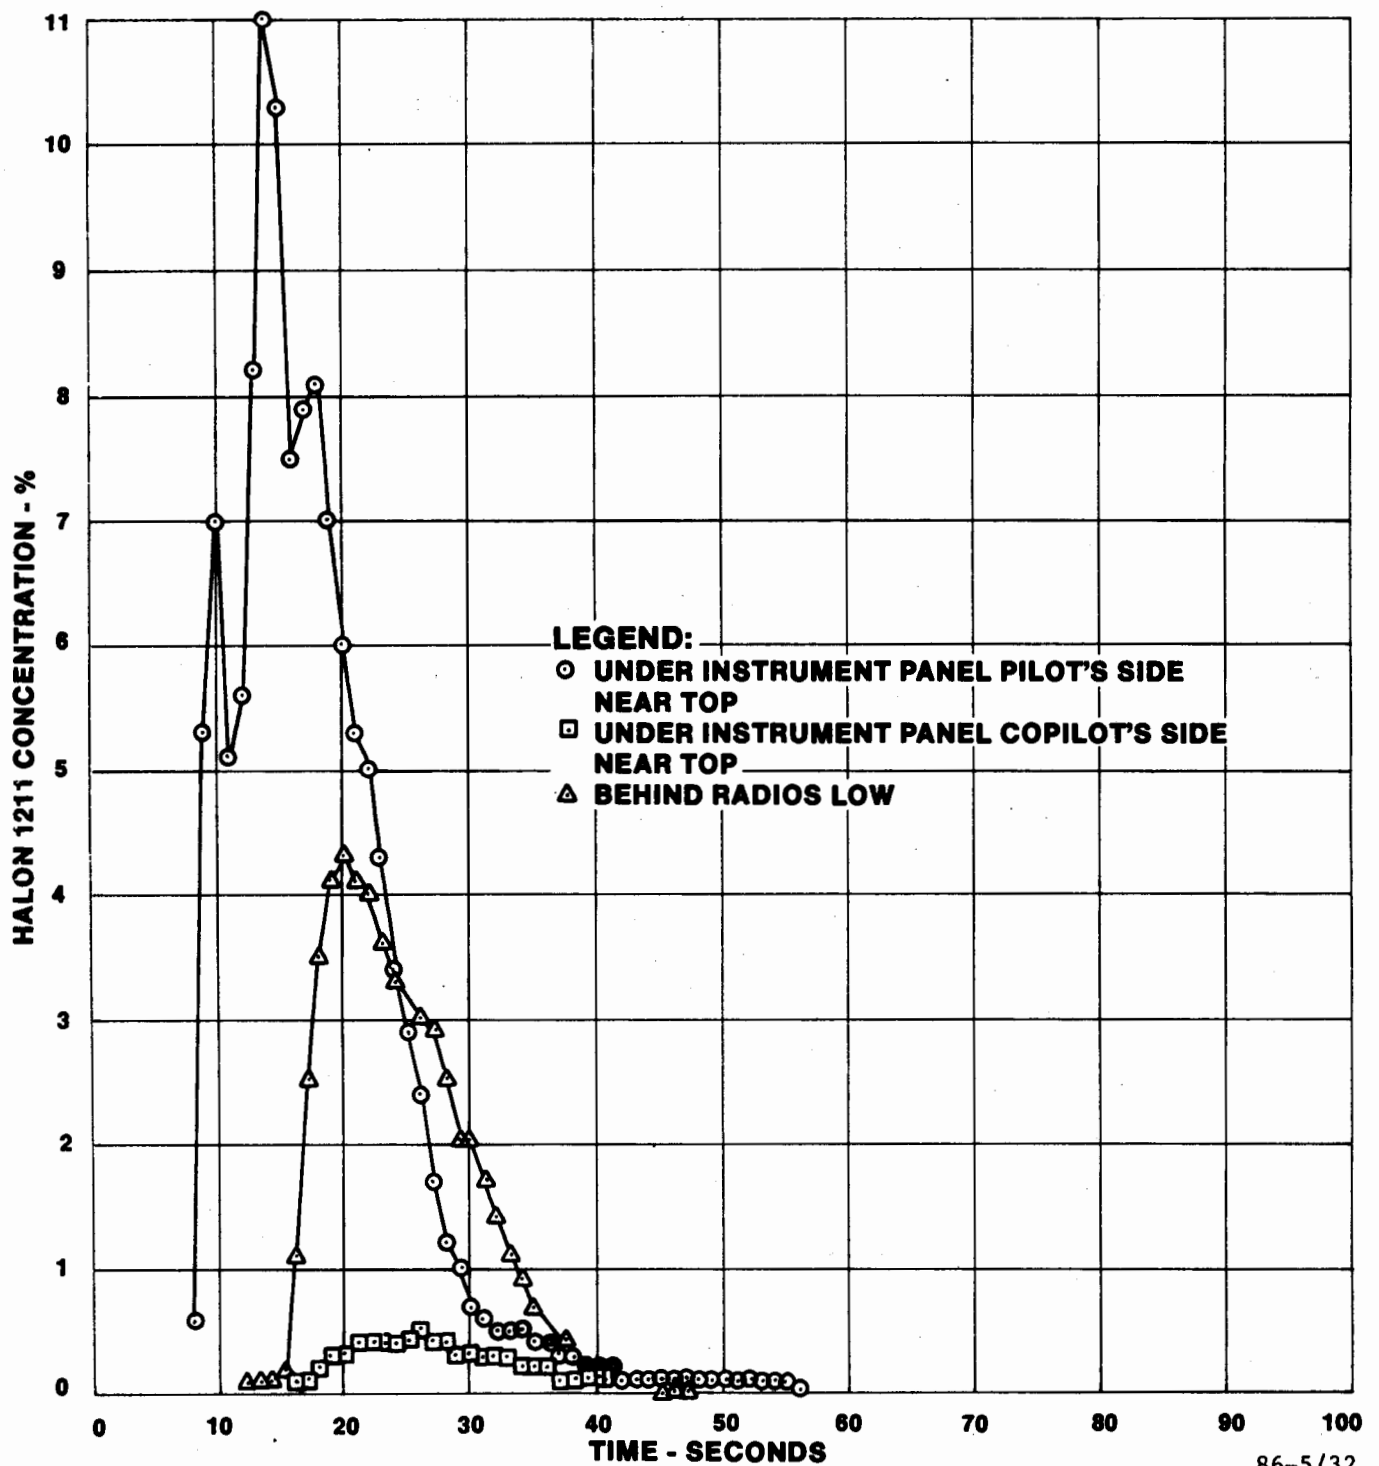
86-5/32

FIGURE 32. HALON 1211 CONCENTRATIONS - 2.5-POUND EXTINGUISHER DIRECTED UNDER THE INSTRUMENT PANEL - PILOT'S SIDE - ALL SAMPLE LINES UNDER THE INSTRUMENT PANEL

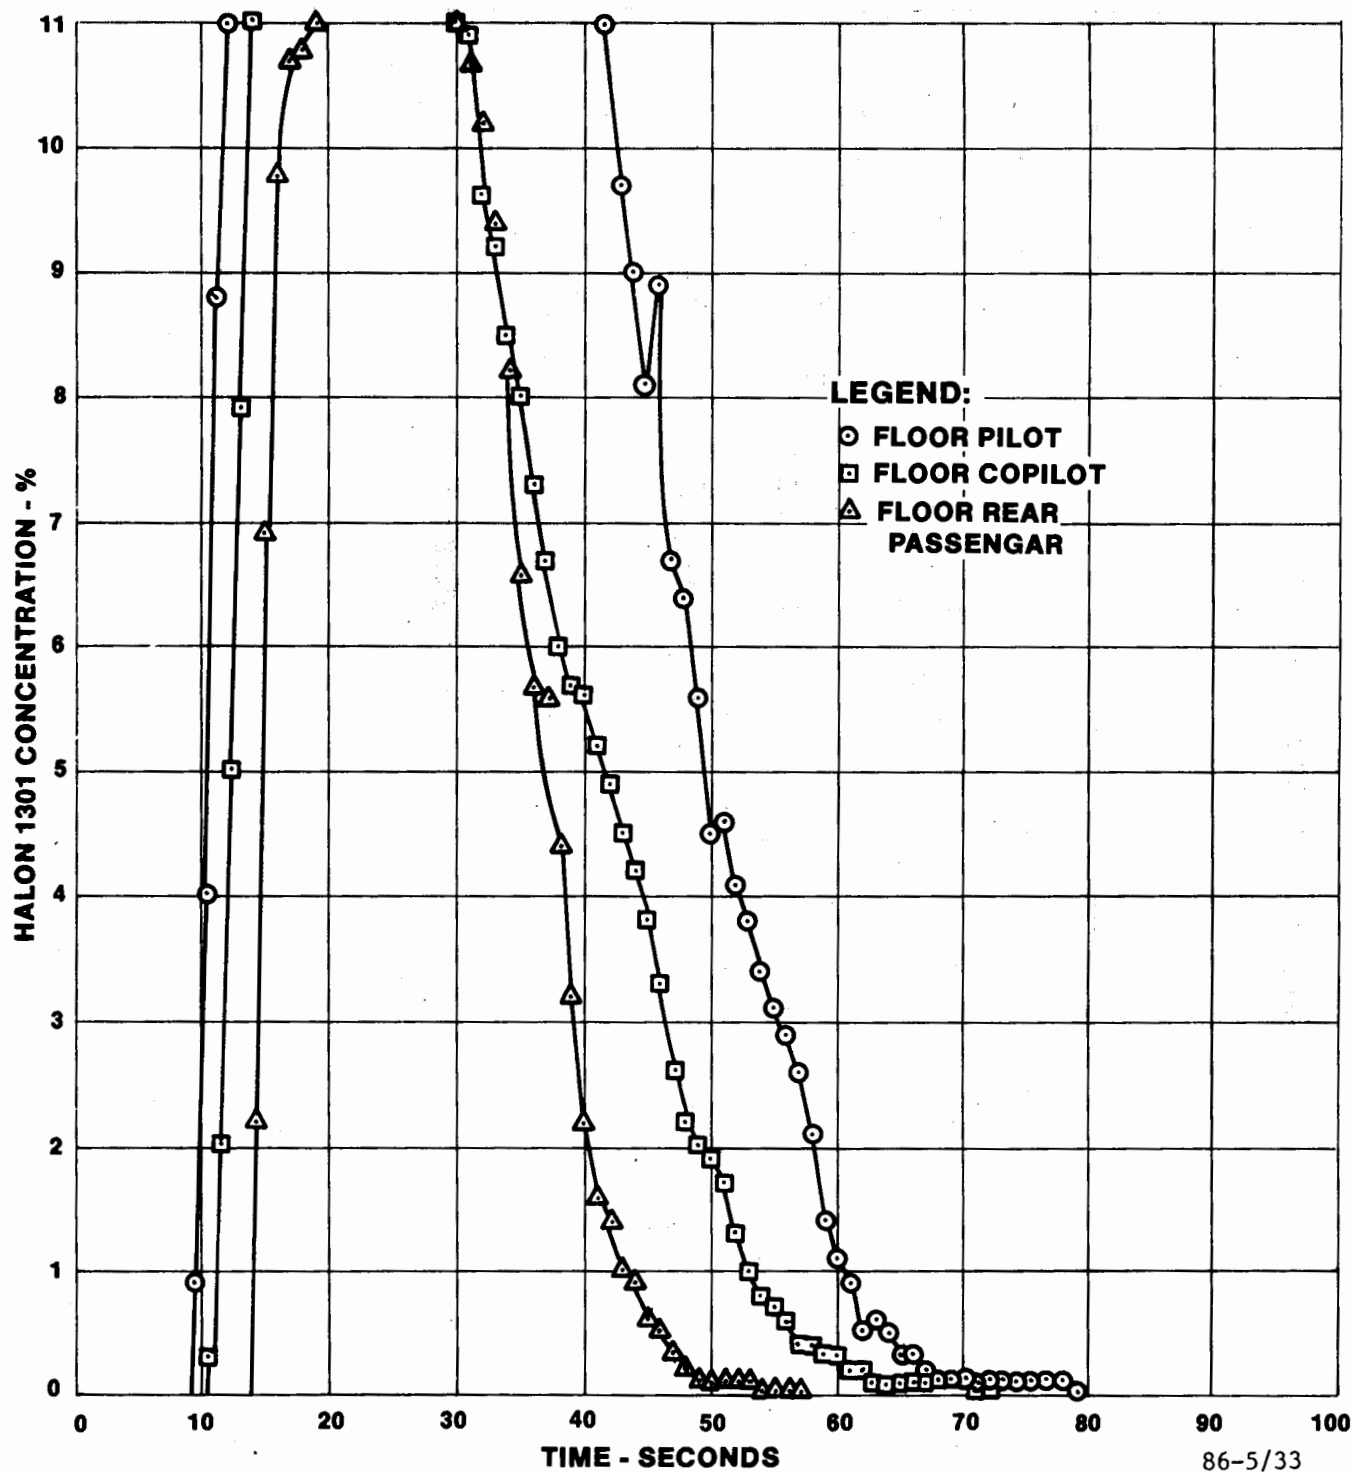
FIGURE 33. HALON 1301 CONCENTRATIONS - 3-POUND EXTINGUISHER DIRECTED TO THE FUEL AND HYDRAULIC SELECTOR VALVES - ALL SAMPLE LINES LOCATED ON THE FLOOR

Testing was designed to measure extinguisher agent stratification within the cabin. The three sample lines were placed on the cabin floor. Single sample lines were placed on the floor both near the pilot and the copilot and on the floor by the rear passenger behind the pilot. The measurements are in figures 33 and 34 and selected values are listed in table 5. The highest Halon extinguisher gas concentrations are located on the floor. In all cases, the gas measurement capability was overwhelmed and exceeded the maximum measurement level of 11 percent. Stratification of the Halon agents are presented in figure 35. Average gas measurements were plotted for the pilot-copilot belt level and for the pilot's nose location. As noted, only one test with each Halon was conducted for measurement of the agents for the floor. Stratification of the Halons is significant as they vary from over 11 percent on the floor to 2.65 percent and 4.03 percent at the pilot's nose and it appears that this relationship is near linear, figure 35.

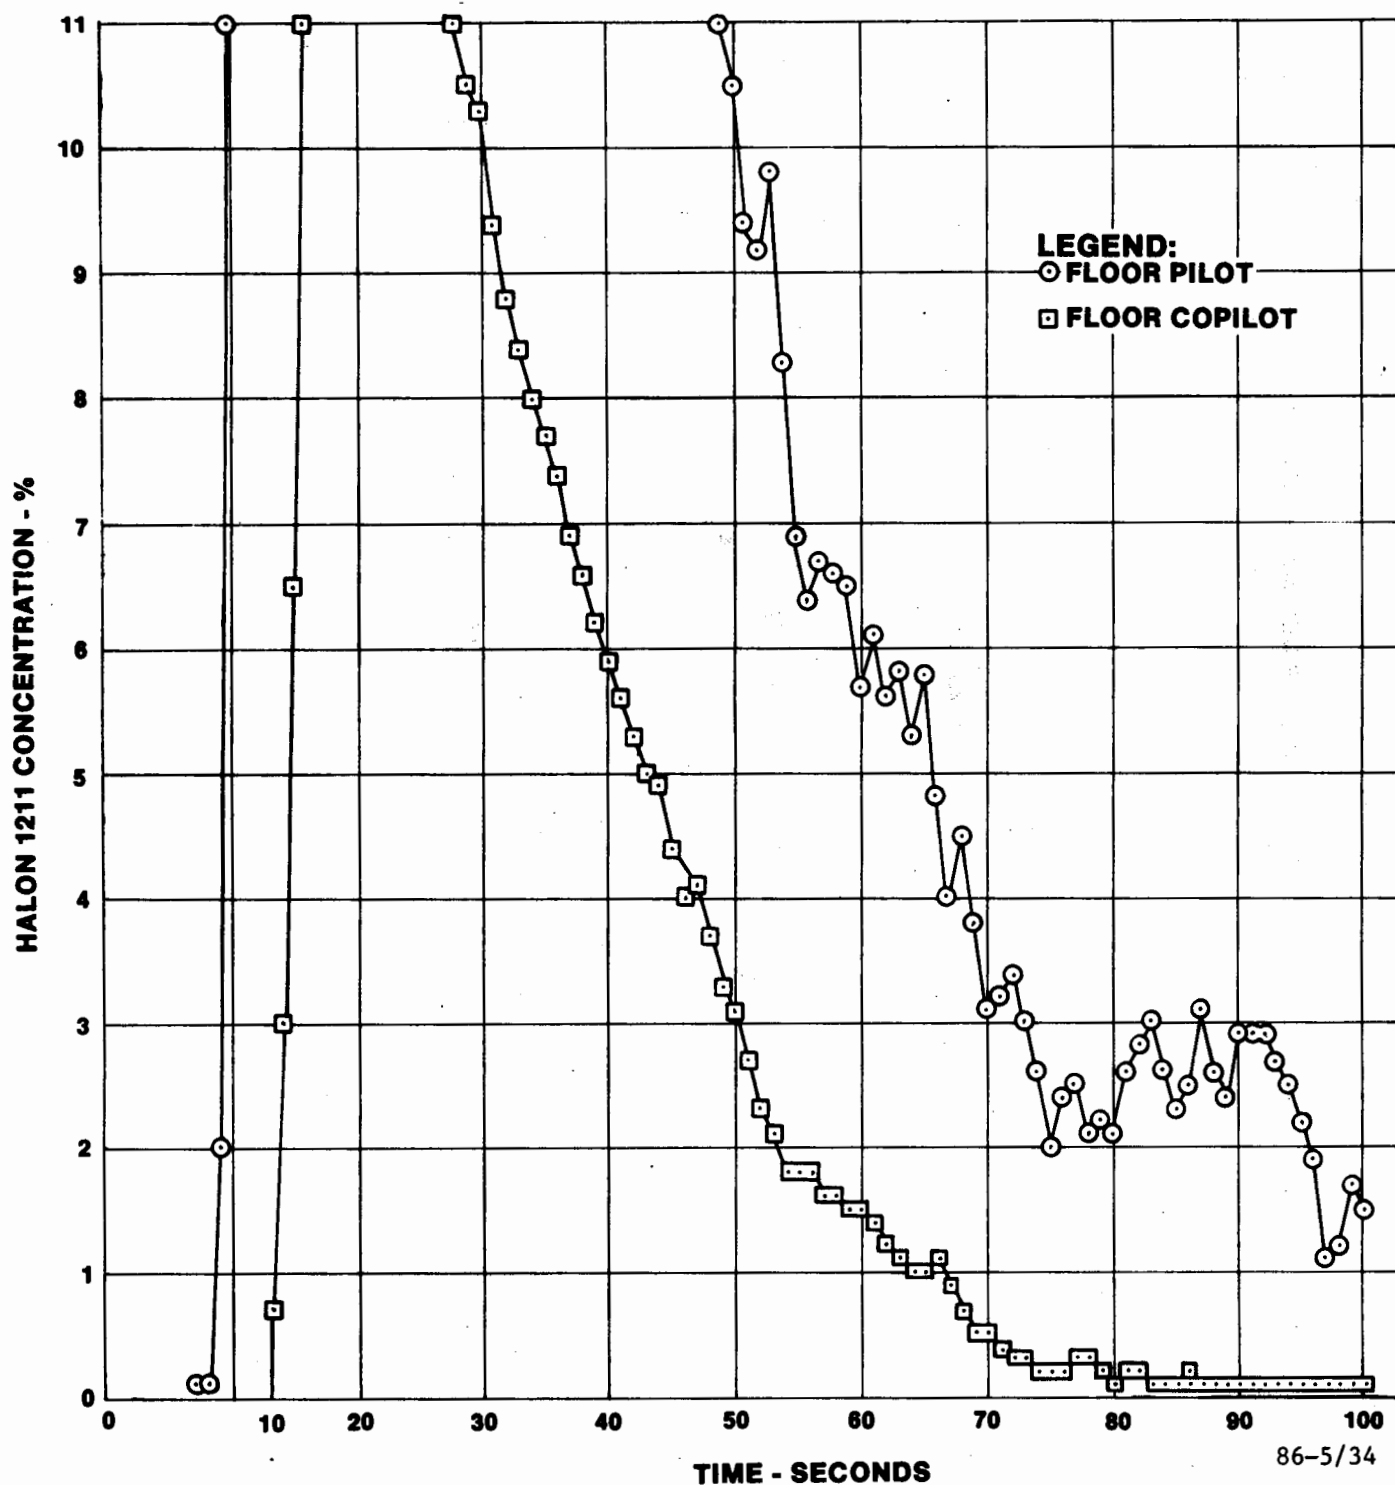
FIGURE 34. HALON 1211 CONCENTRATIONS - 2.5-POUND EXTINGUISHER DIRECTED TO THE FUEL AND HYDRAULIC SELECTOR VALVES - ALL SAMPLE LINES LOCATED ON THE FLOOR
