DOT/FAA/CT-86/5

# Halon Extinguisher Agent Behavior in a Ventilated Small Aircraft

Final Report

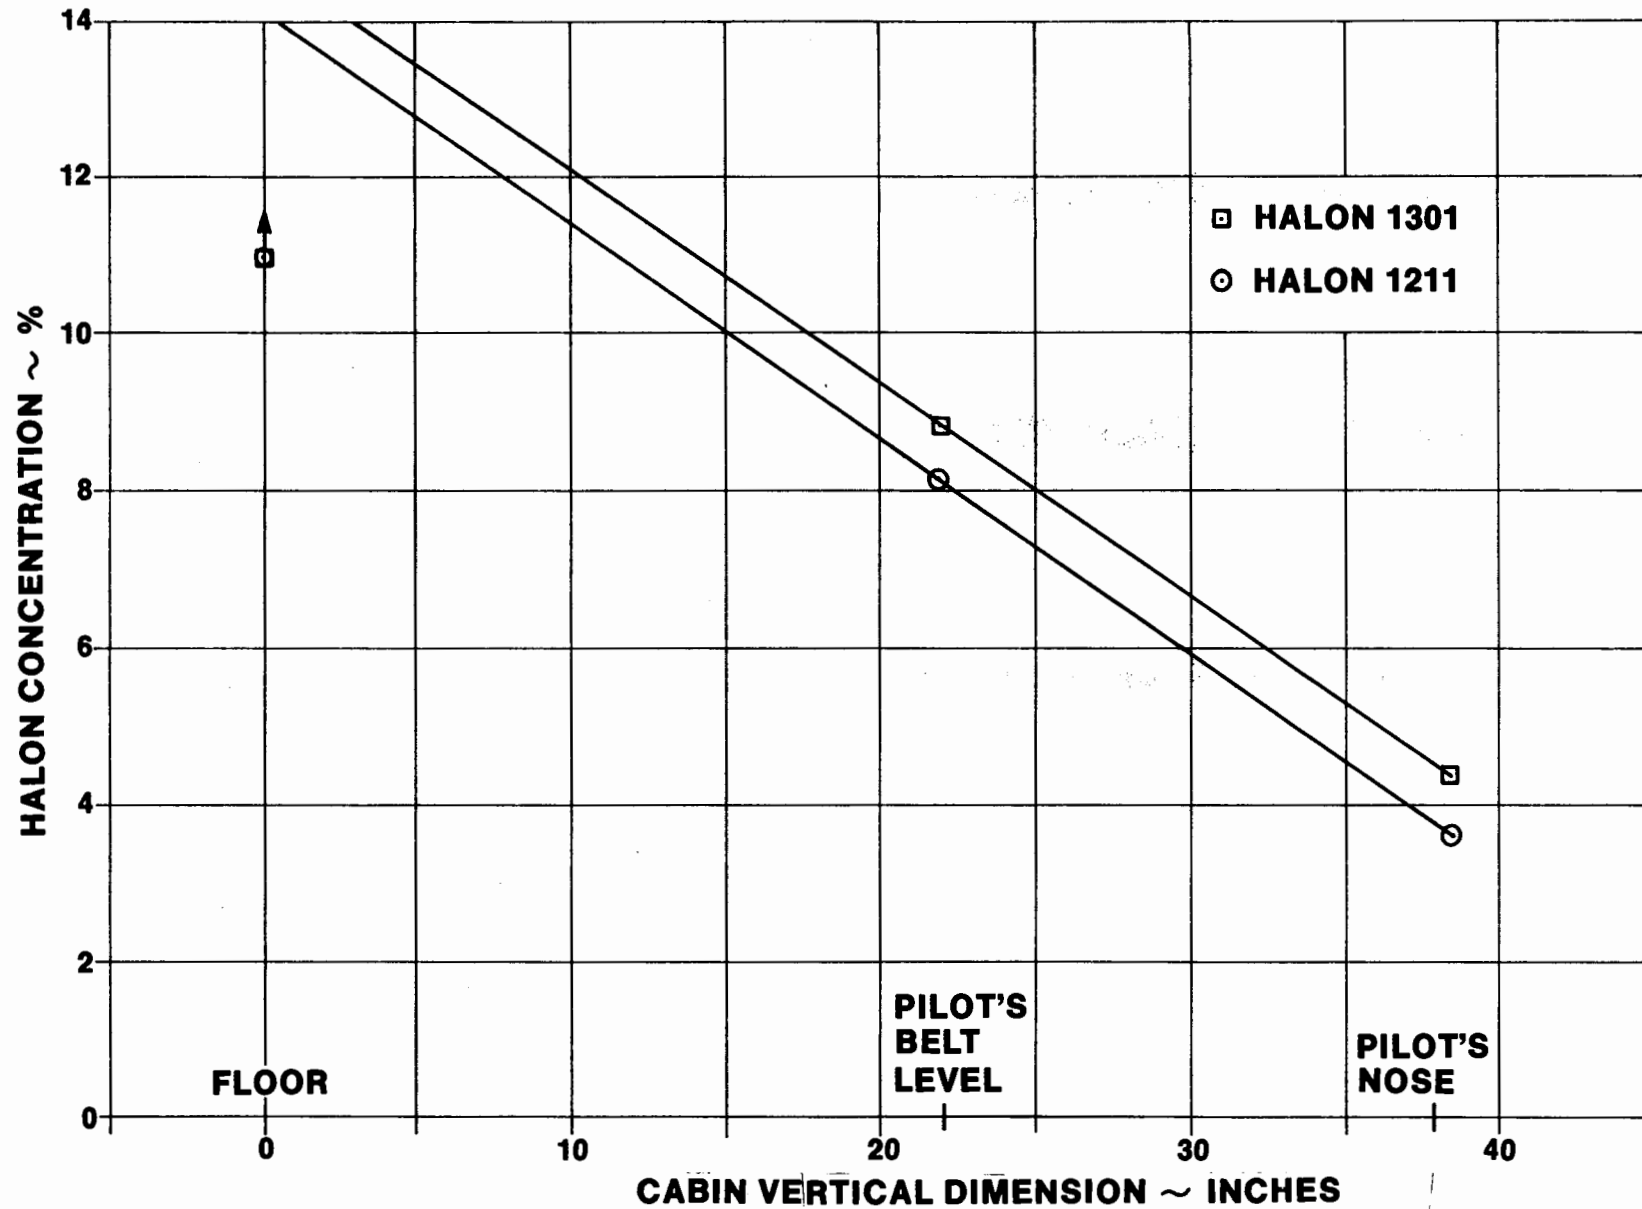
FIGURE 35. STRATIFICATION OF HALON EXTINGUISHING AGENTS

Testing was designed to measure extinguisher agent stratification within the cabin. The three sample lines were placed on the cabin floor. Single sample lines were placed on the floor both near the pilot and the copilot and on the floor by the rear passenger behind the pilot. The measurements are in figures 33 and 34 and selected values are listed in table 5. The highest Halon extinguisher gas concentrations are located on the floor. In all cases, the gas measurement capability was overwhelmed and exceeded the maximum measurement level of 11 percent. Stratification of the Halon agents are presented in figure 35. Average gas measurements were plotted for the pilot-copilot belt level and for the pilot's nose location. As noted, only one test with each Halon was conducted for measurement of the agents for the floor. Stratification of the Halons is significant as they vary from over 11 percent on the floor to 2.65 percent and 4.03 percent at the pilot's nose and it appears that this relationship is near linear, figure 35.
