DOT/FAA/CT-86/26

# Halon Extinguishment of Small Aircraft Instrument Panel Fires

December 1986

Final Report

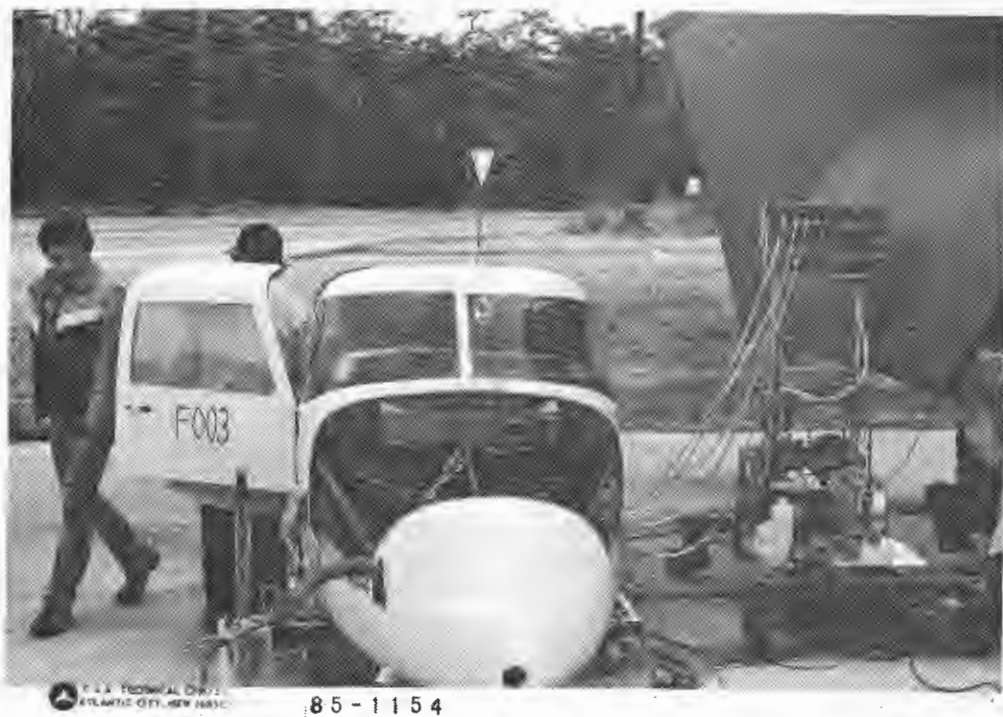
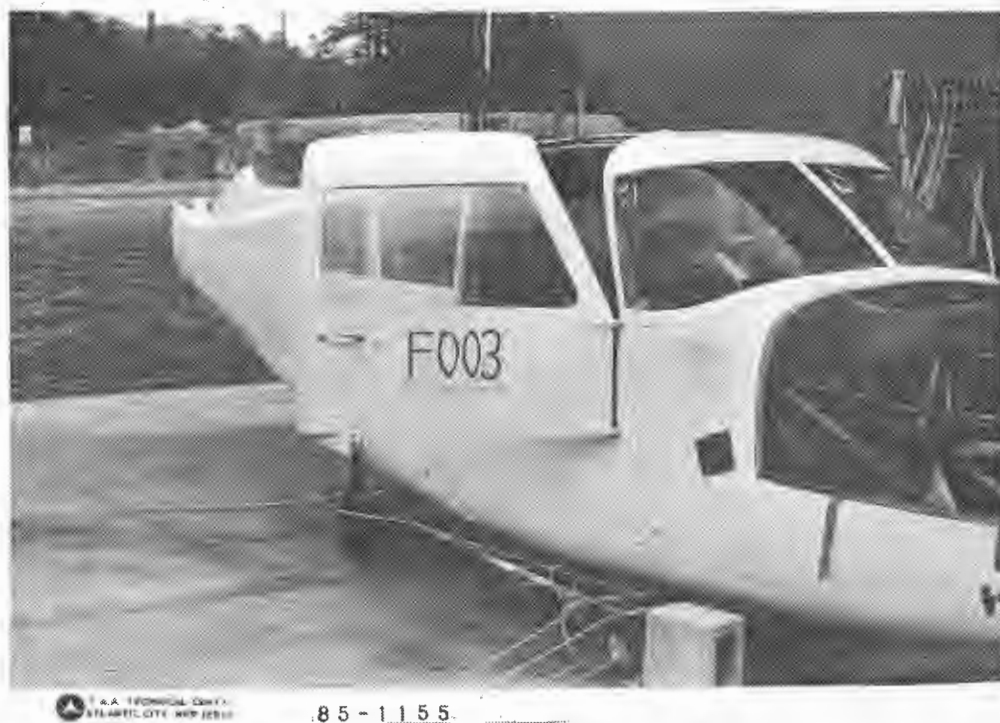
FIGURE 1. PIPER MODEL PA-30 TWIN COMANCHE FUSELAGE

simulated by the addition of compressed air through the aircraft vent system. In this specific aircraft, a ram air port in the nose forces air through ducts in the forward baggage compartment into the cabin. The aircraft test article is shown in figure 1.

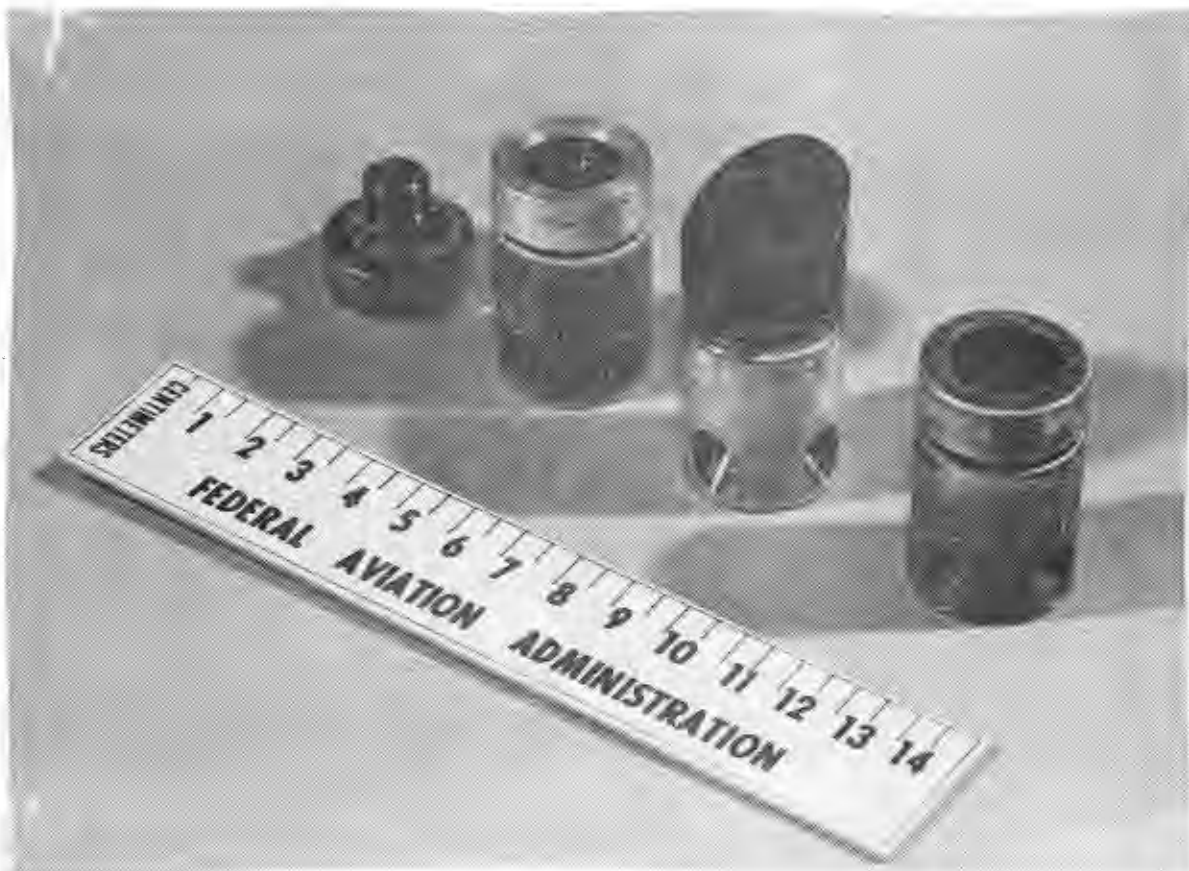
FIGURE 3. FIREPORTS - FRONT VIEW

Fire extinguishers charged with Halon 1211 of 2.5-pound capacity and Halon 1301 of 3-pound capacity were tested. Two types of application of the extinguishers were employed; (1) the extinguishers were discharged directly up under the instrument panel and (2) the extinguishers were discharged through Fireports (provided by White Manufacturing Marketing, Inc., of Omaha, Nebraska) mounted directly through the instrument panel. Fireports were installed as a means to provide direct fire extinguisher agent access to an inaccessible area. The Fireports were of two types. One type consisted of five exit or distribution ports. Four distribution ports were located radially on a cylinder barrel, directing agent in the radial directions, and the fifth port was located in the cylinder barrel cap end, directing agent directly toward the firewall (figures 2, 3, and 4). The second type Fireport was a single port design and directed agent to a specific location. The Fireports incorporated a plastic insert in the front section through which the extinguisher nozzle was inserted to discharge agent through the Fireport into an inaccessible area. A special nozzle adaptor had to be installed on Halon 1301 extinguishers to provide a proper fit with the Fireports. This was a Teflon™ bodied orifice assembly that was used as a substitute for the hand extinguishers discharge horn. It must be noted that use of such a replacement assembly in practice will nullify the basis for the extinguisher's approval status.

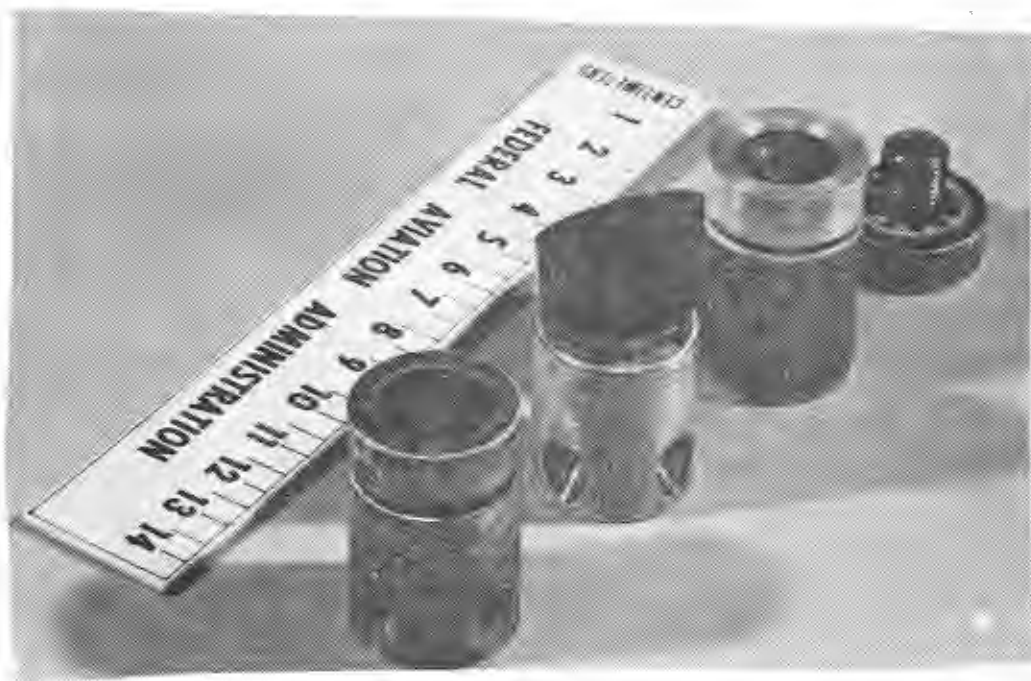
FIGURE 4. FIREPORTS - REAR VIEW
