**DOT/FAA/AR-99/73**

# **A Benefit Analysis for Nitrogen Inerting of Aircraft Fuel Tanks Against Ground Fire Explosion**

December 1999

Final Report

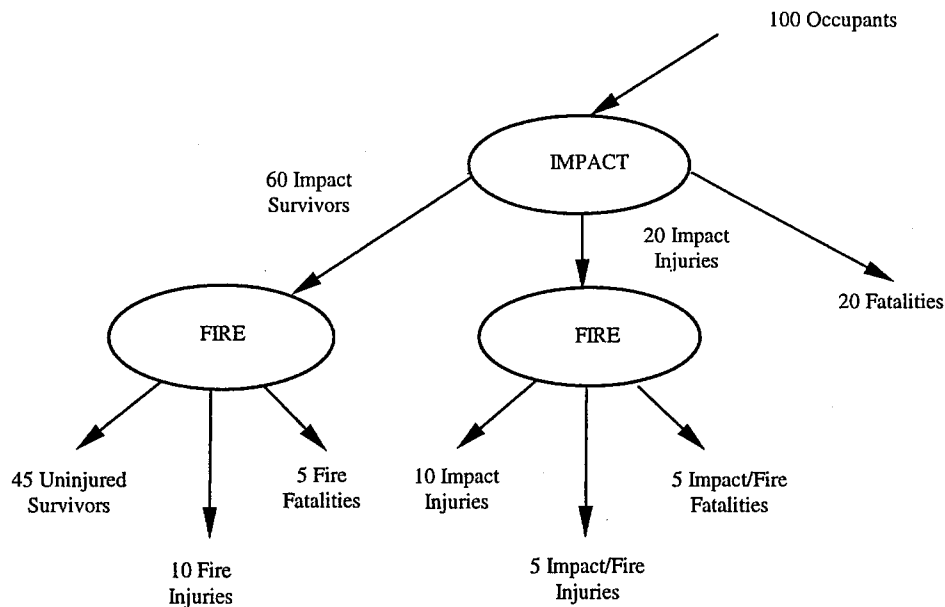
FIGURE 1. EXAMPLE SURVIVABILITY CHAIN

An example of the model and the effects of improvement in injuries and fatalities resulting from nitrogen inerting of fuel tanks are demonstrated in figures 1 and 2. Figure 1 gives a typical survivability chain for a survivable accident scenario.

- 45 uninjured survivors.
- 25 injuries, 10 as a result of the impact, 10 as a result of the fire, and 5 seriously injured as a result of the impact and fire.
- 30 fatalities, 20 as a result of the impact, and 10 as a result of the fire (5 of whom sustained nonfatal injuries from the impact).

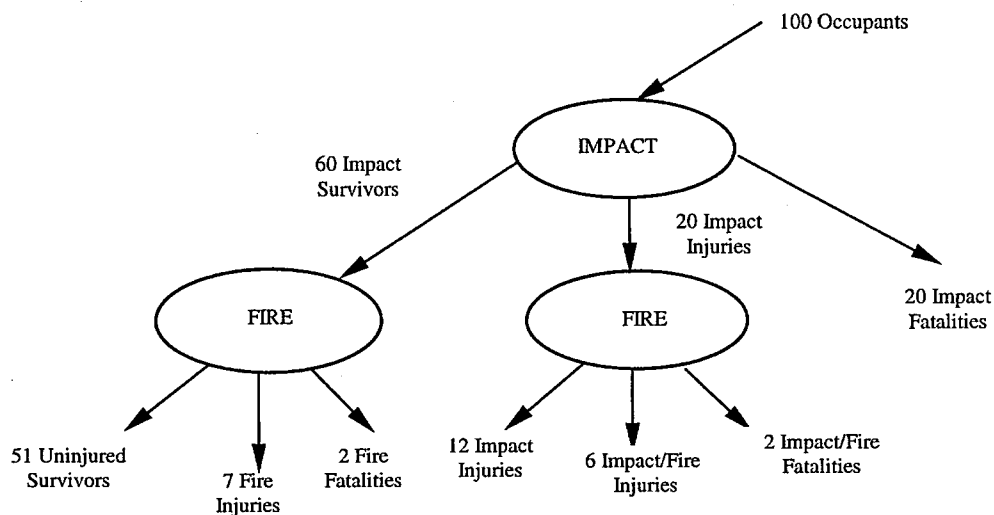
FIGURE 2. EXAMPLE OF SURVIVABILITY CHAIN SHOWING POSSIBLE IMPROVEMENTS IN SURVIVABILITY AS A RESULT OF NITROGEN INERTING

If nitrogen inerting was used in aircraft fuel tanks such that there were now only 2 fatalities and 6 seriously injured of the 20 impact injured occupants, and only 2 fatalities and 7 seriously injured of the 60 impact survivors, then the survivability chain becomes as shown in figure 2.

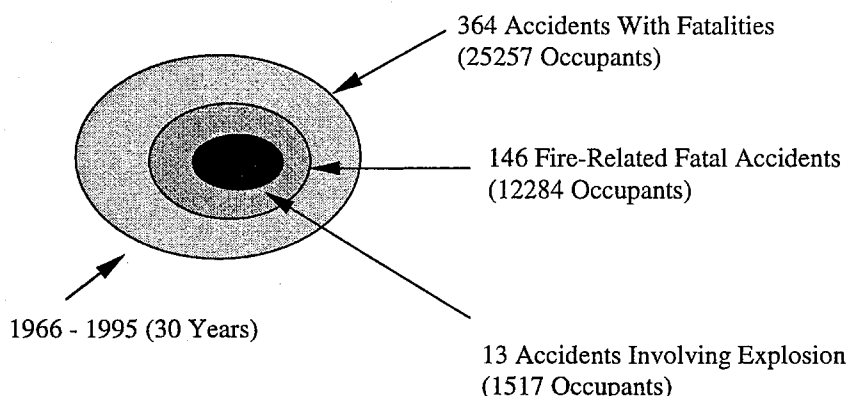
FIGURE 3. BREAKOUT OF FIRE AND EXPLOSION-RELATED ACCIDENTS

Thirteen accidents were identified as matching the selection criteria in section 3 and were considered appropriate to use for the benefit analysis. Figure 3 illustrates the relationship of these 13 accidents with respect to the 364 fatal accidents in the Survivable Accidents Database.

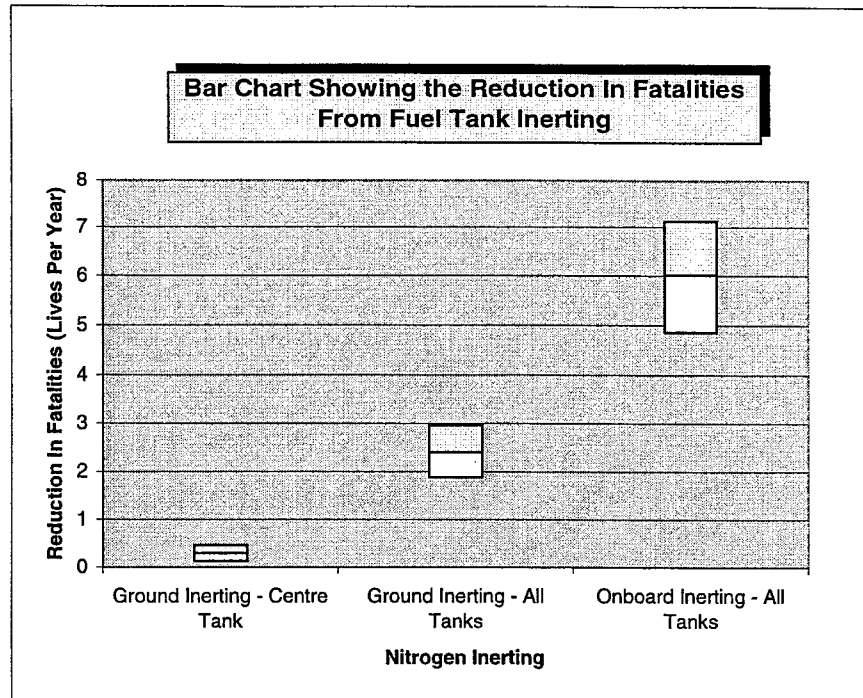
FIGURE 4. NUMBER OF LIVES SAVED PER YEAR

Figure 4. Shows the reduction in fatalities due to the three different nitrogen inerting methods considered together with the 95 percentile range for the prediction.

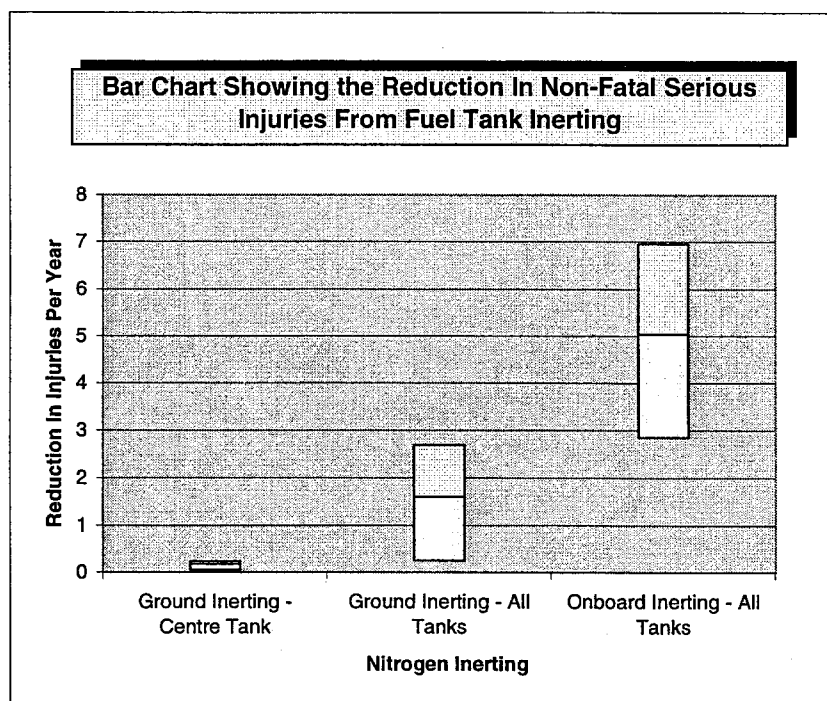
FIGURE 5. REDUCTION IN FATAL AND SERIOUS INJURIES PER YEAR

Figure 5 shows the reduction in number of injuries due to nitrogen inerting systems together with the 95 percentile range for the prediction.

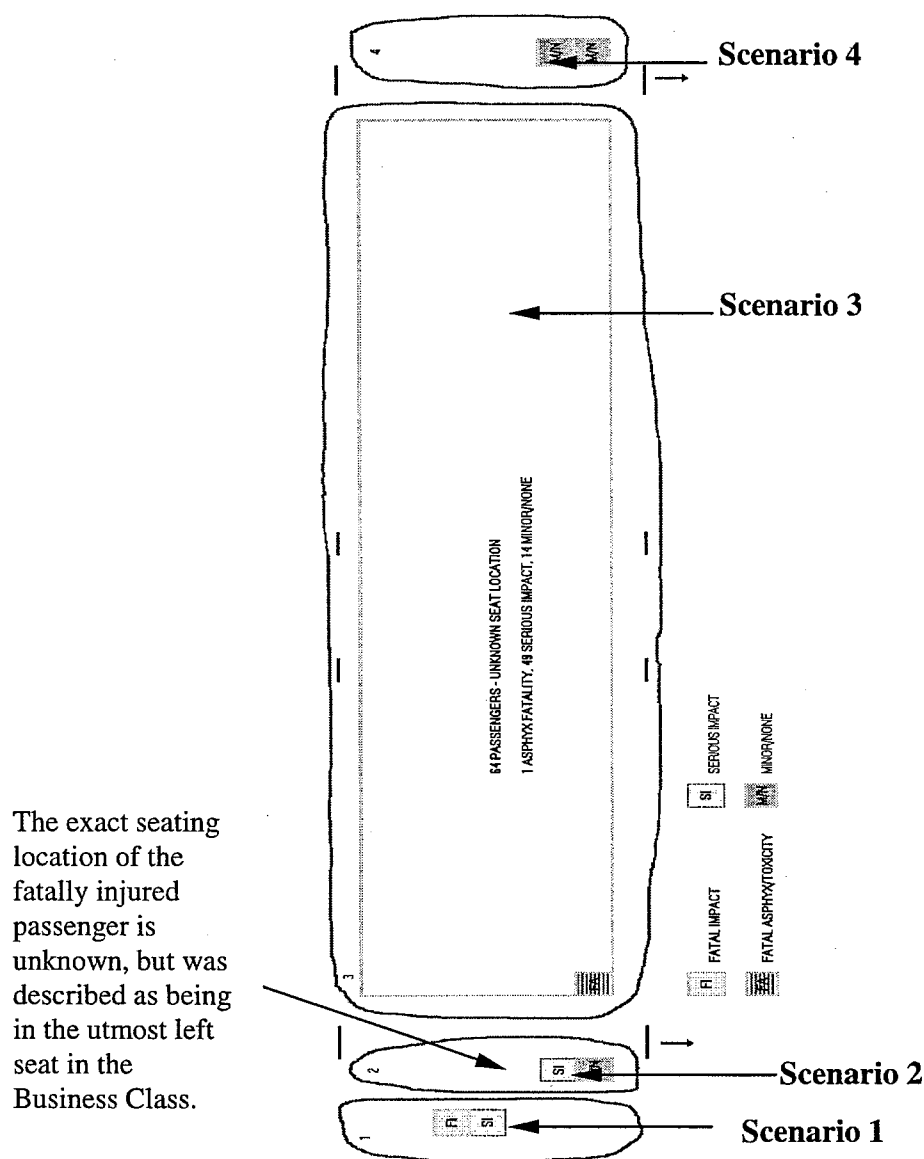
**Figure A-1. Location of Injuries and Scenarios**

This accident is divided into four separate scenarios, as shown in figure A-1.

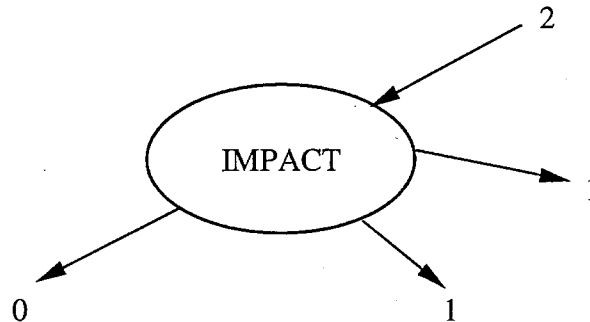
Scenario 1

**Scenario 1** contains the flight deck area where 1 flight crew died and the other sustained serious injuries from the impact.

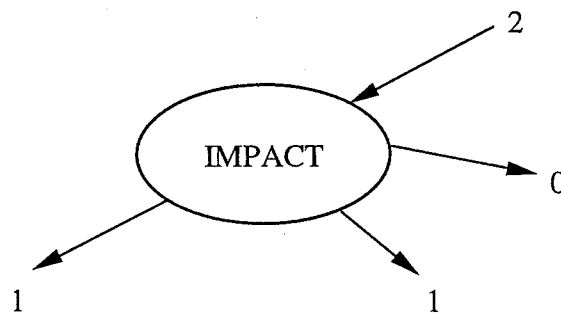
Scenario 2

**Scenario 2** contains the forward flight attendant area where only the chief steward sustained serious injuries from the impact. This scenario contains two flight attendants.

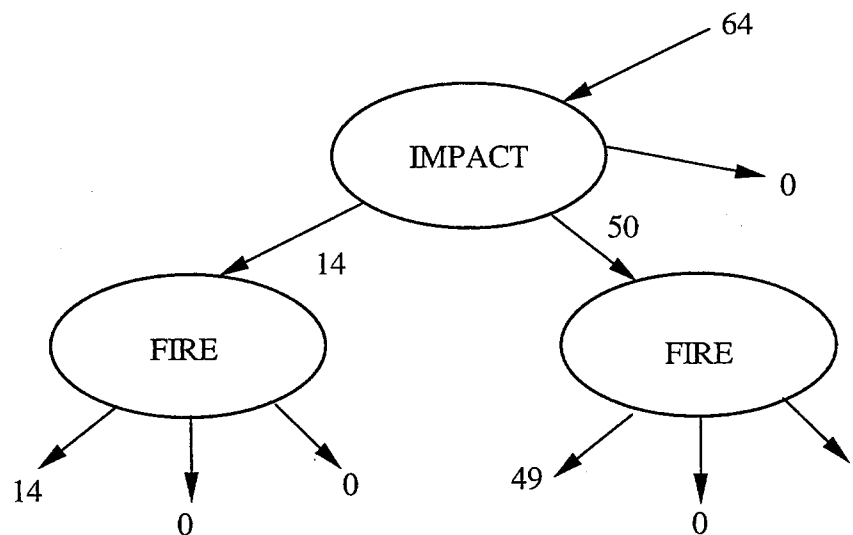
Scenario 3

**Scenario 3** contains the whole passenger cabin. This has been used because of limited detail on passenger locations during the accident. This scenario contains all 64 passengers. From the injury profile, apart from the fatally injured passenger, it was assessed that the 49 passengers received serious injuries as a result of the impact.

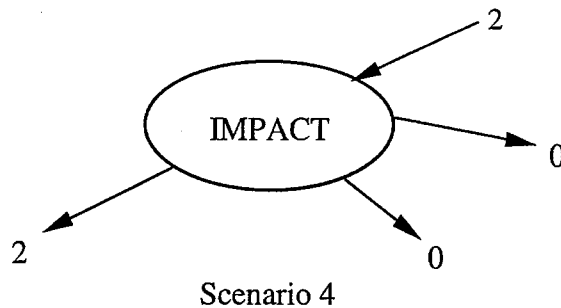
**Scenario 4** contains the rear flight attendant area where the two flight attendants received minor or no injuries from the impact.

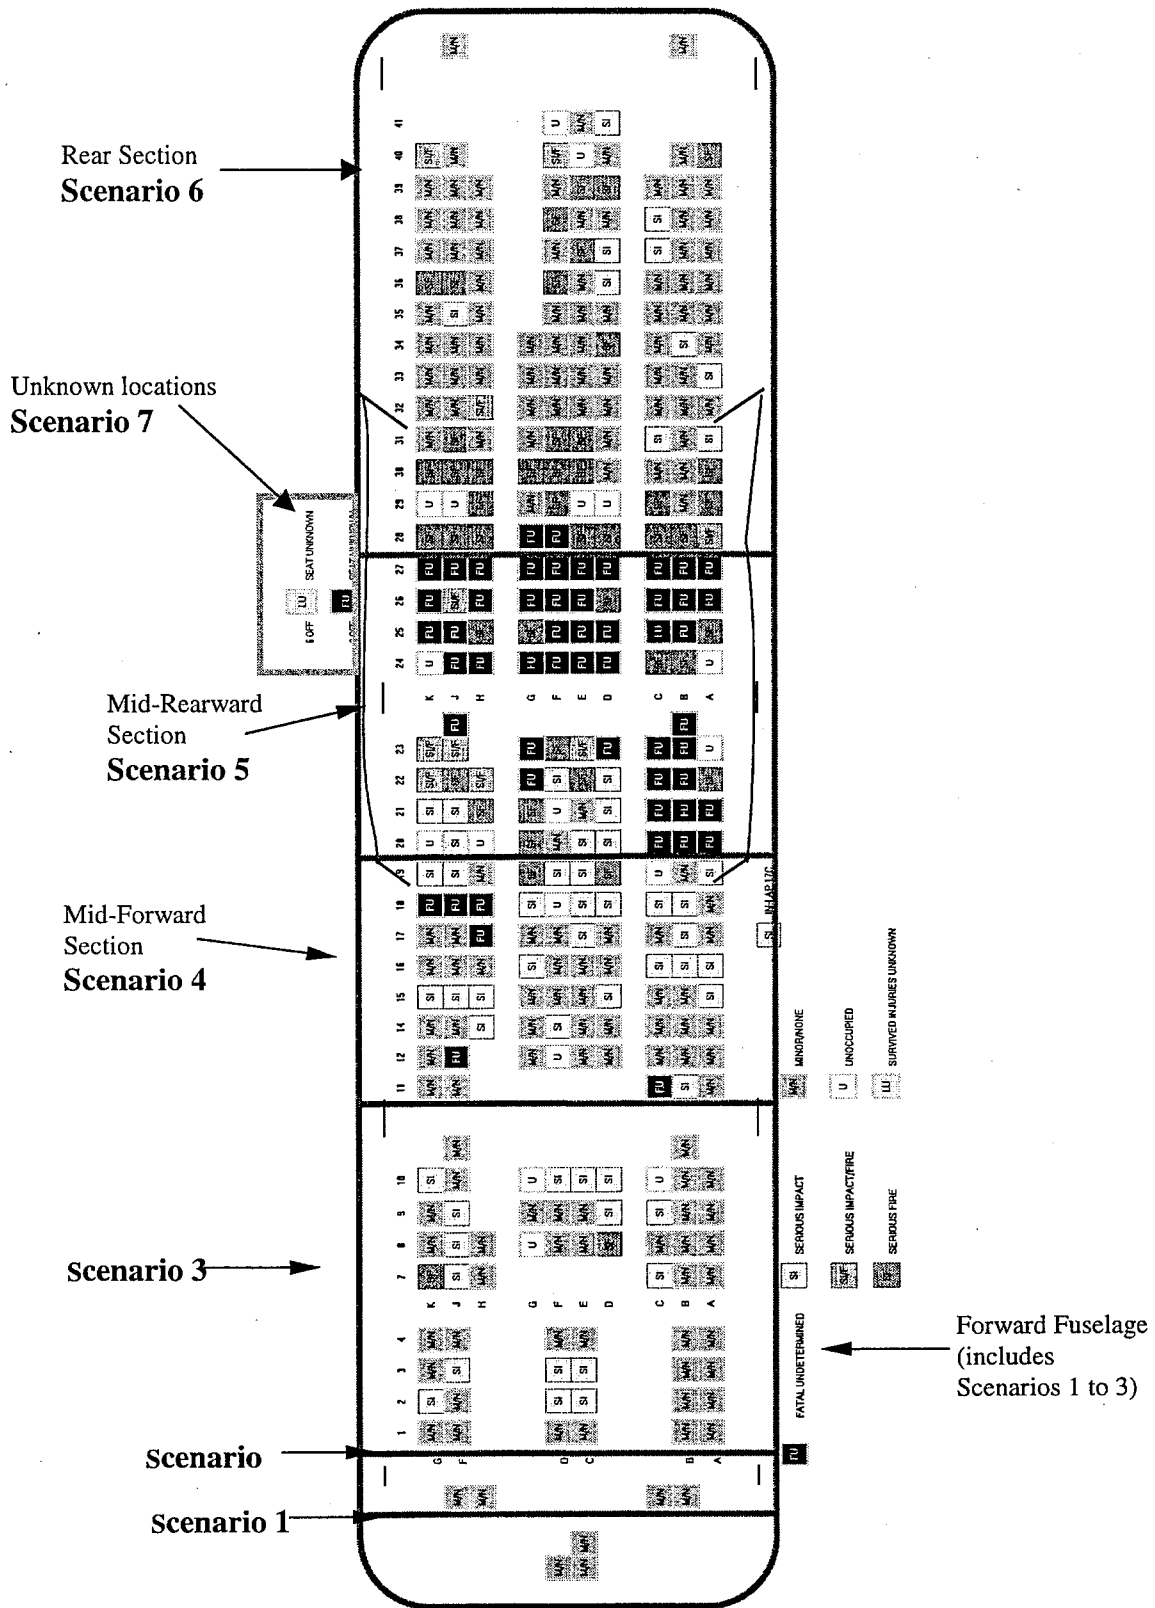
Figure A-2. Location of Injuries and Scenarios

This accident is divided into six separate scenarios, as shown in figure A-2. Scenarios 3 to 6 are bounded by the fuselage ruptures.

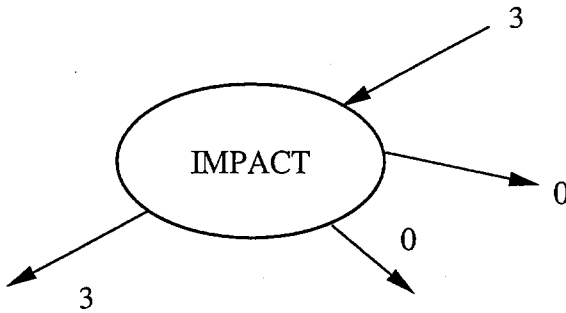
Scenario 1

**Scenario 1** contains the flight deck area which was subjected to the impact and was not fire damaged. This scenario contains the 3 flight crew.

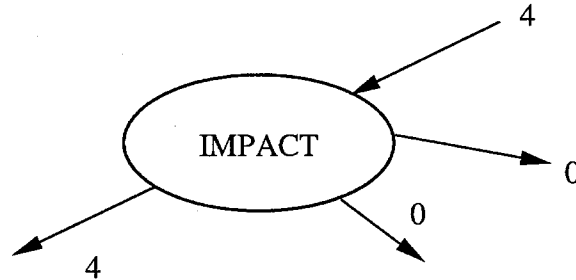
Scenario 2

**Scenario 2** contains the forward flight attendant area and encompasses four flight attendants, none of whom sustained serious or fatal injuries.

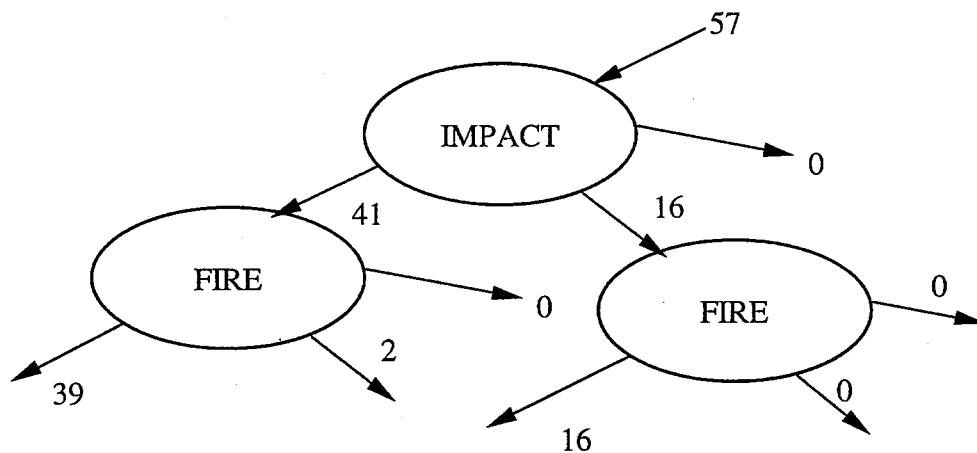
Scenario 3

**Scenario 3** contains the forward fuselage, seat rows 1 to 10, which was subjected to the impact and was not fire damaged. This scenario contains 2 crew and 55 passengers. A total of 2 passengers in this scenario sustained serious fire injuries in the accident, presumably the injuries were caused by the fire outside the cabin during the evacuation.

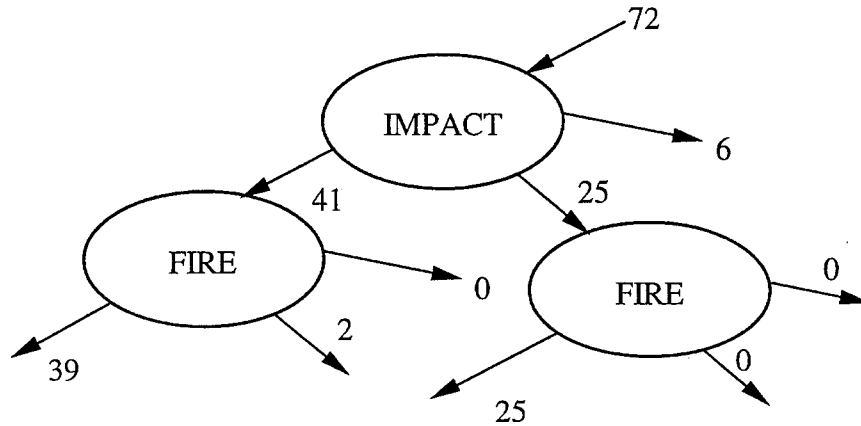
Scenario 4

**Scenario 4** contains the mid-forward section, seat rows 11 to 19, which was subjected to the impact and was not fire damaged. This scenario contains 72 passengers. This section contained no fire during the accident, therefore, it is assumed that the 6 occupants were killed by the initial impact. This is also supported by the fact that a large number of the occupants in this section were ejected during the impact. A total of 2 passengers suffered serious injuries from fire but they were located at a fuselage break and it is assessed that either the fire spread locally across the join or they sustained injuries during egress.

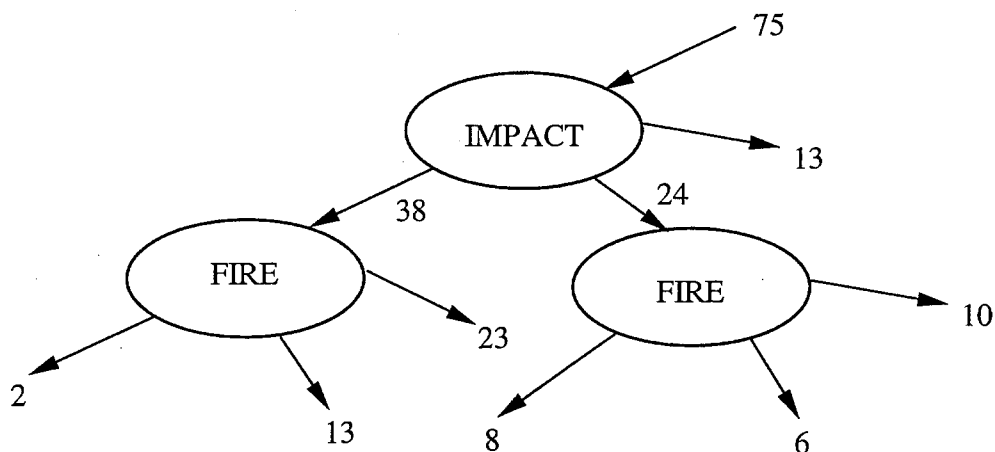
Scenario 5

**Scenario 5** contains the mid-rearward section, seat rows 20 to 27, which suffered explosion and fire after the initial impact. This scenario contains 2 crew and 73 passengers. It was reported that some of the passengers died as the fuselage split, and it is therefore assumed that 13 of the undetermined fatally injured passengers, located along the joins, were killed by impact trauma or were thrown out. Of the remaining 33 fatalities, the 2 flight attendants were known to be killed from the fireball. Of the remaining 31 undetermined fatalities, it is assumed that seat rows 21 to 23 suffered impact injuries and then fire death, and seat rows 24 to 26 killed by fire only.

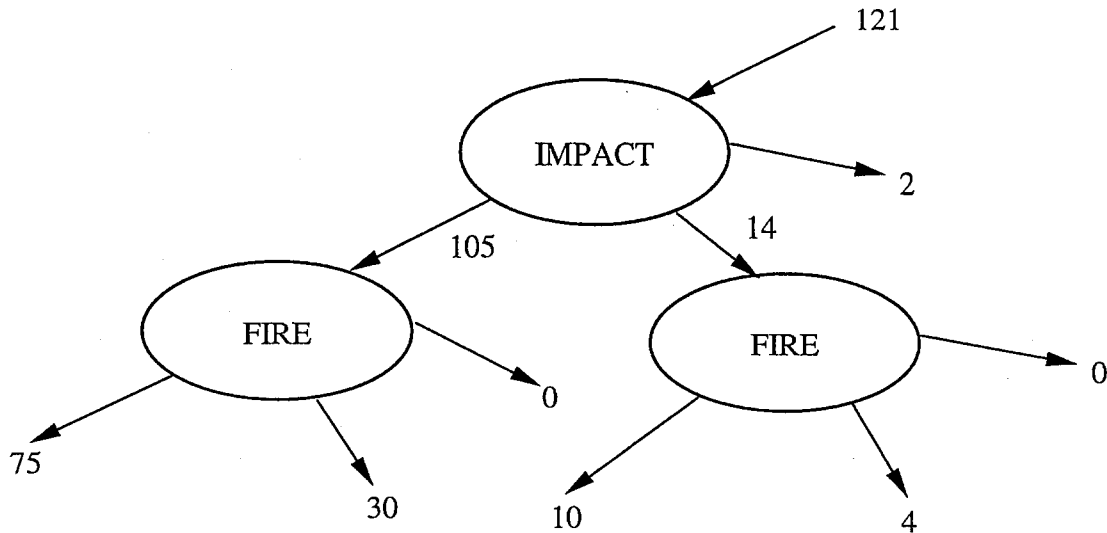
Scenario 6

**Scenario 6** contains the rear section, seat rows 28 to 41, and the rear flight attendant area, which was subjected to fire after the initial impact. The scenario contains the 2 crew and 119 passengers. It is assumed that the 2 occupants seated in row 28F and G were killed by impact trauma as the fuselage split into sections.

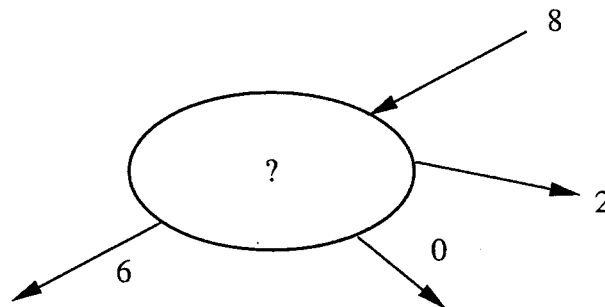
Scenario 7

**Scenario 7** contains the 8 occupants for which seat location and injury was unknown. Absence of information resulted in the following simplified survivability chain. The 6 unknown injuries have been assumed minor or none since they were not significant enough to be reported officially. It is not possible to determine the cause of death for the 2 fatalities.

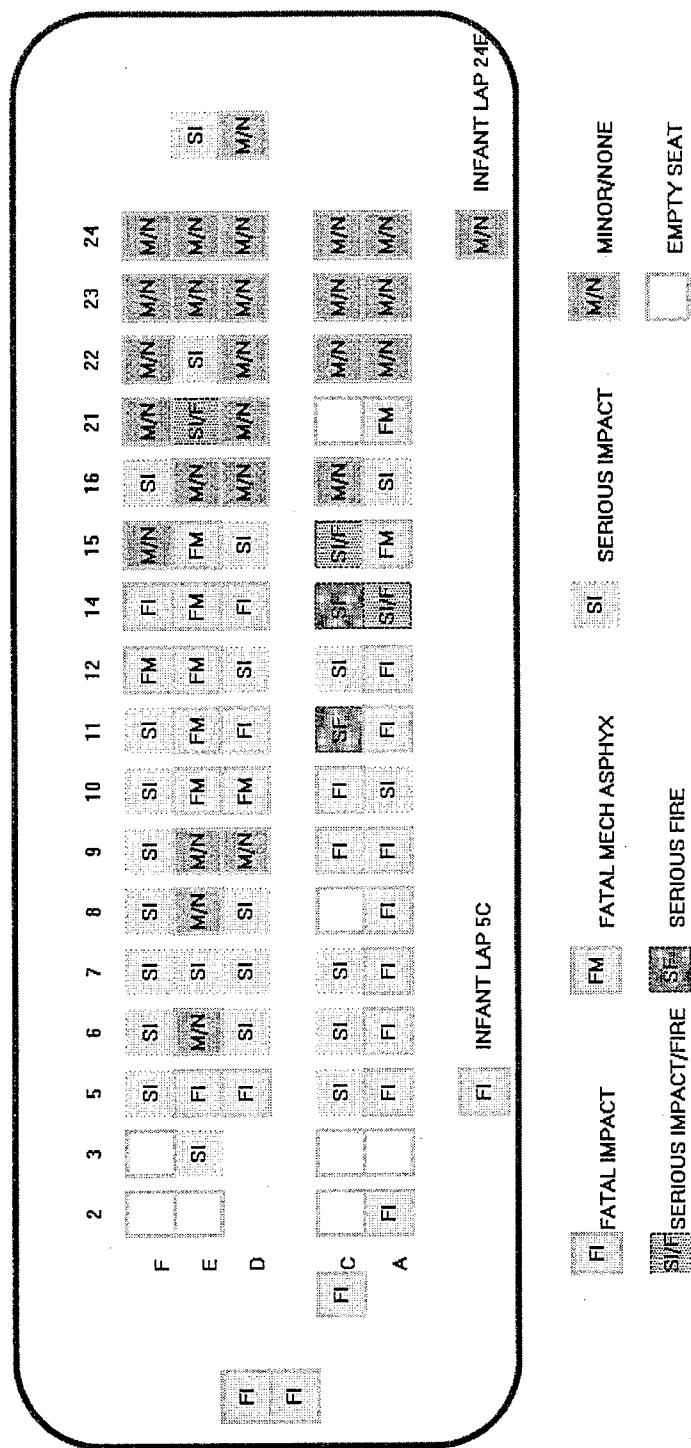
Figure A-3. Location of Injuries and Scenarios

The injury location diagram is shown in figure A-3. All fatalities were as a result of the impact, some of the passengers sustained burns to varying degrees. Whilst this accident could be broken into many scenarios for simplicity, the survivability chain has been drawn for all occupants.

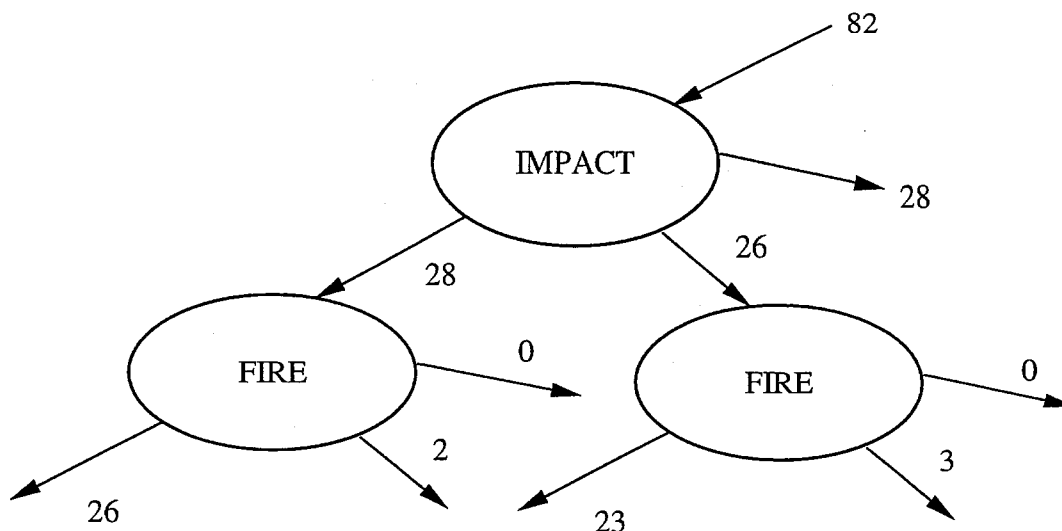
The aircraft and its occupants were subjected to initial impact followed by postcrash fire. There were 5 crew and 77 passengers onboard the aircraft.

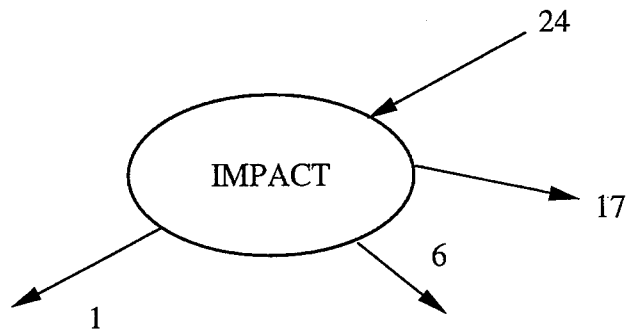
The aircraft and its occupants were subjected to impact followed by a postcrash fire. It was assessed that the 6 seriously injured passengers received their injuries from impact rather than ground fire, since they all had been thrown out of the cabin. In addition, the main fuselage, aft of the wings, and the tail empennage were not damaged by the postimpact fire. There were 2 flight crew, 1 cabin crew, and 21 passengers onboard the aircraft.

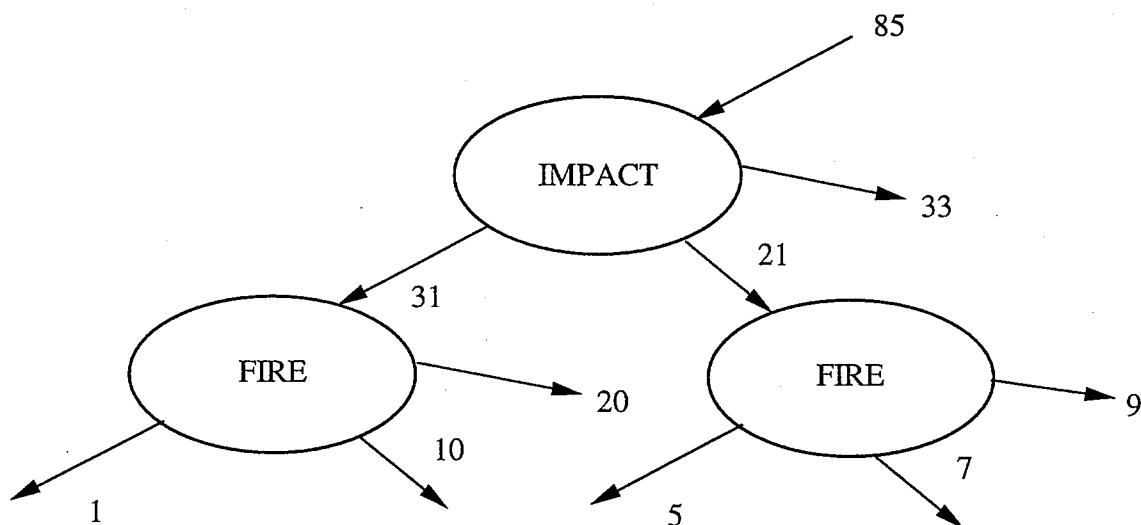
The aircraft and its occupants were subjected to impact followed by postimpact fire. There were 2 flight crew, 2 cabin crew, and 81 passengers onboard the aircraft. It was reported that 20 passengers died from burns and smoke inhalation, 31 passengers and 2 crew died from impact trauma, and 9 passengers sustained impact trauma combined with burning or smoke inhalation. Of the 21 surviving passengers, 4 sustained impact injuries, 10 sustained burn injuries, and 7 sustained a combination of impact and burn injuries. 1 crewmember suffered serious impact injuries. Therefore, the survivability chain is:

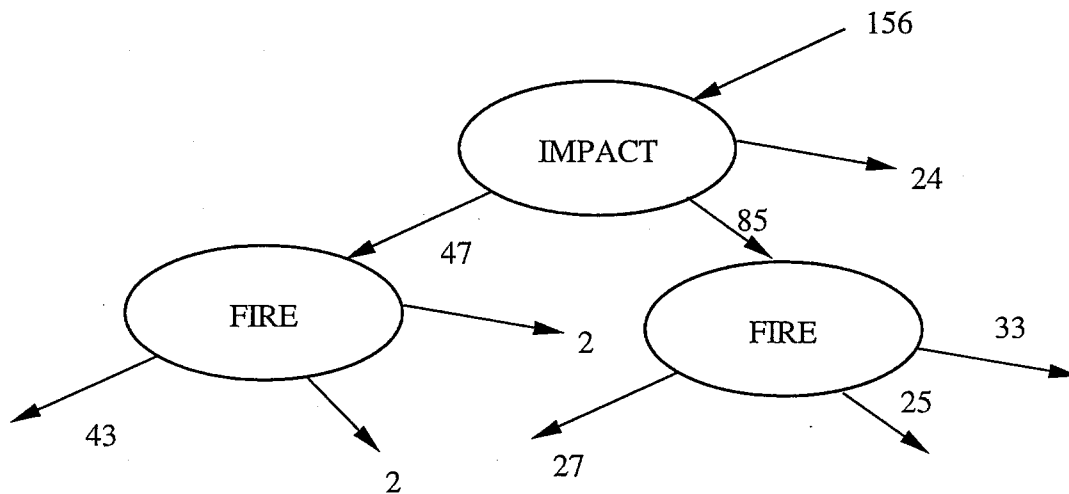
The aircraft and its occupants were subjected to impact followed by postimpact fire. There were 3 flight crew, 14 cabin crew, and 139 passengers onboard the aircraft. Due to the absence of information on the 45 seriously injured passengers, their injuries have been assessed as in the same proportions as known deaths, i.e., impact : impact and fire : fire = 24 : 33 : 2. This results in 18 injured by impact and fire and 2 injured by fire alone.

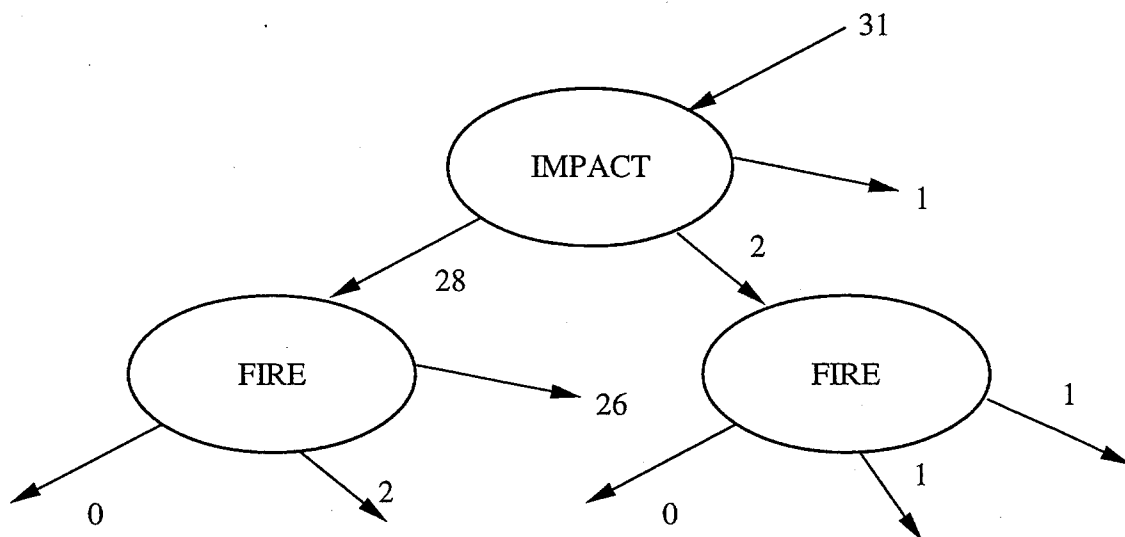
The aircraft was subjected to impact followed by a postimpact fire. There were 2 flight crew, 1 cabin crew, and 28 passengers onboard the aircraft.

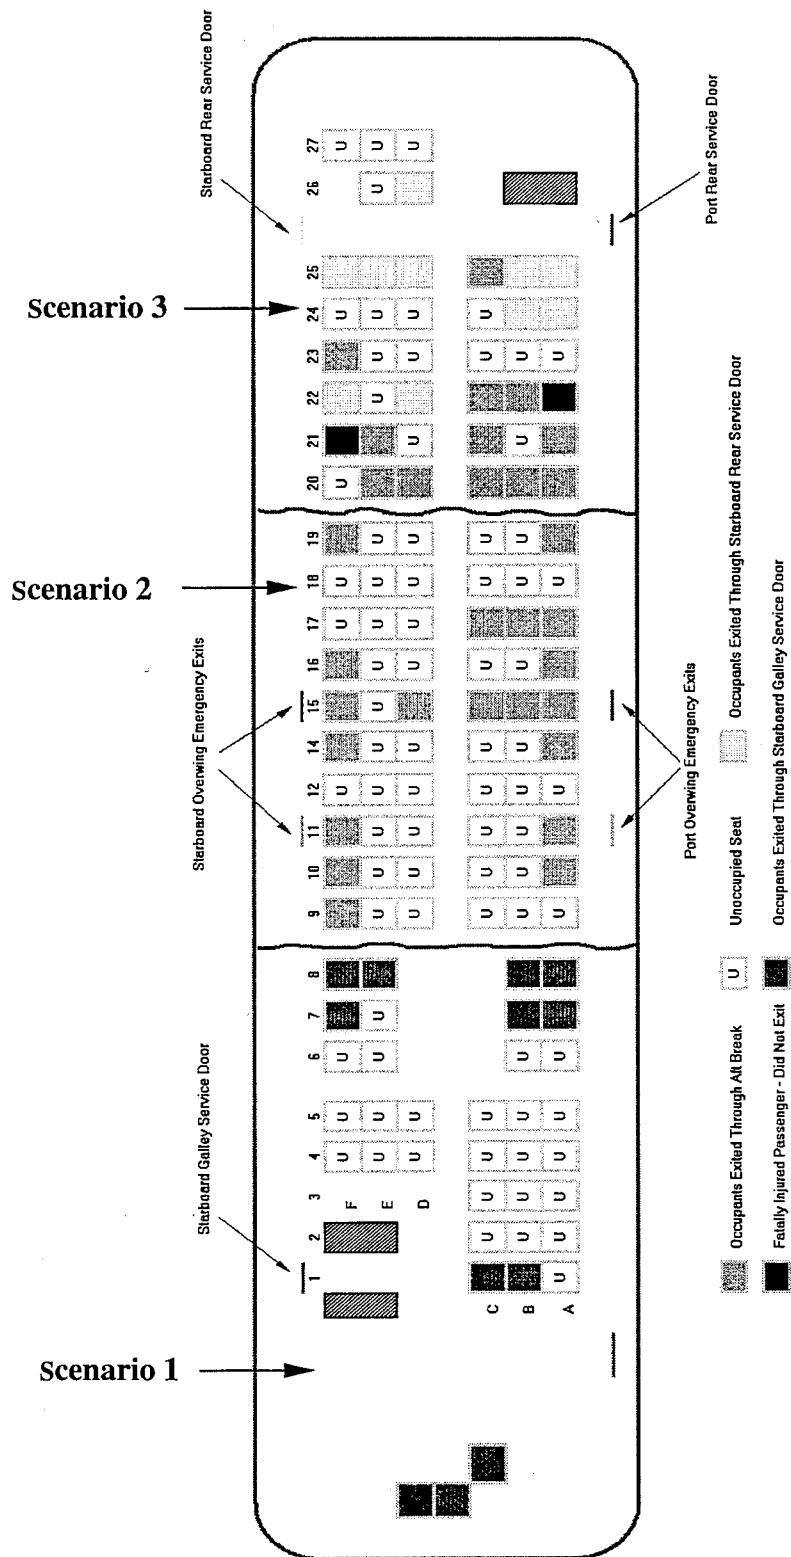
Figure A-4. Occupants Seat Allocation and Exit Use Chart

Due to lack of information on injuries to occupants, figure A-4 is the only data available which shows their seat allocation and exit use in the evacuation. Based on this information the accident is considered as three scenarios.

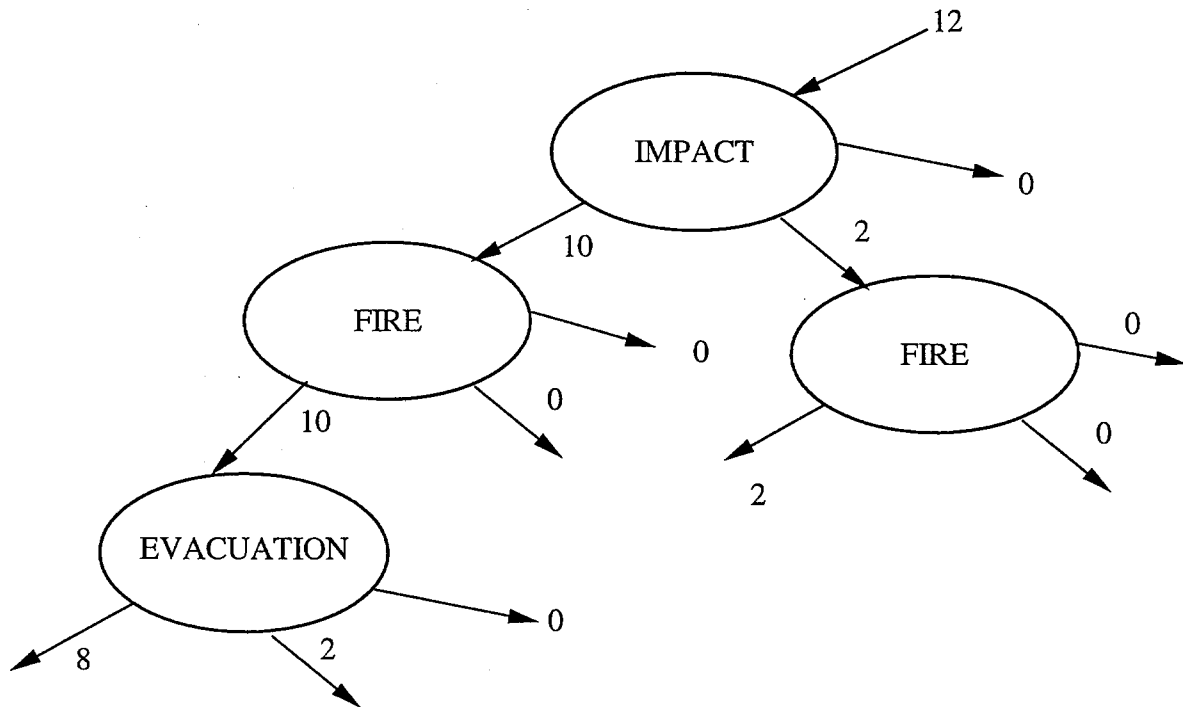
Scenario 1

**Scenario 1** contains the flight deck area and seat rows 1 to 8. It was subjected to impact and postimpact fire. The scenario contains the 3 flight crew, 2 cabin crew, and 7 passengers. All occupants escaped before a small fire developed into a general conflagration, hence no injuries were due to fire.

The captain and flight engineer suffered serious impact injuries and at least 1 passenger sustained serious injury during the evacuation. It is therefore assumed that 2 passengers were seriously injured during the evacuation when they were using the slide at the forward galley door which was about 6 feet above the ground at the lower end.

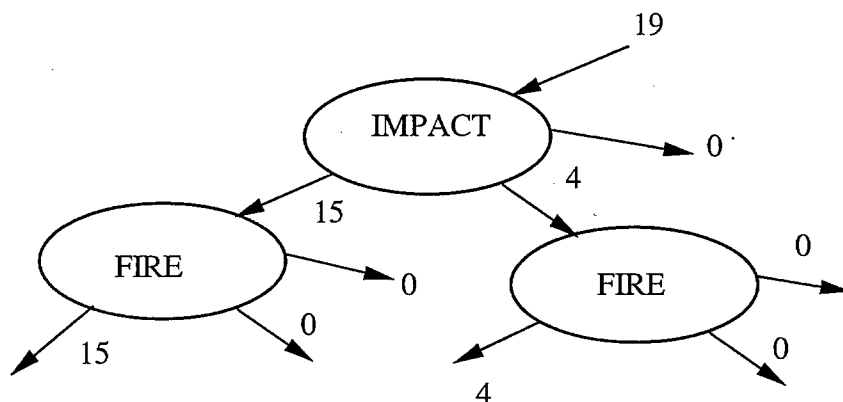
Scenario 2

**Scenario 2** contains seat rows 9 to 19 which was subjected to impact and postimpact fire. The scenario contains 19 passengers. All occupants escaped before fire hampered the evacuation; therefore, it is assumed that all injuries were as a result of impact forces. Further, seat failures were reported in this area which is consistent with the impact injuries. There were 8 seriously injured passengers between scenarios 2 and 3 which had a similar number of occupants. It is therefore assumed that half (4) of the seriously injured passengers were in each scenario.

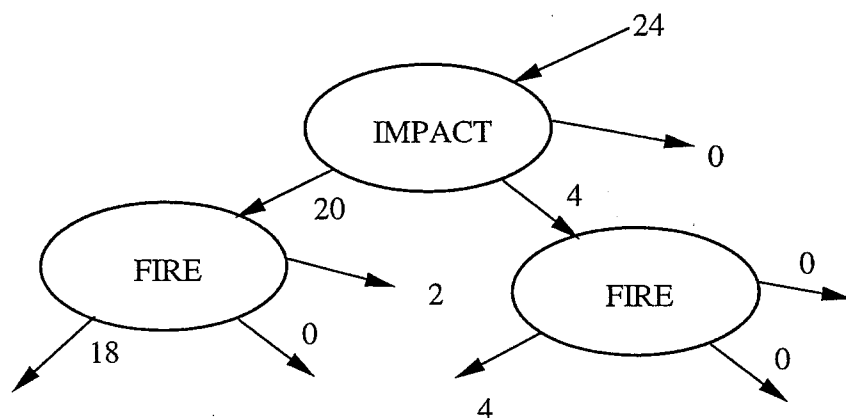
Scenario 3

**Scenario 3** contains seat row 20 to the end of the aircraft. It was subjected to impact and postimpact fire. The scenario contains the 2 cabin crew and 22 passengers. 2 passengers suffered fatal burns. Following the same logic of Scenario 2, it is assumed that 4 passengers received serious injuries as a result of impact forces.

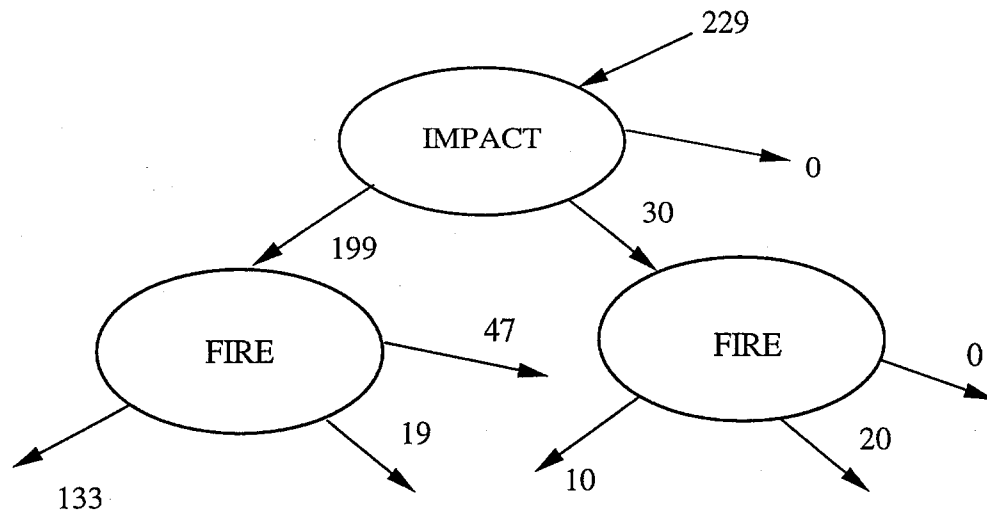
The aircraft and its occupants were subjected to impact followed by postcrash fire. There were 4 flight crew, 6 cabin crew, and 219 passengers onboard the aircraft. 1 flight attendant suffered serious injuries during the impact being thrown from her seat. Some (taken as 4) passengers, having got out of their seats and moving away from the fire, were thrown forward and injured during the impact. 5 passengers were thrown out of the aircraft while still in their seats and are assumed to have suffered serious impact injuries. This leaves 34 passengers and 5 crew with undetermined serious injuries. In the absence of detailed information, it is assumed that half of these suffered burns and half were injured by the impact as well as suffering burns. This results in 17 passengers and 2 crew suffering burns and 17 passengers and 3 crew suffering impact and burn injuries.

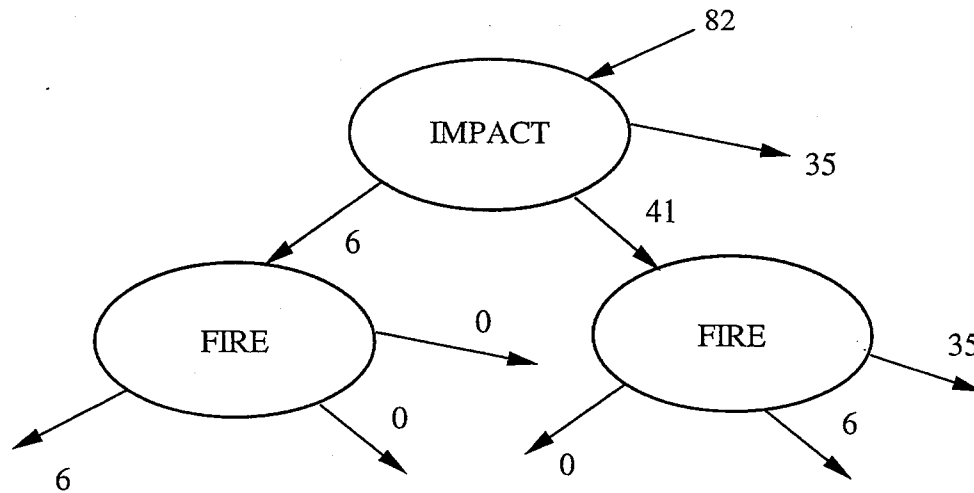
- half of the 70 fatalities died from impact – the aircraft impacted trees and ground several times.
- half of the 70 fatalities died from impact and fire.
- 6 occupants received minor or no injuries – 2 cabin attendants and 4 passengers were interviewed shortly after the accident.
- 6 of the seriously injured occupants received impact and burn injuries (physical condition precluded them from being interviewed).

The survivability chain is therefore:

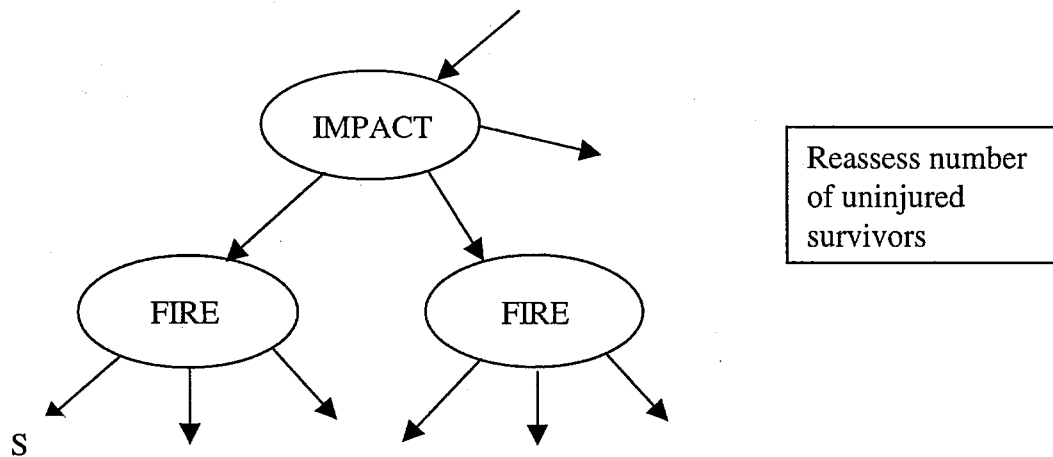
**Figure B-3. Statistical Modelling Process, Stage 3**

Evaluate injury rate improvement using:

$$S_F = \frac{S_B - S}{T}$$

A similar technique is used for fatality rate improvement.
