# STATE HIGHWAY 9 WILDLIFE CROSSINGS MONITORING – YEAR 3 PROGRESS REPORT

*December 2015 through April 2018*

Study Number 115.01

April 2019

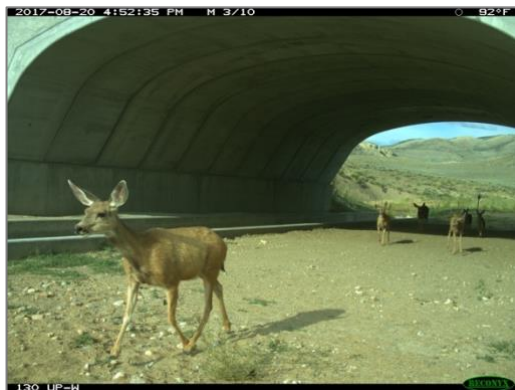
Figure 10. Example of mule deer success movement at the BVA Underpass.

Figure 9 presents mule deer total movements and success movements by month at the BVA Underpass. The peak in monthly movements in Year 2 was higher than the peak in Year 3; however, in Year 2 there was a single peak in February, while in Year 3, two peaks were observed in January and March, with a dip in activity in February and overall activity was higher throughout the winter months. Figure 10 depicts a success movement at the BVA Underpass. Mule deer use continued through the summer months.

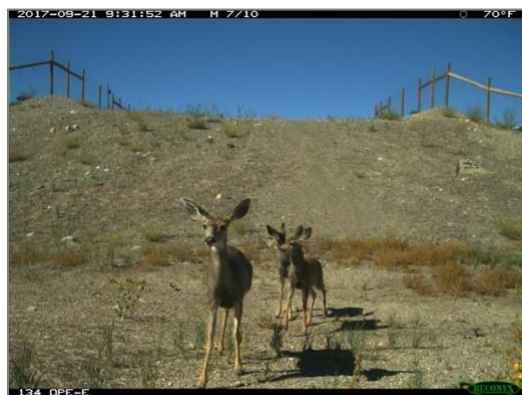
*Figure 14.* Mule deer doe with two fawns crossing the North Overpass.

Figure 13 presents mule deer total movements and success movements by month at the North Overpass. This is the only location where mule deer activity decreased from Year 1 to Year 3. The highest peak in success movements occurred in March 2016. Wintertime peaks in activity in Years 2 and 3 were substantially lower, although overall activity at this structure remained high. Mule deer use continued through the summer months. Figure 14 depicts a mule deer success movement at the North Overpass.

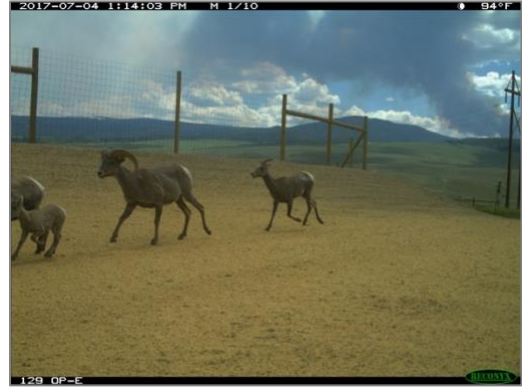
*Figure 17. Bighorn sheep ewe, lamb, ram and yearling crossing the South Overpass.*

Since the onset of this research, pronghorn and white-tailed deer have only been documented using the underpass structures. The majority of pronghorn success movements occurred at the BVA Underpass, while the majority of white-tailed deer success movements occurred at the North Underpass. Moose and bighorn sheep have made success movements at both underpasses and overpasses. The majority of bighorn sheep success movements occurred at crossing structures located in the southern portions of the project area, specifically, at the South Overpass and the Williams Peak Underpass. Of eight total success movements at the South Overpass, four of them were part of a single event by a family group (Fig. 17).

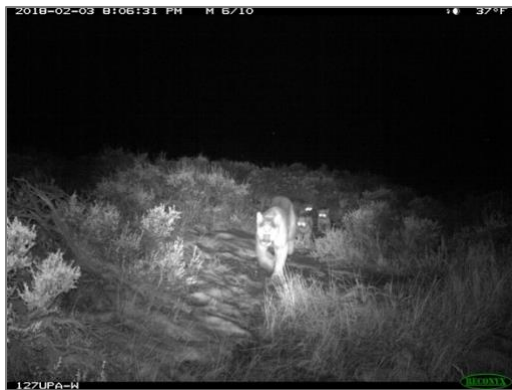
*Figure 19. Mountain lion with 3 kittens approaching the Williams Peak Underpass.*

same individual movement. Figure 19 depicts a mountain lion with three kittens approaching the habitat camera on the east side of the Williams Peak Underpass. In a few cases wildlife that were not captured at the habitat cameras were documented at the structure. However, these events occurred in low numbers and are expected as the habitat cameras are only able to capture a portion of the wildlife activity occurring in the vicinity of a structure.

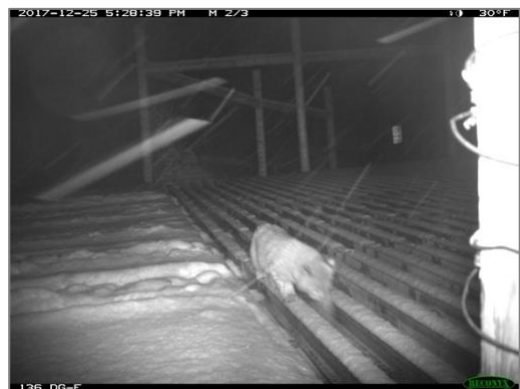
Figure 21. Bobcat entering into the vault at the County Road 33 Wildlife Guard.

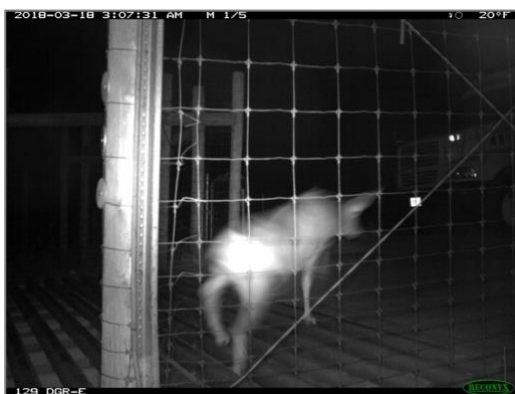
*Figure 22.* Mule deer breaching the Badger Road Wildlife Guard by attempting to walk on top of the round bars.

method of breaching, regardless of guard type, was jumping. On several occasions, deer were captured breaching a round bar guard by attempting to walk on top of the bars (Fig. 22) or walking on the support beams despite the presence of angle iron on the beams to prevent these types of breaches (Fig. 23).

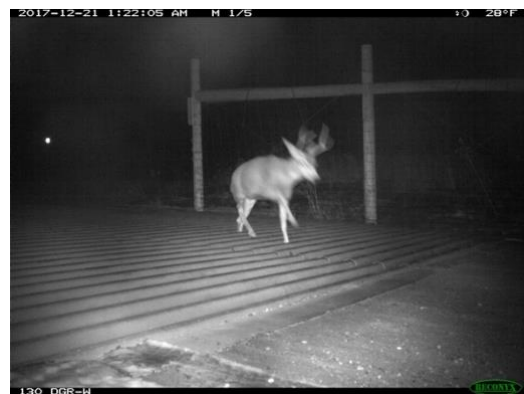
*Figure 23.* Mule deer breaching the County Road 1002 Wildlife Guard (round bar) by walking on the support beams.

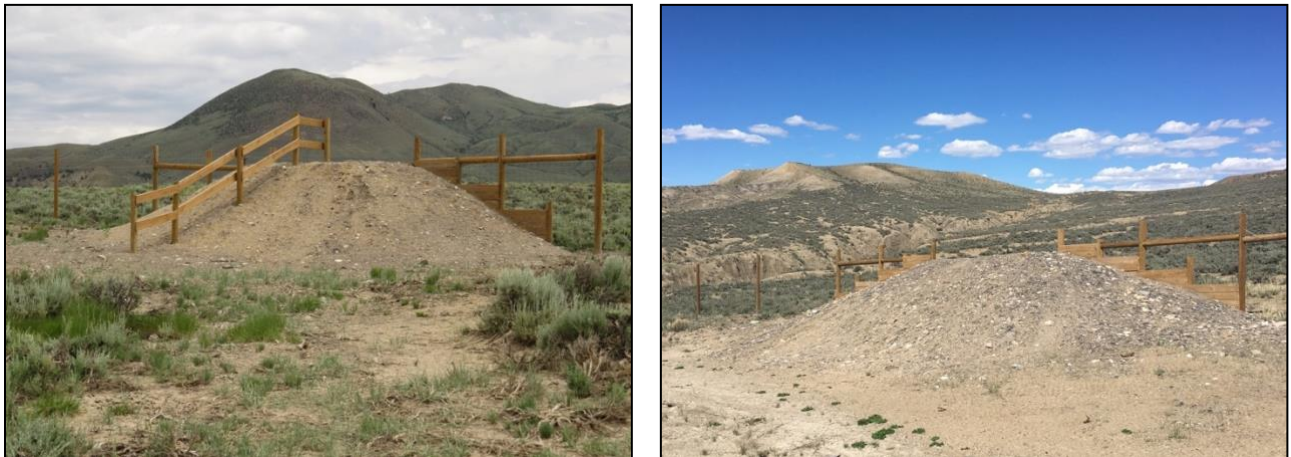
*Figure 30. Example of an escape ramp with a 2:1 slope with perpendicular rail fence (left) and a ramp with a 3:1 slope with no rail fence (right).*

wildlife at the top of the ramp, including successful jump downs as well as jump up attempts from the habitat side onto the ramp. Through Year 3, 13 escape ramps have been monitored for varying lengths of time. In the Phase 1 (north) segment, all ramps were constructed with a 2:1 slope and perpendicular rail fence, except for the North Overpass Escape Ramp, on which rail fence was not constructed. Based on preliminary observations and recommendations by the research team, during Phase 2 construction all ramps were constructed with a 3:1 slope instead of a 2:1 slope (Fig. 24). In general, ramps were constructed with perpendicular rail fence, except for select locations where rail fence was omitted per the request of the researchers, who wanted to evaluate the effectiveness of ramps with and without perpendicular rail fence. In addition, two new 3:1 slope escape ramps were constructed in the Phase 1 segment near existing 2:1 slope ramps. These two ramps are also situated at lower topographic positions relative to the roadway, while the 2:1 slope ramps are at higher topographic positions above the roadway. All of the ramps built in both construction phases are six feet high at the jumping off point, with a 16' wide fence gap.
