# **ROADS AND CONNECTIVITY IN COLORADO: ANIMAL-VEHICLE COLLISIONS, WILDLIFE MITIGATION STRUCTURES, AND LYNX-ROADWAY INTERACTIONS**

**March 2008**

**COLORADO DEPARTMENT OF TRANSPORTATION  
RESEARCH BRANCH**

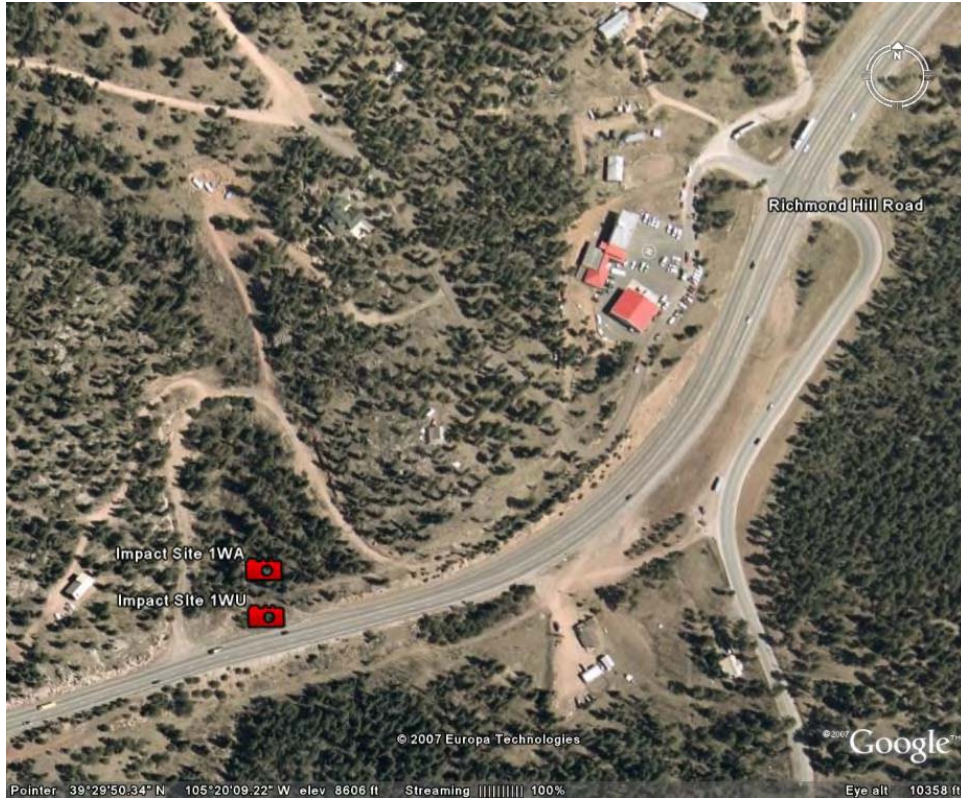
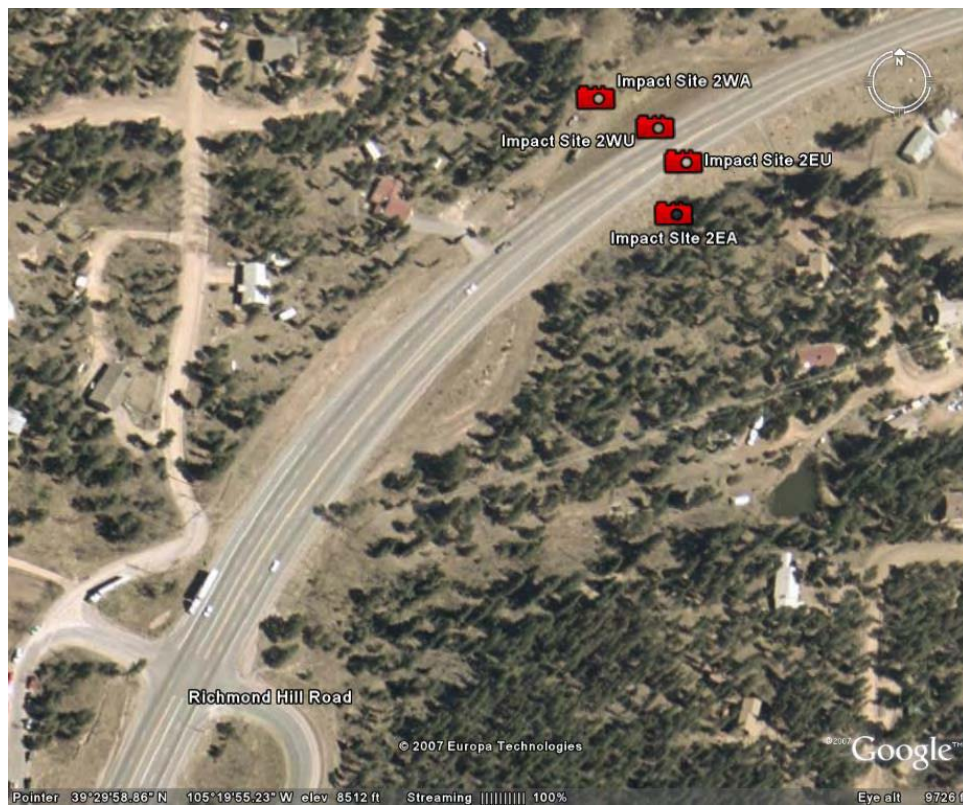
a) Impact site overview and transects (no transect at Impact Site 3)

b) Control site overview and transects

Figures 15 (aerial images) and 16 (schematic diagram) show the locations of the impact site monitoring stations. Figure 15 provides detail of the positioning of the camera stations relative to the surrounding habitat, and GPS coordinates of each station are provided in Appendix B.1. Control Site 1 consisted of four camera stations placed along a transect perpendicular to the highway. Two of these cameras were located at approaches on both the east and west side of the highway and two cameras were placed at opposing entrances to the Deer Creek bridge. Control Site 2 also consisted of four camera stations placed along a transect perpendicular to the highway. Two of these cameras were located at approaches on both the east and west side of the highway and two cameras were placed at opposing entrances to the 8 ft diameter metal pipe culvert. Although these two structures were not be redesigned during the current phase of construction in the impact site, they are slated for improvement during future phases of the U.S. 285 highway improvement project between Conifer and Bailey. While the dimensions of the proposed Deer Creek bridge structure have not been presented, the Roland Gulch culvert will be replaced by a bridge approximately 600 ft in width and approximately 30-40 ft in height. Although it is unknown as to when this phase of highway construction will begin, monitoring these sites will provide valuable baseline data as to the rate of wildlife movement through and surrounding the existing underpass locations. Representative site photos are shown in Appendix B.2.

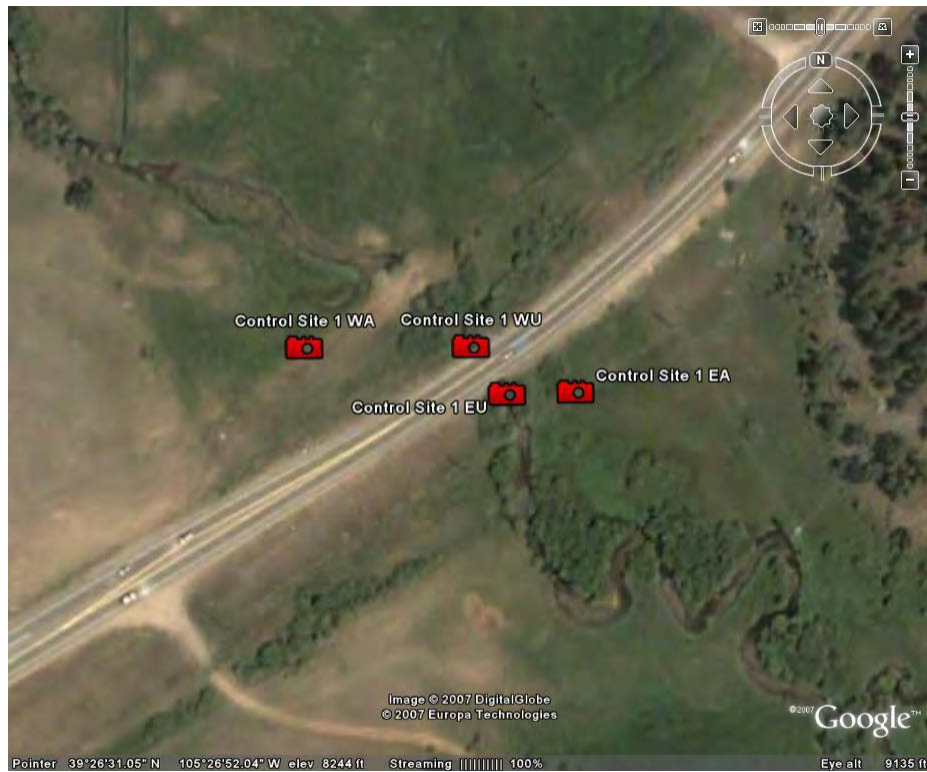
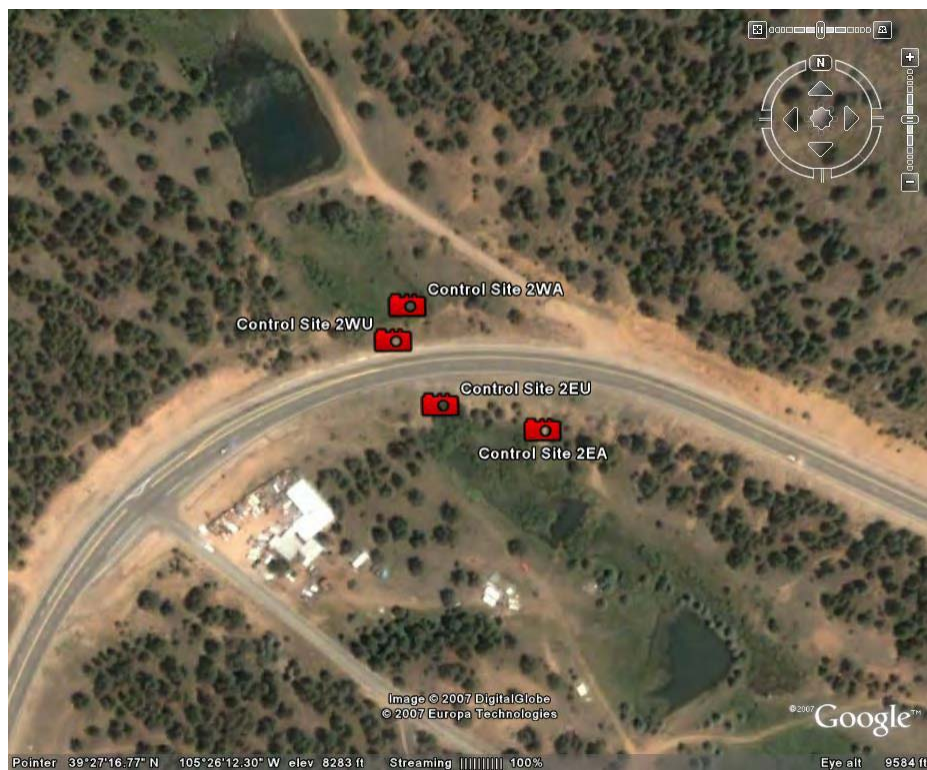
**Figure 15. Aerial images of U.S. 285 Conifer-Bailey a) impact site and b) control site, including a site overview and transect close-up. Station labels include: west approach (WA), west underpass (WU), east underpass (EU), and east approach (EA).**

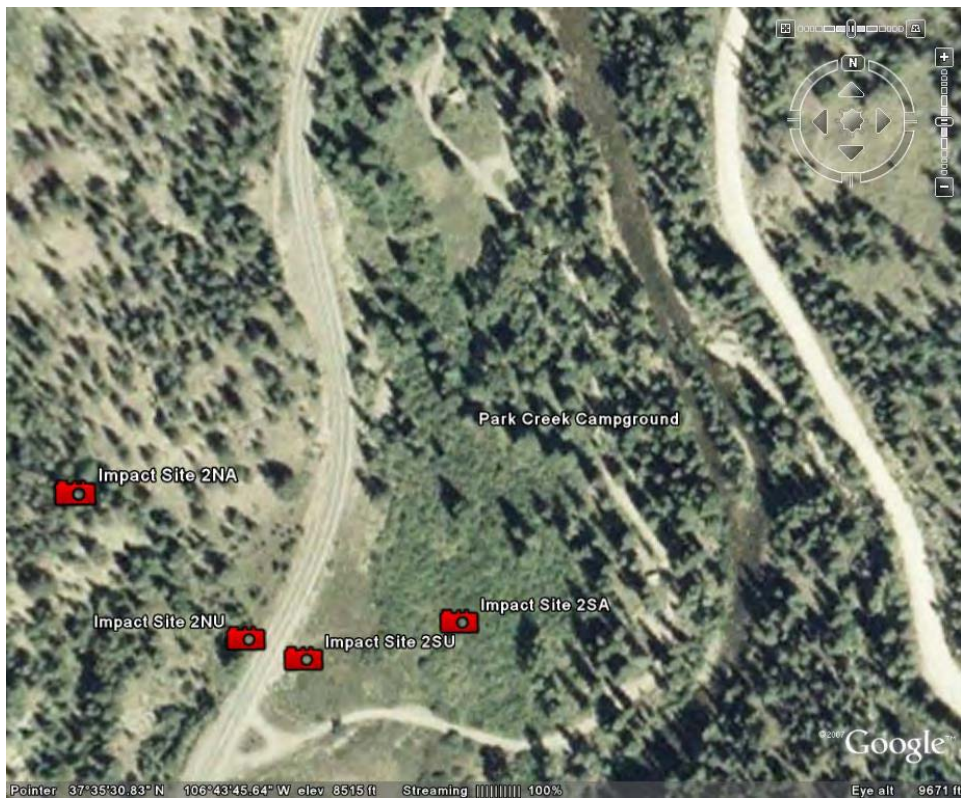
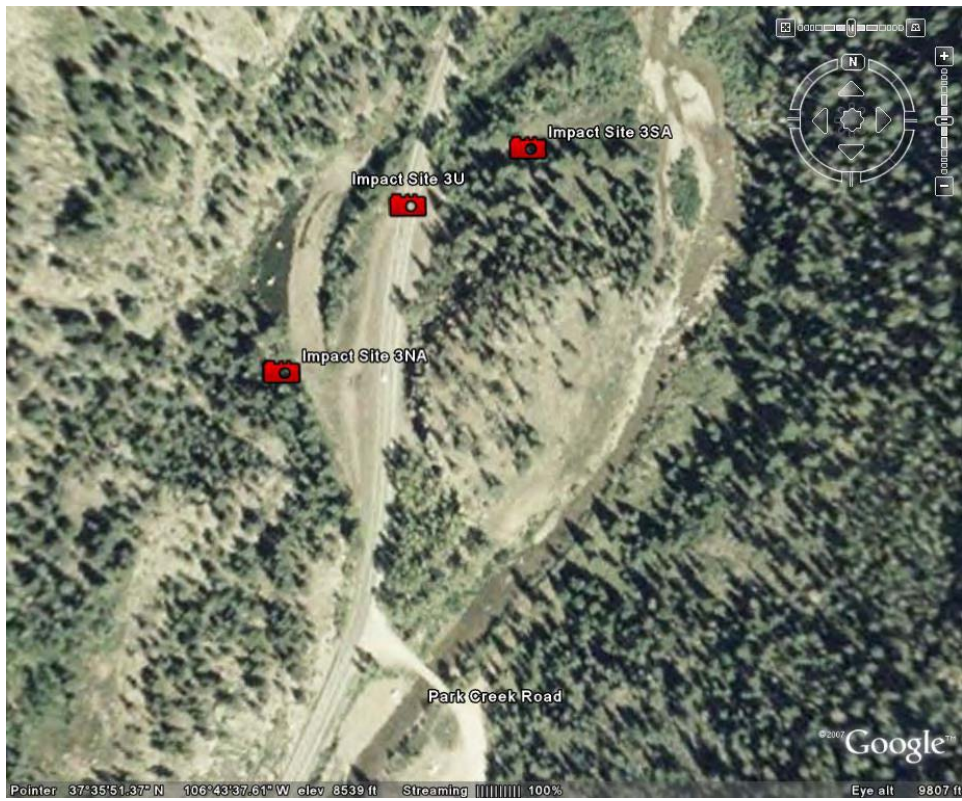
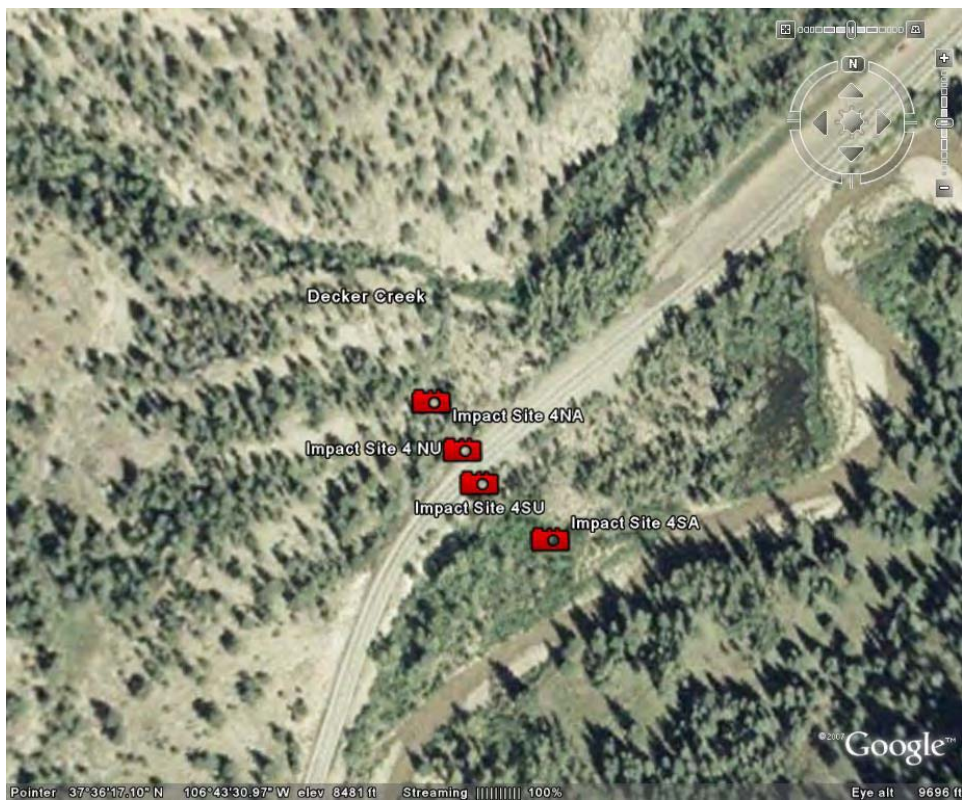
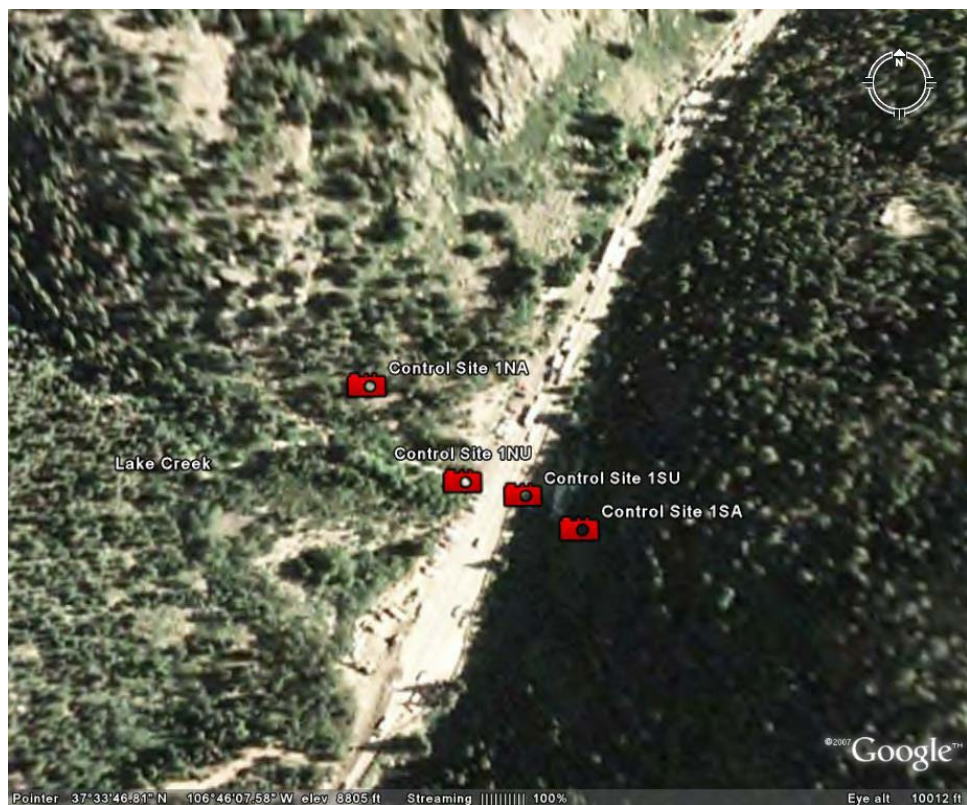
a) Impact site overview and transects (no transect at Impact Site 1)

b) Control site overview and transects, including Impact Site 5

**Figure 18. Aerial image of U.S. 160 Wolf Creek Pass a) impact site and b) control site, including a site overview and transect close-up. Station labels include: north approach (NA), north underpass (NU), south underpass (SU), and south approach (SA).**

Figures 18 (aerial images) and 19 (schematic diagram) show the locations of the impact site monitoring stations. Figure 18 provides detail of the positioning of the camera stations relative to the surrounding habitat, and GPS coordinates of each station are provided in Appendix B.3. Impact Site 1 had one camera positioned along a powerline corridor on the western side of the highway.

Figures 18 (aerial images) and 19 (schematic diagram) show the locations of the impact site monitoring stations. Figure 18 provides detail of the positioning of the camera stations relative to the surrounding habitat, and GPS coordinates of each station are provided in Appendix B.3. Control Site 1 consisted of four camera stations placed along a transect perpendicular to the highway, with the midpoint represented by the Lake Fork culvert (Lynx Crossing K). Two of these cameras were located at approaches on both the east and west side of the highway and two cameras were placed at opposing entrances to the 7 ft 7 in wide x 6 ft high metal culvert. This culvert drains Lake Fork, which occupies the entire width of the structure, thus providing no terrestrial passage for wildlife. Although this structure will not be redesigned during the current phase of construction in the impact site, it is slated to be constructed during a future phase of the U.S. 160 improvement project east of Wolf Creek Pass (dates not yet determined). The structure will be a double concrete box culvert, with one box cell carrying Lake Fork and the other providing a terrestrial passage for wildlife. Each box will be 8 ft high x 10 ft wide x approximately 115 ft long. Thus, monitoring the structure at this location will provide valuable baseline data as to the rate of wildlife movement surrounding the existing underpass location. Control Site 2 consisted of four camera stations placed along a transect perpendicular to the highway at a point where a small tributary to the South Fork Rio Grande crosses the roadway. Cameras were established at two opposing approach locations and along the opposing shoulders of the highway. Representative site photos are shown in Appendix B.4.

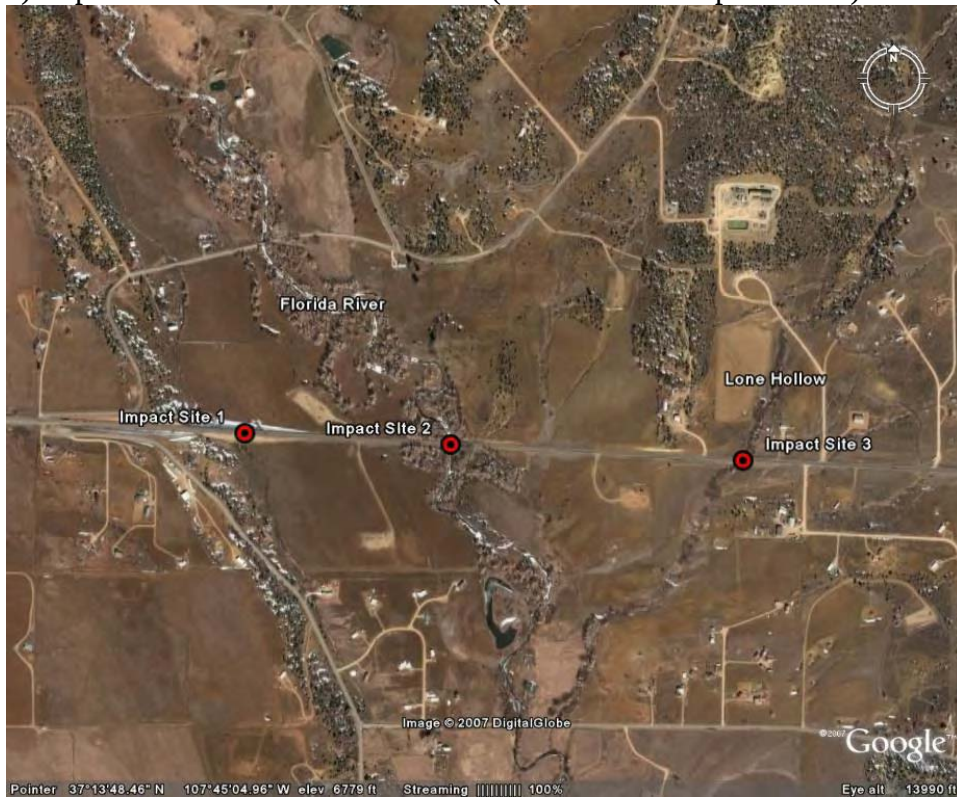
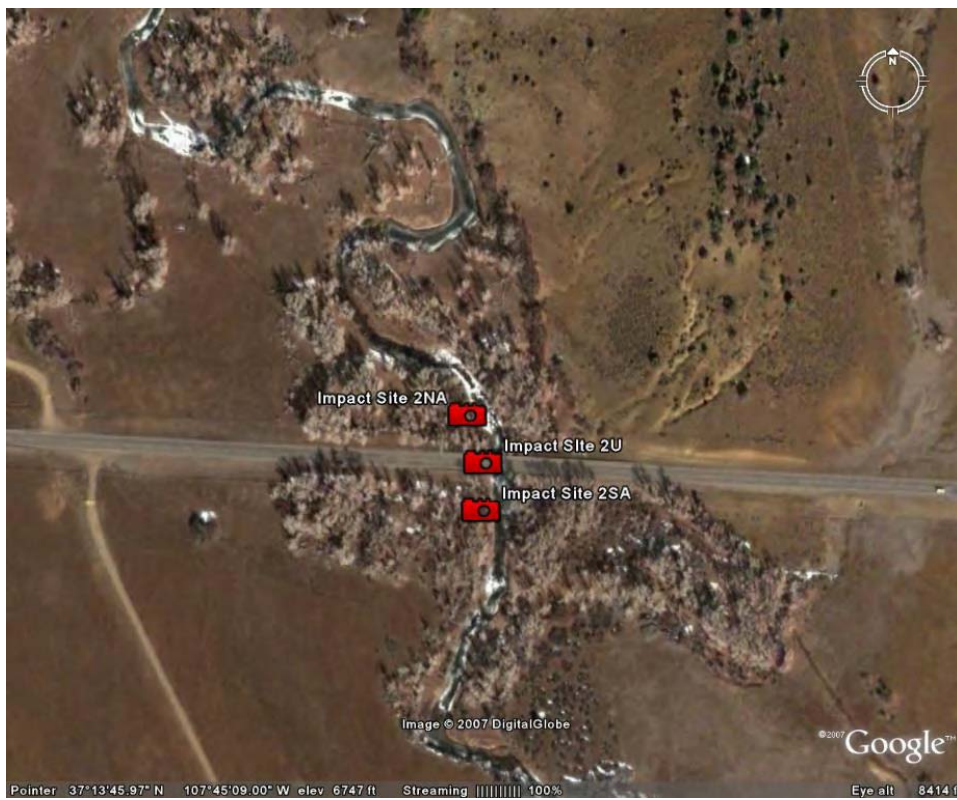
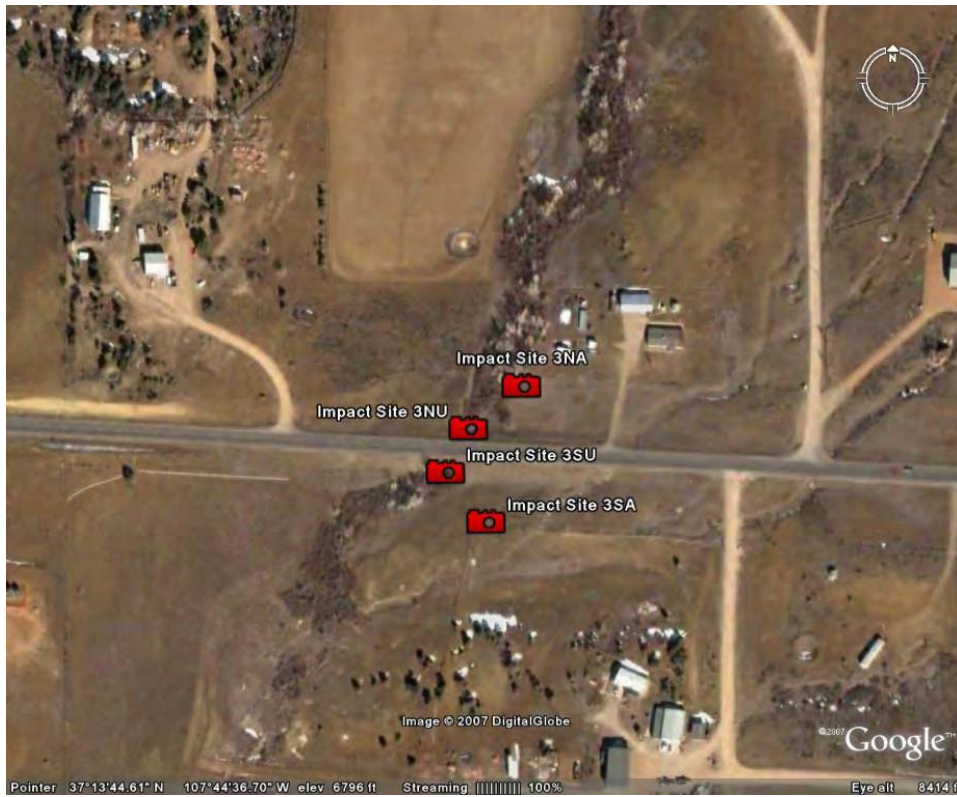
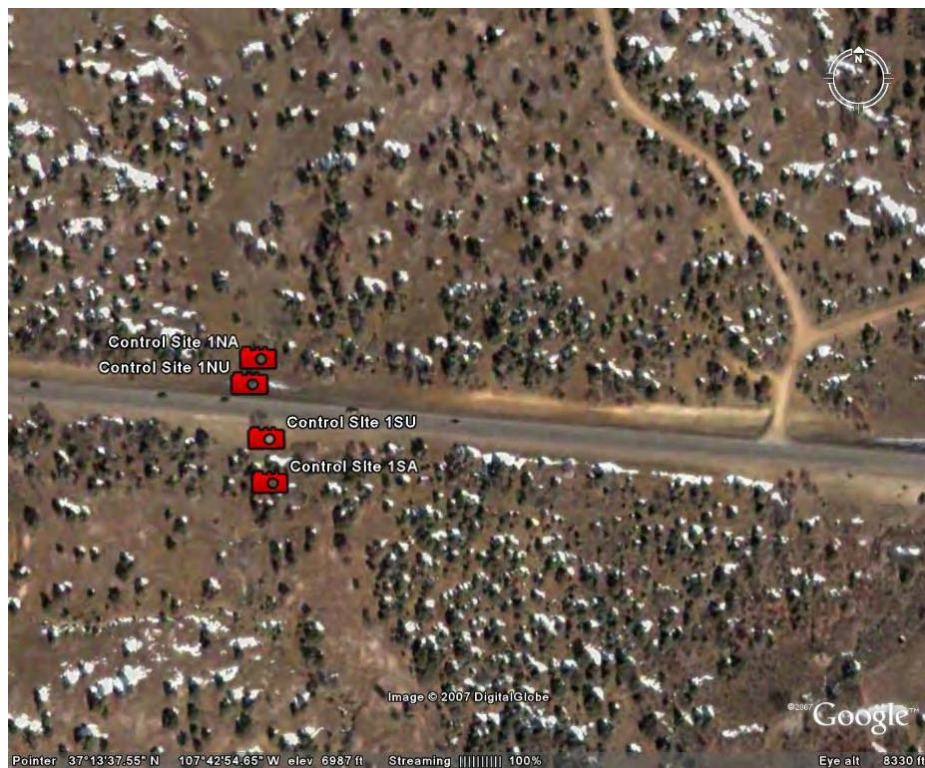
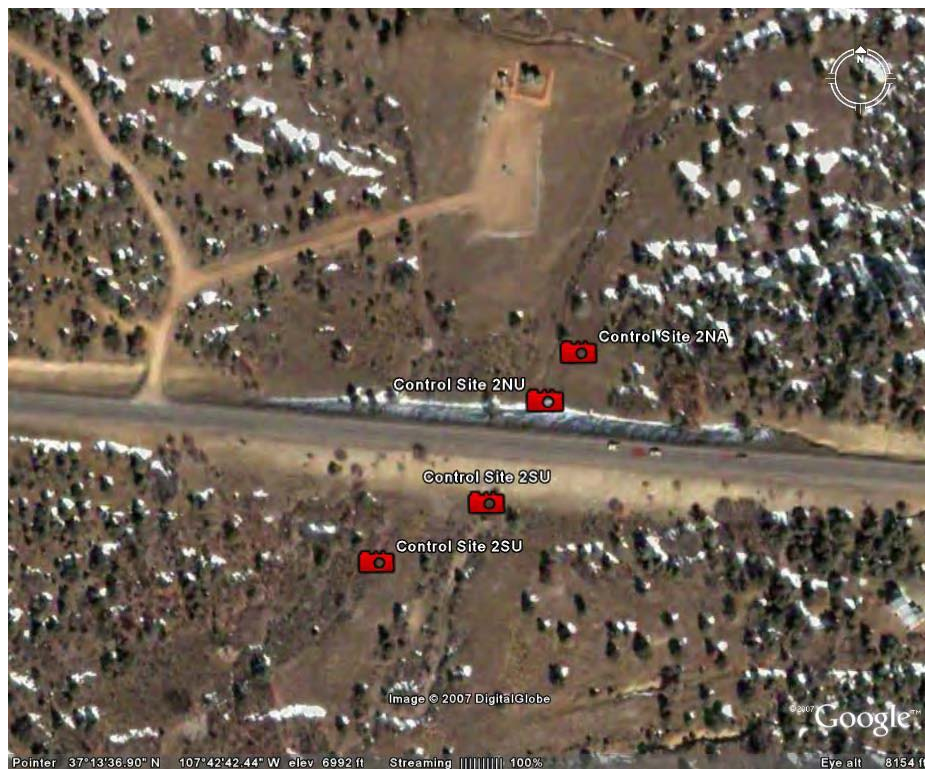
a) Impact site overview and transects (no transect at Impact Site 1)

b) Control Site overview and transects

**Figure 22. Aerial image of U.S. 160 Durango-Bayfield a) impact site and b) control site, including a site overview and transect close-up. Station labels include: north approach (NA), north underpass (NU), south underpass (SU), and south approach (SA).**

Figures 22 (aerial images) and 23 (schematic diagram) show the locations of the impact site monitoring stations. Figure 22 provides detail of the positioning of the camera stations relative to the surrounding habitat, and GPS coordinates of each station are provided in Appendix B.5. Impact Site 1 consisted of a single camera positioned at the base of a long fill

Figures 22 (aerial images) and 23 (schematic diagram) show the locations of the impact site monitoring stations. Figure 22 provides detail of the positioning of the camera stations relative to the surrounding habitat and GPS coordinates of each station are provided in Appendix B.5. Control Site 1 consisted of four camera stations placed along a transect perpendicular to the highway, with the midpoint represented by a small pipe culvert 2 ft in diameter. Two of these cameras were located at approaches on both the north and south side of the highway and two cameras were placed at opposing entrances to the structure. Two remotely-triggered video cameras were also placed on each side of the highway between the underpass and approach digital cameras in order to record surface crossings over U.S. 160 by wildlife. This fill slope is proposed to have a 120 ft long x 36 ft wide x 14 ft high arch culvert installed during a future construction phase on this segment of the highway. Control Site 2 consisted of four cameras placed along a transect perpendicular to the highway, with the midpoint represented by a 145 ft long x 7 ft wide x 7 ft high metal culvert. Two remotely-triggered cameras were located at

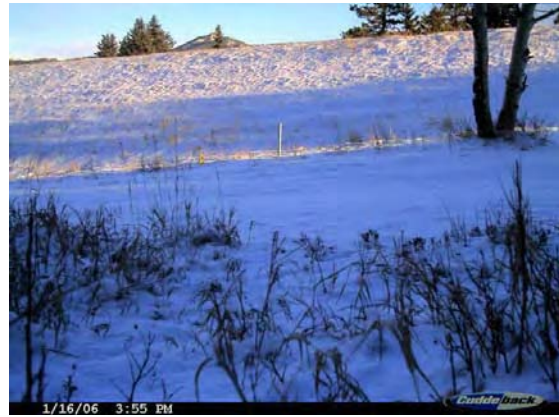
Impact Site 2: Green Valley Grill underpass before construction

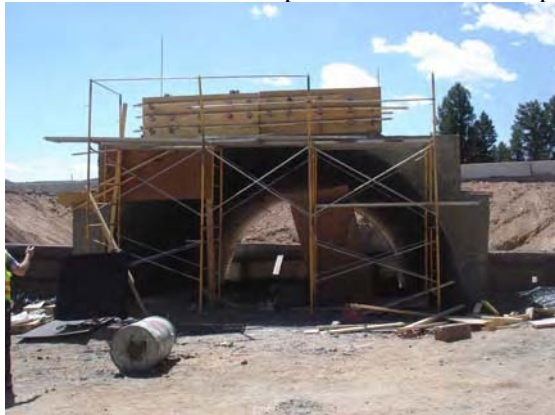
Impact Site 2 during construction of the southbound U.S. 285 portion of the underpass

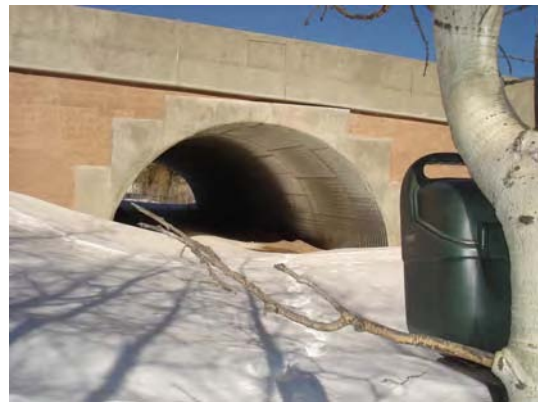
Impact Site 2 after construction

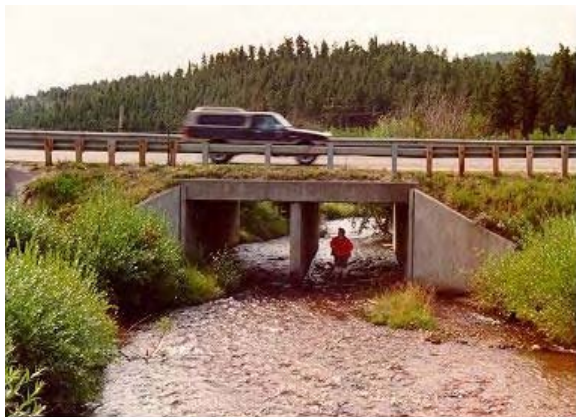
Control Site 1: Deer Creek span bridge<sup>1</sup>

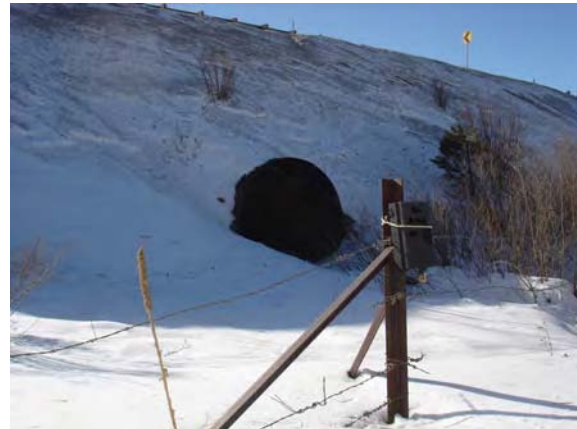
Control Site 2: Roland Gulch culvert, west entrance

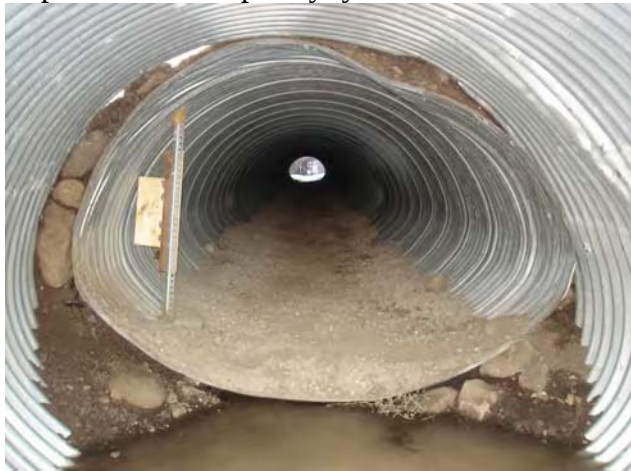
Impact Site 3: temporary lynx structure

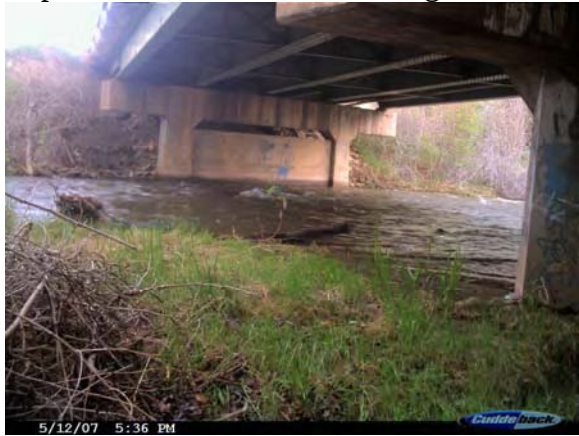
Impact Site 2: Florida River bridge

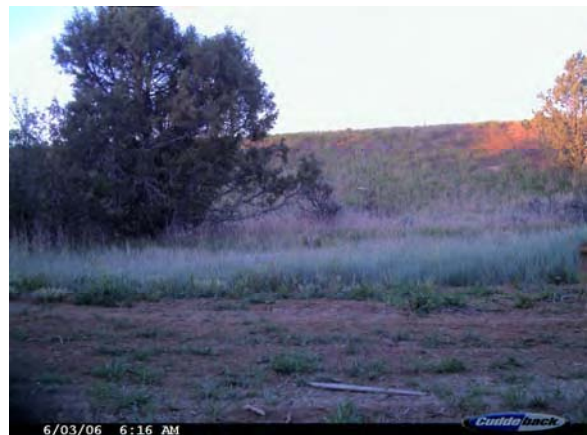
Control Site 1: looking east toward Control Site 2

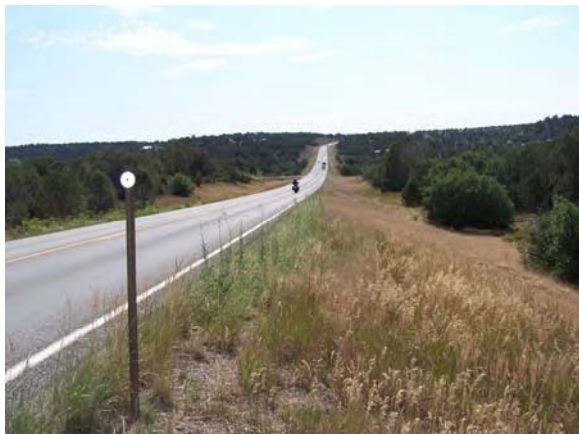
Control Site 2: south entrance to culvert

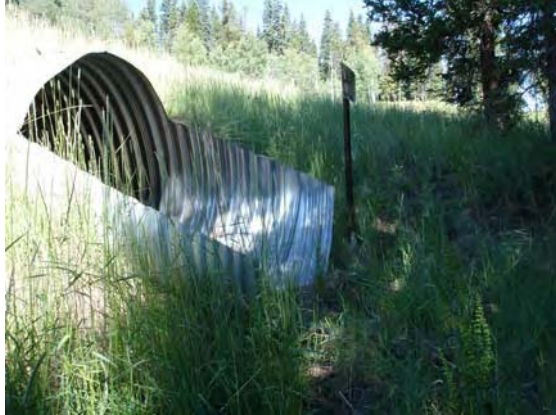
### **Appendix C.3. Representative site photos and underpass conditions at the U.S. 40, Muddy Pass MP1 underpass.**

August 2005 (grass regeneration east side)

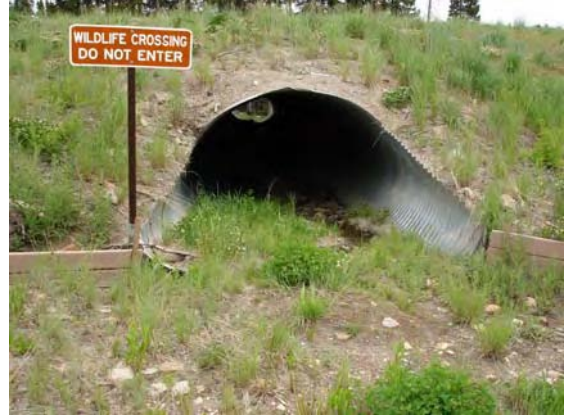
August 2006 (grass regeneration west side)

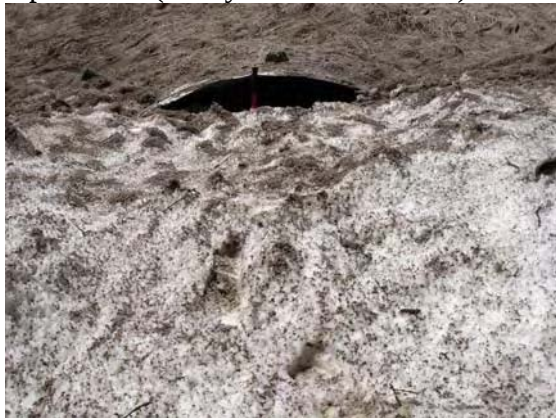
April 2006 (heavy snow conditions)

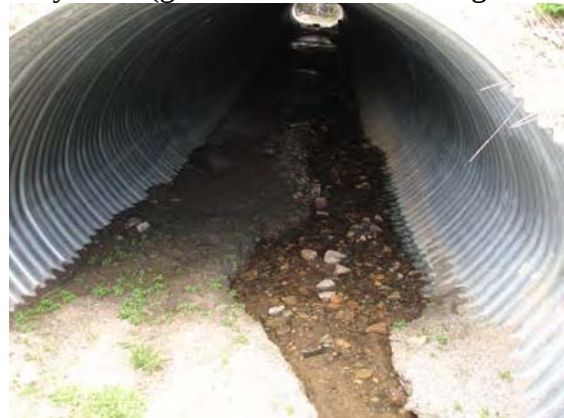
May 2006 (ground water flow through tunnel)

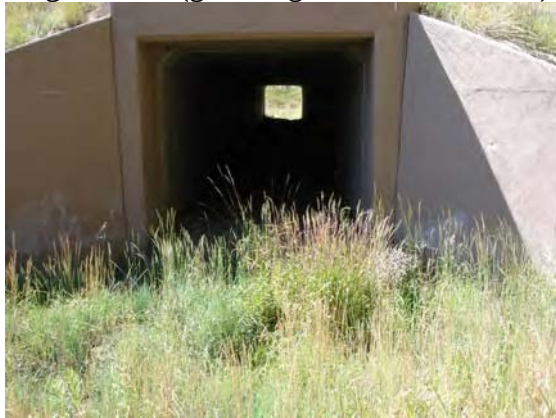
**Appendix C.5. Representative site photos and underpass conditions at the U.S. 40, Muddy Pass MP1 underpass.**

August 2006 (grass regeneration east side)

Representative site photos and underpass conditions are shown in Appendix C.5.

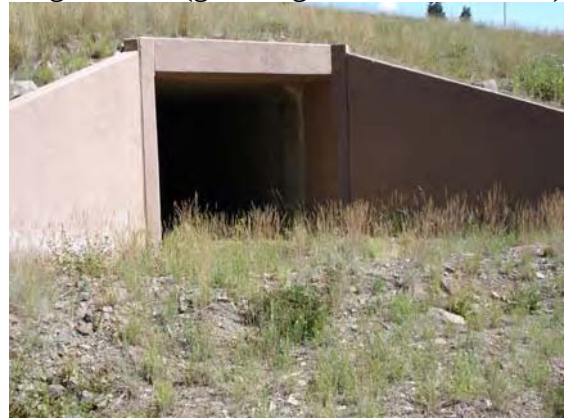
August 2006 (grass regeneration west side)

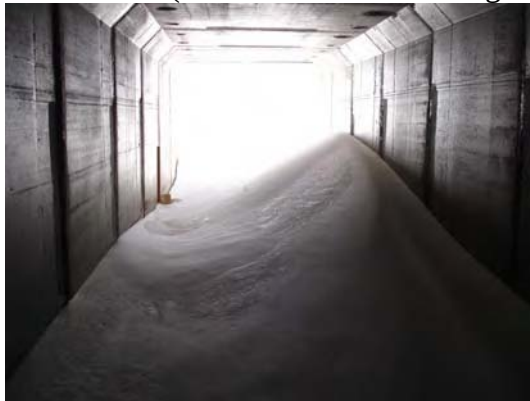
March 2006 (snow drift inside looking west)

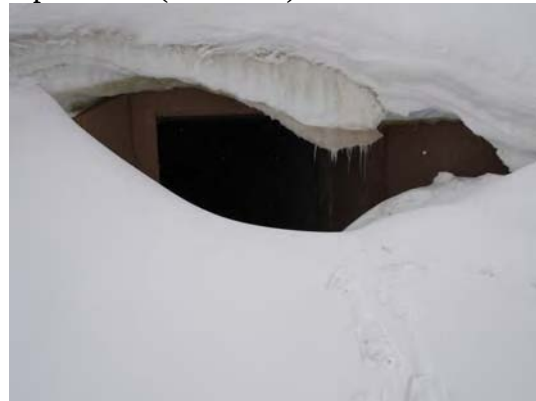
April 2006 (west side)

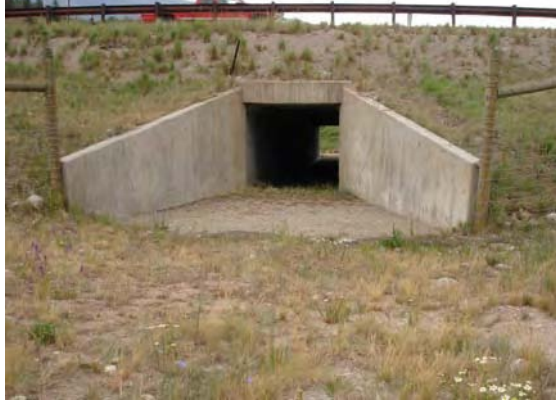
**Appendix C.7. Representative site photos and underpass conditions at the SH 9, Silverthorne S1 underpass.**

July 2006 (grass regeneration west side)

Representative site photos and underpass conditions are shown in Appendix C.7.

The local topography was well suited for wildlife movement on the west side of the underpass. The hills and gully that border the west side naturally channel wildlife towards the underpass. However, the east side of the underpass borders the Blue River, which may act as a barrier for smaller animals, especially during periods of high runoff. The height and width of the tunnel was suitable for all species of wildlife and the length of the tunnel was sufficiently short for light to penetrate and illuminate the interior of the underpass. During the winter and spring months the icy conditions and slight slope of the underpass made it difficult to walk through the tunnel to check the camera station. This may be a limiting factor for larger bodied animals using the tunnel. Snow conditions were mild compared to other underpasses. Constant solar radiation along the east side of the tunnel kept snow levels fairly low and the only deep snow occurred on the west side in the shade. Similar to the underpass at Muddy Pass (MP1), human use was noticeable. Anglers and hunters and other pedestrians used the underpass often. Graffiti was found inside the east entrance in the spring of 2007. There are no signs outside the tunnel notifying the public that the tunnel is for wildlife use only. Overall, S1 seemed to be one of the best tunnels suited for wildlife passage.

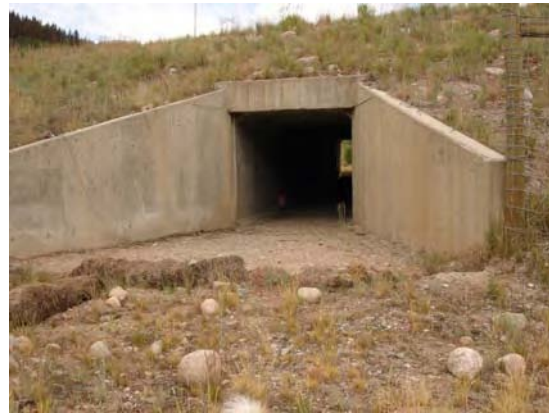
July 2006 (grass regeneration east side)

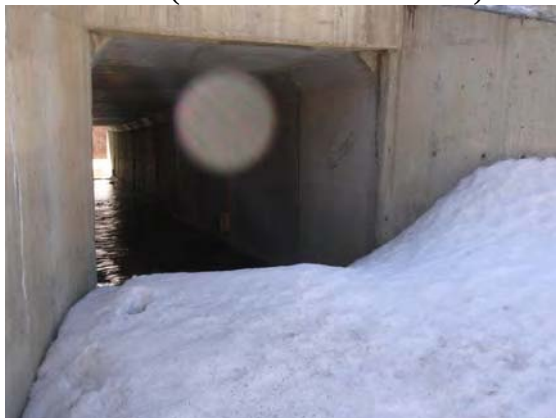
March 2007 (snow and ice west side)

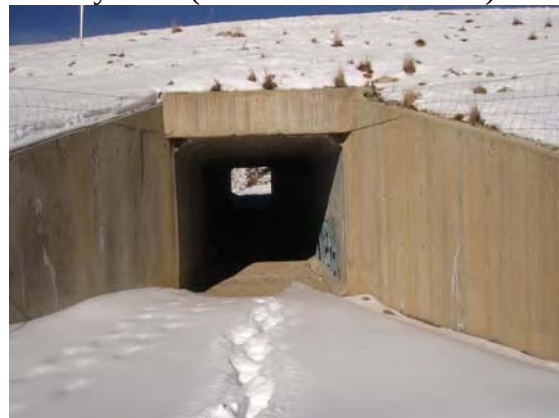
January 2007 (snow outside east side)

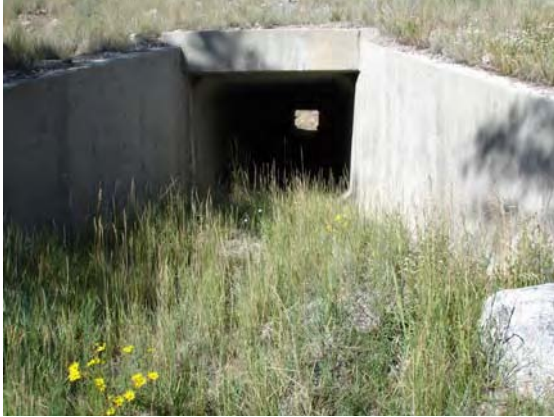
**Appendix C.9. Representative site photos and underpass conditions at the SH 9, Silverthorne S1 underpass.**

August 2006 (grass regeneration east side)

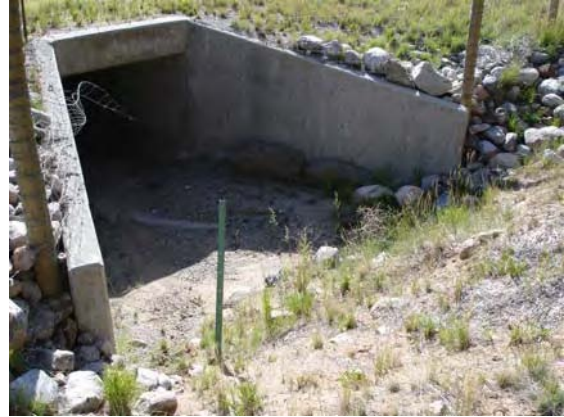
August 2006 (grass regeneration west side)

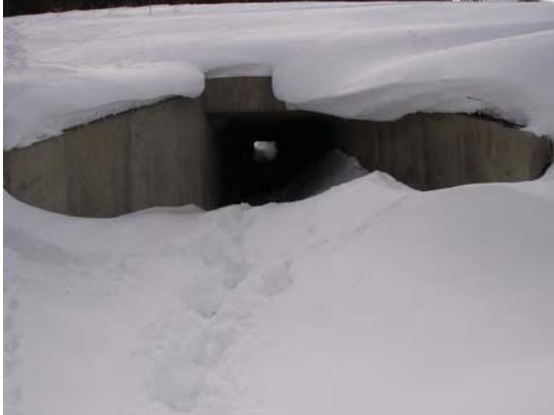
February 2006 (snow conditions east side)

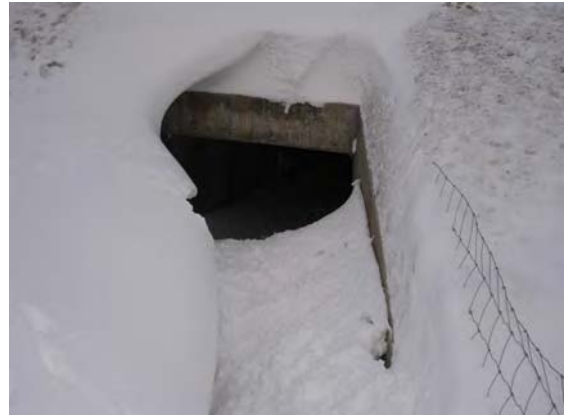
February 2006 (snow conditions west side)

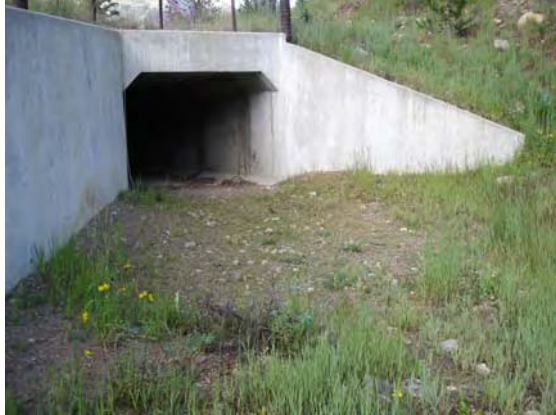
**Appendix C.10. Representative site photos and underpass conditions at the U.S. 40, Berthoud Pass BP1 underpass.**

August 2006 (grass regeneration north side)

Representative site photos and underpass conditions are shown in Appendix C.10.

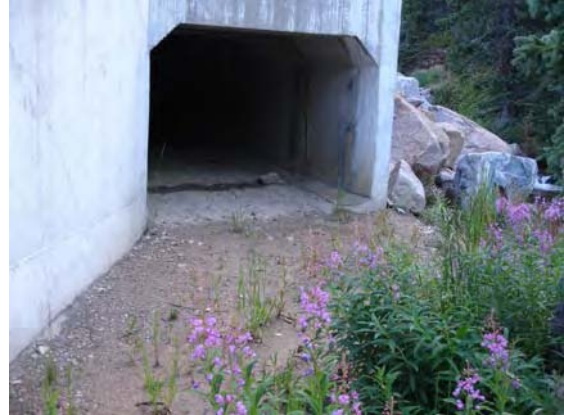
August 2006 (grass regeneration south side)

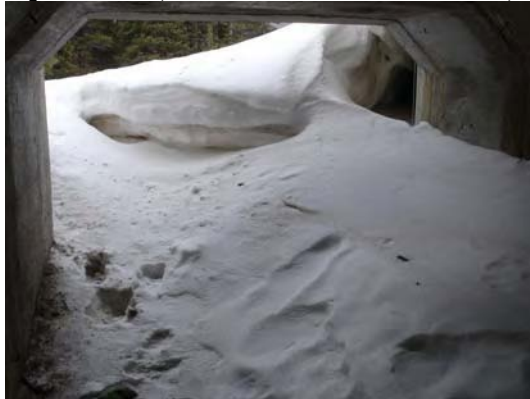
April 2006 (snow conditions north side)

- Late summer 2005: Mud inside tunnel no longer a problem
- Winter 2005 and 2006: Heavy drifting of snow inside north entrance, up to 30 ft inside tunnel
- Late spring 2006: Ice continues to build up over early spring months and lasts until late spring
- It is difficult to access the camera station on the north side due to the slope and ice conditions inside the tunnel which may also limit wildlife use
- Snow levels outside tunnel entrances ranged from 5ft to 6 ft in the winters of 2005 and 2006

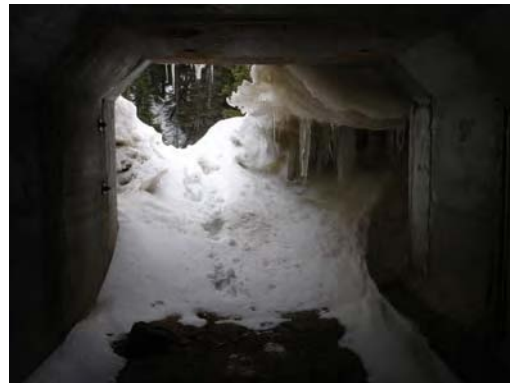
April 2006 (snow conditions south side)

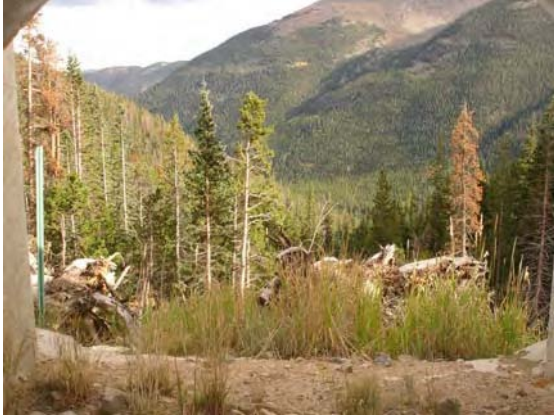
**Appendix C.11. Representative site photos and underpass conditions at the U.S. 40, Berthoud Pass BP2 underpass.**

September 2005 (grass regeneration south side)

Representative site photos and underpass conditions are shown in Appendix C.11.

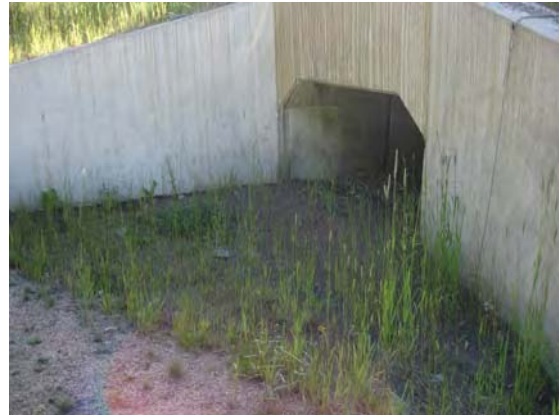
August 2006 (grass regeneration north side)

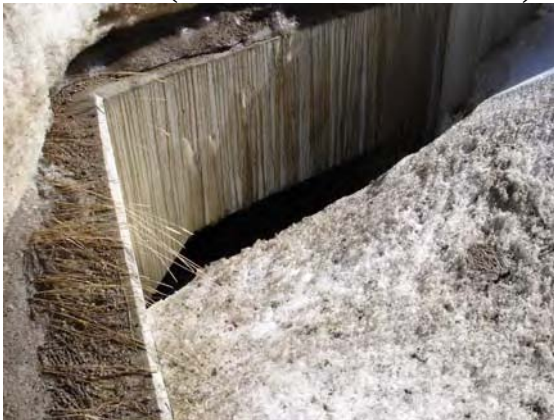
March 2006 (snow conditions north side)

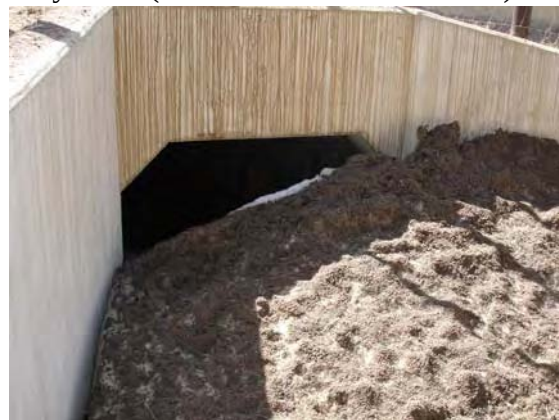
May 2007 (snow conditions north side)
