DOT/FAA/CT-91/2

# Development and Growth of Inaccessible Aircraft Fires Under Inflight Airflow Conditions

Final Report

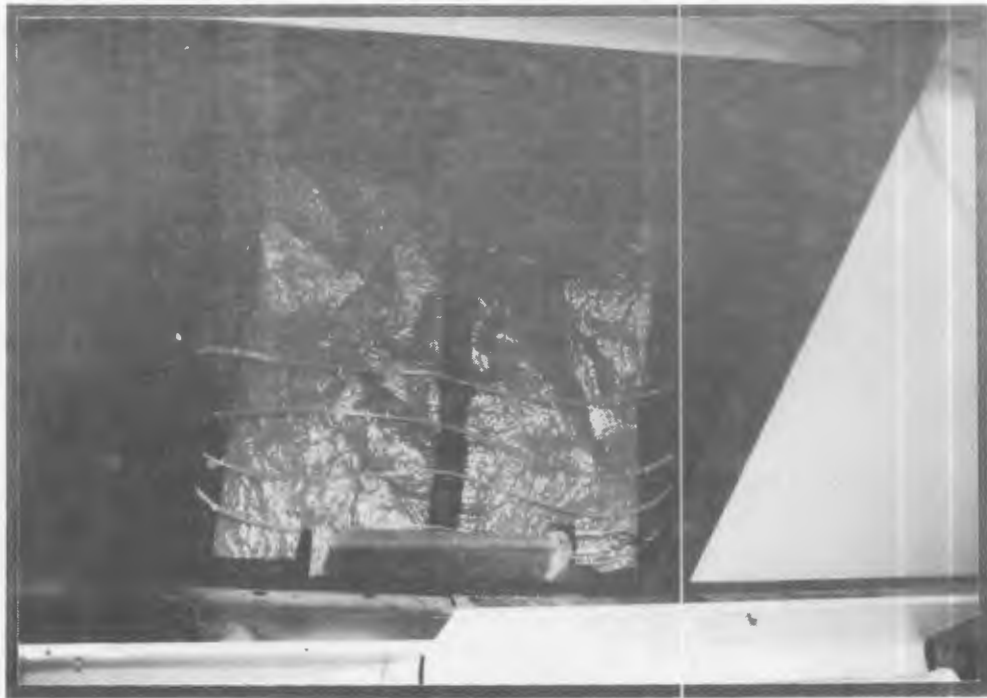
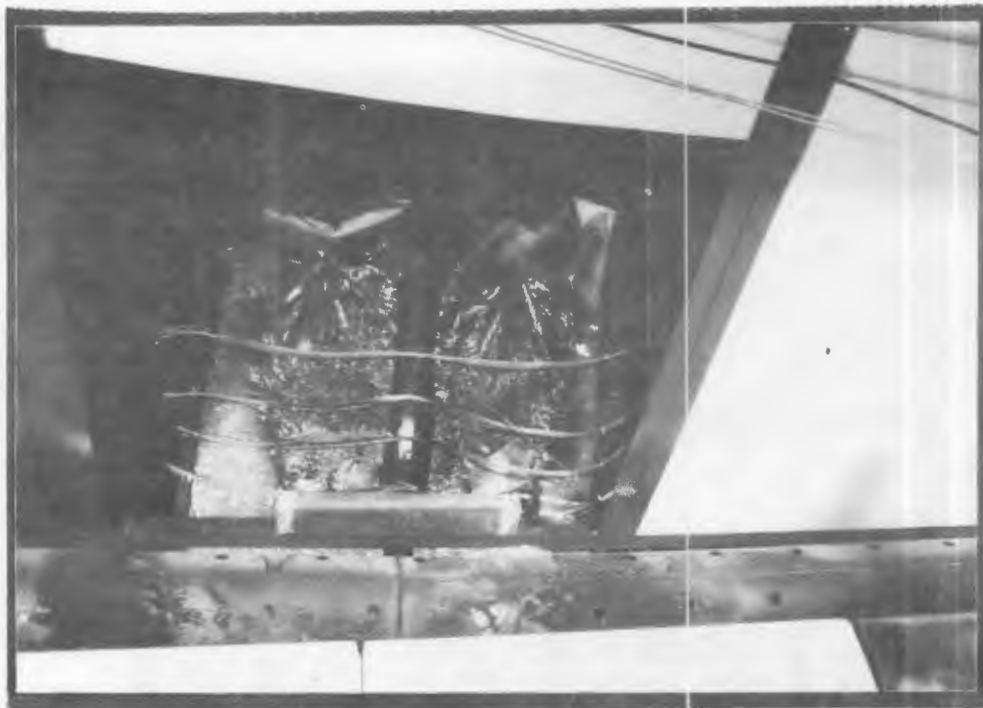
FIGURE 16. WIRE AND INSULATION BEFORE AND AFTER-TEST 31  
(Kapton Wire Insulation/Kapton Covered Batts)

Test 32, with PVC wire and aluminized Tedlar insulation batts, produced significantly more smoke and heat than tests 31 and 33. Figure 13 shows the average temperature above the cabin ceiling for the three tests. The temperature is the average of the six thermocouples in the 950-cubic-foot space above the ceiling. Figures 14 and 15 show the average smoke levels for the three smoke meters above the ceiling and the three smoke meters in mid cabin. It can be seen from these graphs that the main source of smoke and heat in test 32 was from the PVC wire insulation, since test 33 used the same aluminized Tedlar insulation covering as test 32 but produced much less smoke and heat. A PVC/nylon wire insulation will not pass the current flammability test for aircraft wiring which was imposed in 1972. However, it was installed on some aircraft manufactured prior to that date, many of which are still in service. Kapton and Tefzel insulated wires do pass the current flammability test. Figures 16, 17, and 18 show the wire bundles and insulation before and after each of the three tests.

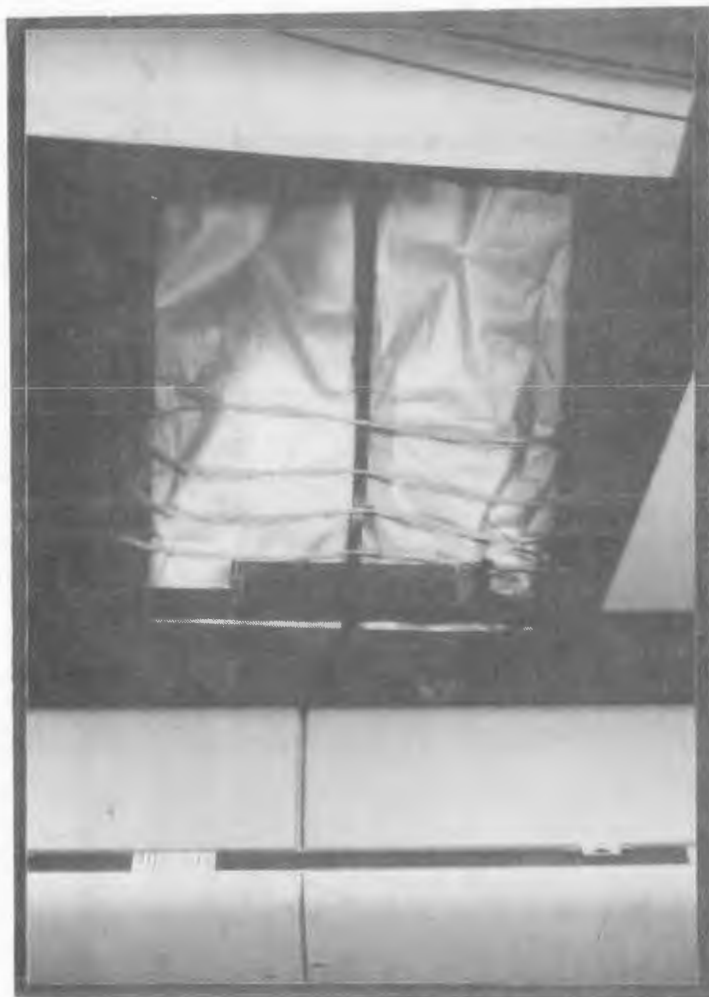
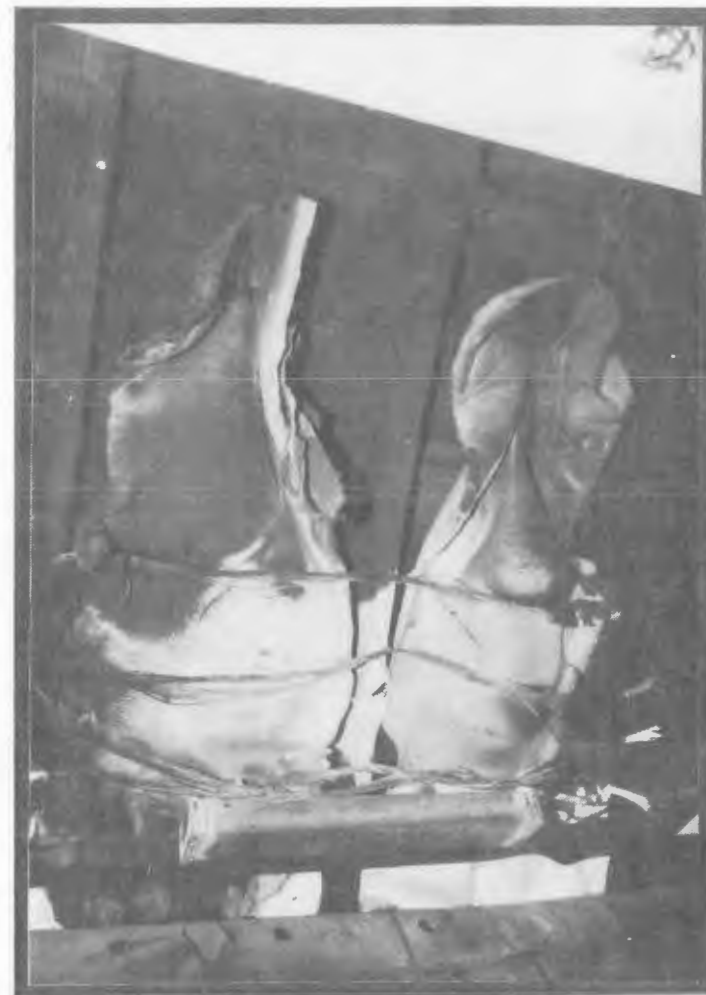
FIGURE 17. WIRE AND INSULATION BEFORE AND AFTER-TEST 32  
(PVC Wire Insulation/Aluminized Tedlar Covered Batts)
