CIVIL AERONAUTICS BOARD

ACCIDENT INVESTIGATION REPORT

STANDARD AIRLINES, INC., CHATSWORTH, CALIFORNIA, JULY 12, 1949

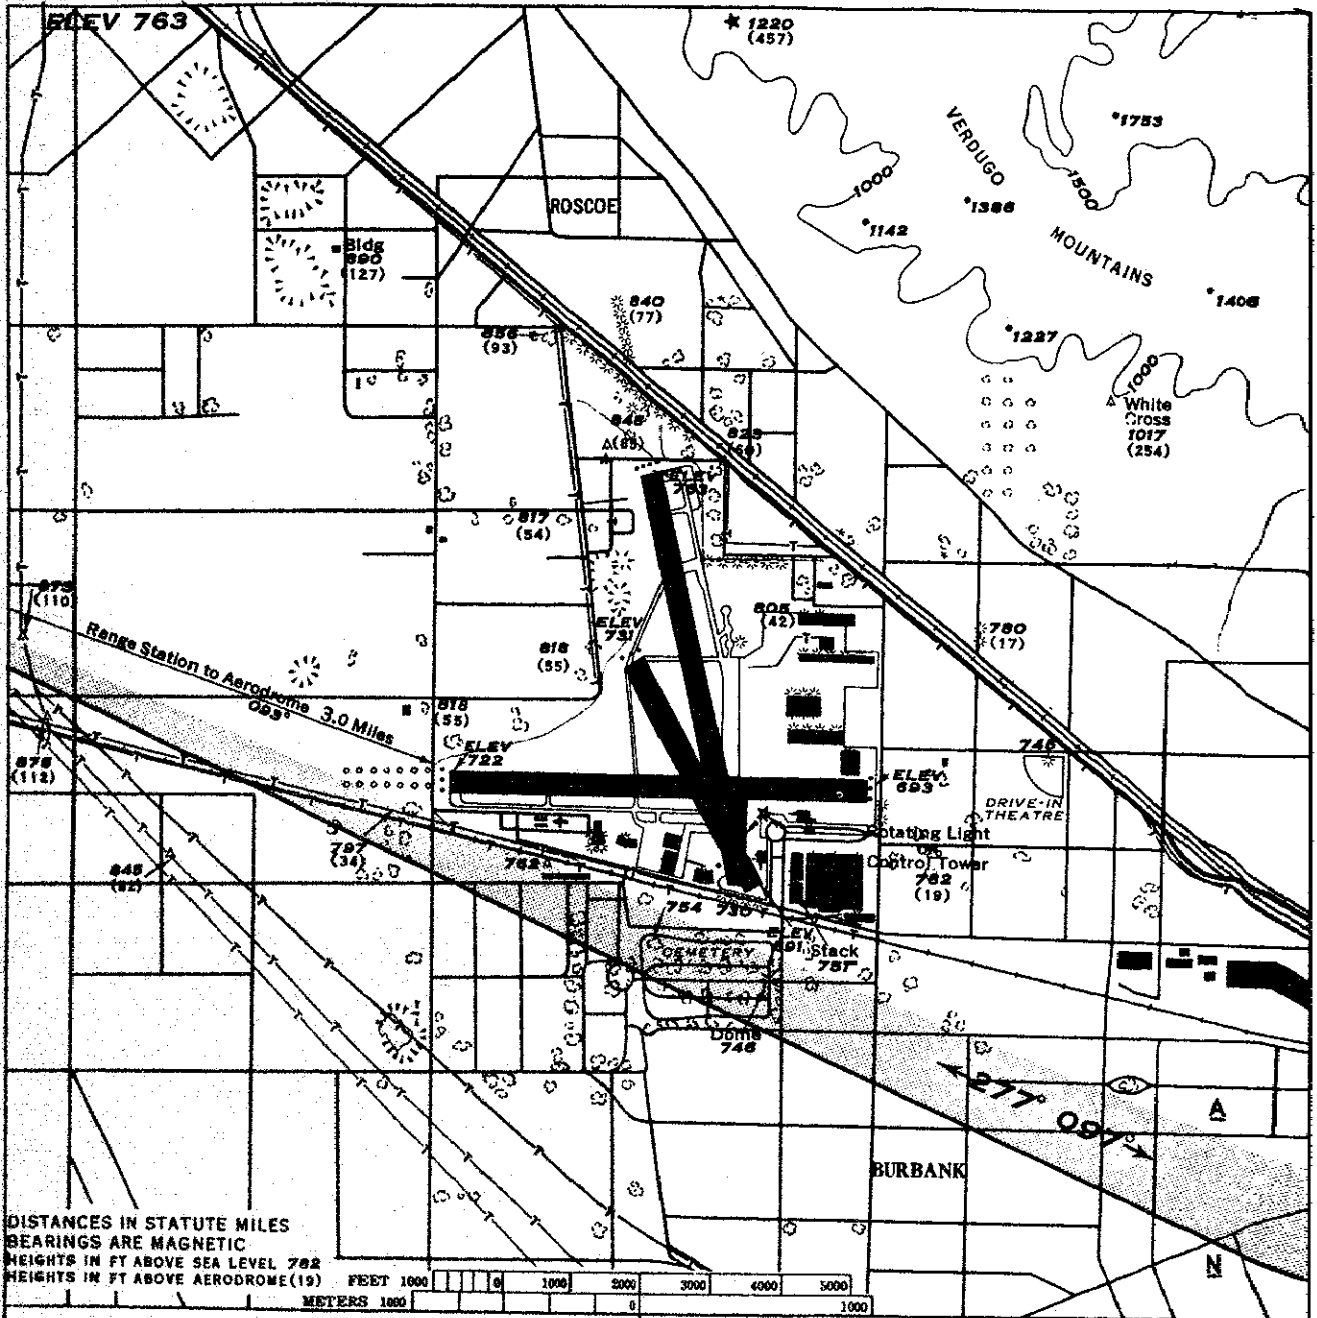
AERODROME POSITION: Lat. 34°12'N., Long. 118°21'W.

RADIO: SBML range, VHF voice, Tower, VHF tower.
