ACCIDENT ON THE
PENNSYLVANIA RAILROAD

CUYAHOGA FALLS, OHIO

JULY 31, 1940

INVESTIGATION NO. 2440

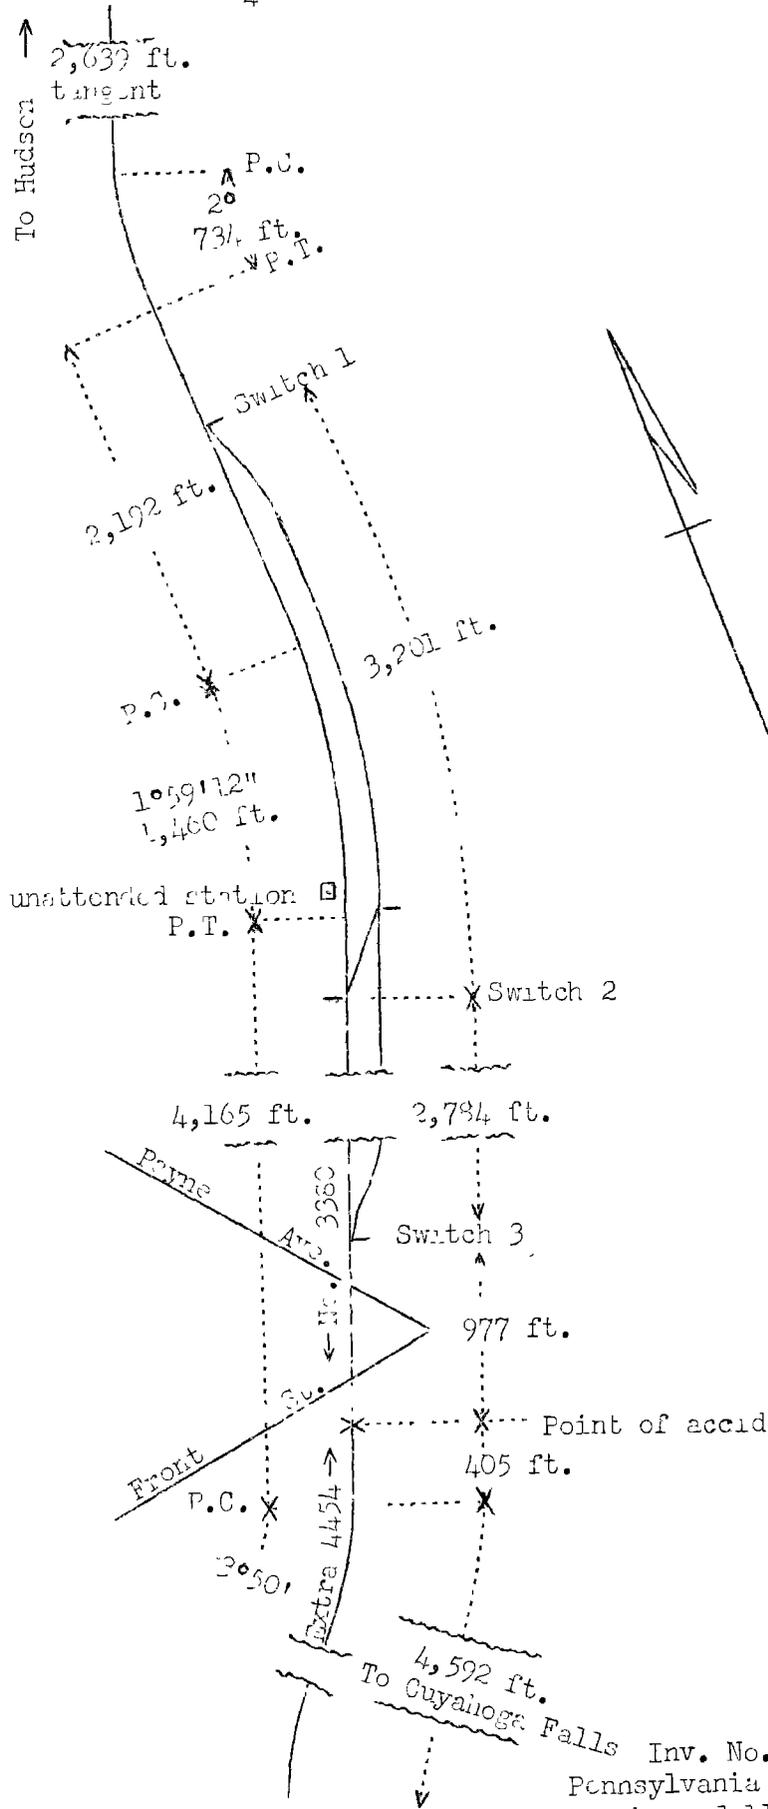
| o | Hudson, Ohio |
| | 6.3 ml. |
| o | Silver Lake |
| | 4,165 ft. |
| x | Point of accident |
| | 4,592 ft. |
| o | Cuyahoga Falls |
| | 5.0 ml. |
| o | Akron |

This accident occurred on that part of the Cleveland Division which extends between Hudson, Ohio, and Joyce Avenue, Columbus, Ohio, a distance of 142.1 miles. In the vicinity of the point of accident this is a single-track line over which trains are operated by timetable, train orders and a manual block system. The accident occurred on the main track at a point 4,592 feet north of the station at Cuyahoga Falls. As the point of accident is approached from the north there are, in succession, a tangent 2,639 feet in length, a 2° curve to the left 734 feet in length, a tangent 2,192 feet in length, a $1^{\circ}59'12''$ curve to the right 1,460 feet in length, and a tangent 4,165 feet to the point of accident and 405 feet beyond. As the point of accident is approached from the south there are, in succession, a tangent 1,625 feet in length, a compound curve to the right 1,787 feet in length having a maximum curvature of $3^{\circ}50'$, a tangent 237 feet in length, a compound curve to the left 1,794 feet in length having a maximum curvature of $3^{\circ}50'$, and the tangent on which the accident occurred. The grade for south-bound trains varies between 0.166 and 0.706 percent ascending a distance of 3,400 feet and then is 0.62 percent descending 1,411 feet to the point of accident. The grade for north-bound trains varies between 0.218 and 0.62 percent ascending a distance of 2,732 feet to the point of accident.

A siding 5,985 feet in length and designated as Silver Lake is north of the point of accident and parallels the main track on the east. The switches are numbered progressively from north to south; the most northerly is designated as switch one, the intermediate, switch two, and the most southerly, switch three; these switches are, respectively, 2.37, 1.58, and 1.05 miles north of the station at Cuyahoga Falls. The accident occurred at a point 977 feet south of switch three. Payne Avenue and Front Street cross the main track diagonally at points, respectively, 677 and 872 feet south of switch three.

An unattended block-station sign is located at a point 2,934 feet south of switch one, 267 feet north of switch two, and 3,050
