University of Missouri-Rolla

RDT 04-024

Evaluation of FRP Repair Method for Cracked Bridge Members

EVALUATION OF FRP REPAIR METHOD FOR CRACKED BRIDGE MEMBERS

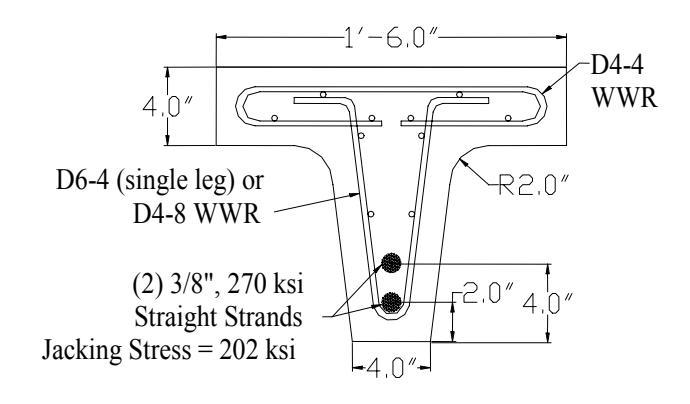
Figure 3-1: Girder Cross-Section

All girders were cast by Prestressed Concrete, Inc. located in Newton, KS. Fabrication was determined based on the reinforcing ratios of the Graham County bridges tested in Phase I of the study (Kansas State University, 2000). Each girder was a 16 feet 6 ½ inches (5,042 mm) long tee-girder. The cross section was 14 inches (356 mm) deep with an average web width of 5 inches (127 mm). The flange was 18 inches (457 mm) wide with a thickness of 4 inches (102mm) (Figure 3-1). The actual concrete strength was found to be 6,207 psi (42.80 MPa) as determined from concrete cylinder breaks.

(1 inch = 25.4 mm, 1 ksi = 6.895 MPa)

Shear Sufficient, D6-4. Two (2) "shear-sufficient girders" were cast which represent the target level of reinforcement. The shear reinforcement consisted of single–leg size D6 welded wire (area = $0.18 \text{ in}^2 (1.16 \text{ cm}^2)$) spaced at 4.0 inches (102 mm) on center. These girders were used as a control to provide a reference for the desired shear strength of the upgraded, "shear-deficient girders". The steel yield strength was equal to $f_v=60 \text{ ksi}$.

Shear Deficient, D4-8. Four (4) "shear-deficient girders" were cast to represent the field condition. The level of reinforcement consisted of double–leg size D4 welded wire (area = 0.12 in² (0.77 cm²)) spaced at 8.0 inches (203 mm) on center. One of these girders was used as the

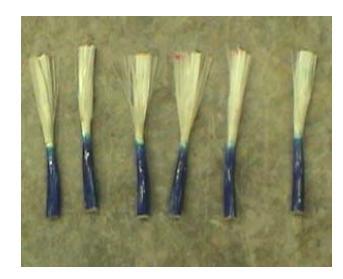
Figure 3-2: GFRP Anchors

To produce the GFRP anchors glass fiber strands were clustered into loose $\frac{3}{4}$ inch (19 mm) bundles that were 5 inches (127 mm) long. Three inches of the anchors were tightly wrapped with plastic to prevent their saturation with the epoxy. The unwrapped end of the anchors were then saturated with Wabo®MBrace Saturant and pulled through a $\frac{1}{2}$ inch (13 mm)

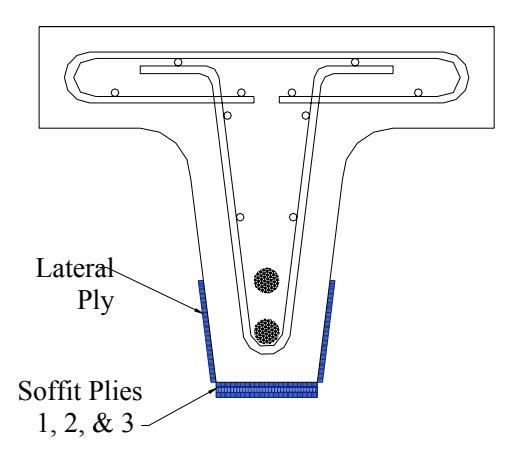
Figure 4-1: Flexural Strengthening

4.2.2. Flexural Strengthening. Flexural strengthening was identical on all girders except the control girder for which no strengthening was provided. Flexural strengthening was provided in order to cause a shear failure of the girders. The flexural strengthening consisted of three soffit plies of CFRP, 4 inches (102 mm) wide. Two 4 inch (102 mm) lateral plies were also

applied, one on each side, as illustrated in Figure 4-1. The flexural strengthening extended 11 feet (3400 mm) and completely encompassed the constant maximum moment region.

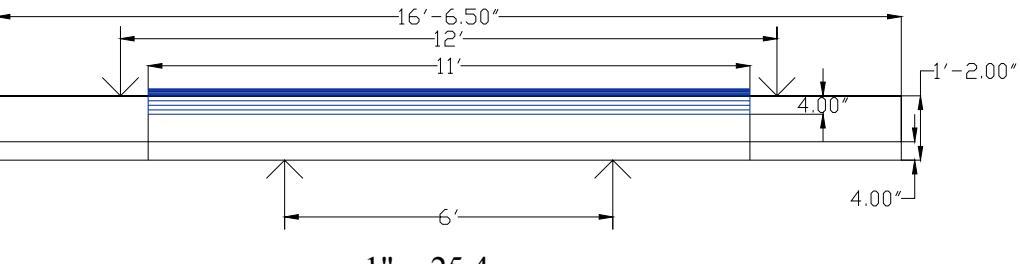
Figure 4-2: 1-Sufficient Strengthening

<u>1-Sufficient.</u> The first "shear-sufficient girder", labeled 1-Sufficient, which has been properly designed for shear, was strengthened in flexure (Figure 4-2).

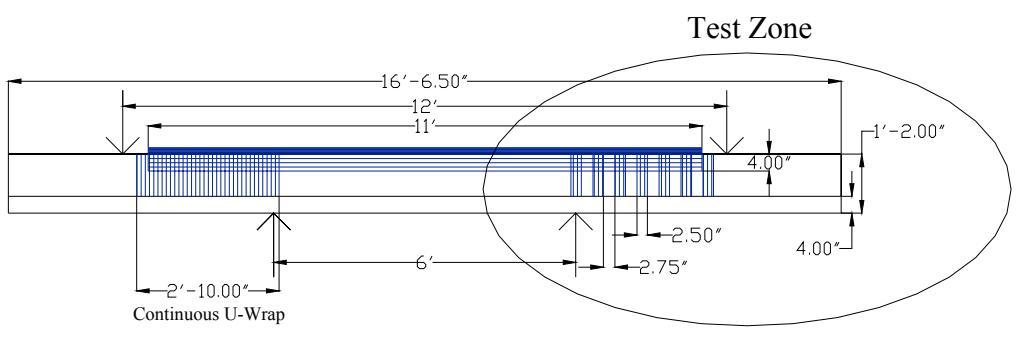
Figure 4-4: 1-UW Strengthening

<u>1-UW.</u> 1-UW, a "shear-deficient girder", was strengthened in shear using CFRP U-Wraps (Figure 4-4). The wraps were 2.5 inches (64 mm) wide spaced at 5.25 inches (133 mm) on center in one shear region to produce the required shear strength (see test zone Figure 4-4).

The other shear region was strengthened with continuous U-Wraps in order to force the shear failure to occur at the other end.

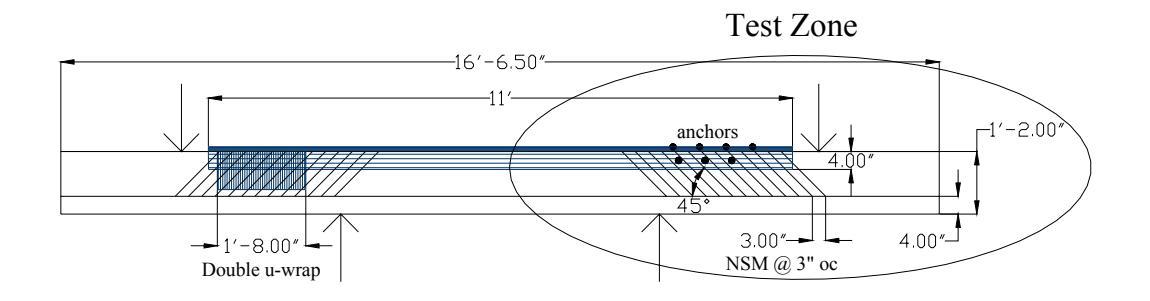
<u>**1-NSM.</u></u> 1-NSM, a "shear-deficient girder", was strengthened with NSM bars (Figure 4-5 and Figure 4-6). The NSM bars were placed at a 45^{\circ} angle and spaced at 3.0 inches (76 mm) on center using twenty-six (26) bars per shear region. At one end of the girder a double U-Wrap anchor was used to force failure in the test zone. In the test zone, GFRP anchors were used to improve flexural bond without effecting shear capacity, as is the case with the U-Wraps.</u>**

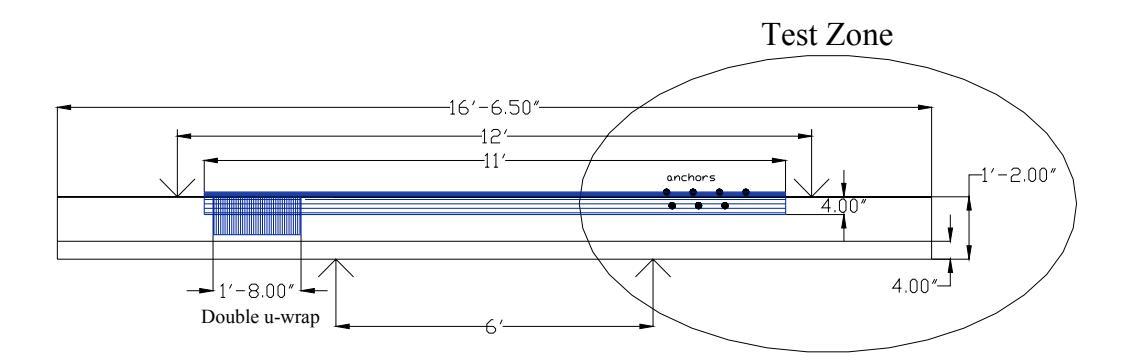
Figure 4-7: 2-Sufficient Strengthening

<u>2-Sufficient.</u> 2-Sufficient, a "shear-sufficient girder", was strengthened in flexure without the defects seen in 1-Sufficient (Figure 4-7). As in 1-NSM, 2-Sufficient GFRP anchors and CFRP U-Wraps s were used to increase bond between the FRP and concrete substrate in the shear regions of the girder. No shear strengthening was performed on this girder.

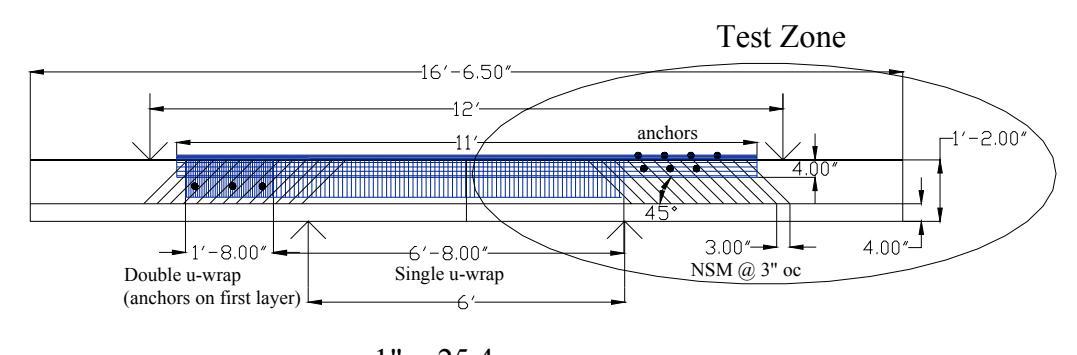
1" = 25.4 mm Figure 4-8: 2-NSM Strengthening

<u>2-NSM.</u> 2-NSM, a shear deficient, was strengthened in the same manner as 1-NSM with added anchorage provided in the mid span-region of the girder in a further attempt to eliminate a flexural debonding failure (Figure 4-8). To prevent debonding from occurring on 2-NSM, U-Wrap anchors were used in the shear region and additionally in the constant moment region. One ply of CFRP wraps was used to continuously anchor the constant moment region. The shear

region was anchored using two plies with the bottom ply anchored to the girder using GFRP anchors. The other shear region was anchored using only the GFRP nails.

This level of shear strengthening was performed in order to have a shear comparison with the debonding failure of 1-NSM.

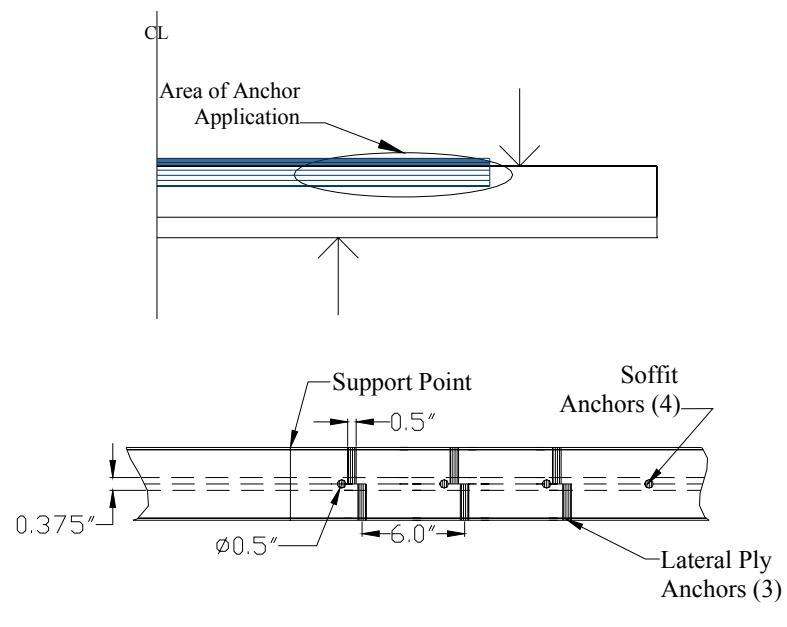
Figure 4-9: Orientation and Location of GFRP Anchors

In order to apply the GFRP anchors first the anchor holes were filled half full with epoxy. The flexural or shear FRP to be anchored was then applied over the anchor holes. Once this was done the holes were located and the CFRP strengthening fibers were carefully separated and the epoxied end of the anchors inserted in the hole with the loose fibers extending through the strengthening. The loose fibers were then saturated with epoxy and flattened out over the strengthening to provide the anchorage (Figure 4-10).

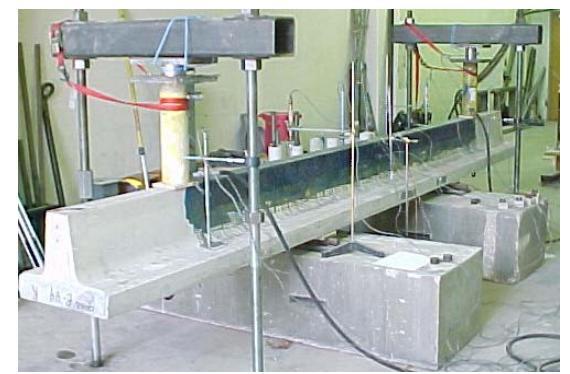
Figure 4-11: Test Set-Up

Direct current voltage transformers (DCVTs) were used to measure the displacement at the supports, load applications, and at the midspan. Strain gages were applied to the FRP at areas of interested to determine the strain in the girders upon loading and at failure. The girders were tested under quasi-static loading conditions. Load cells were placed on top of each hydraulic jack to carry out continuous measurements. All instrumentation was connected to a data acquisition system.

DCVTs were used as shown in Figure 4-11 to record girder deflection. The DCVTs were used to measure total deflection of the girder (Figure 6-7). This was done by taking the average of the deflections at the load points and adding the absolute value to the absolute value of the average of the deflections at the center of the girder. Looking at the results, the load-deflection graph shows that the total deflection at failure was a little over 1.7 inches (43.2mm). The deflection was lower than the analytically calculated value of 2.6 inches (66 mm). The deflection change kept increasing at a more and more rapid rate as additional load was applied until around 10 kips. From there, the deflection increased at a steady rate until failure.

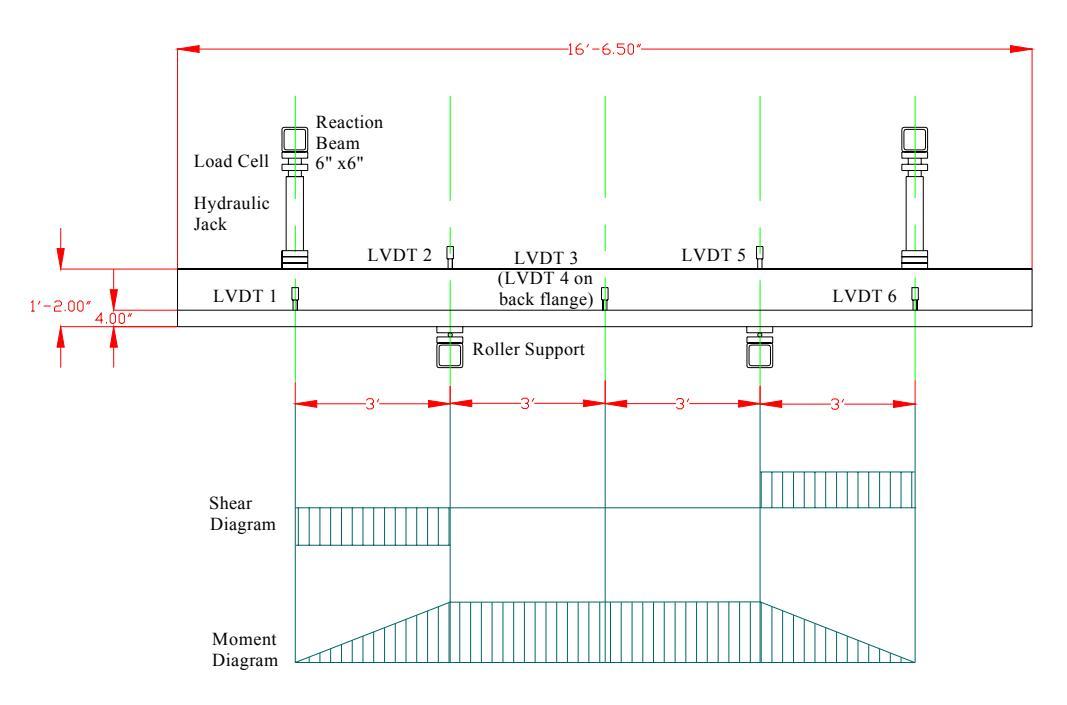
Figure 4-12: Schematic Test Set-Up and Shear and Moment Diagrams

In order to provide safety during testing and observations, the girders were loaded using at least five cycles with observations being made in-between cycles when the load on the girder was low. Before testing, the applied load (P_{cr}) corresponding to the cracking moment (M_{cr}) of the girders was calculated to be 10.2 kips (45.4 kN) using the following formulae:

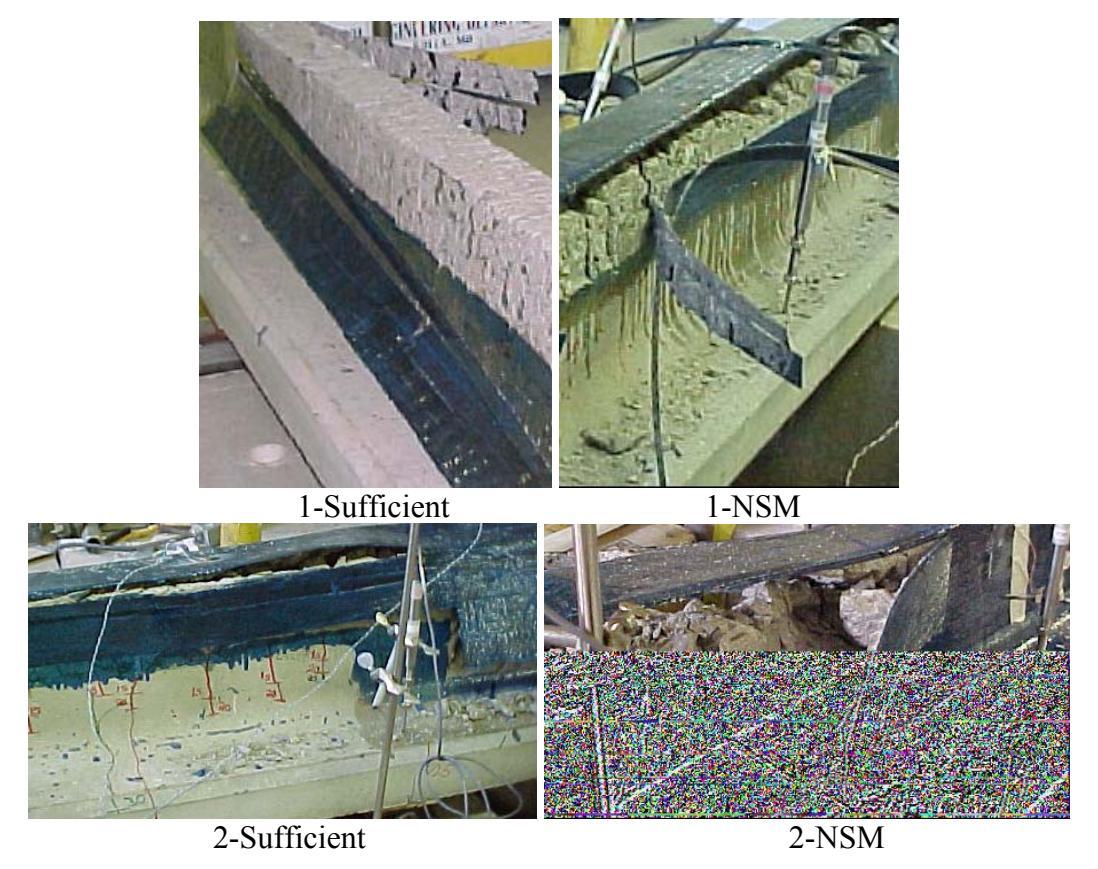
Figure 6-2: FRP Debonding Failure in Four Girders

Flexural FRP Debonding. Girders 1-Sufficient, 1-NSM, 2-Sufficient, and 2-NSM all experienced flexural FRP debonding failure (Figure 6-2). This type of failure was characterized by pieces of FRP and concrete detaching from the girders. Prior to actual failure, a popping noise could be heard giving the indication that the FRP was starting to debond from the concrete. This failure type happened at a load below that of the shear failure expected by analysis.

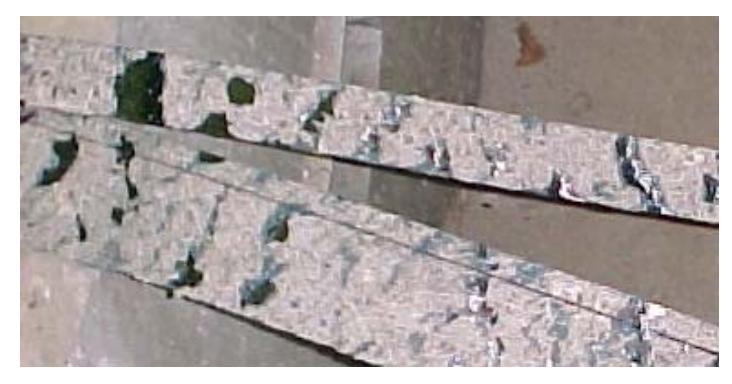
Figure 6-3: Existing Defects on Flexural FRP of 1-Sufficient

6.3.2. 1-Sufficient. 1-Sufficient was strengthened in such a way as to evaluate the effect the quality of FRP installation. The expected failure mode for 1-Sufficient was flexure with a load near 36.8 kips (163.7 kN). Before this load could be reached, however, the girder failed due to FRP debonding. At a load of 26.8 kips (119.2 kN), the three soffit plies debonded from the surface of the concrete. At this point, the girder was unloaded to more closely examine delamination. Upon inspection of the debonded flexural laminates, the defects introduced during installation could clearly be seen.

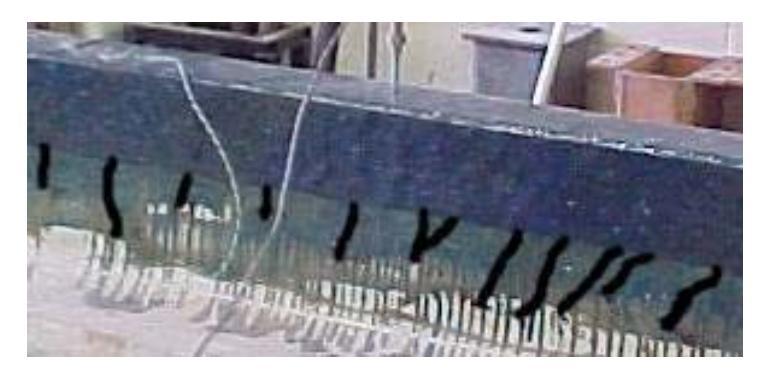
Figure 6-4: 1-Sufficient Shear Cracks

load. Although shear cracks were observed they did not lead to any decrease in load. Upon final inspection of the girder, the concrete substrate showed only small shear cracks.

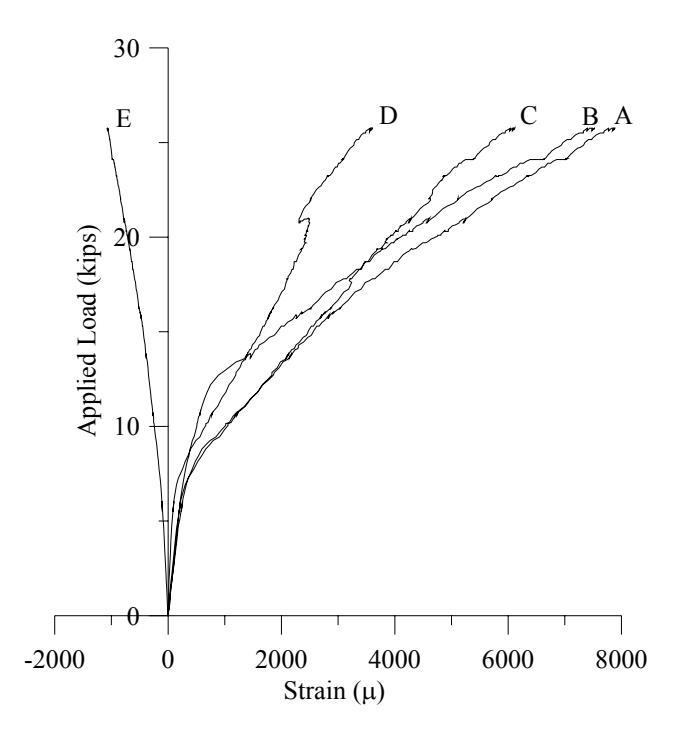
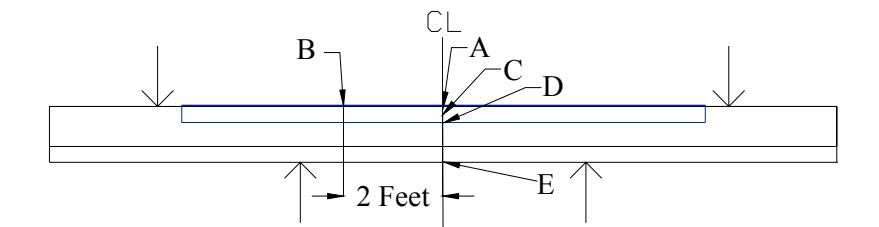
Figure 6-5: Flexural FRP Strain for 1-Sufficient

Strain readings were taken on the flexural FRP and the compression flange of the concrete and plotted as shown in Figure 6-5. The concrete strain was measured in the middle of the flange at the midspan of the girder (gage E). Strain readings were gathered on the flexural FRP at midspan on the soffit plies (gage A), at the midspan both at 1.5 inches (38 mm) (gage C) and 2.5 inches (64 mm) (gage D) down on the lateral plies, and on the soffit plies in the constant moment region at a distance of 2 feet (610 mm) away from midspan (gage B) (Figure 6-5).

The maximum FRP strain found at failure was $8100\mu\epsilon$ occurring at Gage A. The strain reading taken at Gage B gave a comparable result to that of Gage A with a maximum strain recorded of 7600 $\mu\epsilon$. Readings were taken at the midspan on the lateral plies to evaluate change in strain throughout the cross section of each girder and gave values of $6105\mu\epsilon$ and $3500\mu\epsilon$ for Gages C and D, respectively. The concrete strain at failure (Gage E) was recorded to be - $1100\mu\epsilon$.

All readings show that for the first 10 kips of load the strain increased at a fairly rapid rate. From there, the concrete strain at Gage E continued to climb at about the same rate with a mild degree of rate decrease.

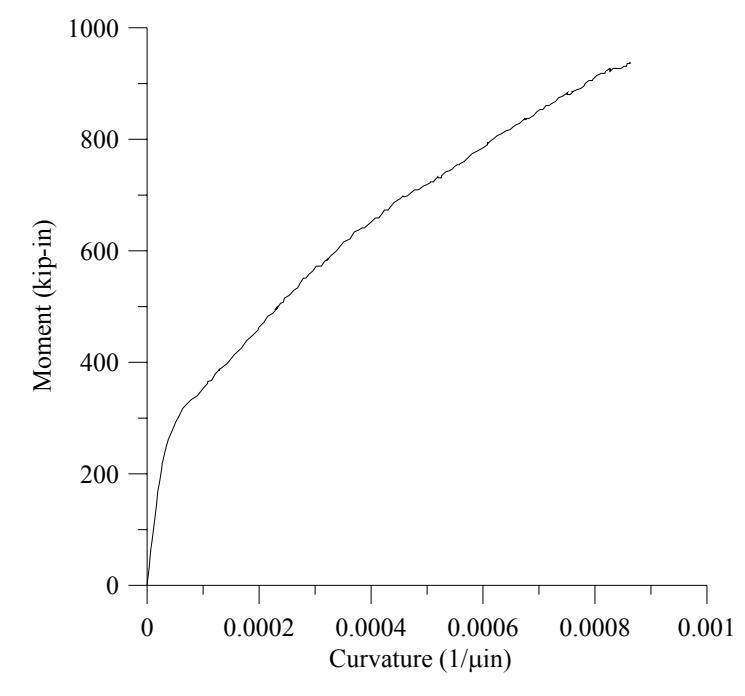
Figure 6-6: Experimental Moment-Curvature Relationship for 1-Sufficient

Since strain readings were taken in both the compression and tension sides of the girder at the midspan, an experimental moment-curvature relationship can be established (Figure 6-6). This relationship gives valuable information as to the deflection and strain of the girder at midspan. It shows that the cracking moment occurred at a moment of 30.6 kip-ft (41.5 kN-m). This value is lower than that given in the calculations for the girder.

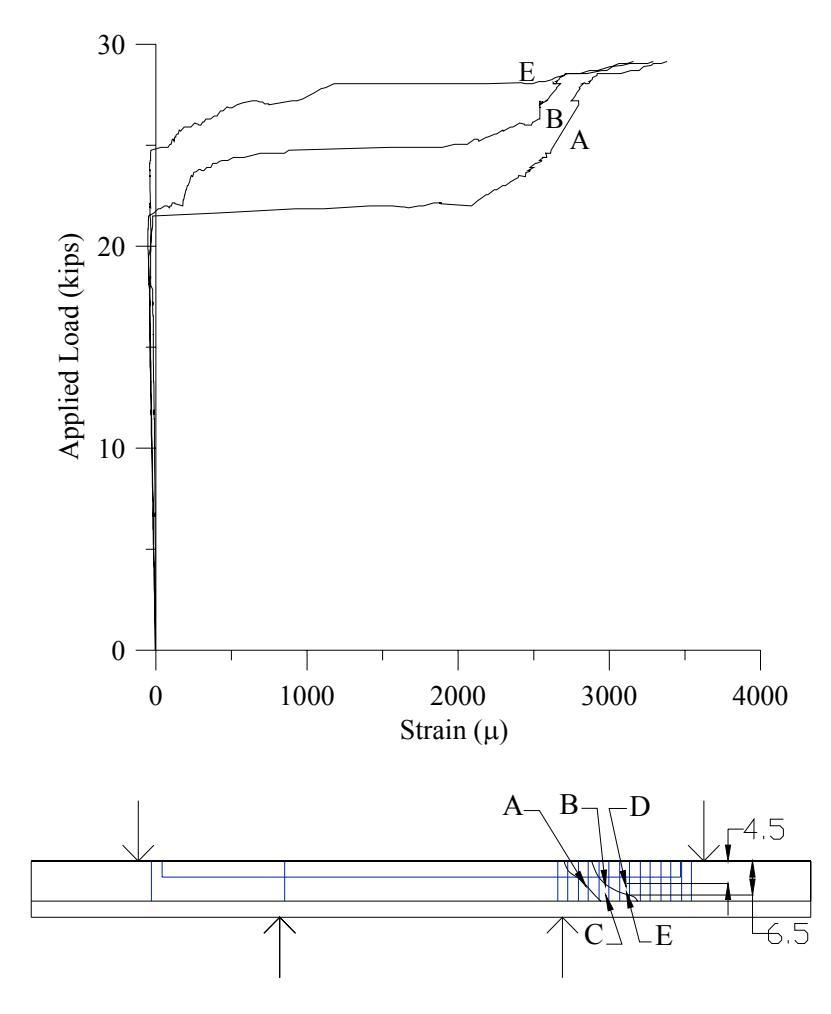
Figure 6-8: Shear U-Wrap Strain Graph for 1-UW

Strain readings were taken on 1-UW to observe the strain in the shear U-Wraps during load application up to failure. Five (5) strain gages were placed on the U-Wraps as shown in Figure 6-8 with gages A, B, and E giving reliable data. The first crack occurred at gage A. The crack was characterized by a sudden increase in strain near a load of 21 kips. After initial cracking the crack propagated with increasing load as shown on the graph until girder failure. Gage A gave the highest strain level of all three gages with a maximum strain of 3380µε. The cracking shown at gage B occurred slightly after that of gage A. The cracking for gage B initiated at a higher load than gage A and then propagated at about the same level as the strain in gage A giving a slightly lower ultimate strain. Gage E experienced a continuation of the cracking started at gage B. Crack propagation occurred slowly and culminated with the failure of the girder.

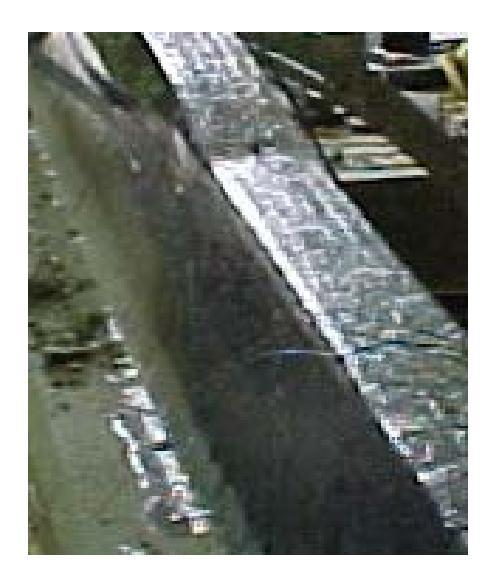
Figure 6-10: Debond Termination in U-Wrapped Anchored Region

During testing, examination of the debonding failure showed the initial areas of debond started towards the midpoint of the girder and propagated outward in both the lateral and soffit plies. The flexural anchorage acted to partially impede the propagation of debonding in the shear zone. In the U-Wrap anchored region the debond propagation terminated at the location of the U-Wrapped anchor (Figure 6-10). In the GFRP anchor region, propagation of the top two soffit plies continued while the bottom, anchored ply remained bonded to the girder (Figure 6-11).

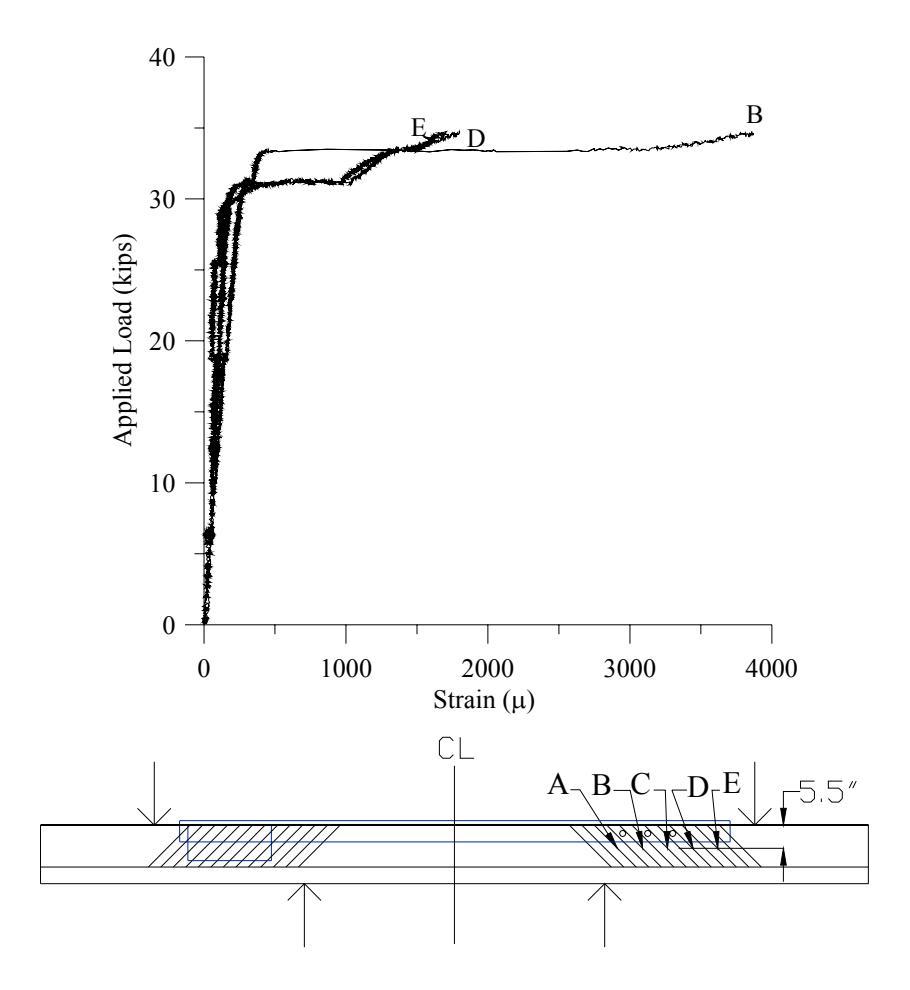
Figure 6-12: Shear NSM Strain Graph for 1-NSM

Strain readings were taken on the NSM bars to observe shear behavior with gages B, D, and E giving reliable data (Figure 6-12). Because shear failure did not clearly occur, the strain values remained relatively low. The maximum strain for the girder was 3850µε occurring in the most heavily cracked area of gage B. This high strain shows a high level of crack propagation in the girder. Gages D and E, in a lightly cracked area, showed the strain at failure to be 1800µε. Since cracking was not as extensive in this area, the maximum strain reached was less than that of the highly cracked area.

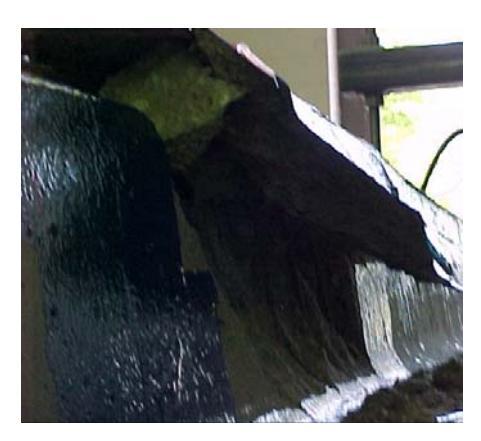
Figure 6-14: 2-Sufficient Shear Crack at Debond

The debonding failure initiated at the midspan of the girder and propagated outward, toward the U-Wrap anchored region where shear effects were greatest (Figure 6-15). Because of significant shear cracks in the U-Wrap anchored region, the debonding ripped the U-Wrapped anchors off the girder with large amounts of concrete still attached to it (Figure 6-14). The characteristic 60-degree crack can also be seen.

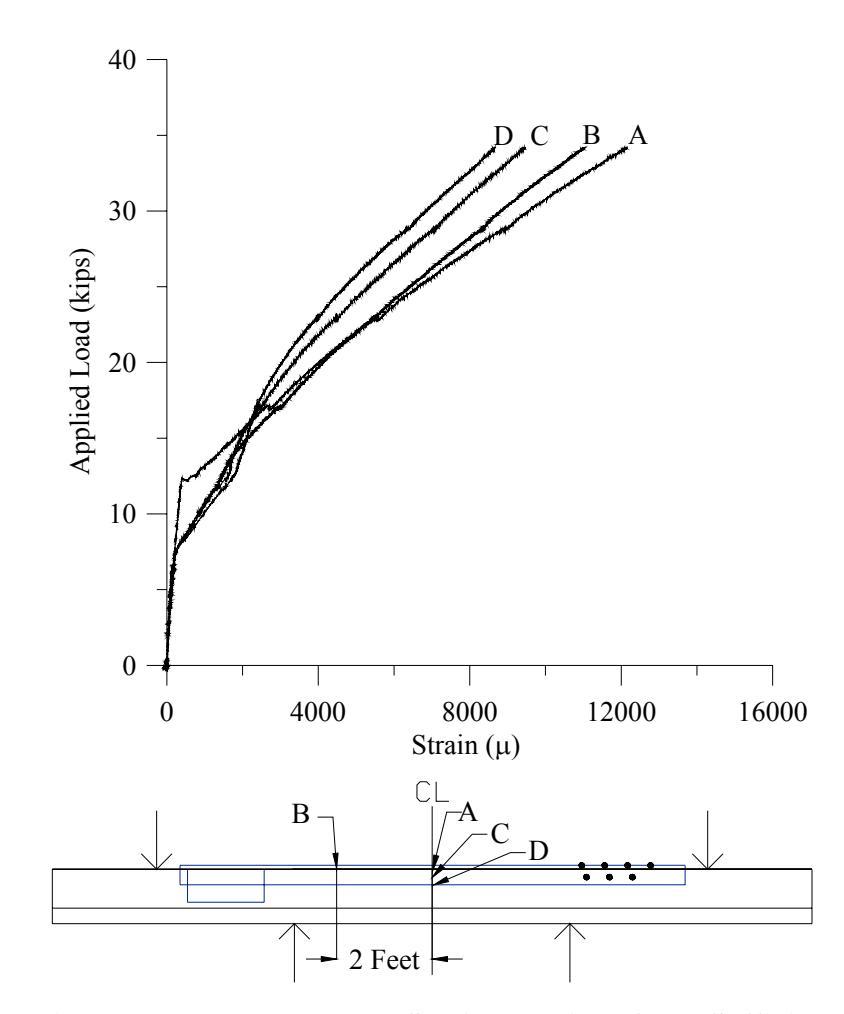
Figure 6-16: Flexural FRP Strain Readings for 2-Sufficient

Strain readings were gathered on the FRP at the midspan on the soffit plies (gage A), at the midspan both at 1.5 inches (38 mm) (gage C) and 2.5 inches (64 mm) (gage D) down on the lateral plies, and on the soffit plies in the constant moment region at a distance of 2 feet (610 mm) (gage B) away from midspan. The maximum strain at Gage A was 12100µɛ with a similar reading of 11000µɛ at Gage B. The lateral strains were 9500µɛ and 8600µɛ at Gage C and Gage D respectively. These values are greater than those obtained for 1-Sufficient and account for the increase in bond due to lack of defects and additional anchorage. The strain value stayed approximately zero up to a stress of approximately 10 kips (44.5kN). From there, a significant increase in strain was noticed as the stress increased showing the initiation and propagation of shear cracking.

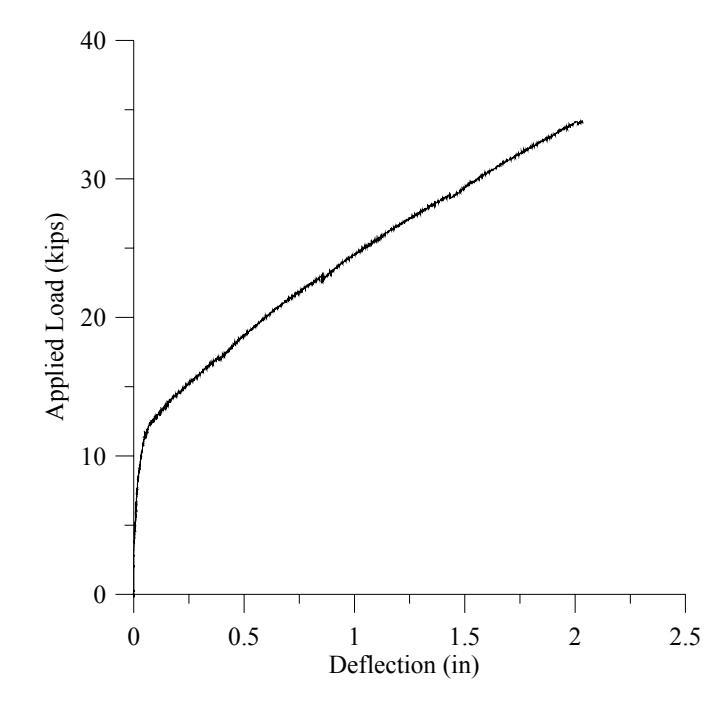
Figure 6-17: Load Deflection Graph for 2-Sufficient

Deflection readings taken for 2-Sufficient showed the highest level of deflection for all the girders being approximately 2.25 inches (57.2 mm). This value is close to the predicted value of 2.6 inches (66 mm).

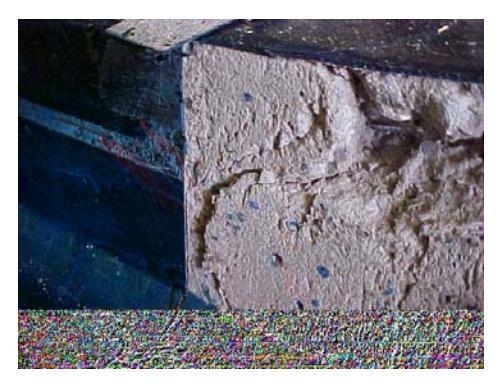
Figure 6-18: Shear Cracks

The expected failure mode for 1-NSM and 2-NSM was a shear failure at a load of 35.9 kips (159.7 kN). The maximum load reached before failure was 31.3 kips (139.3 kN), similar to that of 1-NSM. Significant shear cracks were present in the girder upon failure (Figure 6-18). Sections of concrete remained attached to the FRP during debonding and showed shear crack propagation through the girder.

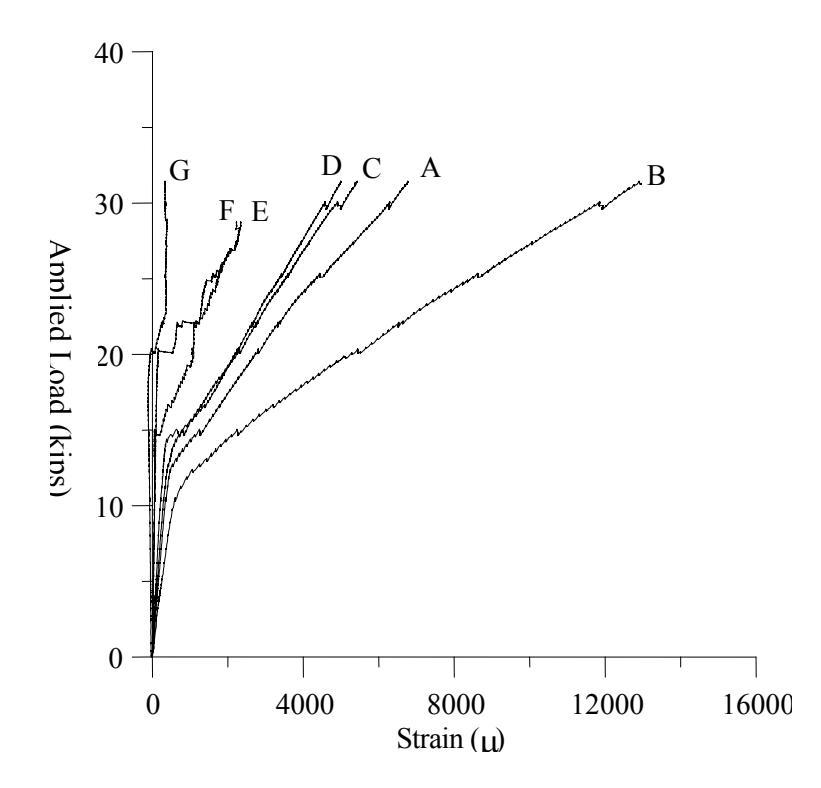
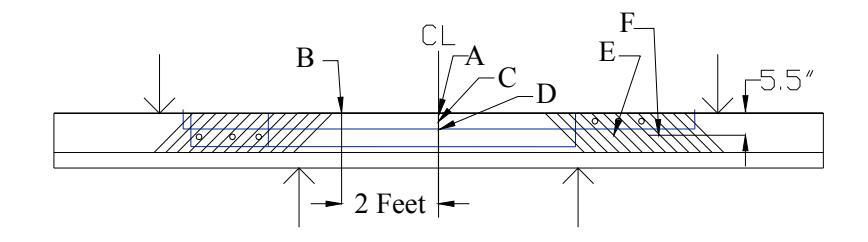
Figure 6-19: Flexural FRP and Shear NSM Strain Graph for 2 NSM

Strain readings were gathered on the FRP at the midspan on the soffit plies (gage A), at the midspan both at 1.5 inches (38 mm) (gage C) and 2.5 inches (64 mm) (gage D) down on the lateral plies, on the soffit plies in the constant moment region at a distance of 2 feet (610 mm) away from midspan (gage B), on the double U-Wrap anchor (G), and on four NSM bars as shown in Figure 6-19.

The maximum strain was $12950\mu\epsilon$ located at Gage B. This value is twice as high as those found at the midspan of the girder. Upon further examination, it was determined that Gage B was positioned at the location of a crack. The strain reading at Gage A, midspan soffit, equaled 6750 $\mu\epsilon$ while the lateral strain was 5350 $\mu\epsilon$ and 5000 $\mu\epsilon$ at Gage C and Gage D respectively.

Measurements taken on the U-Wrap anchors showed negligible strain during testing. The maximum reading taken at failure was 350µε. Almost no strain was noticeable until an applied load of approximately 20 kips (89.0kN) was reached. From there, the strain increased as crack propagation ensued.

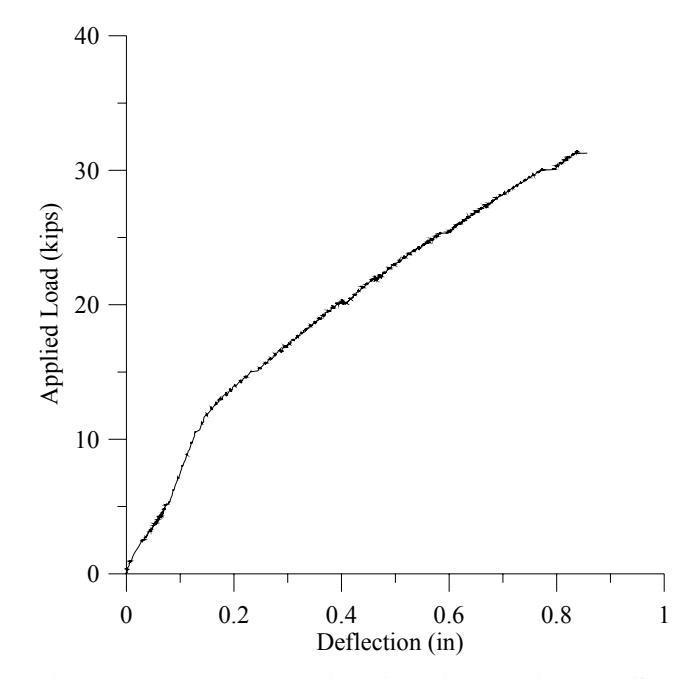
Figure 6-20: Load Deflection Graph for 2 NSM

Deflection readings taken for 2-NSM showed the lowest level of total deflection for all the strengthened girders. The total deflection at failure for the girder was close to 0.9 inches (22.9 mm). This deflection was close to that of the 1-Sufficient girder and more than 1 inch (25.4 mm) lower than that for all other strengthened girders. As with 1-NSM, it is much lower than the predicted value of 2.5 inches (64 mm).
