August 25, 2008 Miami-Dade Pedestrian Safety Project: Phase II FINAL IMPLEMENTATION REPORT AND EXECUTIVE SUMMARY

Pedestrian Safety Engineering and Intelligent Transportation System-Based Countermeasures Program for Reduced Pedestrian Fatalities, Injuries, Conflicts and Other Surrogate Measures: Miami-Dade Site

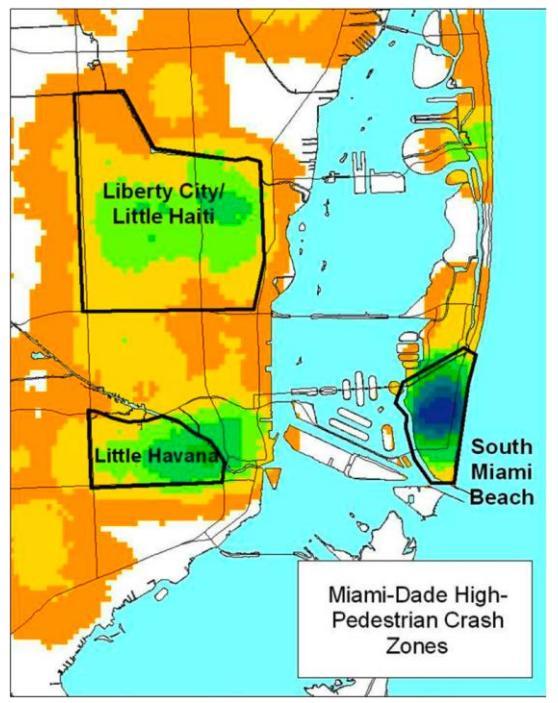
Figure 1.1 Miami-Dade High Pedestrian Crash Zones

Miami-Dade County has the highest incidence of pedestrian injuries and fatalities in the State of Florida, which ranked within the top two states in number of pedestrian crashes as well as per capita pedestrian crashes during the baseline period. In recent years the pedestrian crash rate had remained relatively steady prior to the implementation of the NHTSA and FHWA Pedestrian projects. During the nine years prior to the FHWA project there were a total of 15,472 pedestrian crashes in the DHSMV Miami-Dade County, which included 670 fatal crashes (4.2 percent). Figure 1.1 shows the geographic distribution of pedestrian crashes during the baseline period as a crash density map. High crash zones are represented by darker colors. Figure 1.2 shows the Crash map for South Miami Beach. South Miami Beach has the highest crash density in Miami-Dade County.

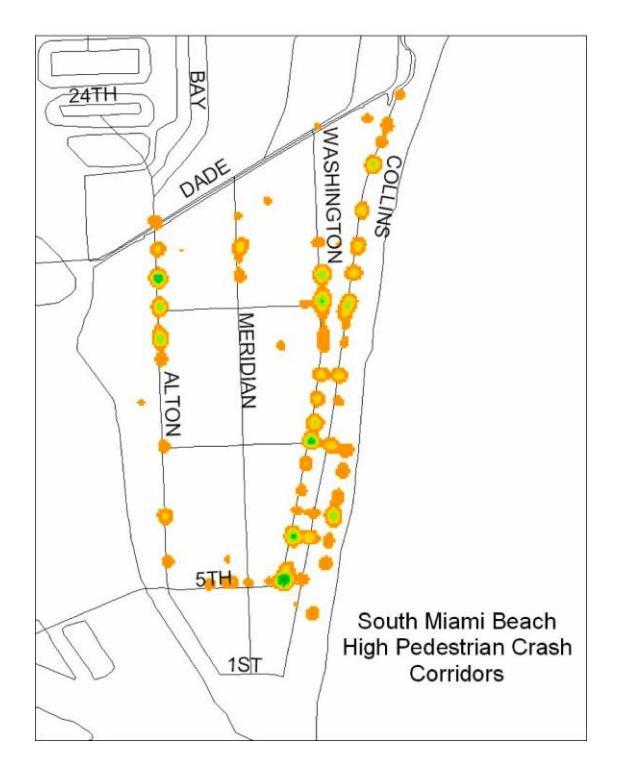
Figure 1.2 South Beach High Pedestrian Crash Corridors

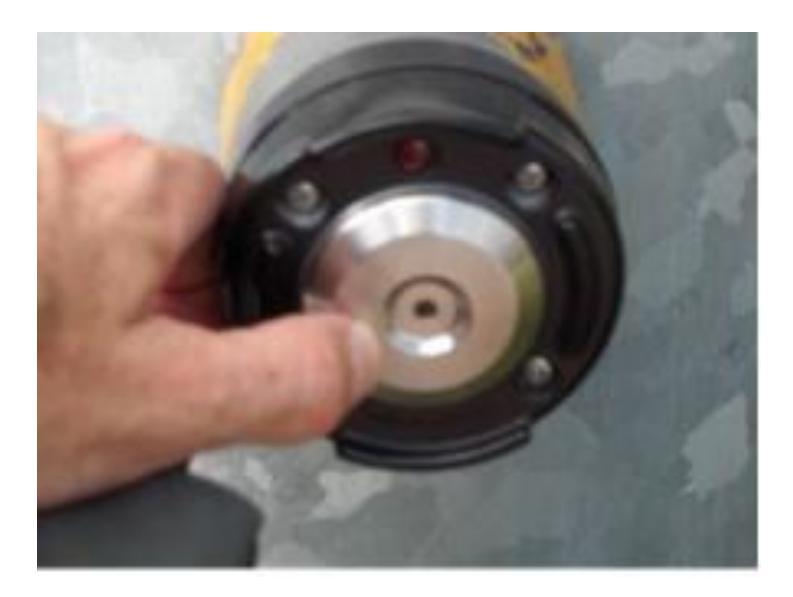
This treatment consists of a pedestrian stainless steel push button with a piezo driven solid state switch that provides two types of feedback when the push button is pressed. First, the button is illuminated with a 1200 mcd red light emitting diodes (LED) for 0.1 s (Momentary LED Model) and second, a 2.6 kHz tone is sounded simultaneously with the LED flash when the button was pressed and a 2.3kHz tone was sounded when the button was released. The device could also be modified so the light remained on until the onset of the "WALK" indication. These buttons were installed at 17 intersections, typically with 2 buttons per intersection.

Figure 3.1 Picture of Pedestrian Push Button That Confirms Press

Notes: It was difficult to see the LED light in bright Florida sunlight. It appeared that the auditory feedback was more critical to the efficacy of the device. In areas with less bright sunlight the pilot light might be more salient. These buttons might also be of useful to visually impaired pedestrians because they confirm the button press. However, accessible call buttons with a locator tone would be preferred when taking into account the needs of visually impaired pedestrians.

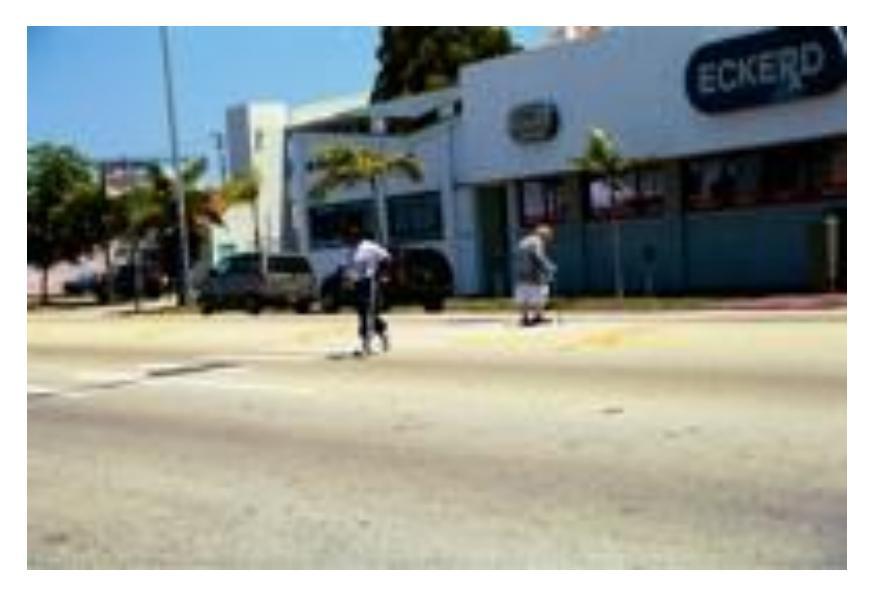
This treatment was installed at mid-block traffic signals. It required the signal to be operated in isolation mode (non synchronous timing). The minimum green time was reduced to decrease pedestrian wait time and increase compliance with the signal. Three of these treatments were installed as indicated in table nine. Prior to the start of the study both signals were run in synchronous mode, and the cycle length was 130 s between 8 am and 8 pm at the Alton Road crosswalk and varied from 90 s to 120 s at the crosswalk on SW 8th Street. Minimum green time was evaluated at 30 s, 1 minute and 2 minutes at both crosswalks. The speed limits at these locations were 35 mph on Alton Rd. and 30 mph on SW 8th St.

Figure 3.2 Picture of Midblock Crossing with Reduced Minimum Green Time

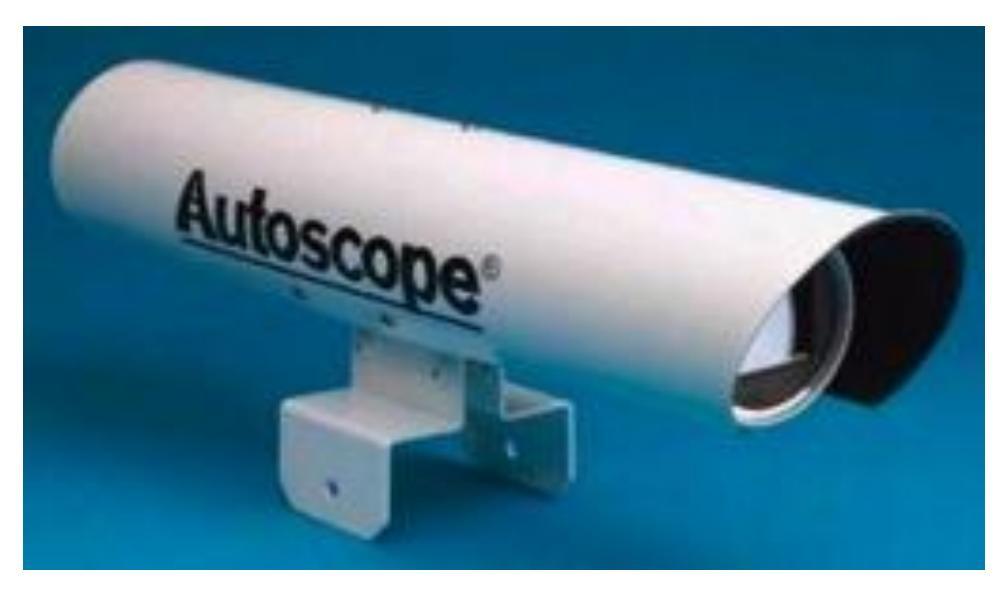
This device uses video detection technology to detect the pedestrian and put in a call for a mid-block traffic signal. An Autoscope Solo Pro was used for pedestrian detection in this study. The processor was included in the camera. The camera sent compressed video via twisted pair. Two rectangular zones were set up on the sidewalk approaching the curb; the pedestrian had to cross both zones to trigger the device. The device could determine direction of movement by the order in which the zones were crossed. With this method the pedestrian only put in a call when entering the crosswalk. This system was installed at one midblock traffic signal on Alton Road.

Figure 3.3 Picture of Device Used For Pedestrian Detection

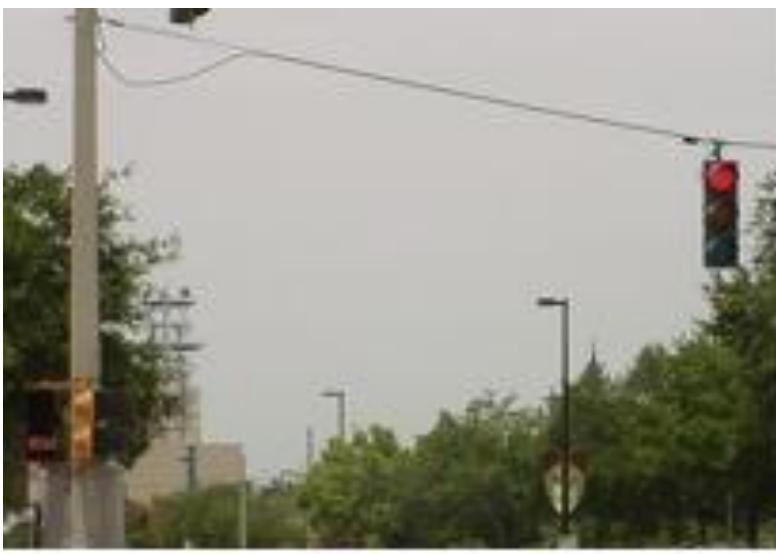
The purpose of this device was to give a head start for pedestrians over left and right turning vehicles at the start of the WALK. Pedestrians crossing the main line receive a 4 second exclusive pedestrian phase while all vehicle signals remained in the all red phase. These vehicles lost 4 seconds of green time in order to give the pedestrians a 4 second exclusive pedestrian phase. This treatment provides the best protection from vehicles turning left and provides less protection from vehicles turning right because they may still turn right on red.

Figure 3.4 Picture of Leading Pedestrian Phase

Notes: This treatment was effective at increasing yielding by drivers turning left but was not effective at improving the behavior of drivers turning right. Prohibiting right turn on red at the start of the WALK when a pedestrian pushed the call button should greatly improve the efficacy of this countermeasure.

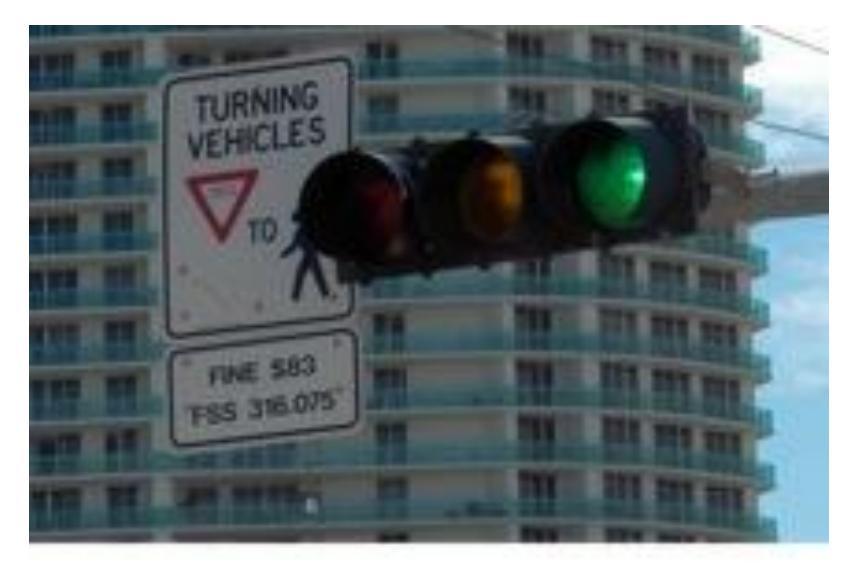
This treatment was a symbol version of the "Turning vehicles must yield to pedestrians" text sign. This sign retained the text message "Turning vehicles" and "to" and substituted the yield symbol for the word "yield" and the pedestrian symbol for the word "pedestrian". The purpose of using this sign in place of the text message sign was to make the sign more comprehensible to tourists that were not native speakers of English and to increase recognition distance.

Figure 3.5 Picture of "Turning Vehicles Yield to Pedestrians" Symbol Sign

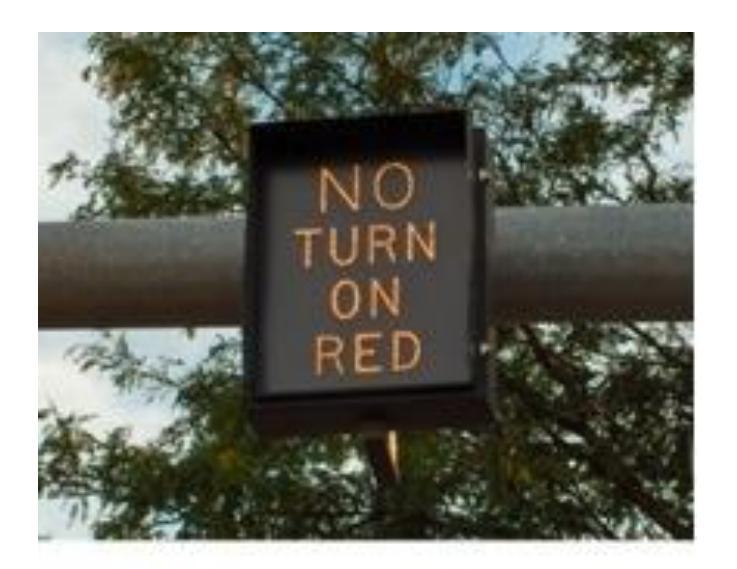
This sign was illuminated when right turn on red was not permitted. The sign was installed on the mast arm in the same location that the static "No turn on red when pedestrians in crosswalk" sign and the "No turn on red" sign were installed. This allowed a direct comparison of all three signs.

Figure 3.6 Picture of Electronic No Turn on Red Sign

Notes: The electronic NRTOR sign reduced the percentage of motorists turning right-on-red when a pedestrian was present over that produced by the two static signs and reduced the percentage of conflicts between vehicles turning right on red and pedestrians crossing within the crosswalk over the other two signs. However there were many violators during all conditions. The electronic sign had an even larger effect on increasing the percentage of violators coming to a complete stop

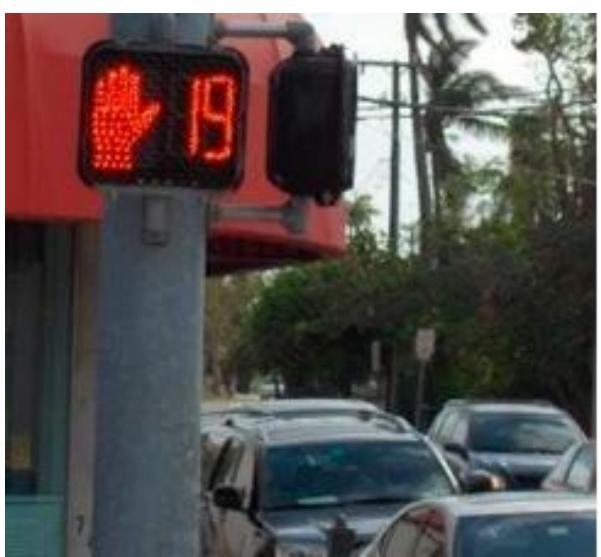
This treatment was a countdown pedestrian signal that displayed a walking person symbol during the "WALK" indication, counted down the seconds in the clearance phase along with the flashing hand display, and displayed the solid hand during The "DON'T WALK" indication which began during the all red phase. These signals were programmed to begin the countdown at the start of the pedestrian clearance (flashing hand) phase and counted down to 0 at the end of the yellow phase.

Figure 3.7 Picture of a Pedestrian Countdown Signal

Notes: The countdown displays decreased the percentage of pedestrian in the crosswalk during the all red phase and were associated with an increase in the percentage of pedestrians that pressed the call button as well as the percentage of pedestrians that pressed the call button that then waited for the WALK indication.

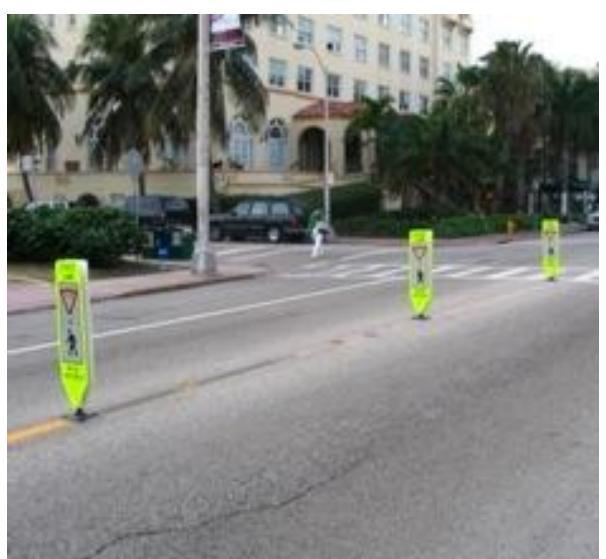
In-Street Pedestrian Signs are intended for use at uncontrolled (not signalized) crosswalks to remind drivers of laws regarding pedestrians' right-of-way. They are more noticeable than roadside signs and may also exert a minor traffic-calming effect by effectively narrowing the inside lanes slightly. Dimensions and color: 12" x 44", fluorescent yellow green diamond sheeting with 10" x 24" white high intensity sheeting inserts. Overall height is 47 inches. The signs can be installed with either a portable or fixed base.

Figure 3.8 Picture of In-street "Yield to Pedestrians" Signs

Notes: These signs were effective but had a very short lifespan. The streets were narrow and did not have a median island to protect the signs. We found that using three signs on each approach was no more effective than using one.

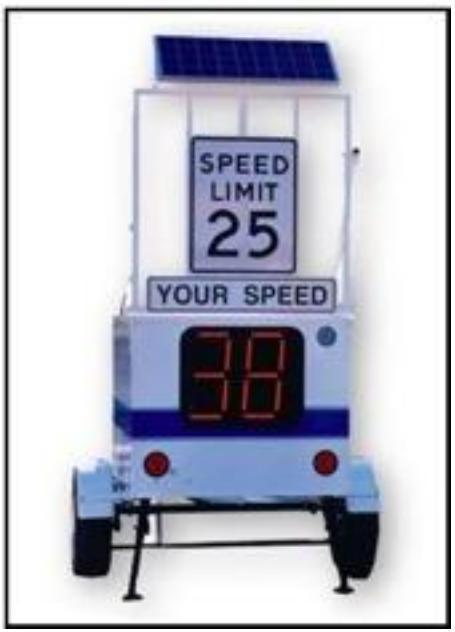
Portable Changeable Message Speed Limit Signs, also known as "radar speed trailers," are used to deter speeding. These devices can be installed along the side of the road; typically in parking areas, and display the speed of each approaching vehicle and can flash LEDs when the approaching vehicle is speeding. A speed limit sign is included on the trailer. Above a user-selected maximum, the sign "blanks out" to avoid enticing drivers into exhibitions of speed. A computer within the device recorded speed data.

Figure 3.9 Picture of a Speed Trailer

Notes: These signs reduced braking for pedestrians but had little effect on vehicle speed. One reason why the sign was ineffective in reducing vehicle speed was most vehicles were already driving within the speed limit.

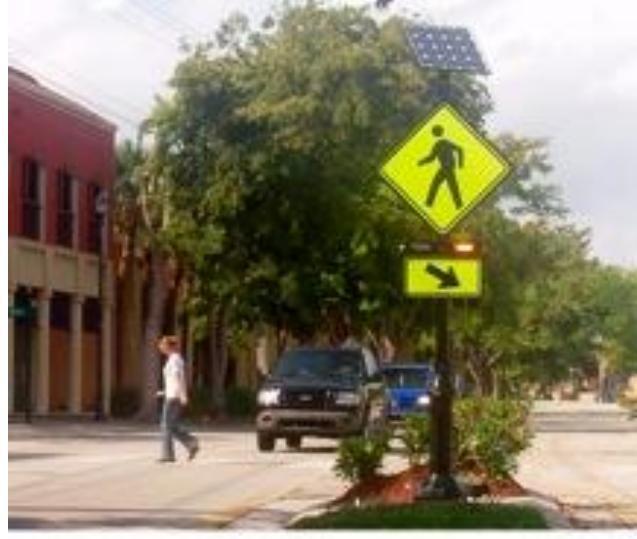
This treatment was the standard pedestrian warning sign with two LED flashers attached (see Figure 1). The LED flashers were each 6 inches wide and 2.5 inches high placed 9 inches apart. Each unit was dual indicated (LED's on front and back). Each side of the LED beacon flashed in a wig-wag flashing sequence (left, then right) the 2 large LED's in combination flashed 76 times in the wig-wag flashing sequence during a 30 second cycle. Of the 2 large LED's, the Left LED, flashed 2 times (in a slower type of a rapid flash) each time it was energized followed by the Right LED, which flashed in a very fast rapid 3 flash volley when energized. The total number of flashes in this combination was 190 total flashes per 30 second cycle. Four signs along with beacons were installed at each crosswalk. The devices were linked by radio frequency transponders so a depression of any of the pedestrian call buttons immediately activated the flashers on all four signs. At the South Bayshore Drive crosswalk a sign was placed on the left side of each approach and on the right side of each approach at the median island. At the NW 67th Street site a sign along with beacons was placed on the left side of each approach and on the right side at a median just after the crosswalk on the northbound approach and before the

crosswalk on the southbound approach. A LED facing the pedestrian flashed to indicate to pedestrians that the system was operating. The system also presented an audible message instructing pedestrians that the light flashing across the street indicates that the device was operating, and instructing them to wait for cars to stop before crossing. Signal duration was timed assuming a crossing speed of 3.5 feet per second.

Figure 3.10 Picture of Rectangular LED Rapid Flashing Beacons

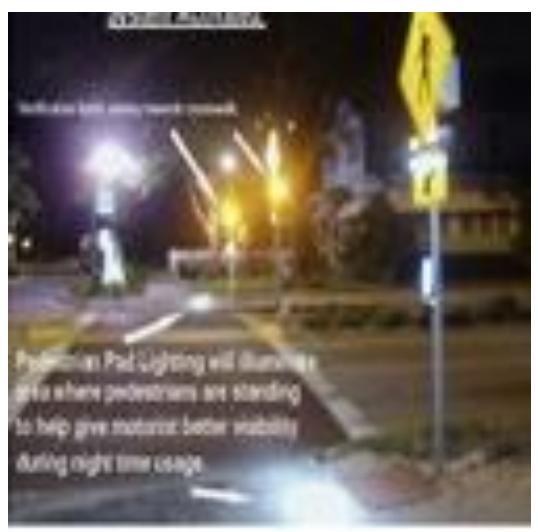
This treatment was used in conjunction with the rectangular LED rapid flashing beacons treatment described above. When a pedestrian pressed the call button to activate the beacon at night, the device was activated and LED white lighting illuminated the departure portion of the curb face and the first 4 feet of the crosswalk. This dynamic pad lighting consisted of four 2.5 by 1.25 inch housings each containing 3 LEDs.

Figure 3.11 Picture of Dynamic Lighting

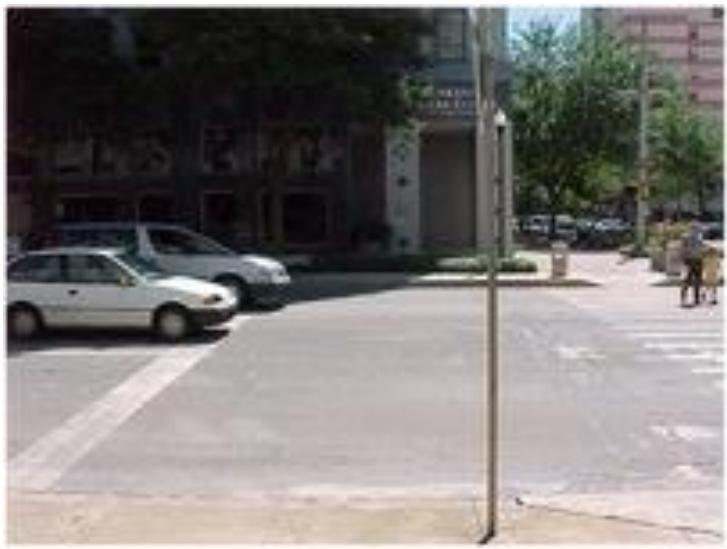
This treatment involved installing stop bars 20 feet in advance of the crosswalk rather than the minimum distance of 4 feet in advance of the crosswalk. Studies have shown that offset and setback stop bars can reduce vehicle/pedestrian conflicts. Setting back stop bars has also been shown to add .75 s to intersection clearance time and can reduce turning vehicle threats by increasing intersection visibility.

Figure 3.12 Picture of Offset Yield Lines

Notes: This treatment is easier to install on fresh pavement.

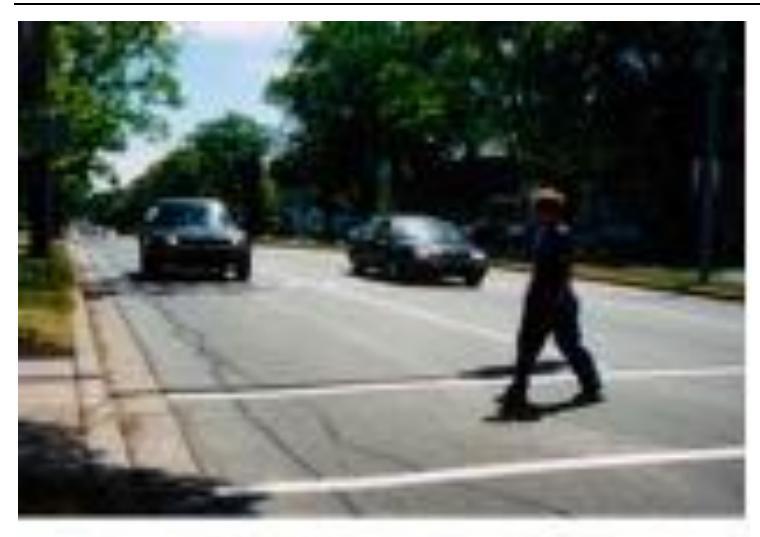
Advance yielding markings may be installed in advance of crosswalks at uncontrolled locations. Previous work has shown that advance yield markings placed 30 feet in advance of the crosswalk increases the distance that drivers yield in advance of the crosswalk. Advance yield markings were only installed at one site because the sign size specified in the 2003 manual was much smaller than the sign used in the research that supported the introduction of this marking into the manual.

Figure 3.13 Picture of Advance Yield Markings

Notes: This treatment is designed to reduce multiple threat conflicts and therefore has been installed at the two multilane locations with the rectangular LED rapid flash beacon.

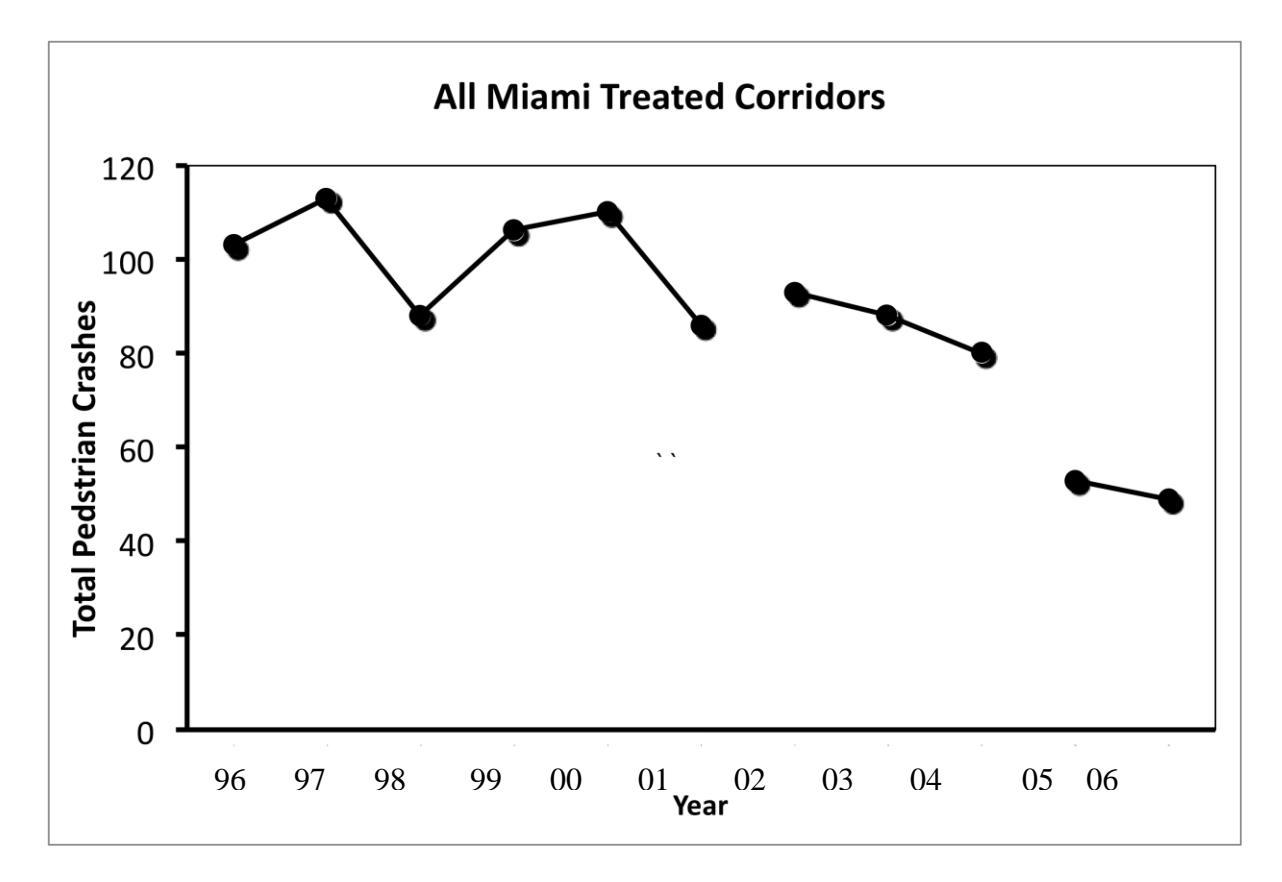
Data were collected for each corridor for 6 years prior to the introduction of the NHTSA project, for the 3 years that the NHTSA project was implemented, and for an additional 2 years that the FHWA project was implemented. This provides a total of 11 years of crash data along these high crash corridors. Figure 4.2.1 shows the crash rate for all eight treated corridors remained reasonably stable with a slight downward trend during the 6 years prior to the introduction of the NHTSA project. The introduction of the NHTSA project appeared to lead to a small decrease in pedestrian crashes form a mean of 101 during the baseline period to a mean of 87 (a decrease of 11.5%) during the three years that the NHTSA project was in effect. The installation of the engineering countermeasures on top of the NHTSA education and enforcement efforts lead to a further reduction to an average of 51 crashes per year. This represents a 50% reduction over the baseline level and a 41% reduction from the NHTSA project levels. It is interesting to note that during the 9 years prior to the FHWA project there were 15,472 pedestrian crashes in Miami-Dade County. Of these 46% occurred on State and County Roads for a total of 7,117 crashes or 791 crashes per year. Around 100 per year or nearly 13% of these crashes occurred along the treated corridors.

Figure 4.2 Crashes per Year for All Eight Crash Corridors from 1996-2006

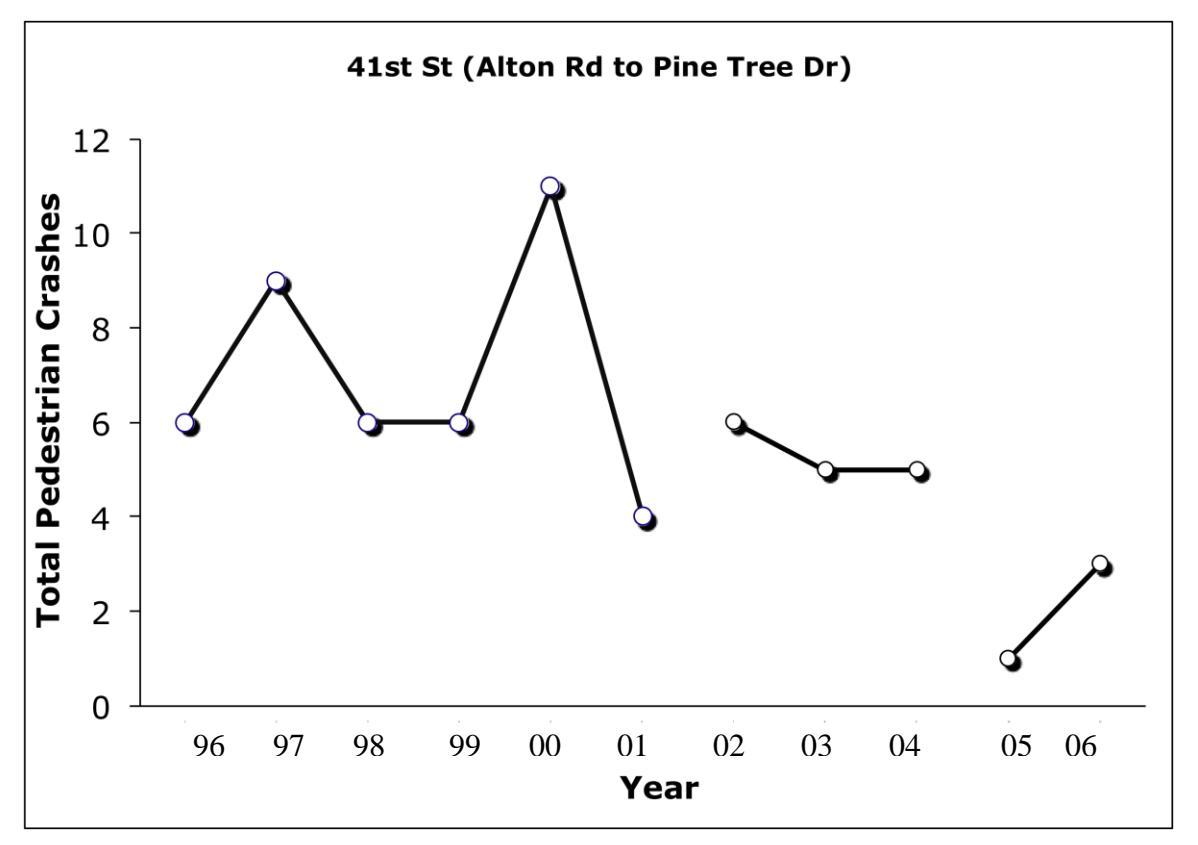
It is interesting to note that crashes declined in each of the eight crash corridors. Data from each corridor is presented below. One corridor that was not particularly responsive to the NHTSA treatment but very responsive to the FHWA engineering treatments was 41st Street; Alton Road to Pine Tree Drive. This corridor had the highest percentage of daytime pedestrian crashes of all eight corridors (81%). The results for this location are presented in Figure 4.2.2. Crashes averaged 7 per year during baseline, 5.3 per year during the NHTSA program, and 2 per year during the FHWA program. This corridor received a large number of countdown timers, push buttons that confirmed the press, the no right turn on red electronic sign, and the prohibited permissive left turn treatment. Data for this corridor are presented in Figure 4.3.

Figure 4.3 Crashes per Year for 41st St.; Alton Rd. to Pine Tree Dr. 1996-2006

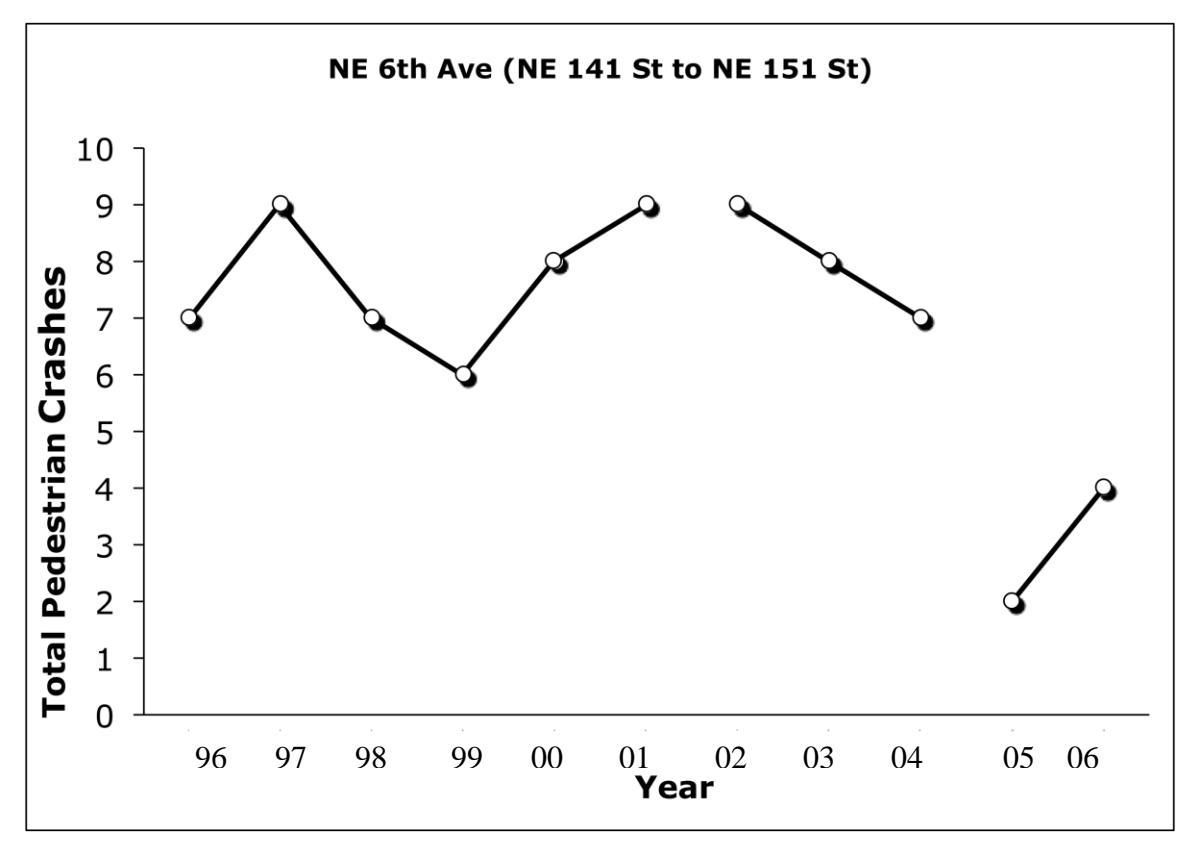
had the highest percentage of crashes involving children and youth (34%) and the highest percentage of crashes involving African American pedestrians (73%). During baseline crashes averaged 7.7 per year at this site and maintained at 8.0 during the three years of the NHTSA project. The FHWA project was associated with at reduction in crashes to 3 per year. This site also received countdown timers and push buttons that confirmed the press at high crash intersections and a large number of pedestrian zone signs. Data from this site are presented in Figure 4.4.

Figure 4.4 Crashes per Year Along NE 6th St. (NE 141st St. to NE 151st St.) from 1996 to 2006

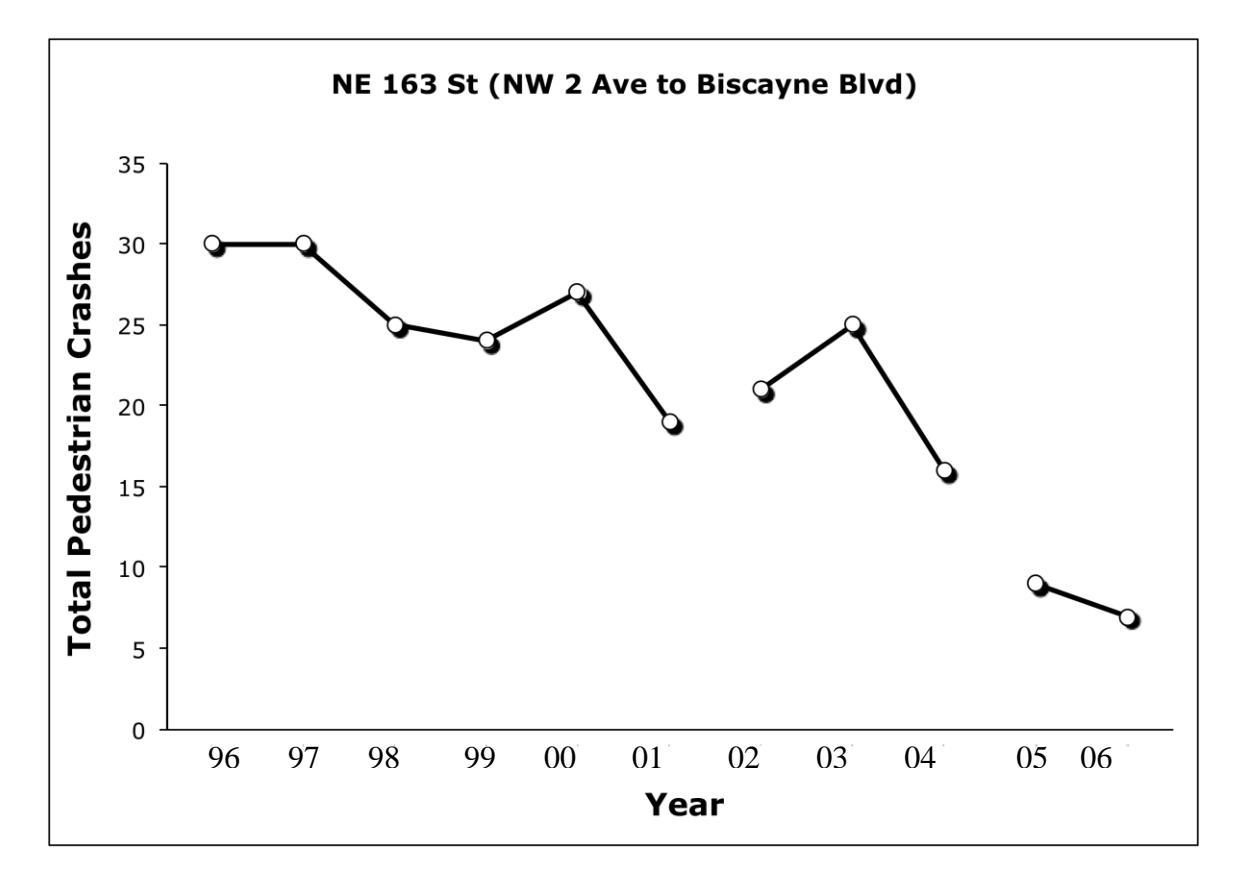
The corridor that showed the largest improvement also had the highest number of crashes per year during baseline, the second highest percentage of African American pedestrians struck during baseline (41%), and the second highest percentage of senior pedestrians struck during baseline (28%). Baseline data show a downward trend during the baseline period. This corridor had the second highest percentage of pedestrian crashes involving turning vehicles (60%). This large corridor along NE 163rd St. had 25.8 crashes per year during baseline, crashes declined to 20.7 crashes per year during the NHTSA project and declined further to 8 per year during the FHWA project. This corridor also received the largest number of countermeasures. This corridor had a large number of countdown pedestrian signals and push buttons that confirmed the press installed. This site also received 'Turning Vehicles Yield To

Pedestrians" symbol signs, and a large number of offset stop lines. Data for this corridor are presented in Figure 4.5.

Figure 4.5 Crashes per Year NE 163rd St. (NE 2nd Ave to Biscayne Blvd.) from 1996 to 2006

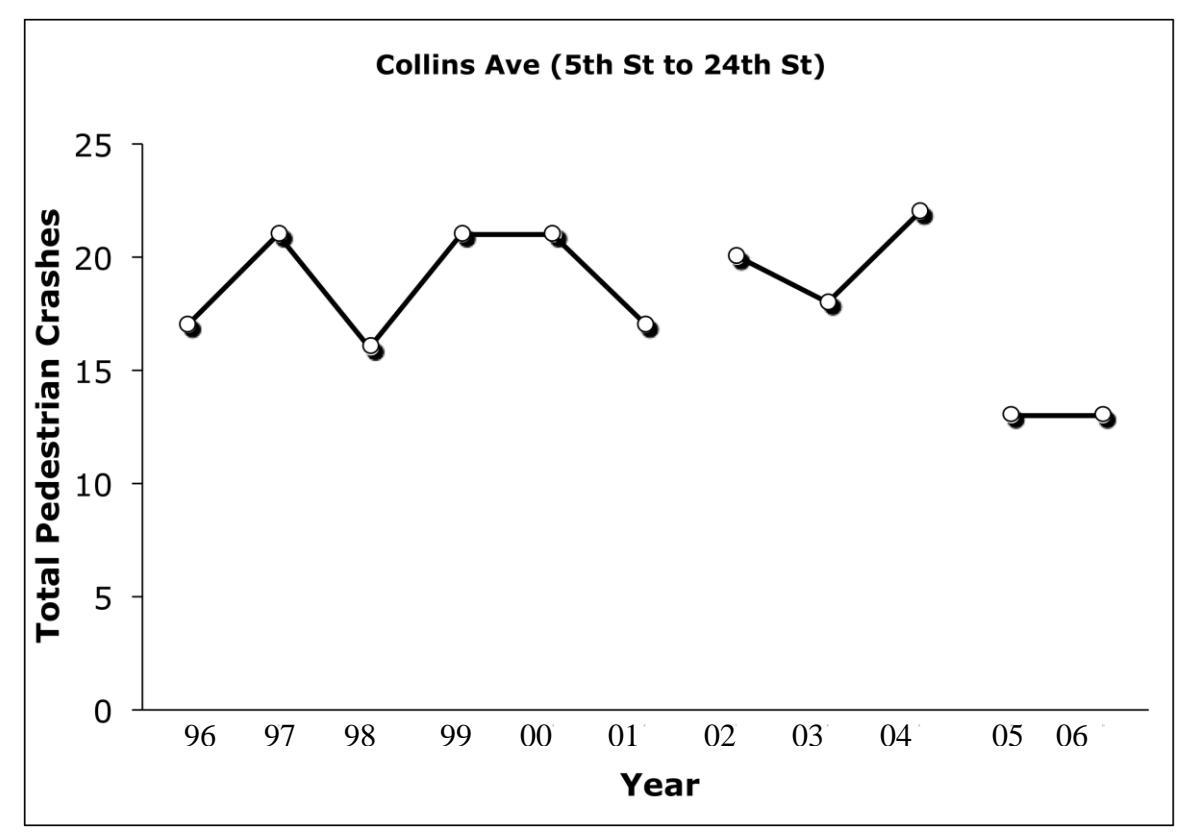
This corridor on Collins Ave. between 5th St. and 24th St. was in the middle of the South Beach recreational area. Therefore it is not surprising that this corridor had the highest percentage of nighttime crashes of all eight corridors (55%). During baseline there were 18.8 pedestrian crashes per year along this corridor. During the NHTSA project there were 20 crashes per year. The introduction of the FHWA project was associated with a decline in crashes to 13 per year. One of the treatments that was effective along this corridor was the in street pedestrian signs. Unfortunately these signs did not stand the test of time and were only in effect for a relatively short period of time. This corridor also received a couple of lead pedestrian intervals, a large number of "Turning vehicles yield to pedestrians" symbol signs, some pedestrian zone signs, and one advance yield marking. Crash data are presented in Figure 4.6.

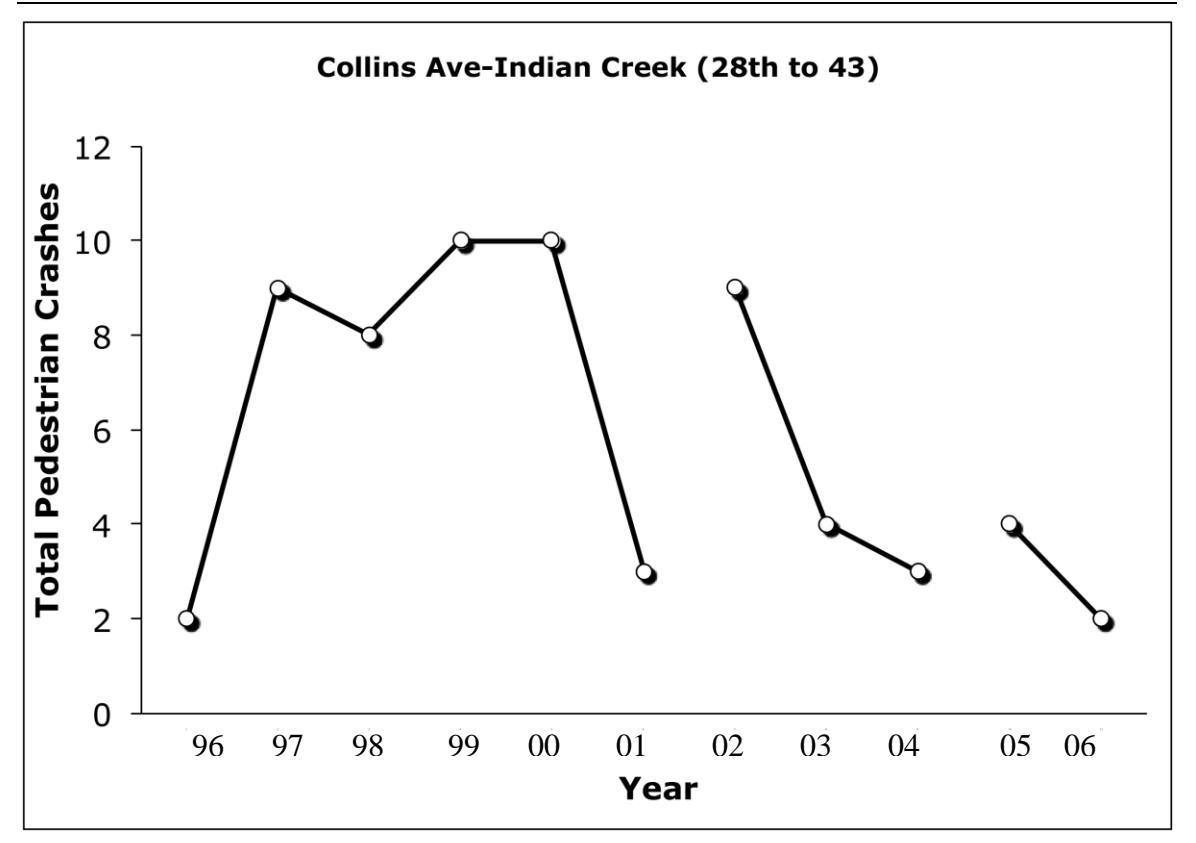
This corridor is immediately adjacent to the Collins Ave (5th to 24th St.) corridor. Treatments installed along this corridor included "TURNING VEHICLES YIELD TO PEDESTRIANS" symbol signs, and the use of the speed trailer, Crashes averaged 7 per year during the baseline period along this corridor, 5.3 per year during the NHTSA project and 3 per year during the FHWA project. The graph of the yearly crash data is shown in Figure 4.6. Although the average number of crashes is lower during the FHWA study there are too few crashes and too much overlap to conclude much about the efficacy of the treatment at this location.

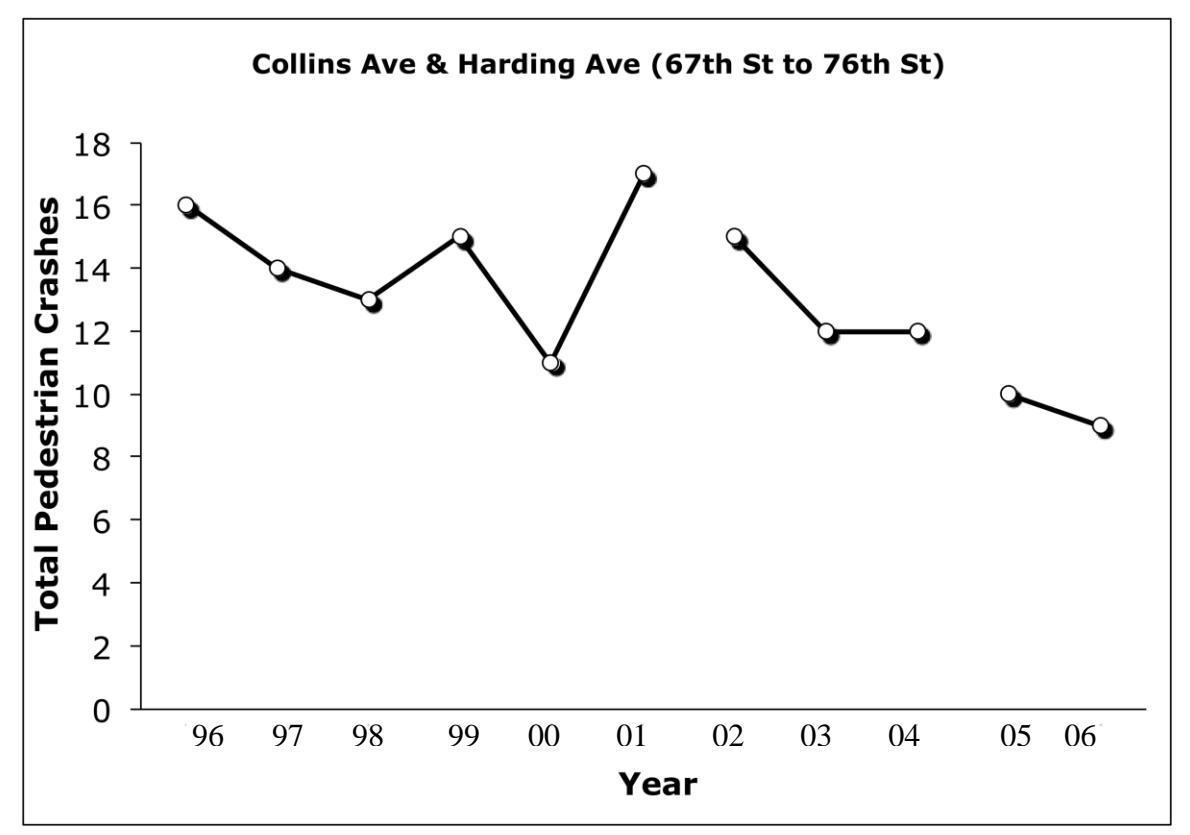
This crash corridor had the highest percentage of crashes involving turning vehicles during baseline of all of the selected corridors averaging 80% and the highest percentage of pedestrians struck over the age of 65 years (49%). Treatments installed along this corridor included "Turning vehicles yield to pedestrians" symbol signs, pedestrian zone signs, and the speed trailer. During the baseline condition the number of crashes per year averaged 14.3, during the NHTSA project crashes averaged 13 per year and during the FHWA project they averaged 9.5 per year. Overall it appeared the treatments were only moderately effective at this site. A graph of the yearly crash data is shown in Figure 4.8.

Figure 4.8 Crashes per Year Collins Ave. and Harding Ave. (67th St. to 76th St.) from 1996 to 2006

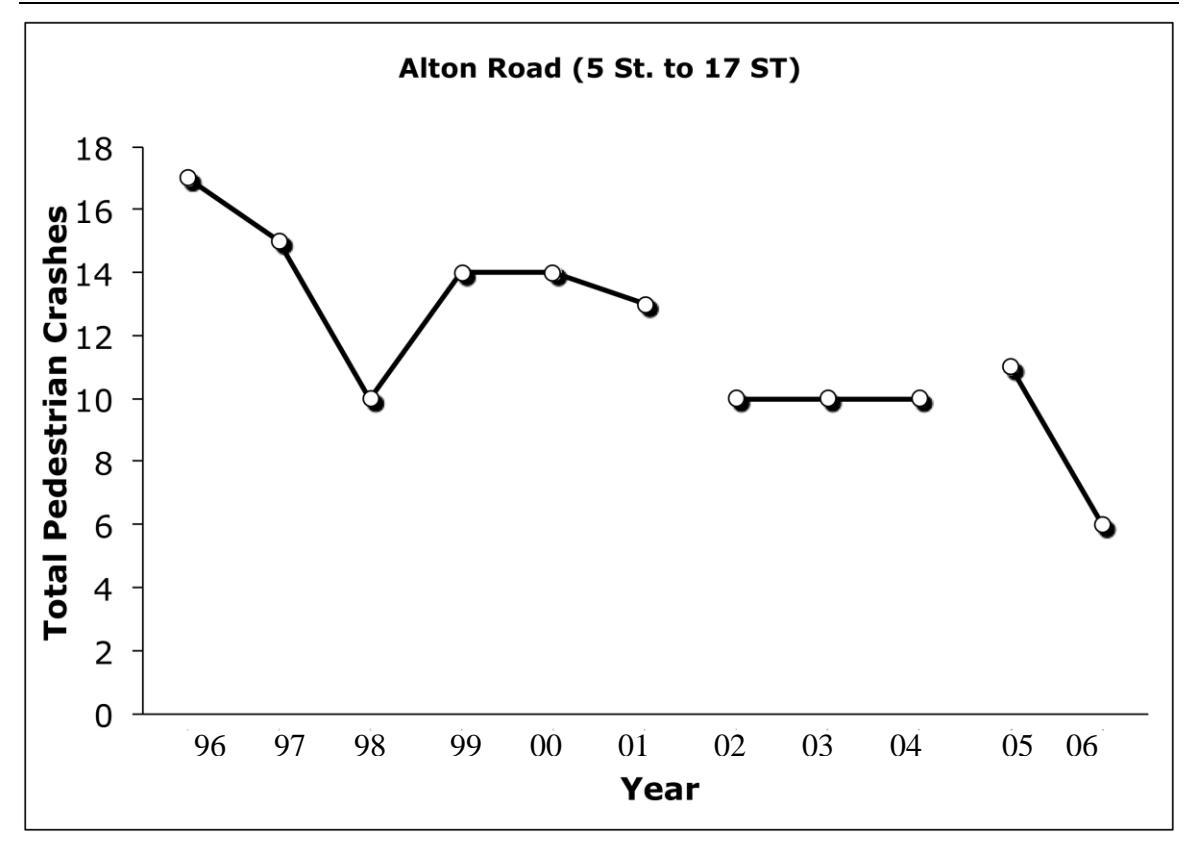
The corridor along Alton Road between 5th St. and 17th St. averaged 13.8 crashes per week during baseline. This corridor had the second highest percentage of daytime crashes (74%) and 42% of crashes occurred at intersections. Alton Rd. received a number of treatments. A large number of push buttons that confirmed the press and countdown pedestrian signals were installed along this corridor. The video detection system was installed at a midblock signalized crosswalk. Three intersections received a leading pedestrian interval, and one intersection received the "Turning vehicles yield to pedestrians" symbol sign treatment. The introduction of the NHTSA project was associated with a decline in crashes to 10 per year and the FHWA project was associated with a further small decline to 8.5% crashes per year. A graph of these data is shown in Figure 4.9.

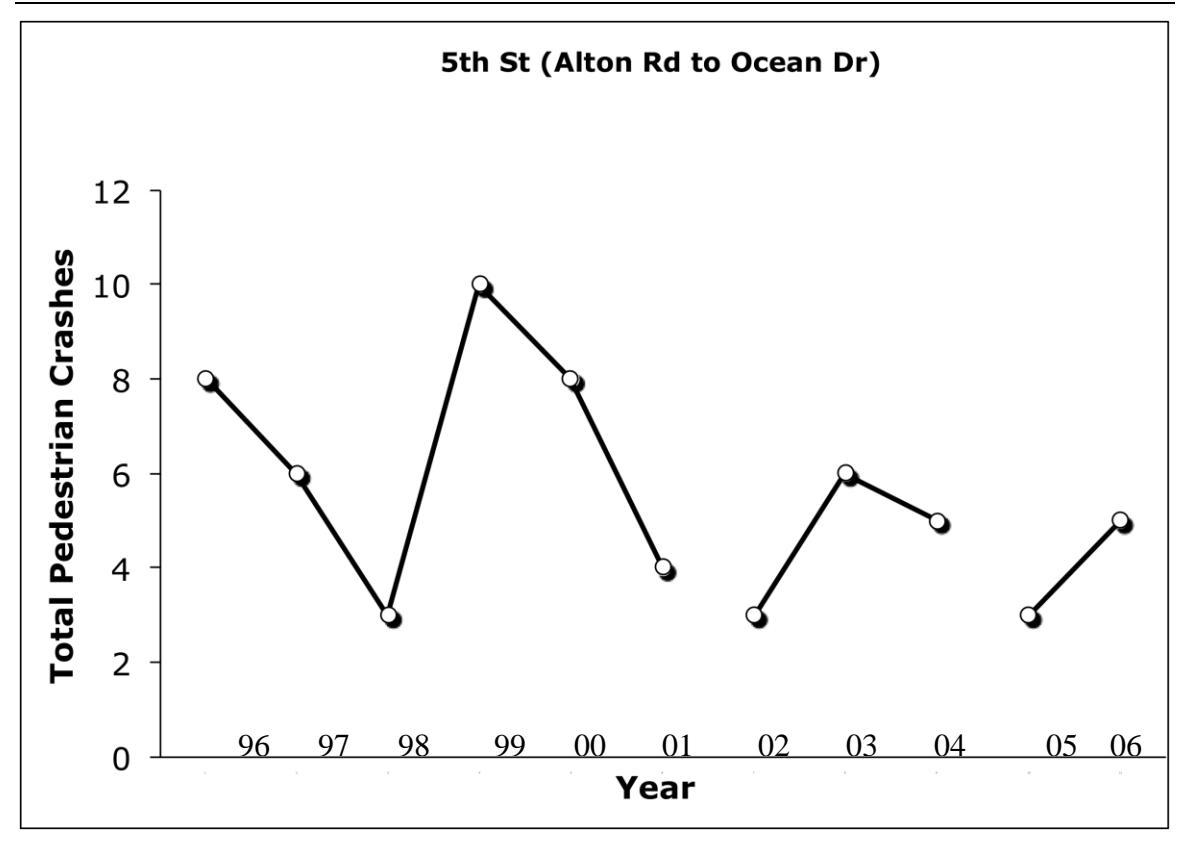
The final graph shows the number of crashes occurring on 5th St. between Alton Rd. and Ocean Drive. More than half the crashes along this corridor occurred at night and only 23% involved turning vehicles. Treatments installed along this corridor included push buttons that confirmed the button press, and "Turning vehicles yield to pedestrians" symbol signs. During the baseline condition pedestrian crashes averaged 6.5 per year. After the NHTSA program was introduced these crashes declined to 4.7 per year and following the introduction of the FHWA project crashes declined to 4 per year. Figure 4.10 shows crashes at this site. Overall there were not a large number of crashes along this corridor and it is difficult to determine whether the treatments had an effect.

Figure 4.10 Crashes per Year on $5^{\rm th}$ St. Between Alton Rd. and Ocean Dr.) from 1996 to 2006
