PROTOTYPE CRAWLING ROBOTICS SYSTEM FOR REMOTE VISUAL INSPECTION OF HIGH-MAST LIGHT POLES

FINAL REPORT

VIRGINIA TRANSPORTATION RESEARCH COUNCIL

July 1997 VTRC 98-R2 Copyright 1997, Virginia Department of Transportation.

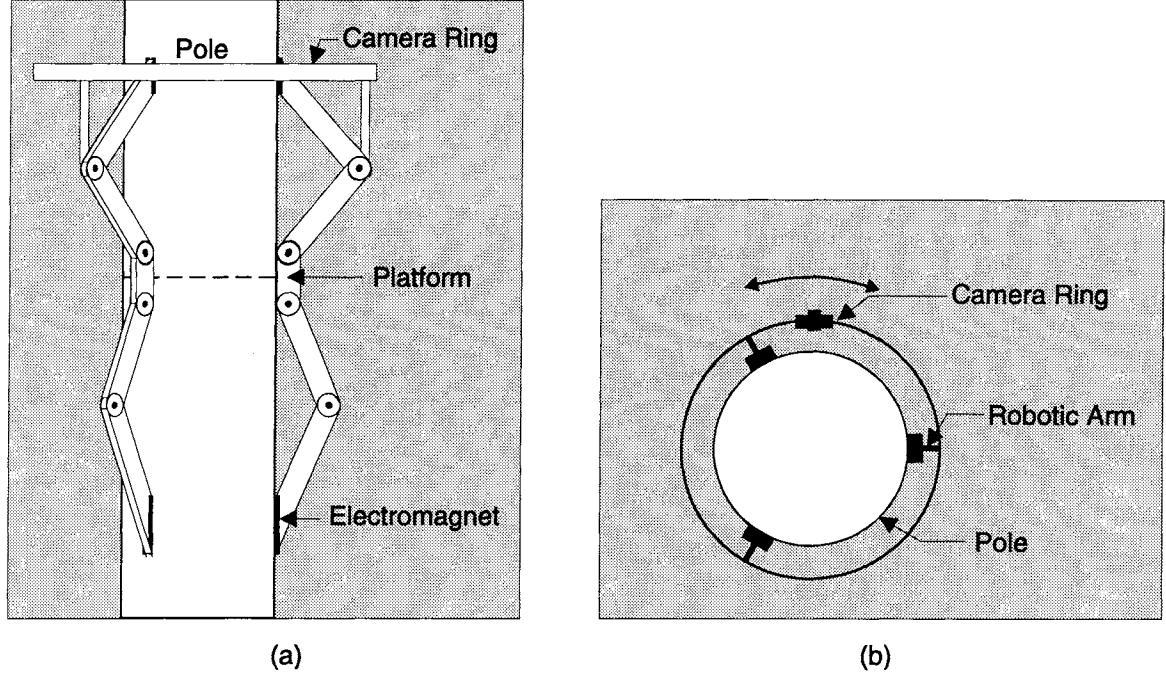
Figure 4. (a) Proposed crawler using three sets of robotic arms; (b) top view of pole showing position of robotic arms around pole

This crawler uses three sets of robotic arms, each having four links magnetically attached to the pole and positioned around the pole to support the platform (see Figure 4). The flexibility of the robotic arm, caused by its various joints, enables the crawler to adjust to the varying diameter of the pole.

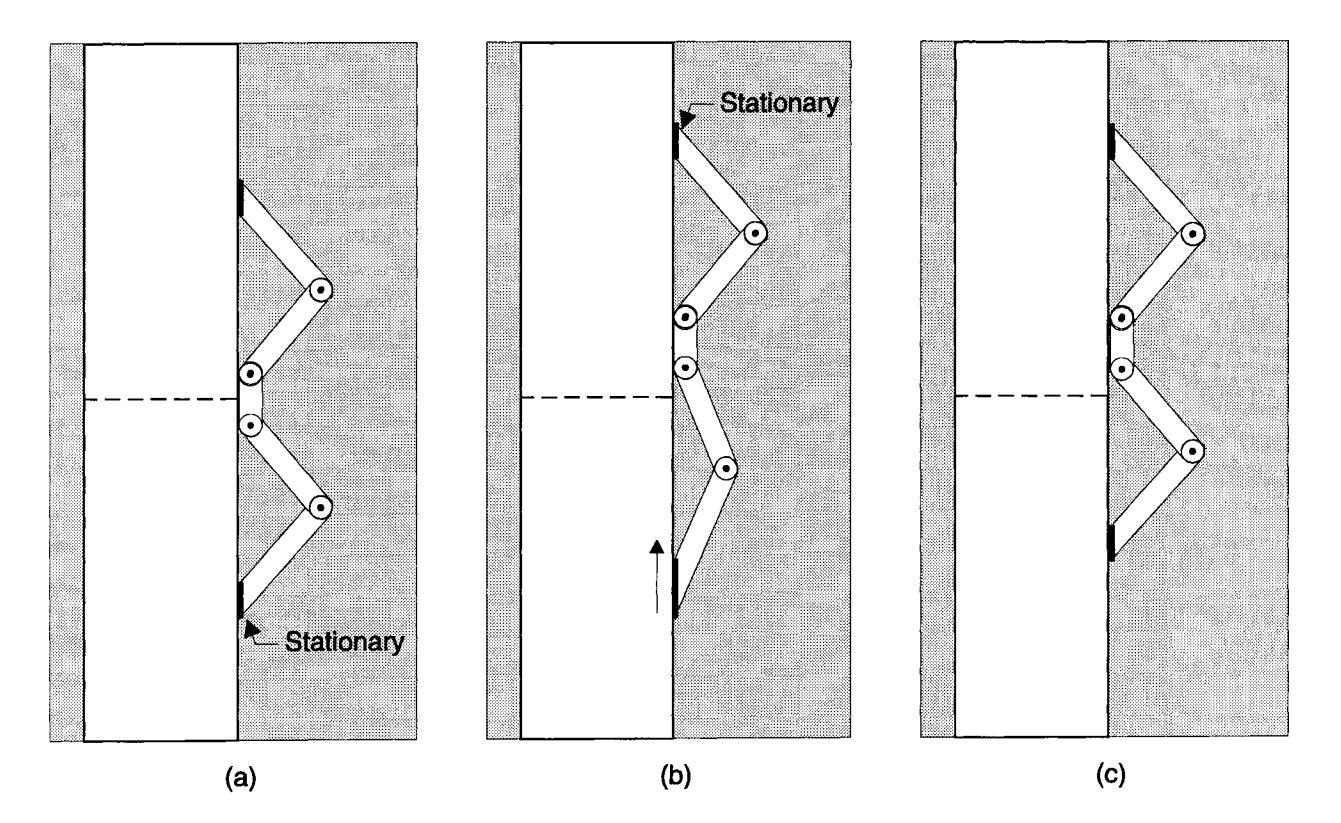
Figure 5. Progressive movements of robotic arms needed to crawl up pole: (a) top magnet moving up pole, bottom magnet stationary; (b) top magnet stationary, bottom magnet moving up pole; (c) crawler further up pole as result of movements

move, the bottom magnet would scale up (down) the pole, thus causing the bottom robotic arm to contract (elongate) and move the platform up (down). This movement would continue and occur at smaller intervals as the platform approached the desired pole joint. Figure 5 shows the movement of a robotic arm up the pole.

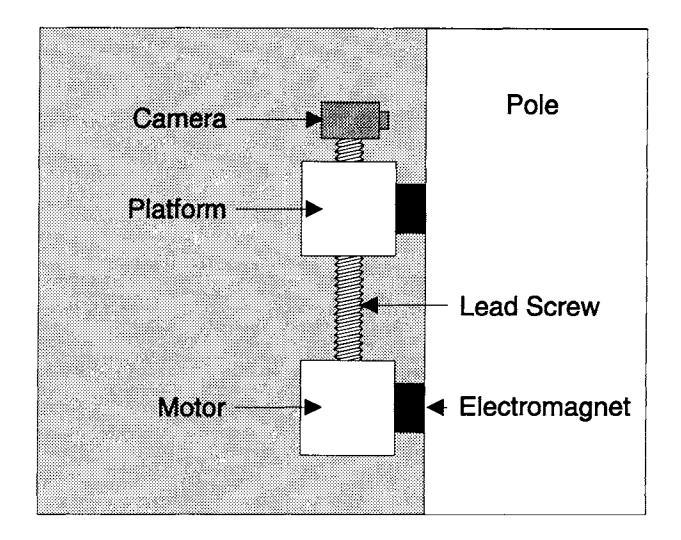
Figure 7. Proposed crawler using lead screws (worm gears) instead of robotic arms

The second proposed crawler uses lead screws (worm gears) positioned around the pole in place of the robotic arms (see Figure 7). The weight of this crawler is significantly less than that of the robotic arm crawler since there are no heavy robotic arms to support and the motors and magnets can be smaller since they, too, are supporting a smaller weight. In this case, an electromagnet connects the platform to the pole and another electromagnet attaches the motor to the pole.

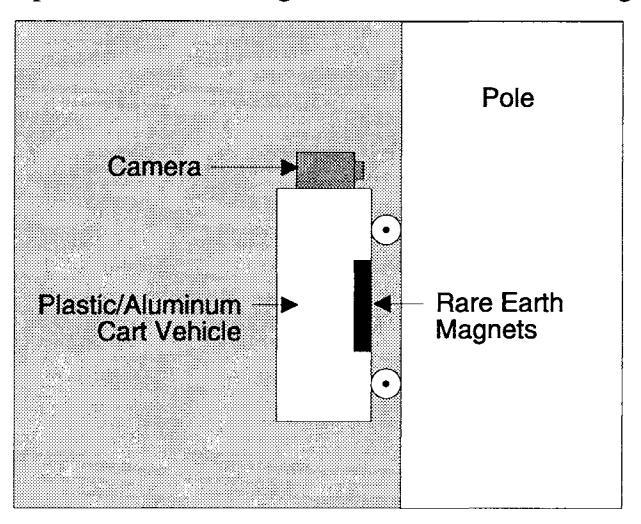
Figure 8. Proposed crawler using permanent magnets distributed along base of vehicle and omnidirectional wheels

The omnidirectional wheels contributed a great amount of flexibility to this crawler design. The wheels are composed of free-rolling rollers that are at a 45-degree angle to the

center core of the wheel, but they form a circle when looked at from the side. Movement in all directions is controlled by a DC permanent magnet motor in the wheel that alters the speed and/or direction of particular wheels to achieve movement in the desired direction. With these wheels, the crawler could change its direction of motion without having to rotate.

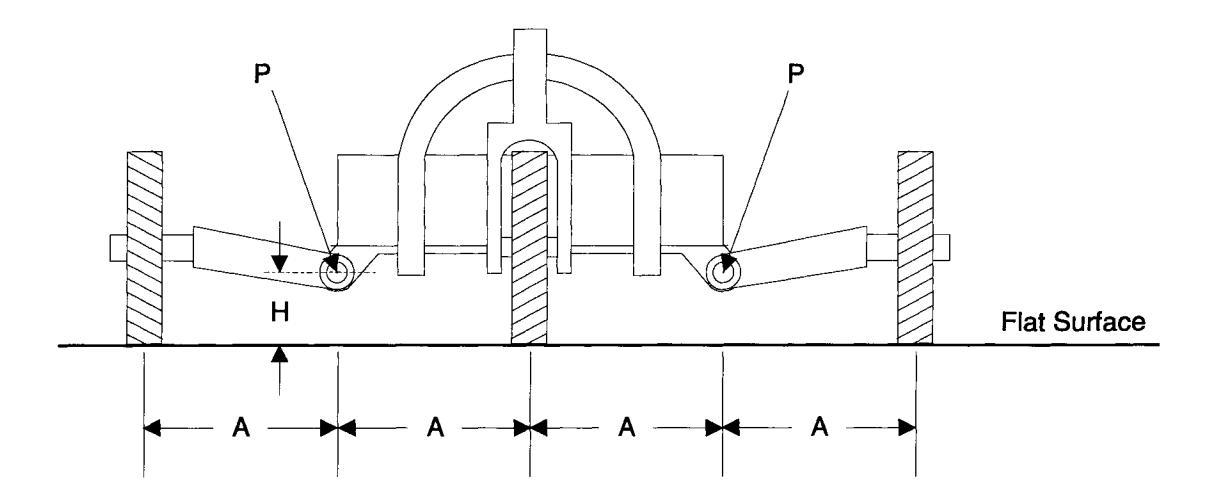
Figure 9. Concept for crawler's chassis wheel on flat surface (front view)

The geometric principle on which the chassis-wheel articulation was based is shown in Figures 9 and 10. Figure 9 shows the concept for the robot from the front when climbing a vertical flat surface, and Figure 10 when climbing a pole. The two outer wheels are hinged to the central frame at points that are equidistant from the center of the main frame to the center of each outside wheel. Figure 10 shows that when the robot is conforming to the cylindrical surface of a pole, the geometry allows the plane of each side wheel to intersect the axis of the pole, which ensures that the wheel surface is tangent to the surface of the pole, maximizing the magnetic attraction between the wheel and the pole. A further consideration was the distance of the points above the surface. In moving from a flat plate (Figure 9) or a large-diameter pole to a small-diameter pole (Figure 10), the outer wheels at their point of contact had to move closer together by sliding sideways as the robot advanced up the pole. This sliding would be minimized if the points were mounted as close as is practical to the surface of the pole. Thus, distance H in Figure 9 should be minimal.

pole. This maneuver causes the drive wheels to move closer together, as shown in Figures 9 and 10. In climbing a gently tapered pole, this is accommodated by a very slight lateral motion of the wheels, but in rotating on a small-diameter pole, the required sliding is considerable. If the sliding does not occur, the main frame, and in particular the central tube, will be forced away from the surface of the pole. To prevent this, a tension spring was added from the lever arm of the wheel assembly to the main frame for both the left and right drive wheels. This tends to spread the wheels during rotation and effectively solved the problem.

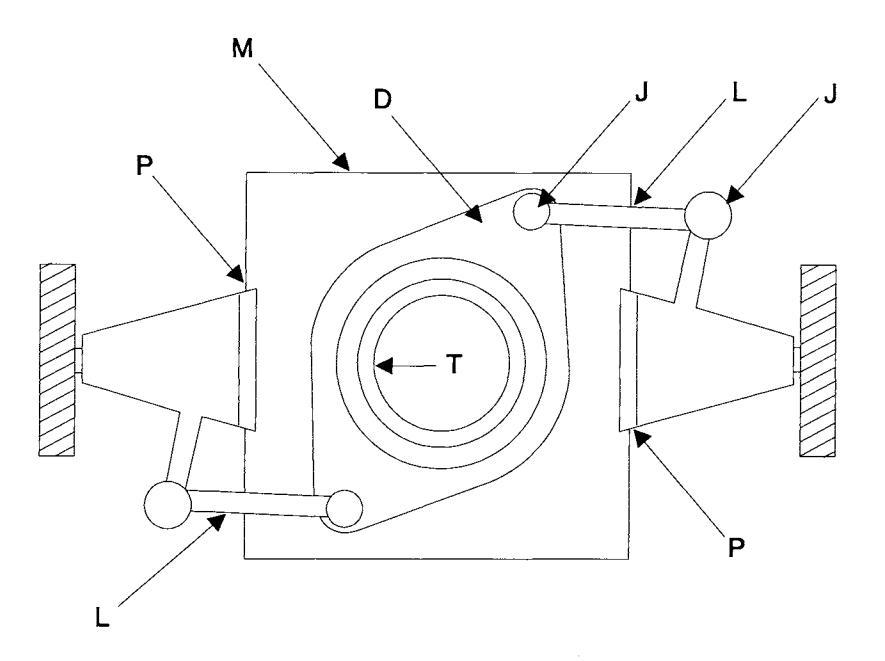
Figure 11. Concept for crawler's system (top view): L = lever arm; P = transfer plats; M = main frame; D = transfer disk; J = ball joint

To maintain this geometry, the outer wheels must move in a symmetrical fashion. This was accomplished by the mechanism shown in Figures 11 and 12. Mounted in the central frame is a tube in which the ultrasound transducer could be mounted. Rotating around that tube on ball

bearings is a transfer disc. Extending from each member that supports the outside wheels is a rigidly attached lever arm. Linking the end of each lever arm to the transfer disc is a link, fastened to the transfer plate and lever arms through the ball joints. Thus, the motion of one outside wheel assembly about point P is simultaneously and symmetrically transferred to the opposite outside wheel assembly. This maintains the desired geometry for all cylindrical surfaces within the required range, 1 to 150 mm in diameter. In addition to maintaining correct wheel contact with the pole, the described geometry also maintains the central tube perpendicular to the pole surface, which is important for ultrasonic transmission.

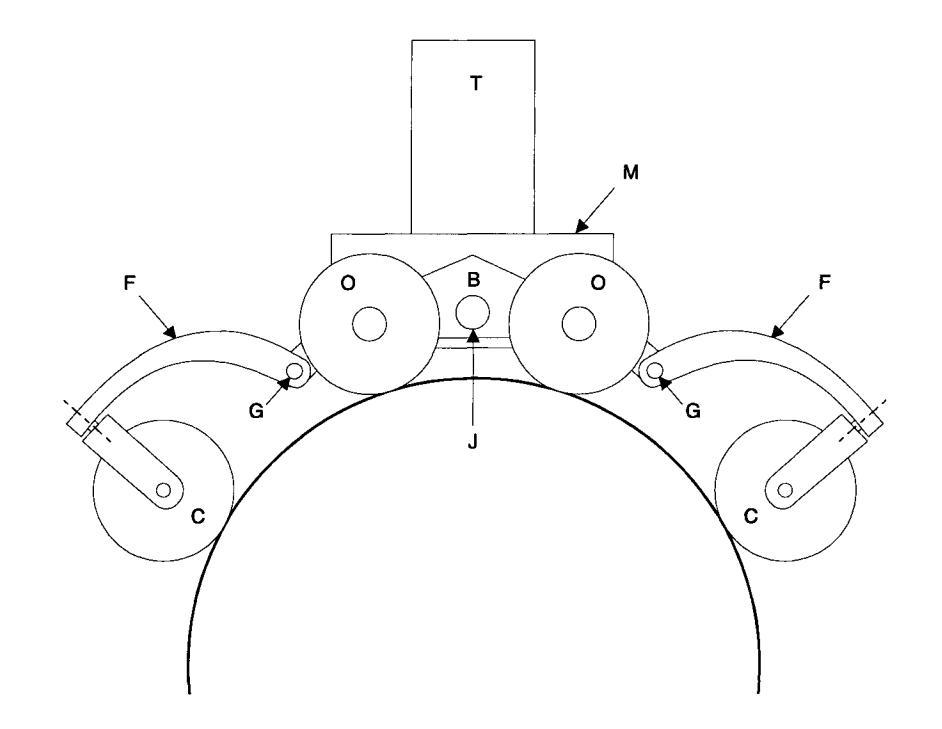
Figure 15. Concept for tandem bogey wheels (cross section, side view): C = caster wheels; C = caster frame; G = joint; O = tandem wheels; T = tube; B = bogey frame; J = ball joint; M = main frame

A second problem was the limitation in climbing over obstacles such as lap joints in the pole. This was overcome by replacing each outside or lateral drive wheel with a tandem pair of wheels, powered with the same motor and mounted in bogy fashion to pivot on the axle of the original drive wheel, as shown in Figure 15. Figure 15 shows the wheels mounted tandem fashion on the bogy frame that pivots on the axle for the original single-wheel design. The geometry connecting the pivot of the bogy frame to the main frame is identical with that already described for the single wheel. In addition to providing greatly increased ability for climbing over obstacles, the traction is doubled, since four traction wheels are used instead of the original two.

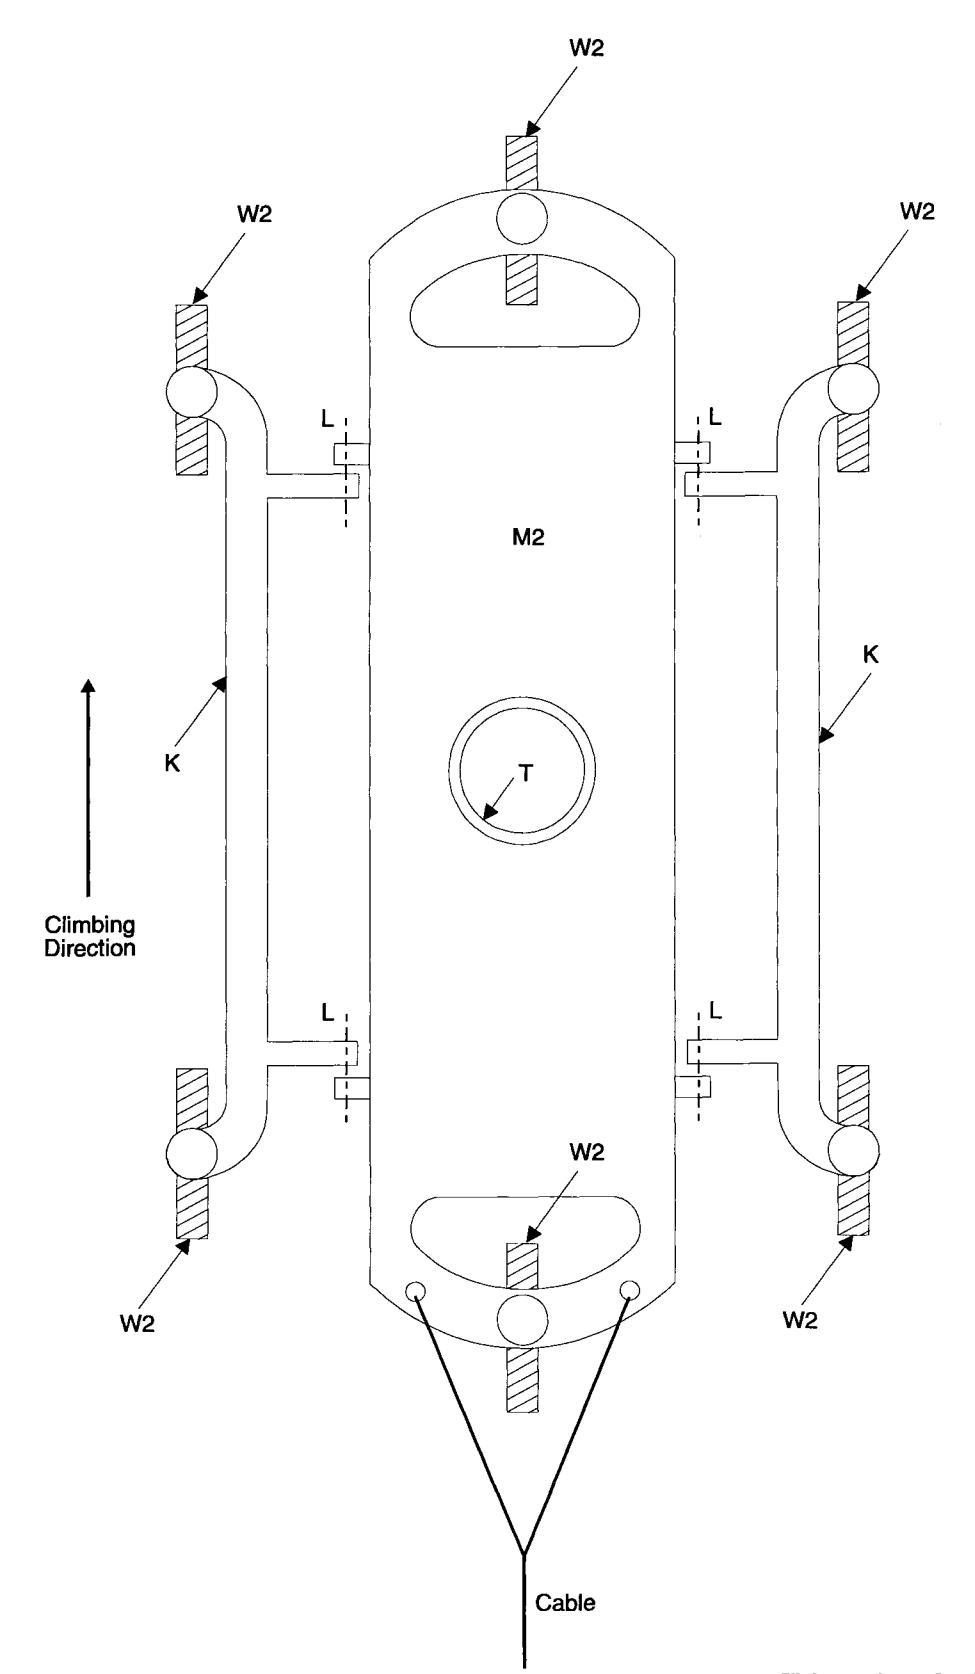
Figure 16. Concept for crawler in climbing position (plan view): K = subframe; W2 = drive wheels; L = hinge line; M2 = main frame; T = tube

The basic geometric principles already described were also applied in a different design for a pole-climbing robot. This is shown in Figure 16, which shows a plan view of the robot on a flat surface. The central frame is rectangular with the central tube as shown. Hinged along each

side on hinge line L are lateral subframes that are made to move in a simultaneous and symmetrical fashion using a similar transfer disc and linkage as previously described. In this example, six drive wheels are attached, two on the central frame and two on each of the subframes, each having its own motor. Each drive wheel and its motor are mounted to its respective frame on an axis perpendicular to the wheel axle and perpendicular to the surface on which the wheels rest. Thus, on a flat horizontal surface, the axis of each drive wheel and motor assembly would be vertical. The purpose for this axis of rotation is to allow the operator to rotate all wheels simultaneously through 90 degrees to the position shown in Figure 17. In this mode, the robot can be driven horizontally around the pole to inspect for cracks, etc. Adjustments in direction can be made by a speed differential between wheels. Similarly, as shown in Figure 16, when climbing up the pole, adjustments in direction can be made by a speed differential between the left and right pair of motors.

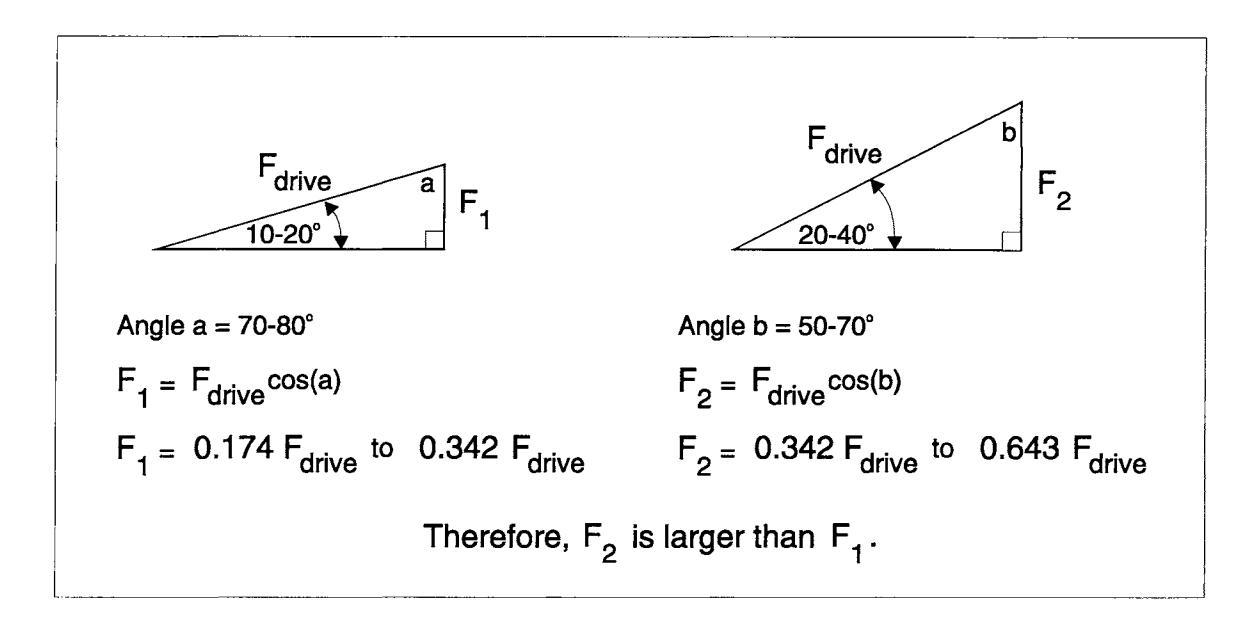
Figure 28. Force vectors

to the horizontal than at a small angle (10 to 20 degrees). This is evident if one considers the force vectors as shown in Figure 28.

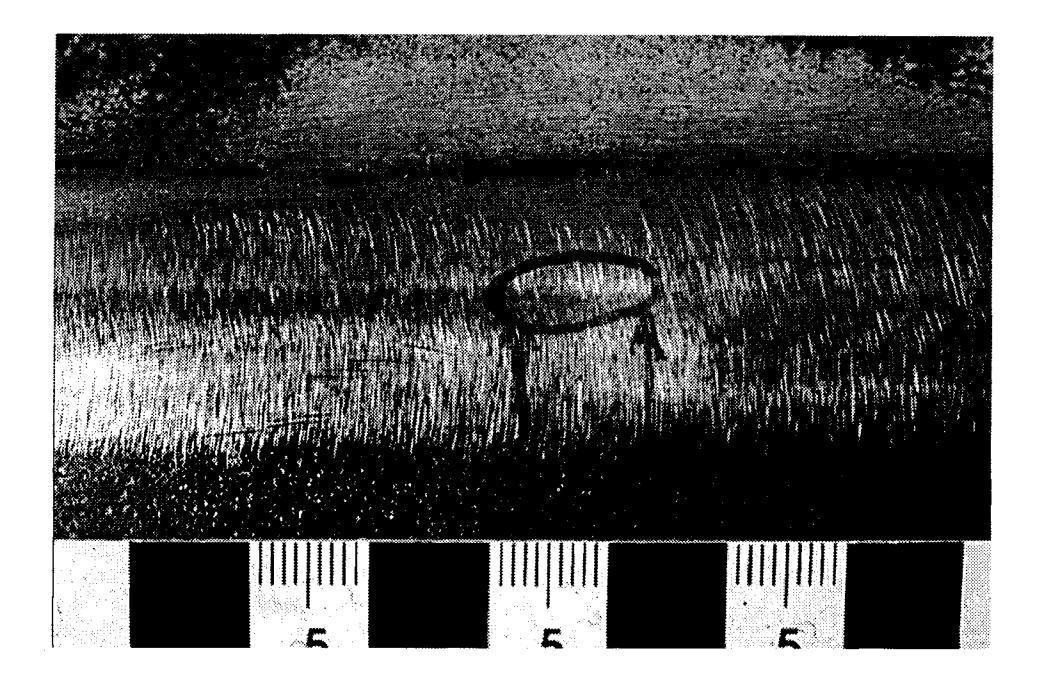
Figure 29. Digital image of flaw 1

The sensitivity of the remote visual device to detect reference cracking on the sample's surface was evaluated briefly. The camera's resolution was good for detecting surface breaking flaws on noncorroded surfaces. Figure 29 shows a digital image of the centerline crack (flaw 1). It was not possible to detect the reference cracks covered with a thin layer of rust. There are still no criteria for detecting cracks during the inspection of the poles.

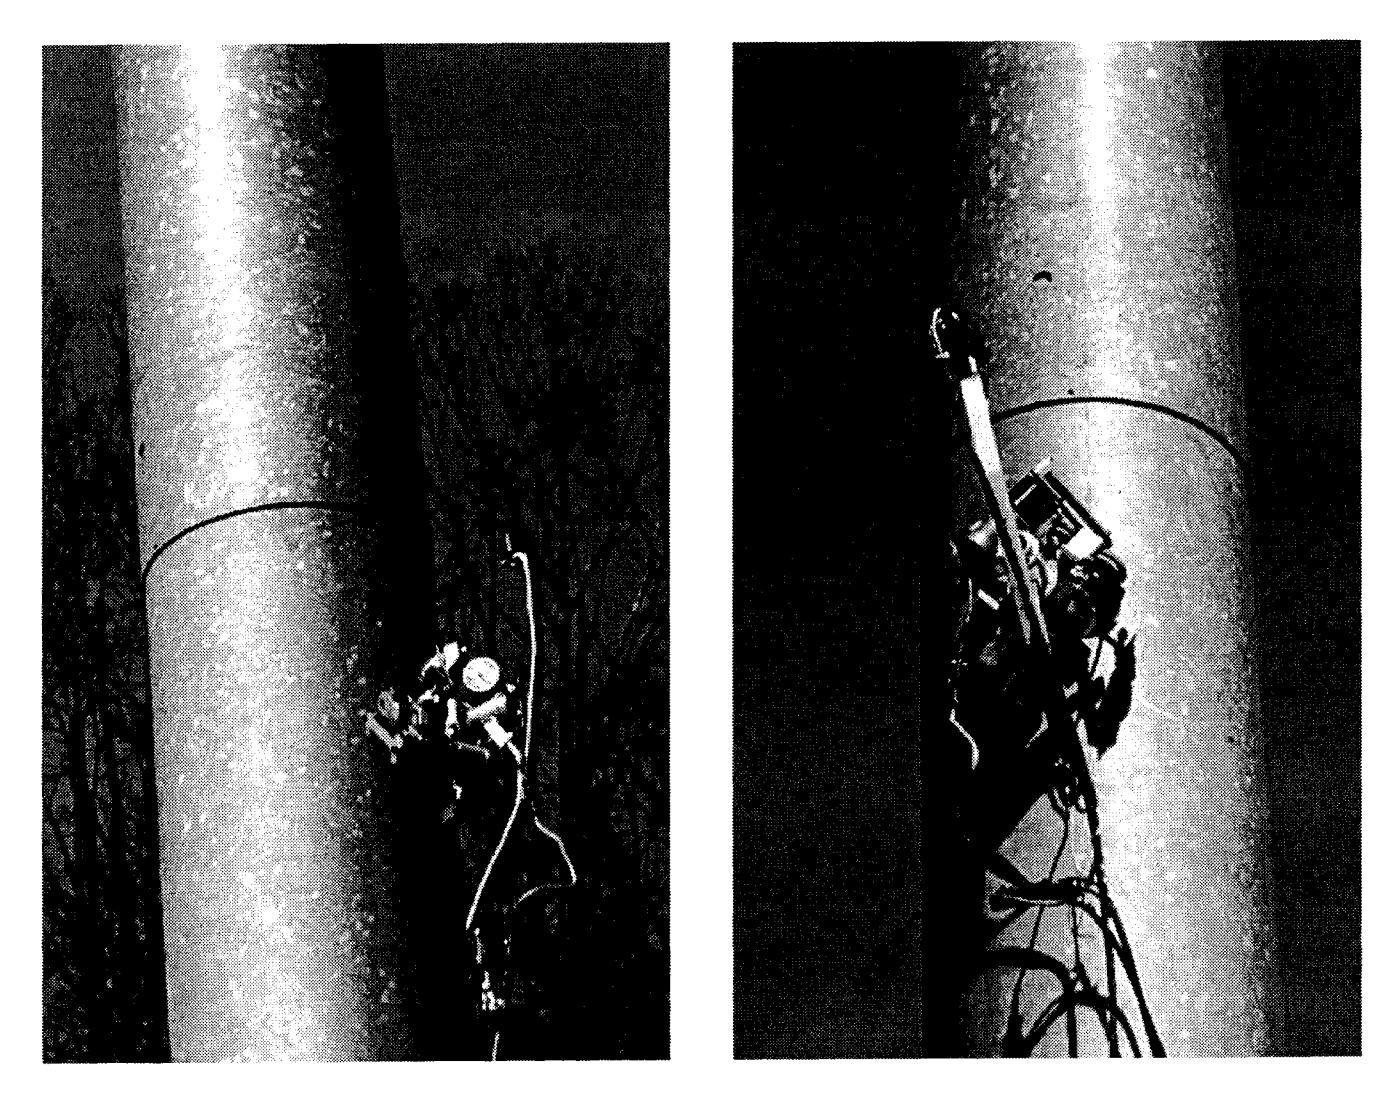
Figure 30. (Left) crawler climbing galvanized pole; (right) crawler rotating on pole

During the first field test, the crawler did not manipulate rotations very easily. The center contact remained very close to the surface of the pole. Figure 30 and shows the crawler during the second test. Five slip joints were inspected on this pole. The field test was not completed the same day because of windy weather.

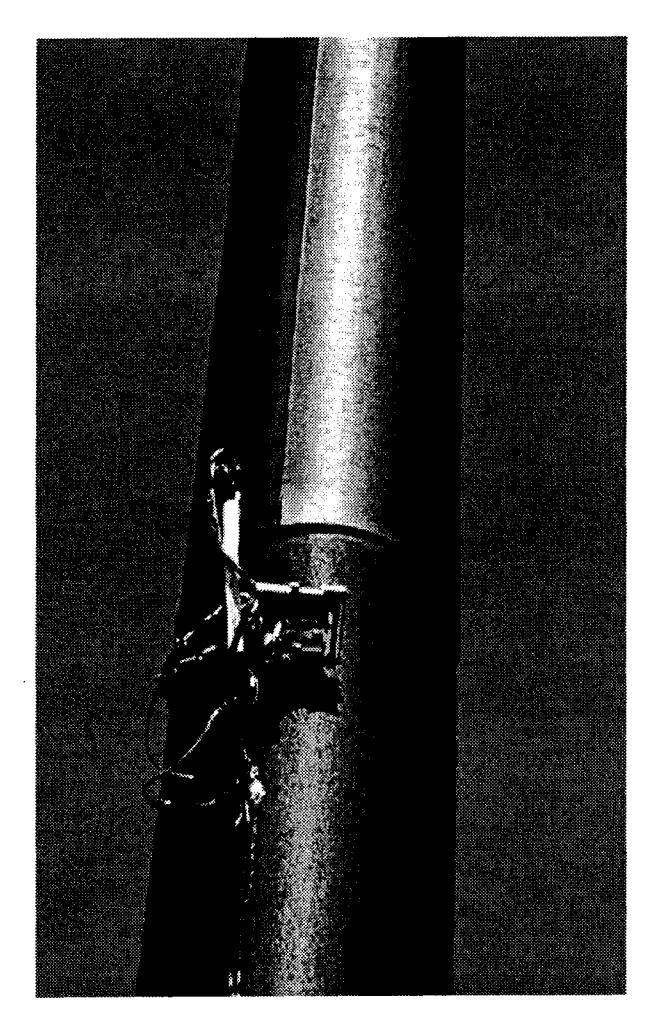
Figure 31. Robotics inspection of steel pole in Hampton, Virginia

Figure 31 shows the surface conditions and the crawler above the third slip joint during the third test. The crawler's speed was 4 mm/s during the climbing and 3 mm/s during the inspection. A surface breaking crack was detected in the female section in the third joint. The zoom of the digital image of the crack is shown in Figure 32. The surface conditions did not influence crack detectability because the crack was 5 mm wide and 75 mm long. During the inspection, real-time full motion pictures were acquired and stored on the hard disk for review and enhancement. The crawler climbed up to 20 m and changed direction from vertical to horizontal and vice versa several times without difficulty. Three slip joints were overcome during this test. Unfortunately, when sitting above the third joint, the crawler occasionally fell to the ground, slipping on the surface without detaching from the pole. The crawler was fixed in the field, and 2 hours later a demonstration to VDOT inspectors was conducted.
