TRANSPORTATION DATA REQUIREMENTS: EVALUATION OF PORTABLE TRAFFIC RECORDERS

Virginia Highway & Transportation Research Council (A Cooperative Organization Sponsored Jointly by the Virginia Department of Highways & Transportation and the University of Virginia)

June 1978

VHTRC 78-R58

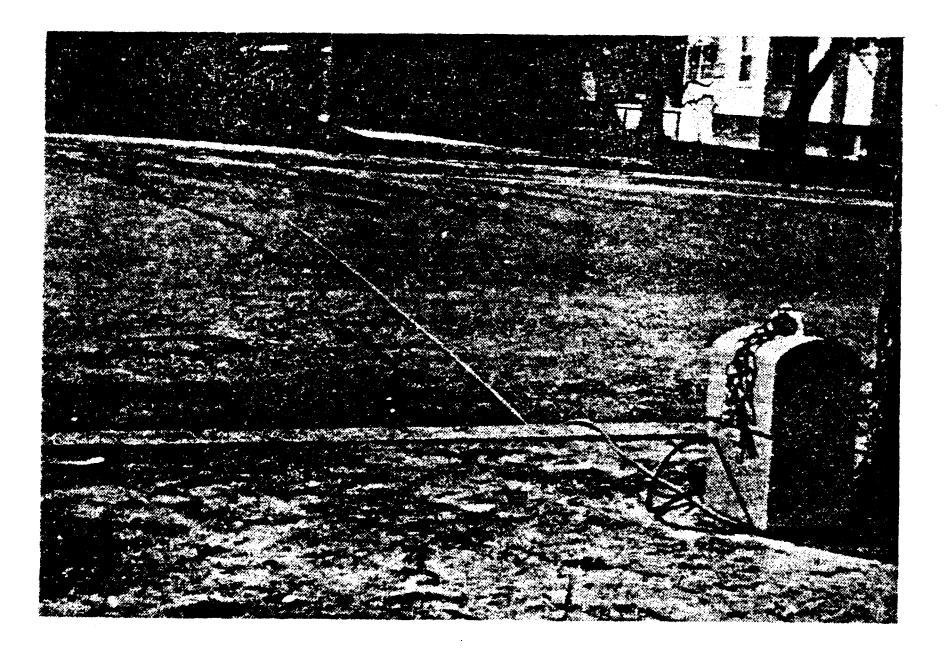
Figure 1. Operational use of roadway hose with traffic recorder, the STREETER AMET TRAFICOUNTER model.

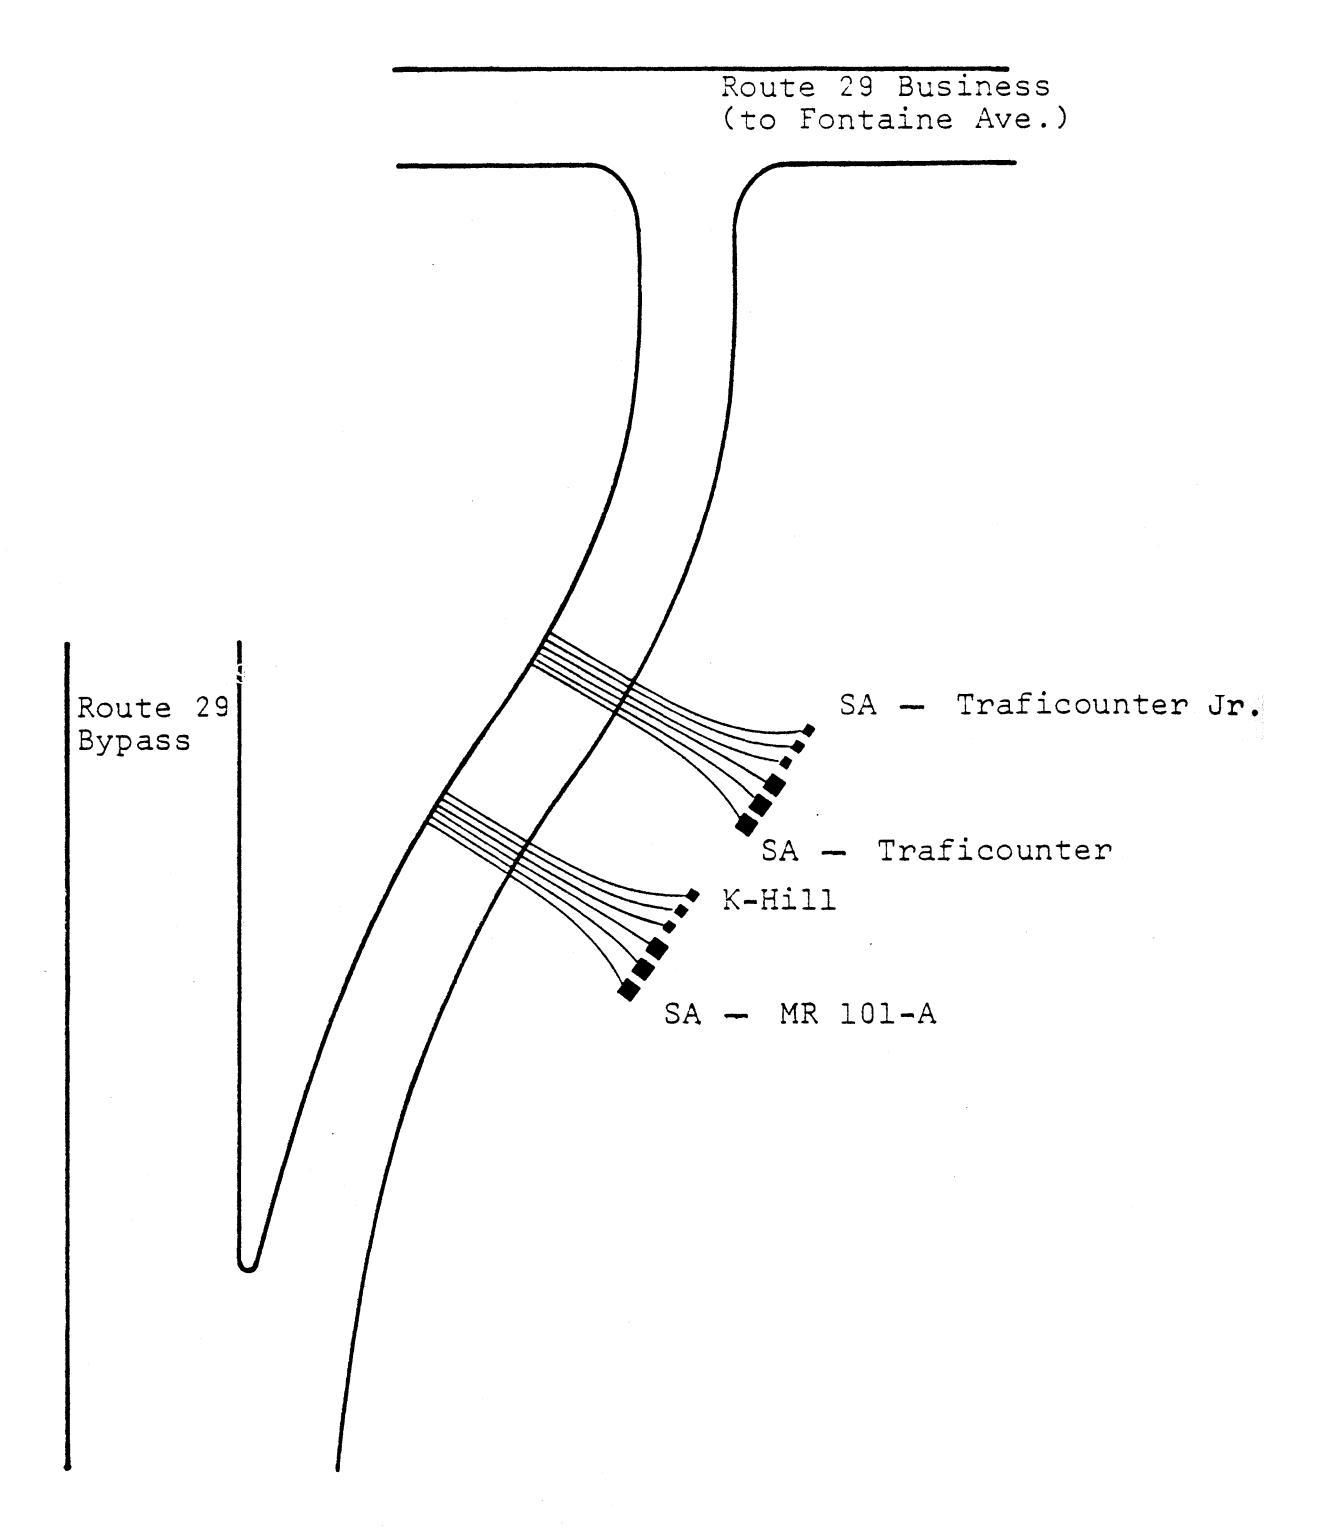
Figure 2. Placement of traffic recorders.

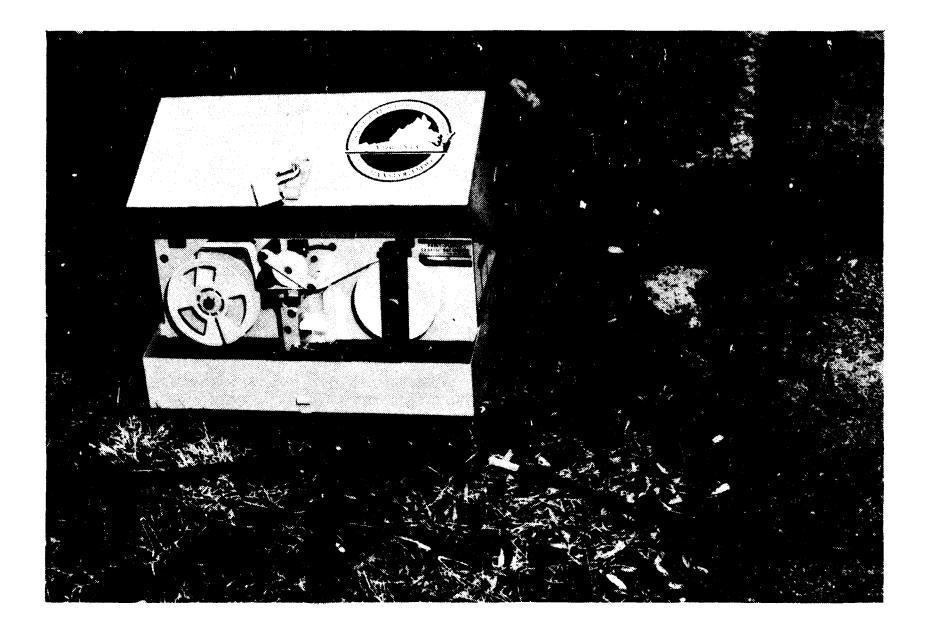
After an initial test phase, a second special procedure was developed by the research technician for use with the Stevens and SA-MR 101-A recorders. A road hose was connected to a 0.91-cm (3/8-in) diameter plastic tee-joint which was linked by short hoses to either two SA-MR 101-A or two Stevens recorders. Preliminary and subsequent testing revealed that this procedure reduced the number of road hoses required without affecting the traffic counts. This procedure has direct application in the regular traffic count program where it is necessary to obtain counts on highways having raised or wide median areas. While separate road hoses are placed on each side of a median area, where conditions permit, both could be connected to an inexpensive plastic tee-joint and to one recorder set in the median area as shown in Figure 3.

Figure 3. Plastic T joint linking two roadway hoses and a Stevens model recorder in a highway median area.

This procedure could provide substantial advantages by reducing both the number of recorder units required and the time necessary to compile and process the data as compared to the established practice of having to use two recorders, one on each road hose.

- 8. It was found that when obtaining traffic counts on divided highways, and where practical, the separate road hoses placed on each side of a median area could be connected by a plastic tee-joint to one traffic recorder to obtain counts on both sides of the highway. This practice could lead to the elimination of one recorder unit and reduce the labor and computer effort for data processing.

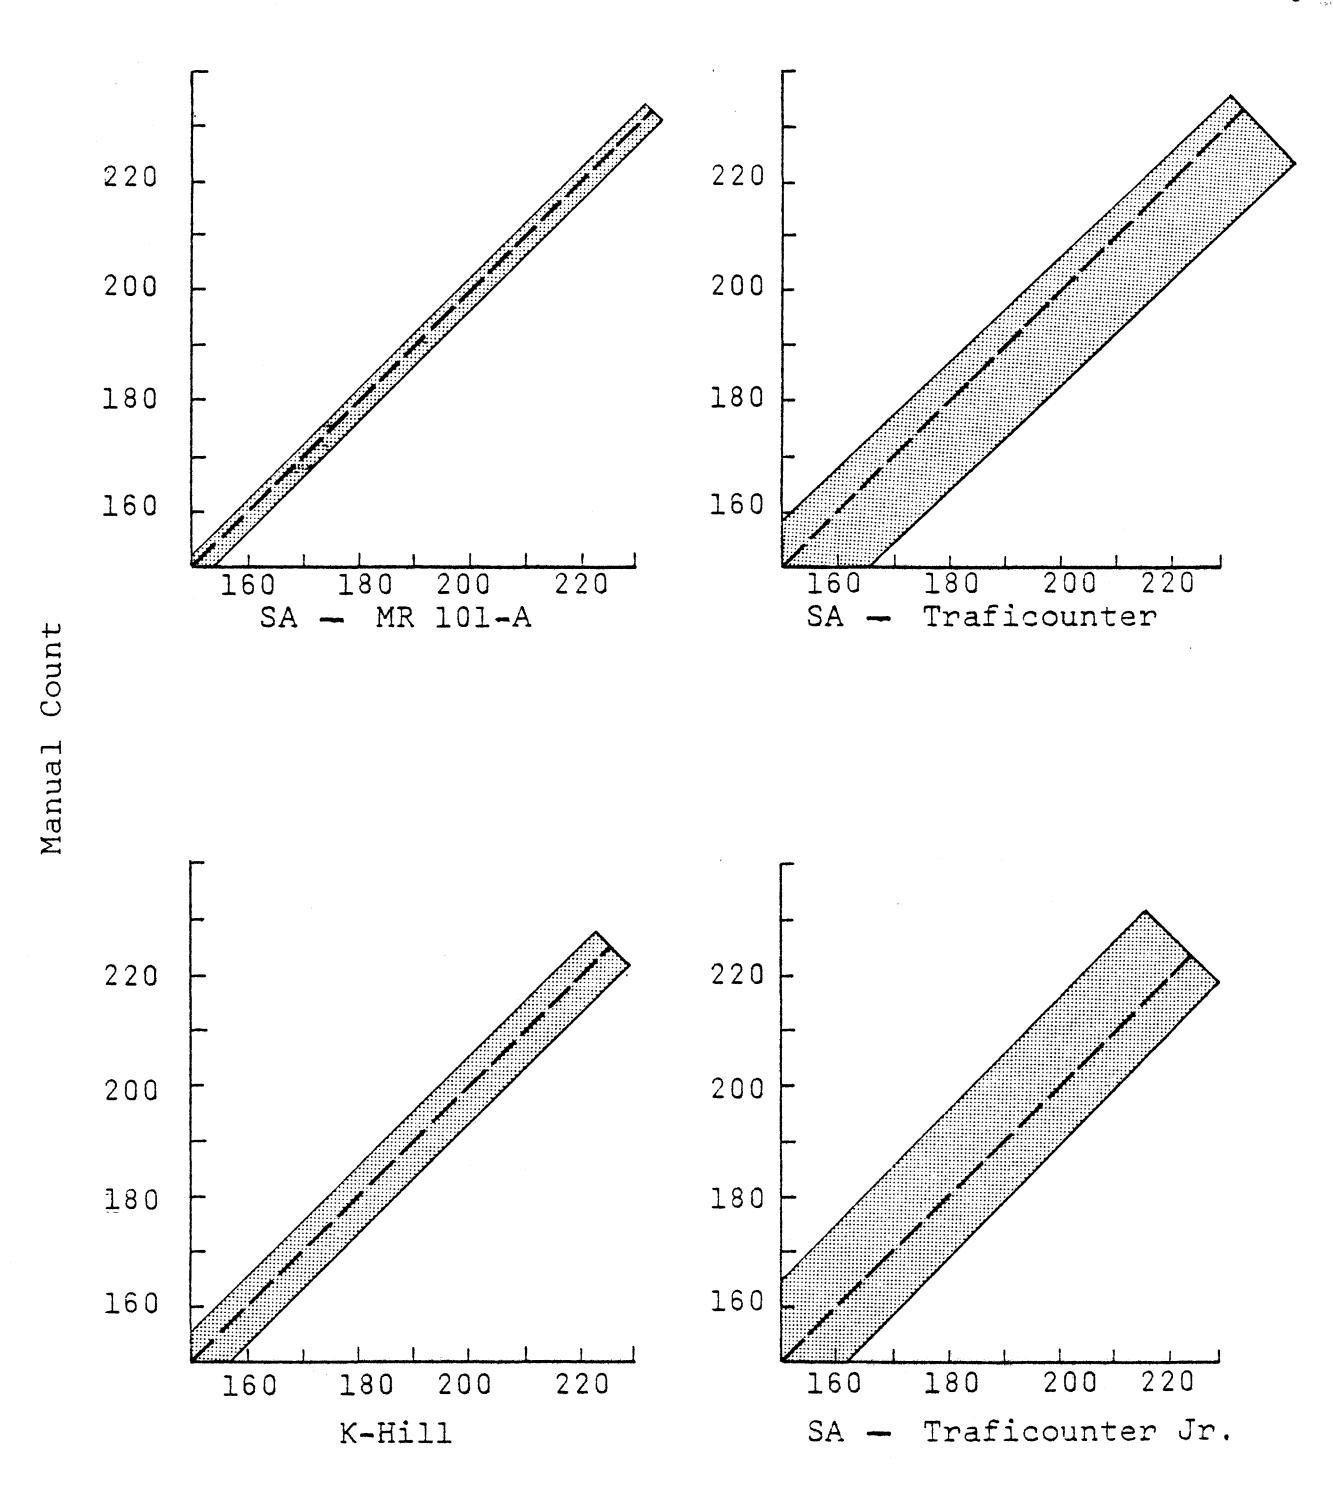
The site 1 traffic count data from Appendix 1 are shown in Figure 4. The graph for the SA-MR 101-A recorder data in the upper left shows that highly accurate traffic counts were obtained; the 95% confidence band was exceptionally narrow and encompassed the 45° match line. By comparison, the graph of the SA-Traficounter data in the upper right showed a

Figure 4. Comparisons of manual versus recorder traffic counts (pairs of axles) for site 1, showing match lines and 95% confidence bands.

trend towards overcounting vehicle axle pairs since most of the area in the 95% confidence band was below the 45° match line. Similarly, the SA-Traficounter, Jr., data in the lower right showed a trend towards undercounting; most of the area in the 95% confidence band was above the 45° match line.

The appendix data, graphs, and computed relative errors, were compared for each of four recorder models. The ranking for the accuracy of the recorder models in descending order and the corresponding relative errors were (1) SA-MR 101-A (0.8%), (2) K-Hill (1.0%), (3) SA Traficounter Junior (2.4%), and (4) SA Traficounter (3.1%). Overall, the four models tested obtained unusually accurate traffic counts, and both the nonaccumulative and accumulative recorders obtained accurate counts under these exceptionally favorable conditions.

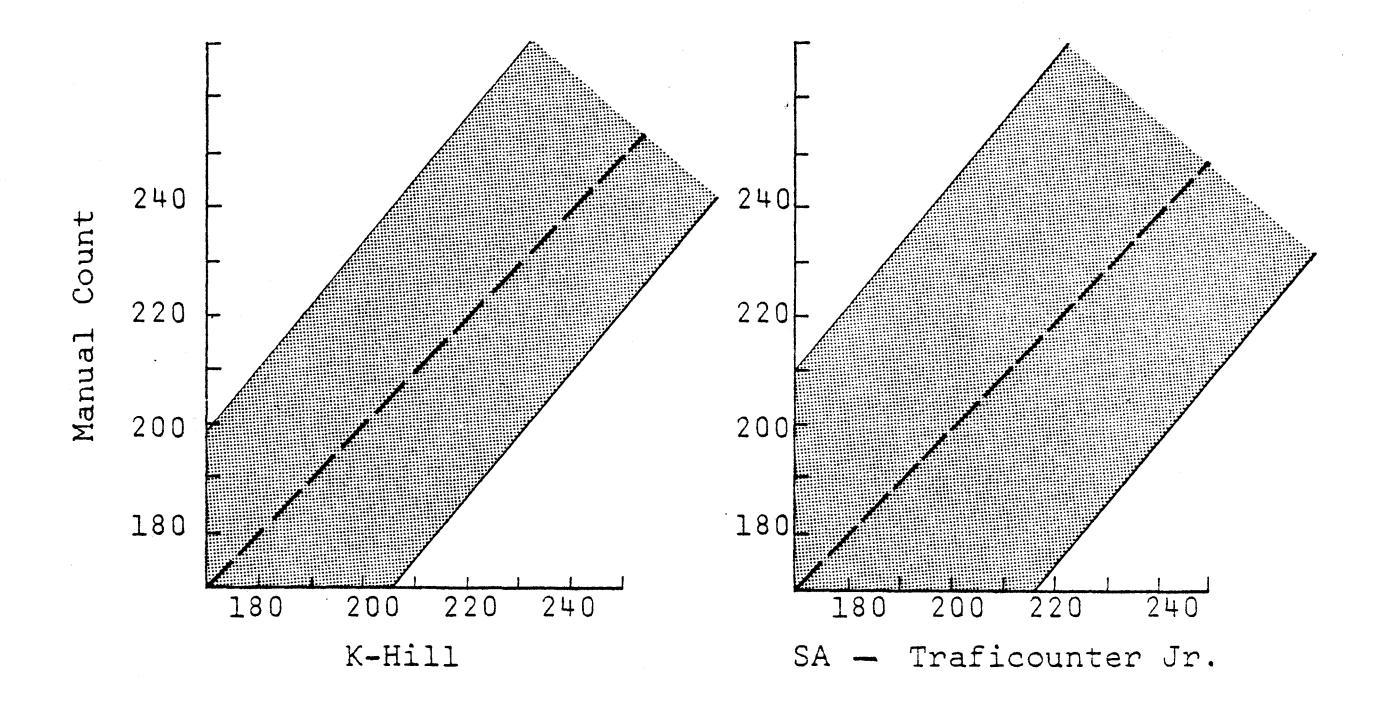
The traffic count data for site 2 from Appendix 1 are shown in Figure 5. Comparisons showed that the ranking order

Figure 5. Manual versus recorder traffic counts (pairs of axles) at site 2.

by recorder accuracy and relative errors were (1) the K-Hill (6.0%) and (2) the SA-Traficounter Junior (7.4%). In this comparison the accuracy of both of these accumulative type recorders on a secondary route were adversely affected by relatively conspicuous errors.

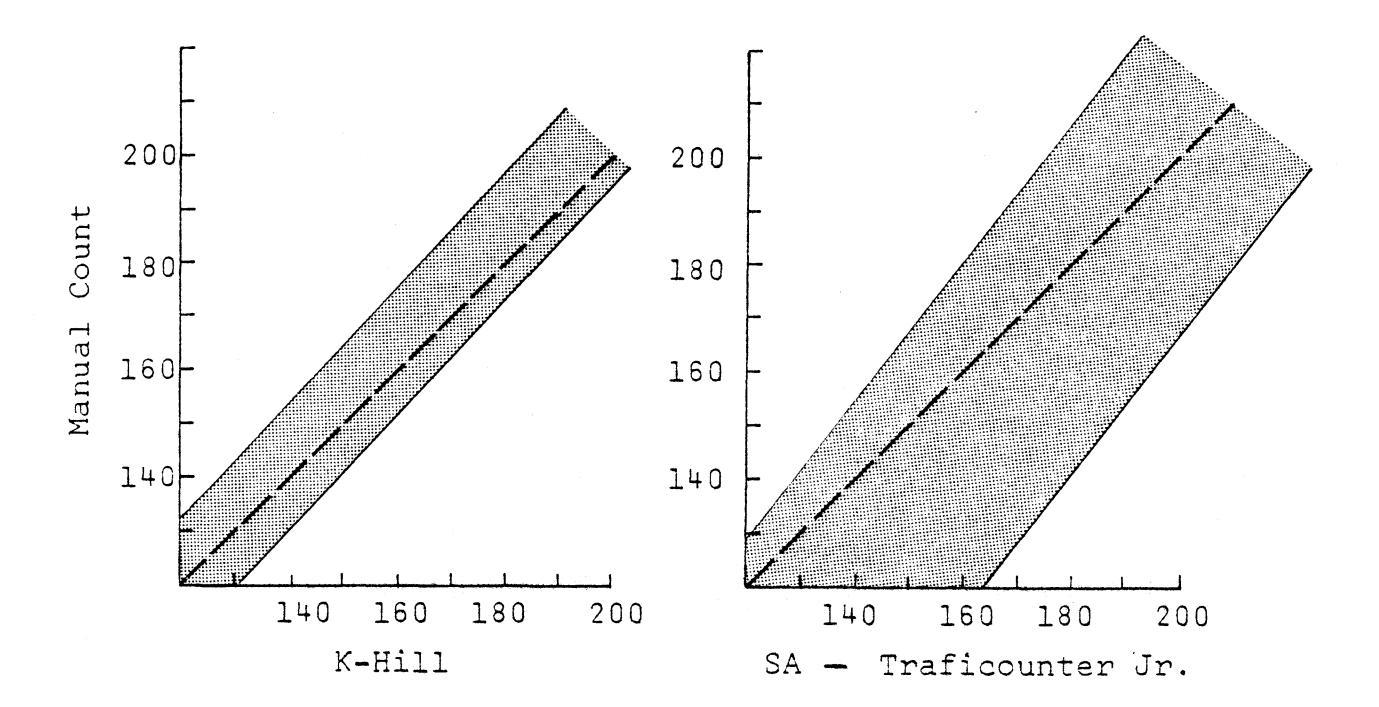
Figure 6 shows the site 3 traffic count data from Appendix 1. The comparisons showed that the ranking by accuracy and corresponding relative errors were (1) the K-Hill (3.4%) and (2) the SA-Traficounter Junior (6.7%). Thus, the K-Hill was the most accurate accumulative type recorder under unfavorable counting conditions on a secondary road.

Figure 6. Manual versus recorder traffic counts for site 3.

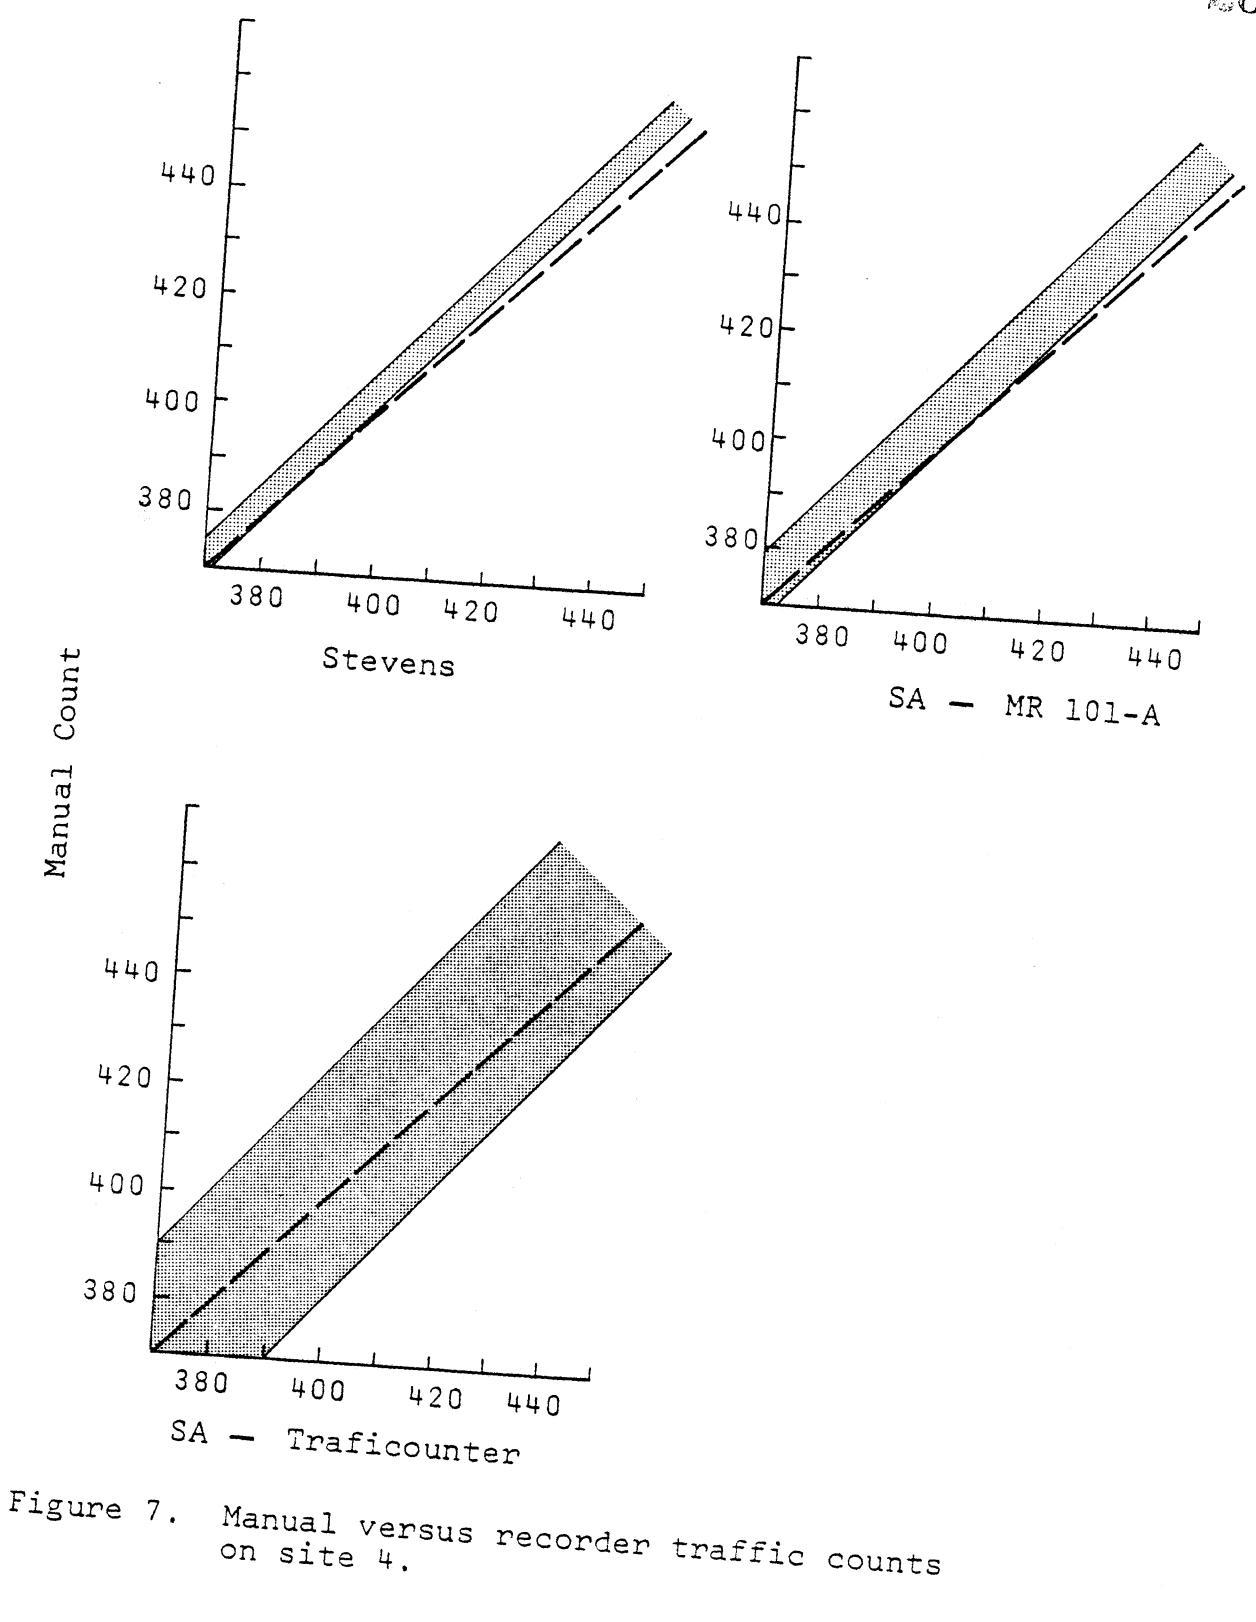
The traffic count data for the site are shown in Figure 7. Comparisons of these data revealed that the ranking order for the most accurate to the least accurate recorders, and their corresponding relative errors, were (1) Stevens (1.0%), (2) SA-MR 101-A (1.5%), and (3) SA-Traficounter (2.0%). Overall, all models obtained exceptionally accurate traffic counts under the moderately favorable conditions on a primary route.

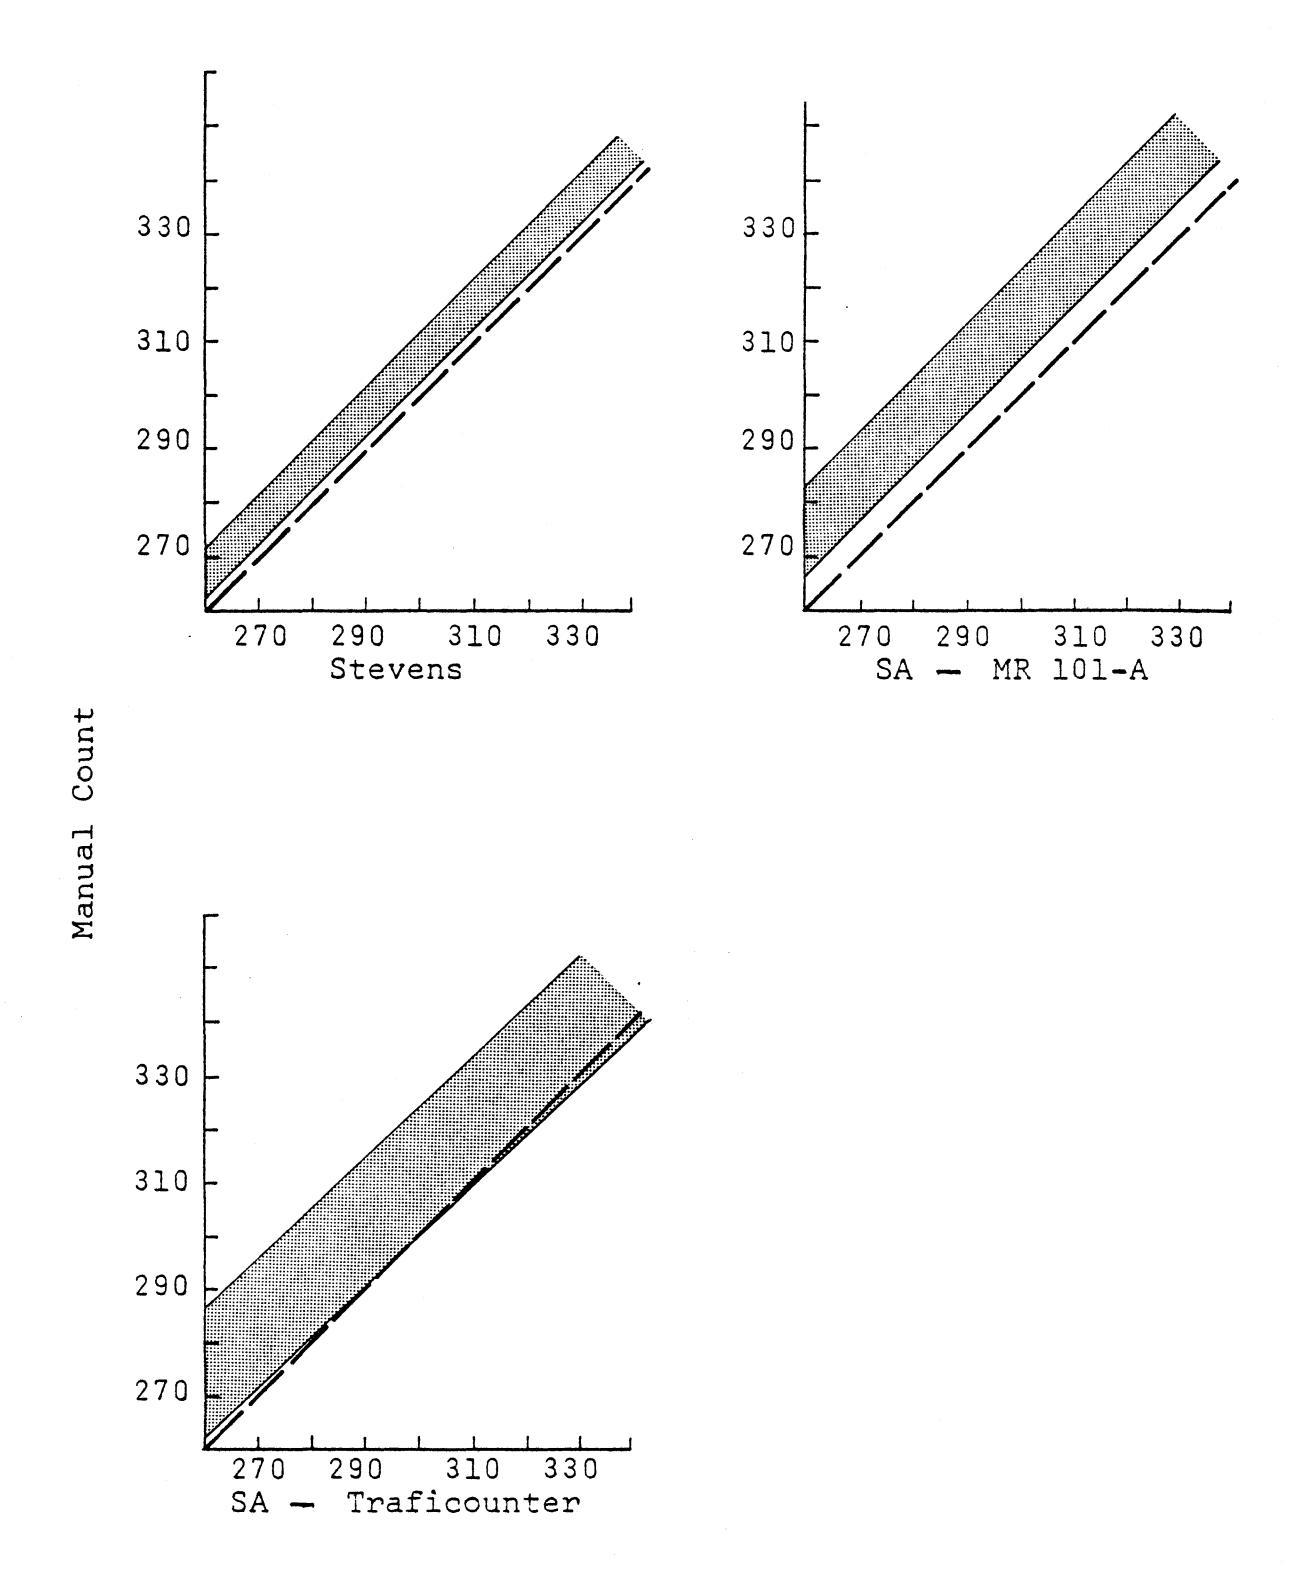
The site 5 traffic count data are shown in Figure 8. Here, the comparisons showed the descending order of accuracy for the recorders and the corresponding relative errors to be (1) Stevens (2.2%), (2) SA-Traficounter (3.9%), and (3) SA-MR 101-A (4.7%). The Stevens was clearly the most accurate nonaccumulative type recorder under unfavorable counting conditions on an arterial route.

Figure 8. Manual versus recorder traffic counts for site 5.

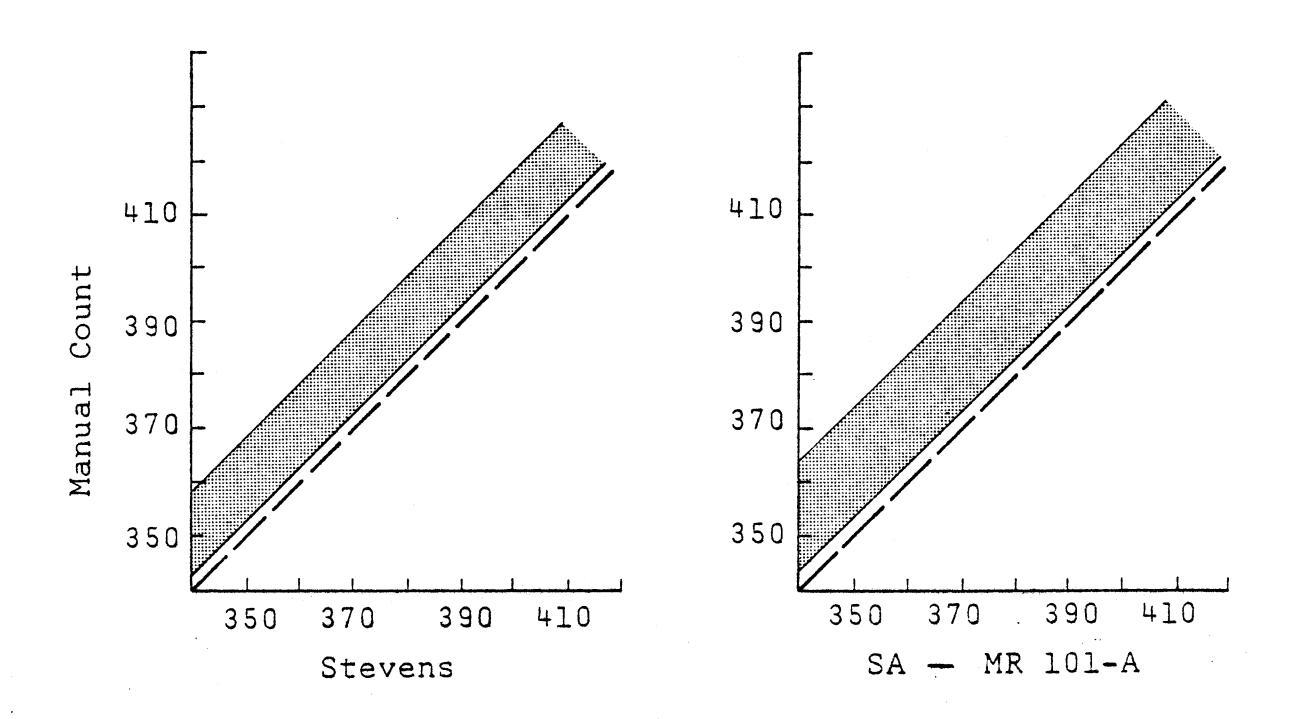
There were no problems with the recorders at site 6. The data for this site 6 are shown in Figure 9. The comparisons showed the ranking by accuracy and relative errors to be (1) the Stevens (2.5%) and (2) the SA-MR 101-A (3.3%). Both of these nonaccumulative recorder models obtained fairly accurate traffic counts under the exceptionally unfavorable counting conditions at site 6.

Figure 9. Manual versus recorder traffic counts for site 6.

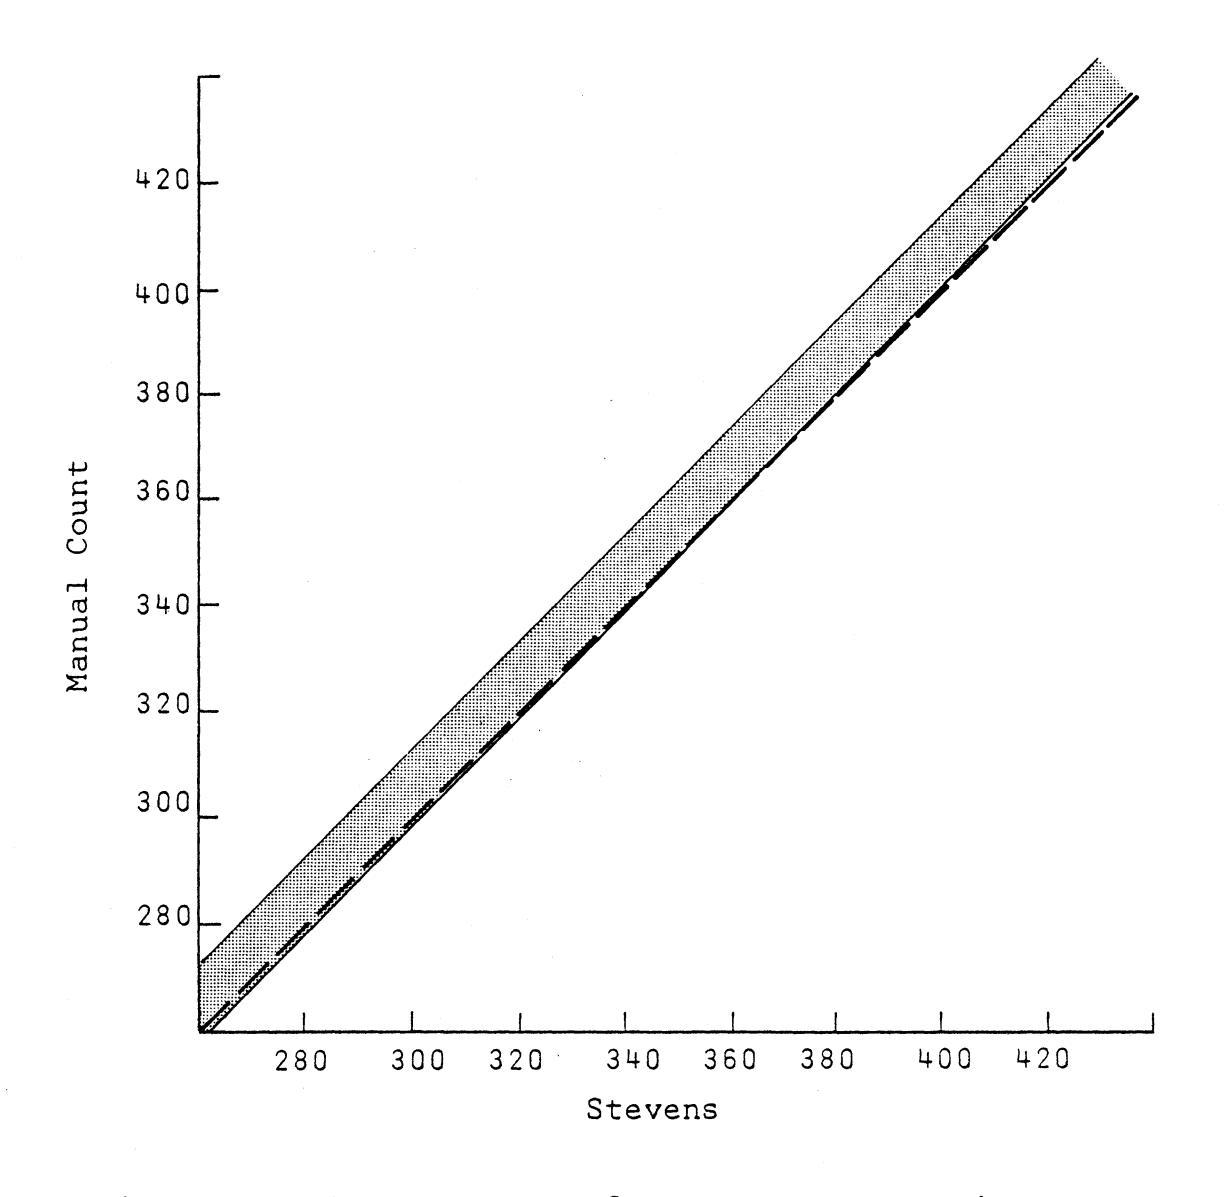
Regression equations, correlation coefficients and the standard errors of the estimate for the combined traffic counts are summarized in Appendix 2. Figures 10 and 11 are graphs of the combined counts for the Stevens and SA-MR 101-A recorders. The figures demonstrate that the recorders are capable of meeting high standards of accuracy because the regression lines are close to the 450 match lines between recorder and manual counts, and the 95% confidence bands are relatively narrow. Generally, the recorder counts were slightly lower than the manual counts, a finding thought to be attributable mostly to vehicles passing simultaneously and the closely spaced axles on tractor trailers, which comprised 1% of the passing traffic. Therefore, it would be possible to improve the accuracy by using correction factors to raise the counts by the recorders, The tendency for the Stevens and SA-MR 101-A recorders to undercount axle pairs by about 2% and 3%, respectively, should be accounted for whenever Department personnel need to calculate mathematical factors for converting axle pair counts into vehicle counts and, subsequently, into annual average daily traffic values.

Figure 10. Manual versus Stevens model traffic counts (pairs of axles) - sites 4, 5, and 6.

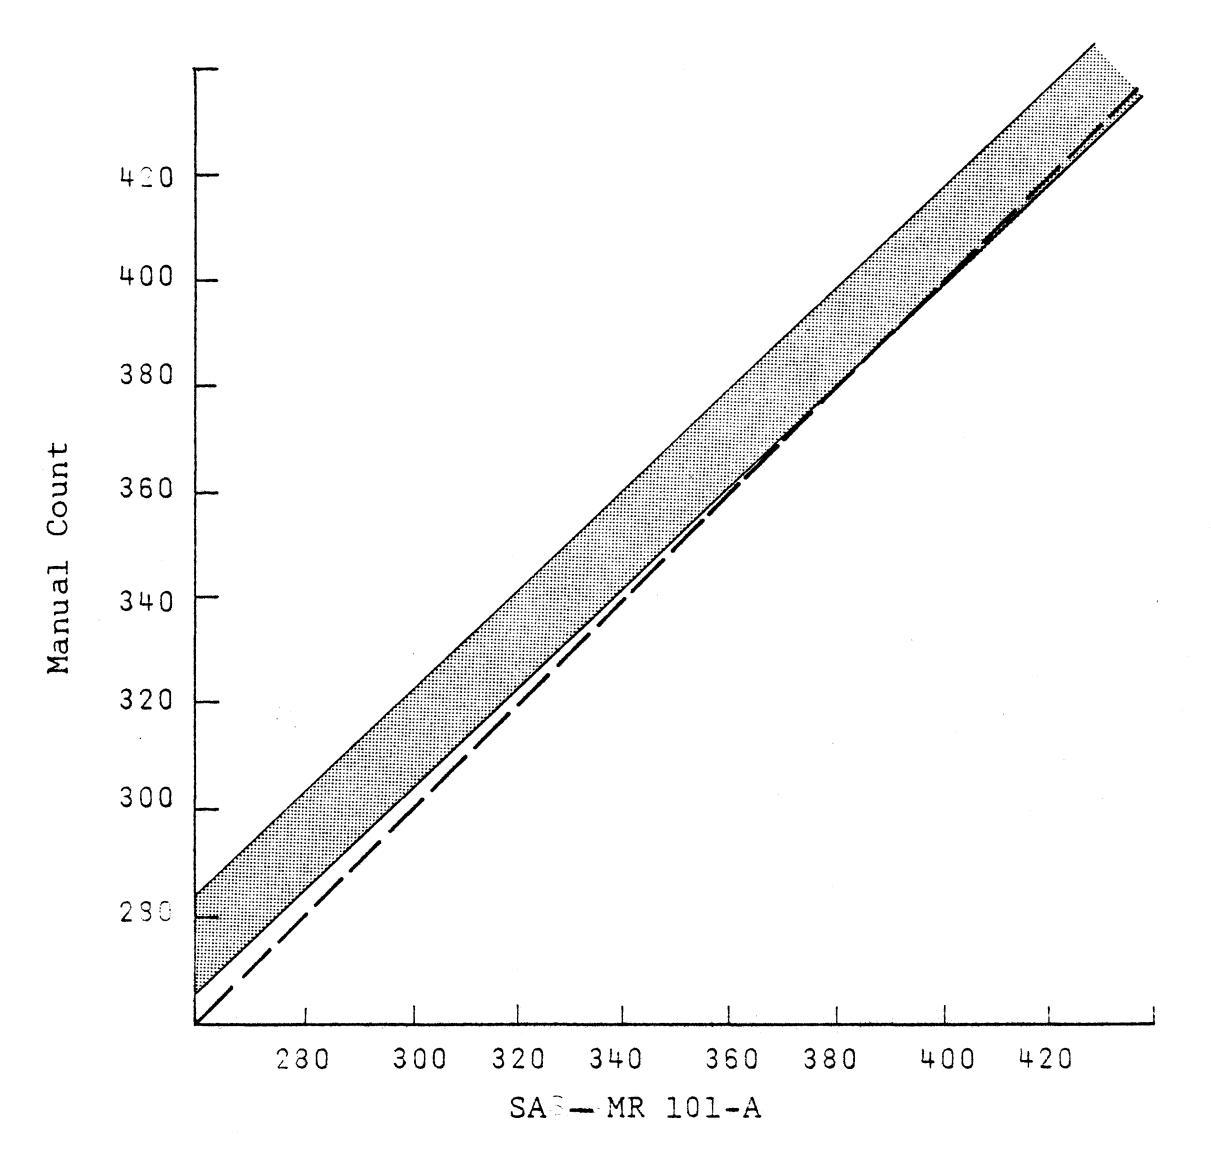
Figure 11. Manual versus SA-MR 101-A traffic count (pairs of axles) — sites 4, 5, and 6.
