## **Research Notes**

## **RSN 09-02**

## **Capacity of Aging Bent Caps**

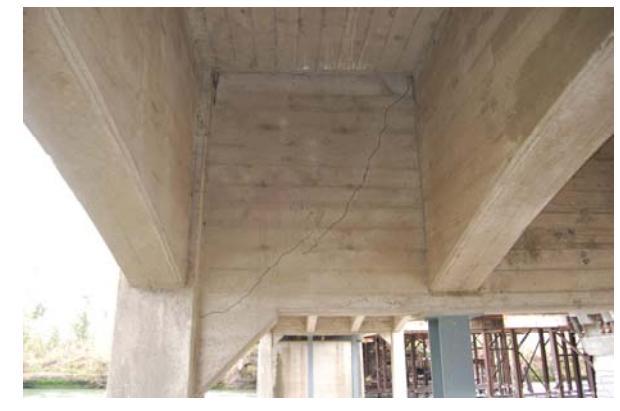
Bent cap with highlighted crack

To investigate bent caps as a system, six full-size bent caps were fabricated with integral column sections and protruding stubs at the interior girder positions. Vintage details from the 1950s were replicated as much as possible including the overall geometry, reinforcement configuration, and material

properties. Load was applied to the girder stubs incrementally up to failure while internal and external strains were measured and crack progression documented. To simulate the effect of 50 years of ambient traffic loading, 1,000,000 cycles of repetitive loading based on in-situ measured stress ranges from three in-service bridges was applied to one of the specimens prior to failure testing.
