JOINT TRANSPORTATION RESEARCH PROGRAM

SPR-3474

Evaluation of Effects of Fire on the I-465 Mainline Bridges—Volume II

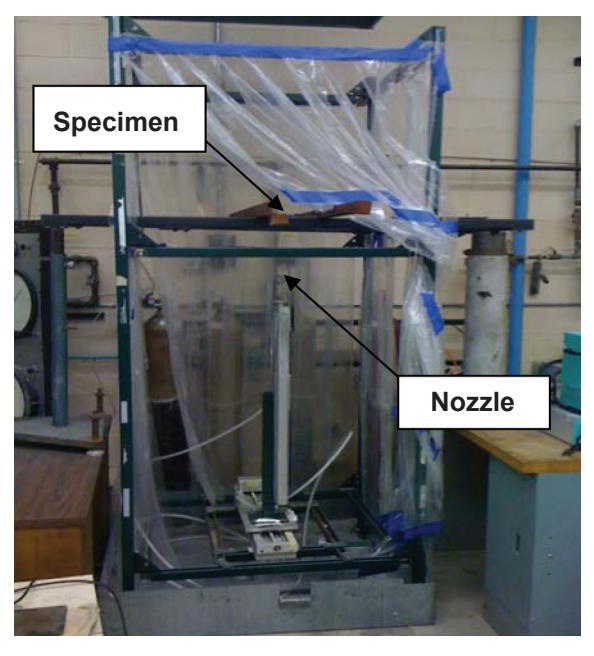
Jet flame test setup.

Testing allowed researchers to examine the differences in outcomes due to a variety of paint coatings on the steel, thickness of steel, temperature and duration of fire exposure. Each specific test is photographed at certain stages that would be seen in the field after a bridge is involved in a fire. These photographs can then be compared to actual bridge damage and a method of repair, if required, can be decided.
