**Mississippi Department of Transportation**

# A Synthesis Study of Noncontact Nondestructive Evaluation of Top-down Cracking in Asphalt Pavements

# FINAL REPORT UM-CAIT/2013-01

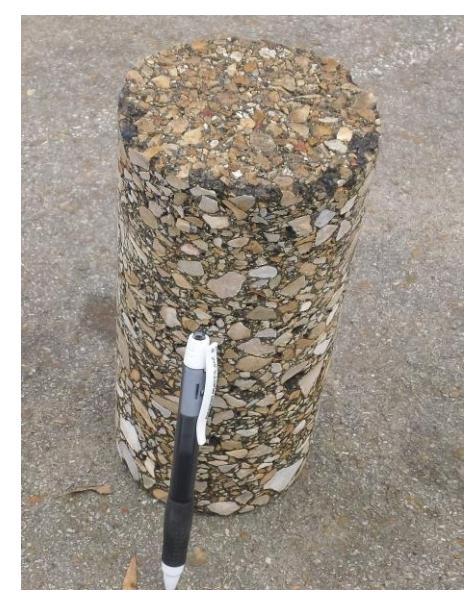
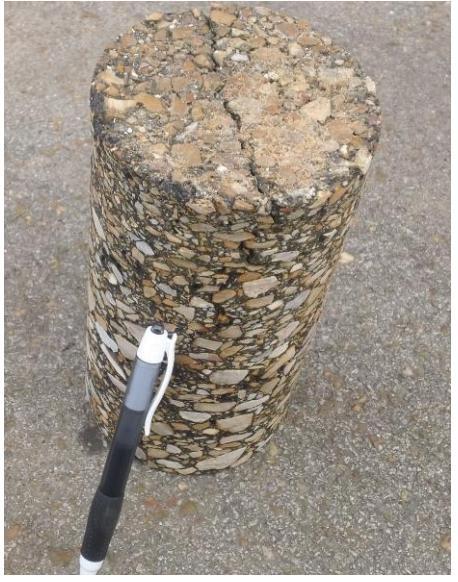
Uncracked core from asphalt pavement

Top-down cracked core from the same asphalt pavement

# Figure 1. Evidence of top-down cracking in a core extracted from an asphalt highway pavement

Top-down cracking (TDC), generally observed in the wheel path of thick asphalt highway pavements, has been identified as an important surface pavement distress in many studies over the last decade. It starts from the surface and propagates downward, which is different from the well-known fatigue related bottom-up cracking. Figure 1 shows TDC to partial depth through a core. This core was extracted on SR 25 asphalt pavement in Leake County, a state highway in Mississippi [1].

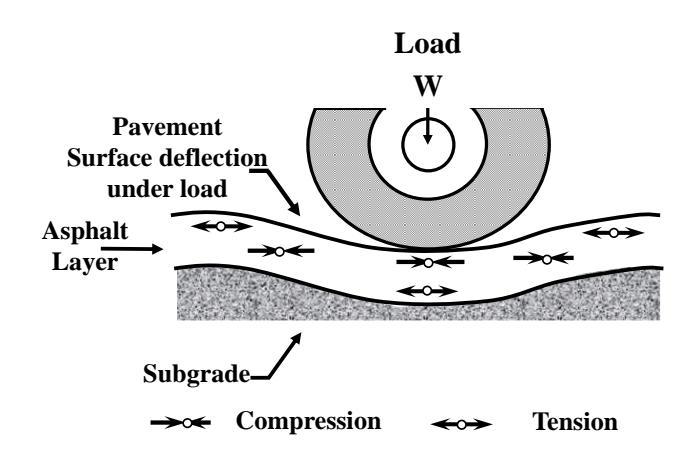
# Figure 2. Stress and strains developed through the asphalt pavement layer subjected to heavy load on the surface of an asphalt highway pavement

Tensile strains and stresses induced by heavy truck traffic loads are the primary mechanisms for both types of cracking, as shown in Figure 2 [2]. A layered elastic analysis shows tensile strains develop at the outer edge of contact loading area, which may initiate TDC at the surface. Surface asphalt resistance to tensile strains and stresses is degraded due to added interaction of traffic loads with binder aging, temperature gradient, and segregation in the top part of the surface asphalt layer [3, 4, 5, 6].

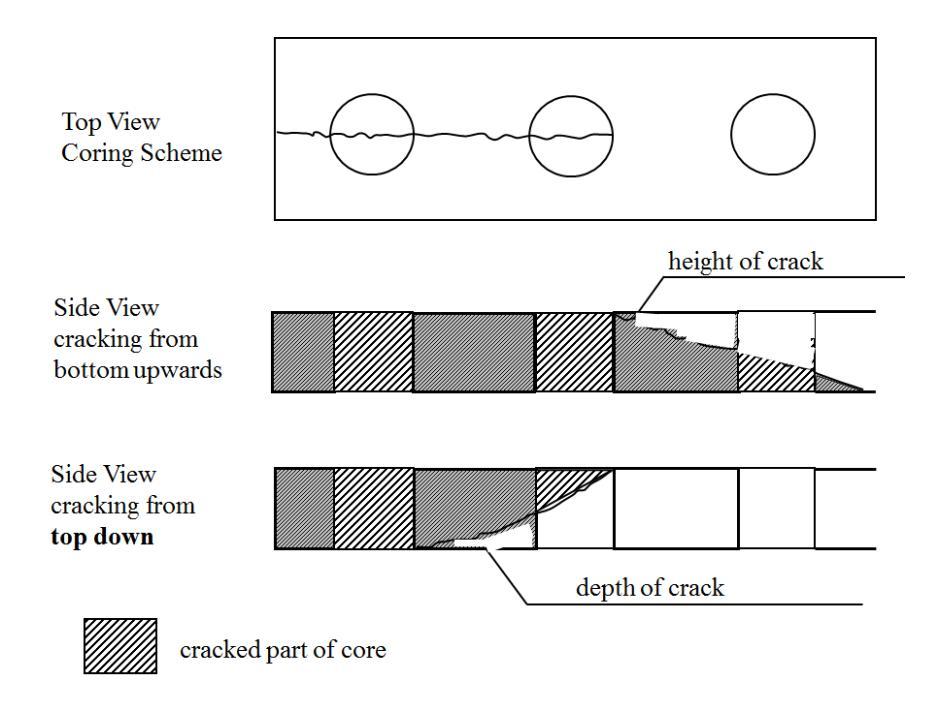
Figure 3. Crack detection using cores (after [7])

Figure 3, taken from the COST 336 Report, illustrates that by analyzing a line of cores extracted close together, attempts can be made to identify whether the cracks originated at the bottom or at the top of the asphalt layer.

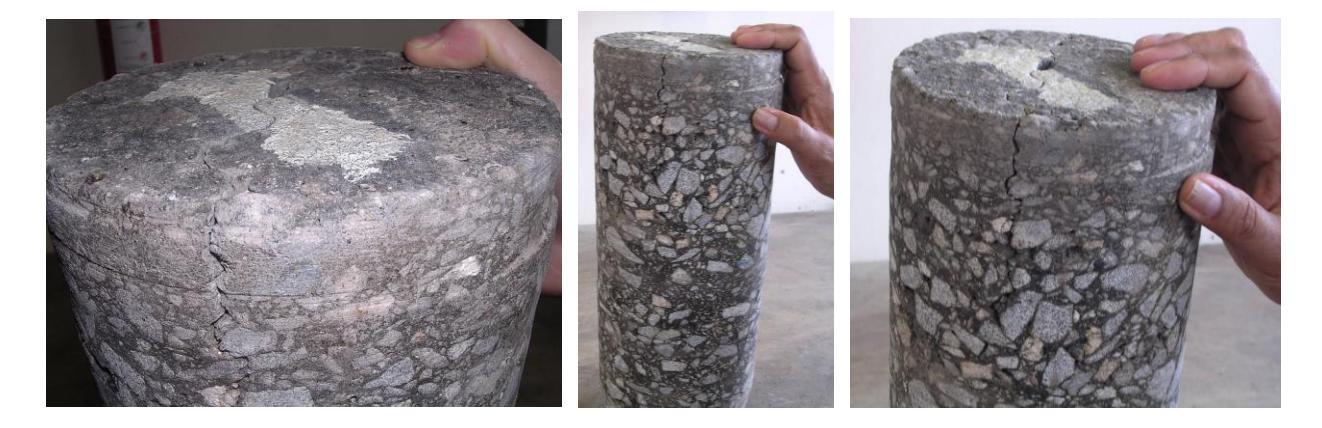
# Figure 5. Cores exhibiting TDC, extracted from thick asphalt highway pavements in Portugal, summer 2003 (Photos by Uddin at the University of Minho's asphalt laboratory, courtesy of E. Freitas)

In most pavement studies, top-down cracking was first identified through visual distress surveys and visual observation of cores. Such was the case in the 2003 highway pavement research study in Portugal by University of Minho researchers [19], who cored through cracks and discovered top-down cracks that had propagated downward partially into the asphalt layer. The author observed this phenomenon for the first time at a tour of Minho's asphalt pavement research facility (Figure 5) during the 2003 MAIREPAV3 international pavement conference [19].

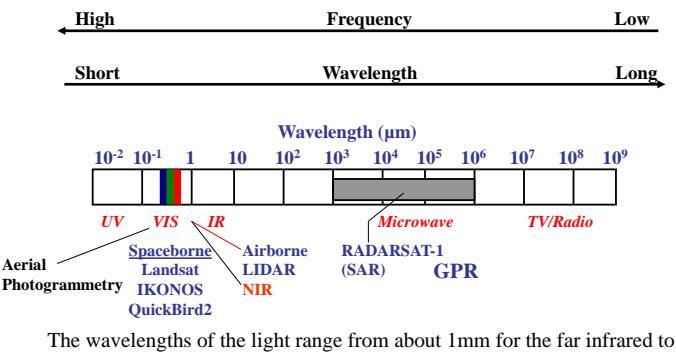
Figure 6. Electromagnetic spectrum (after [38])

Figure 6 shows the electromagnetic spectrum [38]. The shorter wavelength on the left of UV band includes X-ray that has been used in pavement core investigations. The author has seen a recent medical use of UV sensors for highlighting veins in a patient's arm. Both UV and X-ray are active sensors because these EM waves are generated and the response from the test medium is measured and interpreted. Photos and imagery are passive sensors which measure reflections in the visible band.
