Federal Railroad Administration

RR 15-10 | May 2015

# INVESTIGATION OF RAILROAD BRIDGE APPROACH PROBLEMS ALONG HEAVY HAUL FREIGHT LINES

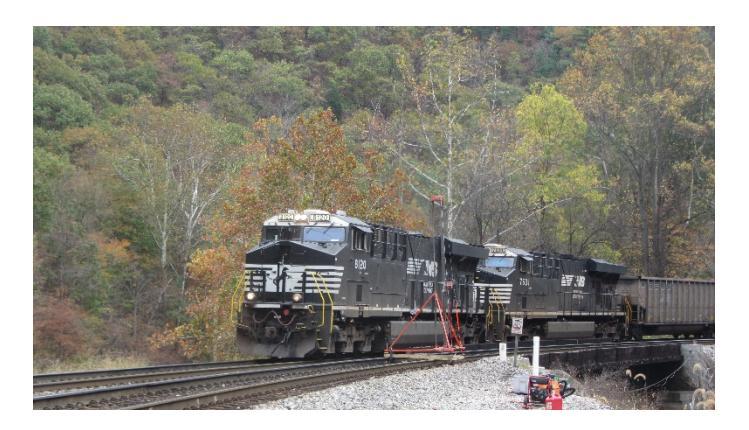
### Figure 1. Instrumentation Drill Rig Setup on Track at the West end of Bridge MP 352.2 on NS N-line

The two undergrade bridge approaches instrumented during this effort are located at mileposts (MP) 352.2 and 352.8 on the NS N-line mainline between Roanoke, VA, and Bluefield, WV. The bridge at MP 352.2 is located on a 10-degree curve and on a 1.1 percent grade, whereas the bridge at MP 352.8 is located on a 9.7-degree compound curve on a 0.9 percent grade. Since loaded trains move downhill from west to east with full dynamic brake and often with air brakes applied, the track speed in the region is 25 miles per hour. Figure 1 shows one of the bridge approaches instrumented during this effort.

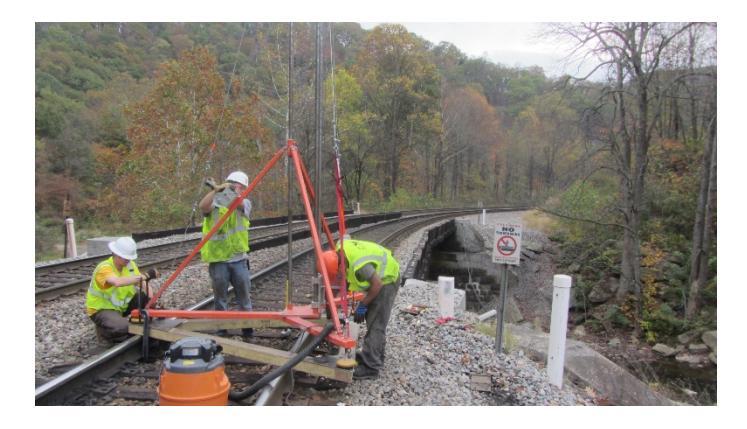
Figure 2. MDD Hole Drilled through a Wood Crosstie

The primary instruments used in this effort were Multi-Depth Deflectometers (MDDs) and strain gauges. An measures the deformation of MDD individual substructure layers with respect to a fixed anchor buried deep in the ground. The MDD consists of five to six linear variable differential transducers (LVDTs) installed vertically at preselected depths in a small-diameter hole (typically 1 ¾ inch diameter). Typically placed in 10 foot deep holes, MDDs can be used to record both permanent (plastic), as well as transient (elastic), deformations at different depths within the track substructure. For this research effort, researchers modified the MDDs to extend to 18 feet. Figure 2 shows the UIUC team drilling an MDD hole through a wood crosstie.

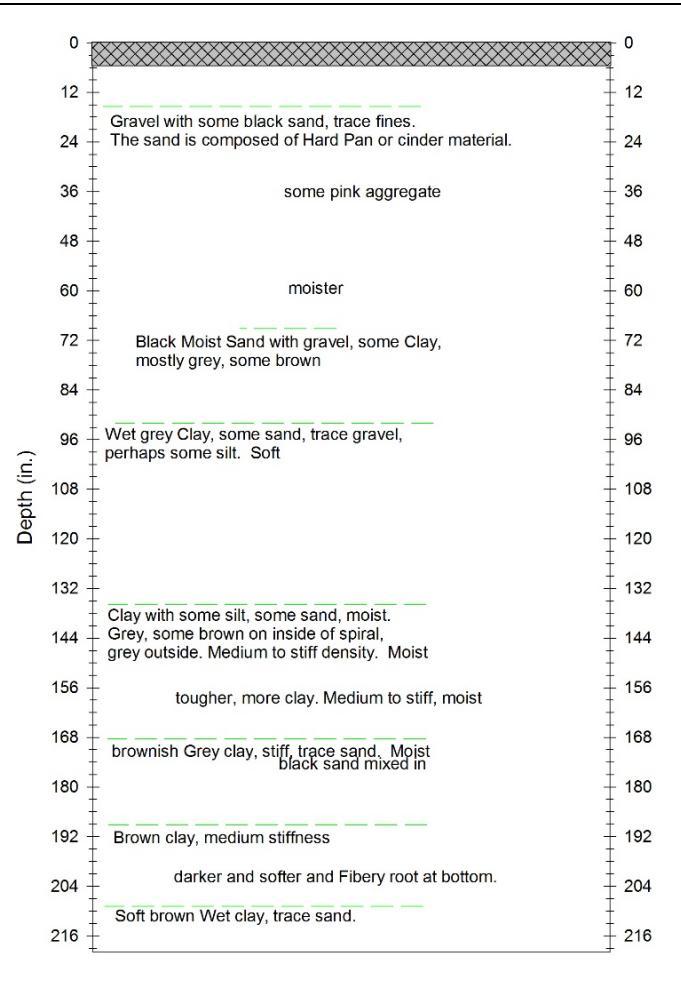
# Figure 3. Example Boring Log Developed in the Field during Drilling

The instrumentation effort took place between October 15, 2013, and November 1, 2013. Soil samples were collected from different depths during the drilling process for subsequent testing and characterization in the laboratory. Figure 3 shows a sample boring log created during the drilling process, along with the soil types encountered at different depths.

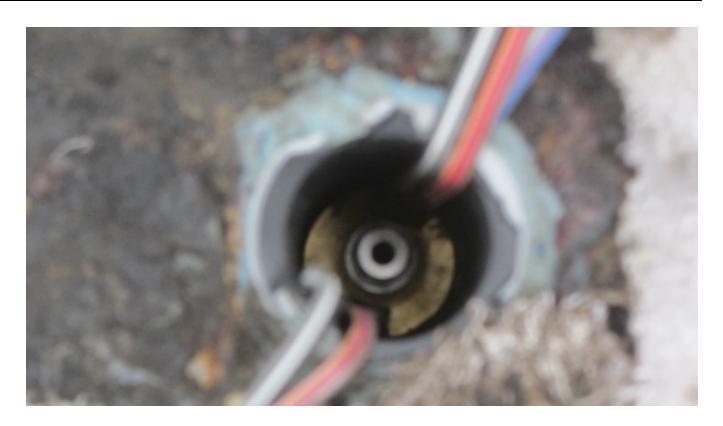
Figure 4. MDD Module Installed within a Crosstie

UIUC installed a total of four MDD "strings," two at each of the bridges (MP 352.2 and MP 352.8) using a customdesigned tool to allow individual monitoring of each LVDT throughout the installation process. Each MDD "string" comprised five to six LVDTs, depending on the depth of the hole. Figure 4 shows a photograph of a top MDD module installed within the crosstie to measure deflections within the ballast layer. The researchers also installed strain gauges on the rails to measure the vertical wheel loads and tie reactions. Wheel loads and tie support conditions recorded by the strain gauges are used to analyze the collected data and numerically model the track dynamic loading behavior of the instrumented bridge approaches.

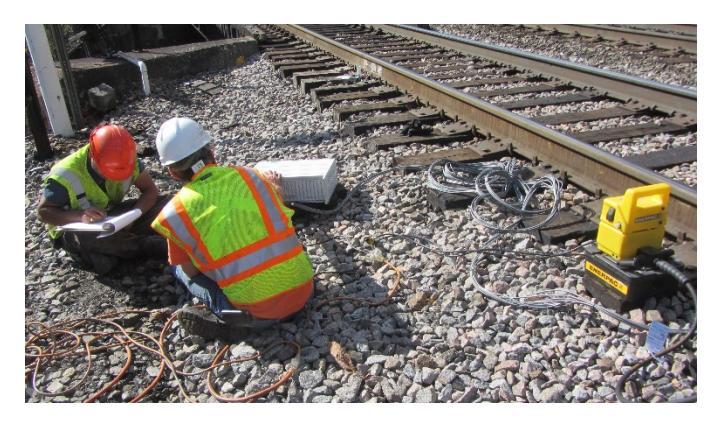
Figure 5. Data Acquisition at Instrumented Crosstie

UIUC will collect data periodically throughout 2014 and monitor the permanent (plastic) as well as transient (elastic) deformations of individual substructure layers, along with time history. The data is being collected with a wayside data acquisition system (see Figure 5). Figure 6 shows a typical vertical wheel load time history recorded by the strain gauges under the passage of a freight train. The differences in weight between loaded and empty cars for the freight train were clearly registered by the strain gauge circuit. Figure 7 shows the corresponding transient responses of the MDD LVDTs under the passage of the same freight train. As shown in the picture, the top LVDT mounted beneath the tie recorded the maximum transient deformations under loading within the ballast layer; these findings were in agreement with previous observations.

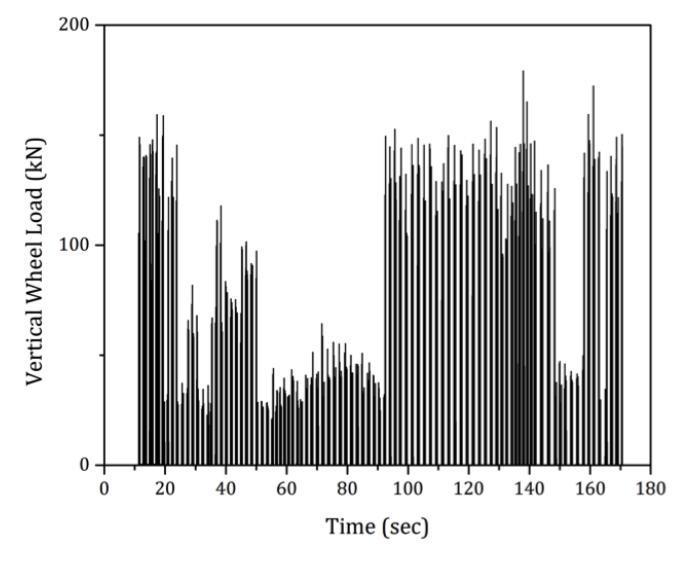
### Figure 6. Vertical Wheel Load Time History under Typical Freight Train Loading

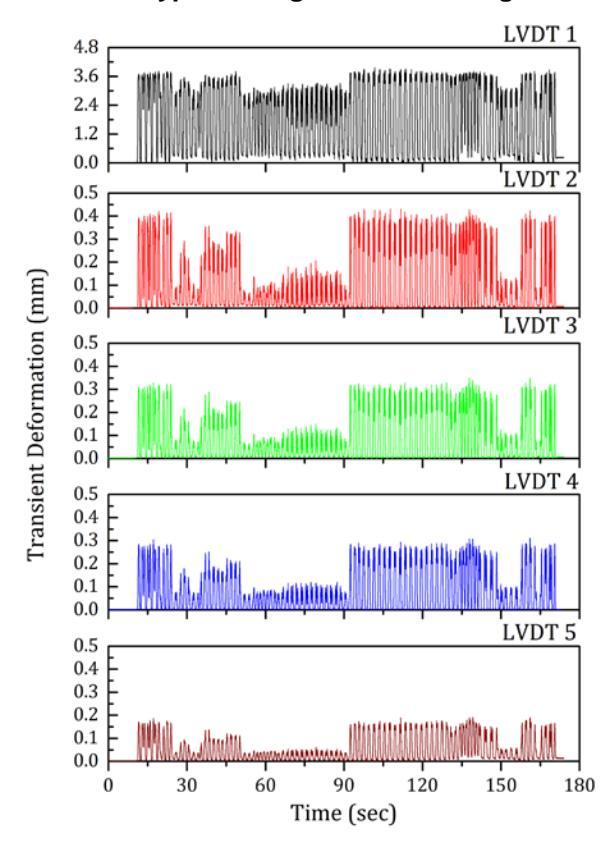
# Figure 7. Typical Transient Response of LVDTs under Freight Train Loading
