Seven Year Performance of City of Shoreview's Pervious Concrete Project

Bernard Igbafen Izevbekhai, Principal Investigator

Office of Materials and Road Research Minnesota Department of Transportation

Research Project Final Report 2017-47

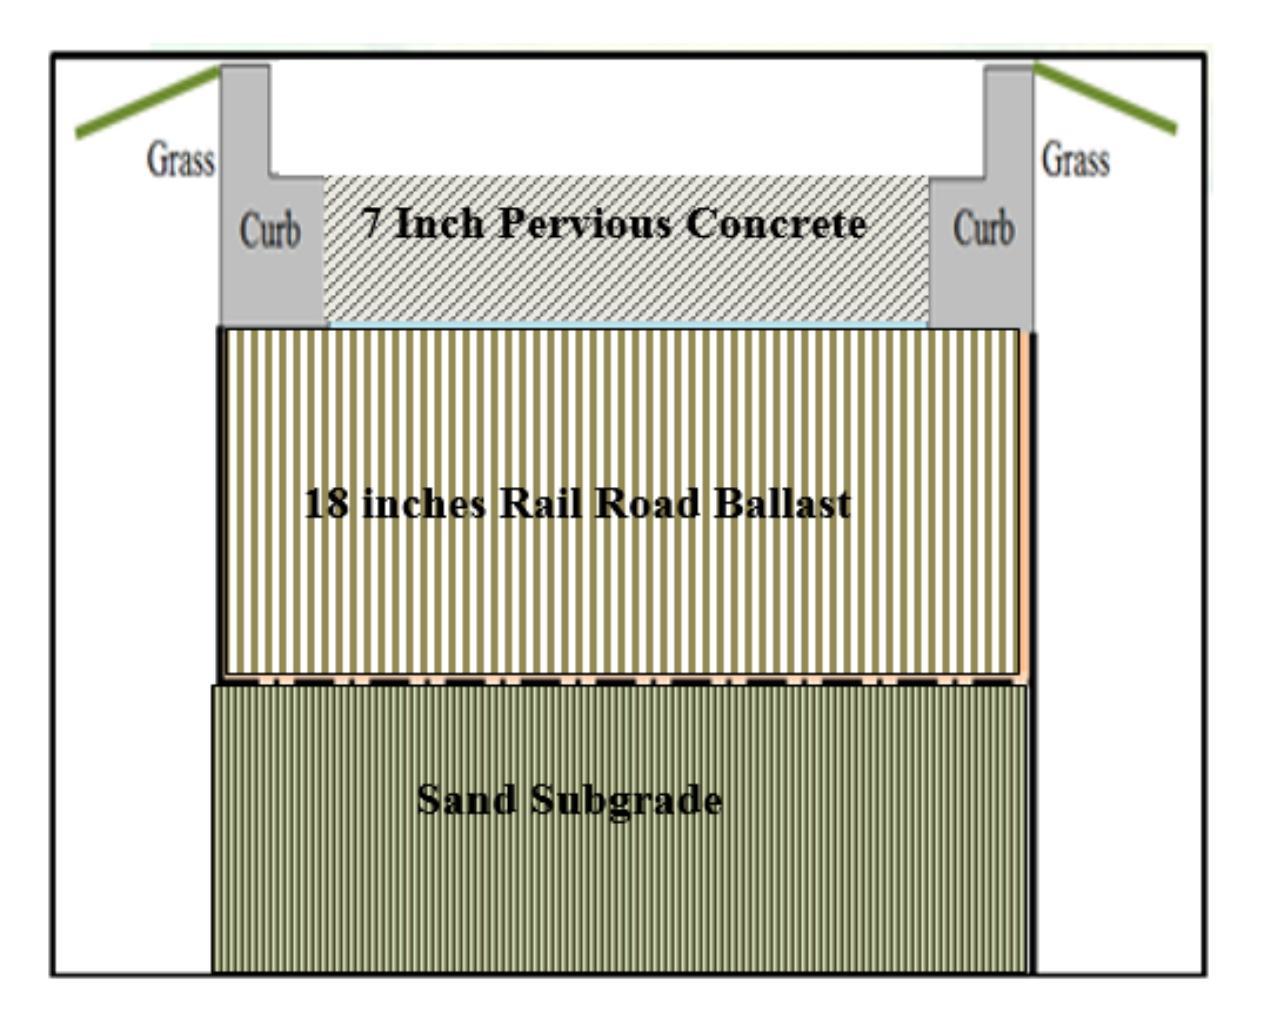
Figure 1 Pervious Concrete Structure

The Woodbridge Neighborhood's pervious concrete system consists of a 7-inch concrete pavement and 18 to 24 inches of railroad ballast as base-course as shown in schematic figure 1. Cemstone Products Company designed and supplied the ready mix concrete for the pavements. The City used fixed form method of construction and established joints by sawing in spite of the fear that the slurry released during sawing could autogenously re-heal and clog the pervious cavities, decreasing hydraulic conductivity of the pavement and compromising its communicating void. After construction MnDOT provided research monitoring.

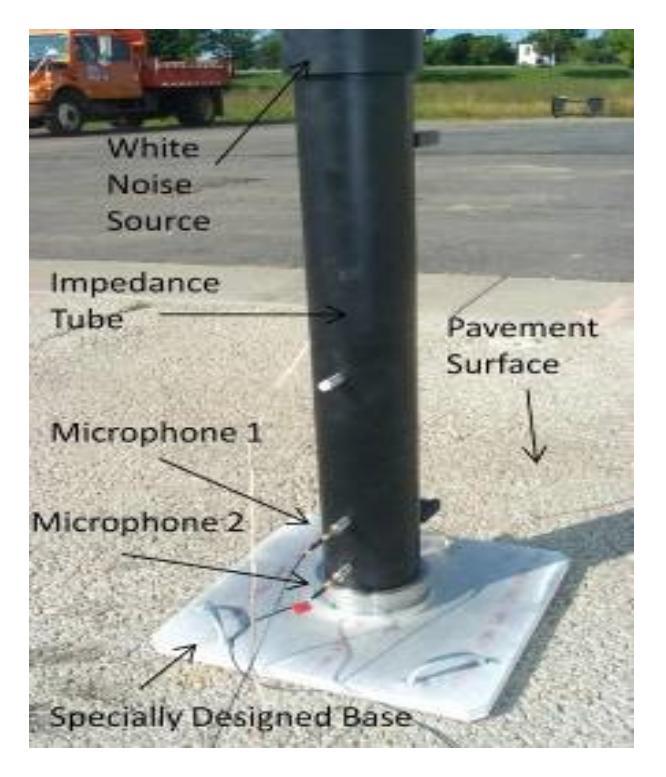
Figure 4 Sound Absorption Measurement with Impedance Tube.

MnDOT did an annual routine measurement of sound absorption on the Shoreview pervious concrete pavements. Data was collected on September 2009, September 2010, May 2011 and August 2015. Generally pervious concrete pavements have better sound absorption capability than ordinary pavements due to the presence of interconnected voids within them. This is a by-product of the pervious void system. Sound absorption capacity of a pavement is described as sound absorption coefficient (\propto) which is the ratio of the absorbed sound energy to the transmitted sound energy when a white noise (315Hz to 1800Hz) is generated and sent into the pavement within an impedance tube placed on the surface of the pavement. Figure 4 shows the in-situ sound absorption measurement system. The test procedure followed a modified version of ASTM E-1050 method which is called standard test method for impedance and absorption of acoustical materials using a tube, two microphones and a digital frequency analysis system. ([2] [3]

During the sound absorption, test, the sound analyzed is not generated by the interaction of the rolling tire with pavement surface but by noise source above the impedance tube. On the BSWA 425 device, a white noise source is used. White noise is a random audio signal with a flat power spectral density that contains noise at the same power at all frequencies. During the test, the impedance tube is placed on the pavement surface and a set of sensitive microphones are attached to the pre-installed housing at the lower end of the tube. These microphones are also connected to an analyzer. The noise source sends the incident sound energy (white noise) to the surface and the incident and reflected waves are captured by the two microphones. Software windows the reflected waves and converts the data to the 3rd octave sound absorption coefficient at 315, 400, 500, 750, 1000, 1250 and 1650 Hertz. Thus, the coefficients need to between one and zero where a value of one would mean that all of the sound is being absorbed.

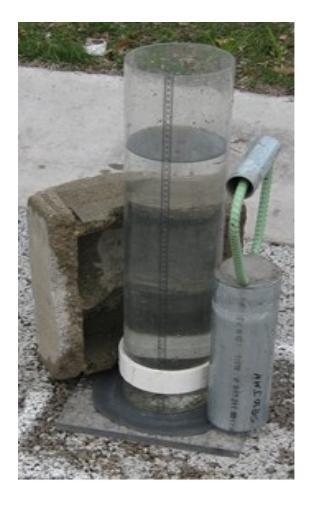
Figure 5 Original Falling Head Tube.

The data collection frequency for this test was the same (three times per year) as the sound absorption test data collection period. The ability of pervious concrete pavements to infiltrate runoff water from rain and snow melt is measured by a hydraulic conductivity. Hydraulic conductivity results could trigger maintenance activities beyond the scheduled rate. It is obvious that the hydraulic conductivity of pervious pavements decrease through time due to clogging of the pores of the pavements. Sediments, falling leaves, and small plastics transported in the draining water tend to clog the voids of the pavements and hence decrease the volumetric dissipation rate of the pervious pavement. The falling head hydraulic conductivity test tube was utilized in two different ways. The original equipment consists of an approximately 70 centimeter long, 6 inch diameter clear tube contented to a water source tank with a hose (Figure 5).

The tube is placed vertically on the pavement surface and sealed using a duct seal compound. The tube is completely filled with the connected hose from the water tank. Before testing begins, the water is allowed to drain into the pavement until a smooth, steady flow is developed. Once it reaches a constant flow, the time it takes for the water to drain from the stabilized upper mark to the 10 cm mark is recorded. This recording was then used in the following equation to calculate the dissipated volumetric rate.

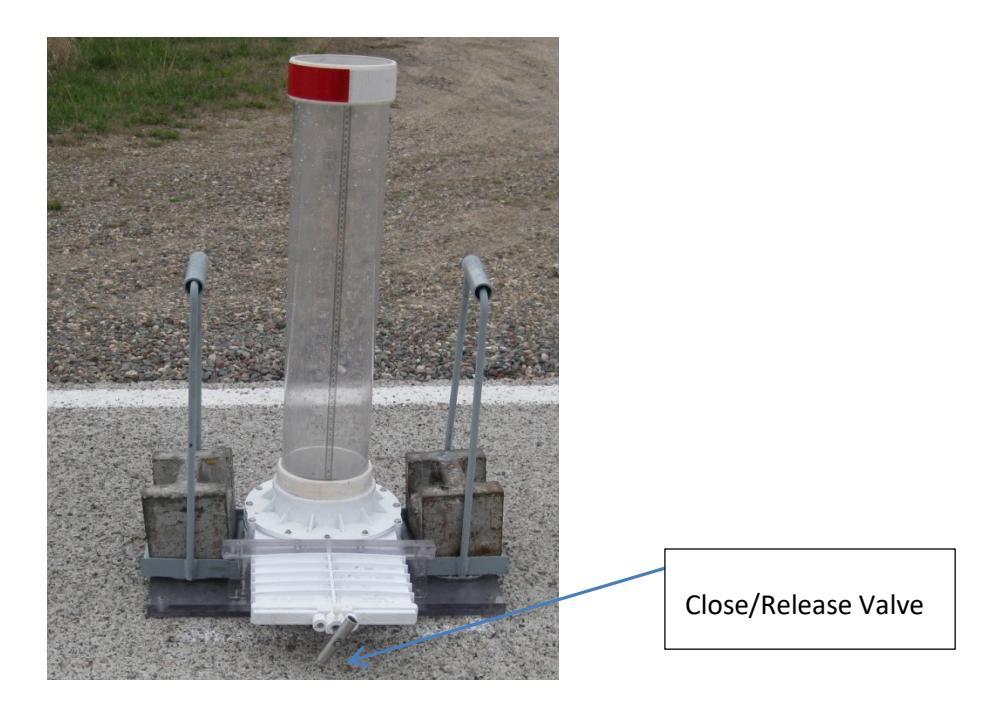
Figure 6 Modified Falling Head Tube with Valve.

Sustaining the original water level in the falling head tube proved to be a challenge due to the rapid flow of water via the open bottom of the tube into the pavement. The original falling head tube was modified to the mid-level of the tube, now with a release valve introduced to stop the flow of water before actual testing was started. The addition of the valve at the base of the testing tube increased the accuracy of the hydraulic test due to the absence of saturation of the pavement's materials before hydraulic conductivity test begins. The introduction of the release valve, which is locked when water is being poured to the desired level of the test tube also simplifies the testing procedure. During the original falling head test it was difficult to record exact field measurements (for instance it took time for water to drop from upper head to lower head) due to the higher dissipation rate of the pervious pavements. The modified falling head test tube is shown in figure 6 below.

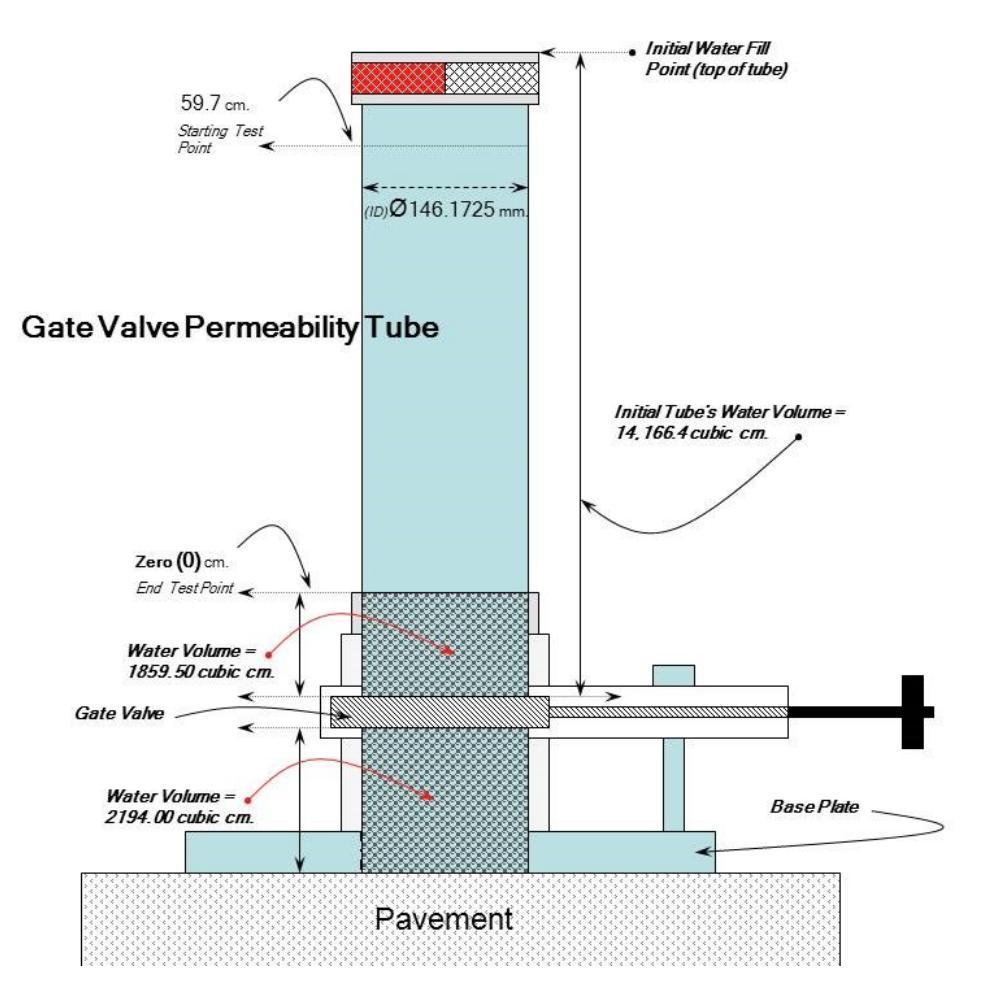
Figure 7 Modified Hydraulic Conductivity Tube Improvised with Gate valve

With the new modification to the device, a duct seal is used to seal the tube to the pavement and the gate valve is placed in the closed position. The tube is then fully filled with water. The actual starting test height is then calculated by sealing the tube to a non-porous surface, filling it to the top with the valve closed, and then releasing the valve to see where it drops to. After the tube has been filled when testing over pavement, the gate valve is released, allowing the water to drain into the pavement. The time it takes for the water to reach the zero centimeter mark for each test is then recorded (5). The detail of the modified testing tube is shown in Figure 7 below.

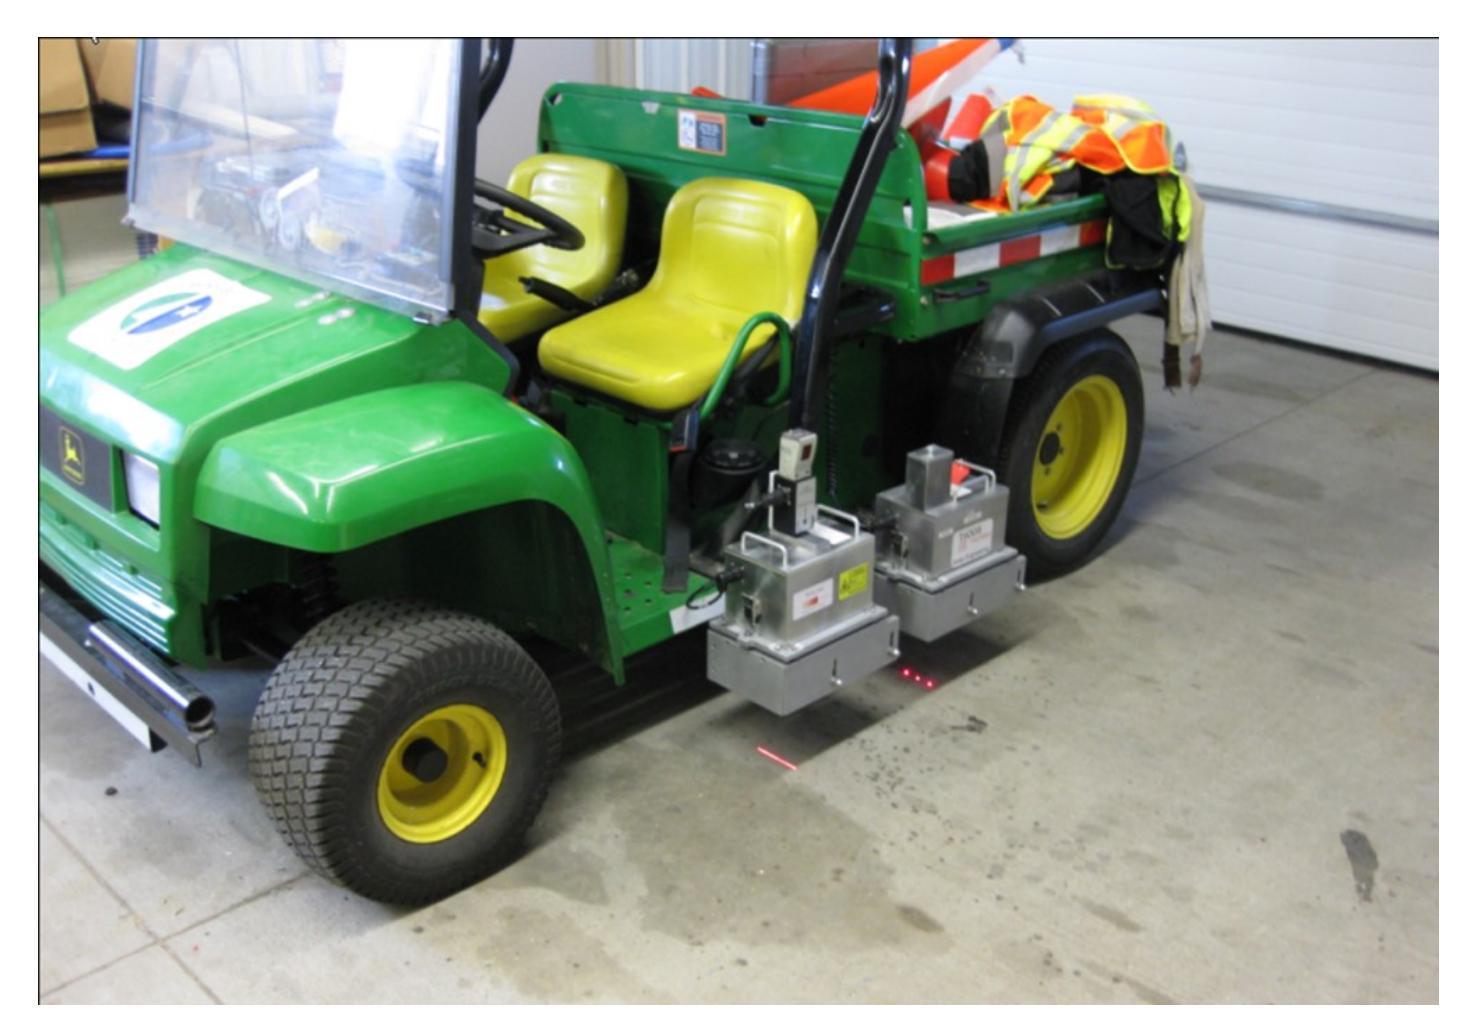
Figure 8 Lightweight Inertial Surface Analyzer

IRI can be calculated from profiles obtained with any valid measurement method, ranging from static rod and level surveying equipment to high-speed inertial profiling systems. MnDOT measures IRI with a Lightweight Inertial Surface Analyzer (LISA) shown in Figure 8. The LISA is a profile device that measures the amount of vertical rise over a horizontal distance. This is done with two separate laser sources on the side of the vehicle. One line laser, the "ROLINE", takes continuous profile measurements over a four inch path. The second laser, the "TriODS" (triple laser) measures three discrete profiles across the four inch path. The raw data from these lasers is then used to calculate the IRI, with higher IRI corresponding to rougher pavement.

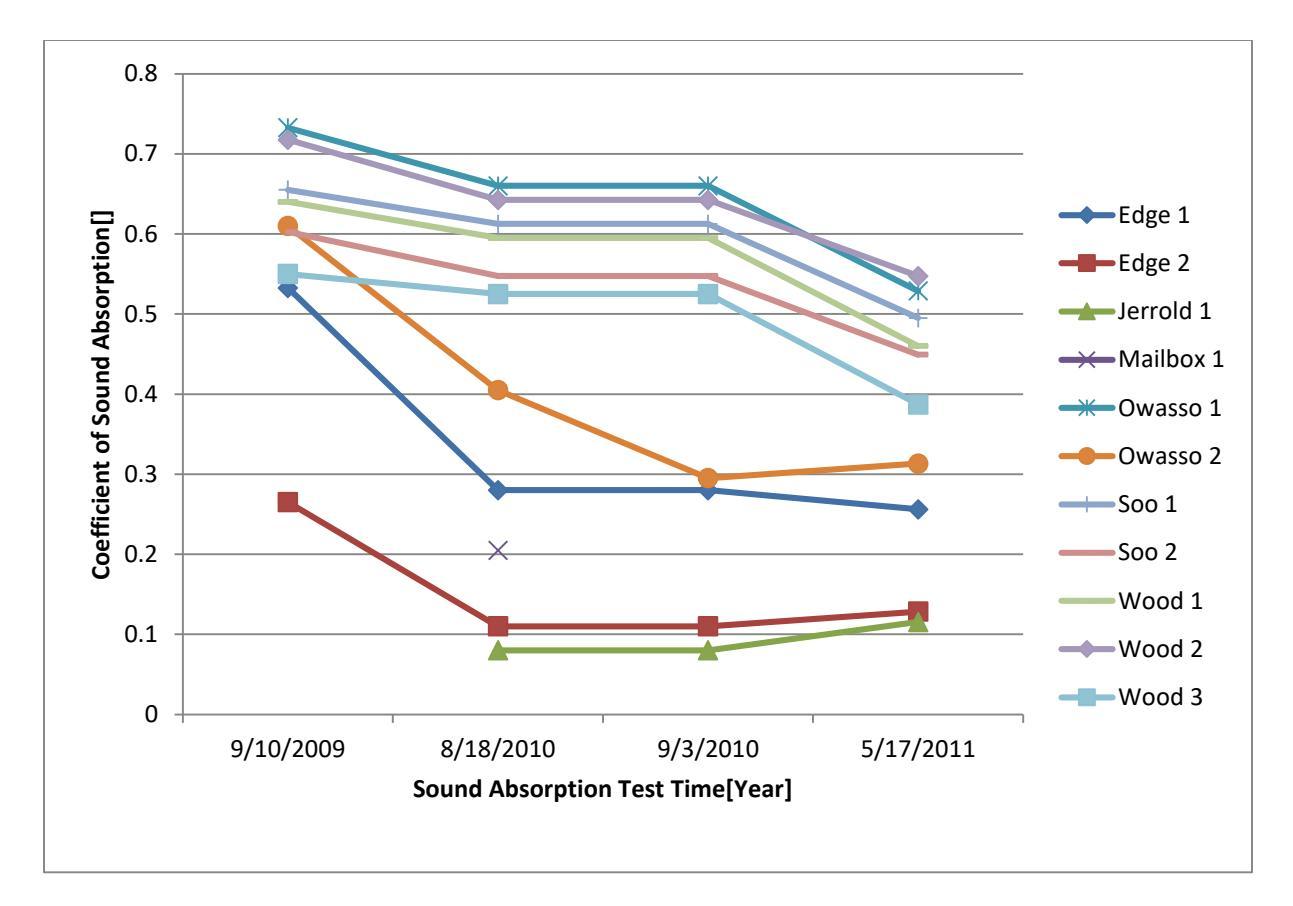
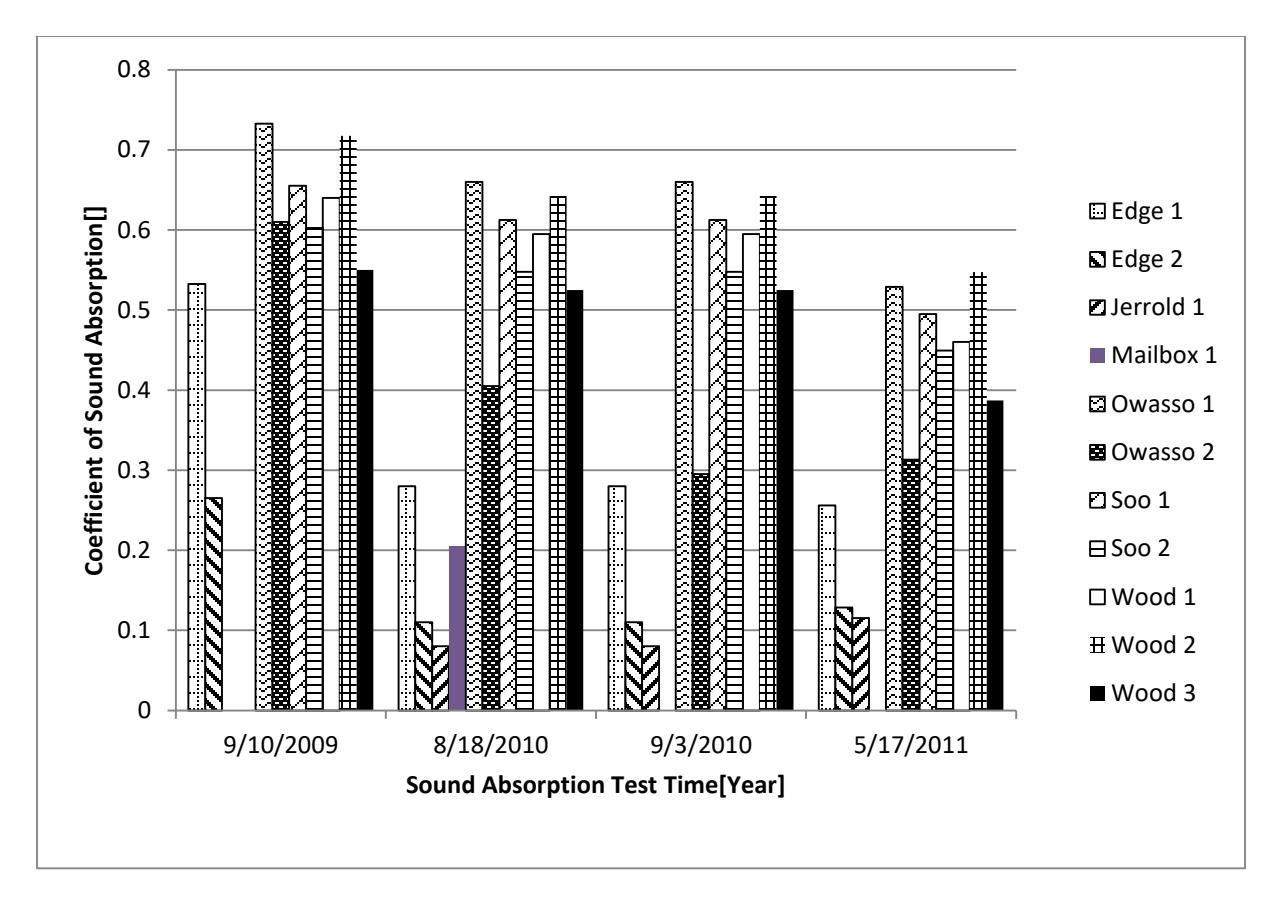
It is important to note that all tests were conducted on the right lane of the right wheel path of roadway except for Jerold Street (denoted as Jerold 1) in (Figure 9). Sound absorption coefficient decreased for most of the road sections through time on Shoreview pervious concrete pavements. The decrease in sound absorption is attributed in part to clogging of the pervious voids of the pavement materials. The clogging particles were found to be debris from the pavement itself or carried by tires of moving vehicles, fallen leaves, or similar materials. However, the coefficient of sound absorption was increased for Jerold 1 and Edge 2 from 2010 to 2011. The increase was likely due to effective cleaning and vacuuming effect. Regular maintenance (cleaning and vacuuming) is important in pervious concrete pavements to maintain communicating void structure. The test results for Jerold 1 in 2010 is from data collected at the center lane. The average coefficients of sound absorption were found to be 0.08 and 0.12, respectively for the years 2010 and 2011.

From these results, (see figure 9 and 10) it can be concluded that the impact of traffic on the outer lane right wheel path was the reason why the sound absorption value (0.08) in 2010 was still smaller than the sound absorption value (0.12) in 2011. The center lane line of Jerold Street does not encounter much traffic, therefore it absorbs the least amount of sound.

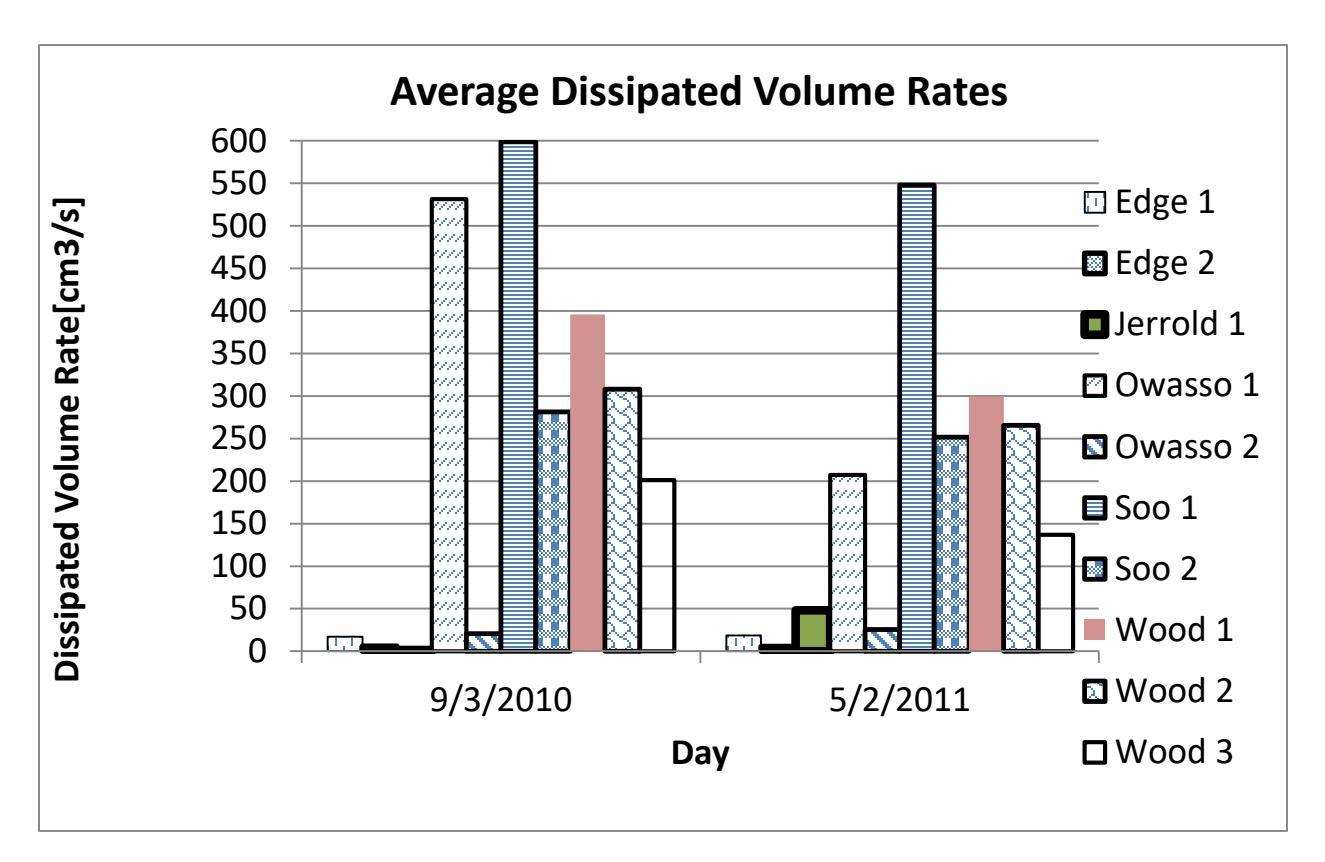
Figure 11 Average Volumetric Dissipated Rate vs Test Time

Figure 11 below illustrates the volumetric dissipation rates of the rainwater test results for the data collected in September 3, 2010 and May 2, 2011.

From Figure 11 the general time trend from 2010 to 2011 shows a decrease in dissipated volumetric rate for most of the road sections. Conversely the rates for Edge 1, Jerold 1, and Owasso 2 had increased on May 5, 2011. As discussed in the sound absorption section, the decrease in volumetric dissipation rate is due to clogging and in some instances due to the impact of traffic. There is an abrupt dissipation rate decrease in Owasso 1 and an abrupt increase in Jerold 1. The rapid decrease happened in Owasso 1 may not have an immediate explanation but the sudden increase in Jerold Street (Jerold 1) is due to the an actual difference in the spot tested. By observing figures 10, 11 and 12, both the coefficient of sound absorption and volumetric dissipation rate of pervious concrete pavements are found to be decreasing through time mainly due to clogging of the porous media of the pavement structure. Figure 11 and 12 below show the combined data results of coefficients of sound absorption and volumetric dissipation rates for 2010 and 2011.

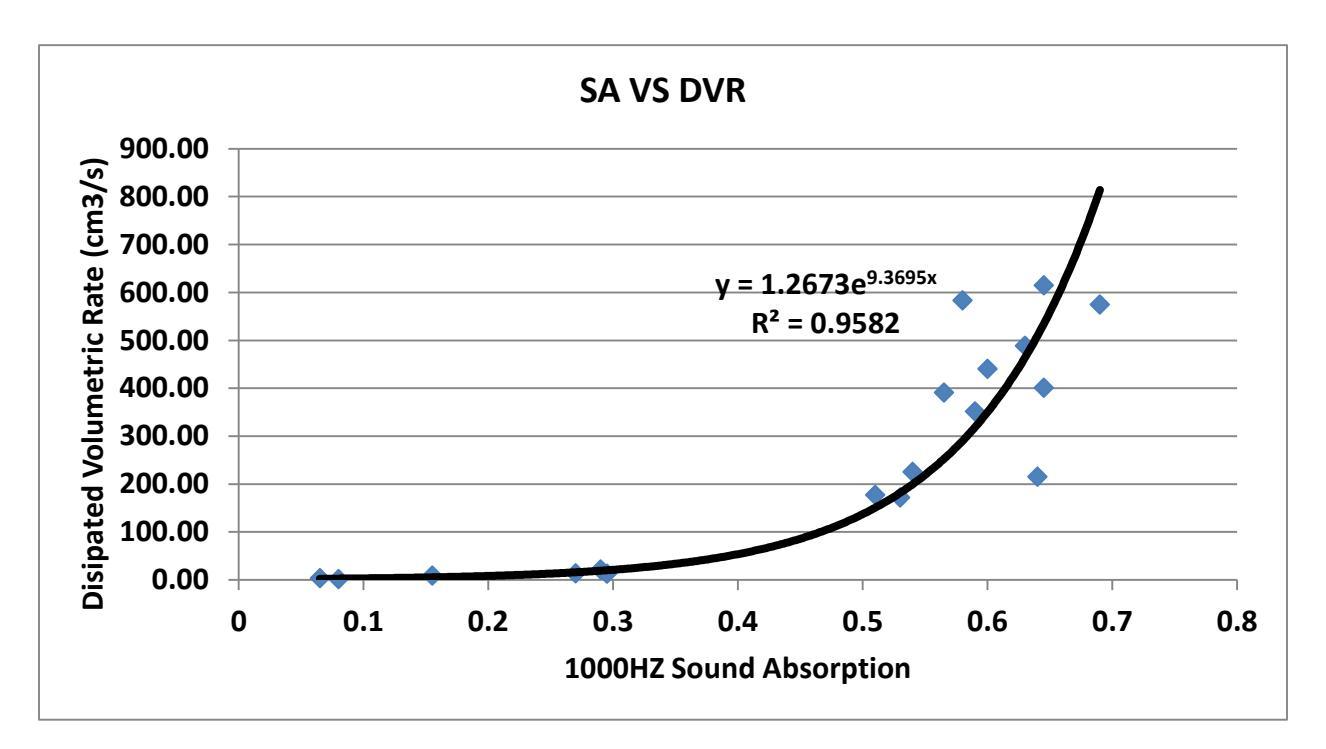
Figure 13b SA and HC Correlation

As explained earlier, figure 13b illustrates the decrease of coefficient of sound absorption and hydraulic conductivity rate over time.

A correlation between HC and SA was established as shown in Figure 13b. The SA values used here were those at 1000 Hz. The relationship is exponential meaning that at high dissipated volume rates, changes in SA are only marginal or infinitesimal.

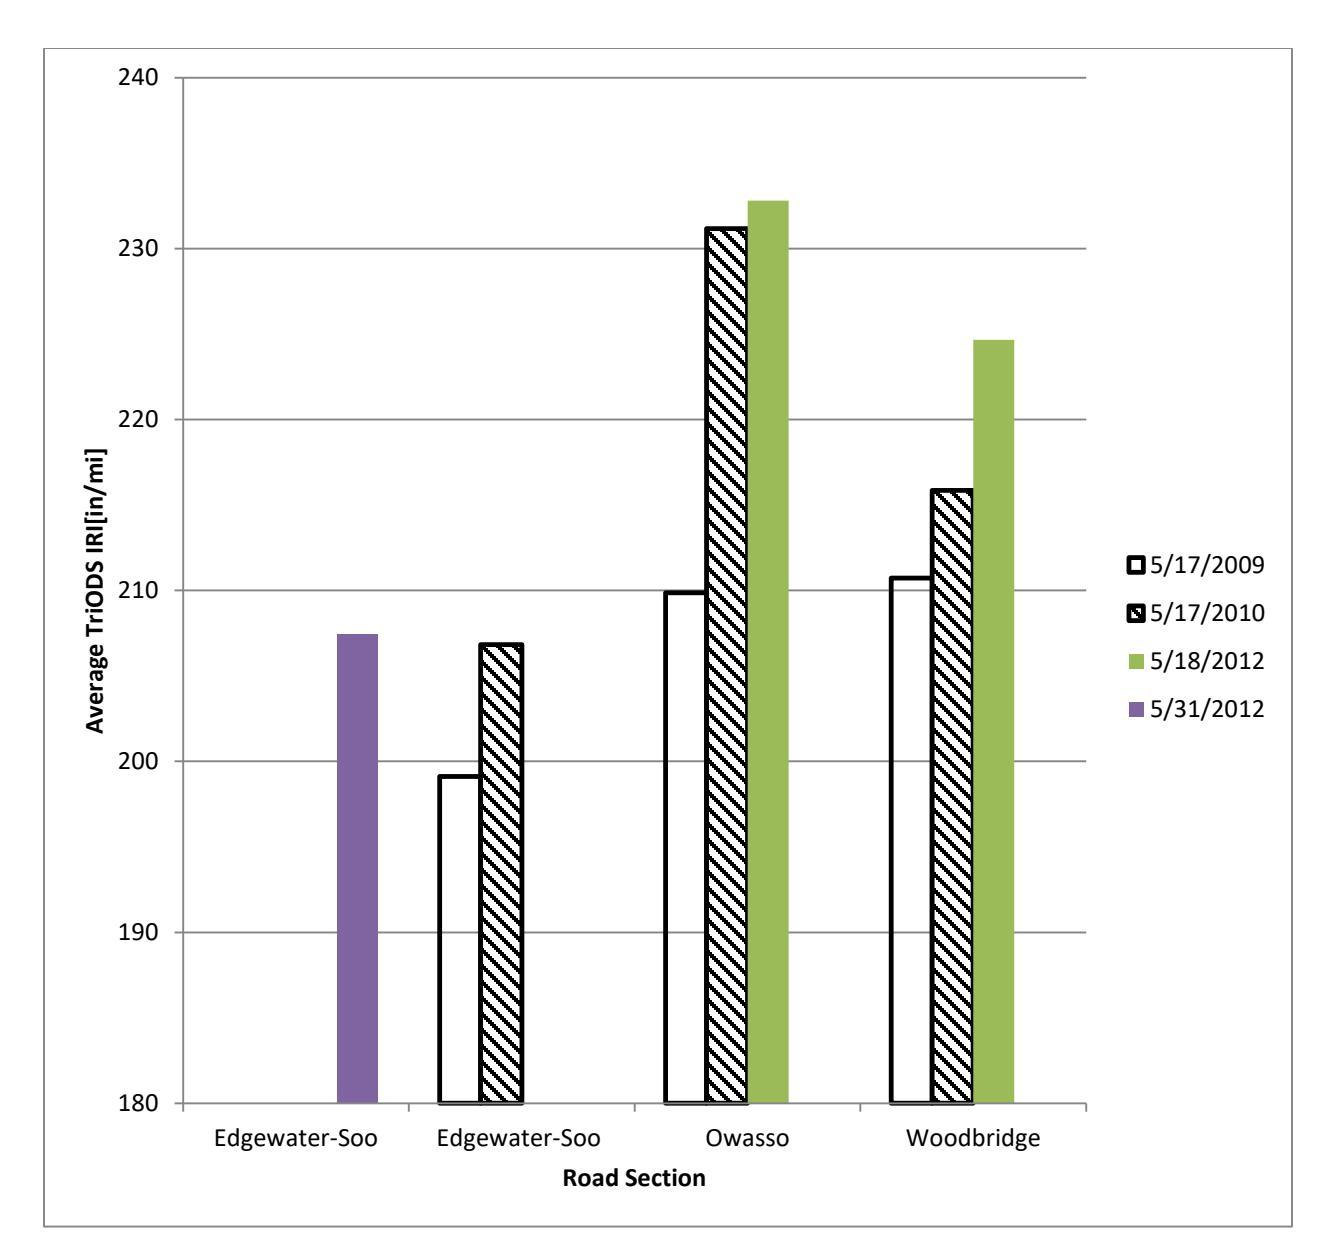
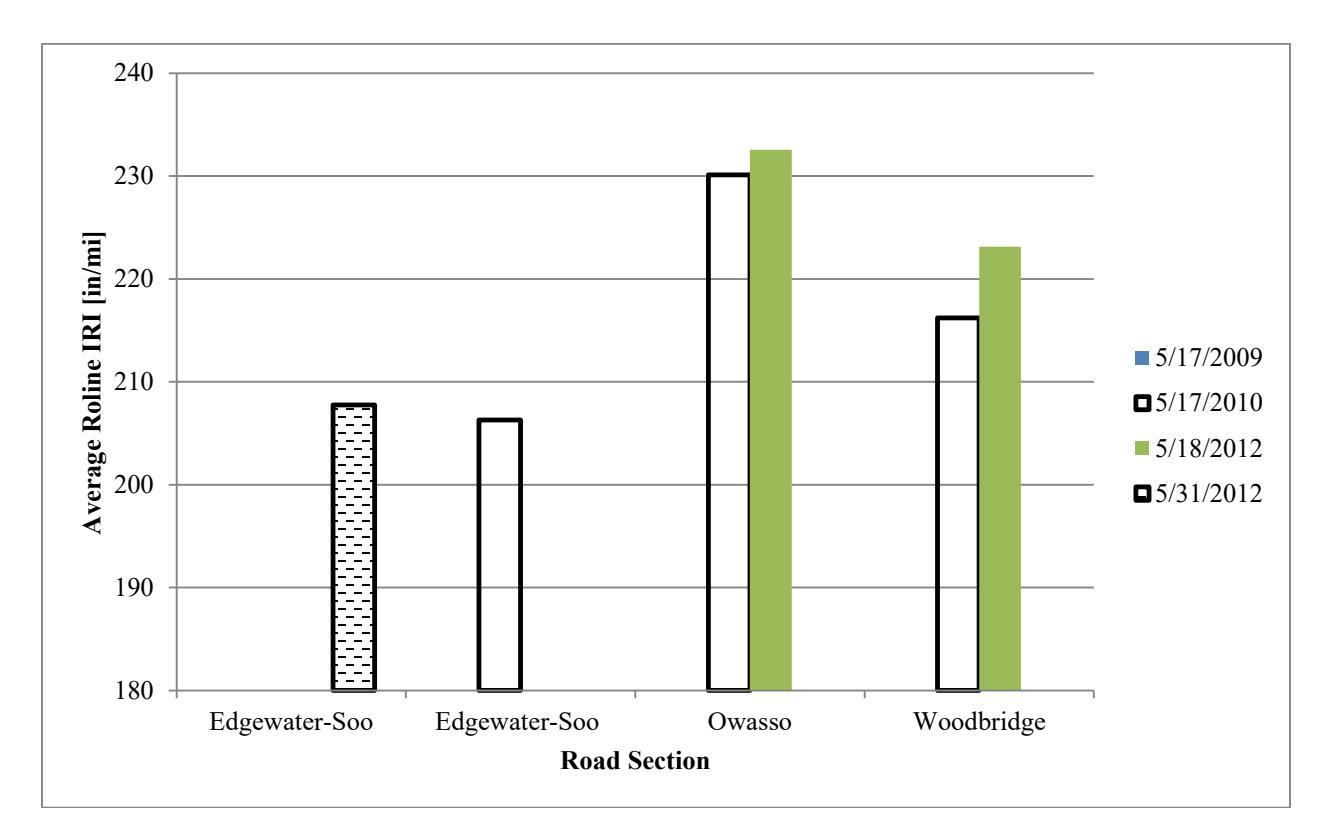
As Figures 14 and 15 above show, the IRI value increases over time. The increase in IRI, which shows a decrease in ride quality, is expected as the pavement roadway becomes deteriorated through time with a lot of dips and bumps which force the driver's vehicle to oscillate up and down (accelerate vertically) as it rides over the concrete pavement roadway. The two figures above also illustrate that there is not any substantial difference between the ROLINE and TriODs IRI values of test results. The ROLINE is a line sweeping laser and the TriODS is a Triple Point Laser. The proximity of ROLINE to TRIODS indicates that texture influences on IRI on these surfaces are minimal and inconsequential unlike certain textures that necessitate IRI correction due to texture. It exposes the fact that there is no subtle anisotropy in the pervious surface. Certain textures though isotropic, when analyzed in various orders of wavelength are found in some to be anisotropic. Such hidden features can confound predictions of pavement performance.

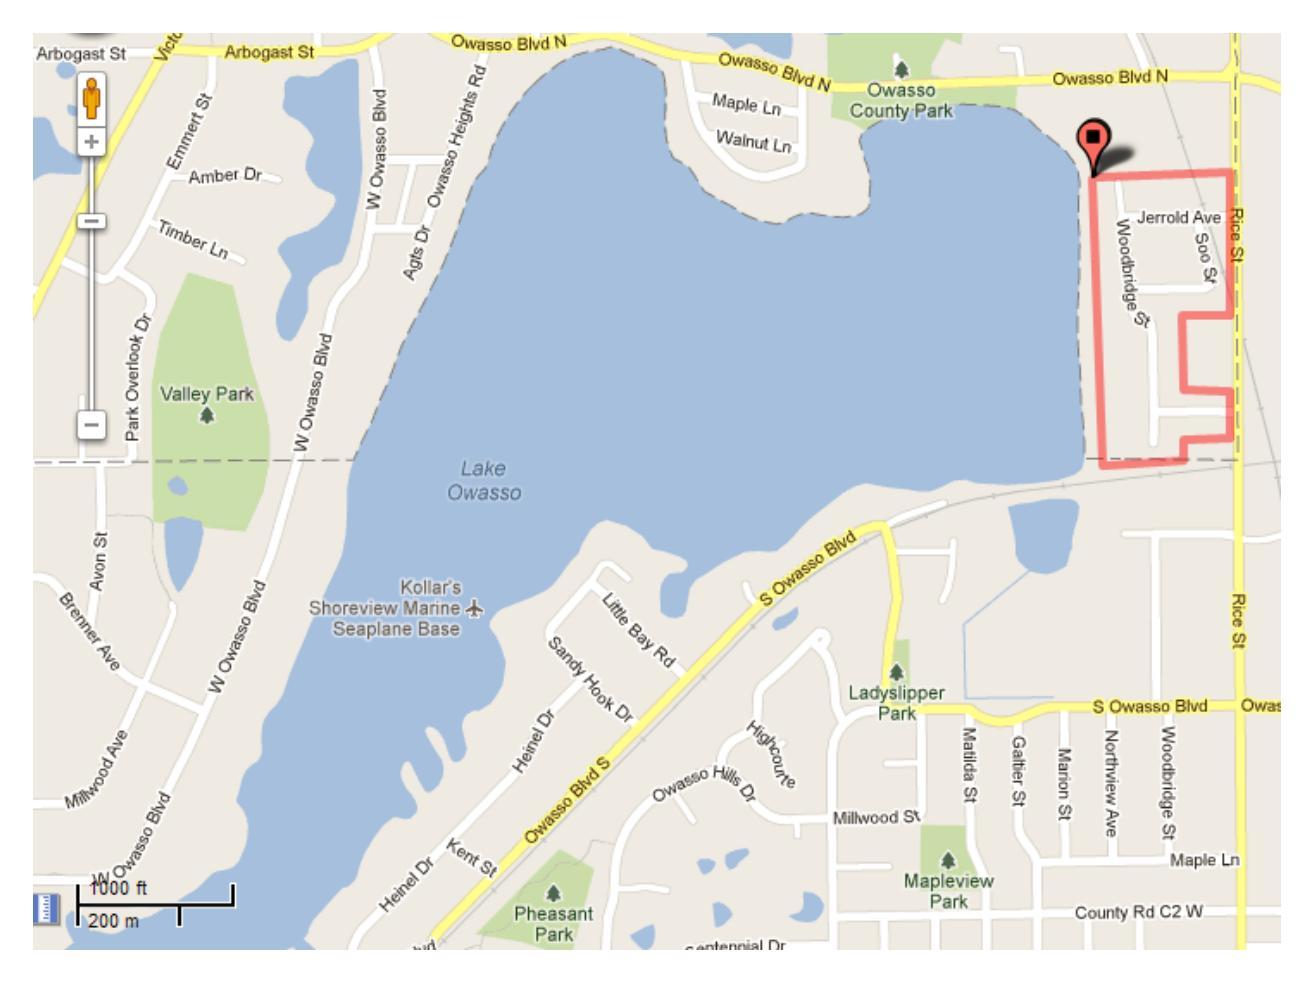
Figure 16 Hydrologic Catchment Area (Thick Red Line Boxed Area)

In Figure 36, a polygon encircles the catchment area for the pervious pavements. It is assumed for the purpose of computation that every precipitation within the catchment area that does not infiltrate the grassed area gets into the pervious concrete. Calculations are based on the given rainfall, land use type and an assumed time of concentration since the singular rainfall events are not individually analyzed but the annual rainfall is used.

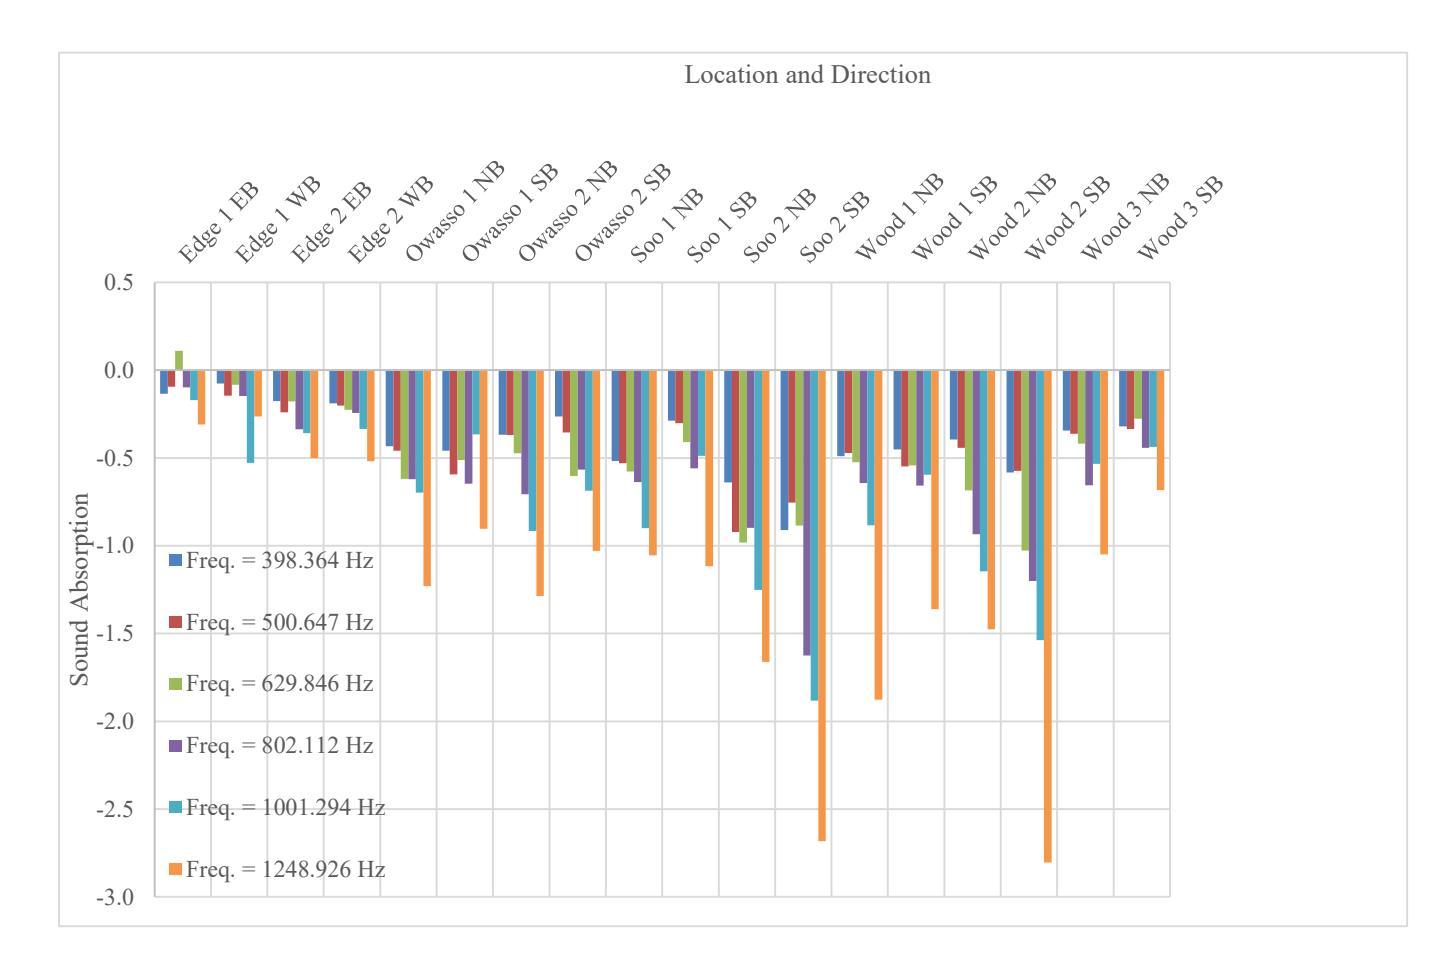
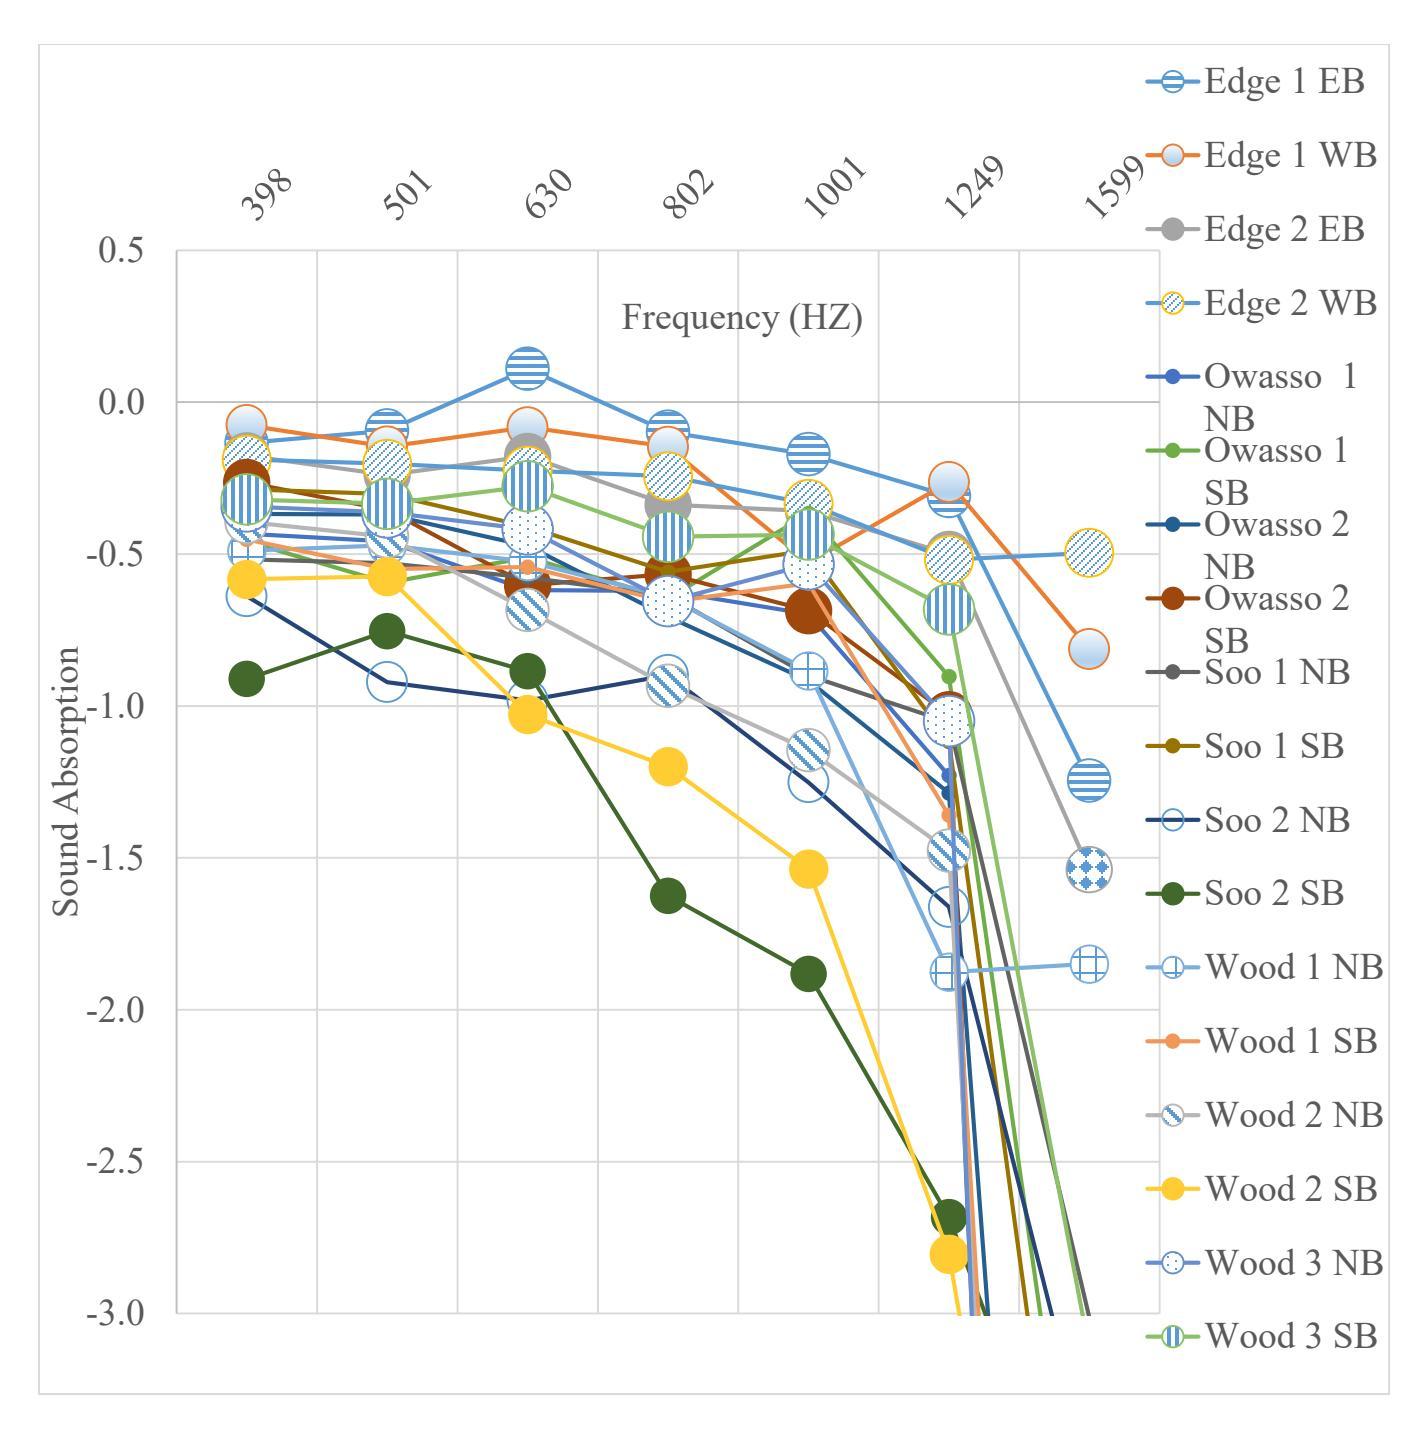
From results shown in Figures 19 and 20 it is evident that these sound absorption values are all negative with the exception of one (Edge 1 EB at a Frequency of roughly 630 Hz). Since the sound absorption is a ratio, all of these negative values can be thought of as sound absorption values that are equal to zero. When comparing the results displayed in Figures 18 and 19 to the results shown in Figure 10 in the previous chapter, it can be concluded that the sound absorption data for all locations has significantly

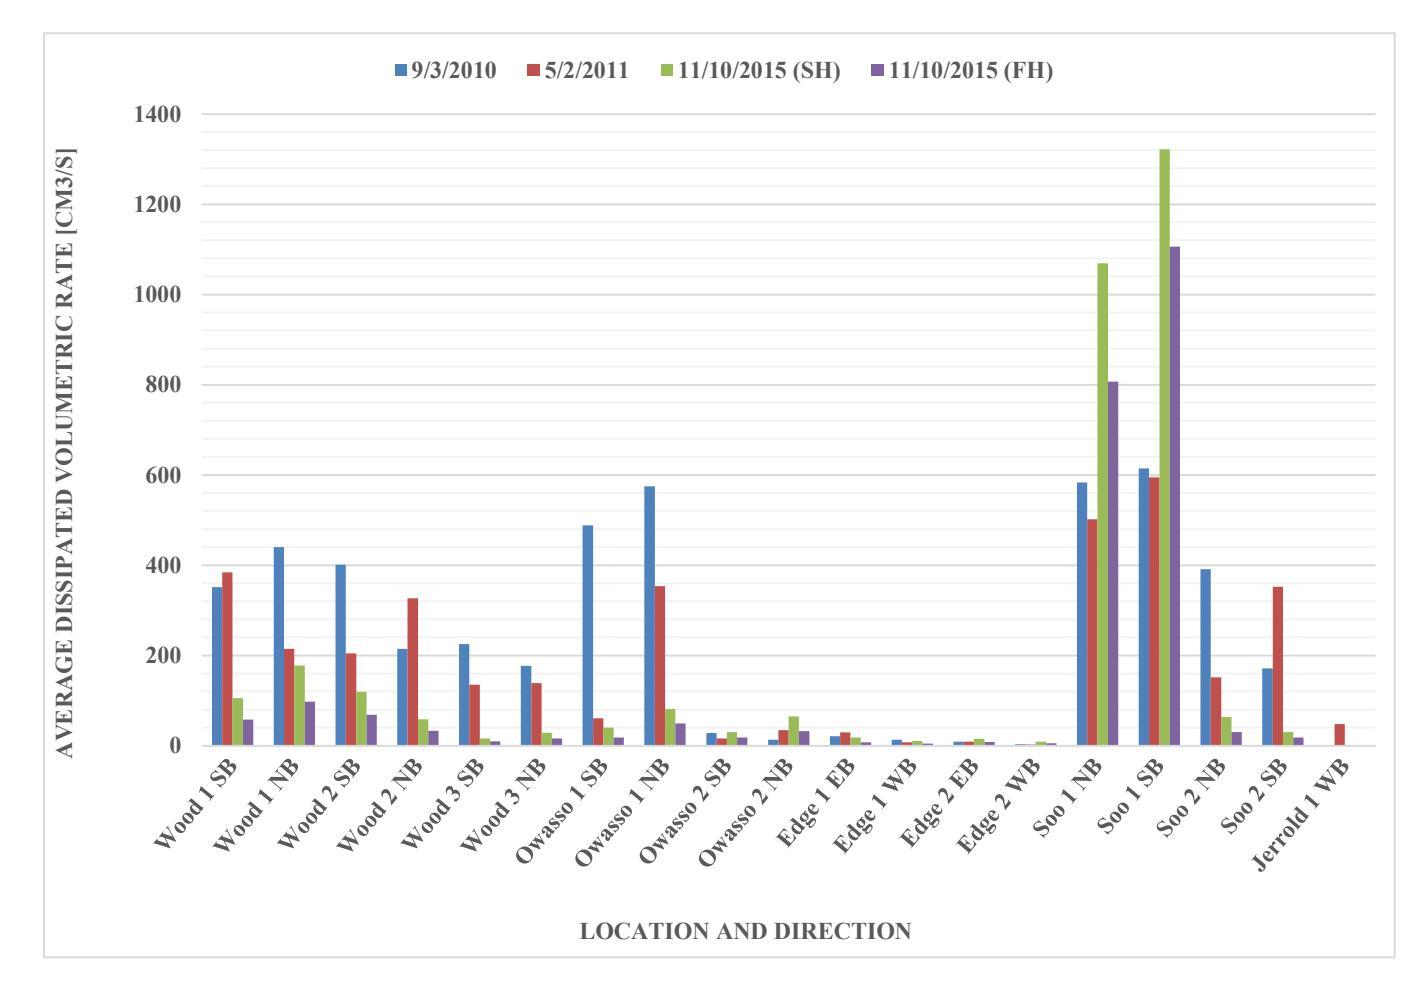
Figure 30 Volumetric Dissipation Rate Test Results of 2010, 2011, and 2015 for each Location

From Figure 30 it can be observed that there is a large distribution of dissipated volumetric rates from location to location. The locations Owasso 2, Edge 1, and Edge 2, in both directions of travel analyzed, show extremely small volume dissipation rates for all field test dates, regardless of their general time trend. The concern in regards to these three locations is that the 2010 dissipated volumetric rate is extremely small, which could indicate that there was an issue during construction of the pavement structure - leading to this poor initial hydraulic conductivity. The Soo 1 location shows the largest dissipated volumetric rate for both directions traveled, and it is also one of the few locations that shows an increasing trend in hydraulic conductivity. Aside from the four locations mentioned previously, all other locations portray initial dissipated volumetric rates that are relatively large, which is what was expected for this pavement structure. However, all these remaining locations still show either a steady or a rapid decrease in the dissipated volumetric rate over time. For the majority of these locations, by 2015 the volumetric dissipation rate is as bad as the Owasso 2, Edge 1, and Edge 2 locations. This

ultimately leads back to the impact that the clogging of the voids in this pavement structure have on the hydraulic conductivity in this pavement.
