Seven Year Performance of City of Shoreview's Pervious Concrete Project

Bernard Igbafen Izevbekhai, Principal Investigator

Office of Materials and Road Research Minnesota Department of Transportation

Research Project Final Report 2017-47

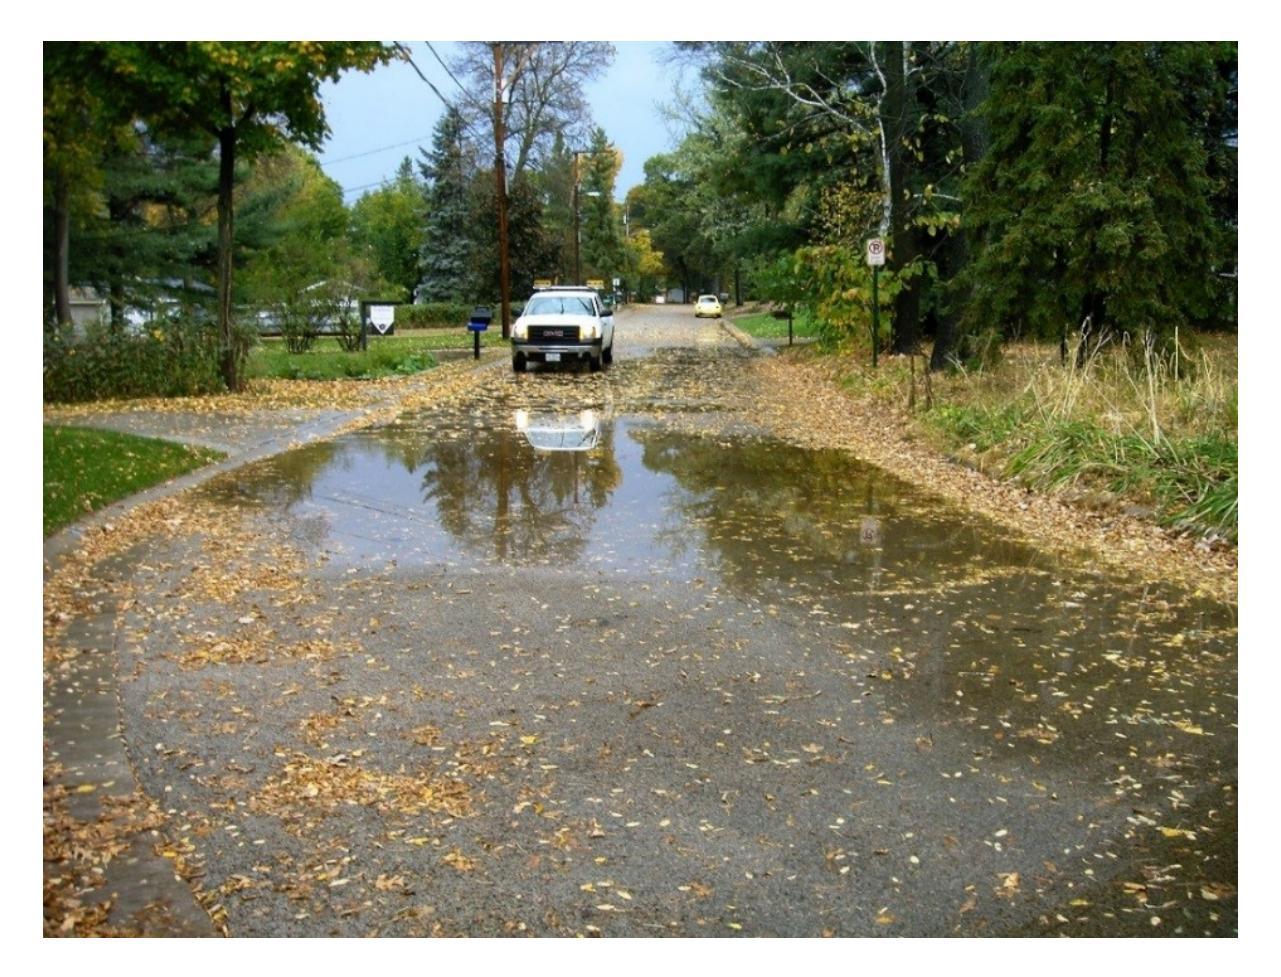
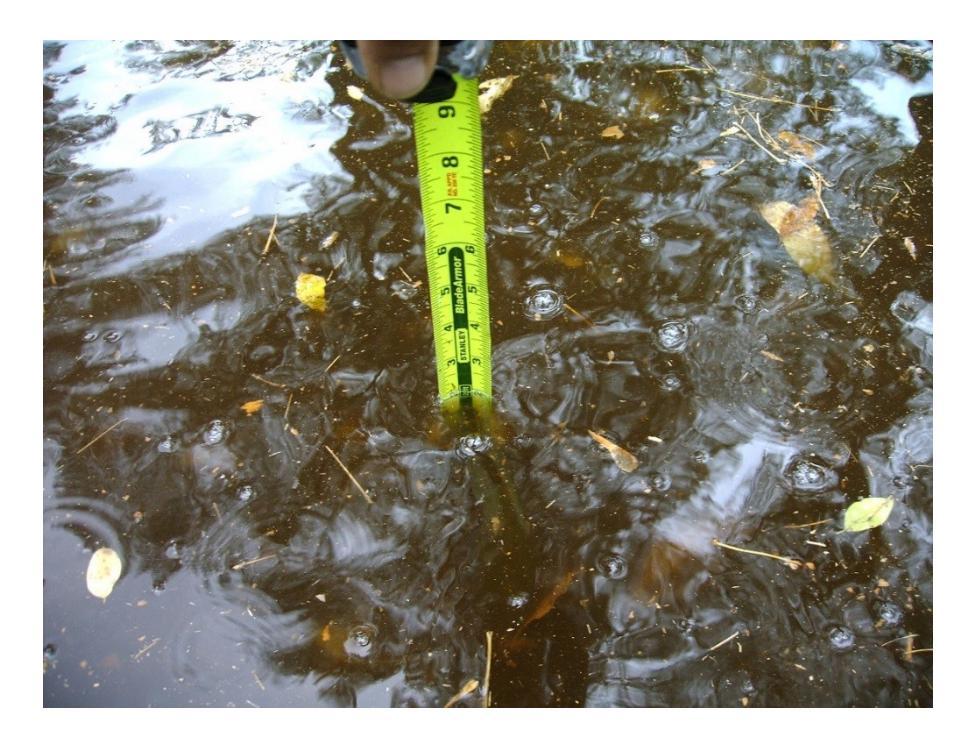
The Figures 31 and 32 were taken in 2011 on Owasso Lane. These images showed standing water on top of the pervious concrete, providing a glimpse of how severely clogged the pores are within this pavement structure at certain points within this road network. Standing water has the potential to freeze up and the resulting ice lenses exert sufficient lateral; pressure to damage the pervious concrete. This can only occur when the pores are clogged over time or are non-communicating on account of poor mix design. The latter does not apply. However this validates the earlier research [5] indicating that most of the clogging agents are organic (leaves). Clogging can result in poor acoustic properties [3] and [6]

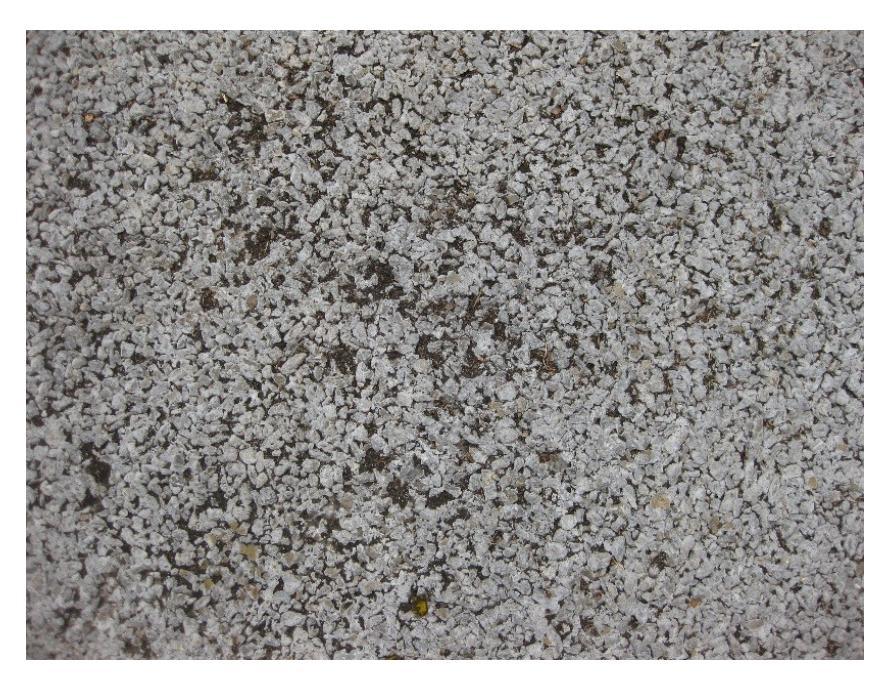
Figure 33 Clogged Pores Overdue for Vacuuming

Figure 33 shows a clogged portion of the roadway with evidence of granular and organic debris.

Finally, it is recommended that constant vacuuming be done at least 4 times a year. This practice will mitigate reversible clogging and its secondary problems. It will also increase hydraulic conductivity, restore sound absorption and decelerate the effect of freeze thaw cycles. Pervious concrete pavements lower the impact of storm-water runoff on environmental pollution and recharge the City's ground water. The percentage of the test results that were preceded by vacuuming was not clear but the long-term measurements in 2015 that were not preceded by vacuuming showed obvious clogging with visible clogging agents and standing water. When such clogged sections go through freeze thaw cycles, ice lenses could exert tremendous pressure that could distress the concrete matrix and cause extensive damage.

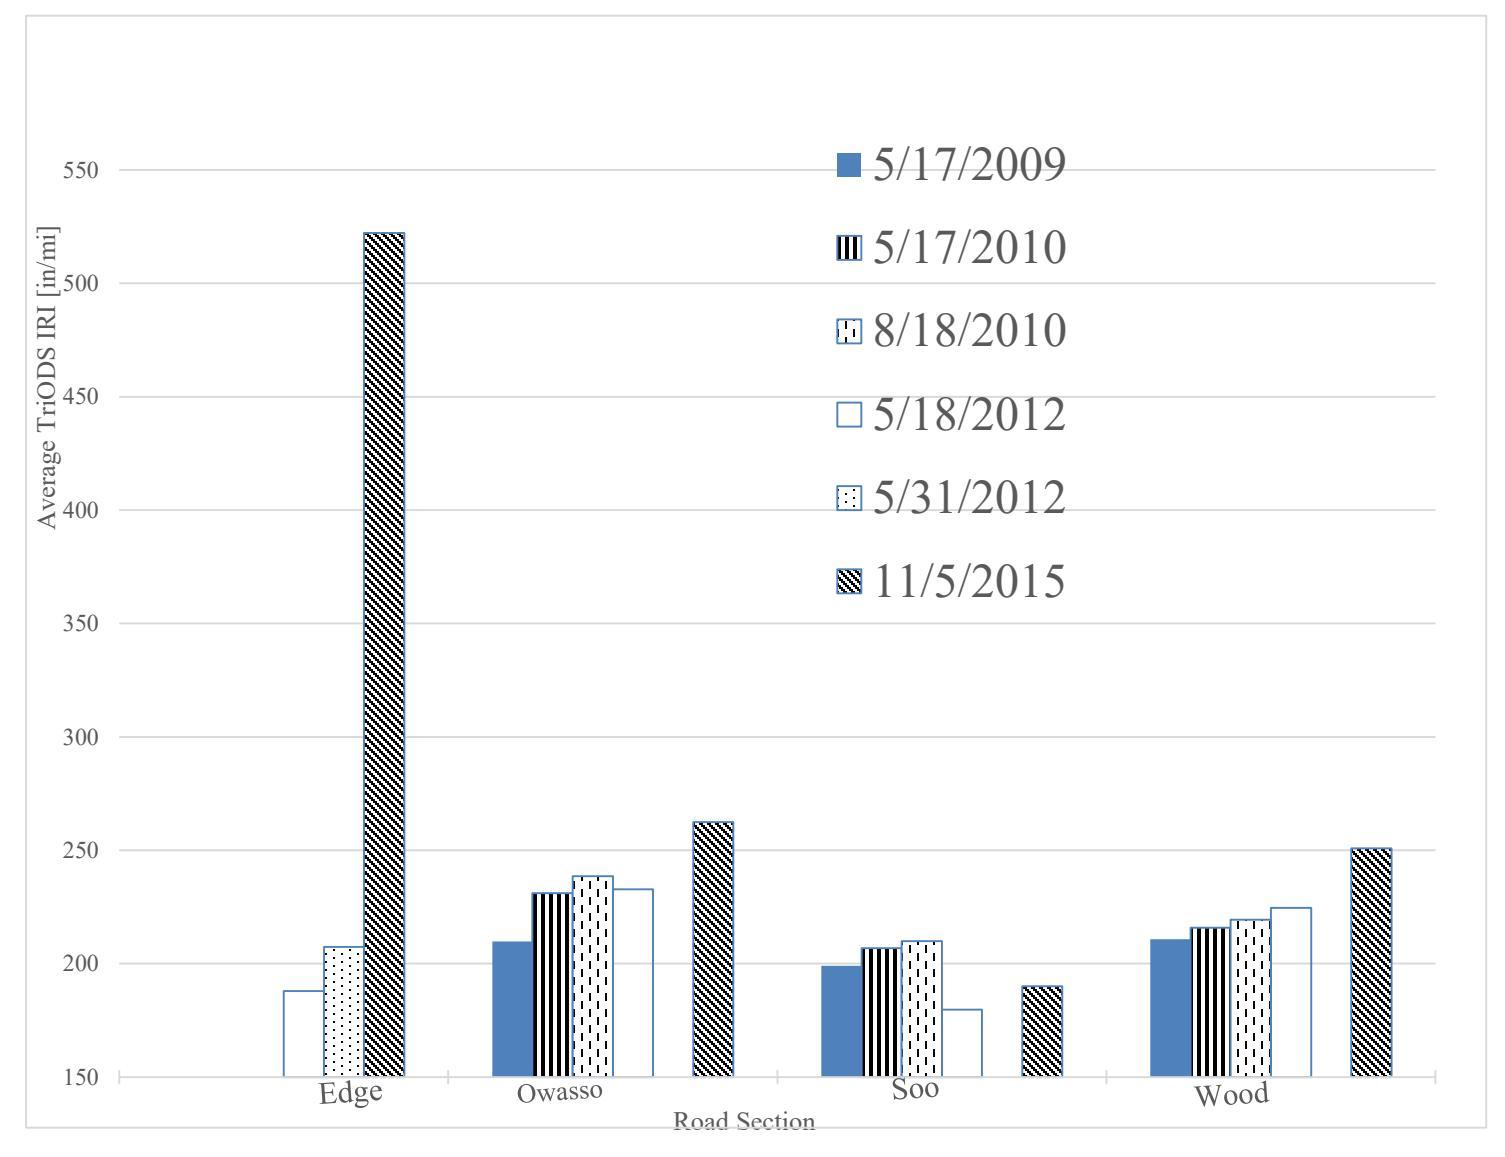
Figure 34 Average IRI ROLINE Value versus Test Time

The results shown in Figures 34 and 35 show trends of ride quality. They elucidate IRI changes with respect to time as an indicator of pavement deterioration although ride quality is not a requirement for acceptance pf pavements where speeds are less than 45 miles per hour. The IRI showed an overall increase from 2009 to 2015 for three of the four road sections tested in this road network. For each the ROLINE IRI and the TriODS IRI, the road section at Edgewater Avenue showed a rapid increase from 2012 to 2015; noting that this location had no IRI data recorded prior to 2012. The other two locations that showed an overall increase in both IRI values recorded were Owasso Lane and Woodbridge Street. The IRI values recorded at Soo Street showed a slight decrease from 2010 to 2012. The TriODS IRI values at Soo Street showed a steady increase from 2009 to 2010, similar to that of all other locations, and after experiencing that small decrease in 2012, it remained to show a steady increase to the final field test date in 2015. Regardless of going back to steady increasing for the TriODS IRI, the Soo Street location showed an overall general time trend decrease in IRI for both IRI values recorded. From the figures, it can be shown that the Soo Street location has the lowest average IRI values for both the ROLINE and TriODS, indicating that this location has the best ride quality out of the road sections tested. The Owasso Street location has the largest average IRI values for each field test date, aside from the 2015 test. This implies that for all field tests prior to 2015, the Owasso Street road section has the poorest ride quality experienced by drivers. The Edgewater road section showed a tremendous increase in average IRI for the field testing that took place in 2015, displaying an IRI value that much higher than others.

It must be emphasized that ride measurements are taken here to detect any trend in structural layer moduli and to detect detached and freely rocking panels. The differences in ride values observed in these sections are not indicative of severe structural deterioration. However the drastic change in IRI from 2012 to 2015 in Edgewater Street should be noted. Although all sections tested recorded higher IRI in 2015 only the change experience in Edgewater Street is a matter of structural concern.
