LOCOMOTIVE CRASH ENERGY MANAGEMENT COUPLING TESTS

Patricia Llana Karina Jacobsen Volpe National Transportation Systems Center United States Department of Transportation Cambridge, Massachusetts, USA

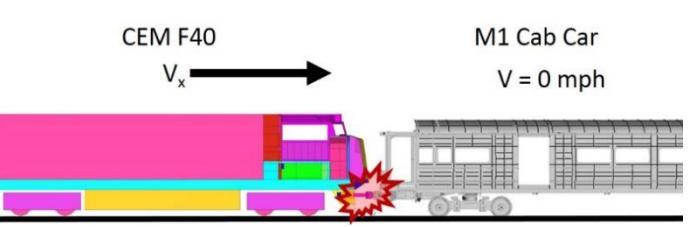
Figure 1. Schematic of CEM coupling test initial conditions.

The CEM coupling tests were conducted repeatedly with the same CEM-retrofit F40 locomotive and M1 cab car, with targeted impact velocities of 2 mph, 4mph, 6mph, 7mph, 8mph, and 9mph, or until the PBC triggered, as shown schematically in Figure 1. At impact, the CEM F40 locomotive was traveling at speed and the M1 cab car was braked. The couplers on both vehicles were open upon impact. A total of six impact tests were

conducted, with the final test conducted at a target speed of 9 mph. The vehicle weights were approximately 233 kips for the locomotive, and 90 kips for the M1 car.

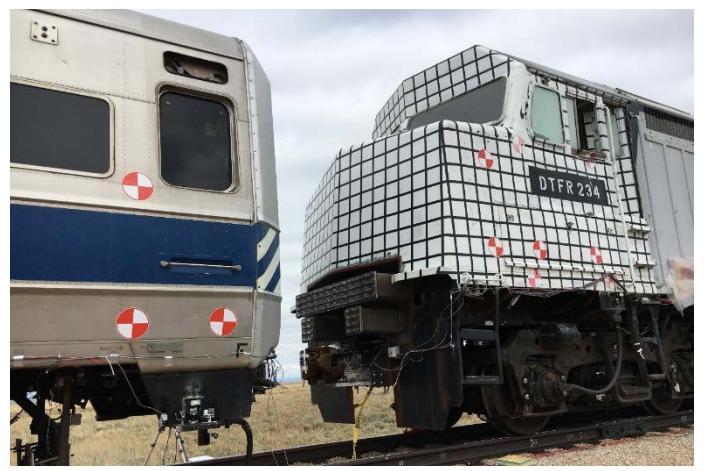
Figure 2. Pre-test photos of M1 cab car No. 8221 (left) and F40 locomotive No. 234 (right) used in the CEM coupling tests.

The equipment used in the CEM coupling tests were retrofit F40 locomotive No. 234, and M1 passenger cab car No. 8221, shown in the pre-test photograph of Figure 2. Figure 3 shows the DAC and PBC retrofit to the F40 locomotive. These two components comprise the CEM system. Figure 4 shows the PBC installed within the sliding lug, and Figure 5 is an exterior view of the shear bolts, which hold the sliding lug to the draft pocket. During an impact that occurs at greater than typical coupling speeds, the PBC is triggered at approximately 680 kips. Once the fuse is triggered, the PBC absorbs energy as it pushes back at that load level. When the PBC stroke is exhausted, the shear bolts are broken by the mounting impact force at approximately 1,000 kips. This causes the sliding lug to slide back. At this point, the load path transfers from the PBC completely to the DAC, which crushes in a controlled manner thereby absorbing more collision energy. The entire CEM system is designed to have the colliding vehicle ends engage while absorbing the energy of the collision. This minimizes lateral buckling and ramp formation due to uncontrolled crush, both of which promote override. The design development and requirements of the CEM components are detailed in previous papers [5], [6], [7].

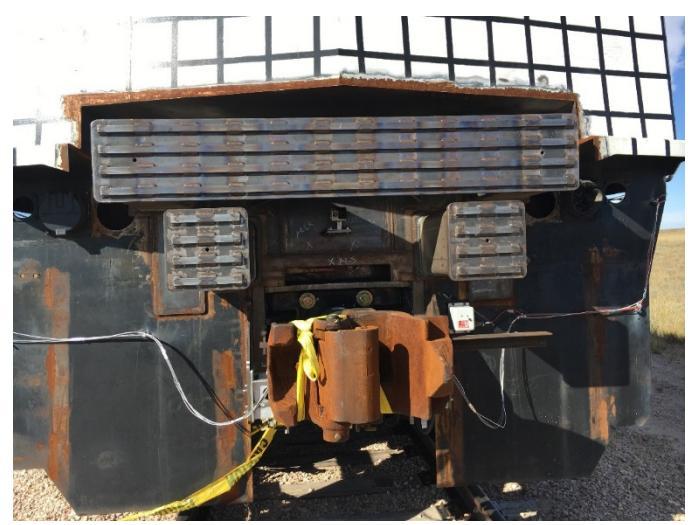
Figure 3. The DAC (top) and the PBC (bottom) comprise the locomotive CEM system.

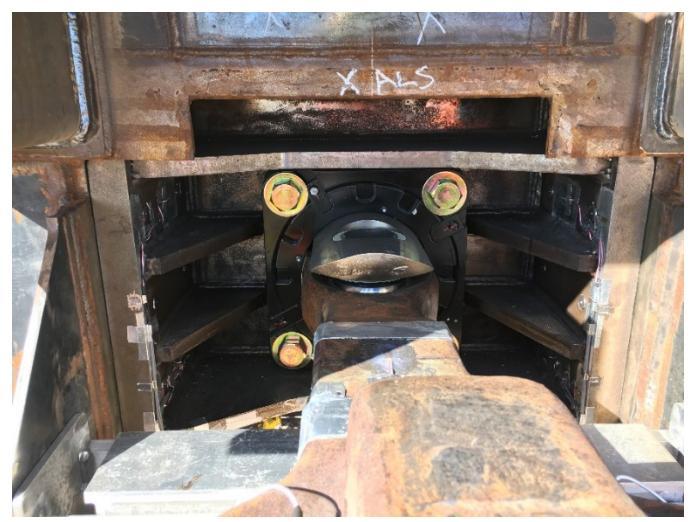
Figure 4. PBC installed within the sliding lug.

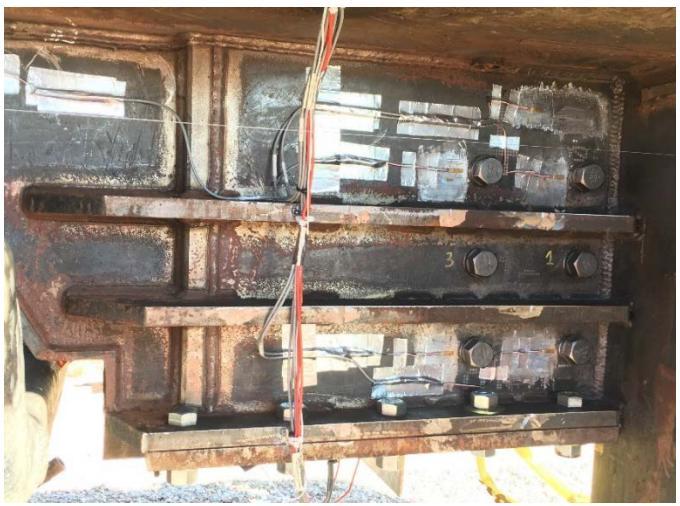
Figure 5. Exterior view of the shear bolts installed through the draft pocket.

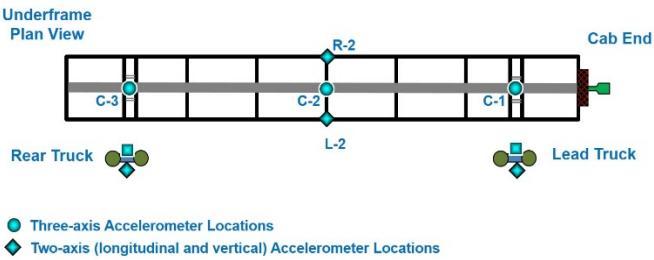
Single-axis (vertical) Accelerometer Locations

Figure 6. Schematic illustration of M1 cab car accelerometer locations

Figure 6 shows a schematic illustration of the accelerometer locations for the M1 car. Accelerometers were placed in similar locations on the F40 locomotive. The accelerometers on the carbody captured the three dimensional gross motions of the carbody – longitudinal, lateral, and vertical accelerations, as well as yaw, pitch, and roll.

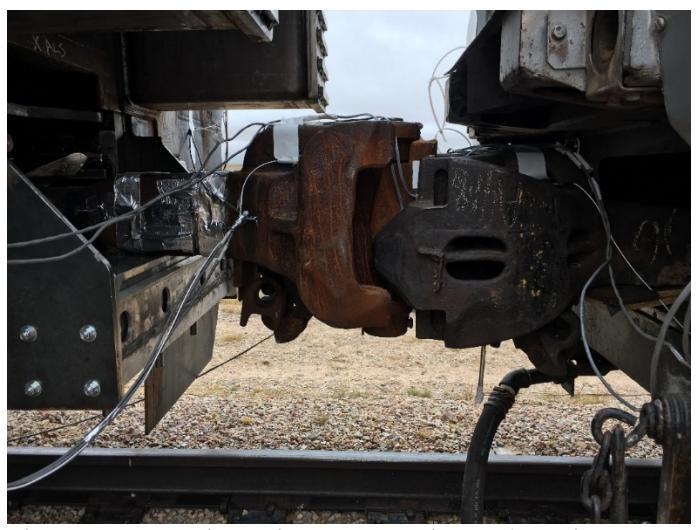
Figure 7. The vehicles did not couple in the 6mph impact.

The actual speed of the impact test was 5.7 mph. The PBC did not trigger. The vehicles did not couple upon impact, as seen in Figure 7. The figure also shows the small misalignment between the couplers. Upon visual inspection after the impact, there was no apparent structural damage to the F40 locomotive. However, as a result of the impact, the front truck transom bar of the locomotive contacted the PBC flag (orange in color and shown in Figure 8) and bent its connection bolt. The purpose of the PBC flag is to give a more visible indication that the PBC deformation tube has triggered. When the PBC deformation is initiated, the flag's connection bolt is sheared, causing the flag to drop and hang by its chain.

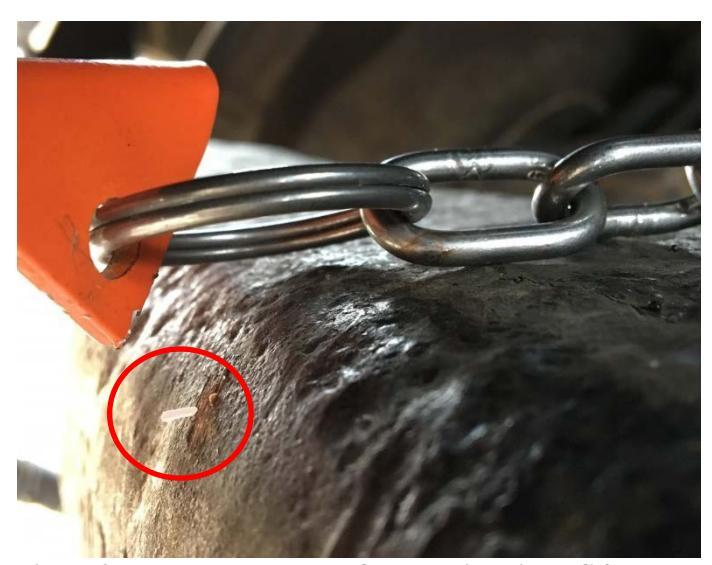
Figure 8. Front transom bar of locomotive hit PBC flag.

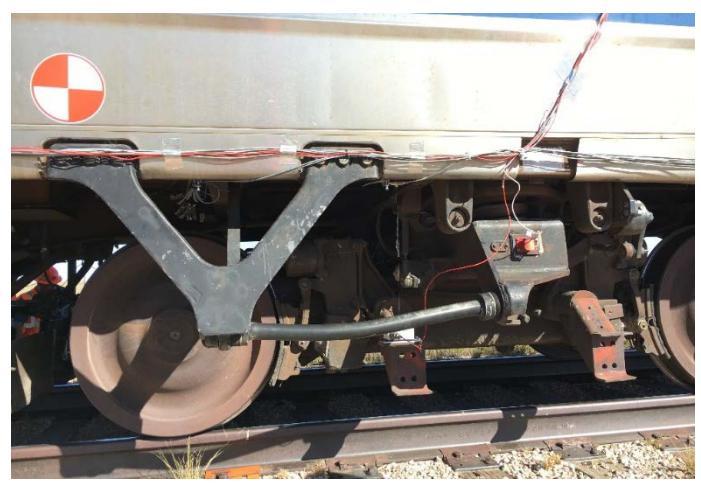
Figure 9. M1 front left traction rod deformed after 6mph test.

There was no apparent structural damage to the coupler, draft gear or draft pocket of the M1 cab car. However, the traction rod on the left side at the connection to the front truck was bent by the impact, as shown in Figure 9. This traction rod was replaced before the next test, the 7 mph impact.

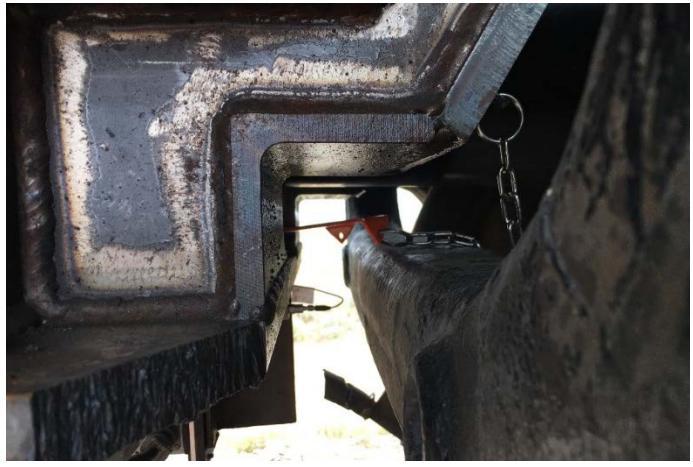
Figure 10. PBC flag and transom bar after 7mph impact.

The actual speed of the impact test was 6.8 mph. The vehicles did not couple upon impact. The PBC did not trigger. Upon visual inspection after the impact, there was no apparent structural damage to the F40 locomotive. However, as a result of the impact, the front truck transom bar of the locomotive contacted the PBC again. Figure 10 shows the space between the rear of the draft pocket and the transom bar. The PBC flag can be seen at a slight angle, due to its interaction with the transom bar. The bolt connecting the flag was slightly bent, but still very much attached to the PBC.

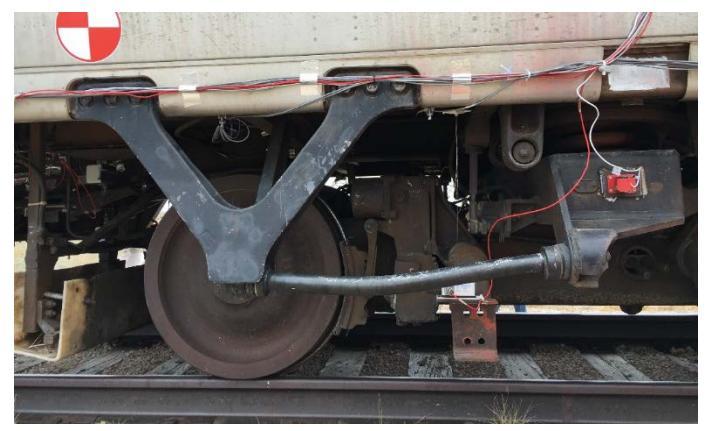
Figure 11. New M1 front left traction rod deformed again after 7mph test.

There was no apparent structural damage to the coupler, draft gear or draft pocket of the M1 cab car. However, the new traction rod on the left side at the connection to the front truck was bent again by the impact, as shown in Figure 11. This traction rod was not replaced and was left as is for the remaining tests, as there were no more replacements.

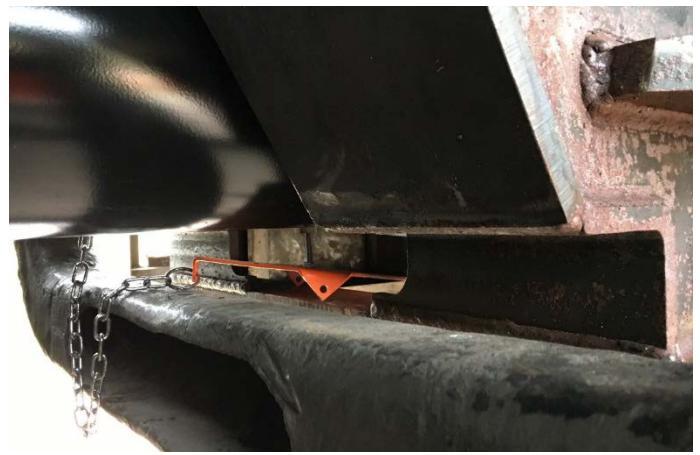
Figure 12. PBC flag and transom bar after 8mph impact.

contacted the PBC. Figure 12 shows the space between the rear of the draft pocket and the transom bar. The PBC flag can again be seen at a slight angle, due to its interaction with the transom bar. The bolt connecting the flag is slightly bent, but still attached to the PBC, as shown in Figure 13.

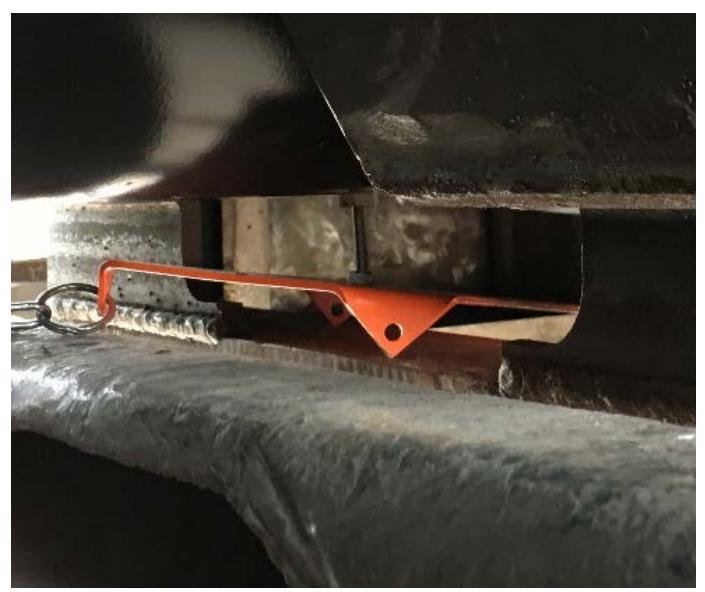
Figure 13. Close-up of the PBC flag and bolt after 8mph impact.

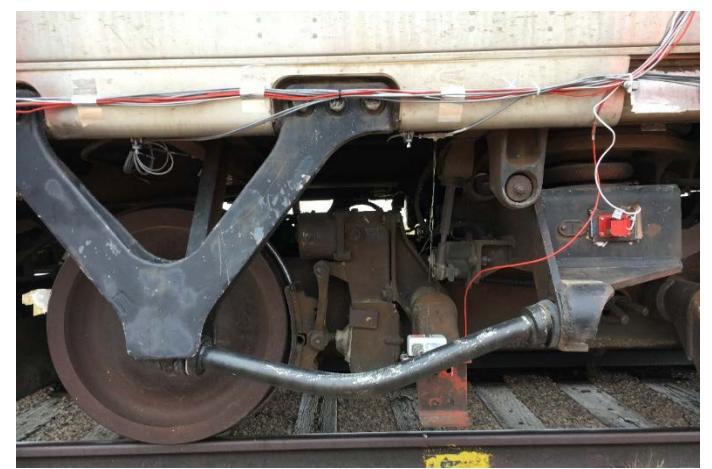
Figure 14. M1 front left traction rod deformed more after 8mph test.

There was no apparent structural damage to the coupler, draft gear or draft pocket of the M1 cab car. However, the deformed traction rod on the left side at the connection to the front truck was deformed even more by the impact, as shown in Figure 14. As stated previously, this traction rod was not replaced and left as is for the next test. New damage that occurred during this test was a broken piece of the front left truck, as shown in Figure 15. This occurred due to interference between parts of the truck as a result of the deformed traction rod, as shown in the photograph on the right side of Figure 15.

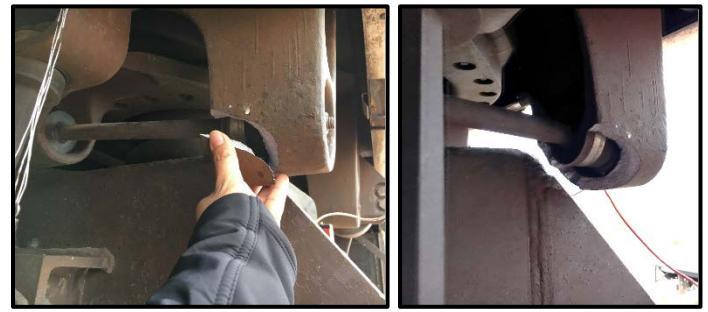
Figure 15. Piece broken off of M1 front left truck, with piece held up to its former place (left).

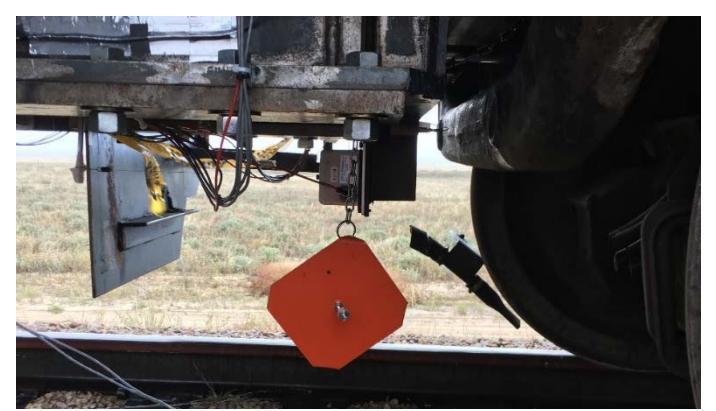
Figure 16. PBC flag detachment indicates the PBC was triggered.

The actual speed of the impact test was 8.9 mph. The vehicles did not couple upon impact. The PBC did trigger. Figure 16 shows the PBC flag detached from the PBC and hanging underneath the draft pocket. The flag is attached to the PBC by a bolt that shears when the crush of the deformation tube is initiated. This allows the flag to fall away from the PBC, indicating that tube crush has been initiated. Figure 17 shows the flag and its bolt, which was bent in the previous impacts due to interaction with the transom bar. However, this did not interfere with the operation and performance of the bolt, indicating robustness in the design.

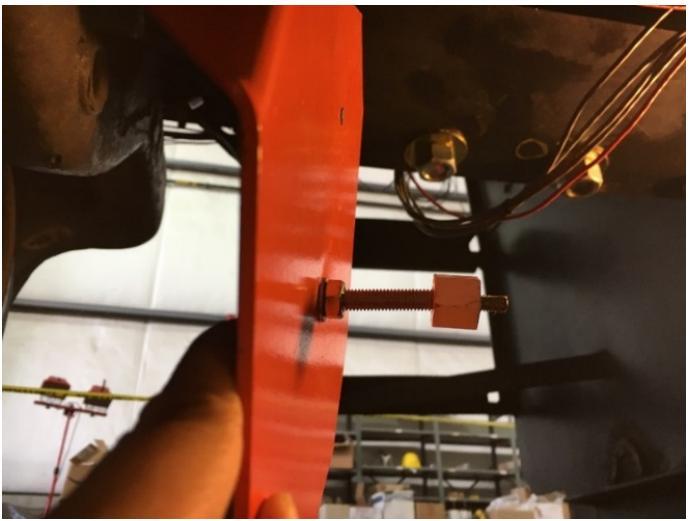
Figure 17. The PBC trigger indicator is an orange flag that is attached to the PBC by a bolt.

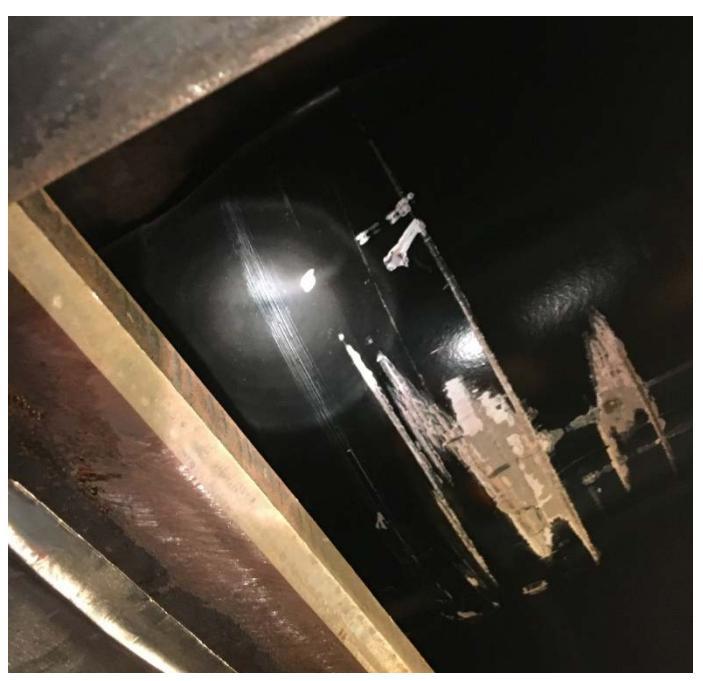
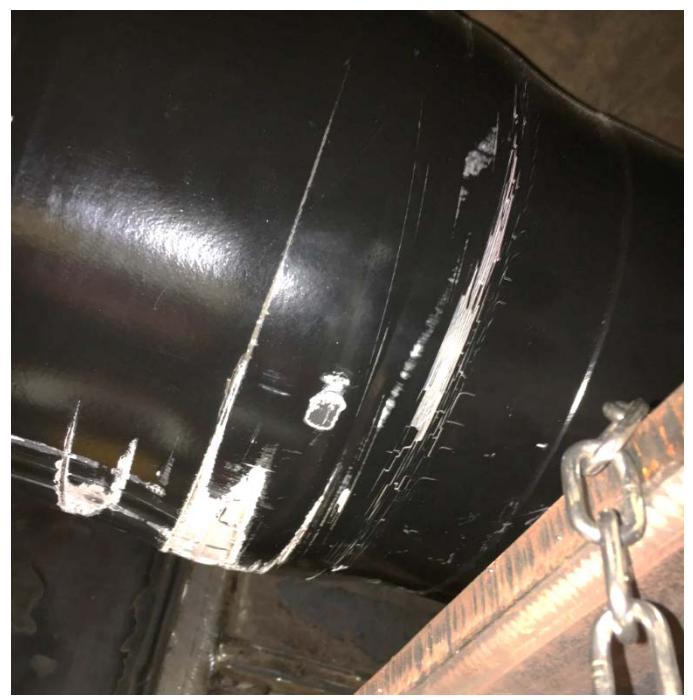
Figure 18. Cracked paint on the right side of the PBC deformation tube indicating tube crush.

Figure 19. Cracked paint on the left side of the PBC deformation tube indicating tube crush.

The deformation tube was inspected after the tests to determine that approximately 5/8 inch of crush stroke was achieved. This can be seen by the peeling paint on the exterior of the tube in Figure 18 (right side) and Figure 19 (left side). The paint on the exterior of the tube is designed to peel off when deformation occurs. The other damage to the paint that is visible in the two photos occurred during shipment prior to the test. This had no effect on the performance of the deformation tube.

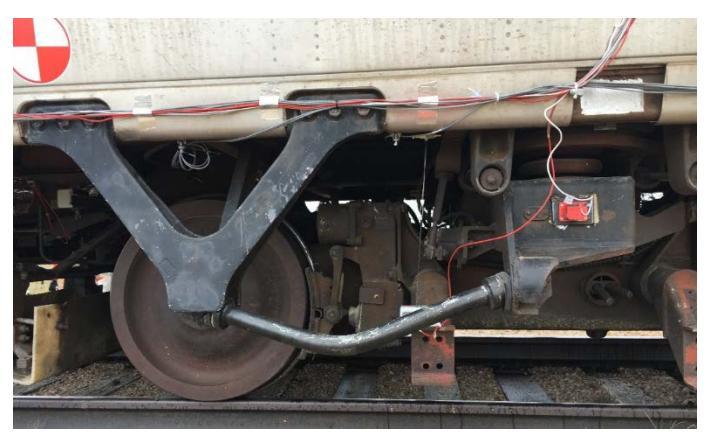
Figure 20. M1 front left traction rod deformed more after 9mph test.

There was no apparent structural damage to the coupler, draft gear or draft pocket of the M1 cab car. However, the deformed traction rod on the left side at the connection to the front truck was deformed even more by the impact, as shown in Figure 20. It is important to note that there was no deformation to the side sills at the connections to the front truck. This is markedly different from what occurred in the conventional coupling tests, where there was extensive deformation, and eventually fracture, in the side sills at the connections to the front truck [10].

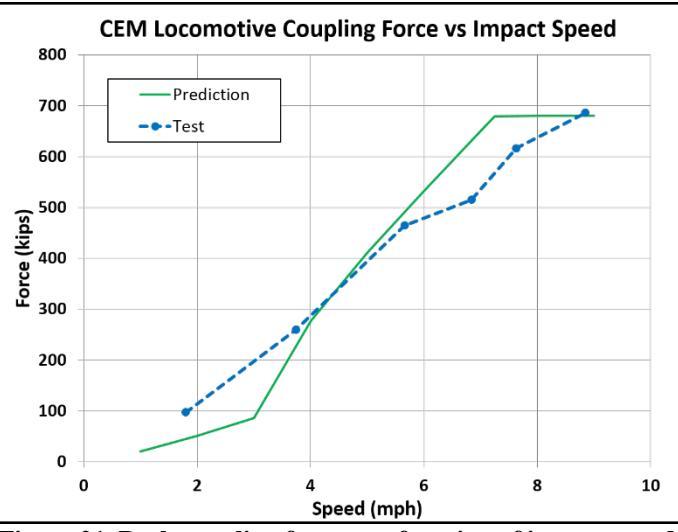
Figure 21. Peak coupling force as a function of impact speed.

Prior to the test a simplified lump-mass model was created to estimate the speed at which the PBC would trigger [11]. This model estimated the PBC force-displacement behavior and utilized typical vehicle weights and a typical conventional locomotive draft gear. Figure 21 shows peak coupling force as a function of impact speed comparing the pre-test prediction with the test results. The figure shows that the test results compare favorably with the prediction.

However, the model predicted that triggering of the PBC would occur at an impact speed of between 7 mph and 8 mph. The test demonstrated that the PBC triggered at just under 9 mph. Additionally, the pre-test modeling predicted that damage would

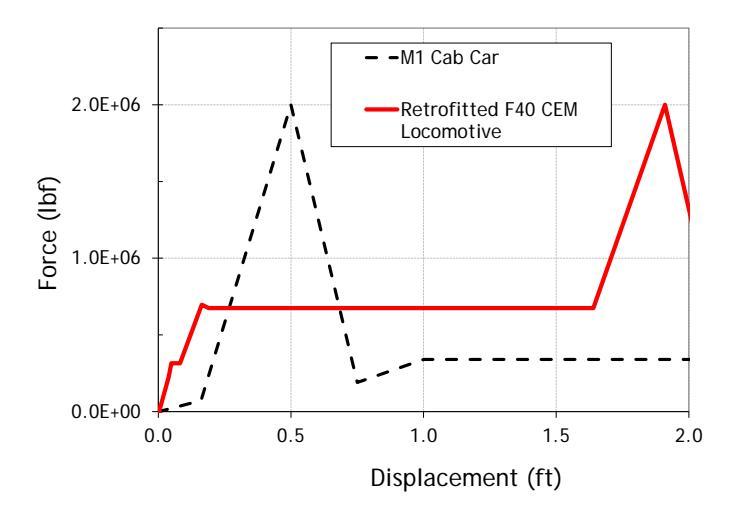
Figure 22. Idealized force-displacement characteristics of colliding vehicles.

As part of the collaboration to conduct the CEM coupling tests, Voith (the PBC supplier) provided updated dynamic measurements of the draft gear and PBC behavior. The plot in Figure 22 shows an idealized representation of the forcedisplacement behavior of the Voith PBC retrofitted onto the F40. This characteristic does not include the contribution of the DAC in the collision. The PBC draft gear characteristic has more than twice the energy absorbing capacity than a typical conventional draft gear.

TTCI measured the final weights of the equipment after the test was conducted. The retrofitted CEM locomotive weighed 232,600 lb and the M1 cab car weighed 89,700 lb. With the correct masses and the idealized PBC characteristic updated after the conduct of the test, a post-test collision dynamics model estimates that the PBC triggers between 8 and 9 mph. This estimate is closer to what occurred in the tests than the original pre-test prediction.
