# Truck Accident Countermeasures on Urban Freeways

Technical Report Documentation Pag
1. Report No. FHWA-RD-92-059	2. Government Acce	ssion No. 3. Recipient's Catalog No.
4. Title and Subtitle TRUCK ACCIDENT COUNTERMEASURES ON URBAN		URBAN October 1992
FREEWAYS		6. Performing Organization Code

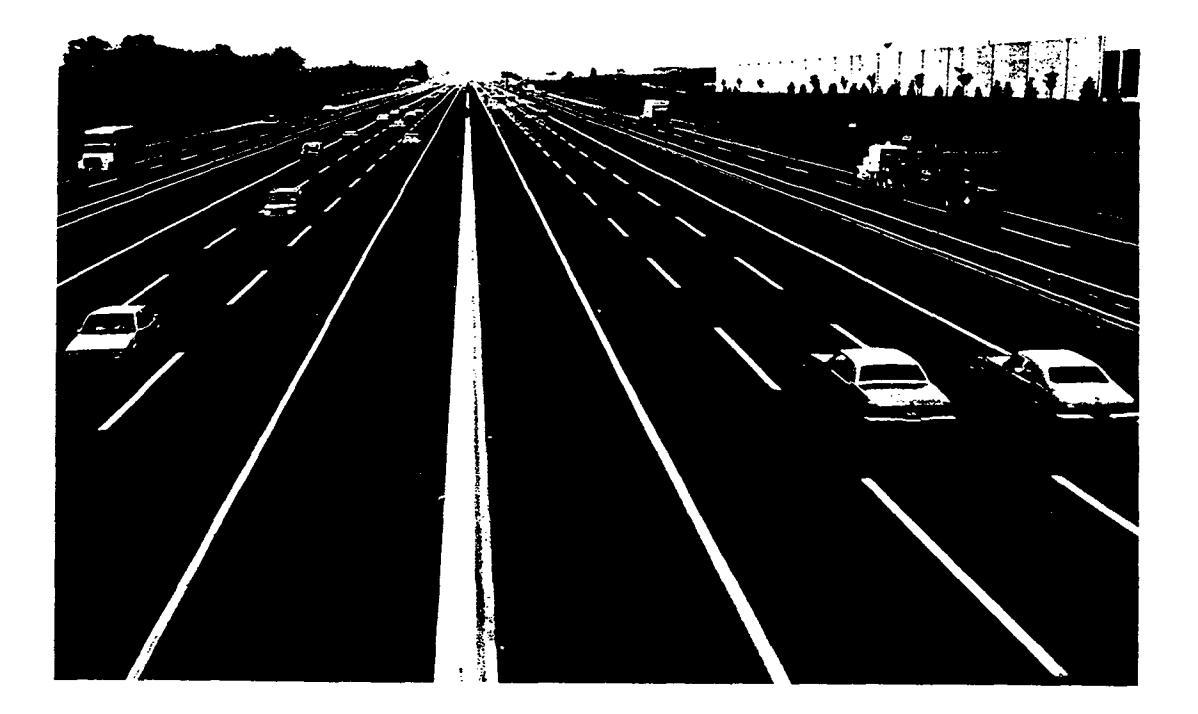
Figure 2. New Jersey Turnpike cross-section.

The New Jersey Turnpike consists of interior (auto) lanes and exterior (truck/bus/car) lanes within the same right-of-way. For 37 km (23 mi) of the Turnpike, the interior and exterior roadways in each direction have three lanes. On the 14 km (9 mi) section that opened in November 1990, the exterior roadway has two lanes while the interior roadway has three lanes per direction (see figure 2). Each roadway has 3.67-m (12-ft) lanes and

3.67-m (12-ft) shoulders. Directional flows are separated by a concrete median barrier, and the inner and outer flows are separated by a metal beam guardrail. Trucks and buses are restricted to the outer roadway, but smaller vehicles can use either the inner lanes or outer lanes. The current mix of automobile traffic is approximately 60 percent on the inner roadways and 40 percent on the outer roadways. The turnpike authority believes segregation of vehicles by size represents an improvement in safety for all motorists using the facility.

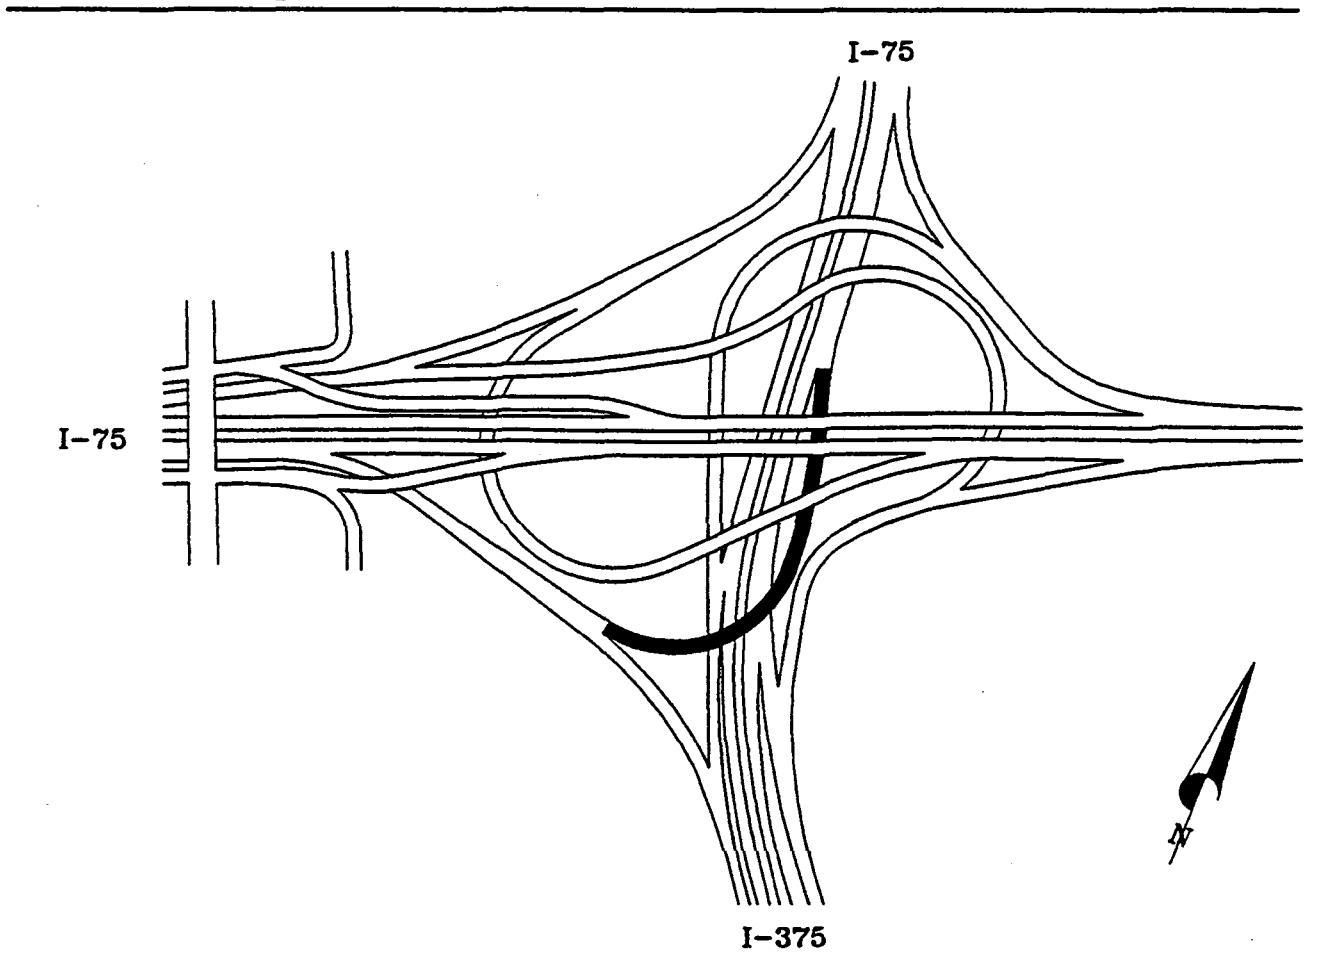
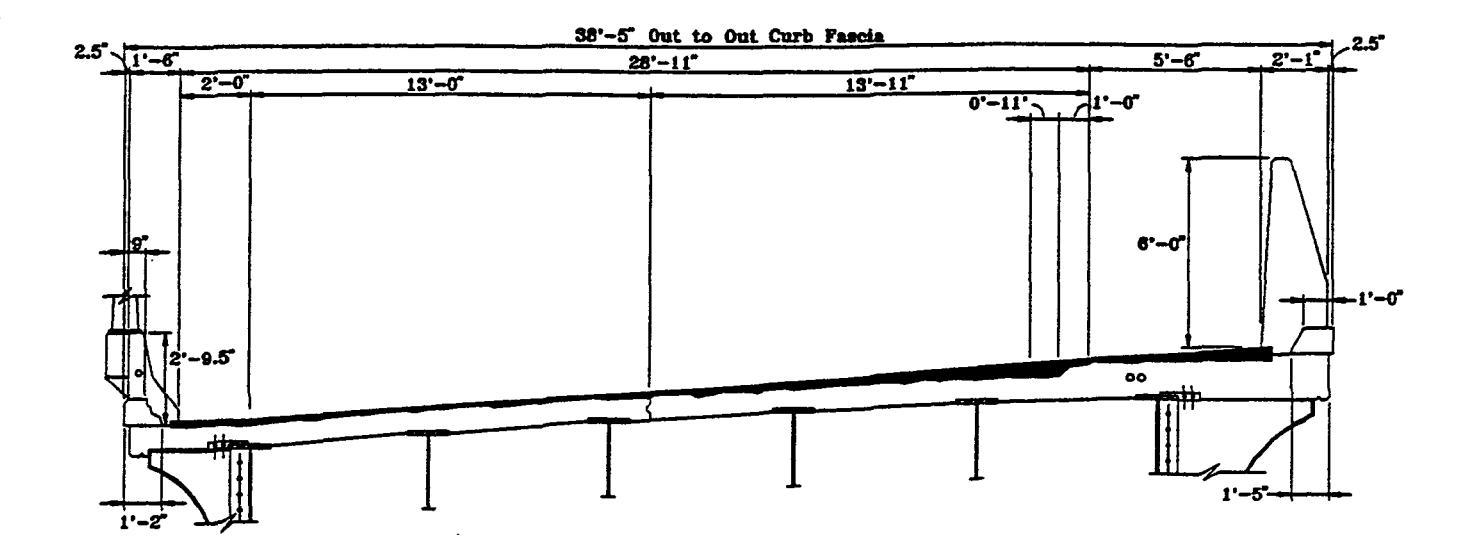
A freeway ramp has been altered with ramp treatments to mitigate accidents involving trucks. The ramp is a two-lane freeway-to-freeway connector located in downtown Detroit, where I-75 (Chrysler Freeway) northbound traffic continuing on I-75 must exit the freeway mainlanes onto this ramp. The directional orientation of traffic on I-75 northbound changes

from an easterly direction to a northerly direction. Interstate 375 traffic must also interchange at this location (see figure 5). No specific truck counts were available for this ramp, but Michigan DOT personnel stated the daily number was approximately 6,000.

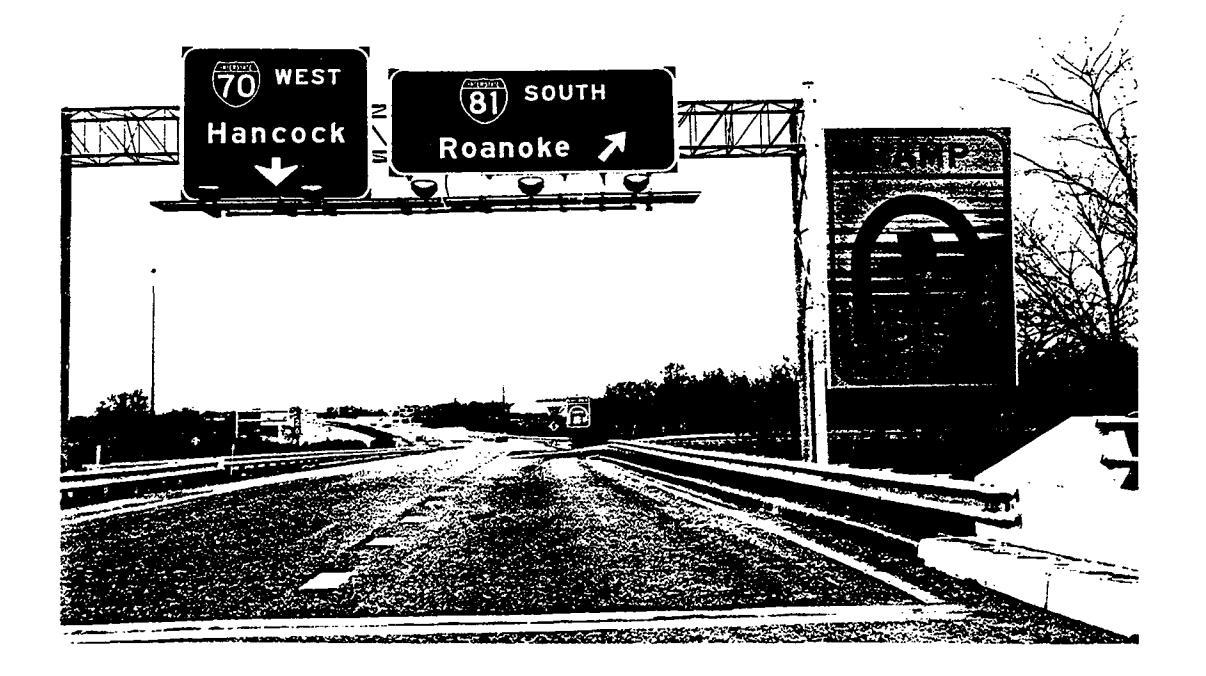
Figure 6. Truck tipping sign in Hagerstown, Maryland.

In 1984, MSHA installed oversized truck tipping signs on the eastbound and westbound exit ramps of I-70 in an attempt to reduce the number of truck rollover accidents that had occurred there (see figure 6). The ramps were used for a recent research study sponsored by the FHWA to determine the effects of these signs on truck speeds.<sup>(16)</sup> Both of the ramps are loops, each built with a radius of 70.12 m (230 ft) and on a descending grade.

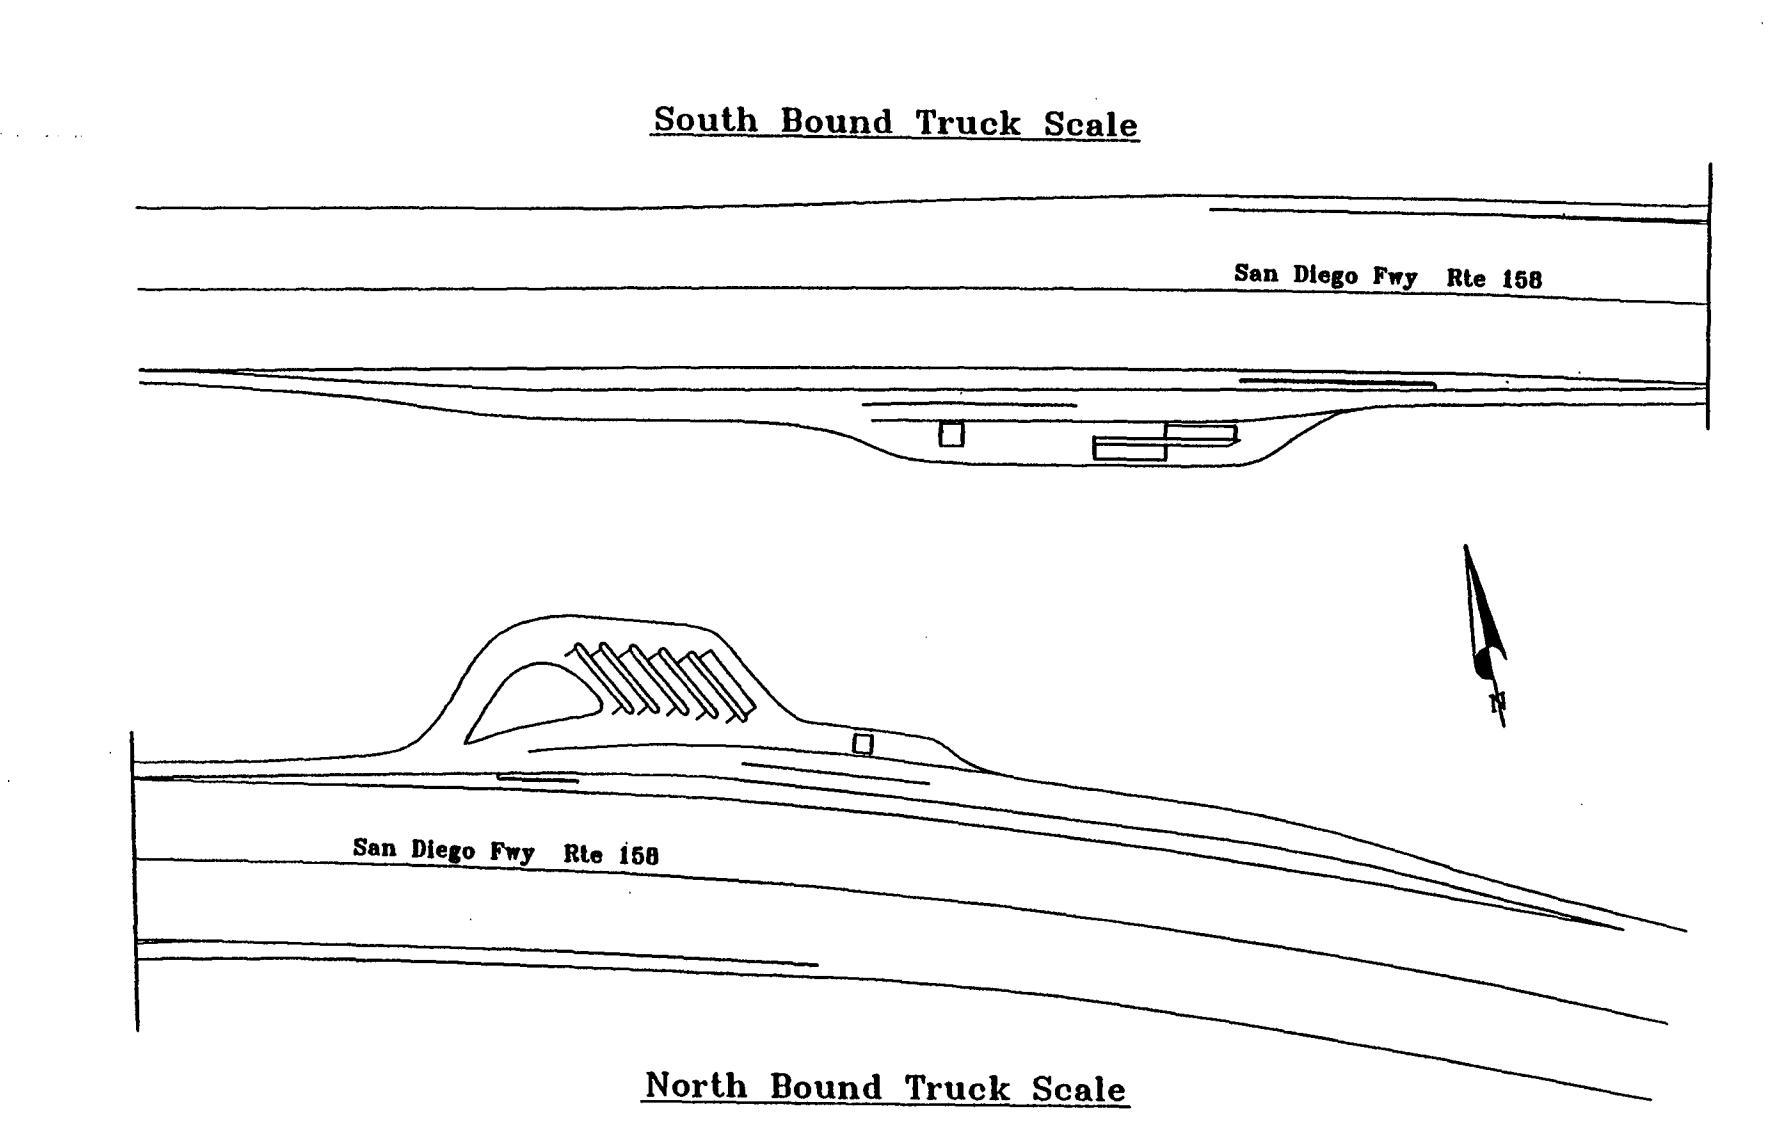
# Figure 7. I-405 weigh/inspection facility.

The inspection station on I-405 and others in California were constructed by CAL-TRANS. The money is from the same fund that is available for highway construction projects. Funding for maintaining inspection stations is from the highway maintenance fund. The cost of these urban inspection stations is highly variable, but one currently under construction (not in Los Angeles) is expected to cost \$14 million.

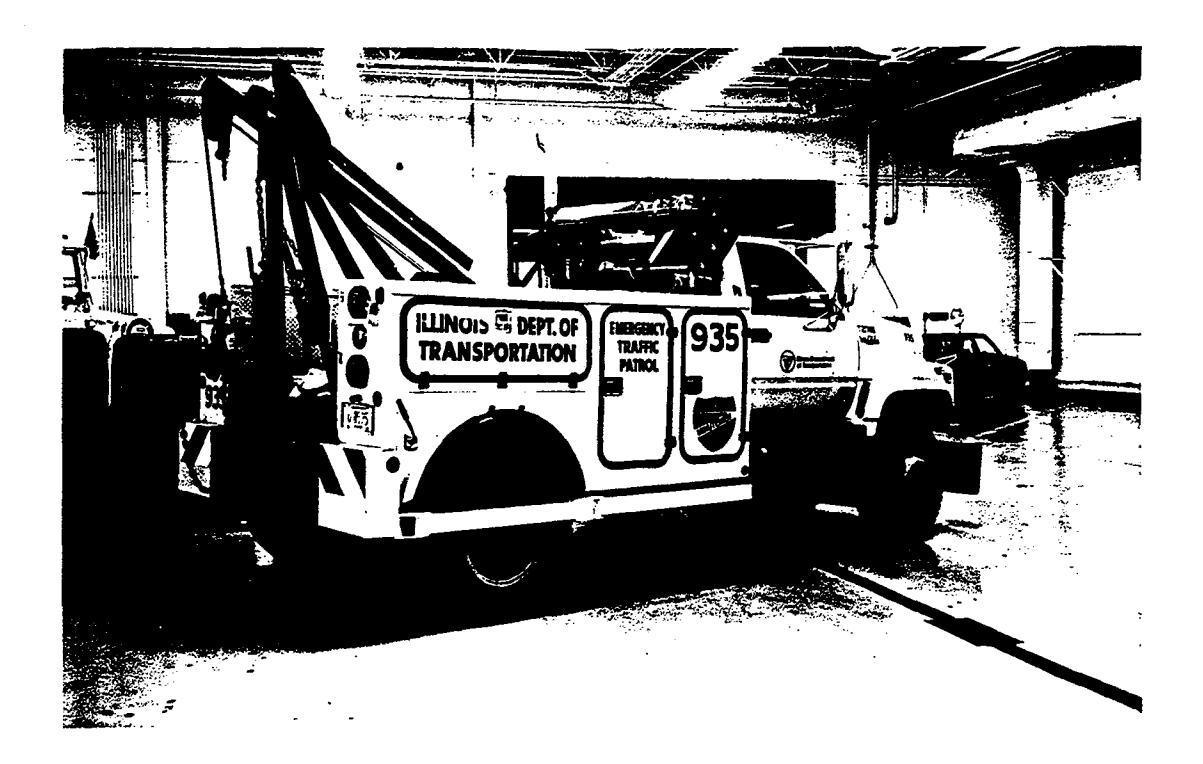
Figure 8. Emergency patrol vehicle.

Elements of freeway surveillance, communication, and control, which are currently in place on the Chicago freeways include: the Minutemen with their EPV's (see figures 8 and 9), the Traffic Systems Center, and the Communications Center. The Traffic Systems Center monitors input from an extensive pavement sensor system (1,800 inductive loops on 190 km (118 mi) of freeway and 95 ramp metering stations), controls messages displayed on the 12 changeable message signs and controls messages broadcast by the Highway Advisory Radio (HAR). The Communications Center, located at the Illinois Department of Transportation (IDOT) district office, receives cellular phone messages from the highly successful \*999 program. This program allows cellular car phone users to call in free of charge and describe freeway conditions they are experiencing. The \*999 calls are received at a rate of 10,000 to 13,000 calls per month. According to IDOT, this program, in combination with

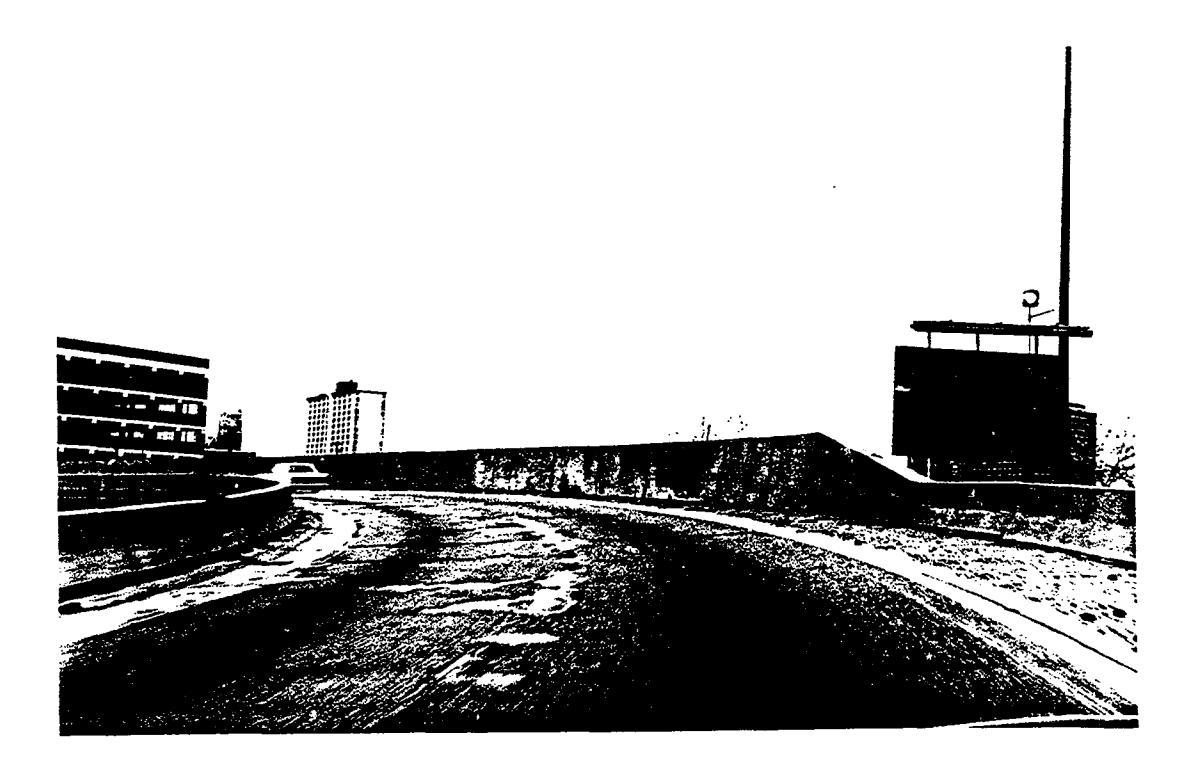
Figure 10. Close-up of barrier on I-75 northbound.

One improvement at the northbound I-75 to I-75 connector removed the differing cross-slope rates and formed a constant superelevation rate of 7.4 percent over the full width of the ramp to the outside barrier (see figure 10). The other major improvement was construction of a tall barrier on the outside of the ramp curve to contain high center-of-gravity vehicles and loads that might be dumped on other ramps and the freeway below. The second ramp is a two-lane ramp on the I-94 (Ford Freeway), serving traffic in the westbound direction to southbound on I-75 (Chrysler Freeway). The improvement at this ramp included only the addition of a taller barrier similar to the other ramp for the purpose of containing trucks and their loads. Barriers at both ramps are 1.8 m (6 ft) high and their base thickness is 635 mm (2 ft, 1 in). The improvements on this ramp were completed between 1977 and 1980, according to Michigan DOT.

According to a Michigan DOT traffic engineer, the problem at both ramps was practically identical. Both ramps were built with tight geometrics; one was built next to a large building that limited available right-of-way. Michigan DOT had installed extensive signing first in an attempt to reduce accidents, but results were insufficient. The typical truck incident involved rollover with a spilled cargo. According to a Michigan DOT engineer, only one truck had ever penetrated the shorter barrier prior to the installation of the 1.8 m (6-ft) barrier.

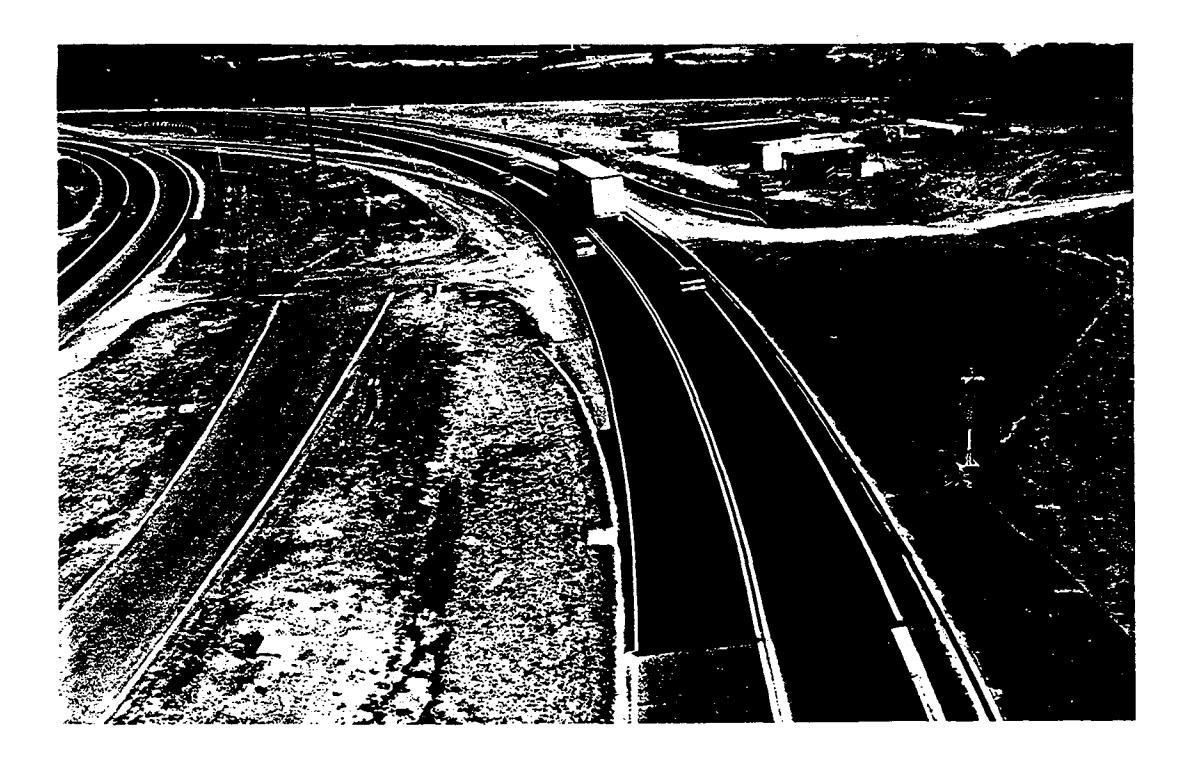
Figure 11. Eastbound exit from Blue Mountain Tunnel.

On a mainlane curve to the left, superelevated sections slope to the inside of the curve (right to left as seen by motorists), but design standards allow the shoulders to slope downward to the outside of the curve (left to right as seen by motorists). When vehicles traversing a curve to the left veer onto this shoulder, their effective superelevation is decreased. A slot-drain became necessary with the new design to collect drainage across the shoulder. The accident problem was apparently caused by excessive speeds and not being able to recover at the outer edge of the travel surface. After the improvements, more recovery area was available to vehicles by use of the shoulder.

Sketches provided by the turnpike commission show the existing maximum superelevation for this 5-degree curve at 7.87 percent on the mainlanes. Prior to improving the shoulder, a 1.8 percent negative cross-slope existed, resulting in an algebraic difference of 8.6 percent. Turnpike sources believe the improvements have significantly reduced the number of truck accidents at this location.
