# FINAL REPORT

Department of Civil and Environmental Engineering Florida International University Miami, Florida

Submitted to Atorod Azizinamini Director, ABC-UTC June 2018 ABC-UTC

EXPERIMENTAL	INVESTIGATION	OF	HIGH	PERFORMING	PROTECTIVE	SHELL	USED	FOR
RETROFITING BR	IDGE ELEMENTS							
VALIKHANI								2018

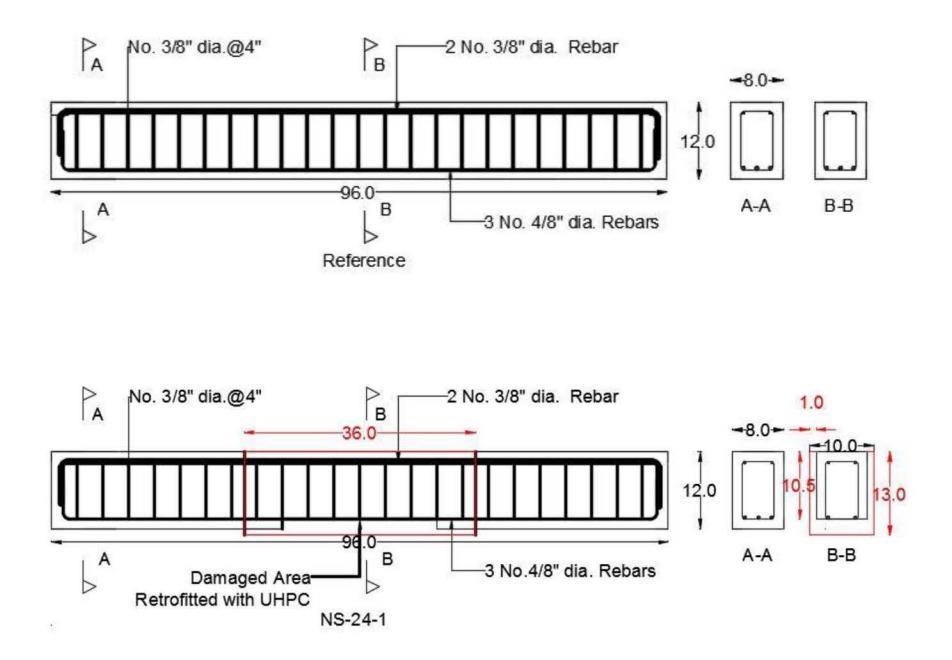
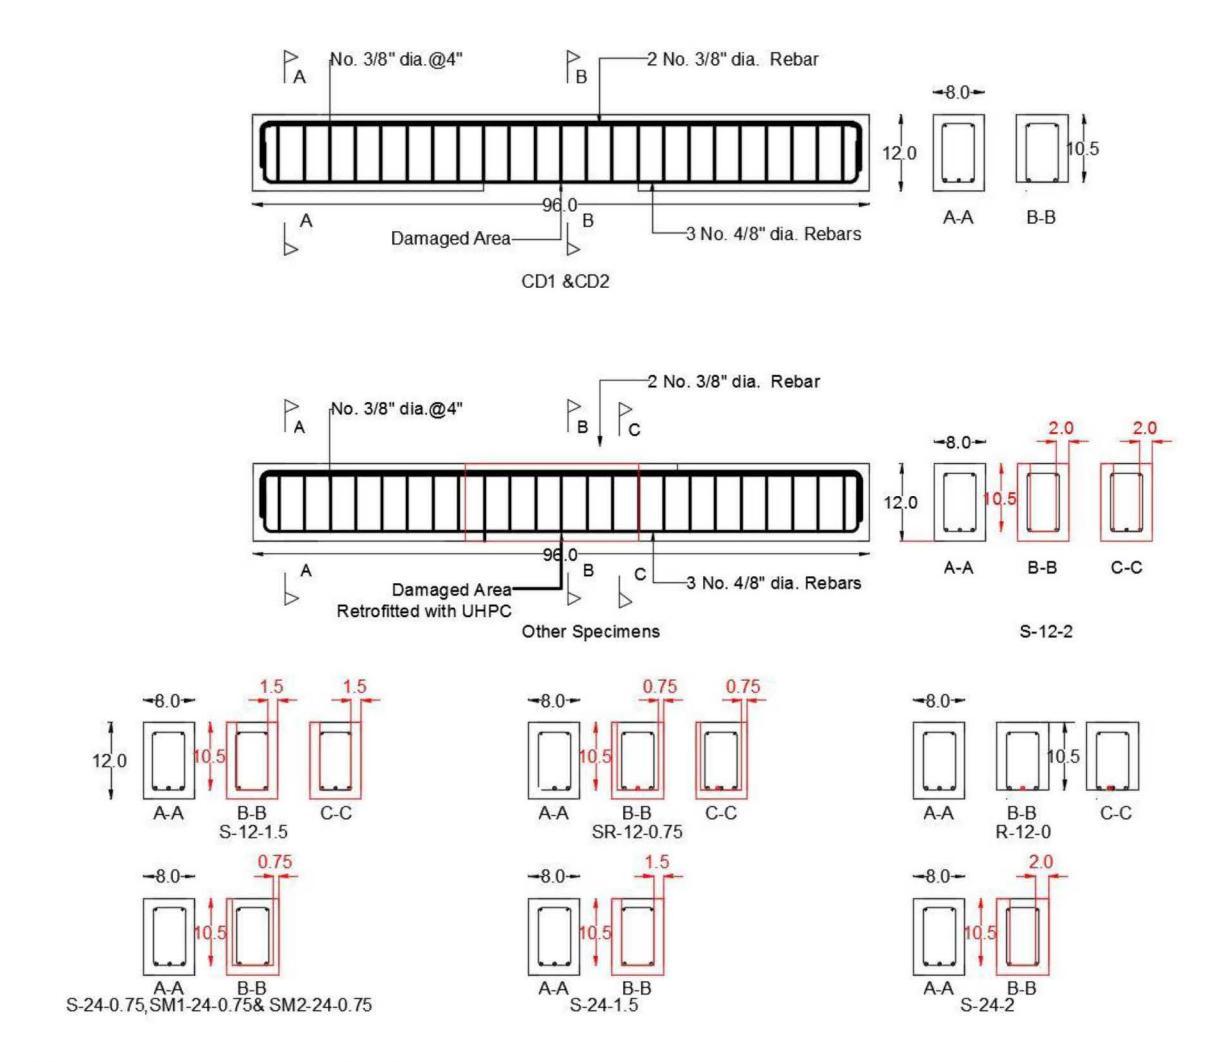
FIGURE 1 Test specimens details.

As shown in Figure 1, in all damaged specimens, part of the bottom concrete cover was removed, exposing the longitudinal tensile reinforcements. The discontinuity in concrete is 8 x 1.5-in., and 24-in. long in the middle of the beam. Each specimen included three number 4 reinforcing bars. In damaged specimens, in the middle of the beam, one of longitudinal reinforcements was cut.

These damages are in the form of removing cover concrete in the bottom of the beam and removing some of the longitudinal tension reinforcement. Specimens CD1, CD2 and NS-24-1 were identical, except that the simulated damage area in specimen NS-24-1 was repaired using thin layer of UHPC shell.

SM1-24-0.75 and SM2-24-0.75 were repaired using thin layer of UHPC shell and using mechanical connections between the UHPC shell and regular concrete with different patterns. Specimens S-24-1.5 and S-24-2 were identical as specimen S-24-0.75 in concept of using only UHPC in the damaged area without any mechanical connections and their difference is the thickness of UHPC shell in the sides. As shown in Figure 1.

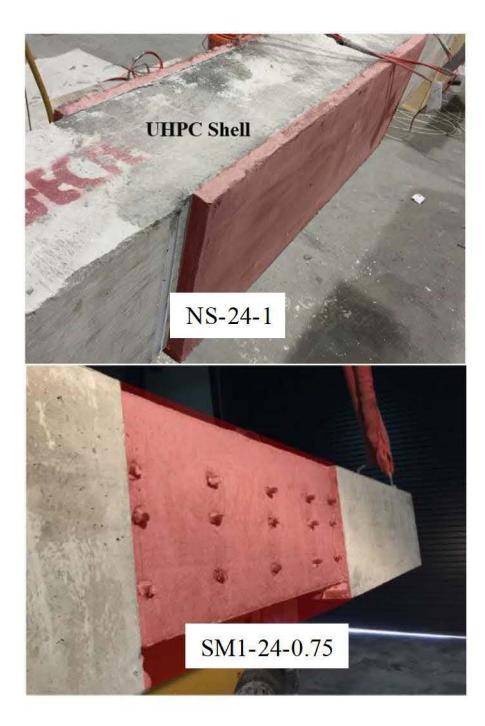
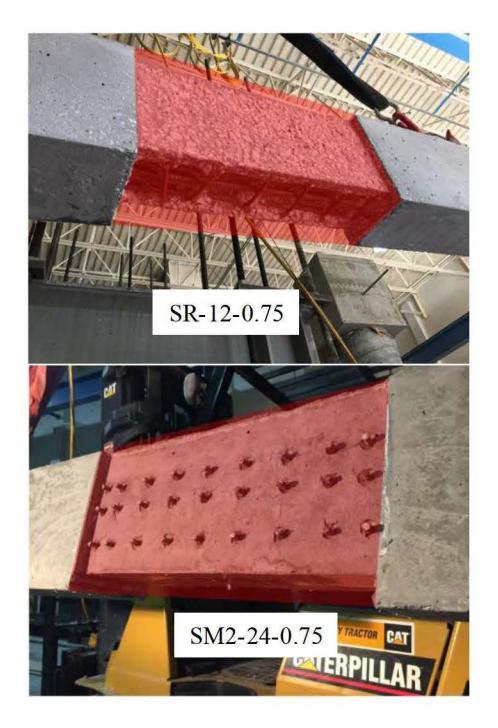
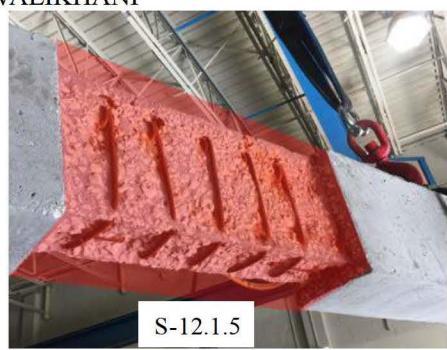
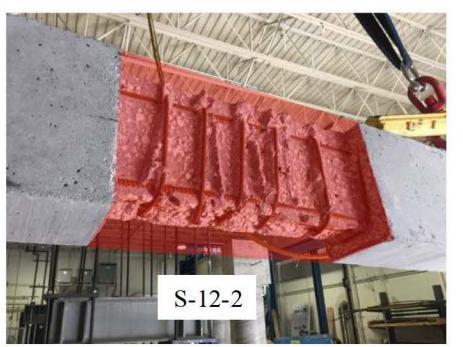
## FIGURE 2 UHPC shell detail.

For specimen NS-24-1, the UHPC was poured from one side of formwork to ensure a uniform shell around the damaged area Figure 2. It should be noted that the UHPC shell placed on sides of test specimen NS-24-1 was firmly attached to the bottom side of the beam, while the vertical sides did not incorporate any mechanism for positive attachment. Further, the surface of the beam was not prepared in any way prior to placing the UHPC. For the rest of test specimens, the selected strategies include mechanical connections and having the entire shell element being flushed with surface of existing concrete and sand blasting the damaged surface before retrofitting with UHPC as shown in Figure 2.

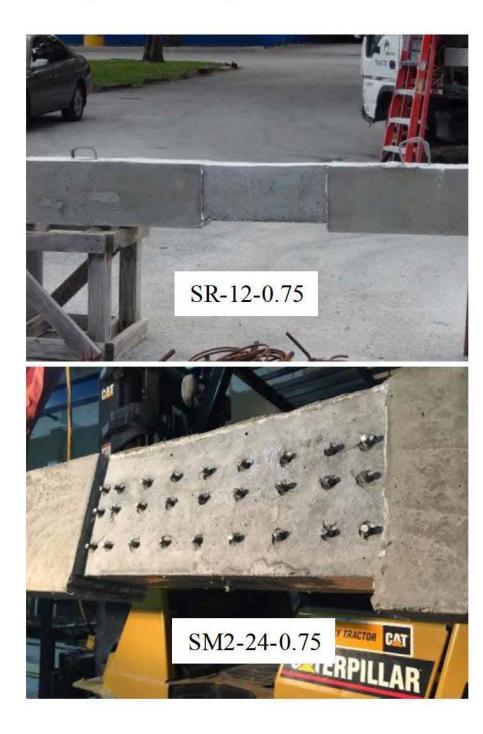
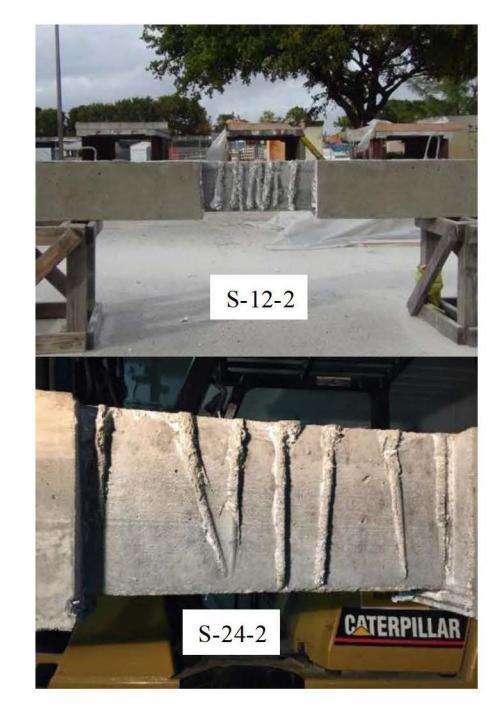
FIGURE 3 Detail of the test specimens surface before sand blasting.

For most of damaged test specimens, surfaces were prepared with the sand blasting and making the surfaces coarse for making better bonding between the UHPC shell and the regular concrete Figure 3 and Figure 4 show the surfaces before and after preparation. For rest of test specimens, the cut length of rebar was 12 inches long and for SR-12-0 and SR-12-0.75 a rebar with length of 22 inches was added to the damaged area.

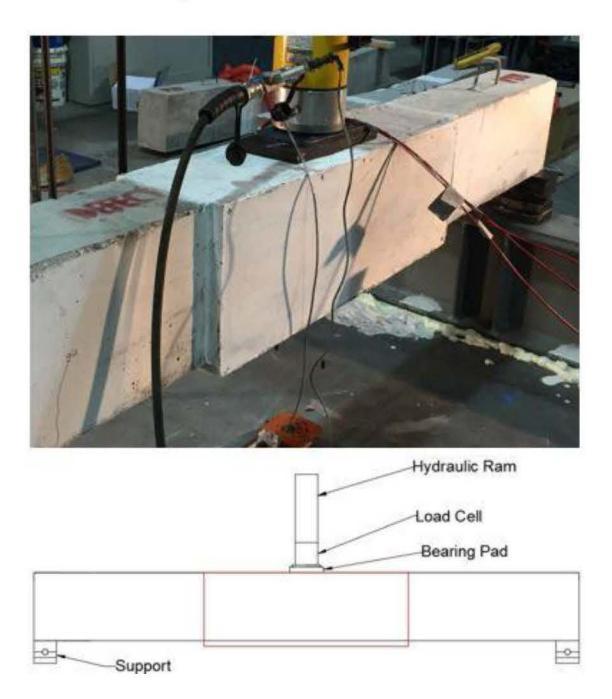
FIGURE 5 Test set up detail.

Flexure testing using three-point loading was used. Testing of specimen was achieved by placing the beams over roller type supports and loading each specimen using single hydraulic jacks, as shown in Figure 5.

Deflections of the test specimens were measured by using three linear string potentionmeters which were located at supports and mid-span. Each specimen was loaded until failure load and deflection was observed continuously during the tests.

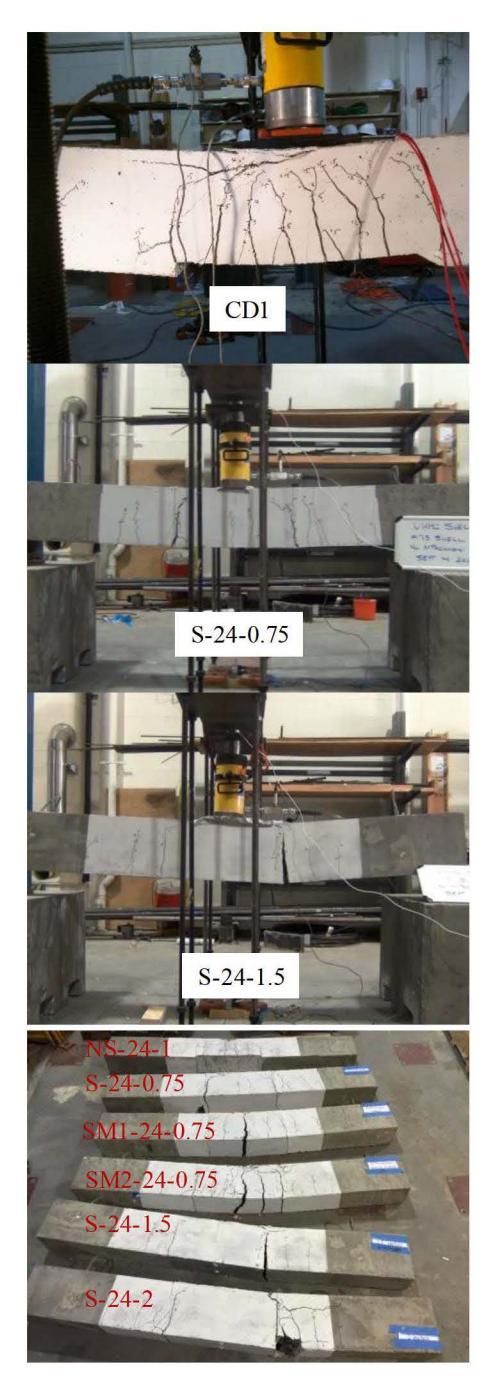
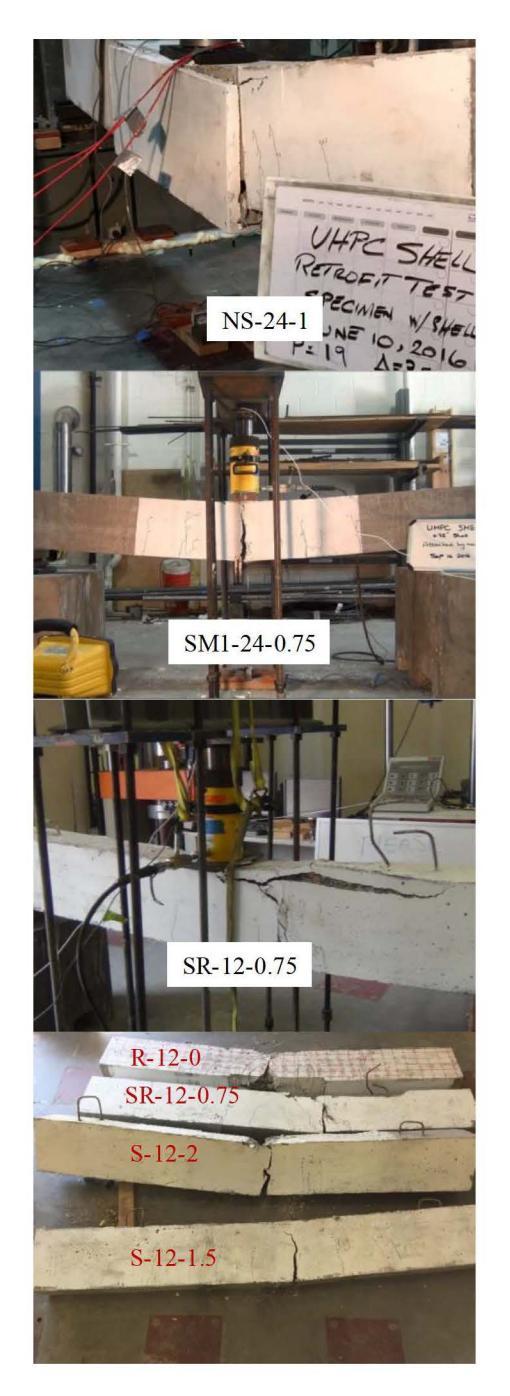
FIGURE 6 Failure of test specimen.

Specimen CD1 was loaded with the rate of 0.62 Kips/min. The first crack was observed at the load of P=5 kips,  $\Delta = 0.04$  in. and by applying more load more flexural cracks were observed at the bottom of the beam in tension area. Crushing of concrete in compression side was first observed at the load of P=16.89 kips,  $\Delta = 1.55$  in. The final failure occurred at the load of P = 17.5 kips,  $\Delta = 3.2$  in. (Figure 6).

By increasing the load up to P = 17 Kips,  $\Delta = 1.6$  in., a uniform crack was observed around the boundary of the UHPC and the regular concrete and at the load P = 18.3 Kips,  $\Delta =$

1.96 the separation of UHPC shell from regular concrete on sides of the beam was very apparent. (Figure 6).

Test specimen S-24-1.5, had its first crack on the surface of UHPC at load of 5.7 kips and at the load of 8 kips the first crack appeared outside of UHPC. For this case even at load of 14 kips no more cracks were observed in load of 15.5 kips the stiffness increases. At a load of 15.5 kips and deflection of  $\Delta = 0.3$  in two large cracks were observed between connection of UHPC shell and regular concrete. At the end of the test the regular concrete was crushed Figure 6.

Test specimen R-12-0 developed first crack at 9 kips, and next crack was observed at load 11 kips, by increasing the load the specimen crushed at load of 17 kips and  $\Delta = 1.16$  in. For test specimen SR-12-0.75, the first crack appeared at load of 11.5 kips and  $\Delta = 0.11$  in. At load 22 kips UHPC started to detaching from the beam and load dropped.at load 20 kips,  $\Delta = 0.17$  in the load started to increasing but at the end the beam failed in compression at load of 19.5 kips,  $\Delta = 1.7$  in. Even until load 18 kips and  $\Delta = 2.2$  in No damaged was observed on the UHPC surface and all the damages were observed in the bond of UHPC and regular concrete in boundary of one sides and also as crush of regular concrete at the tops side of regular concrete Figure 6.

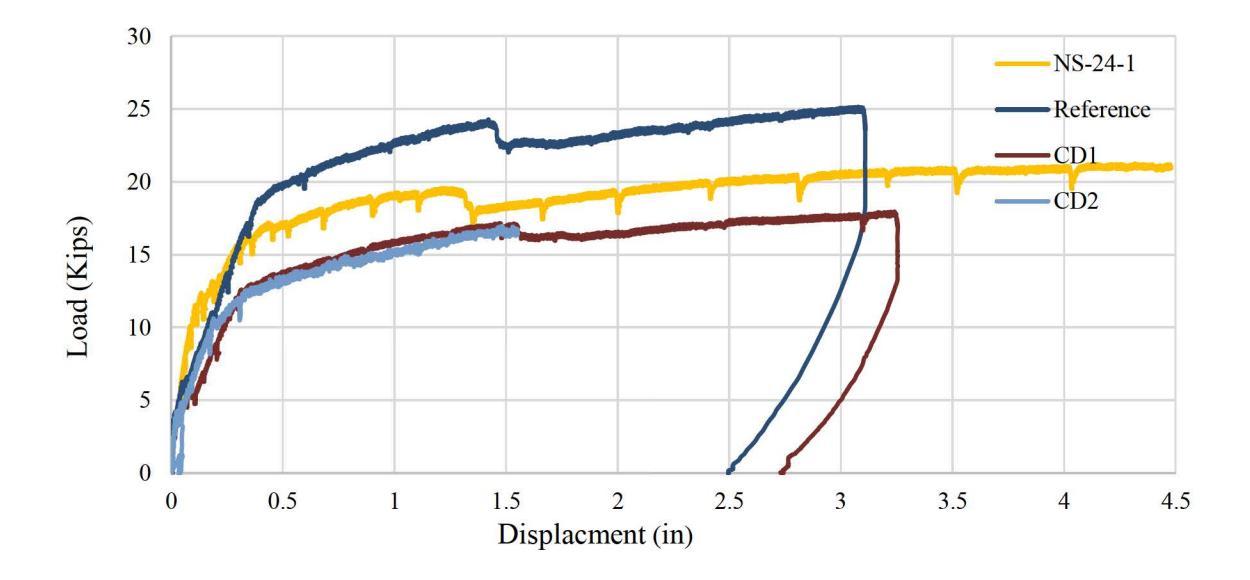
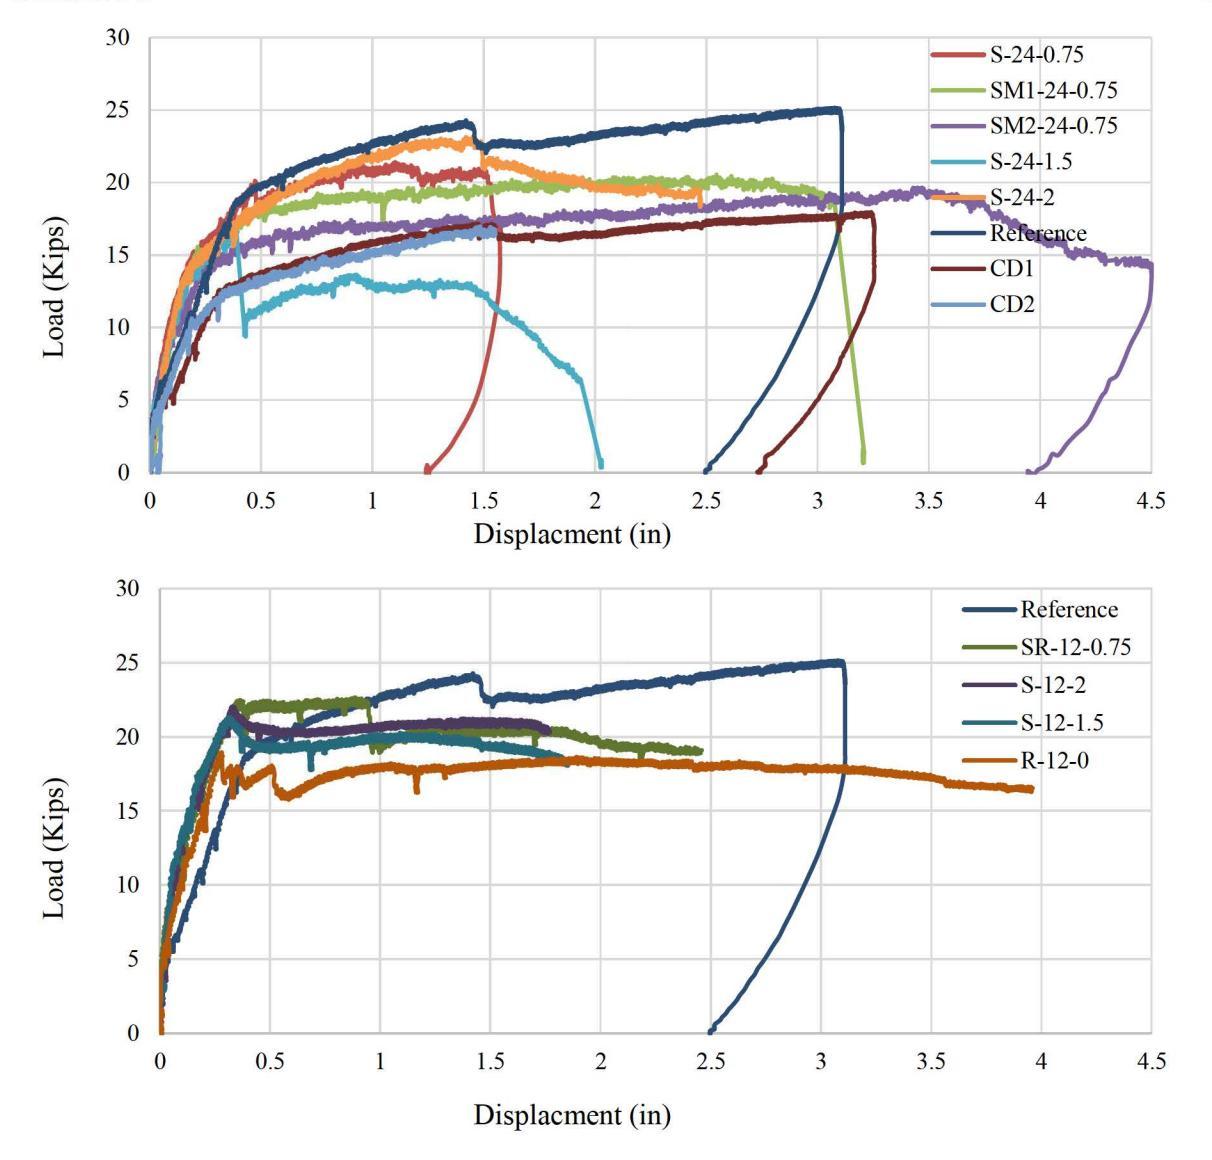
FIGURE 7 Test specimens results.

the middle of UHPC and outside of the UHPC on the regular concrete. By increasing the load up to 20 kips,  $\Delta = 0.37$  in, the flexural cracks increased in the middle of UHPC shell an at the end test specimen crushed at load of 19.5 Kips,  $\Delta = 1.4$  in. The resulting load displacement responses of all thirteen specimens are provided in Figure 7. The results of retrofitted beams show an increase of almost 35% capacity in the flexure capacity of the beam compared to damaged beams.

Refrence specimen was loaded at a rate of 0.4 kips/min. The first flexural cracks were observed at the load of P = 5 kips,  $\Delta = 0.07$  in. By increasing the loads the flexural cracks increased in the length and the height of the beam and the beams failed when applied load reached 23.kips with corresponding deflection,  $\Delta = 0.14$  in (Figure 7).
