# **Corrosion Durability of Reinforced Concrete Utilizing UHPC for ABC Applications**

**Final Report**

March 2019

Sponsored by Accelerated Bridge Construction University Transportation Center

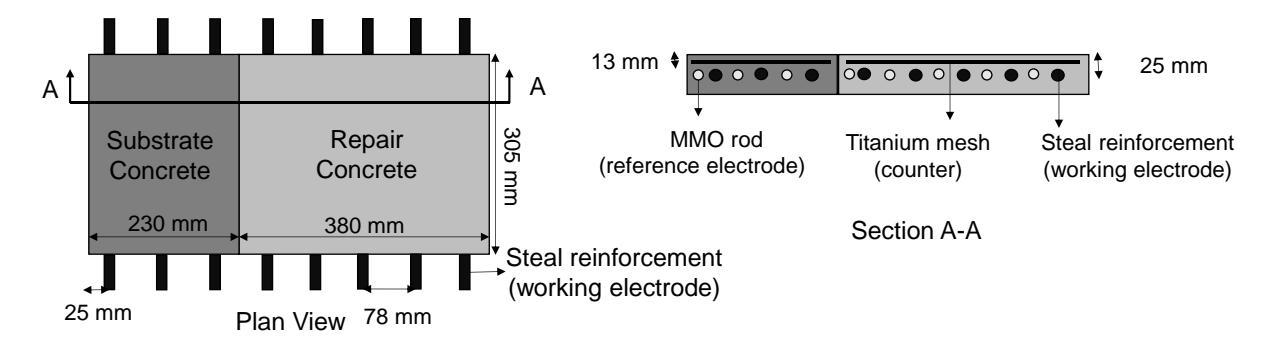
Figure 1. Test Slab Geometry

Sixteen reinforced concrete prisms were cast and divided into two groups according to the type of repair concrete material (NSC or UHPC). All testing was conducted on duplicate samples. Each prism contained a concrete portion made from the Chloride Mix to represent the substrate concrete and a concrete portion made from either the Regular Mix or UHPC to represent repair concrete. The interior side of the initial cast concrete section surface was roughened with a mechanical grinder; and prior to casting of the final concrete section, this interface surface was kept moist to facilitate bond at the cold joint. The details of the test specimen are shown in **Figure 1**.

Each concrete prism had geometry 610x305x76 mm and contained eight equidistant 9.5 mm-diameter deformed steel rebar with 25 mm clear cover from the top, bottom and side surfaces. Three of these bars were placed in the substrate concrete and five bars were placed in the repair concrete. To eliminate steel corrosion on the bar sections extending out of the concrete, the outer 508 mm sections of the rebar were coated with epoxy. Activated titanium reference electrodes were placed in between each bar and two discrete activated titanium mesh were embedded on the near surface of the prism. Each bar was electrically coupled via electrical switches to allow macrocell current measurements from steel electrodes in the substrate concrete and repair concrete with a current meter. The electrical switches also allowed for changes in sample configuration cathode and anode size. Cathode-to-anode ratio (5:3, 5:2, 5:2, 5:1, 4:3, 4:2, 4:1, 3:3, 3:2, 3:1, 2:3, 2:2, 2:1, 1:3, 1:2, 1:3)) were varied by systematically decoupling rebar electrodes. Cathode-to-anode ratio 1 and 2 had multiple configurations.

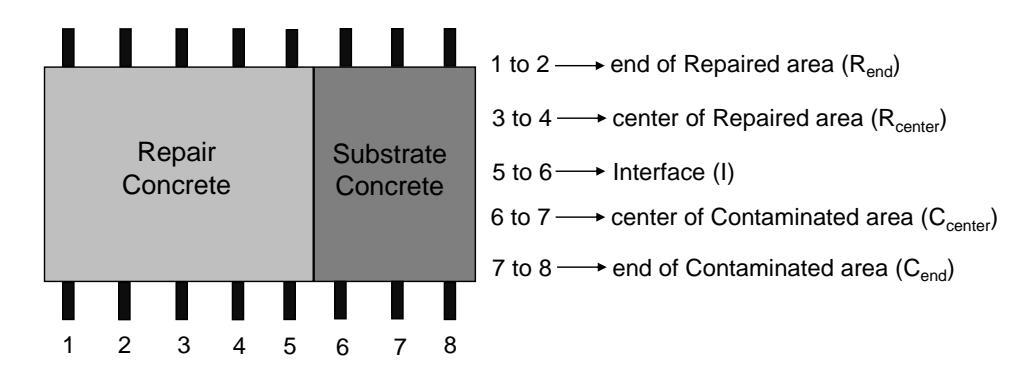
Figure 2. Configuration for Resistance Measurements

The resistance between every two working electrodes was measured using two-point resistance measurements prior to and after ponding the samples to see the effect of concrete wetness on the resistivity. The measurements were made for five configurations as shown in **Figure 2** including resistance measurements in the substrate concrete, repair concrete, and the interface.

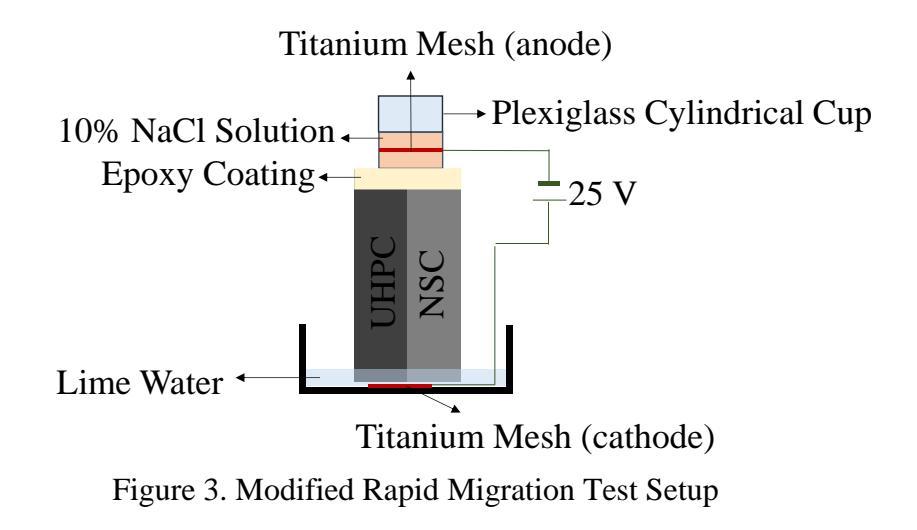
A modified Rapid Migration Test was used to assess chloride penetration through the cold joint. The test setup is shown in **Figure 3**. The flat portions of the cylindrical specimen were uniformly ground to create smooth surfaces. An acrylic tube used as a ponding dam was attached to the top surface. An epoxy sealer was used around the base of the ponding dam and extended on the outer surface of the cylinder to minimize salt solution leakage and weeping on the surface of the specimen. The pond was filled with a 10% NaCl solution. The bottom portion of the specimen was set into a shallow solution of lime water. Titanium mesh electrodes were placed at each end and 25 Volts was applied by a DC power supply for 21 days to allow electrical migration of chloride ions to flow through the concrete.

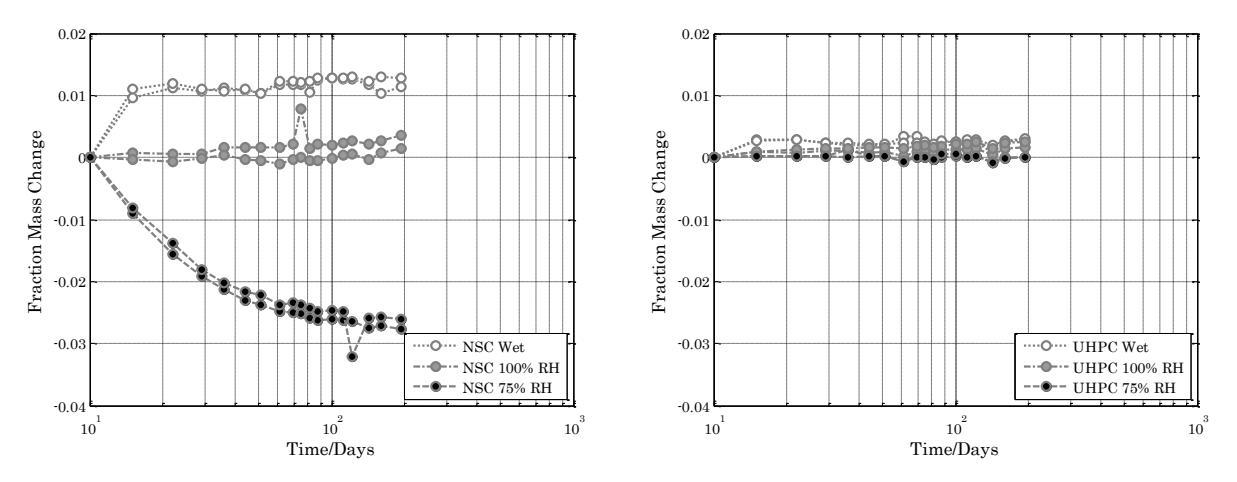
Figure 4. Mass Change for NSC and UHPC in Moisture Exposure Environments.

**Figure 4** shows the results of concrete mass change for NSC and UHPC exposed in immersed conditions, 100% RH, and 75% RH. As expected, there is a small mass loss during hydration of the conventional concrete in ambient 75% RH conditions and some mass increase during hydration when exposed to high moisture conditions such as in immersion or 100% RH conditions. In the high moisture conditions, excess available moisture is retained in the developed concrete macropores. Only minor to no increase in mass was observed for UHPC in all of the tested moisture exposure conditions. This may be due self-dessication of concrete due to the high cement content and low concrete porosity

- Only minor to no increase in mass was observed for UHPC in all of the tested moisture exposure conditions possibly due to self-dessication of concrete.

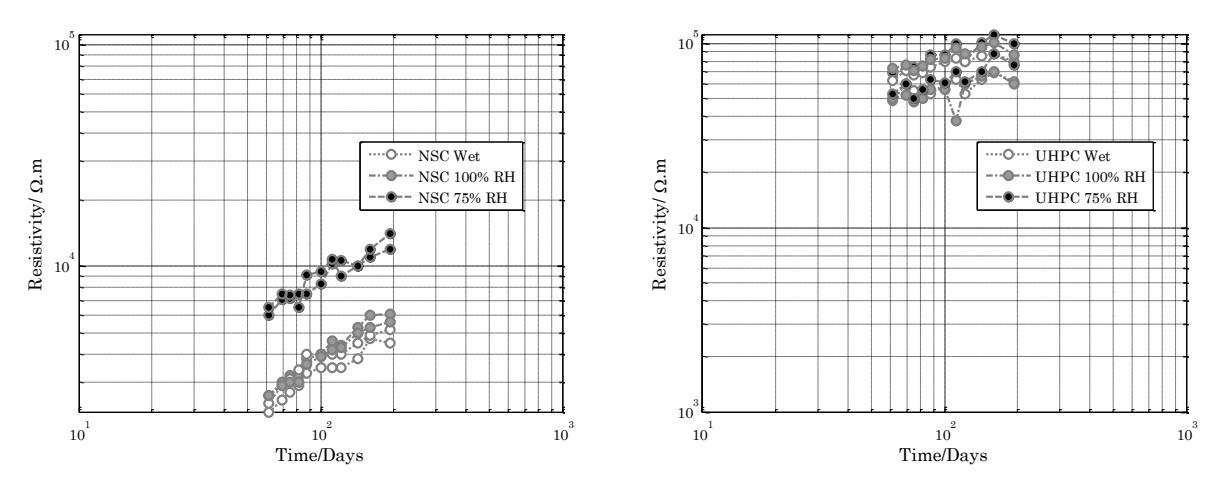
Figure 5. Bulk Concrete Resistivity for NSC and UHPC in Moisture Exposure Environments.

**Figure 5** shows the calculated bulk resistivity of the concretes in the moisture exposure environments. For conventional concrete and UHPC, the increase in bulk resistivity regardless of expected internal moisture presence (due to the various moisture exposure environments) is indicative of early cement hydration. In the conventional concrete, the lower bulk resistivity developed in the moist exposure conditions is due to filling of pore spaces with excess moisture (as supported by the increase in mass with time in those samples). UHPC showed bulk resistivity up to an order of magnitude larger than the tested conventional concrete, consistent with its higher cement factor and relatively low internal moisture content due to its low permeability.

- UHPC showed bulk resistivity up to an order of magnitude larger than the tested conventional concrete, consistent with its higher cement factor and relatively low internal moisture content due to its low permeability.

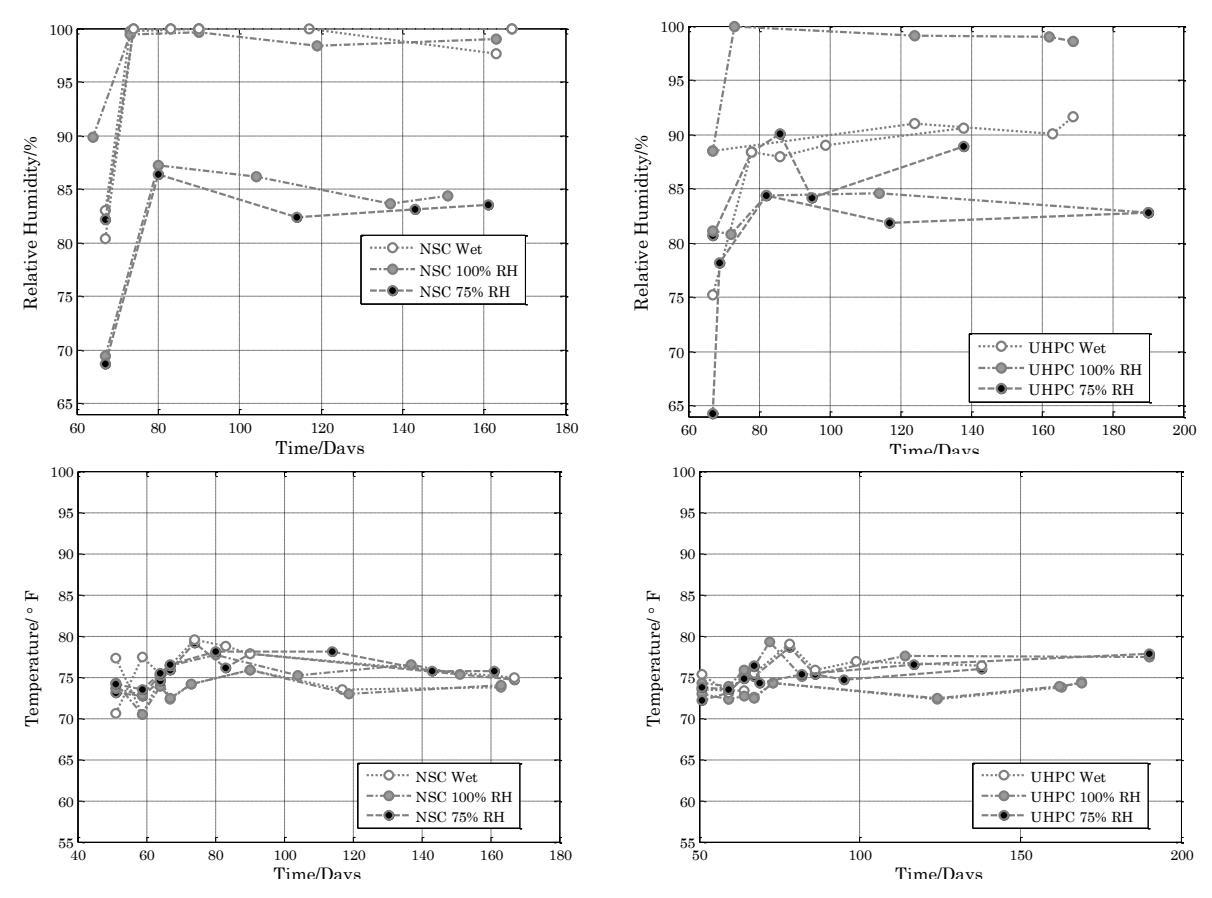
Figure 6. Internal Relative Humidity and Temperature of NSC and UHPC in Moisture Exposure Environments.

**Figure 6** shows the internal relative humidity (IRH) for conventional concrete and UHPC. As expected, the IRH was higher for the moist exposure conditions than at 75% RH. Also, UHPC generally showed lower internal relative humidity consistent with low internal moisture content that was also described by the low mass gain and high bulk resistivity for samples exposed in both 75% RH and higher moisture conditions. Therefore, the results verify high quality, low permeability characteristics of UHPC in both ambient and high moisture exposure environments.

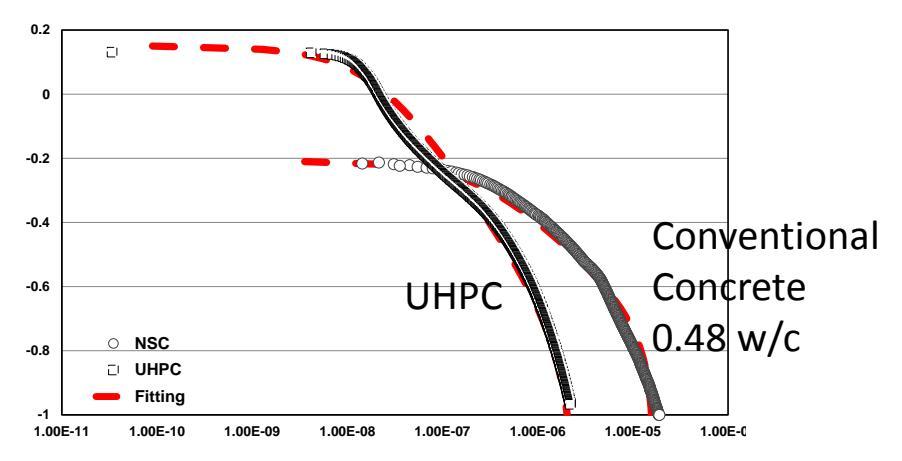
Figure 7. Example of Cathodic Polarization Curve Fitting Results.

Characterization of oxygen transport through UHPC is important to identify if the highquality concrete may mitigate corrosion by slowing the rate of oxygen reduction. The limiting current was calculated by least square fitting of the cathodic polarization scans. An example of that procedure is shown in **Figure 7** for UHPC and conventional concrete conditioned in 100%RH. The findings for the small-scale testing indicate low permeability for UHPC in moist exposure conditions. Per earlier discussion, the UHPC would then be expected to have low porosity and low internal moisture content where one could pose that the reduced moisture presence may enhance gas transport. However, the larger cement factor in UHPC would provide a denser material. Indeed, the calculated approximate oxygen diffusivity (**Figure 8**) for UHPC was much lower than the conventional concrete, and lower diffusivity was observed in UHPC exposed in immersed conditions than in ambient humidity conditions. Therefore, development of corrosion cells is expected to be mitigated in part due to low gas permeability.

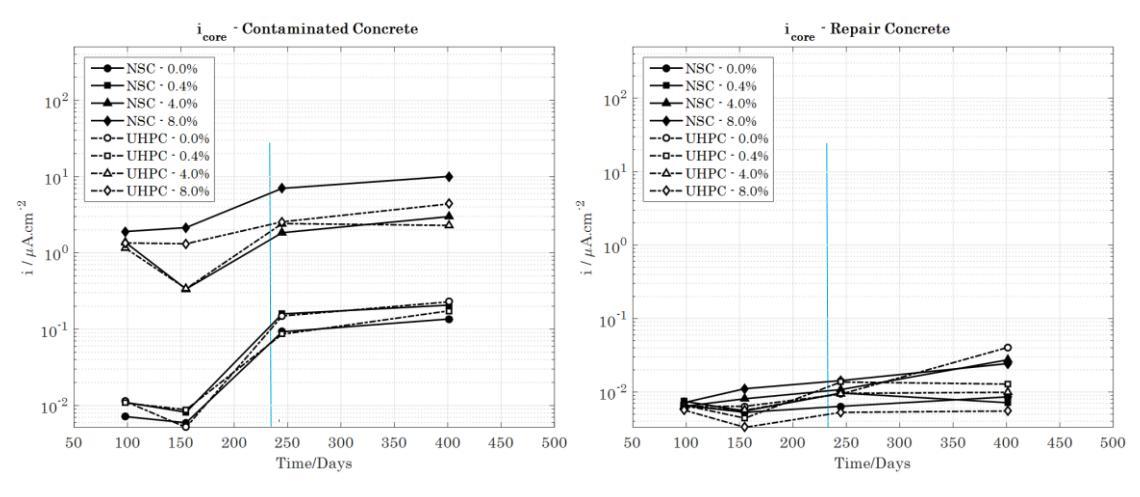
Figure 9. Corrosion Current Density

Consistent with OCP measurements, low corrosion currents were measured in the chloride-free repair UHPC and NSC concrete before and after wetting (see **Figure 9**). As expected, high corrosion current densities were measured for the substrate NSC concrete contaminated with 4 and 8% chlorides; these corrosion current densities showed further increase after concrete wetting due to the expected lower solution resistance of wet concrete. The unexpected activation after wetting of the substrate NSC concrete with 0 and 0.4% chloride in all test samples showed an increase in corrosion current density relative to corrosion current densities measured for those electrodes when passive in the dry condition.

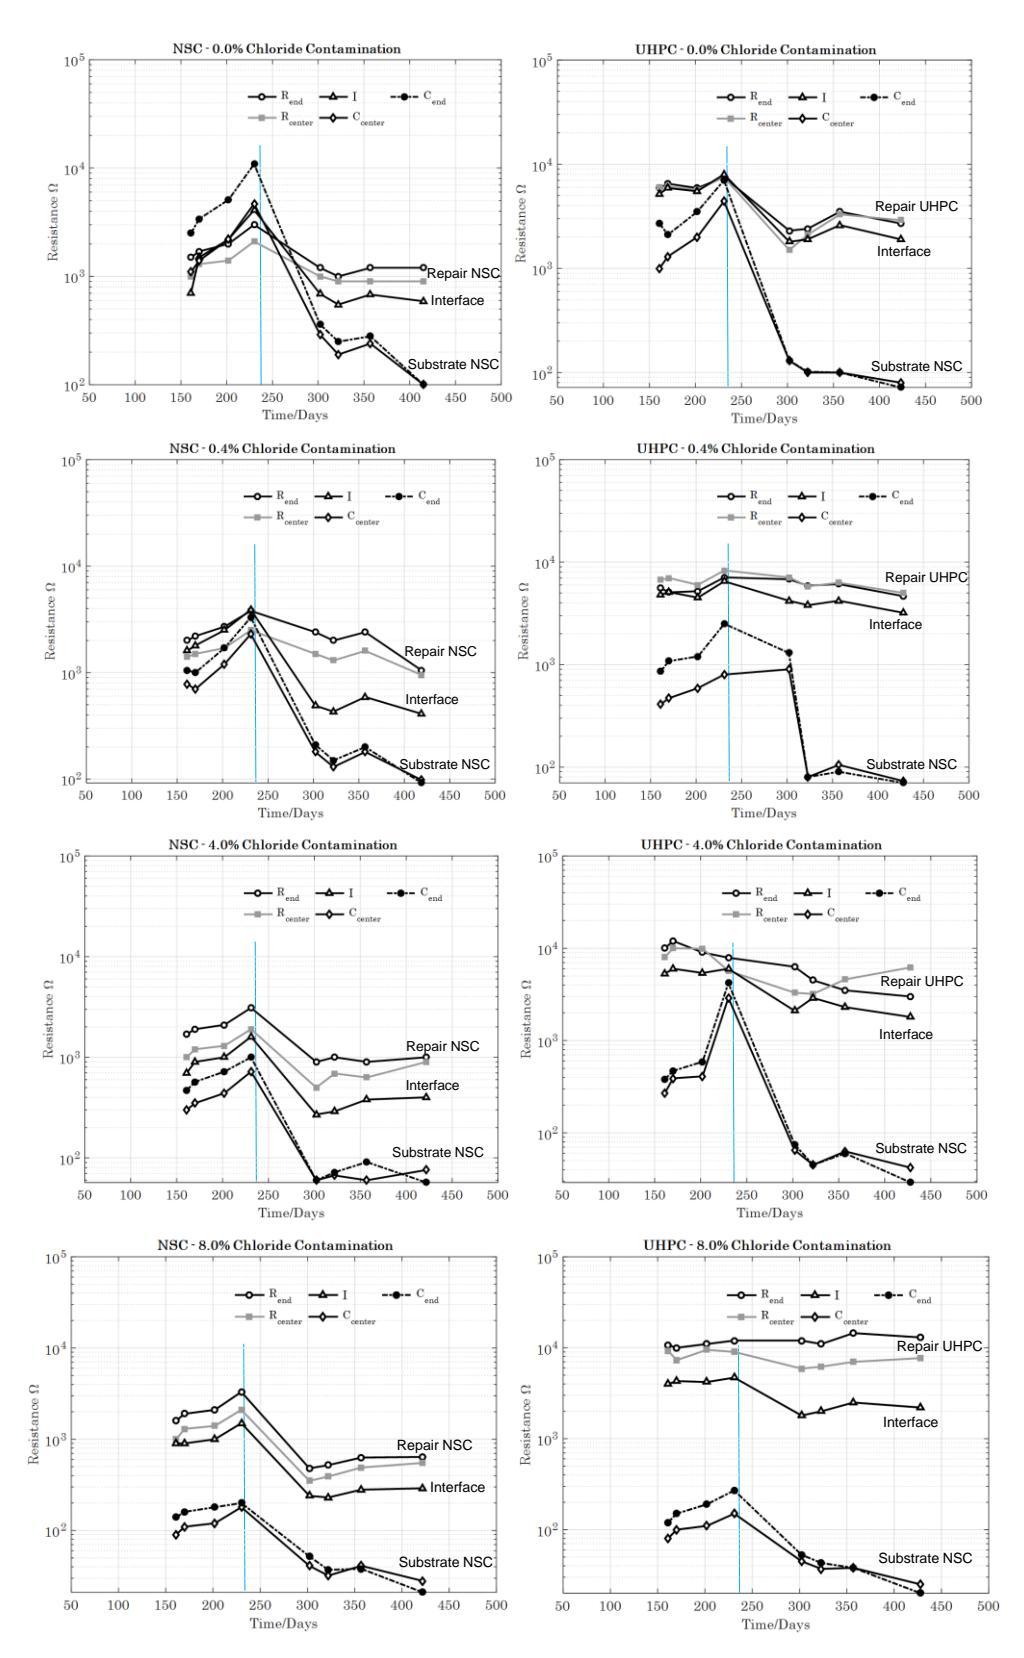
Figure 10. Concrete Resistance

The results of measured two-point resistance of the samples is shown in **Figure 10.** The resistance of the samples regardless of the location on the concrete samples decreased after wetting; however, this reduction was significantly less in UHPC consistent with the low permeability of the material. The changes in the concrete bulk resistance was consistent to the trends observed in the macrocell measurements and further illustrate the positive use of UHPC.

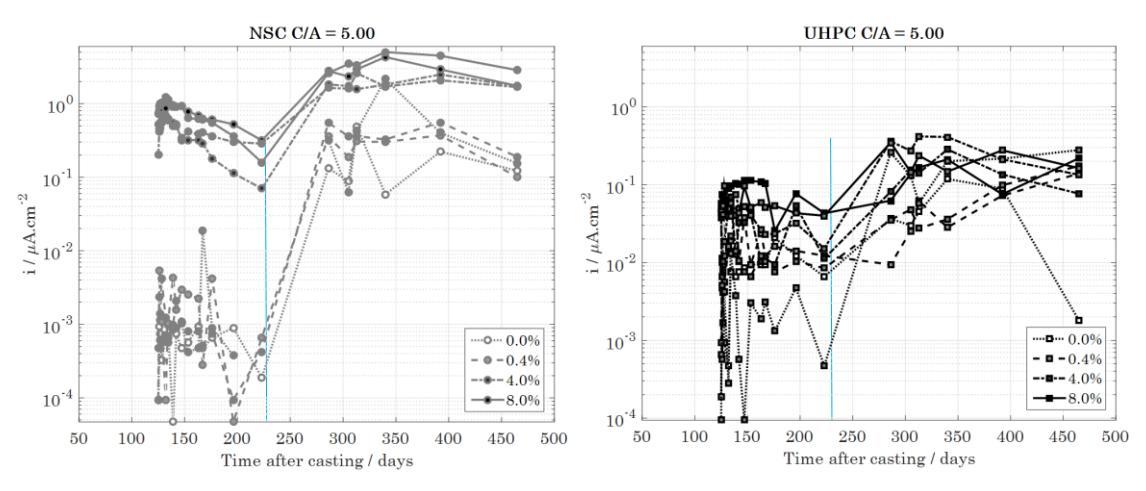
Figure 11. Example of Macrocell Current Data of Steel Embedded in Substrate and Repair Concrete.

After coupling all rebar electrodes together, the macrocell current between the electrodes in the repair and substrate concrete was measured. Low macrocell currents were measured for NSC in the dry condition where passive corrosion conditions were present for rebar in both substrate and repair concrete (0 and 0.4% wt Cl in substrate concrete). After wetting, the OCP values showed unexpected activation of the rebar in the substrate concrete for these test samples. The developed macrocell current, correspondingly, showed an increase. When rebar in the substrate concrete in the presence of higher chloride content (4 and 8% wt Cl-) had active corrosion, large macrocells developed. These values showed a significant increase after wetting (see Figure 11). As will be described later, macrocell current can be enhanced with larger cathode-to-anode ratios. In contrast, low macrocell current developed between the rebar electrodes embedded in the UHPC repair and substrate concrete regardless of the level of anodic activity in any of the chloride content in the substrate concrete. Wetting of the concrete did indicate overall increase but current levels still remained significantly smaller than comparative samples cast with repair NSC. The results indicate that regardless of corrosion activity, there is a mitigating effect by the placement of UHPC. Galvanic coupling of rebar electrodes between the repair and substrate concrete is reduced due to the high electrical resistivity provided by the UHPC and enhancement due to moisture is mitigated by the low permeability characteristics of the material.

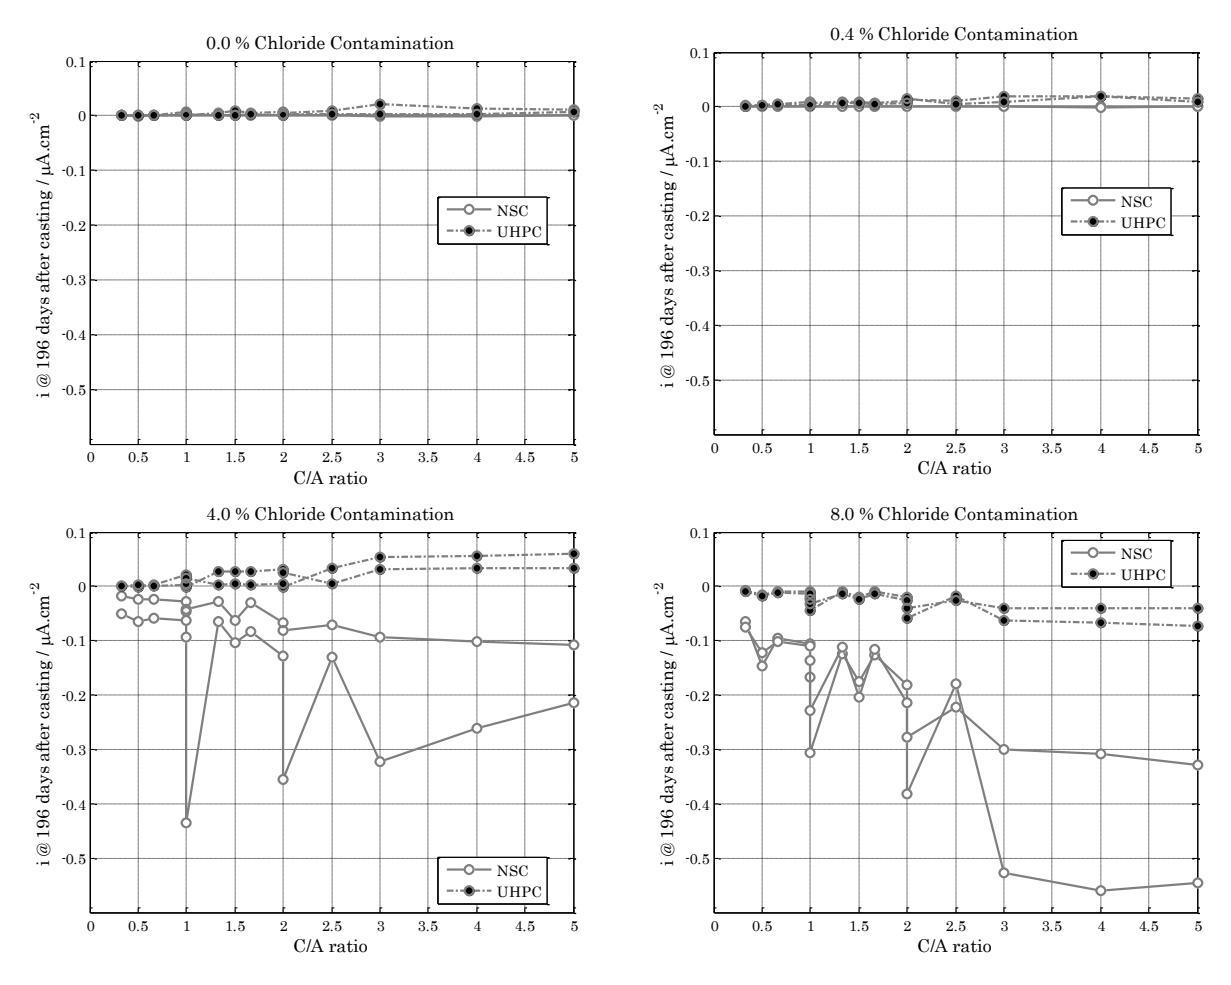
Figure 12. Effect of Cathode-to-Anode (C/A) Ratio for Rebar Embedded in NSC or UHPC Repair Concrete in Dry Condition.

Consistent with the earlier OCP and LPR results, low macrocell currents developed in samples with conventional and UHPC repair concretes when the vestigial chloride content in the substrate concrete was low. At higher vestigial chloride contents in the substrate concrete, the macrocell current was enhanced at higher C/A for samples utilizing conventional concrete for the repair concrete. This is consistent with the fast deterioration of conventional patch repairs in marine bridges. In contrast, as mentioned earlier, macrocell current was much reduced in samples repaired with UHPC even with higher vestigial chloride presence in the substrate concrete. In conditions with 0, 0.4, and 4wt% chlorides, the macrocell was negligible, although some cases showed that the steel in the UHPC repair concrete was net anodic. In the condition with 8wt% chlorides in the substrate concrete, some enhanced macrocell developed with increased C/A.

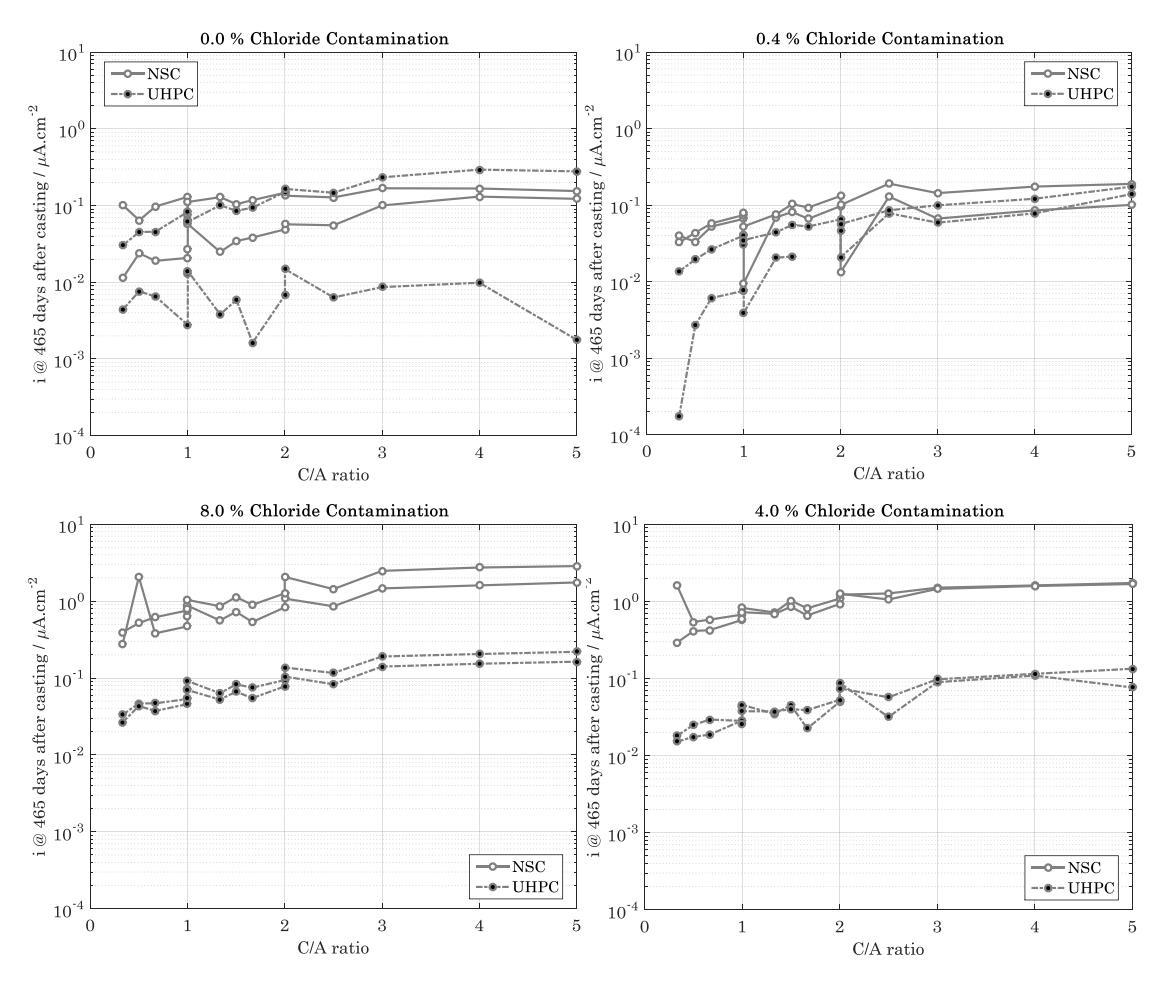
Figure 13. Effect of Cathode-to-Anode (C/A) Ratio for Rebar Embedded in NSC or UHPC Repair Concrete in Wet Condition.

Similar trends in the wet concrete was observed as in the dry concrete; however, as described earlier, macrocell currents were overall higher for all conditions including with the use of UHPC as the repair material. Low macrocell currents developed in samples with conventional and UHPC repair concrete when the vestigial chloride content in the substrate concrete was low. For both NSC and UHPC the macrocell currents increased with higher C/A. In comparison to results for concrete in dry condition, the macrocells were elevated for all concentrations. Identifying material characteristics, corrosion parameters, and environmental conditions would be important to specify practical threshold vestigial chloride content before corrosion damage can propagate in concrete. The results from the laboratory testing would indicate that substrate concrete containing significant chloride content should be removed prior to application of any repair materials including UHPC.

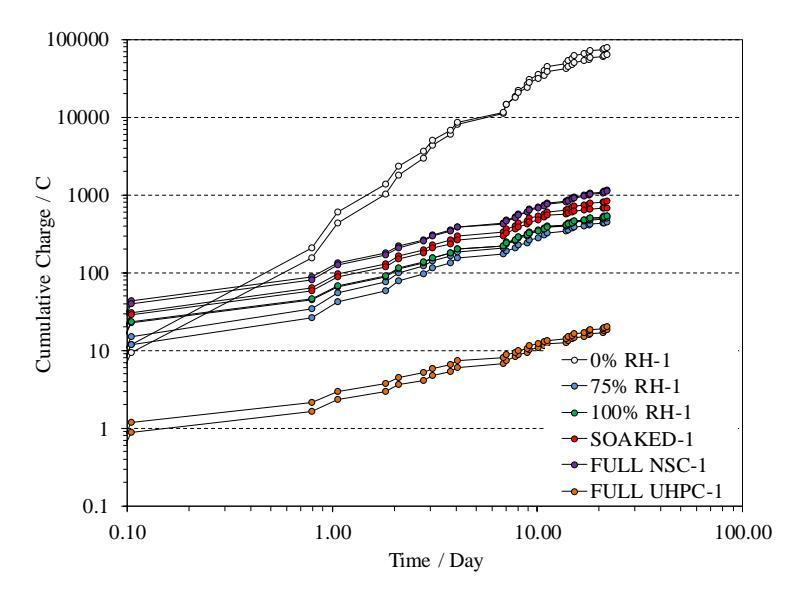
Figure 14. Cumulative Charge Data for Modified Rapid Migration Test

Error! Reference source not found. shows test results in terms of total charge passed (TCP) in coulombs for the NSC, UHPC, and composite NSC/UHPC specimens. The plain UHPC specimen exhibited the lowest TCP values (i.e. 8 and 21 coulombs at 7 days and 21 days, respectively), while the plain NSC specimen exhibited TCP value more than 1000 coulombs after 21 days. All the composite specimens, except the composite samples where substrate was conditioned at 0% RH before UHPC placement, exhibited TCP lower but within the same order of magnitude as the plain NSC specimens. This was likely attributed ionic current passing through the NSC portion of the concrete specimen. The high TCP value for of the composite samples where the substrate was conditioned at 0% RH before UHPC placement can be part contributed to the capillary absorption of the concrete substrate leading to quick absorption of chloride solution.

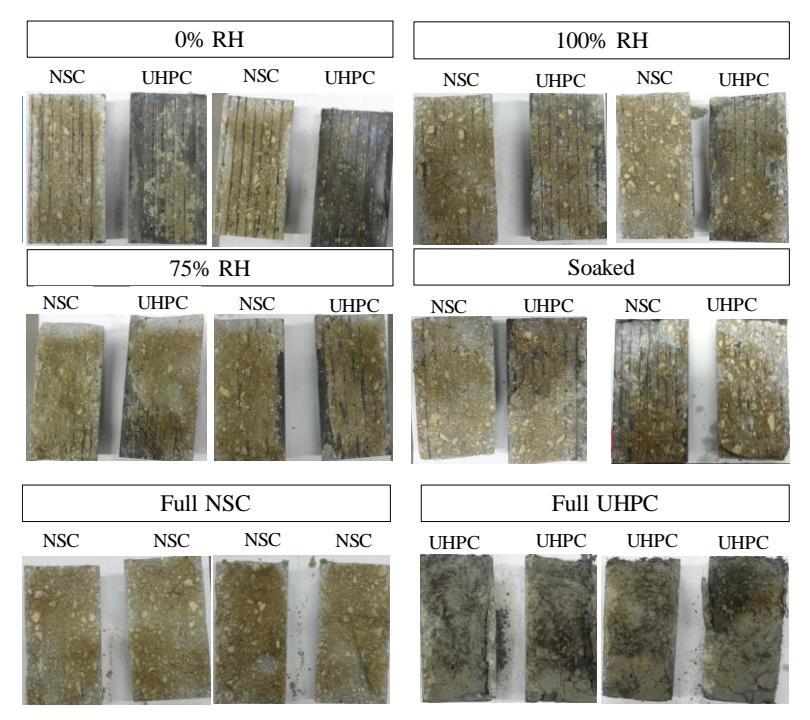
Figure 15. AgNO<sub>3</sub> Spray Indicator for Chloride Penetration.

After splitting the samples under load, both surfaces were sprayed with 1M AgNO<sub>3</sub> solutions. The photos after spraying AgNO<sub>3</sub> indicator are shown in Error! Reference source not found. Chloride penetration could be readily observed by the differentiation in surface coloration on the NSC portion of the specimen. Bulk chloride penetration can generally be seen at the upper portion of the specimen and was larger for specimens with higher moisture levels. It was apparent from the color indicator that the large TCP for the composite specimens conditioned at 0%RH occurred largely along the edge of the specimen as moisture from the test solution had preferential transport there.

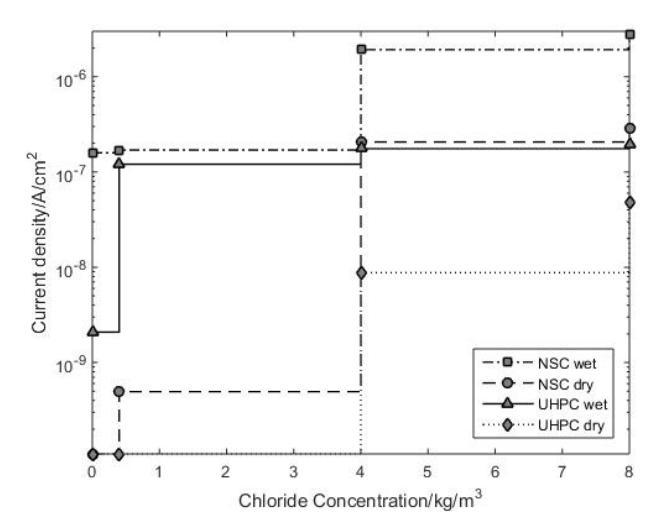
Figure 16. Macrocell Current Densities

From the experimental work described above, macrocell currents developed between local anodes in the substrate concrete and the steel in the repair material. These macrocell currents were greater at higher chloride concentrations in the substrate concrete and furthermore enhanced in wet conditions. For the simple damage projection calculations, the macrocell current magnitudes were discretized based on the chloride levels used for testing (0, 0.4, 4, and 8% wt Cl-) as shown in **Figure 16.** Based on the chloride levels calculated by simple diffusion transport at time t, the macrocell current corresponding to the next higher discretized chloride step was selected. This was thought to be a conservative approach given the rather coarse level discretization. The cumulative mass loss (based on Faradays Law) was calculated using the given macrocell current for the time period required for chlorides to diffuse to the next higher chloride level step. The process was repeated (summing up the total mass loss) with each successive step of chloride level concentration (and the corresponding macrocell current). If the chloride concentration at the bar cover depth already exceeded lower steps, the next higher macrocell level was assumed. If chloride levels exceed 8%, the macrocell current at 8% was retained.

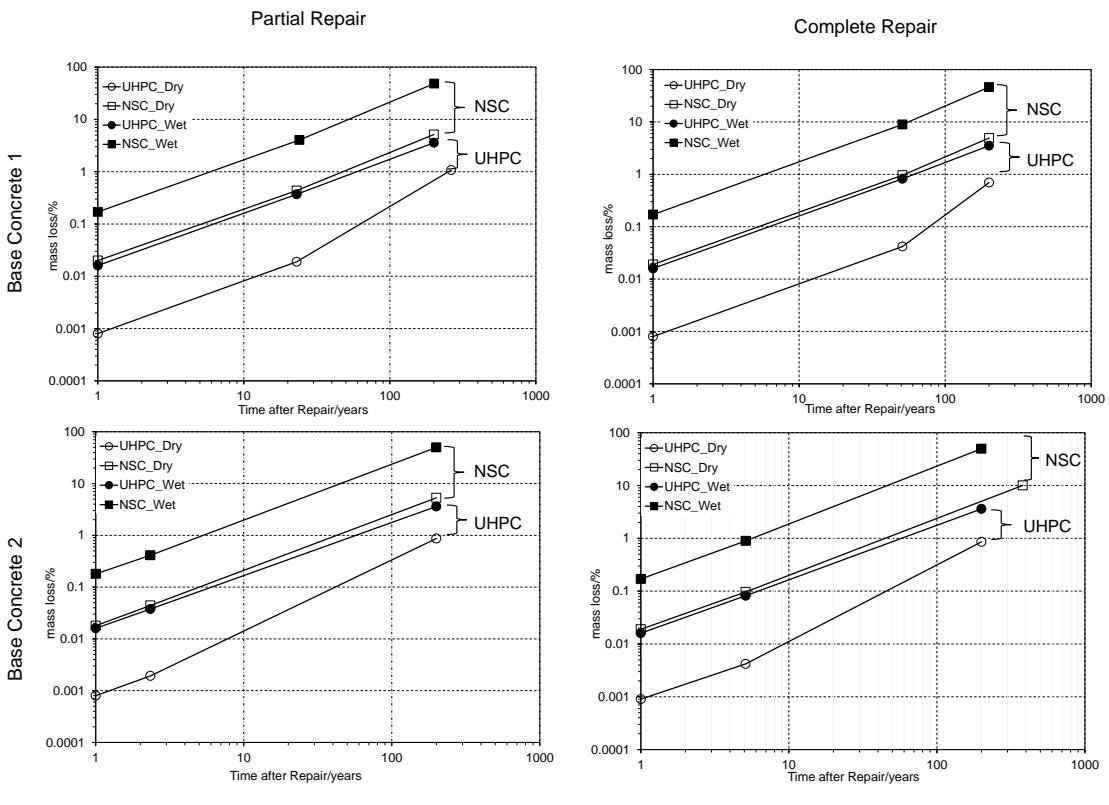
Figure 19. Calculation Results for Repair Service Time

**Figure 19** shows the calculation output results for conjectural cases for 2 concrete mixes (Base Concrete 1 and 2) characterized by its chloride ion diffusivity:  $1 \times 10^{-12} \text{ m}^2/\text{s}$  and  $1 \times 10^{-11} \text{ m}^2/\text{s}$ , respectively. For those concretes, a hypothetical repair was made by replacing damaged concrete either within the tidal zone (partial repair) or in the upper splash zone (complete repair) with UHPC or with NSC.

Generally, the influence of the substrate concrete quality was readily evident. For the conjectural cases, the calculated chloride levels in the zones adjacent to the repair concrete at the time of repair already exceeded 0.4%. Therefore, following the calculation protocol, the time for diffusion of chlorides to 4% was used for initial calculations for initial macrocell corrosion. Base Concrete 2 with  $D=1x10^{-11}m^2/s$  reached that initial chloride step 10 times faster than Base Concrete 1 with  $D=10x10^{-12} m^2/s$ . In a similar way, the extent of the repair material (i.e. partial or complete repair) was evident by the diffusion of chlorides where longer service time to reach 4% chloride was evident for the complete repair compared to the partial repair. Mass loss was faster for the calculation conditions assuming the concrete was in wet condition due to the enhanced macrocell currents there.

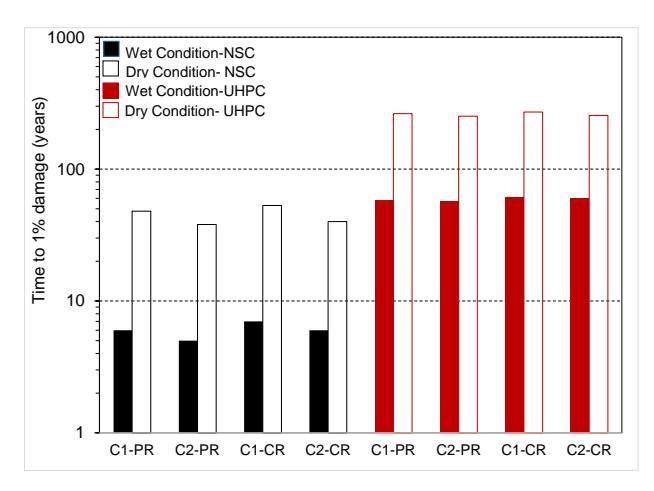
Figure 20. Calculation Results for Comparative Time to 1% Damage.

**Figure 20** shows a compilation of calculations for repair service time for 1% corrosion damage. It was evident that extended service time in comparison to conventional patch repairs can be afforded by application of UHPC repair based on the assumptions of the calculation approach. The effect of substrate concrete quality, moisture level, and repair placement can also be summarized in the figure.

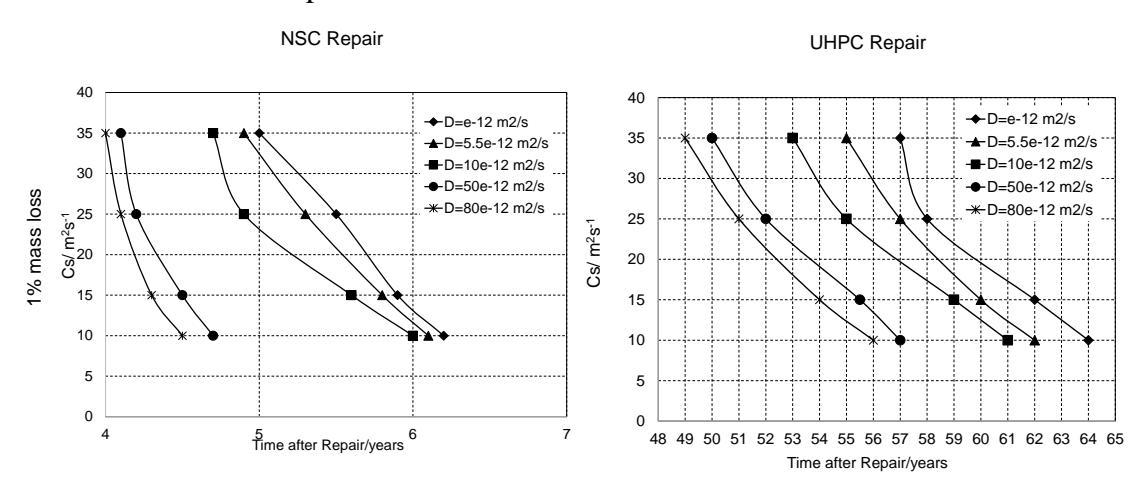
Figure 21. Output Results for Conjectural Cases

**Figure 21** shows calculation output results for conjectural cases for 5 different concretes characterized by chloride ion diffusivity ranging from  $1 \times 10^{-12}$  m<sup>2</sup>/s to  $8 \times 10^{-11}$  m<sup>2</sup>/s for 1% corrosion of rebar after repair with UHPC or NSC. The service life to 1% corrosion was calculated for various chloride exposure environments characterized by Cs. Only macrocell currents from laboratory testing in the wet condition were considered here as similar trends but with longer service time were calculated for dry conditions. Generally, the influence of low macrocell currents measured for UHPC samples compared to NSC samples is readily apparent in the calculation results. Much longer time to damage after repair was calculated for the UHPC repair than NSC concrete repair.

The simplifying assumptions in the calculation approach would not necessarily provide accurate service times but the results due provide information to quantitatively compare the effect of repair with UHPC compared to NSC for the given assumptions based on empirical data on macrocell development and mass diffusion. Even though the macrocell current step (used in the calculation for a given chloride level) used current values from laboratory testing at higher chloride levels, the enhancement of the macrocell in the lab sample may not necessarily reflect actual structures due to the fact that extended cathodes in poor quality substrate concrete where coupling could be enhanced. However, comparative conjectural cases with NSC concrete have similar limitations.
