**SLEEVE EXPANSION OF BOLT HOLES
IN RAILROAD RAIL**

Volume I - Description and Planning

BOEING COMMERCIAL AIRPLANE COMPANY
P.O. Box 3707
Seattle WA 98124

FEBRUARY 1980

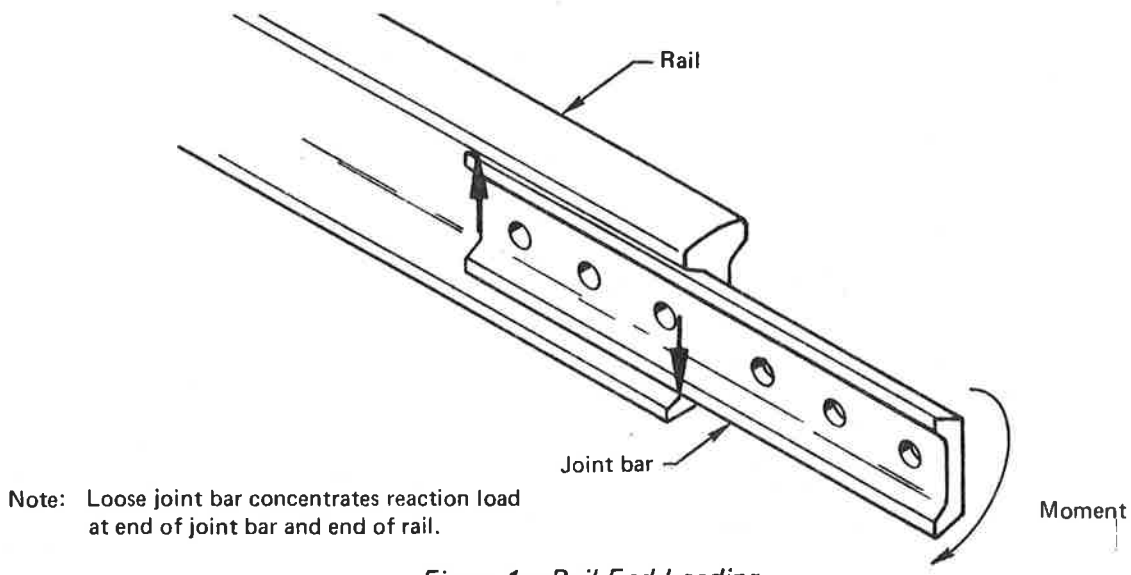
Figure 1.—Rail End Loading

The cracks originating from bolt holes are the result of shear stress that develops in the rail end when the joint bar transmits the bending moment across the joint through concentrated point contact at the rail and at the end of the joint bar (fig. 1). This condition occurs whenever the joint bar becomes loose or, on installation, was not nested correctly between the head and flange of the rail. The shear stress is then magnified by the stress concentration effect of the bolt hole and corrosion pits that may be present.

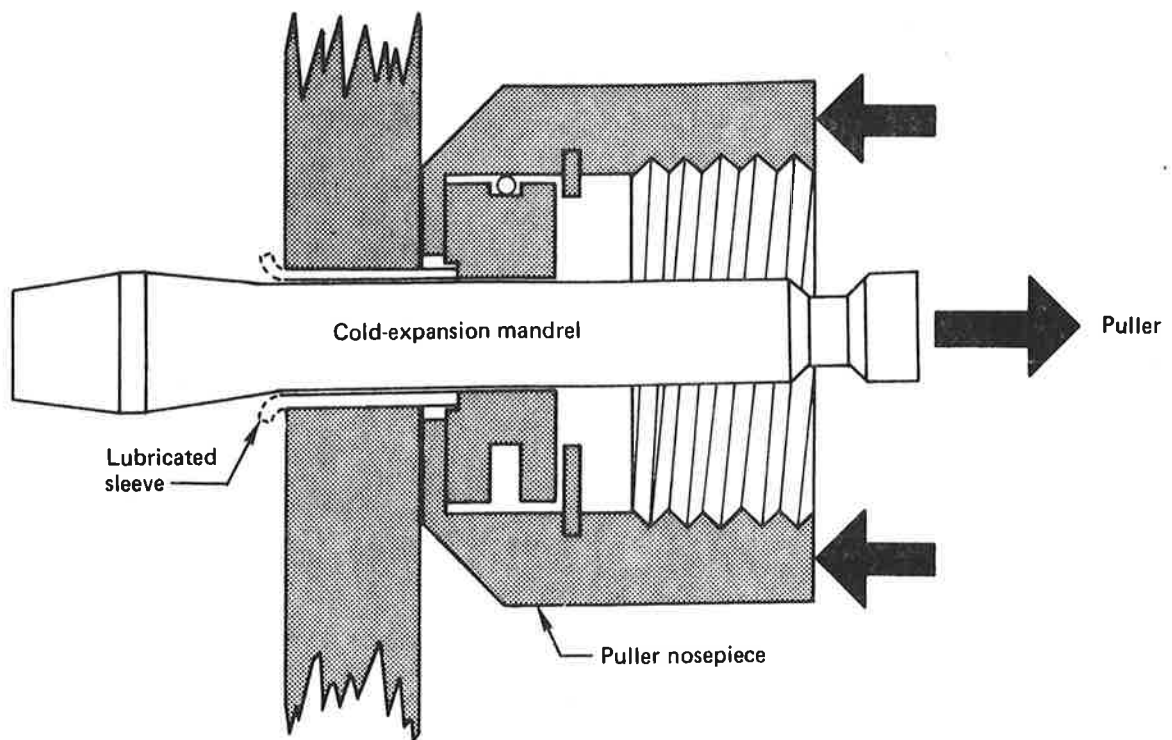
Figure 2.—Sleeve-Expansion-Process Schematic

The sleeve expansion process, schematically illustrated in figure 2, consisted of pushing or pulling a high-strength steel (RC₆₀) mandrel through a solid-film-lubricated stainless-steel sleeve that was placed within the hole to be treated. The mandrel and sleeve were sized to develop a controlled radial interference fit of typically 0.050 inch as the maximum diameter section of the mandrel passed through the hole. The key to the success of the process was the solid-film-lubricated inside surface of the sleeve that permitted the mandrel to be pulled through the hole without metal seizure under the estimated 500,000-psi contact stress. The sleeve was held in the hole primarily by friction between its unlubricated outside surface and the bore of the hole. Initial positioning of the sleeve was achieved by bearing one end against the nosepiece of the puller fixture. Positioning was also achieved by using a flare on the sleeve as shown by the dotted lines in figure 2. The sleeve thickness was 0.012 inch, and it was made from full-hard-type 301 stainless steel.

Sleeve expansion was performed as illustrated in figure 2, using a universal testing machine in place of a portable puller so that maximum loads could be determined. The test setup is shown in figure 7.

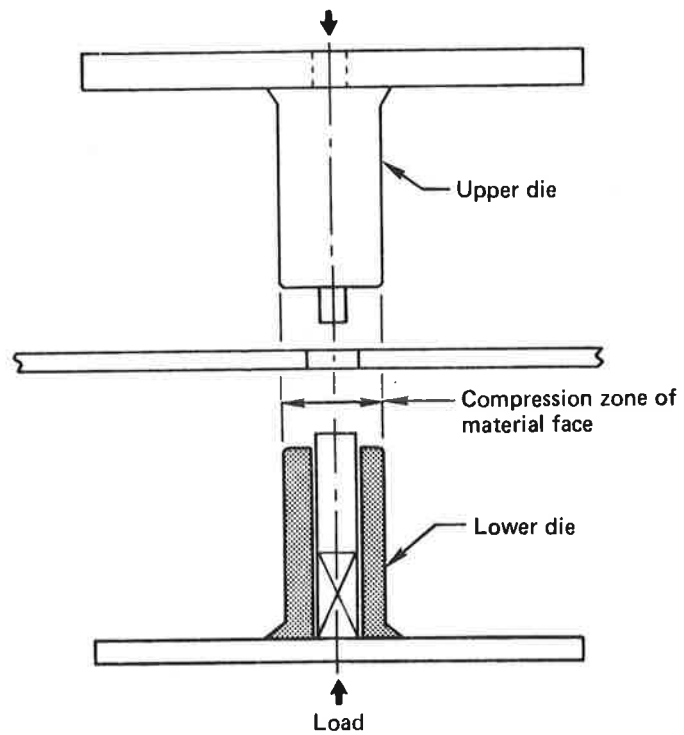
Figure 3.—Pad Coining

The pad-coining process, schematically illustrated in figure 3, consisted of pressing hardened-steel circular dies against opposite surfaces of the hole to be treated and applying sufficient force to press the pads several thousandths of an inch into the surfaces.

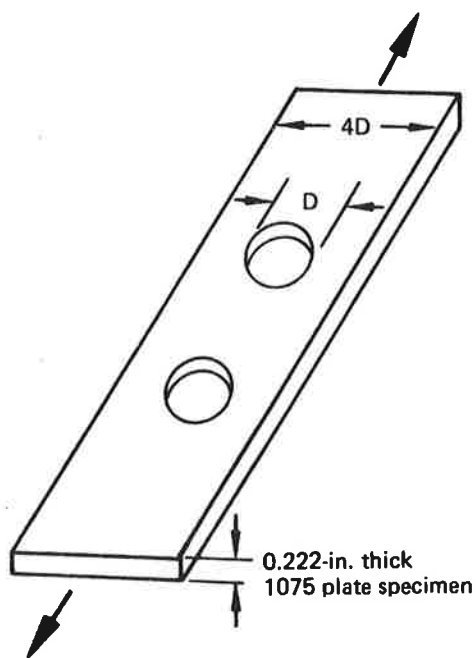
Figure 5.—Process-Optimization Details

Hole treatment	Hole diameter
None Coined	1.0 1.0
None 0.025 expansion 0.043 expansion 0.053 expansion 0.064 expansion	1.25 1.25 1.25 1.25 1.25
None 0.038 expansion 0.045 expansion 0.055 expansion	1.50 1.50 1.50 1.50
0.064 expansion typical (0.050 out-of-round)

Elongated axis inclined 45° to specimen axis.

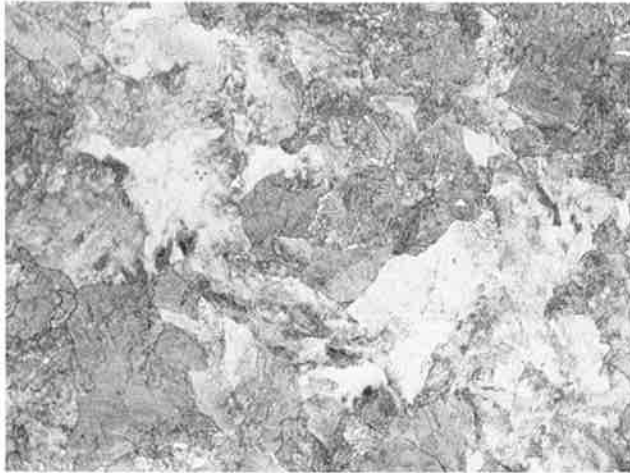
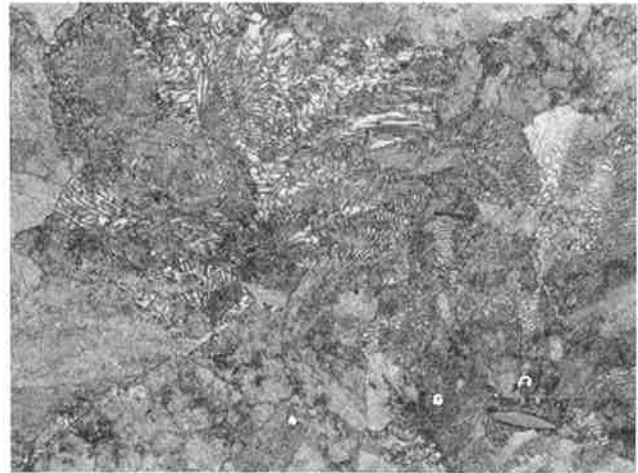
Figure 6.—Microstructure

**A. 1075 PLATE PEARLITIC MICROSTRUCTURE
(500X)**

**B. 112-LB RAIL MICROSTRUCTURE
(500X)**

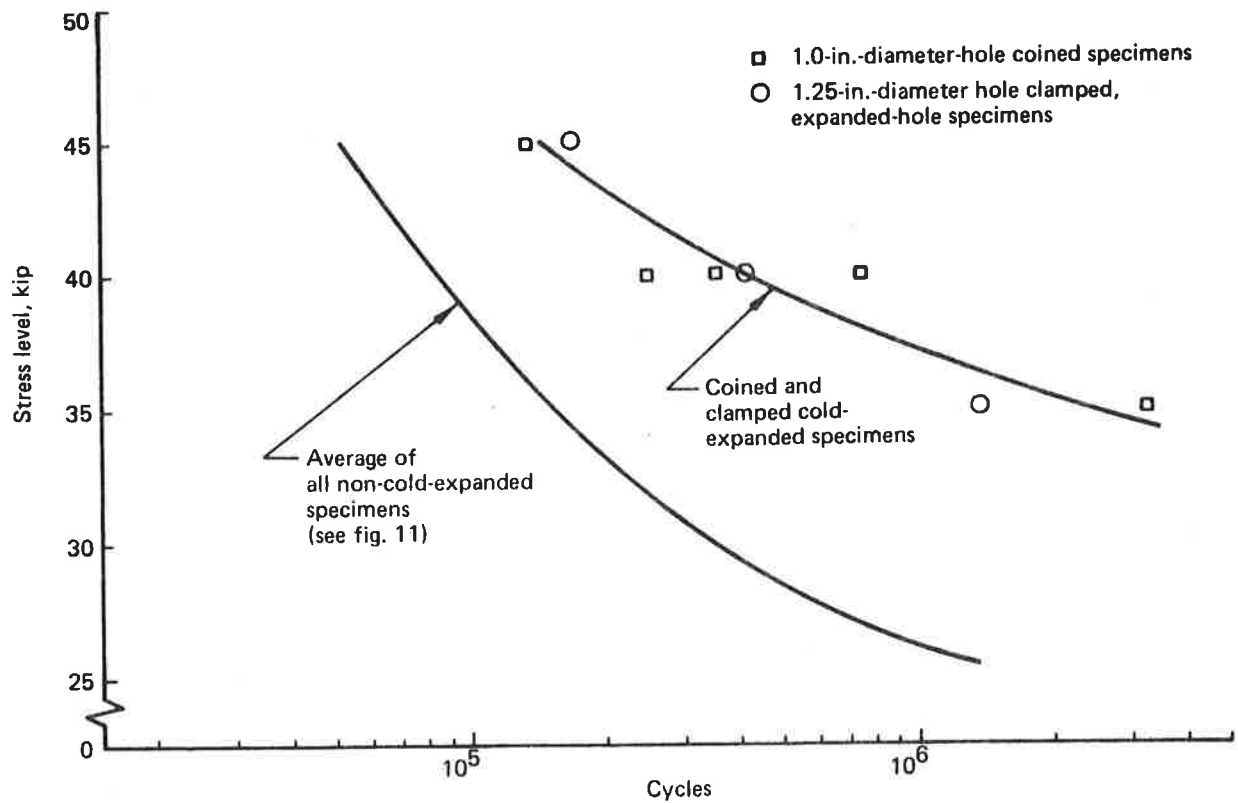
Figure 12.—Non-Cold-Expanded/Cold-Expanded, Coined, and Clamped Specimens

It is clearly evident that the thinness of the AISI 1075 steel plate had a detrimental impact on the hole-expanded specimens. A review of figure 11 indicates that the 1.25- and 1.50-inch-diameter-hole specimens, tested without correction for specimen distortion, show an increase in fatigue-life properties when compared to the baseline (noncold expanded) 1.25- and 1.50-inch-diameter-hole specimens. However, the hole-expanded specimens tested without correction did not demonstrate the fatigue-life improvement of the 1.25-inch-diameter-hole expanded specimens tested with correction for plate buckling, clamping (sec. 2.4.3), and the coined specimens. This last group, figure 12, demonstrated a significant improvement in fatigue life when compared to the non-cold-expanded specimens.

Fatigue test data are tabulated in appendix A and graphically presented in figures 11, 12, and 13.

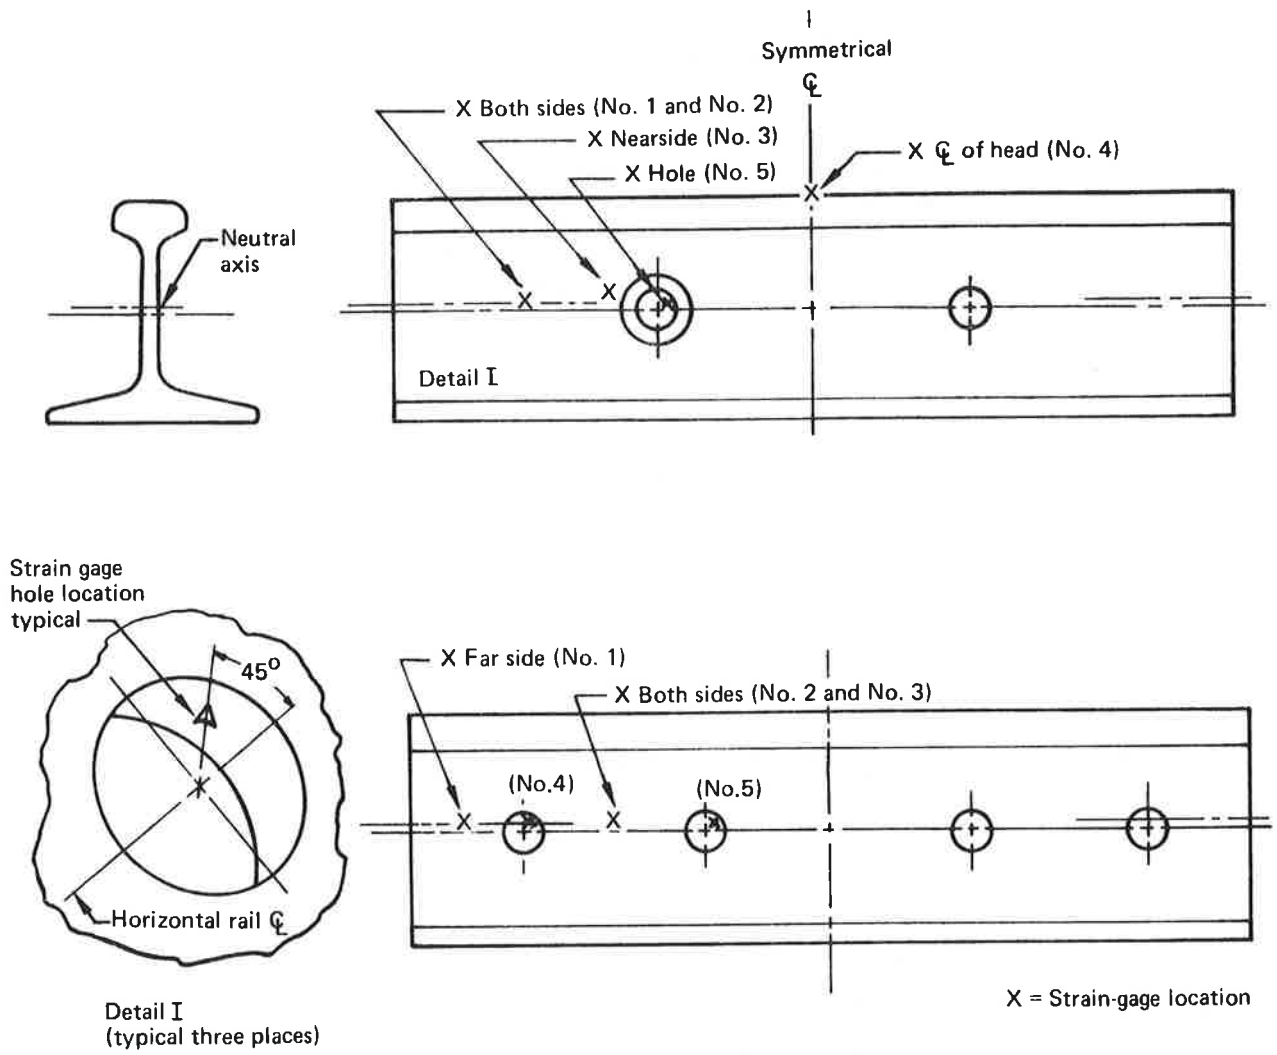
Figure 16.—Strain-Gage Location

Prior to fatigue testing, the state of stress of the two- and four-hole rail specimens, when loaded at 170 kips, was experimentally determined. A specimen of each configuration was instrumented with strain gages as shown in figure 16. The specimen then was placed in the fatigue test fixture and loaded statically. An additional loading device, a turnbuckle arrangement (fretting fixture), described in section 3.3.3.1 and illustrated in figure 15, was used as a compression member to apply a load between the bolt holes of the two-hole specimen. When loaded, strain at points on the specimen (indicated in figure 17) was recorded by strain readout instrumentation. These data were processed by computer program to establish the specimen state of stress.

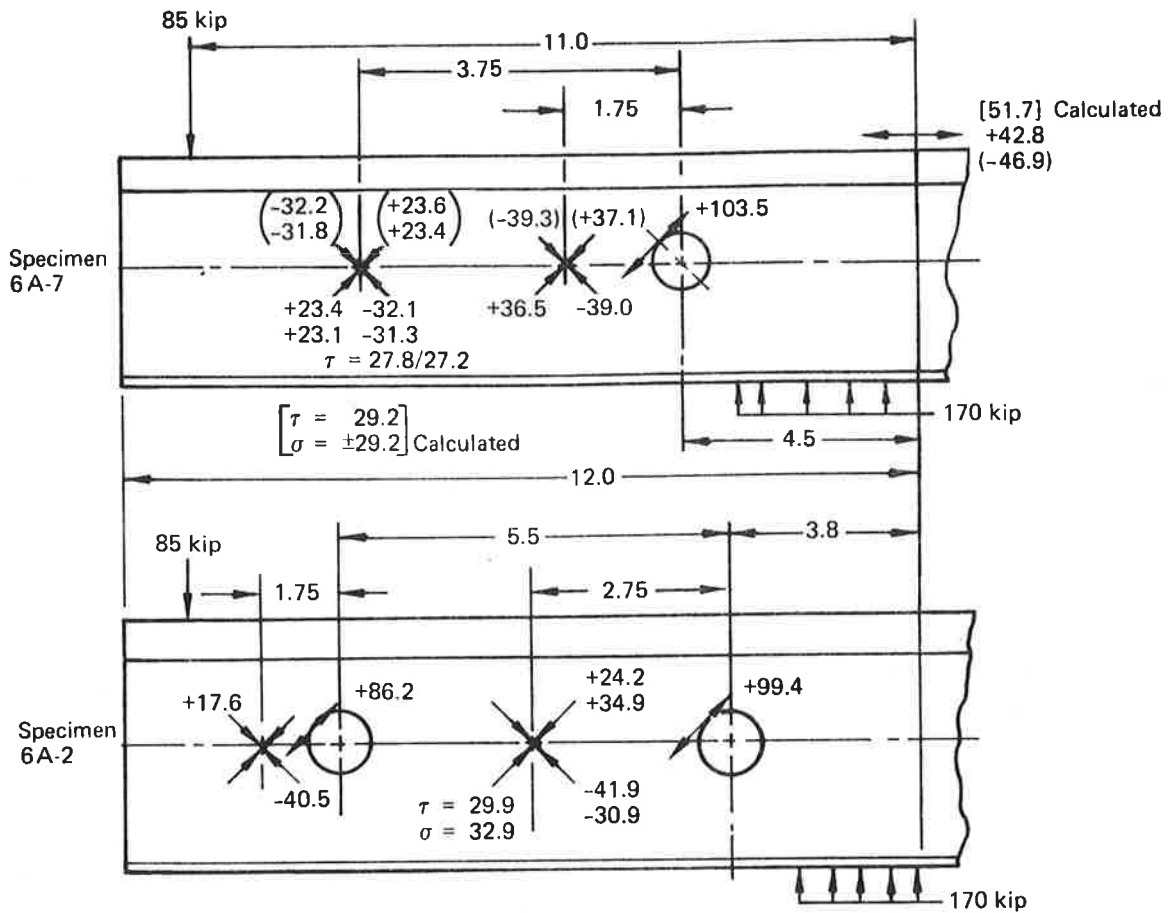
Figure 17.—Rail Stress

- Notes:
- Dimensions in inches, stress measurements in ksi, all others as noted.
 - Measurements in parenthesis measured with fretting fixture attached and loaded. Hole diameter = 1.25 in.
 - Where two data are given, two back-to-back gages were used.

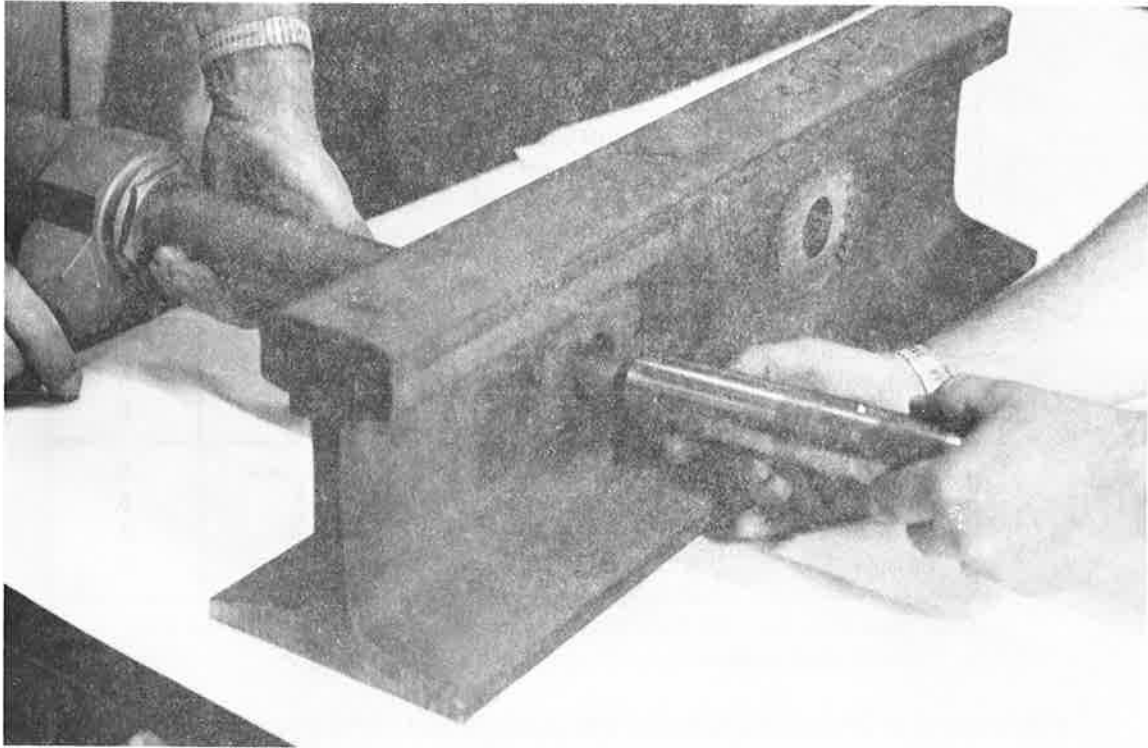
Figure 18.—Mandrel and Pull-Gun Application

Cold expansion of the rail specimens was accomplished with a portable mandrel pull gun and air-operated hydraulic power supply capable of exerting 18,000-pound pull force. The cold expansion process, mandrel, and lubricated sleeve used for cold expansion of the rail specimens were as described in section 2, except for the use of the portable pull gun (figs. 18 and 19.).

Some difficulty was experienced in sleeve expanding the first rail specimens, as mandrel pull forces approached 16,000 pounds. This problem was caused by inadequate lubricant (dry film) coating on the sleeve interior. The sleeves were returned to the supplier and relubricated. This problem primarily was a result of the large-diameter sleeves, exceeding the diameter of those normally produced, creating a conflict with normal lubricant coating and quality-control procedures. The supplier's procedures were altered to compensate for the larger sleeve diameters, and correctly lubricated sleeves were supplied. As a result of sleeve lubricant correction, pull forces required to cold expand the remaining rail specimens were reduced to 8,000 pounds maximum.

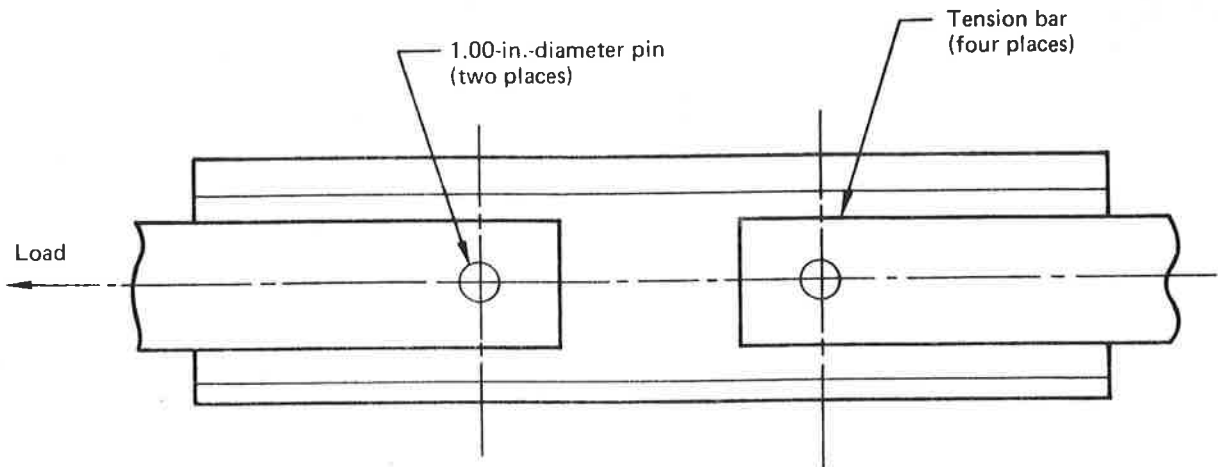
Figure 21.—Elongation Fixture

The load-induced elongated holes in both non-cold-expanded and cold-expanded specimens were developed by pin loading the specimen, using a 1-inch-diameter pin as illustrated in figure 21. A load was applied until a deformation was detected. Deformation and loads are shown in table 8.

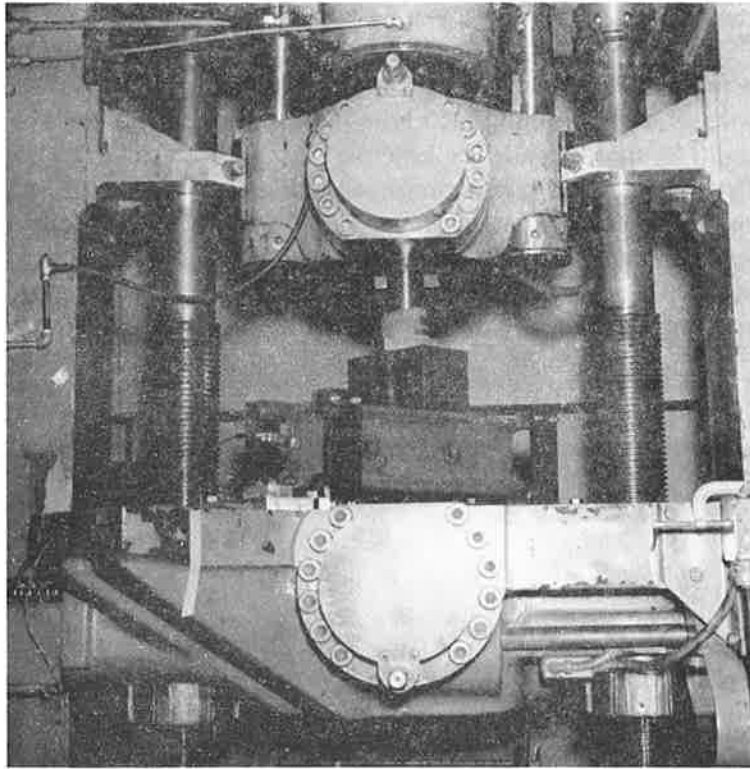
Figure 22.—Rail Fatigue Test Setup

The fatigue tests were performed using a 180-kip double-acting fatigue machine operating at 10 Hz. The rail specimens were mounted in the inverted position, the rail head supported at 22-inch centers, with the machine load pad driving downward on the rail base (figure 15). A 5- by 5- by 8-inch pad applied load forces to produce a fatigue ratio of 0.05. Figure 22 shows the actual specimen loaded in the test machine. The pad initially was made of oak; however, the low modulus of oak resulted in the rail base bending and cracking (fig. 23) at the large number of cycles required to fail the sleeve-expanded specimens. The block was changed to aluminum and rail base cracking was no longer observed.

The test setup was altered for the fretting tests. A double turnbuckle arrangement was attached to 1.0-inch-diameter pins in each hole (fig. 15) and a load of 8,000 pounds applied, the turnbuckles serving as compression members. Fretting motion was induced by the flexure of the specimen under the cyclic fatigue loading of the rail base.

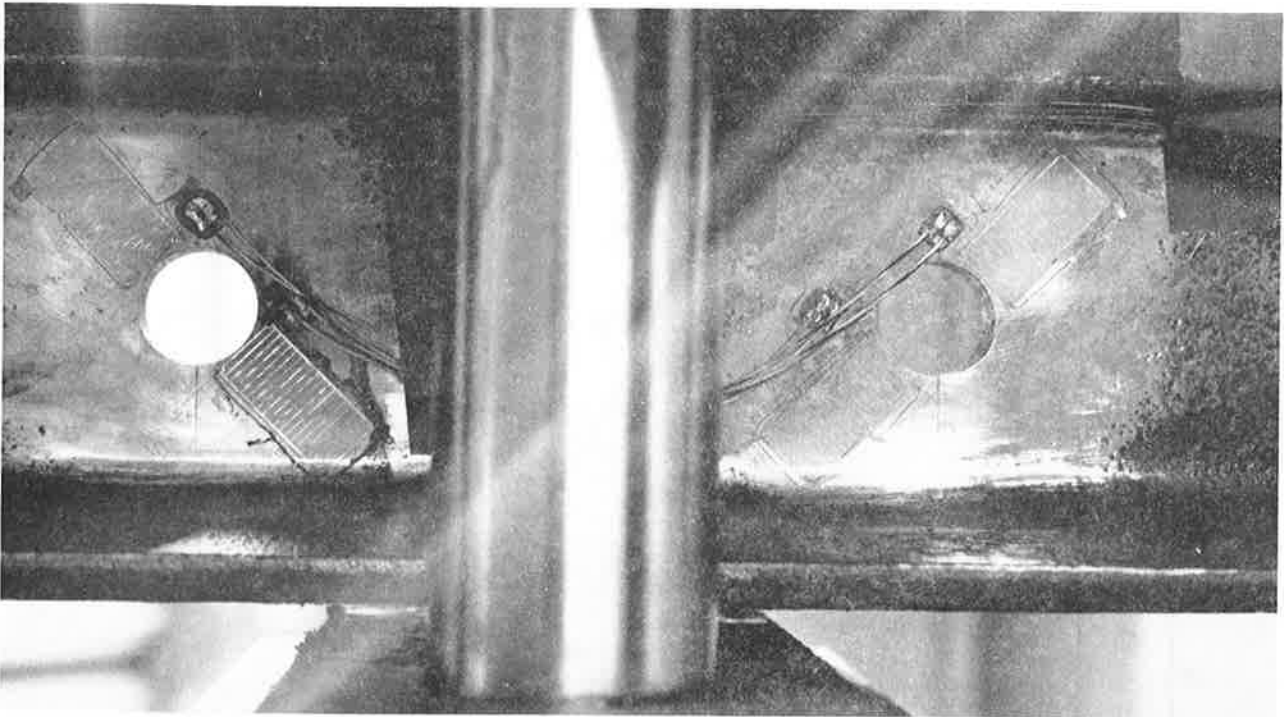
Figure 25.—Crack-Growth-Rate Gages

Tests to determine crack growth rate were conducted on cold-expanded and non-cold expanded specimens. The rail stress analysis and prior test results indicated that hole-crack initiation would occur at an angle of 45° from rail centerline, generally in the direction of the rail head. Consequently, two four-hole specimens (one cold-expanded and one non-cold-expanded) were instrumented with crack-growth-rate detection gages. The gages consisted of a series of parallel wires brought to a junction, forming a portion of the crack detection circuit. The particular gages used (fig. 25) were composed of 20 wires spaced at 0.08 inch, permitting crack growth to 1.60 inches to be studied. Trace readout devices permitted fatigue-machine cycles to be recorded as each wire was failed by the propagating crack.

The cold-expanded specimen (5B-5) achieved 1,277,000 cycles before failure of the first gage wire (crack length = 0.080 inch). However, a 4-inch-long crack had developed in the rail web as indicated in figure 25, preventing further testing of this specimen. A second cold-expanded specimen tested disintegrated at the end hole at 600,000 cycles, prior to any indication of failure of the two center, gaged holes.

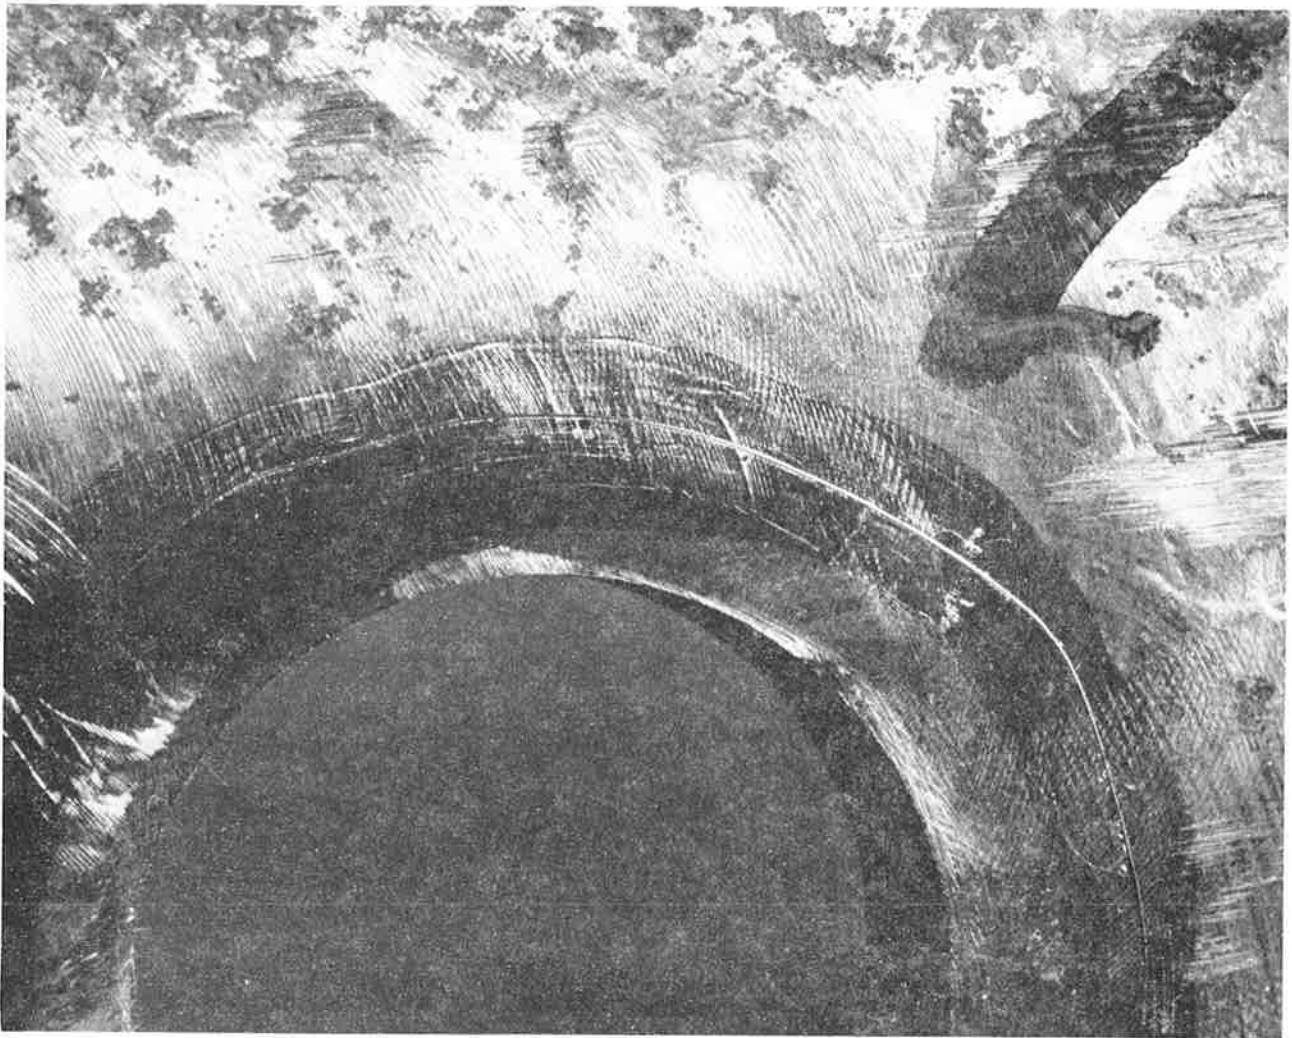
Figure 28.—Bolt-Hole Failure

The 170-kip load used during this accelerated testing is many times the wheel loading encountered in service; however, the test did demonstrate correlation to rail-failure history. All non-cold-expanded specimens failed at the bolt hole (fig. 28), a frequent failure point for in-service rail. All cold-expanded specimens exceeded 1×10^6 cycles or failed at a point remote from the bolt hole. This suggests that cold expansion of rail bolt holes would reduce the failure rate to the level of those failures not associated with the bolt hole.

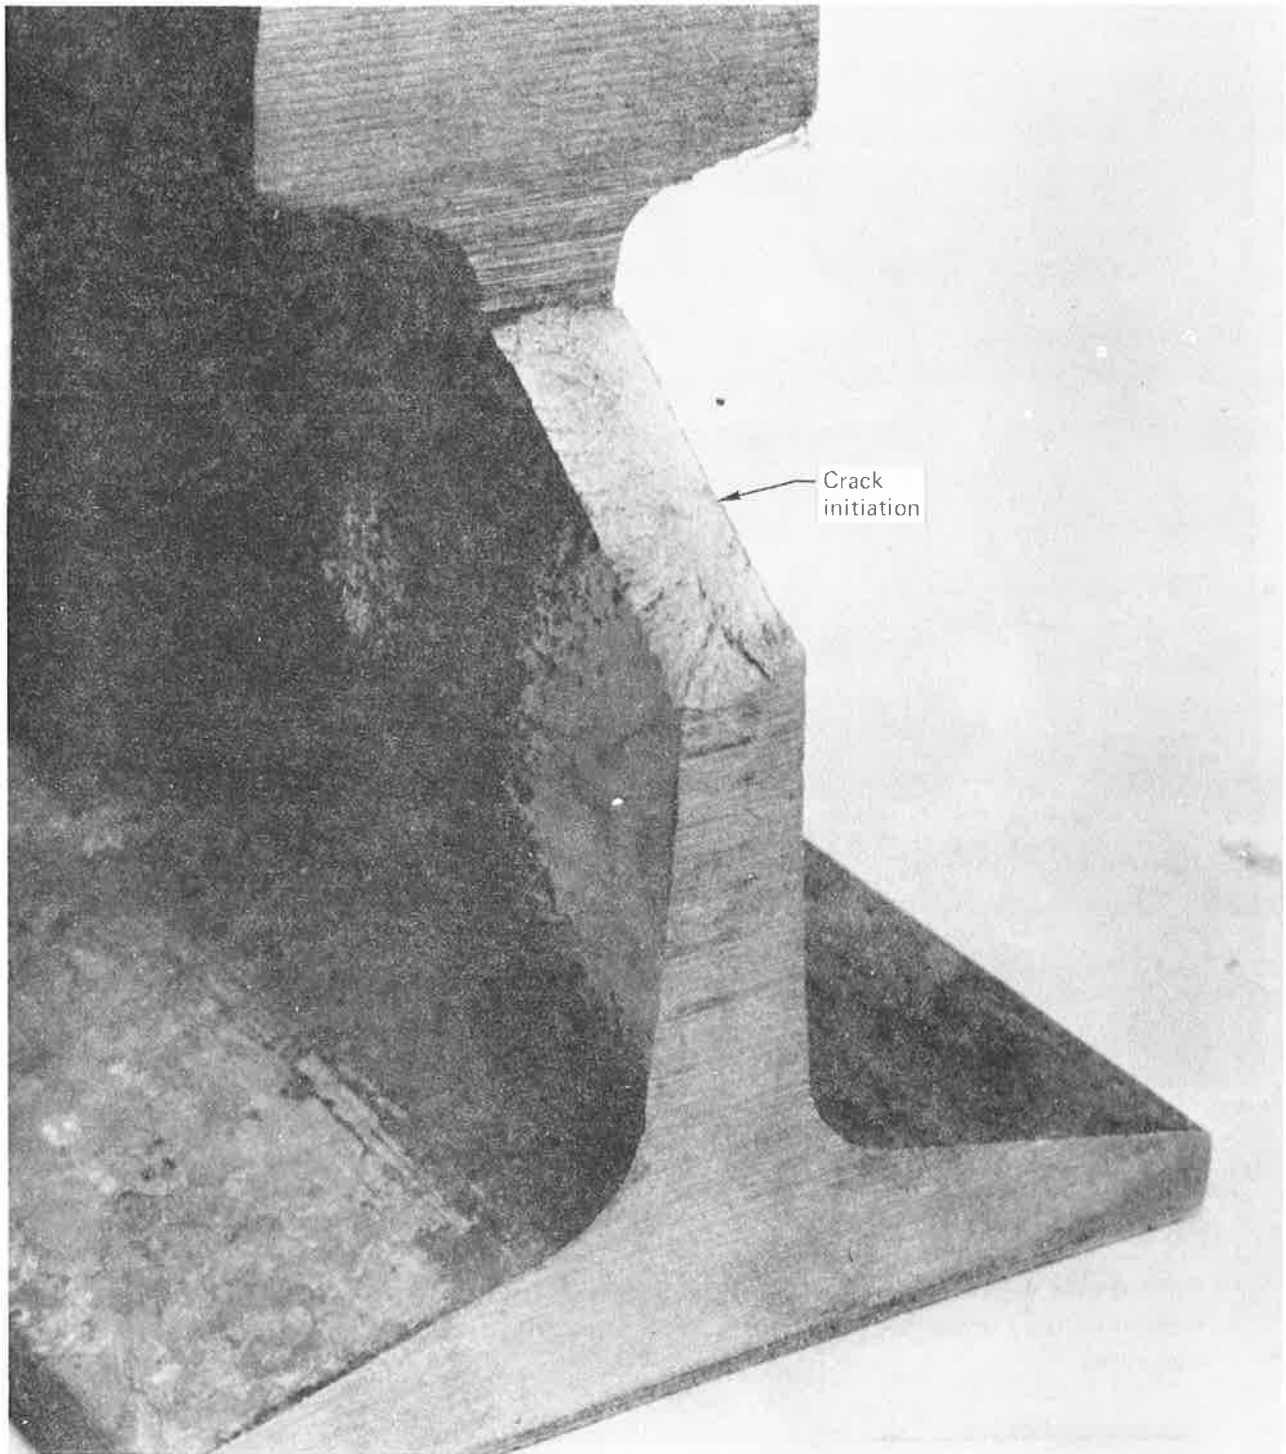
Figure 29.—Web Failure

Data in appendix C show that cold-expanded specimen 1B-1 (fig. 27) displayed web failure at 643,820 cycles, the first cold-expanded-specimen failure to occur under 1,000,000 cycles other than the base failures. Accordingly, the specimen was cut open for evaluation of the failure face. The crack was arrayed at an angle of 40° from horizontal rail centerline, extending from the web neutral axis upwards toward the rail head. Crack initiation occurred at the web surface near the point of minimum web thickness and progressed in both directions, toward the head and toward the hole (fig. 29). The crack progression toward the hole intersected the crack detection circuit, stopping the test. The crack initiation occurred just outside the area of maximum anticipated hole cold-expansion effect, as estimated by rust removal during the cold-expansion process. No obvious metallurgical defects were noted.

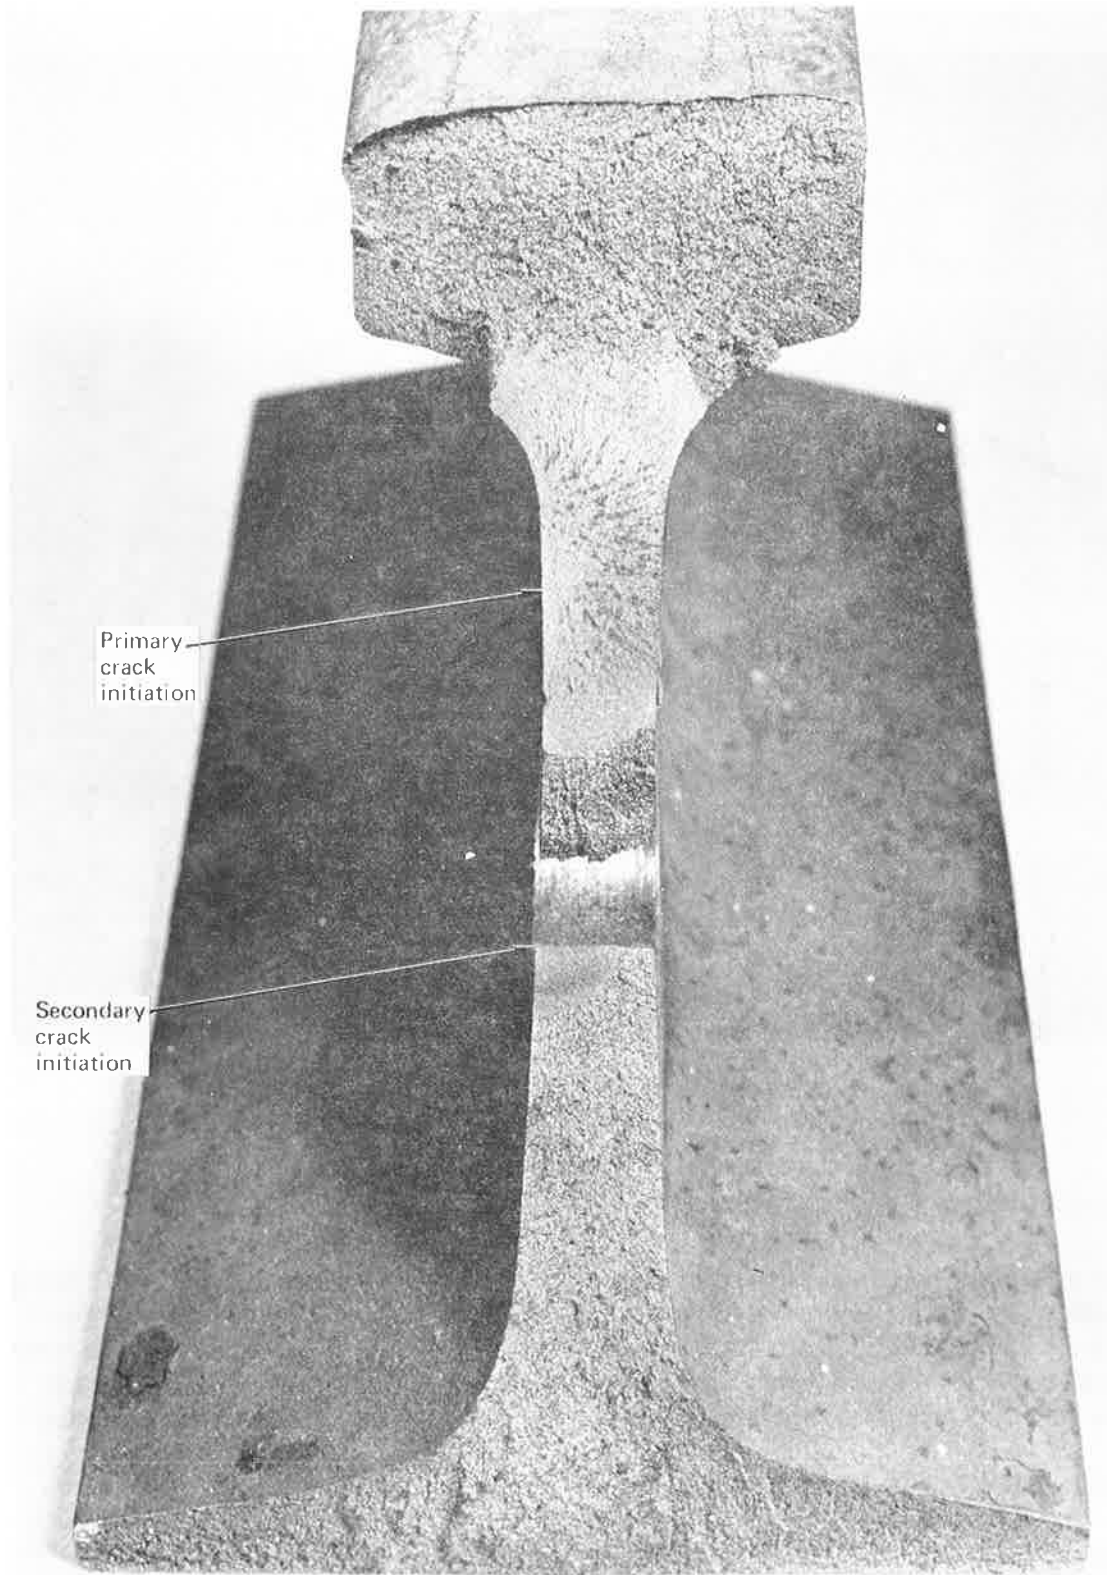
Figure 31.—Fretting Specimen Web Failure

The non-cold-expanded specimens consistently failed at the hole, with little variation from 100,000 cycles. The cold-expanded specimens were equally divided between web and hole failures. The impact of fretting is demonstrated by specimens 5B-7 and 6B-7 (fig. 27), as these were the first cold-expanded specimens to fail at the bolt hole at less than 2×10^6 cycles. Figure 31 illustrates the web failure mode encountered with fretted cold-expanded specimens. Figure 32 shows a typical fretted specimen hole failure (0.25-inch-long crack).

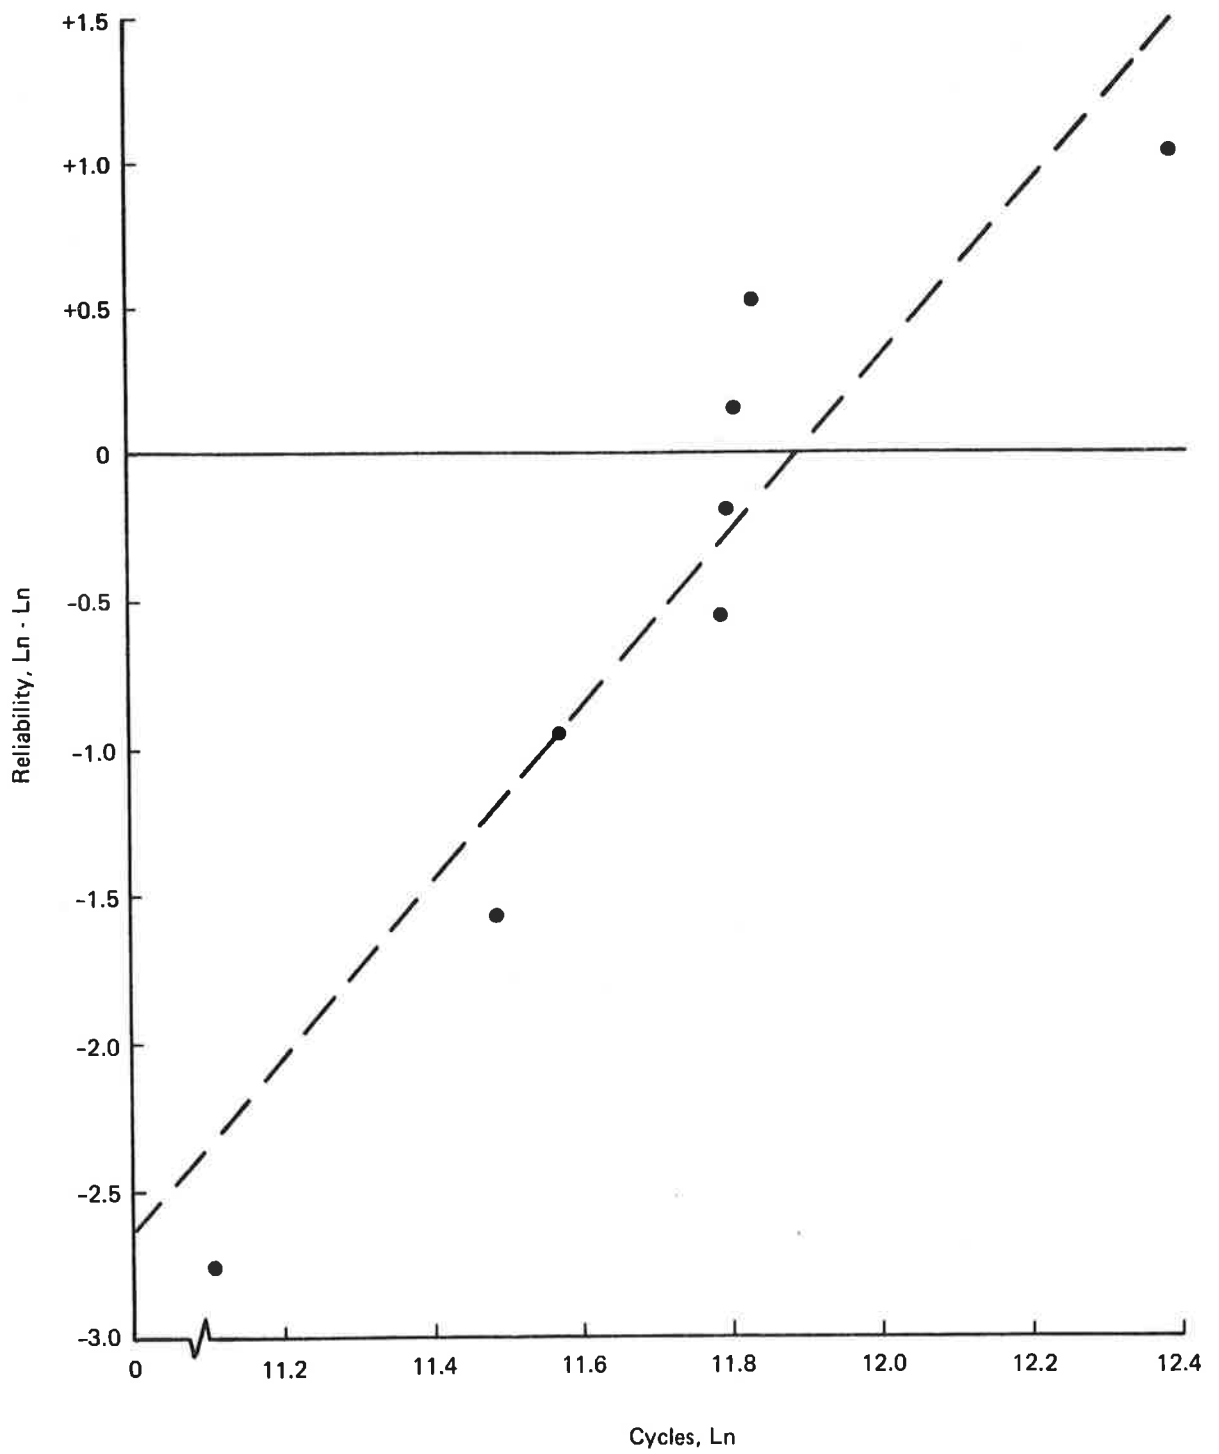
Figure 34.—Reliability Plot

where A is the scale parameter and B is the shape parameter. Examination of the data through reliability plots supported this assumption (e.g., fig. 34).

In life testing, it is common to assume that shape parameter D (the inverse of the slope in the reliability plot) is the same for the two populations. This permits comparison of two populations by comparing the location parameters L. The expression $\exp(L_A - L_B)$ estimates the ratio of expected lifetime A to expected lifetime B for A and B to achieve the same reliability R and is independent of R.

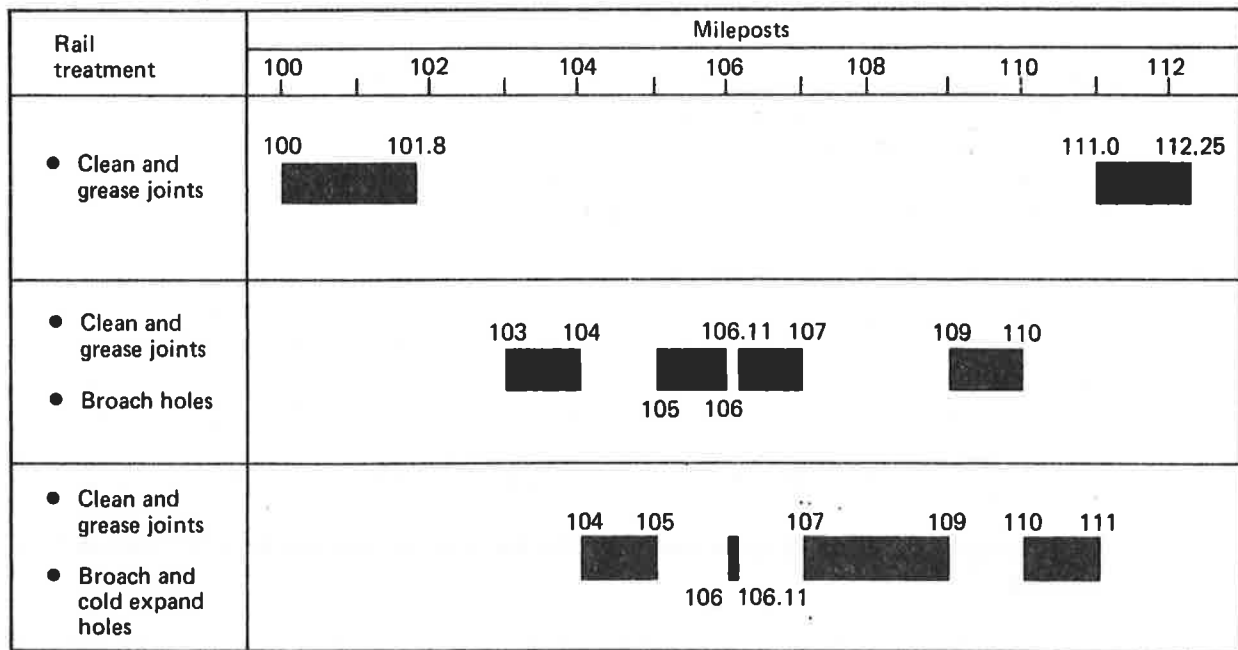
Figure 35.—Updated Test Plan for Silvercreek, Nebraska Site

The miles of track receiving treatment are shown in figure 35. Approximately 811 rails were cleaned and greased (3.05 miles); 1071 rails were cleaned, greased, and broached (3.89 miles); and 1129 rails were cleaned, greased, broached, and cold expanded (4.11 miles). Prior to treatment, a detector car covered the area, and all but three detected cracks were removed. Three rails with 1/4-inch-long bolt-hole cracks were cold expanded and left in service. These rails were clearly marked with yellow paint visible outside the joint bars and are to be inspected every 30 days for evidence of crack growth. This inspection will continue for an anticipated 1-year period.

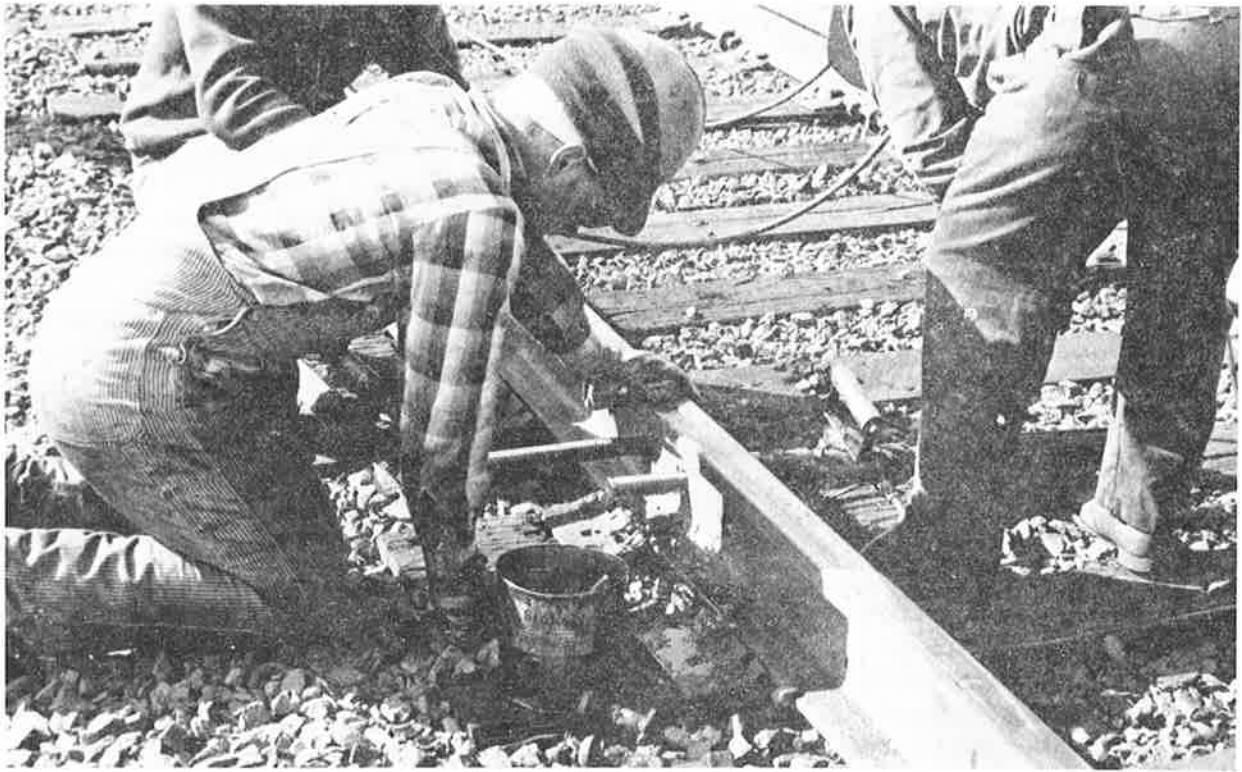
Figure 36.—Broaching Track Joint Holes in the Field

1. A reamer (to remove elastomeric packing and grit from rail bolt holes)
2. Broach gun operator, tool handler, and lubricator (fig. 36)
3. Air compressor operator (fig. 37)
4. Cold-expansion gun operator and two assistants, one to load the sleeve and remove the mandrel from the gun, and one to mount the mandrel in the rail bolt hole (fig. 38)

The broach operation employed two broach tools and one broach pull gun; one man inserting one broach in the next bolt-hole bore while the second broach was being pulled through the previous hole, thereby increasing hole diameter to the 1-5/16-inch starting-hole size for cold expansion (table 3, sec. 2.0). The third man brush-applied cutting oil to the broach as it was being pulled through the bore. Time lapse from hole to hole averaged 22.5 seconds, including all delay time other than that required to move the compressor and crew from joint to joint and the delay when the track was cleared for traffic on the eastbound track.

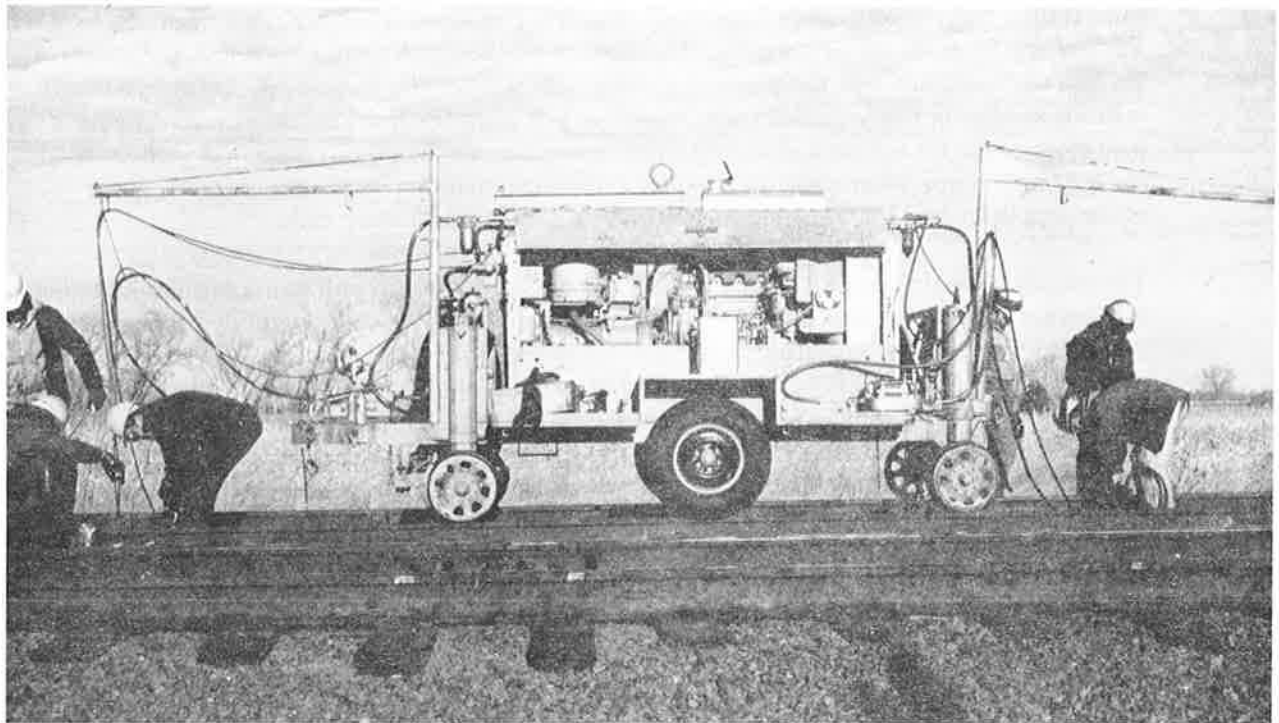
Figure 37.—CP805 Power Supply on Mobile Air Compressor

The air compressor (a wheeled, diesel-powered, 600-cfm unit maintaining a constant 115-pound air pressure) was arranged between the broach station and the cold-expansion station, permitting simultaneous operation of both pull guns. The air-operated hydraulic power supplies for the two pull guns were mounted for convenience on the sides of the air compressor.
