**SLEEVE EXPANSION OF BOLT HOLES
IN RAILROAD RAIL**

Volume I - Description and Planning

BOEING COMMERCIAL AIRPLANE COMPANY
P.O. Box 3707
Seattle WA 98124

FEBRUARY 1980

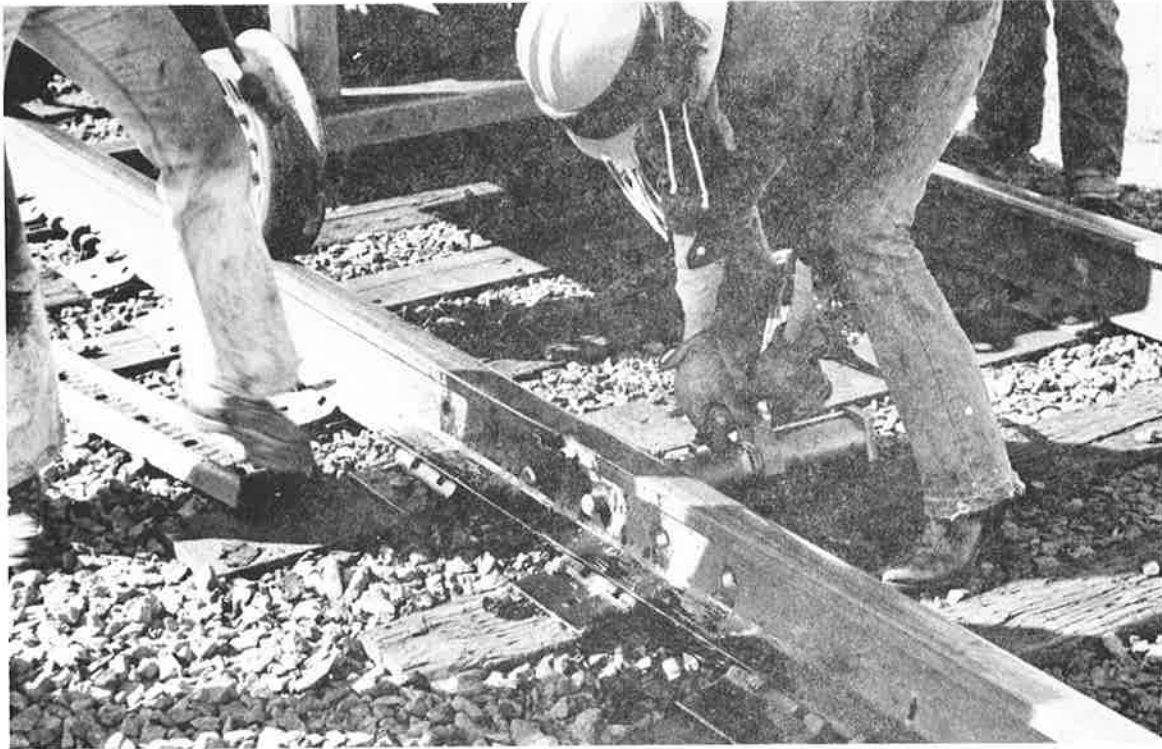
Figure 38.—Cold Expanding Joint Holes in the Field

1. A reamer (to remove elastomeric packing and grit from rail bolt holes)
2. Broach gun operator, tool handler, and lubricator (fig. 36)
3. Air compressor operator (fig. 37)
4. Cold-expansion gun operator and two assistants, one to load the sleeve and remove the mandrel from the gun, and one to mount the mandrel in the rail bolt hole (fig. 38)

The cold-expansion process was accomplished using two mandrels and one cold-expansion pull gun. One man placed a split sleeve on the mandrel and inserted the mandrel in the bolt-hole bore. The automatic chuck of the pull gun grasped the tang of the mandrel and drew the mandrel through the bore, the 0.055-inch diametrical interference between mandrel/sleeve and bore developing the cold-expansion effect. The flare of the split sleeve (fig. 43) caused it to remain in the bore. As one operator removed the sleeve by using a single rap of a plastic-head hammer, the second man placed the other sleeve mandrel in the bore. Thus, the cold-expansion gun was operated nearly continuously at a rate one-third again as fast as the broach operation, due to the shorter stroke and slightly faster pull rate.

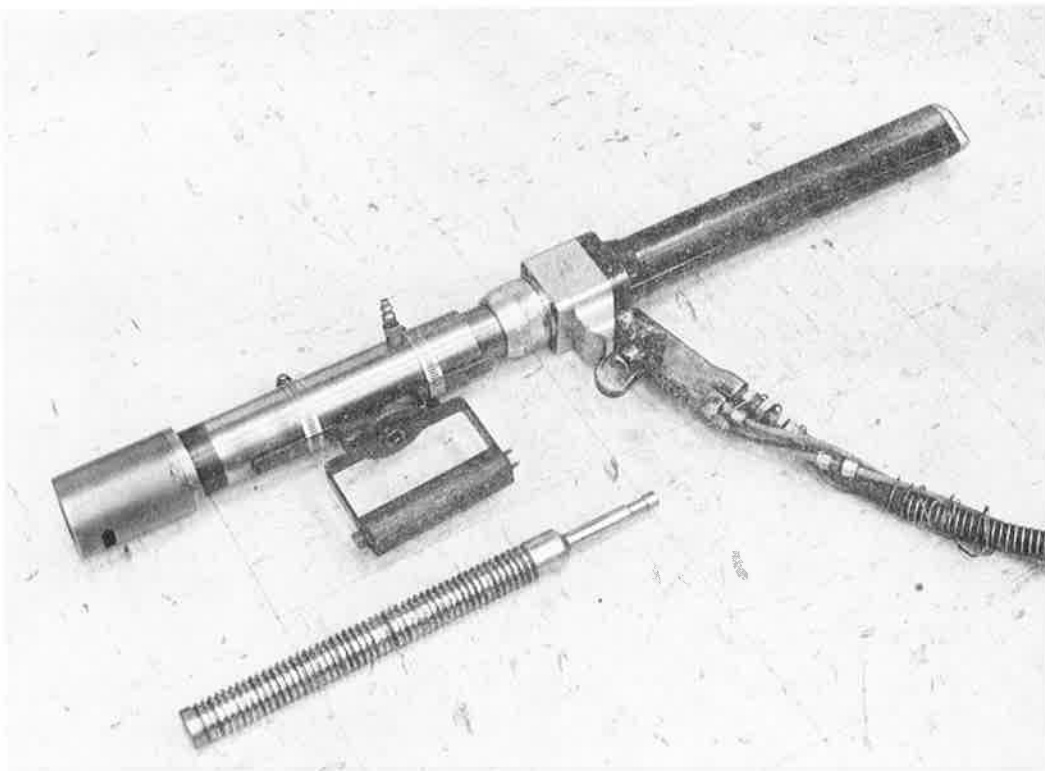
Figure 39.—Broach Pull Gun and Broach

Figure 39 shows the broach pull gun and broach; figure 40, the broach pull gun and power supply; and figure 41, the cold expansion (mandrel) pull gun and power supply. The cold-expansion mandrel and sleeve are shown mounted in a rail cross-section in figure 42.
