1. Report No. DOT-TSC-UMTA-73-1		2. Government Accession No.		3. Recipient's Catalog No. PB-220 795	
4. Title and Subtitle DEVELOPMENT AND TESTING OF A COMPLETELY PASSIVE, AIR SUSPENDED, AIR PROPELLED PERSONAL RAPID TRANSIT VEHICLE				5. Report Date April, 1973

6. Performing Organization Code	
7. Author(s) Charles H. Smoot et al				8. Performing Organization Report No. DOT-TSC-UMTA-73-1	
9. Performing Organization Name and Address Uniflo Systems Company 7401 Washington Avenue South Minneapolis, Minnesota 55435				10. Work Unit No. UM306/R3722

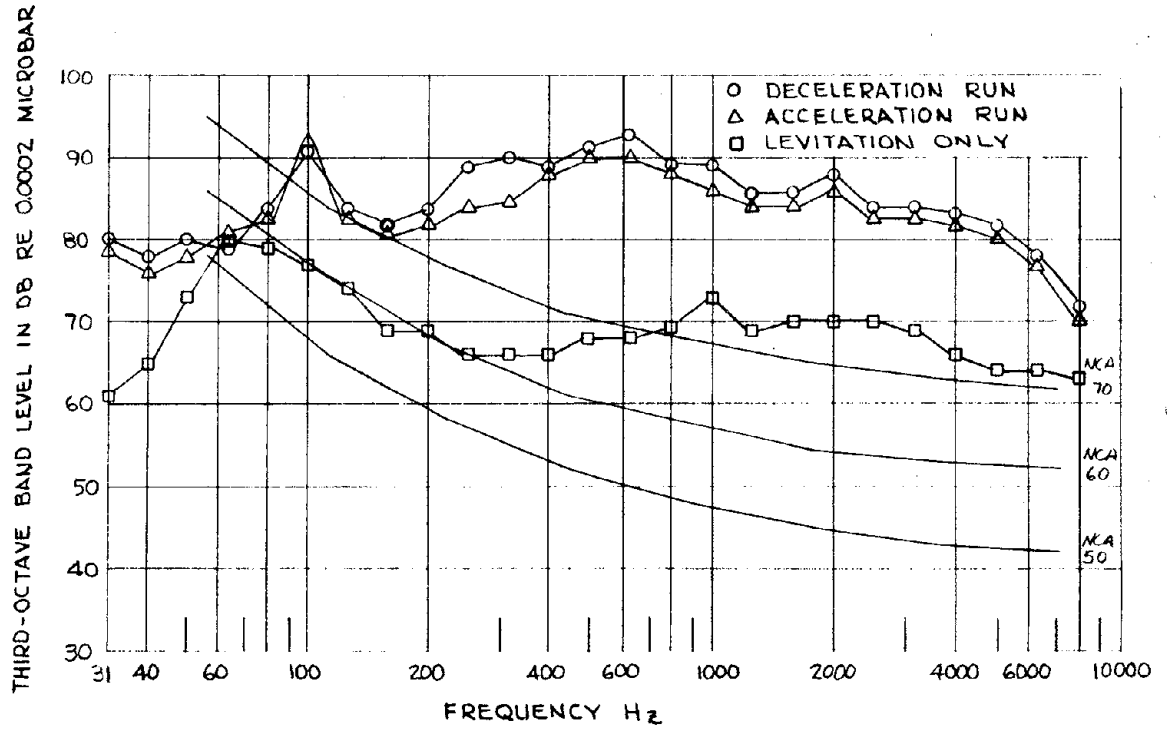
Figure 3-4. Sound Pressure Levels, 25 foot from Guideway, direct measurement, full vehicle.

Figures 3-4 and 3-5 show the measured sound pressure levels at the 25 ft. point for the conditions specified above. The data shows slightly higher sound pressure levels (2 dB) for the deceleration than the acceleration. The turbine modules are generating more thrust during deceleration, and indicate the noise level is dependent on thrust level.

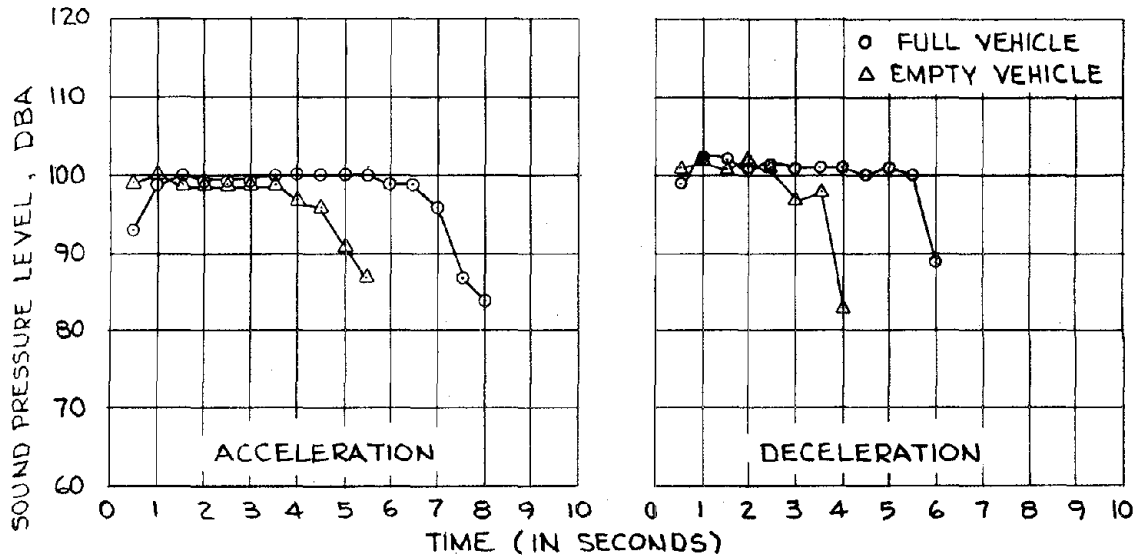
Figure 3-10. Sound pressure levels, DBA, as measured directly, 25' from guideway, versus time.

Figures 3-10 and 3-11 show the A-weighted sound level time history for fully loaded and empty vehicle during acceleration and deceleration, both inside the vehicle and at the 25 ft. point. From the plots the peak values at the 25 ft. point are 102 dBA. Inside the vehicle the levels peak at 94 dBA. The dBA values would be reduced by about 3dB for the free field for the frequency range 315-4000 Hz (see Figure 3-4 through 3-7).
