# Clean Air Program

## Compressed Natural Gas Safety in Transit Operations

October 1995  
Final Report

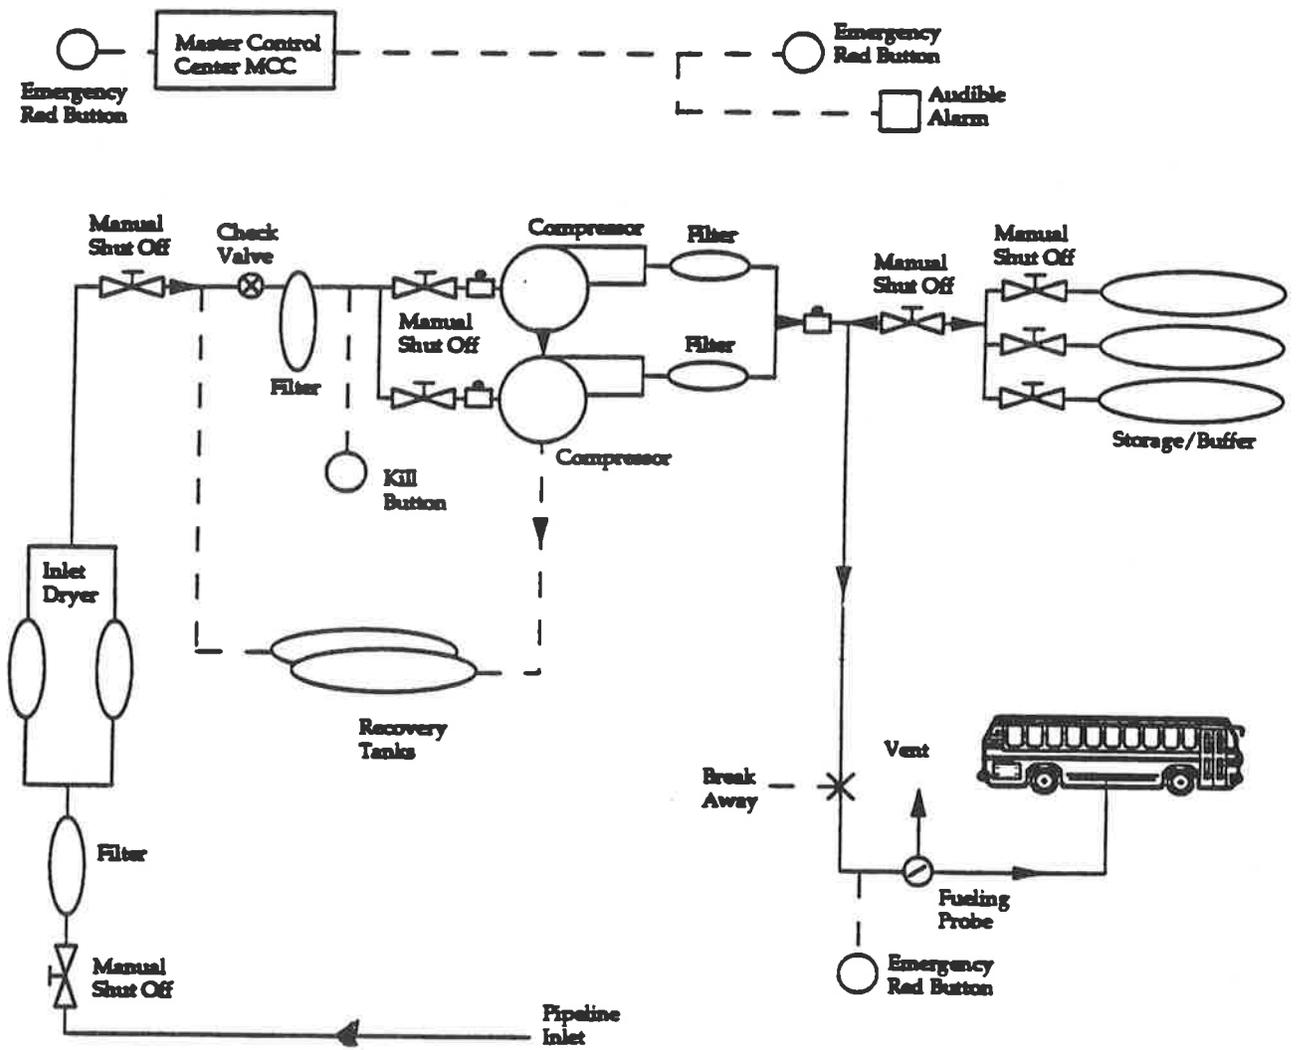
Figure 1-1. Schematic of CNG Fueling Facility

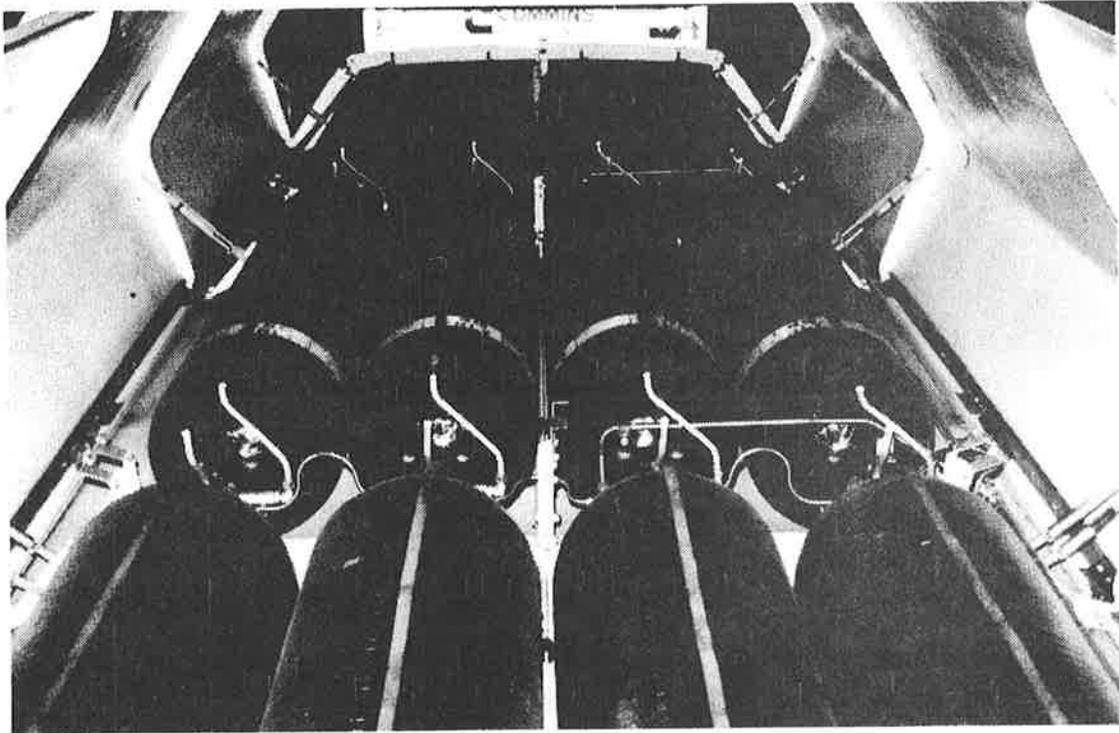
**Figure 1-2. CNG Fuel Tanks Mounted on Roofs of Buses**

Whereas a 40-foot Flxible CNG bus has six fuel tanks, the 30-foot bus design allows for only two fuel tanks and, thus, has a very short range. The problem of the short range of 30-foot CNG buses is compounded by unreliable fuel pressure gauges on some CNG buses. A modest increase in range can be effected by replacing the air start with an electric start and replacing the air tank with two small fuel tanks (about 6 equivalent diesel gallons).

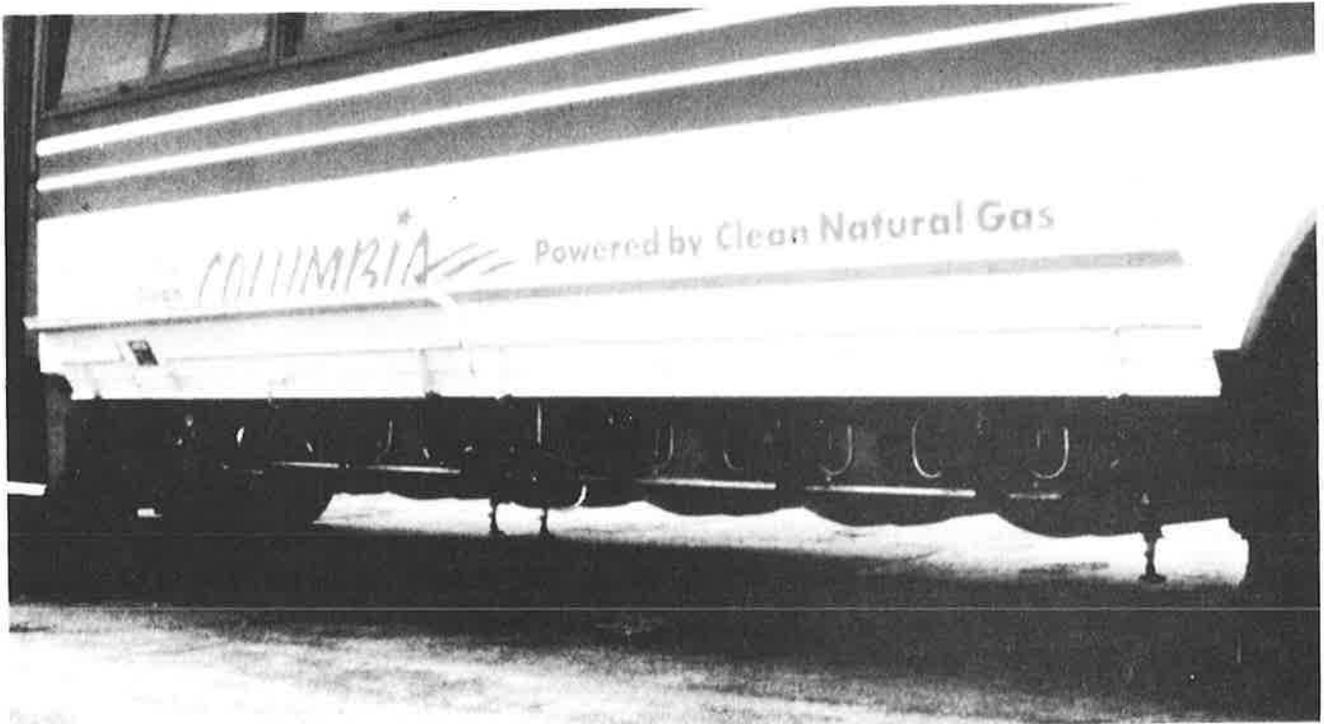
**Figure 1-3. CNG Fuel Tanks Mounted Below the Floor**

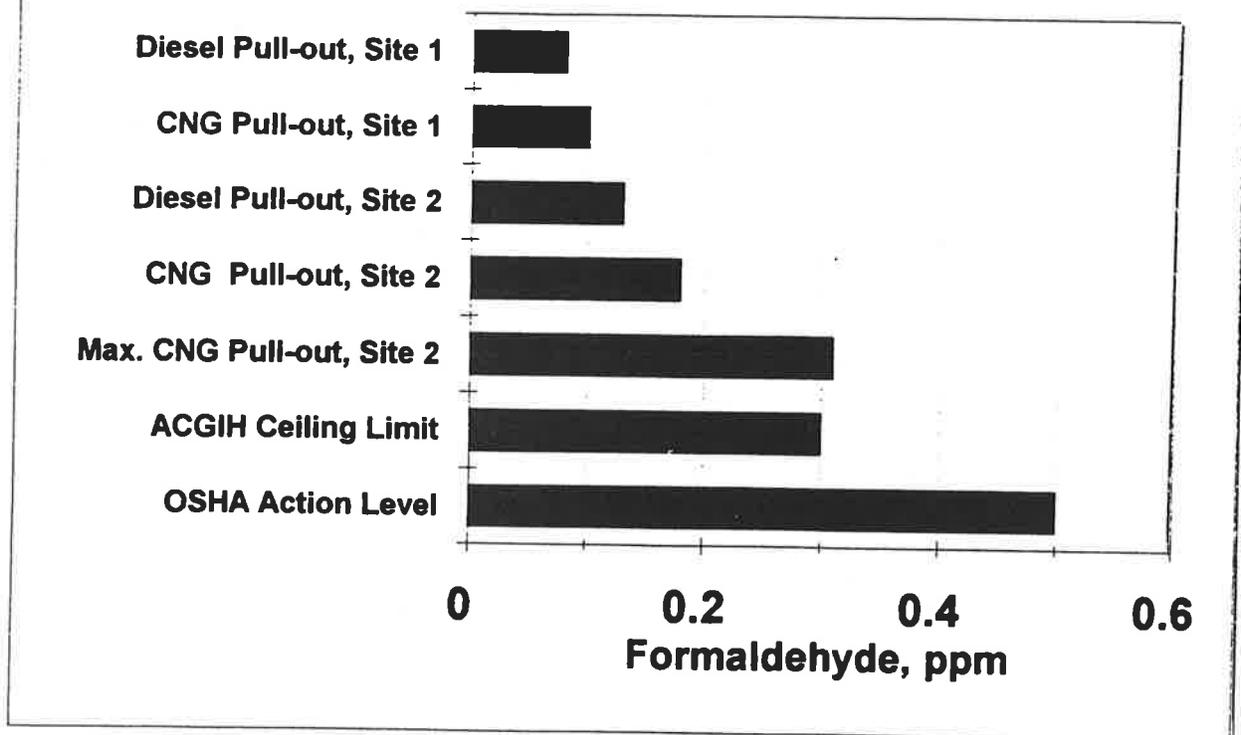
Figure 1-4. Formaldehyde Levels and Comparison with Standards

A naive extrapolation would predict that, as the fraction of CNG buses in the total fleet increases, the formaldehyde concentration would increase in like fashion. However, diesel buses also produce some formaldehyde, so not all of the measured formaldehyde can be attributed to the use of CNG. Also, as the number of CNG buses increases the fleet would receive the benefit of more of the existing ventilation capacity, due to the greater area the CNG fleet would occupy in the garage.

Even considering these factors, transition to an all CNG fleet would be likely to increase the existing formaldehyde concentration within bus storage facilities. The level of this exhaust product should be monitored as CNG bus fleets expand. Greater ventilation rates or different bus operating strategies may have to be considered if concentrations exceed recommended levels.

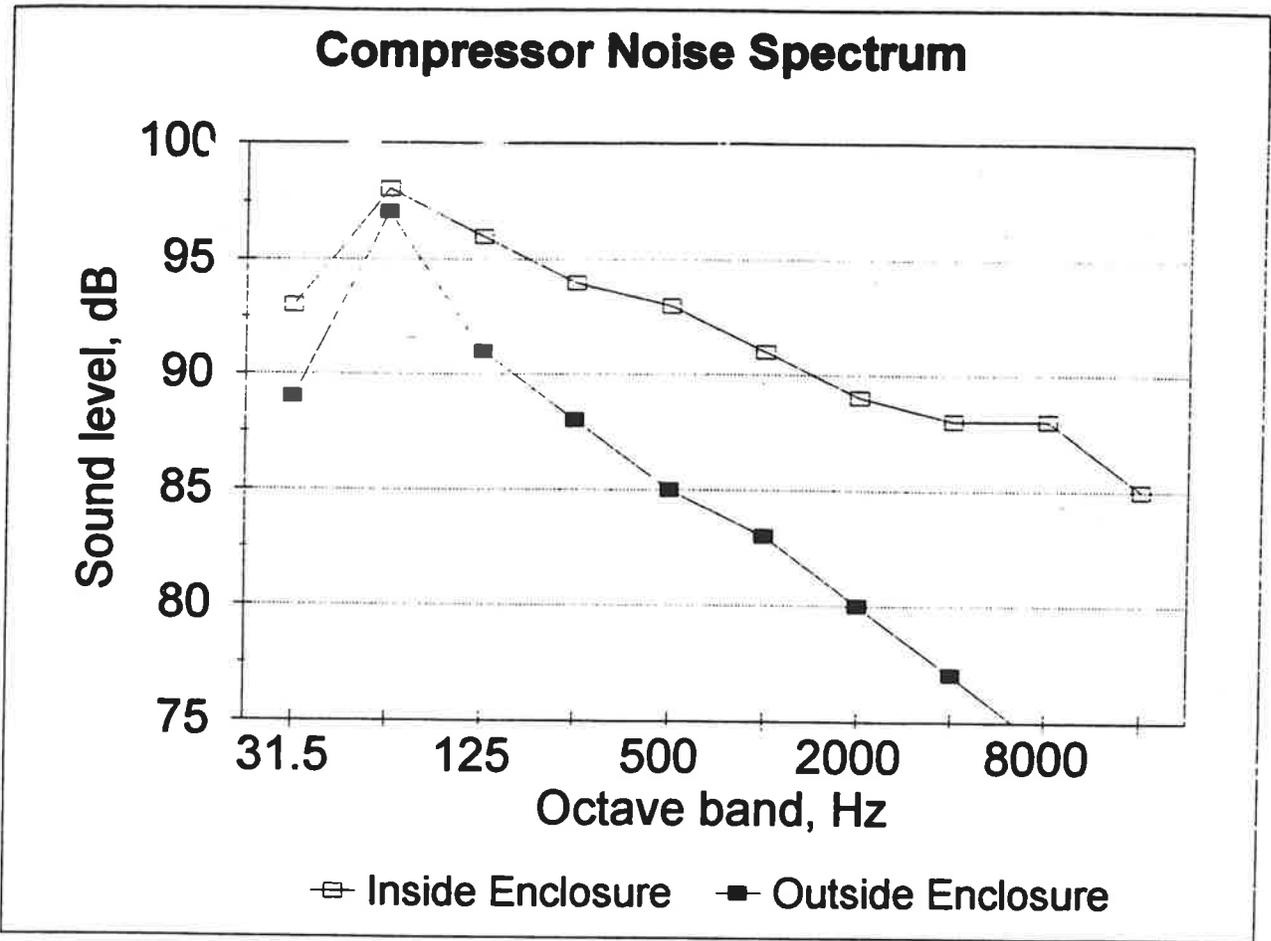
**Figure 1-5. Compressor Noise Spectrum**

At one site, the measured noise levels were lower than the OSHA limit for noise with the exception of the area directly in front of the open door to the compressor enclosure. Subjectively, conversation was not unduly hampered by compressor noise. At this location, a sound attenuating compressor enclosure was provided and proved very effective as a method of noise control. Figure 1-5 shows both a typical natural gas compressor noise spectrum and the sound attenuation provided by a partial enclosure.

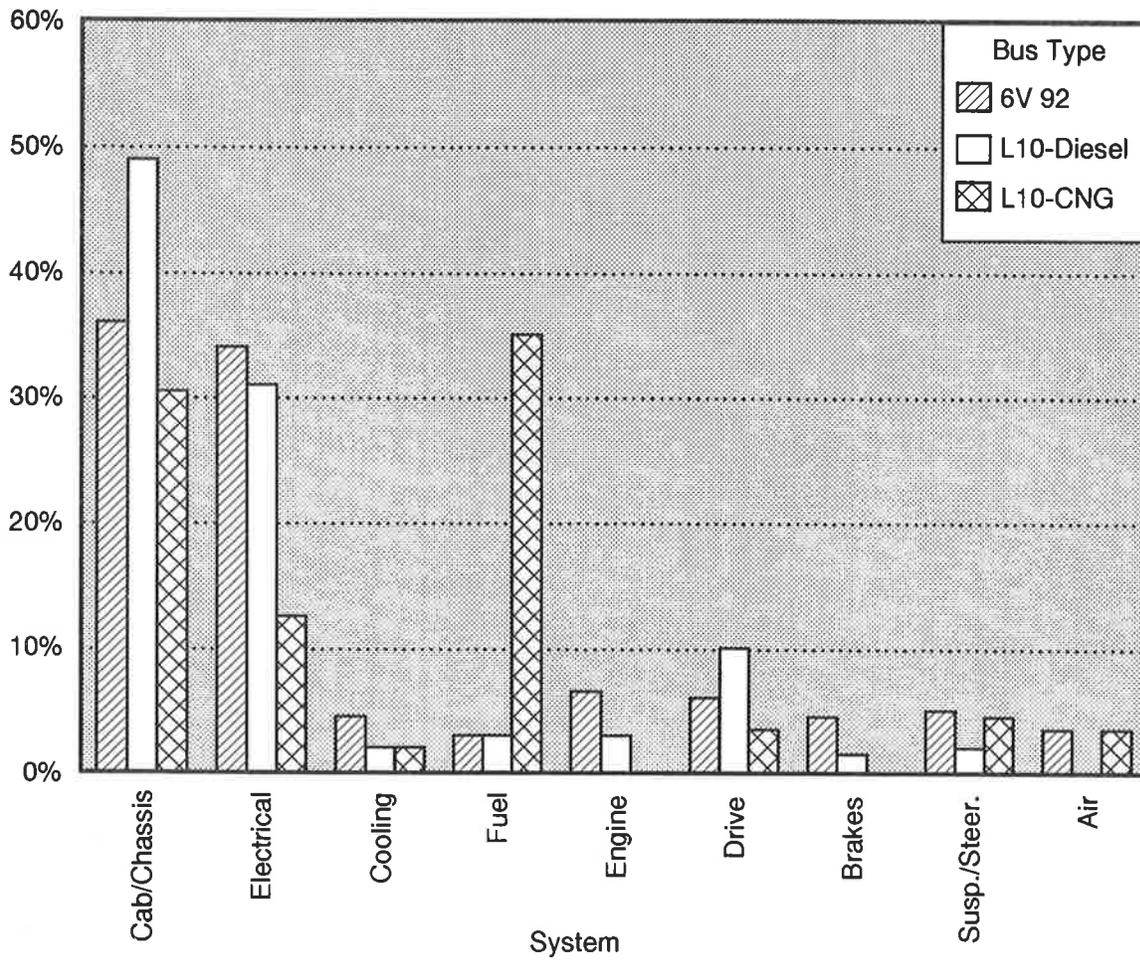
Figure 2-1. Road Calls by Major Bus System

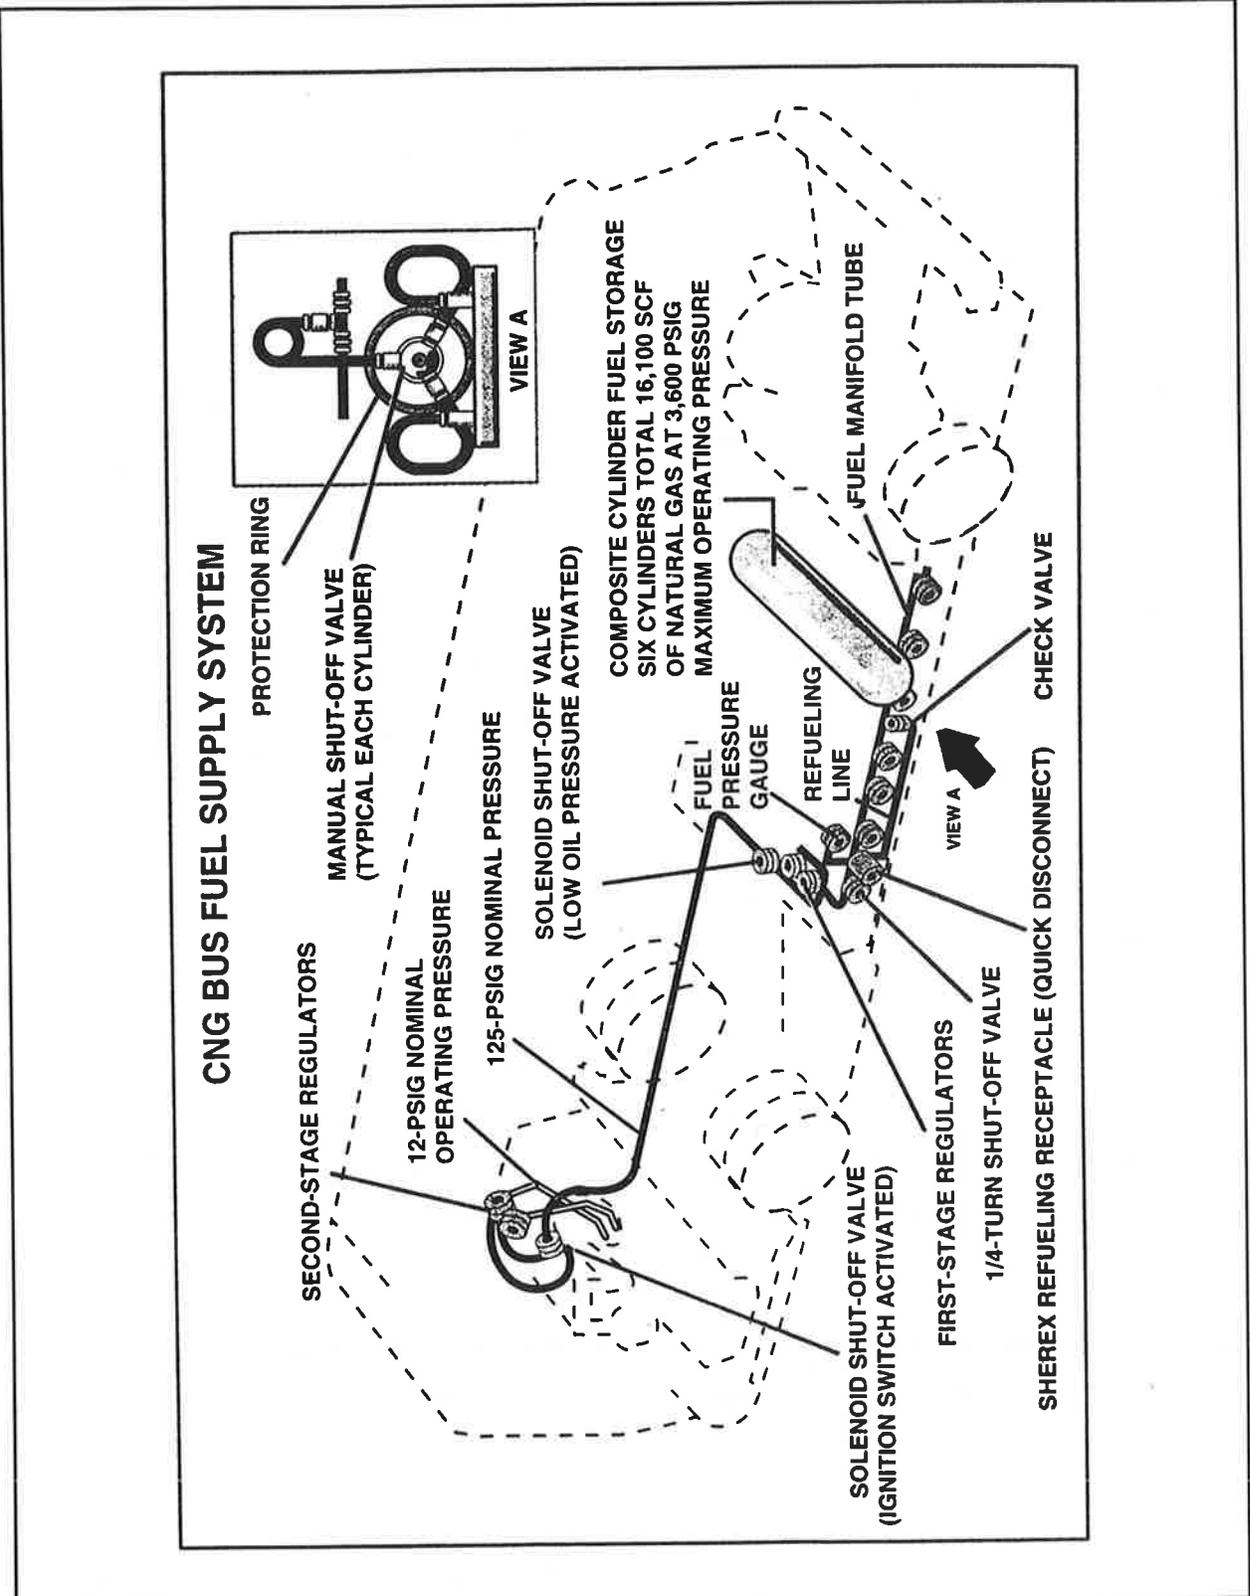
Figure 2-2. Flexible Corporation Bus Fuel System Arrangement

The volume of the fuel required to travel the standard 400-mile operating range between refuelings is approximately 16,000 standard feet<sup>3</sup> of natural gas (at standard temperature and pressure). To get this volume of gas into the tanks, the gas is compressed to 3000-3600 psi. In the bottom-mounted buses, the gas is compressed to 54 feet<sup>3</sup>, and contained in six DOT-certified high-pressure cylinders. Each cylinder has a water capacity of approximately 9 feet<sup>3</sup> or 67 gallons. Orion buses originally had 9 cylinders on the roof. The common arrangement is now

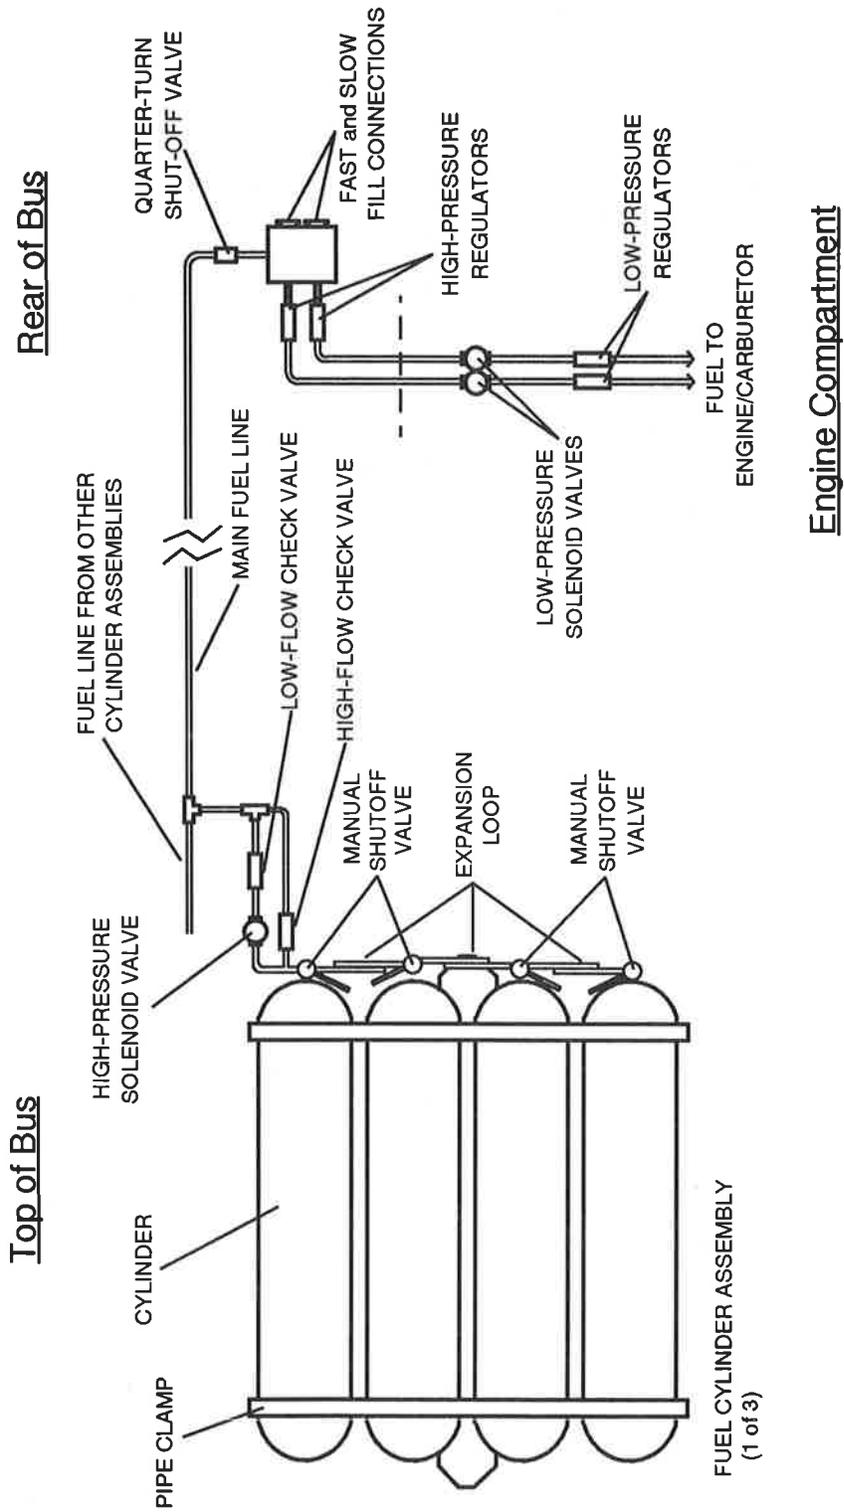
Figure 2-3. Orion Bus Fuel System Configuration

12 cylinders. Pressure transducers coupled with dashboard-mounted gauges provide the bus operator with a rough indication of on-board fuel available.

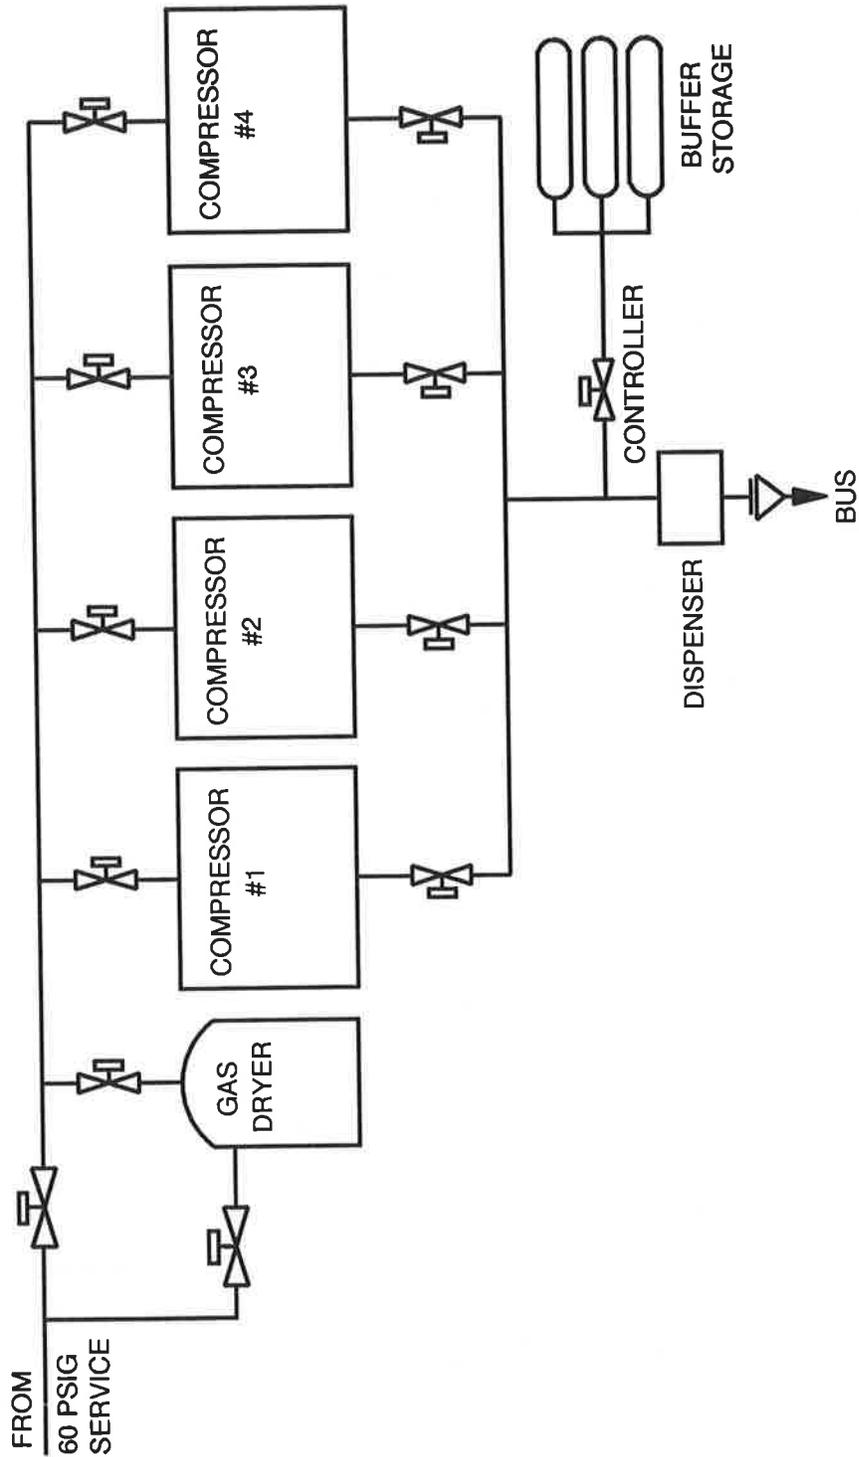
Figure 2-4. Typical Fuelling Station Schematic

- Storage Banks -- Each site used multiple vessels grouped into banks. Each vessel has a valve for isolating it for maintenance and a pressure relief device for safety. Cascade and buffer storage banks are used. Cascade storage fills the buses from the lowest pressure tank first. The compressor simultaneously fills the tanks. Buffer storage allows the compressor to fill either the tank or the bus, and allows the tanks to empty into the bus while filling.

- **Fill Posts** -- Each site has multiple fill posts at the fuel island, which is separated from the compressor area. Each fill post is equipped with a Sherex CC-5000 nozzle, breakaway connection for safety, shut-off valves, pressure gauge, nozzle relief valve for venting (to allow removal of the nozzle from the vehicle if seized), and an electrically-operated solenoid valve that closes when a ceiling-mounted gas monitor detects natural gas. A micron filter was added to several units to capture dirt and welding slag.

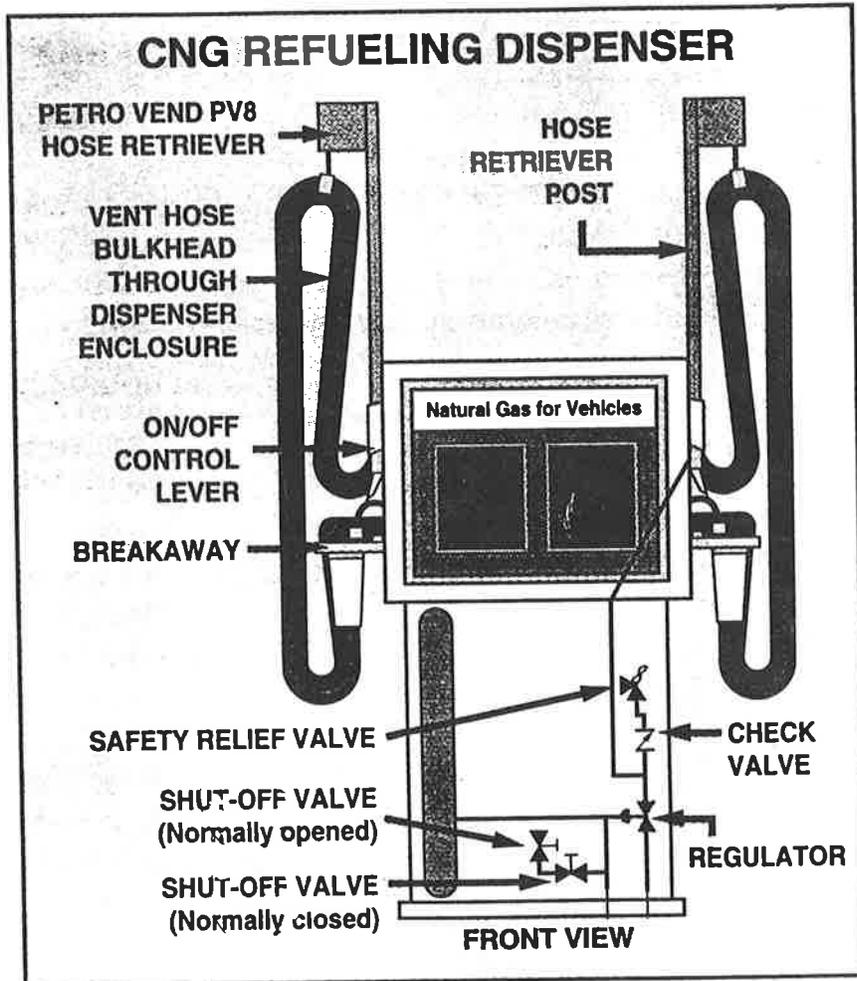
Figure 2-5. Typical CNG Dispenser
