FAA-RD-80-53

INTERFERENCE AND NOISE IN AND ADJACENT TO THE LORAN-C SPECTRUM AT AIRPORTS

MAY 1980

U.S. DEPARTMENT OF TRANSPORTATION

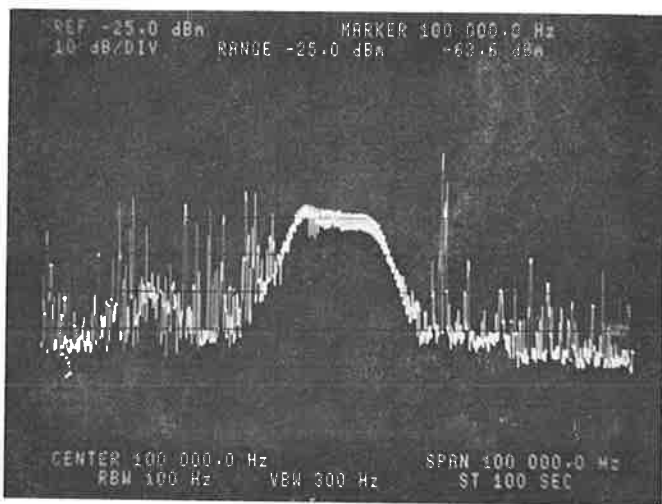
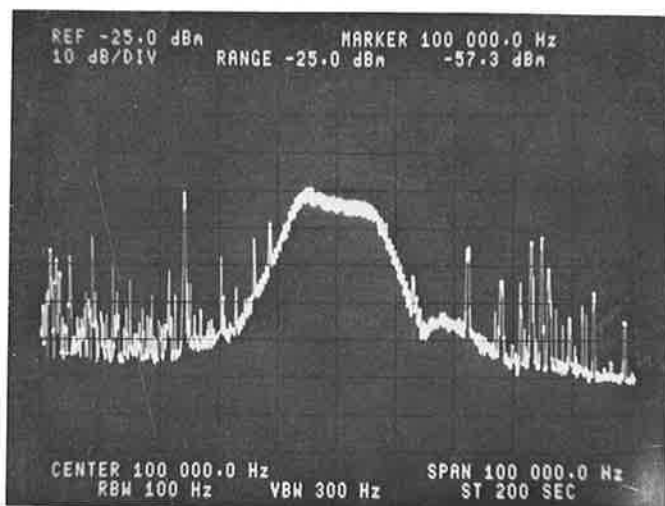
FIGURE 5-3. LORAN-C SPECTRUM ADJACENT TO A BOSTON SUBWAY LINE

a) No traffic passing measurement site

b) Passing train causes interference and noise for the first forty seconds of the 100 second sweep.

c) Passing train causes interference and noise for first forty seconds of the 200 second sweep.

After accumulating two successive sweeps at Boston's Logan airport, the spectral lines due to noise become so dense they raised the base line level by 20 dB. An example of this is shown in Figure 5-5. The radio was replaced and the noise was cleaned up entirely, but the experience highlights the necessity for EMI reduction capability in cockpit equipment, especially for unlikely sources and receptors such as a radio receiver's audio section and a LORAN-C receiver.

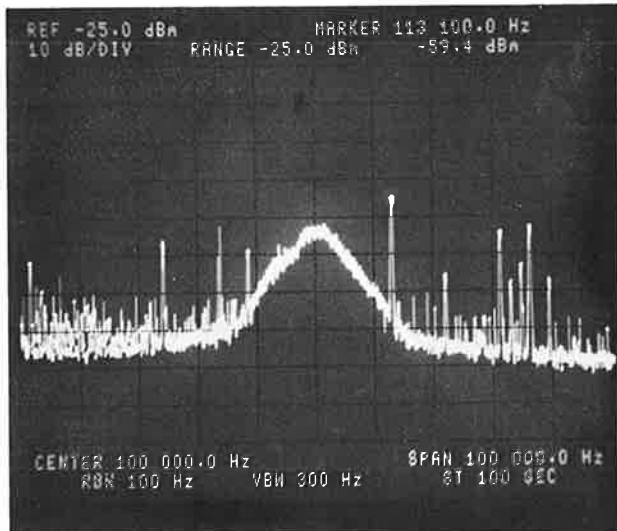
FIGURE 5-4. LORAN-C SPECTRUM WITH AND WITHOUT OPERATING A DEFECTIVE AIRCRAFT TO GROUND RADIO IN THE RECEIVER MODE ONLY

a) No internal interference

b) Aircraft radio generating interference.

Note the increase of transient spectral lines interspaced between existing external interference spikes

This feature was used to advantage in displaying the noise transient produced by a defective air to ground radio used in the test van. In order to cross runways, permission from the ground controller tower was required. A Collins VHF-20 radio was used for the contact. While this radio was monitoring the ground control frequency, a number of noise pulses appeared on the analyzer's display which coincided with voice modulation coming from the radio. It was discovered that the voice amplifier in the radio was clipping the voice waveform and producing harmonics spread out across the entire 50 to 150 kHz band. Figure 5-4 shows an analyzer display photographed at the Burlington, Vt. airport.

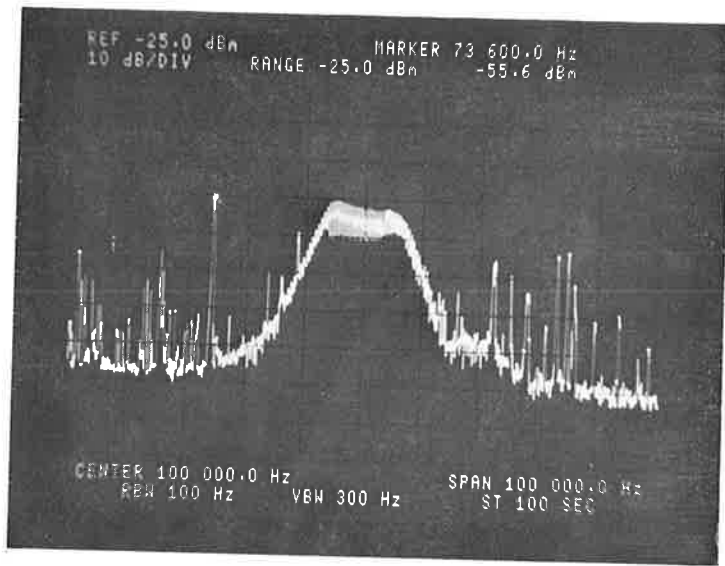
FIGURE 5-5. COMPARISON OF NOISE AND INTERFERENCE IN THE LORAN-C SPECTRUM WITH THE ADDITION OF AN AIRCRAFT RADIO IN THE RECEIVE MODE ONLY INTERNAL TO THE MEASUREMENT VAN

a) LORAN-C spectrum at Logan Airport, Boston Ma. without internal interference

b) Increase in broad band noise caused by aircraft to ground receiver brings up base line by 20 dB besides adding transient spikes
