UMTA-MA-06-0025-81-3
DOT-TSC-UMTA-81-66

ESCALATOR DESIGN FEATURES EVALUATION

May 1982
Final Report

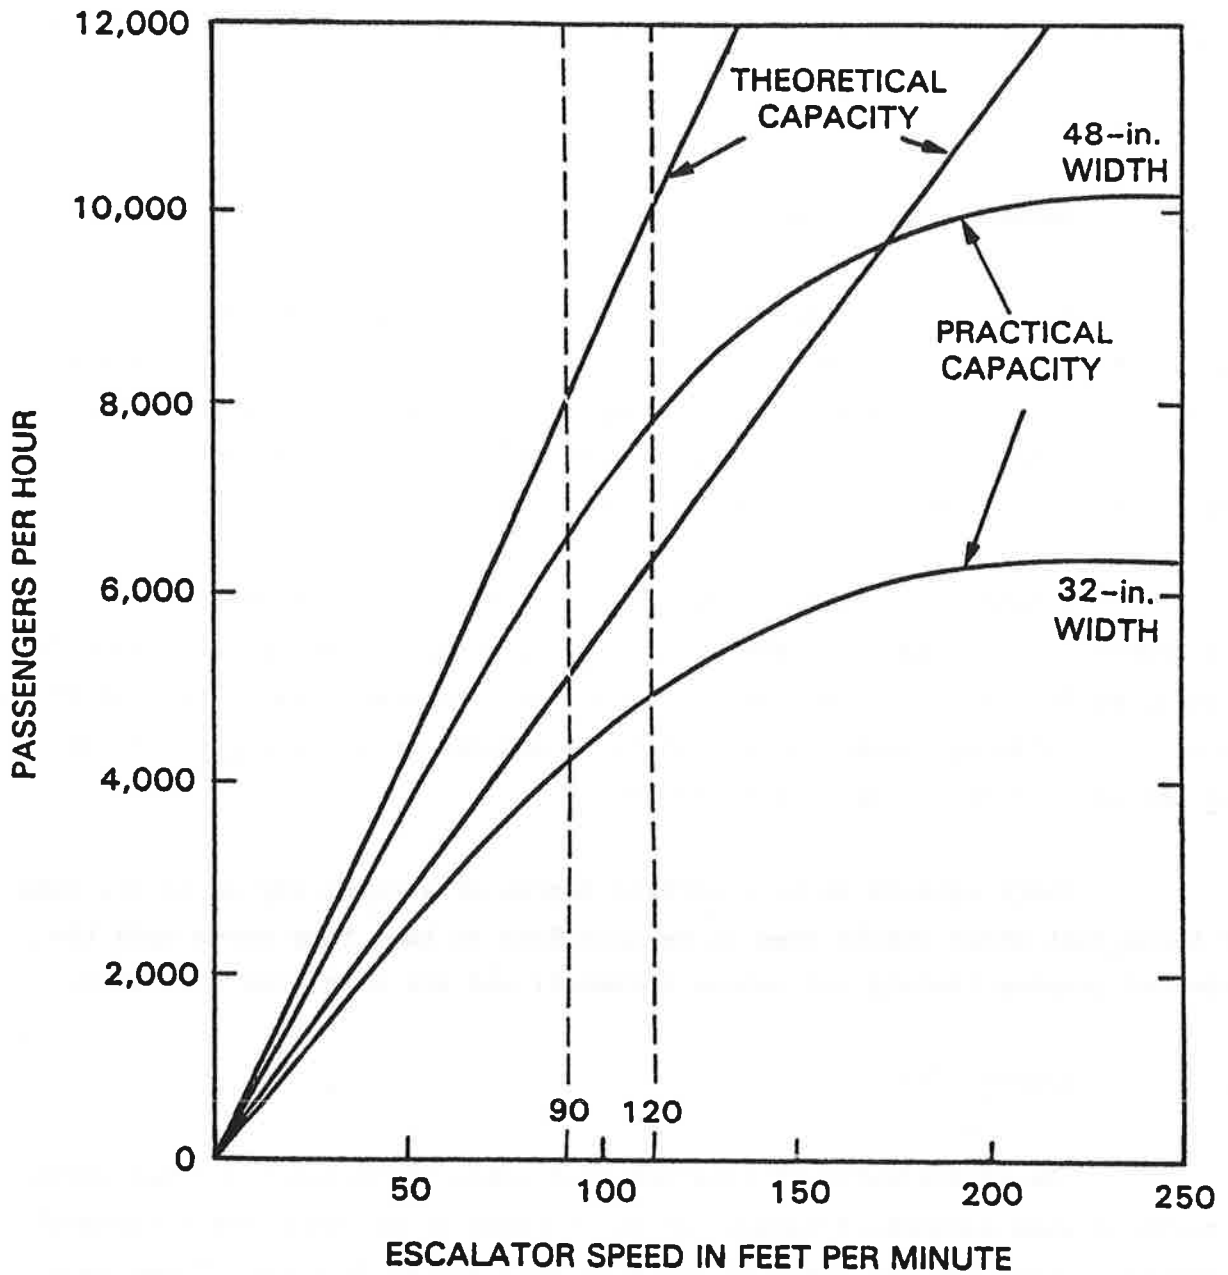
FIGURE 2-1. ESCALATOR CAPACITY AT VARIOUS SPEEDS

Generally, an increase in speed results in an increase in capacity. However, this relationship is not linear as shown in Figure 2-1. The theoretical values in Figure 2-1 are based on the assumption of 1.25 passengers per step on the 32 inch and 2.0 passengers per step on the 48 inch wide escalator. The practical capacities are based on field measurements of traffic flows. Studies (Refs. 11, 12, 14) indicate that an actual increase in passenger capacity from 90 fpm to 120 fpm escalator speed is around 12%. This

increase in capacity is of marginal value at low or moderately loaded stations. However, at stations experiencing high passenger flow rates during the peak hours, a 12% increase in carrying capacity could help clear the station platforms more quickly.

The escalator capacity in practice is lower than the theoretical at higher speeds due to hesitation of passengers at higher speeds to get on an escalator (Refs. 12, 14). This hesitation delays a patron's first step onto an escalator and results in several steps being empty to cause the capacity reduction.

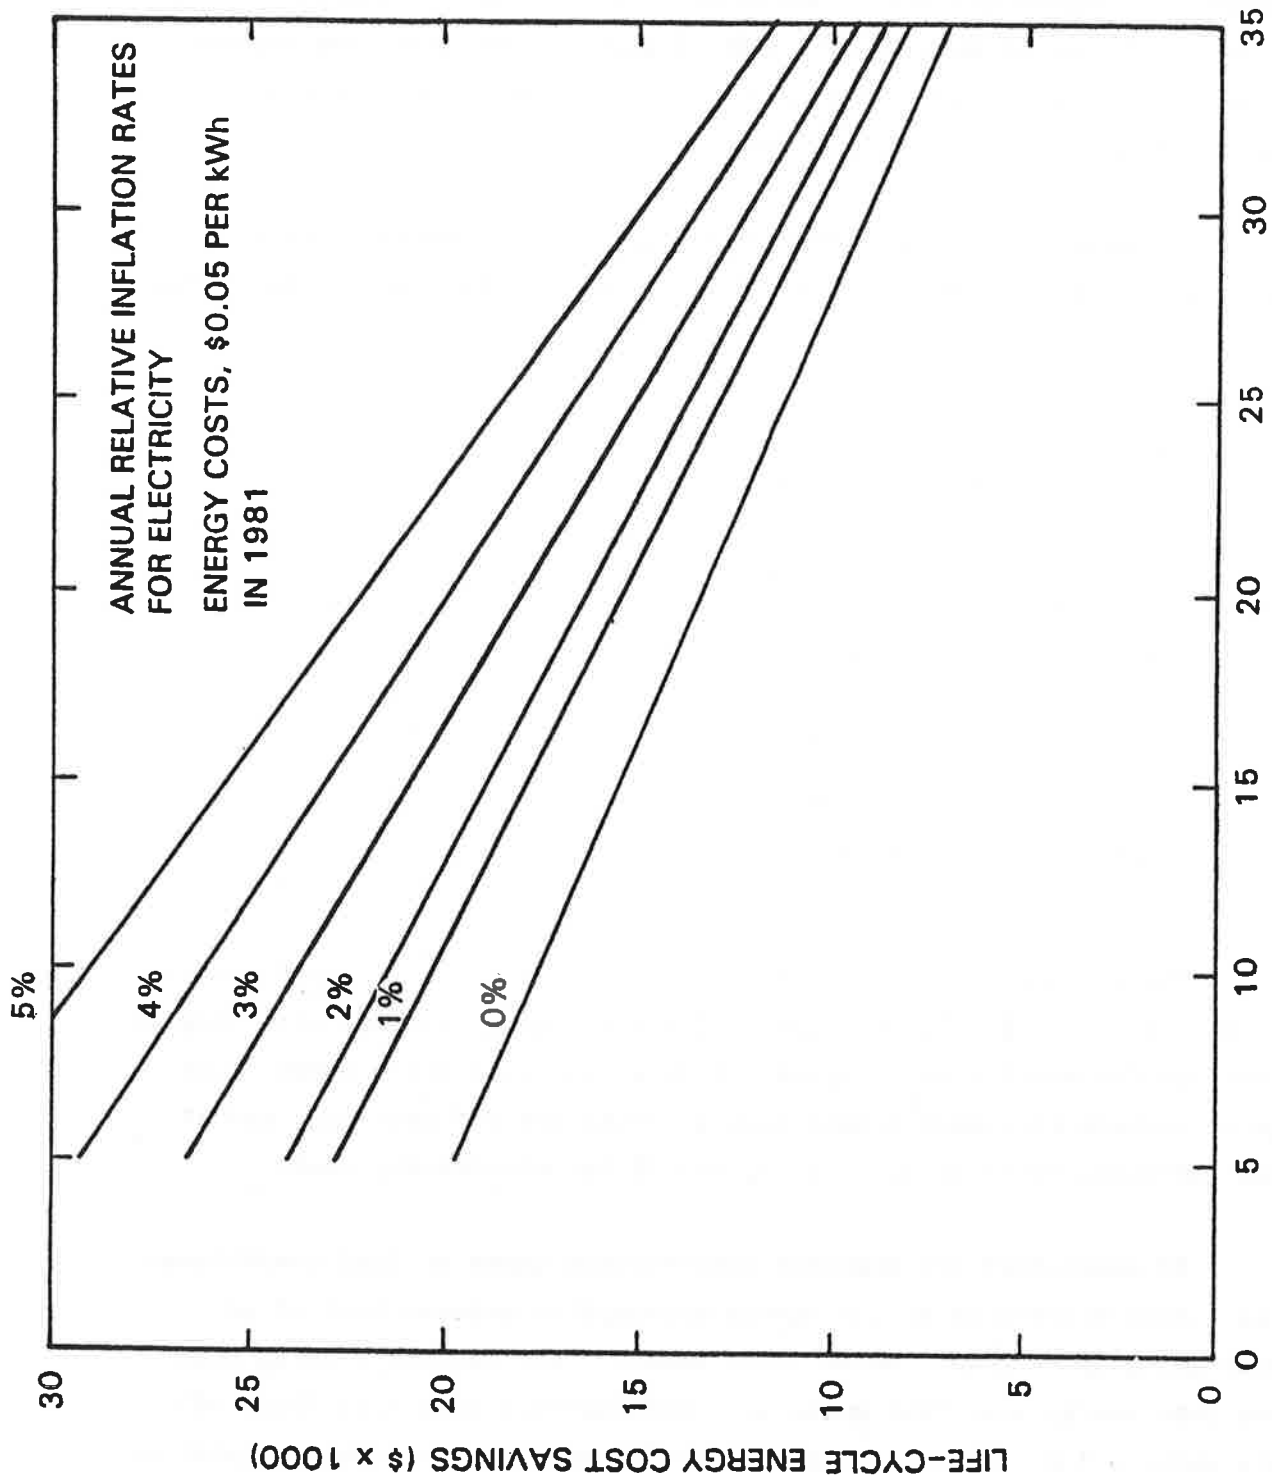
FIGURE 3-1. LIFE CYCLE ENERGY SAVINGS USING MAT OPERATION

Thus, under all cases, a total present mat operation cost penalty of \$10,000 + \$2,550 = \$12,550 is easily offset by energy savings utilizing the mat operation for escalators. Figure 3-1 shows the life cycle energy cost savings at various escalator demand levels during the off-peak hour and at relative inflation rates of 1, 2, 3, 4, and 5% for electricity cost.

If escalators are operated continuously under no load conditions, there is little difference in the energy consumption between that of an escalator going up or down. Under load, however, the escalator going down consumes less energy than that going up. Westinghouse test data (Ref. 16) indicate under a load of five passengers, the consumption in the up direction is 2.8 kW, but drops to 0.764 kW in the down direction. As the load increases, the down direction escalator starts consuming less energy. Westinghouse test

data also show that the down escalator becomes regenerative for loads more than 10 passengers. OTIS (Ref. 5) test results show similarly that a load of 30 passengers travelling in the down direction provides sufficient regeneration to allow enough energy to power an escalator going up carrying five passengers. The calculations shown in this report are applicable for escalators operating in either direction.
