Developing New Low-Temperature Admixtures for Concrete A Field Evaluation

April 1997

SPECIAL REPORT

Special Report 97-9

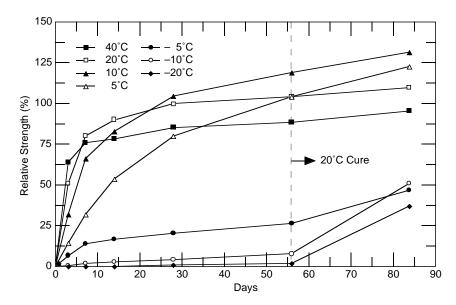
Figure 1. Effect of temperature on strength gain of normal concrete. All strengths are referenced to the 28-day strength of the $20^{\circ}C$ concrete. The 40, 10 and $5^{\circ}C$ lines are based on relations presented by ACI. The other data are from laboratory tests at CRREL.

Construction standards require that normal concrete be kept at or above 5°C (ACI 1988) until it has cured. As temperatures drop to this mark, finishing operations take longer and forms cannot be stripped as fast as they can during the summer. The strength gain of concrete is slowed. At a few degrees below zero, not only is the hydration rate of cement slow, the mix water begins to turn into ice. At -3°C, 90% of the water will freeze (Korhonen 1990). If freezing occurs, the concrete may lose half its strength. Figure 1 shows the effect of temperature on the strength of normal concrete.

From a strength development standpoint, the antifreeze concrete was equal to or better than the concrete placed inside a heated enclosure. Dry heat can create problems. In fact, if the temperature of concrete is not closely regulated, high temperatures can cause significant strength loss, as shown in Figure 1 for the 40°C concrete.

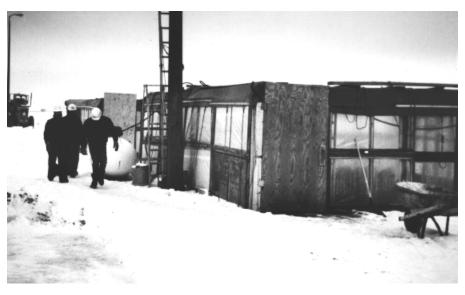
Figure 2. Temporary heated shelter.

The site was prepared by jackhammering out alternate sections of concrete, replacing 15 cm of base material with coarse gravel, and setting forms and reinforcing steel. The slabs that remained between the removed sections provided work space for finishing operations. A temporary, propane-heated enclosure (Fig. 2) was erected over one slab as a control section (admixturefree) to provide a comparison between normal and antifreeze concreting operations. An unheated enclosure covered one of the admixture sections as a secondary test. Concrete made with admixtures was placed in the two sections exposed to ambient air outside the shelter and in the section in the unheated shelter.

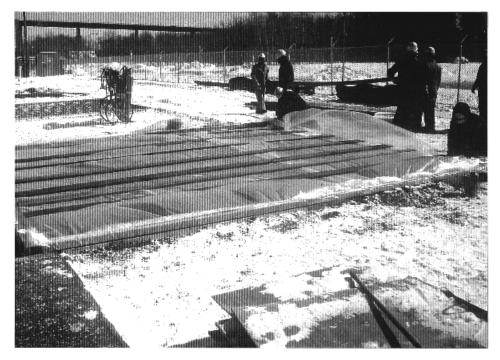
Figure 3. Plastic was placed over the antifreeze concrete cured outdoors.

The concrete for all sections was placed and finished in the normal fashion. No extra effort or skill was required to work outdoors compared to doing the same work inside the heated shelter. The workers found the freedom of movement better outdoors than in the temporary enclosure. The heated shelter was useful as a warming hut between concrete deliveries. The workers stayed outdoors for approximately 2-hour periods. Except for the heated control section, the concrete was thermally unprotected. A plastic sheet was placed over the two exposed concrete sections for 7 days to minimize water loss (Fig. 3). The concrete in the two shelters was uncovered.

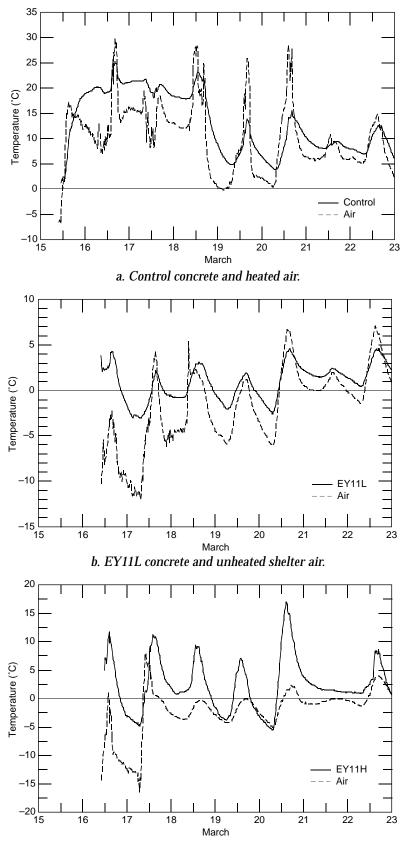
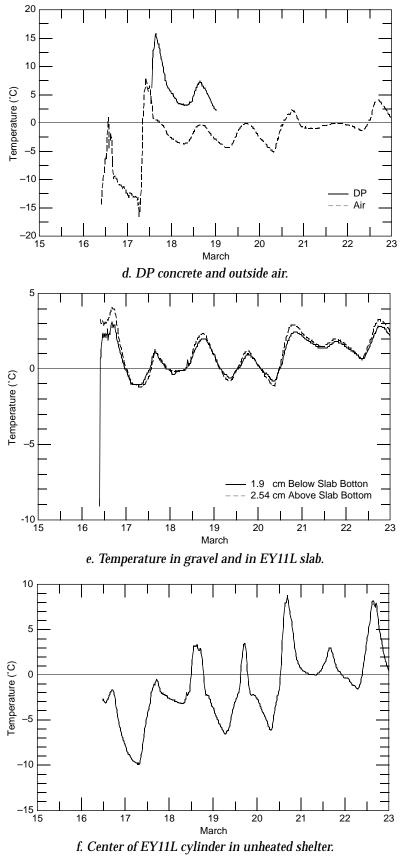
Figure 4a shows the temperatures of the control concrete and the heated air in the shelter. The shelter was heated for several days before 15 March to thaw the frozen ground. To facilitate placement of the control concrete, two walls of the shelter were removed at 10:30 a.m. on 15 March and replaced at noon. The air inside the shelter cooled to -6.6° C by the time concreting started, but, after the walls were replaced, the shelter warmed up again. However, the shelter

temperature fluctuated daily. The maximum of 29.7°C occurred at 4:10 p.m. on the 16th, and two lows of -0.2°C and 0.4°C occurred at 3:30 a.m. on the 19th and at 6:45 a.m. on the 20th respectively. The two low temperatures were caused by a malfunction of the heating equipment. The heat was turned off at about 4 p.m. on 22 March. The average air temperature in the shelter for the recording period was 10.5°C.

The control concrete was delivered to the site in two separate shipments, at a temperature of about 12°C for each shipment. (All other concrete was delivered in one truck per section.) By the time both control shipments had been placed and the shelter walls were reinstalled, the concrete had cooled off to 1.3°C (Fig. 4a). It wasn't until 5 p.m. of that same day that the heat supplied by cement hydration and the shelter warmed the concrete to 12°C. The concrete continued to warm until it reached 20.3°C at 7 a.m., 16 March, in spite of the air cooling to 9.4°C. Like the air, the concrete temperature fluctuates throughout the recording period. It reached a maximum temperature of 25.3°C at 4:10 p.m. on the 16th and a minimum of 3.8°C at 7:10 p.m. on the 20th, closely corresponding to the high and low shelter air temperatures. The average temperature of the control concrete through 4 p.m. on 22 March was 13.3°C. It never dropped below zero during this period.

Figure 4b shows the temperatures of the EY11L concrete and the air inside the unheated shelter. The EY11L mix was placed at 9:45 a.m., 16 March. It was delivered at a temperature of 3.3° C. As was done with the control section, two walls of the unheated shelter were removed temporarily. When exposed to the -10° C (but warming) air, the concrete temperature dropped to 2° C, but almost immediately began rising, reaching 4.3° C by 4 p.m. Then, the concrete temperature dropped to -3° C, its lowest recorded temperature, at 3:30 a.m. on 17 March. This concrete contained a low admixture dosage and had an expected freezing

point of around -3°C. Its average temperature was 0.9°C through 4 p.m., 22 March.

Figure 4c shows the temperatures of the EY11H concrete and the outdoor air. The freezing point of this concrete was -5° C. The EY11H mix was cast outdoors at 11:40 a.m., 16 March. It, too, began at 3.3°C. But, instead of cooling off when exposed to the -7.3° C air, it warmed to 11.8°C at 2:10 p.m., before dropping off to -4.4° C at 7 a.m., 17 March. It reached its lowest temperature of -5.5° C at 7 a.m., 20 March, 4 days after being cast. Its average temperature was 2.4°C through 4 p.m., 22 March.

Figure 4d shows the temperatures of the DP concrete and the outdoor air. The freezing point of this admixture was -5°C. The DP concrete section was cast outdoors at 1:10 p.m., 17 March. It was delivered to the site at 7.2°C, when the air temperature was 4°C and falling. The concrete temperature rose to a high of 15.8°C at 2:30 p.m. on 17 March. Because of a data recorder malfunction, concrete temperatures were not recorded after midnight, 18 March. The average air temperature from the time of placement to midnight, 18 March, was -1.6°C and from placement through 4 p.m., 22 March, was -1°C. The average temperature of the concrete through midnight, 18 March, was 6.3°C. The DP concrete probably did not drop below -5°C through 22 March.

Figure 4e shows the temperatures of two points near the bottom surface of the EY11L slab. The EY11L slab had the lowest average surface temperature of all the slabs. As can be seen in Figure 4e, the bottom surface of the concrete, which was halfway between the two thermocouple positions, could not have frozen. The lowest temperature of the two thermocouples was -1.2° C, 21 hours after the concrete was placed. Recall that the freezing temperature of this concrete was -3° C. The EY11H slab, with a -5° C freezing temperature, experienced the lowest single surface temperature of all the slabs. Its bottom surface temperature reached a low of about -3° C (not shown), 4 days after the concrete was placed.

Figure 4f shows the temperatures of an EY11L cylinder stored on grade in the unheated shelter. The cylinder's temperature dipped below -5° C on several occasions, the first at 8:00 p.m. on 16 March, about 10 hours after it was cast. The average temperature of the cylinder through 4 p.m., 22 March, was -1.3° C.

Their compressive strengths cannot be used as an indicator of the in-place strength of the antifreeze concrete because, as Figure 4f shows, the cylinders probably froze. At CRREL, subsequent petrographic analysis of the suspected frozen cylinders revealed typical ice lens patterns. Strengths reported by the testing laboratory indicate that the cylinders developed only about half of their potential strength, which is indicative of concrete that has frozen while curing.

The test showed that, at times, a plastic sheet provided more than just protection against moisture loss. Figures 4b and c show that the concrete under the plastic sheet was actually warmer than the concrete inside the unheated shelter, at least on sunny days. The sheet-covered concrete was 5 to 10°C warmer during the day on all but 21 March, which was a cloudy day. On that day, the two concrete temperatures were nearly identical. At night, the opposite occurred: the concrete in-

side the unheated shelter was up to 1.5°C warmer. These observations can be explained by the effect of the large volume of air in the shelter. The plastic sheet, having essentially no air to heat up and cool off, allowed the concrete to heat and cool faster than could the concrete inside the shelter. The 6-day temperature of the concrete under the plastic sheet averaged 2.4°C, vs. 0.9°C for the concrete in the unheated shelter. A blanket of insulation would undoubtedly have performed even more effectively.

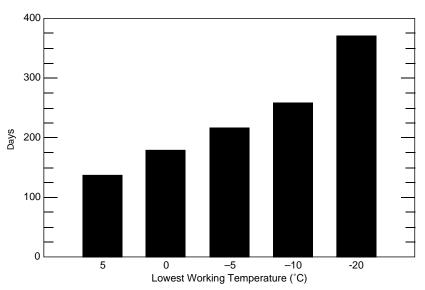
tests was how the work would Figure 5. Extension of construction season possible with various low temperprogress in cold weather. The ature limits (unpublished chart from Horrigan, 1995).

seen, pushing the temperature envelope to -5° C increases the length of the construction season by nearly 80 days. More working days become available at lower temperatures, to the point that concreting is a year-round proposition without the need for heat. The climate at the Soo is similar to that of the coldest areas in the contiguous U.S.

The potential effect on the length of the construction season of being able to place and keep concrete at -5° C, instead of at the current limit of 5°C, can be determined by looking at weather records. The number of days that the maximum air temperature at the Soo exceeded various low temperatures are shown in Figure 5. As can be
