MONOGRAPH

# Construction, Maintenance, and Operation of a Glacial Runway, McMurdo Station, Antarctica

March 1998

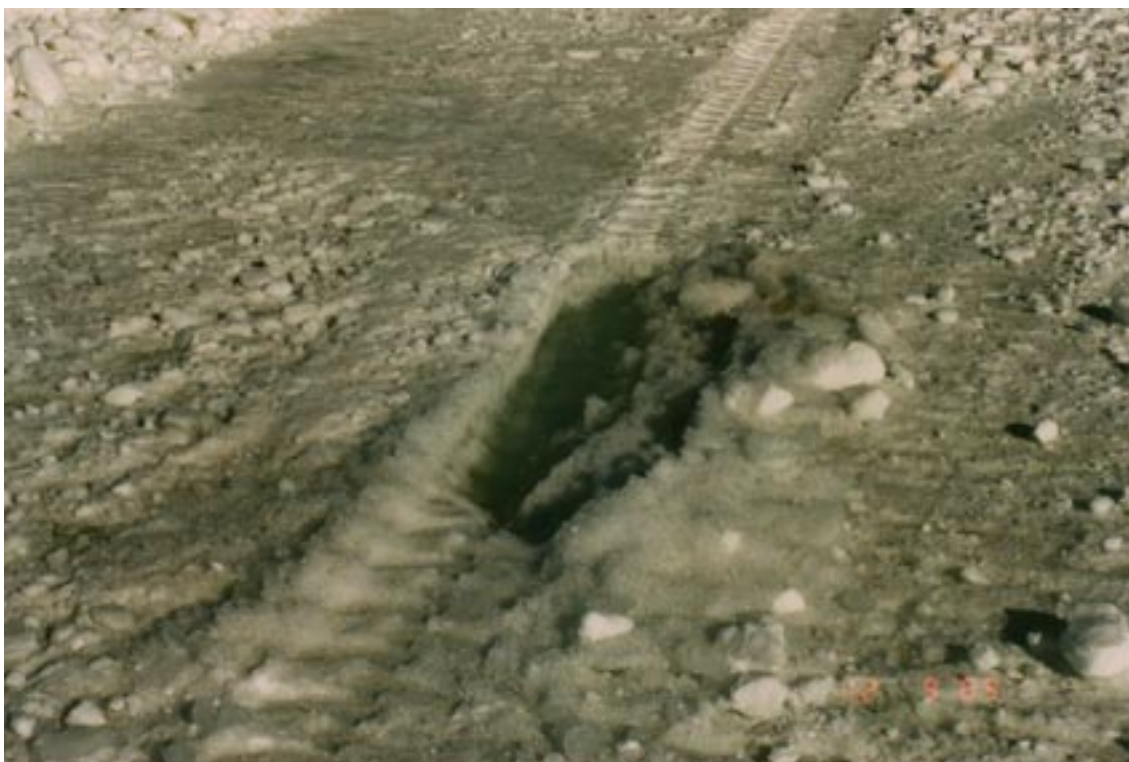
*Figure 23. Grader tracks showing breakthrough of thin ice cover over subsurface melt pool.*

Ice temperature profiles are the most important ice information because the mechanical behavior of ice subjected to loading is strongly influenced by its temperature. Vital information is the maximum temperature, particularly during the time period the runways would operate, and its location within the ice column. Subsurface melting may not always be obvious, but it could easily be disastrous for wheeled traffic (Fig. 23). If tem-

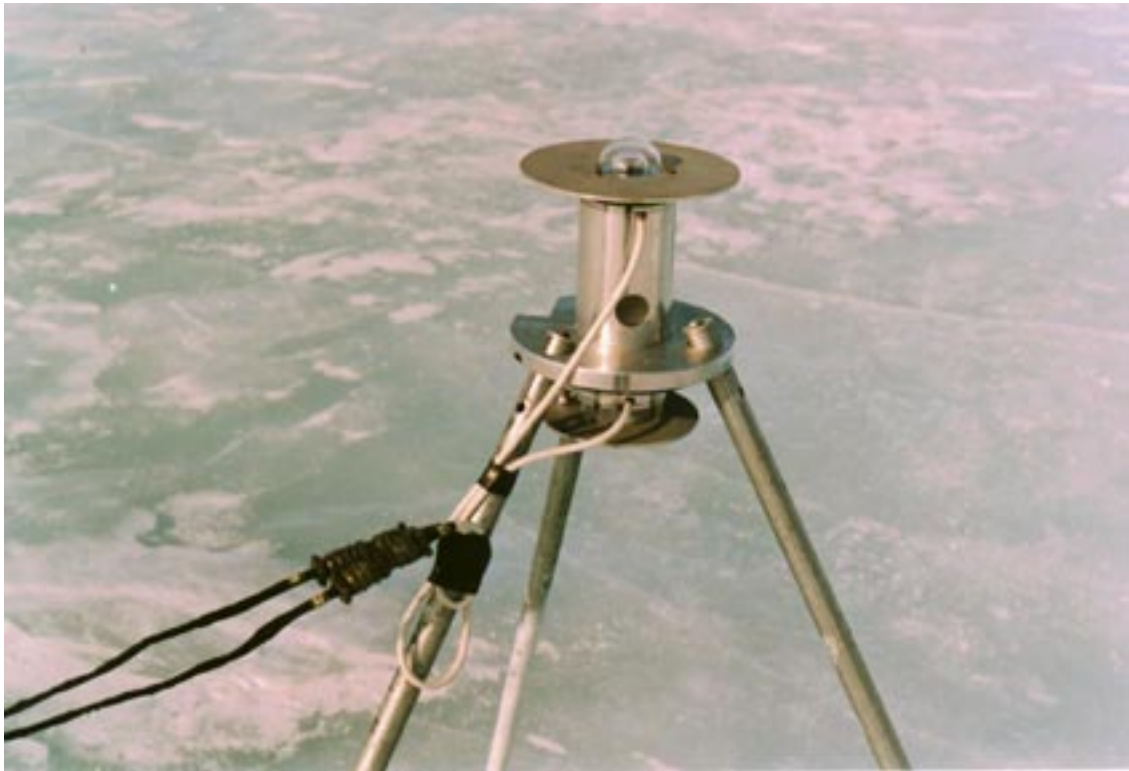
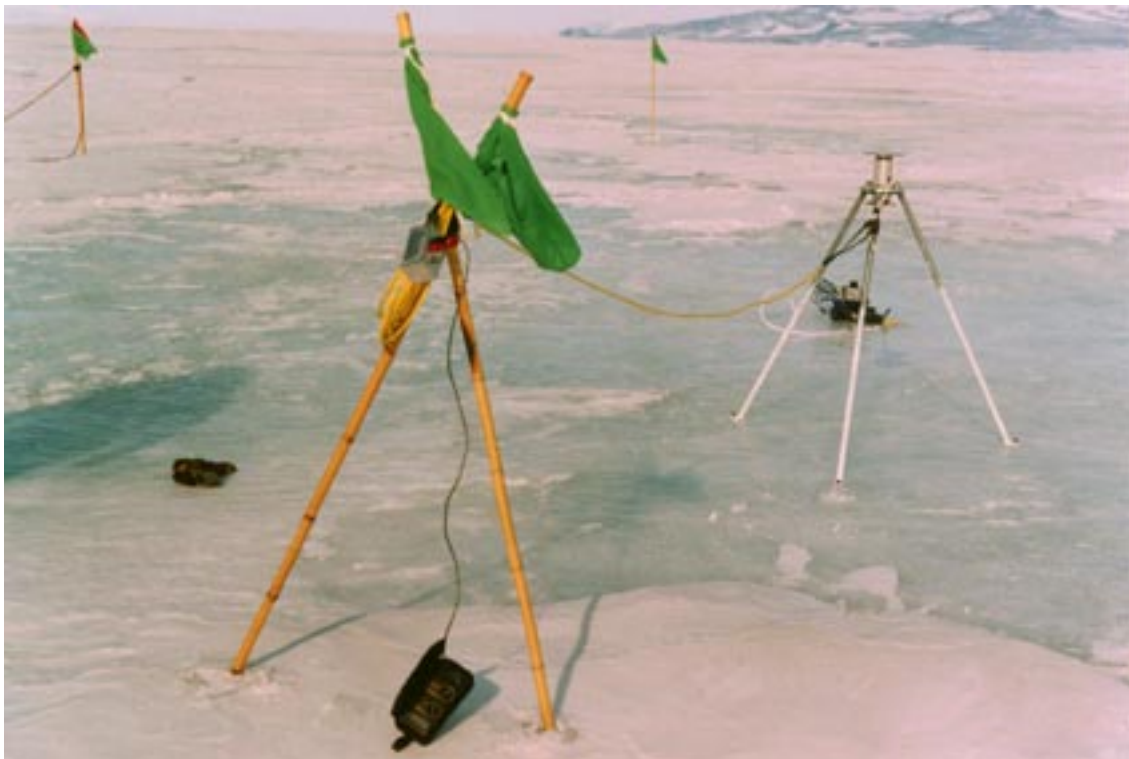
*Figure 24. Radiometer pair used to measure albedo of snow and ice surfaces.*

At the Pegasus site, we used Eppley pyranometers on several occasions during the peak of the austral summer. Unfortunately, we have never had the opportunity to connect them to a data acquisition system and thus only have spot readings. We used a tripod system for mounting the

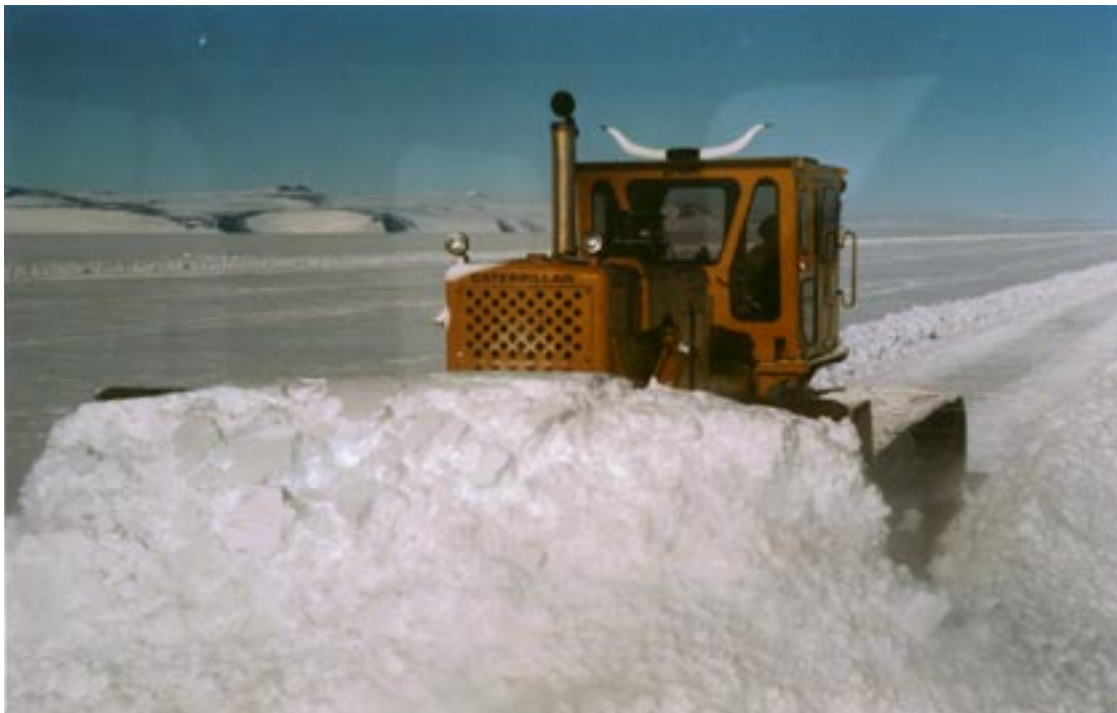
*Figure 28. Initial snow stripping on the Pegasus runway using a bulldozer with U-blade.*

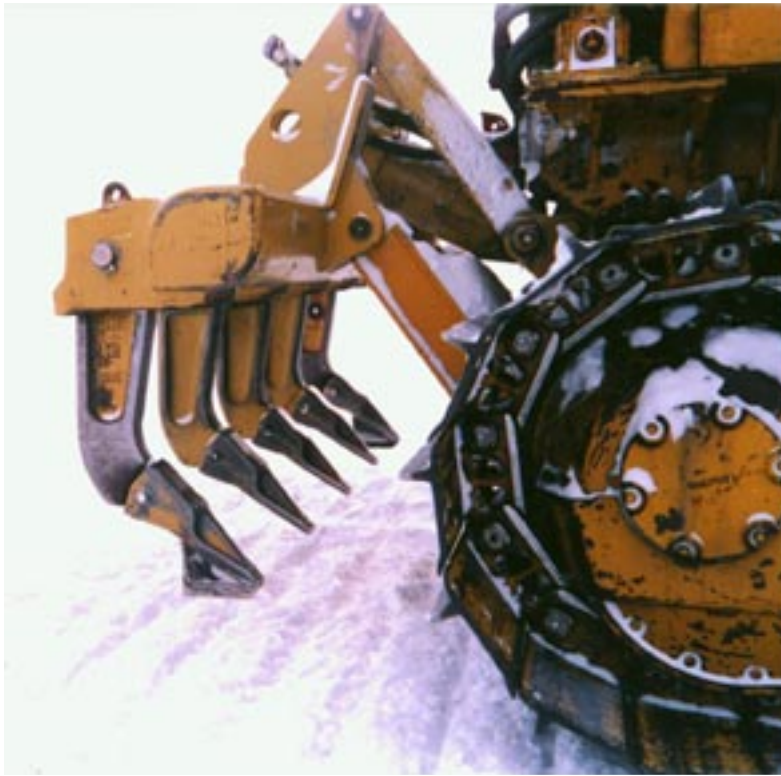
*Figure 30. Ripper equipped with skids on outer teeth.*

An attempt was made to strip the snow directly from the ice surface with the snowblower. The problem of ice gouging, as experienced with the blades, was also found to exist for the cutting edge of the blower. We equipped the blower with skids similar to those for the bulldozer blade, and

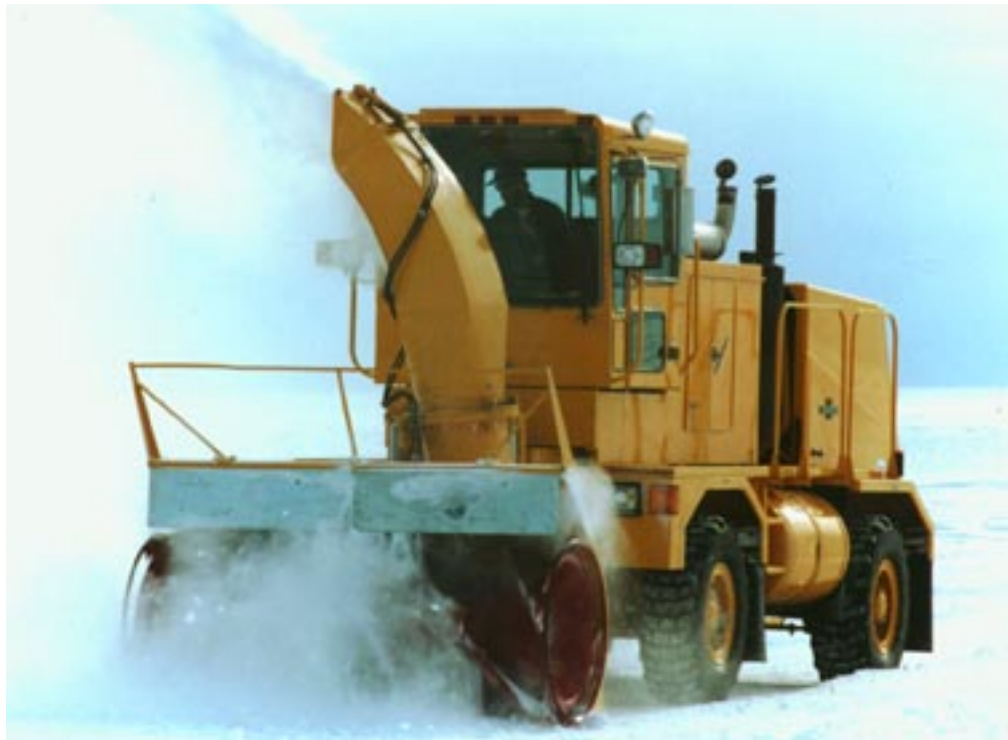
*Figure 31. Rolba ribbon-type snowblower mounted on Oshkosh truck.*

To remove the snow from the runway area, we used an Oshkosh prime mover equipped with a Rolba snowblower (Fig. 31). The 2.6-m (8.5-ft)-wide, two-stage blower with a 1.5-m (4.8-ft)-diam. ribbon-style drum was mechanically driven (drive shaft). Separate motors powered the blower (300 kW or 400 hp) and the prime mover. The unit we used had four-wheel drive and four-wheel steering, the latter being unnecessary for our application. The blower was rated for 2720 tonnes/hr (3000 tons/hr) with a casting distance of 46 m (150 ft). The blower head was controllable for up and down (including down pressure), tilt forward and back, and casting direction (roughly 140° centered about the vertical with infinitely adjustable

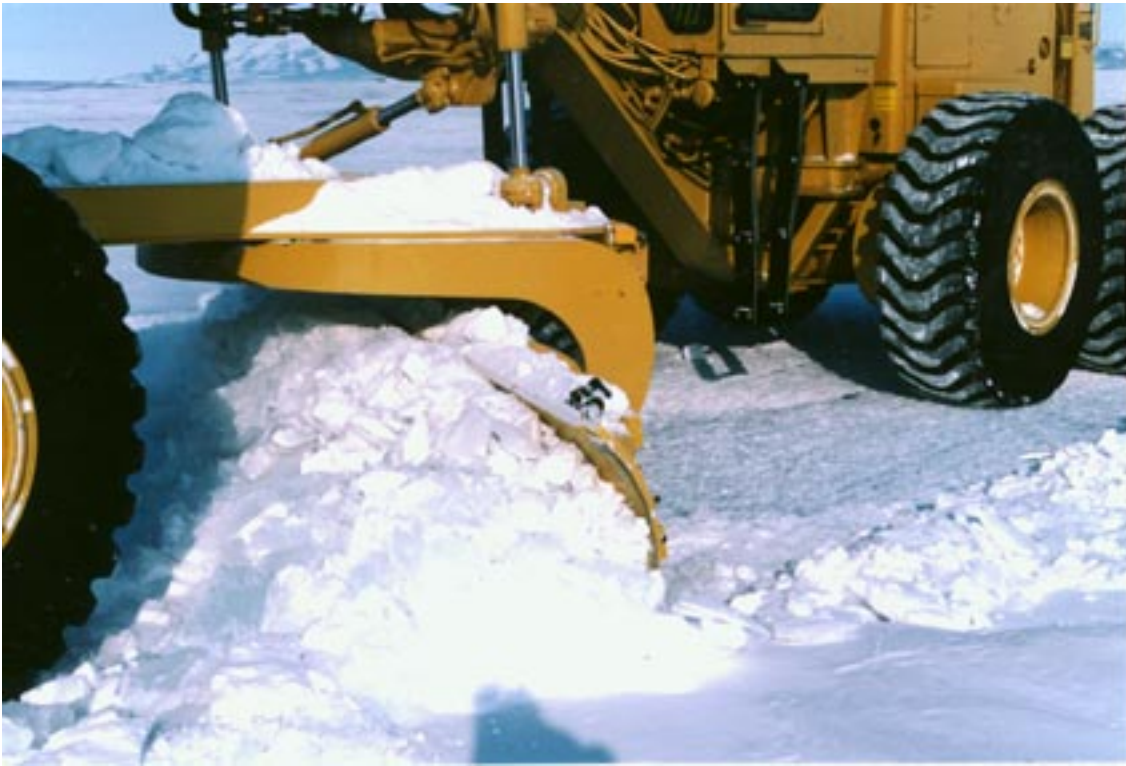
*Figure 34. Aggressive grader blade removing up to 20 cm (8 in.) of glacial ice in one pass.*

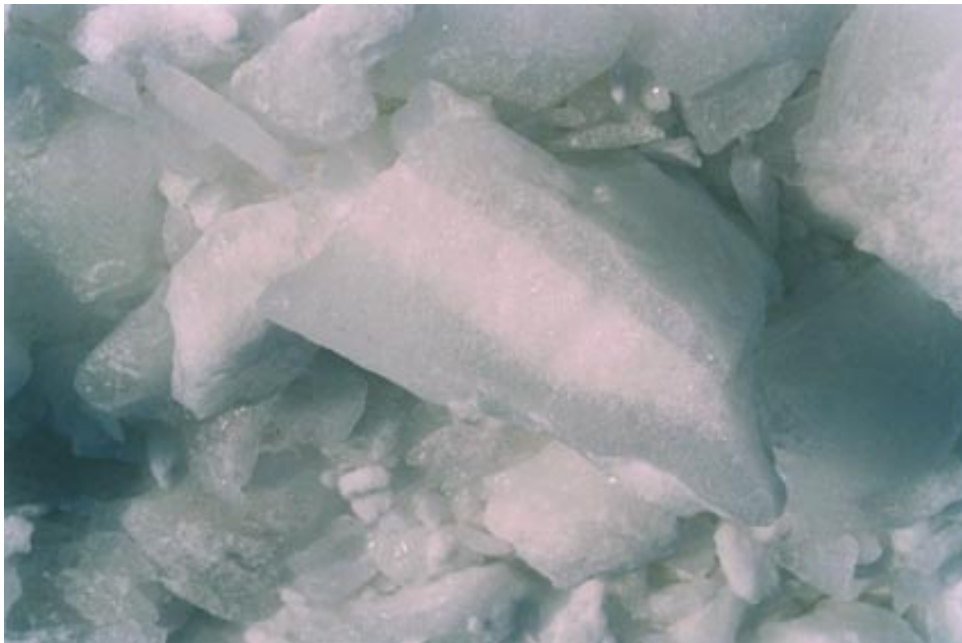
Figure 41. Poorly consolidated ice including snow pockets.

Following initial grading and debris removal, the runway should be carefully inspected and sampled to determine ice integrity, including the presence of cracks, variations in ice appearance or surface strength, potholes or other melt features, and to affirm the topography revealed from the initial survey data. Cores should be taken, especially in low spots, to determine how much ice might need to be graded to remove all porous or weak ice. This weak ice, which we called trash ice, is typically found in the shallow basins on the runway surface and often has large bubbles, incorporated lenses of snow, high concentrations of mineral particles, and occasionally is held together only with thin segments of ice plates (Fig. 41). The trash ice we discovered

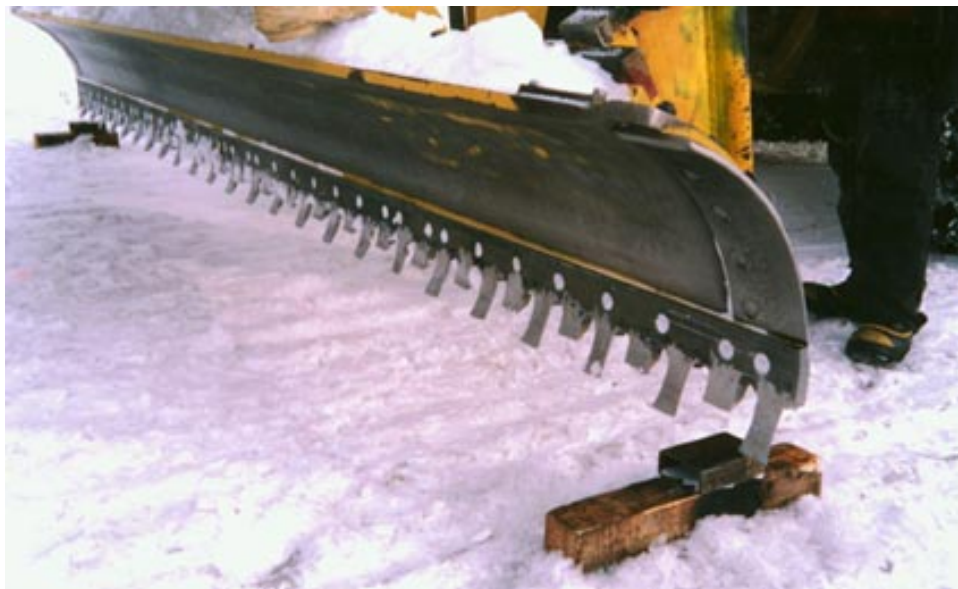
*Figure 45. Custom built chisel-tooth grader blade used during finish grading of runway.*

For finish grading, we used a different chisel-tooth design for the blade (Fig. 45) than was used for initial grading. This blade appeared more aggressive than the one used for the first passes and was designed with an alternating tall- and short-tooth pattern to assist in cleaning the surface of all debris. The geometry of the cutting teeth was similar to the rough grade blade with an included angle of  $42^\circ$  and side relief angles of  $41^\circ$  (Fig. 46). However, the cutting teeth were considerably longer, at 9.6 cm (3.8 in.). The cleaning teeth had an internal angle of  $60^\circ$ , a height of 5.7 cm (2.2 in.), and no side relief cut-out. The lower edge of the cutting teeth was flared to a width of 5.7 cm (2.2 in.) and was 4 cm (1.6 in.) closer to the ice than the cleaning teeth. For most of the runway, only one pass was required to arrive at the de-

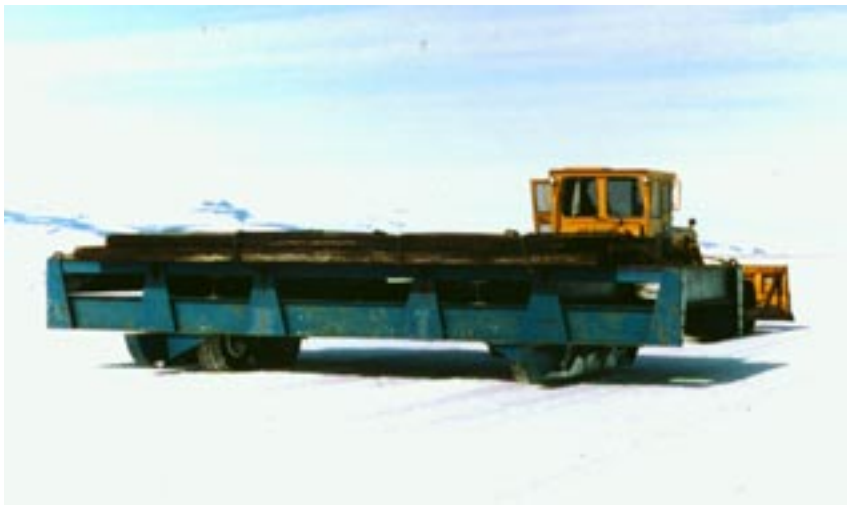
Figure 49. Cart for proof rolling the Pegasus runway shown configured for C-130 landing gear; ballast is steel plate.

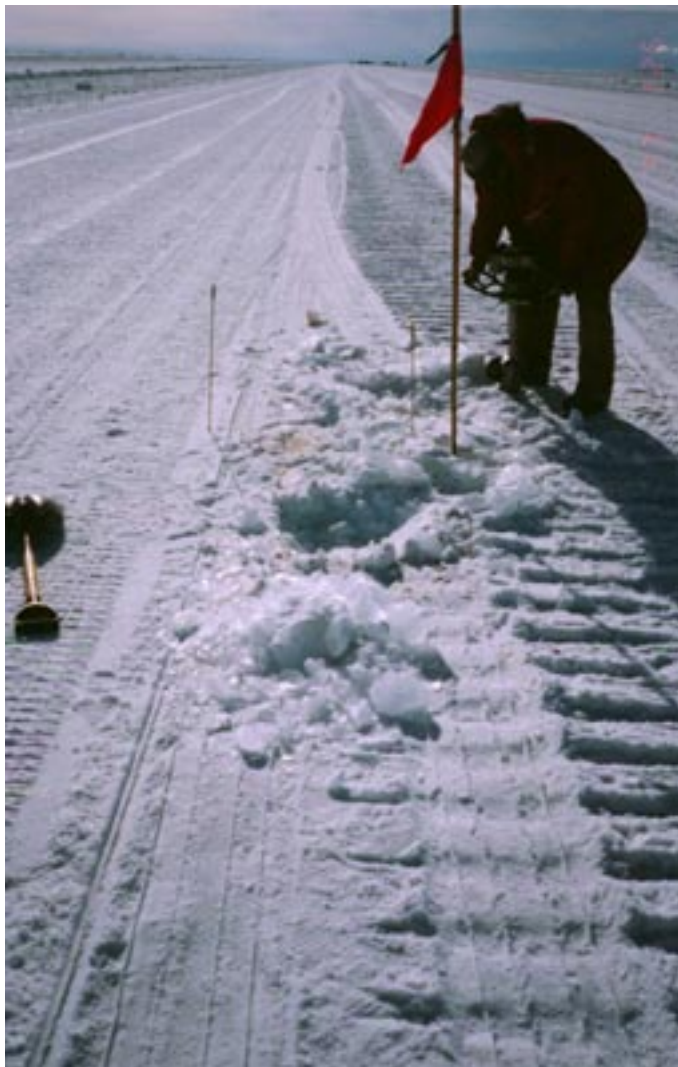
*Figure 51. Site of failed runway ice caused by proof cart.*

Close examination of the failure points revealed that they were all located in meltwater ice (ice that formed from freezing of water from the prior season's melt pools or the snow melter water used to fill the large depressions in the natural ice surface). Blocky pieces of ice were generally present

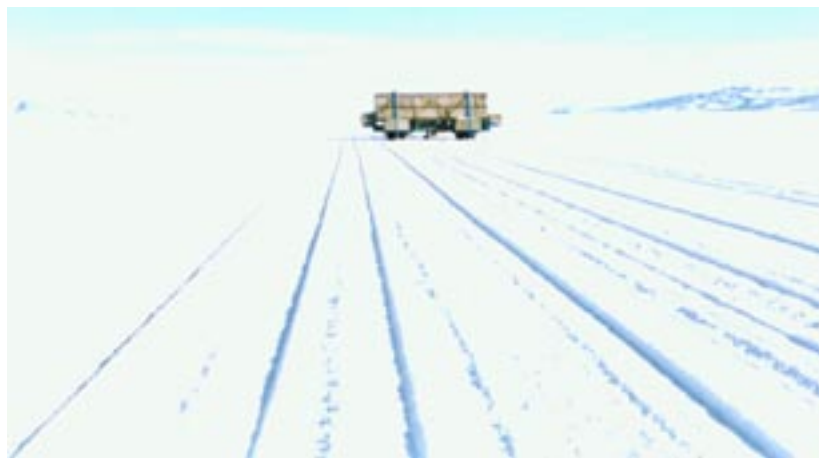
*Figure 52. Closely spaced proof cart tire tracks during full-scale load certification of runway.*

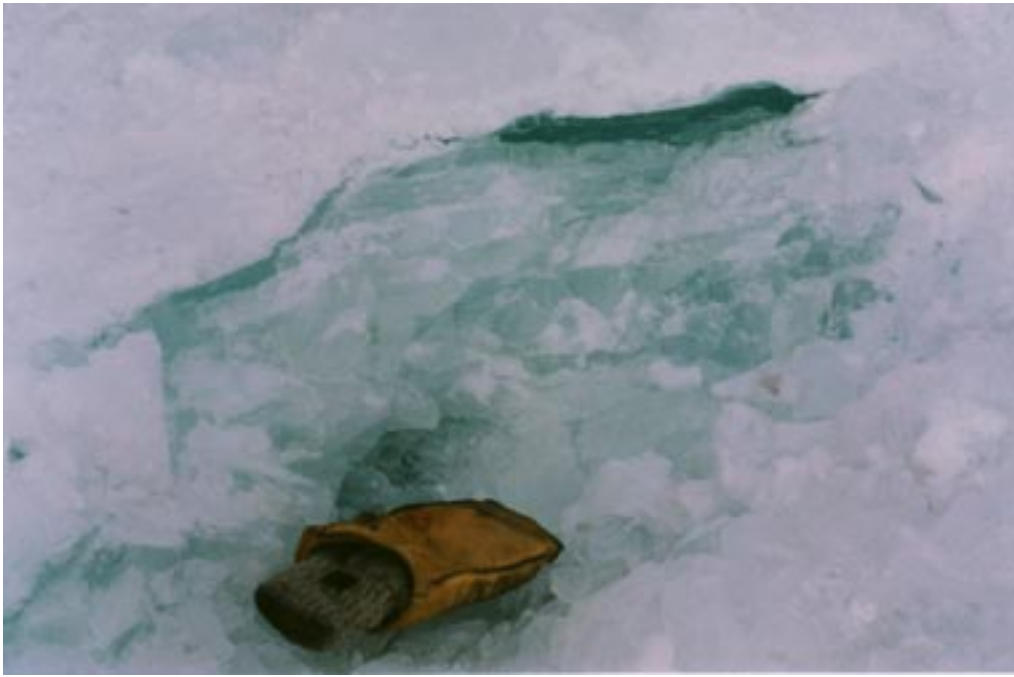
Figure 53. Failure planes in ice extending into sides of main cavity of failed area.

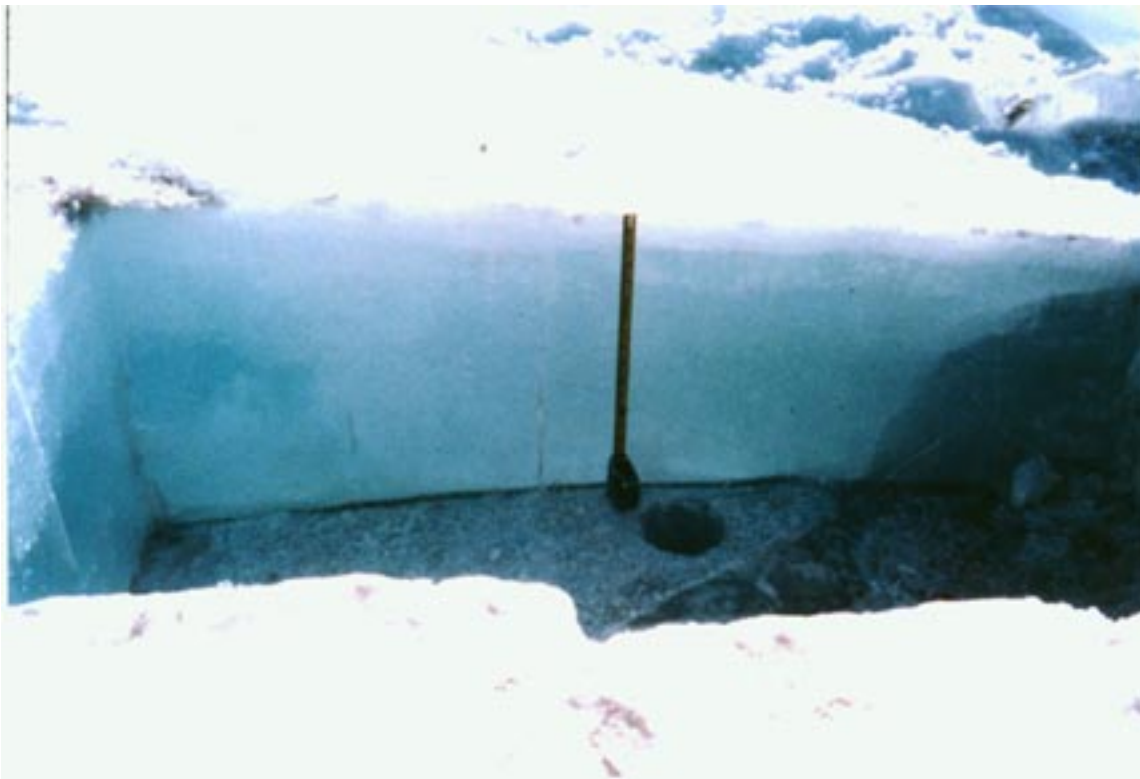
*Figure 58. Dissected ice blister showing gap between upper melt/refreeze ice and lower natural glacial ice.*

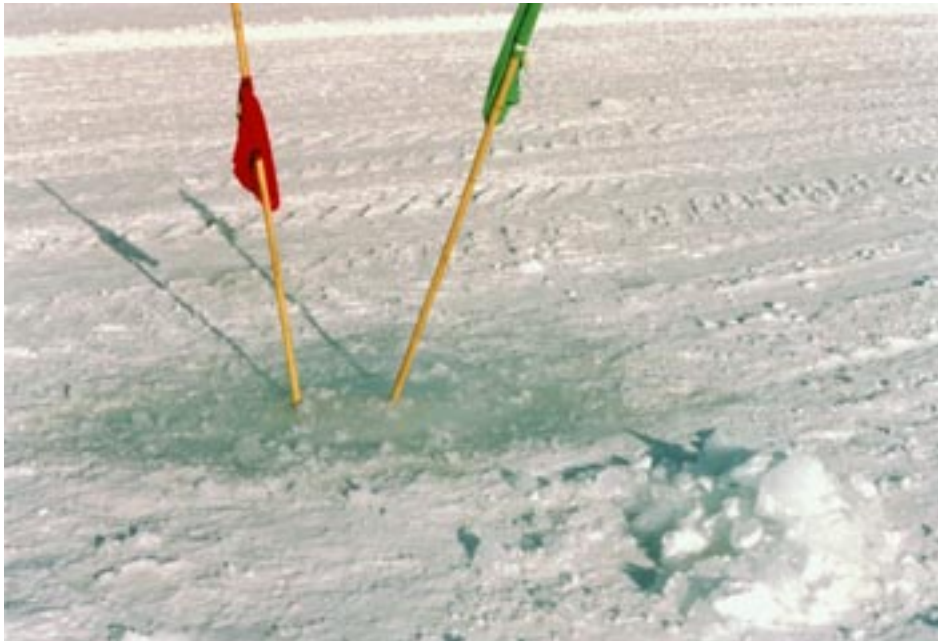
*Figure 61. Freshly patched failure site approximately 4 hours after flooding with water.*

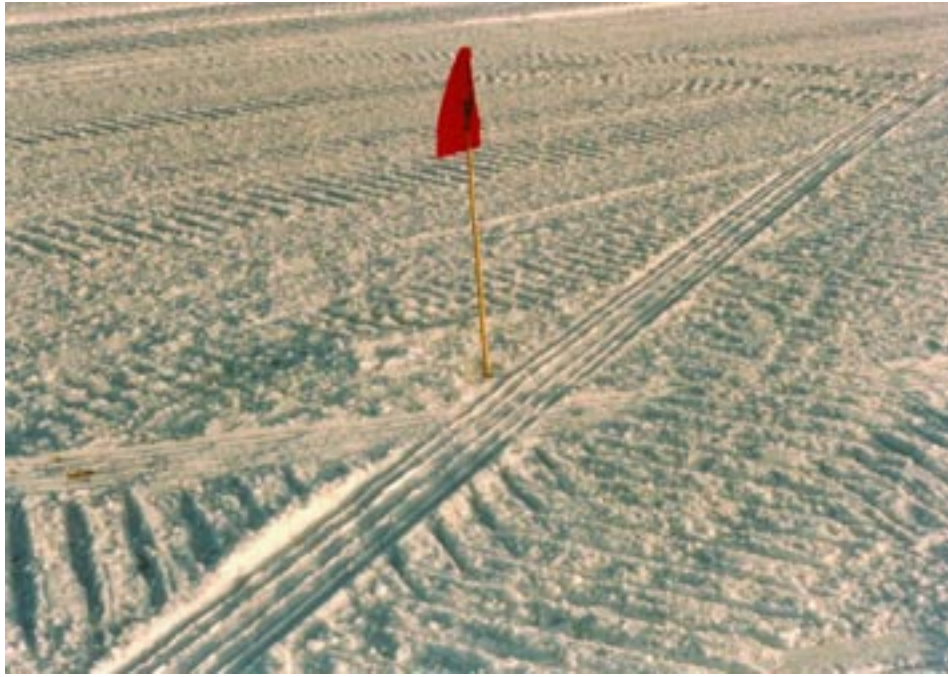
*Figure 62. Tracks of proof cart on area patched 48 hours earlier.*

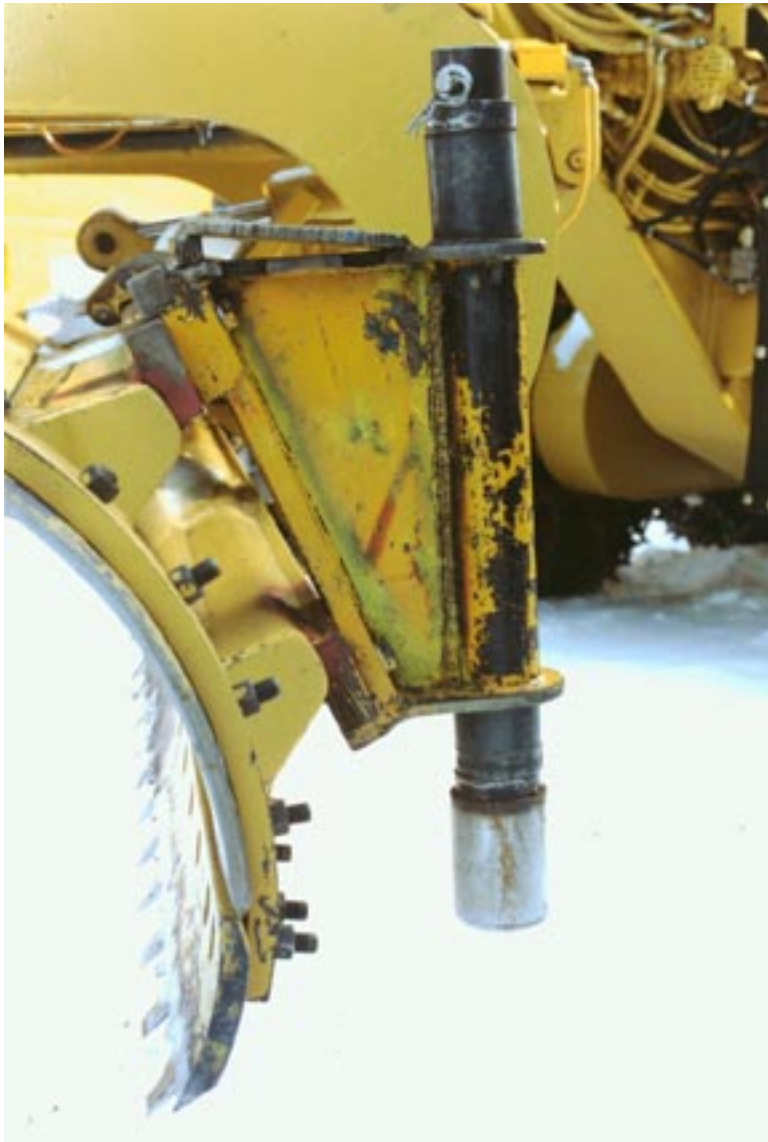
*Figure 80. Adjustable skids used to assist in “floating” grader blade.*
